THE ROTUNDA

APPENDIX D

# UNIVERSITY OF VIRGINIA ROTUNDA

## MEP/FP FINDINGS & RECOMMENDATIONS Feb 12<sup>th</sup> 2007

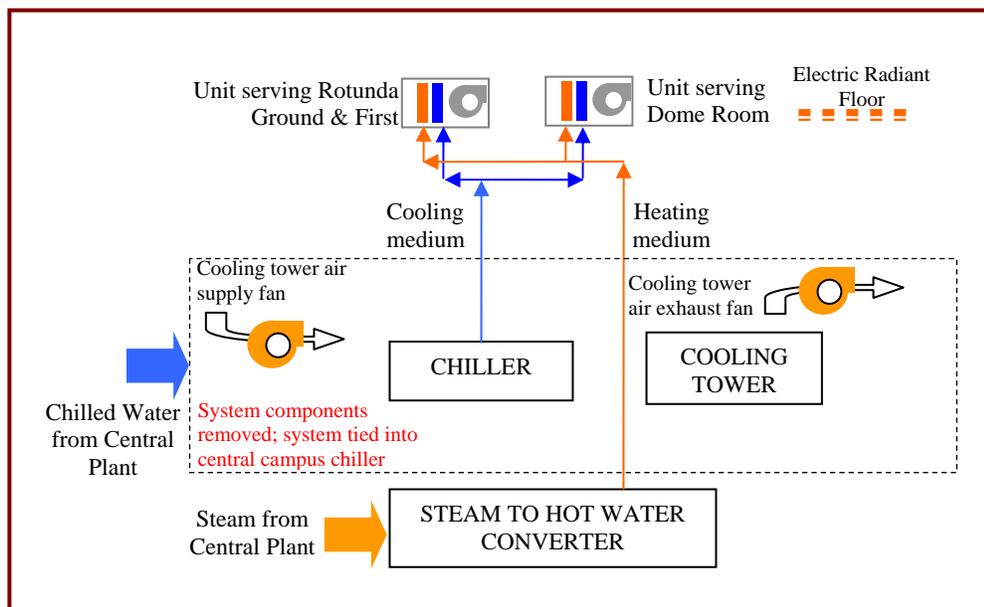
The 1974 HVAC system configuration and later modifications are illustrated below.

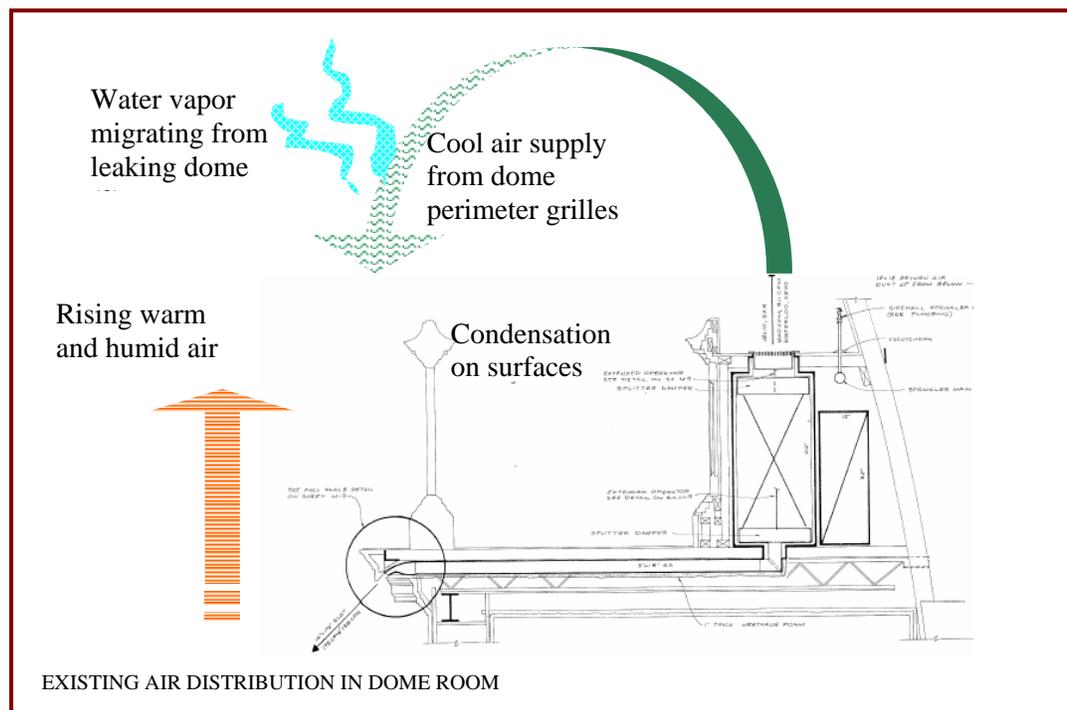
- The air-handling unit, AC#1, serving the Dome Room has a chilled-water cooling coil for dehumidification and cooling. It is likely that the chilled water supply temperature during moderate outdoor conditions is not low enough to provide adequate dehumidification. Relative humidity levels in the Dome Room (301) may exceed 60%~70% for extended periods.
- Mold spores are in relative abundance during mild seasons.
- Any source of water leakage and infiltration of moisture must be investigated.
- Abundant vegetation on the campus provides the necessary mold spores. This combined with relatively high humidity levels can result in microbial growth problems.

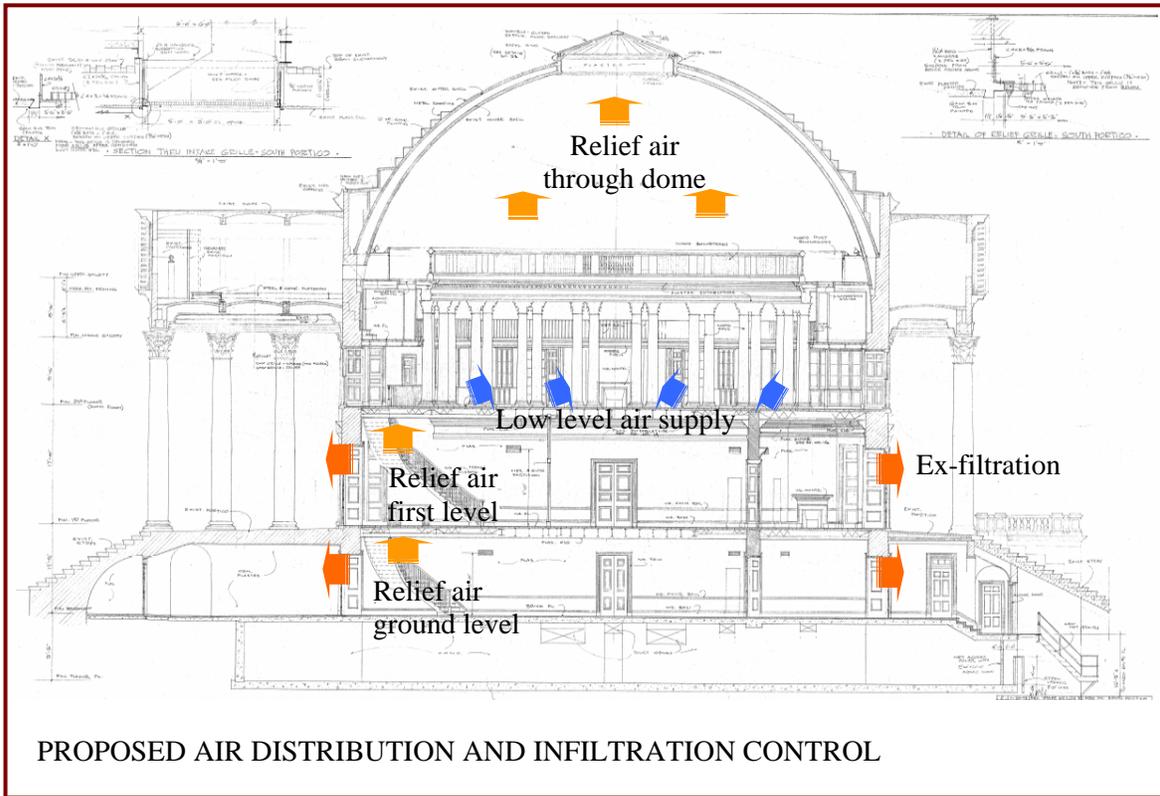
The Dome Room air-conditioning system should be replaced with a new system that incorporates desiccant dehumidification technology. The air distribution in the Dome Room should be reversed. The existing perimeter supply at the base of the dome is not necessary. More effective air distribution, known as displacement ventilation, would provide low-level supply air and relief-air in the same direction as the buoyant forces (see illustration below). This will provide better comfort both in summer and winter. It will also provide improved indoor air quality, natural rise of warm air for relief through the dome skylight, and warmer air temperatures which results in lower relative humidity.

We also anticipate a lower volume of air supply with the implementation of a displacement ventilation system. This will need to be confirmed during the design phase.
