McGUFFEY COTTAGE

H I S T O R I C S T R U C T U R E R E P O R T

HISTORIC STRUCTURE REPORT

JOHN G. WAITE ASSOCIATES, ARCHITECTS
2018

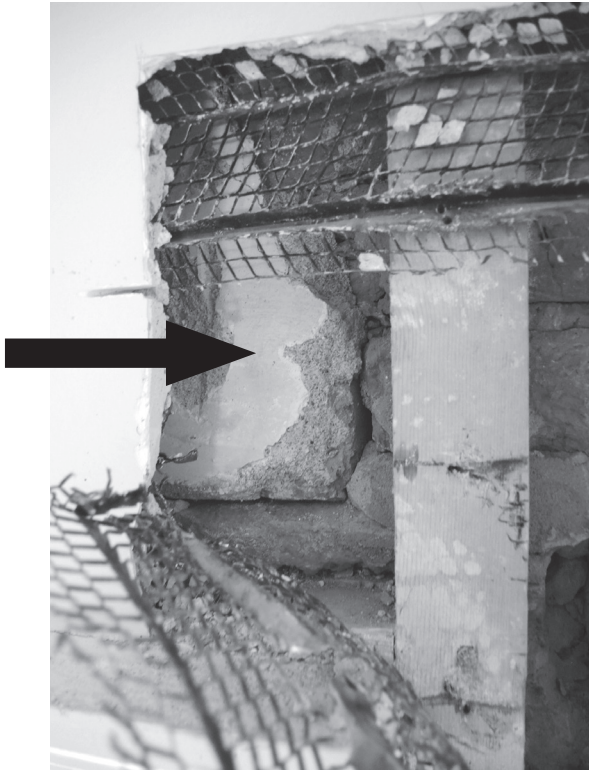
Figure 53. A probe above the south end of the southeast window opening revealed a hard cement mortar applied to the brick wall.

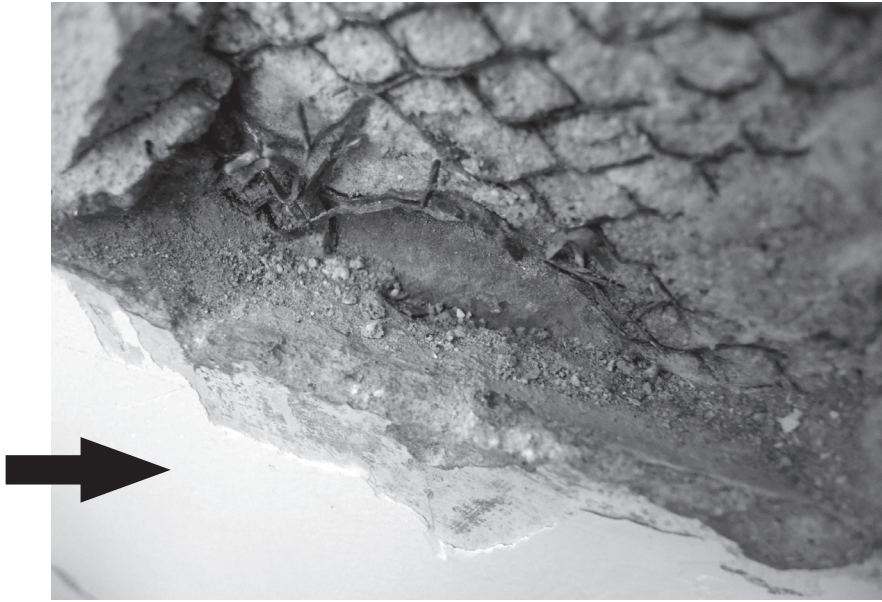
Figure 57. A small probe into the back wall of the pantry closet revealed a hard cement mortar on the chimney mass, probably covering an original fireplace opening.

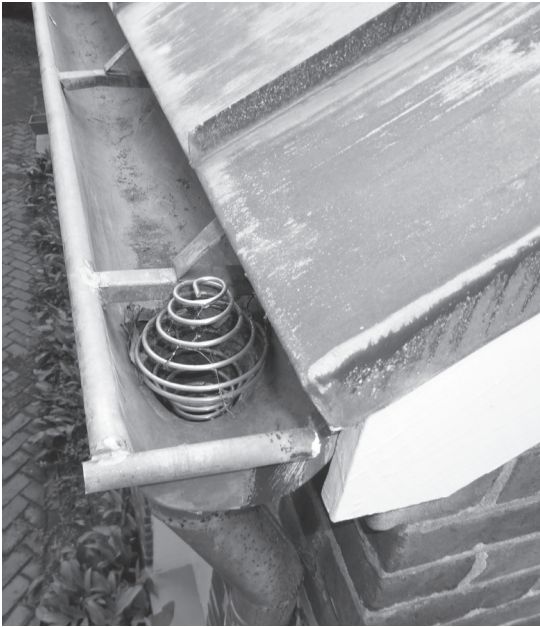
Figure 63. The terne-coated stainless-steel sheet metal roofing developed an abnormal oxidation with a brown “rusted” appearance. The roof was painted between August and October 2017, obscuring this condition.

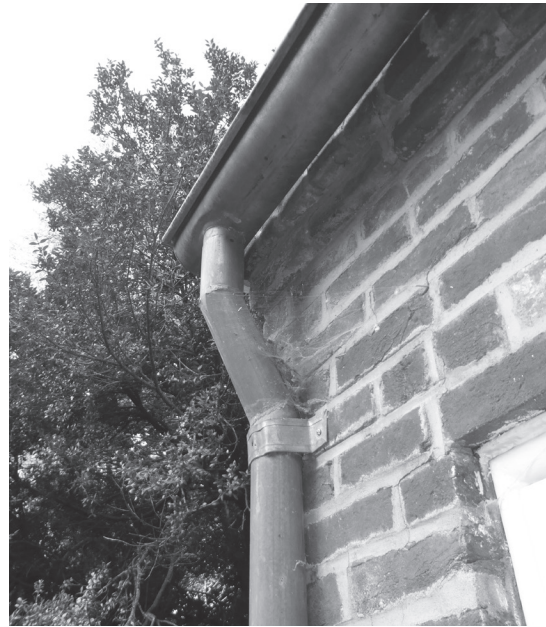
Figure 64. There is stepped cracking of the repointed mortar joints on the east elevation of the cottage, at the upper southeast corner. The mortar has been heavily applied and buttered over the edges of the bricks.

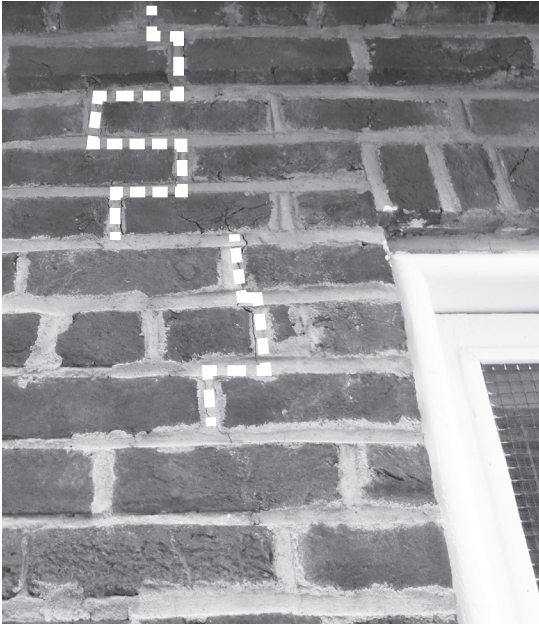
Figure 65. There is stepped cracking in the brick wall construction adjacent to the upper south corner of the northeast window opening. The cracking appears to be active; cracks have opened in repointed mortar joints (highlighted by the dotted line).

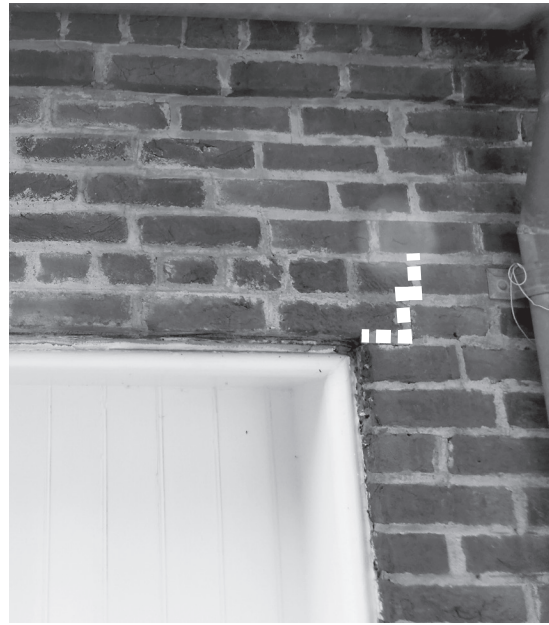
Figure 66. The pointing repairs made above the northeast door are muddled and irregular. The steel lintel above the door opening is rusted; the expanding rust may be jacking the masonry. Cracks have developed in the repair mortar at the north end of the lintel (highlighted by the dotted line).

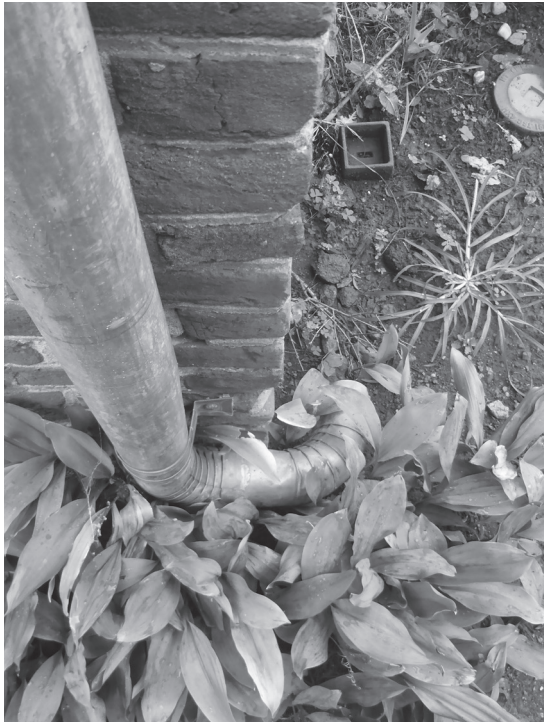
Figure 67. The downspout at the northeast corner drains to grade against the north elevation of the building.

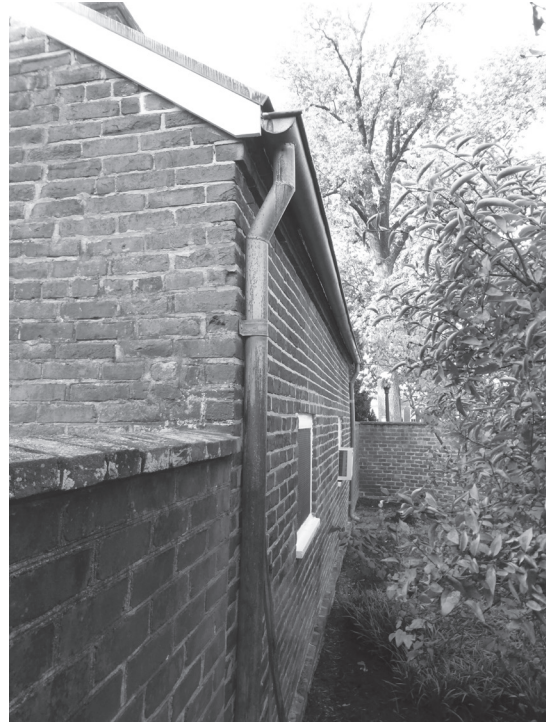
Figure 68. The brick masonry on the north elevation of the cottage, at the northwest corner, has eroded mortar joints and broken brick. Algae and lichen are growing on the brick.

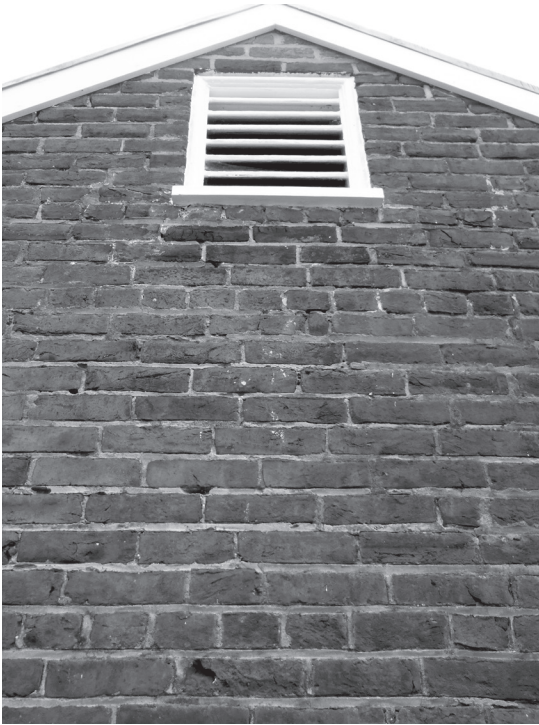
Figure 69. There are open pockets in the mortar joints near the center of the north elevation.

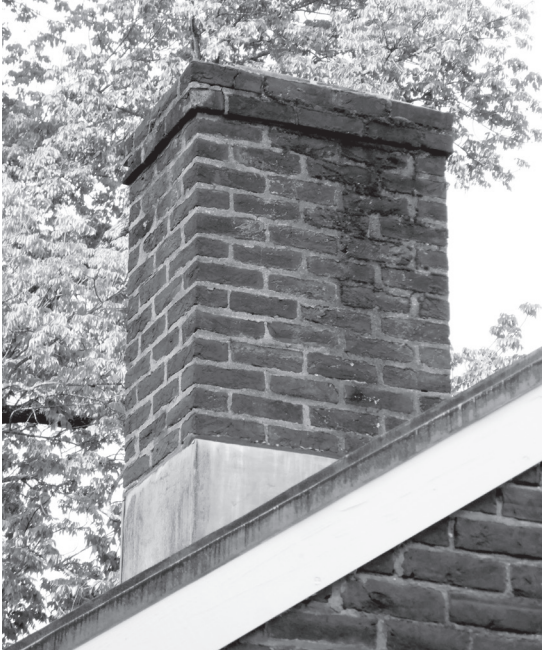
Figure 70. The mortar joints in the chimney construction above the roofline are deteriorated; the mortar is cracked and loose. Moss is growing in the mortar joints on the north elevation of the chimney, and the brick is soiled.

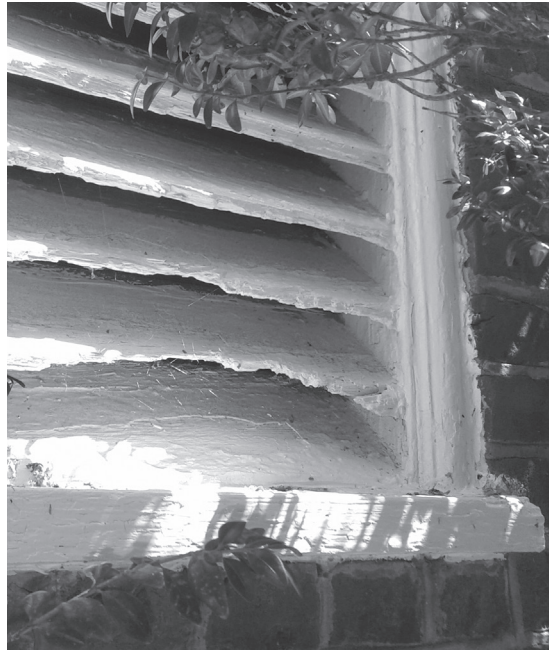
Figure 71. The painted wood slats of the louvered south gable vent are heavily eroded.

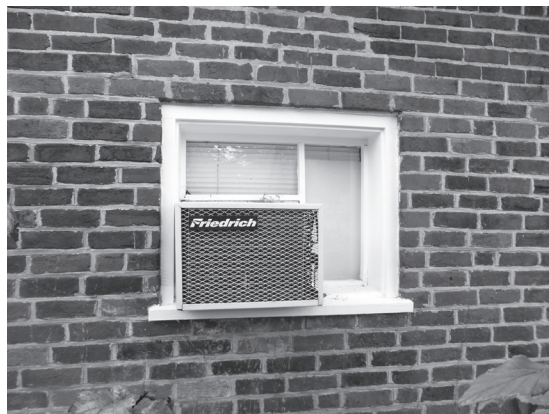
Figure 73. The air-conditioning unit in the southwest window opening is visually obtrusive. The sash has been altered to accommodate the air conditioner.

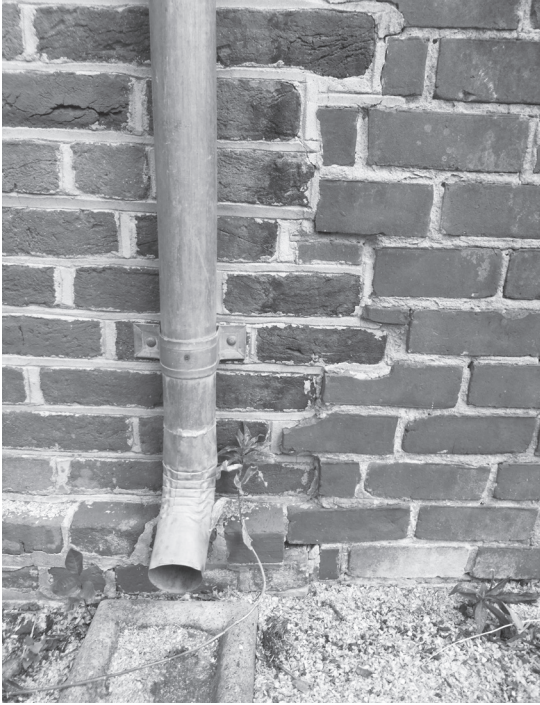
Figure 74. On the west elevation, the brickwork at the juncture of the garden wall and the southwest corner of the cottage is awkwardly resolved. The brick coursing is offset and does not align; there are open mortar joints near grade level.

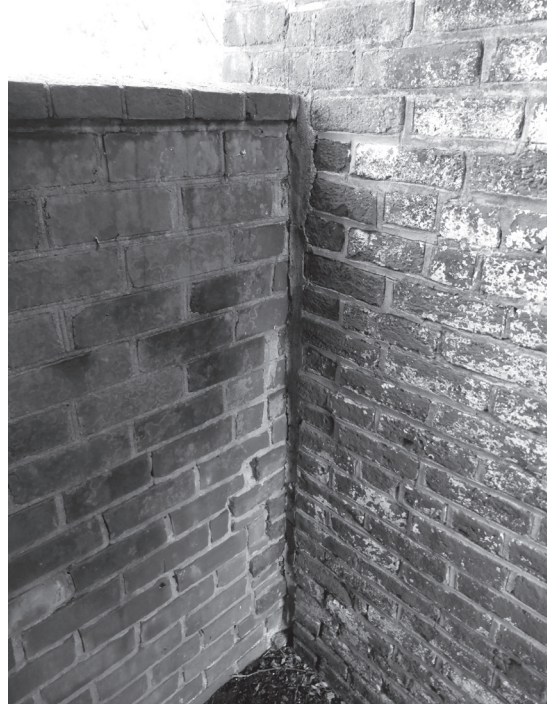
Figure 75. Mortar is smeared on the face of the brickwork at the inside southwest corner, between the cottage and garden wall. The mortar is uneven, and the joint is open. Algae is growing on the brick. Near grade level the mortar is deteriorated and the brickwork is irregular, with open joints and cavities.

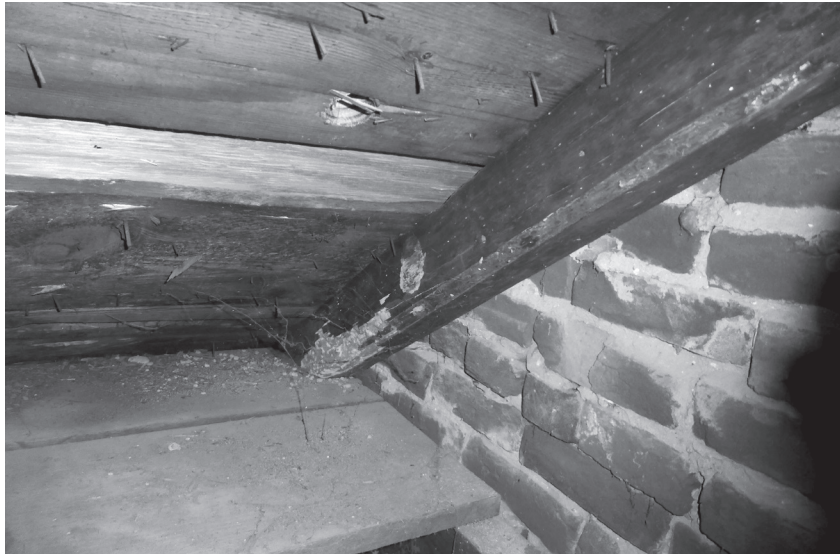
Figure 76. The base of the west roof rafter adjacent to the north gable wall is rotted. The mortar at the interior face of the gable wall is deteriorated.

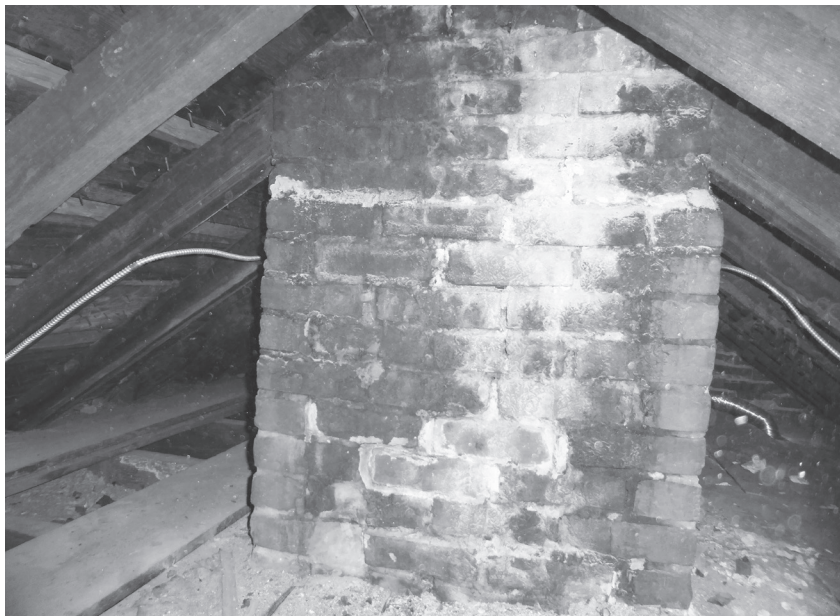
Figure 77. There are open joints in the brick chimney at the attic level. Mortar has been smeared on the face of the brick, and creosote appears to have migrated through the mortar joints.
