PAVILION VIII

UNIVERSITY OF VIRGINIA

HISTORIC STRUCTURE REPORT

JOHN G. WAITE ASSOCIATES, ARCHITECTS PLLC
2017

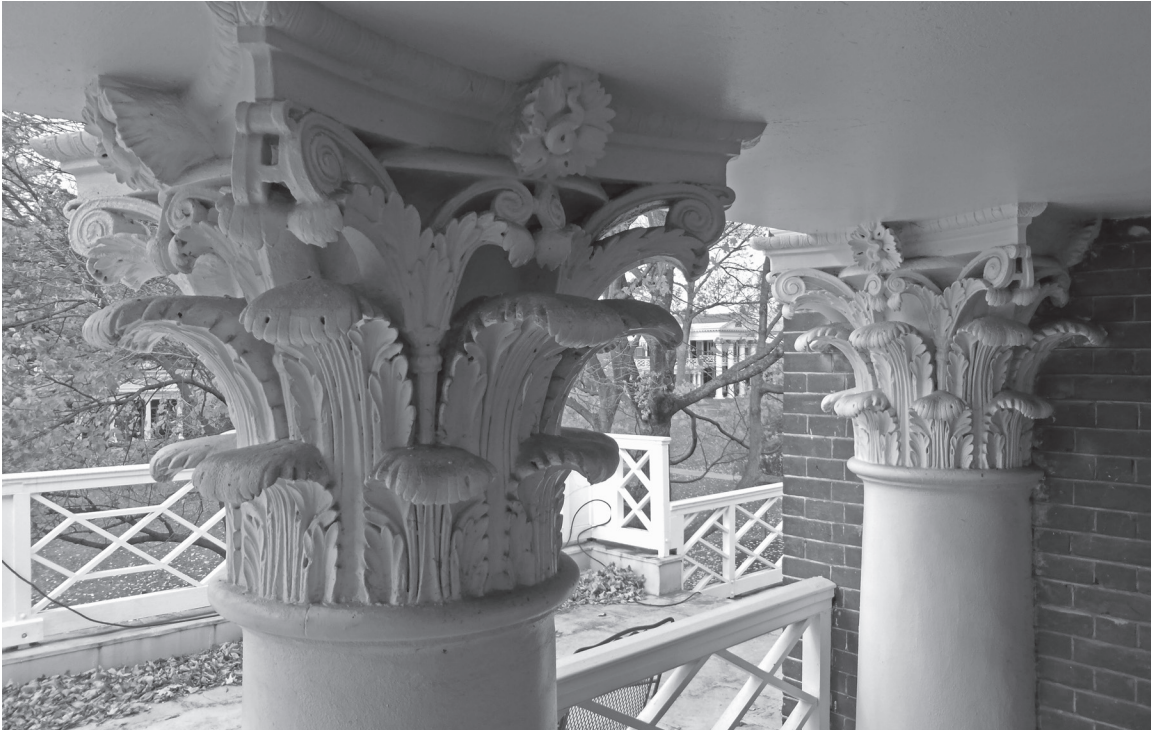
The Corinthian capitals have been painted, obscuring the original marble surface. The painted finish is dirty, and there is paint overspray on the adjacent brick.

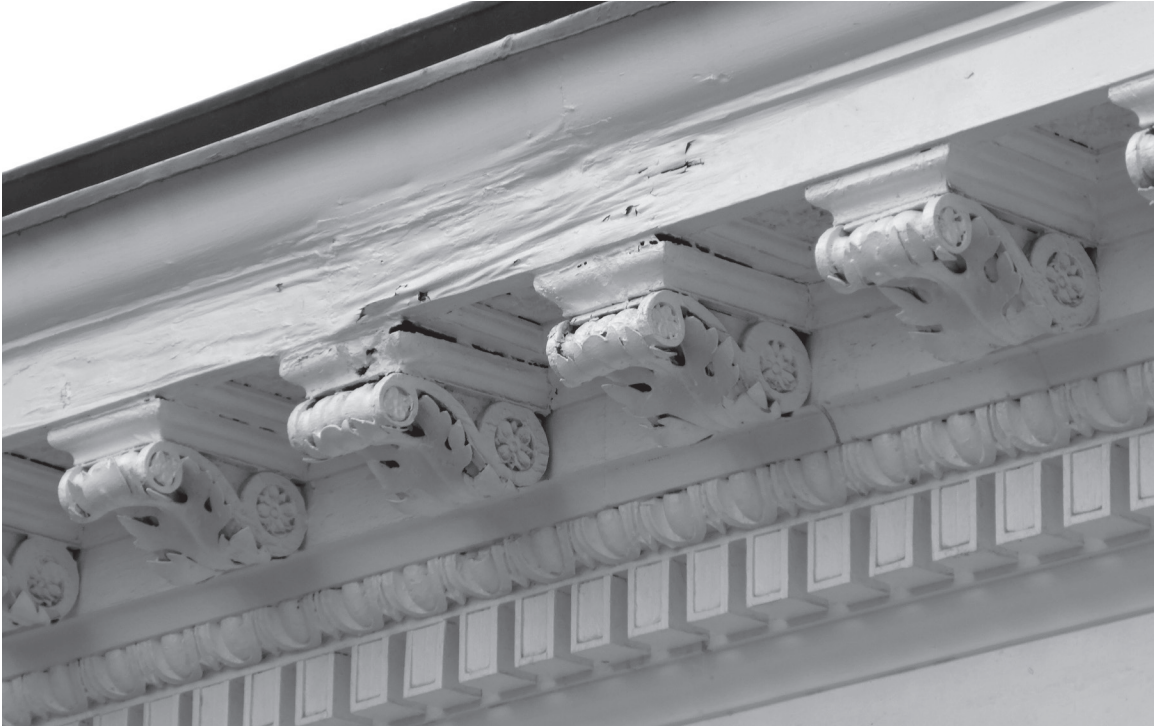
Leaks in the seams of the sheet metal roofing and rust-through perforations in the sheet metal are causing the wood cornice moldings and modillions of the north elevation to rot.

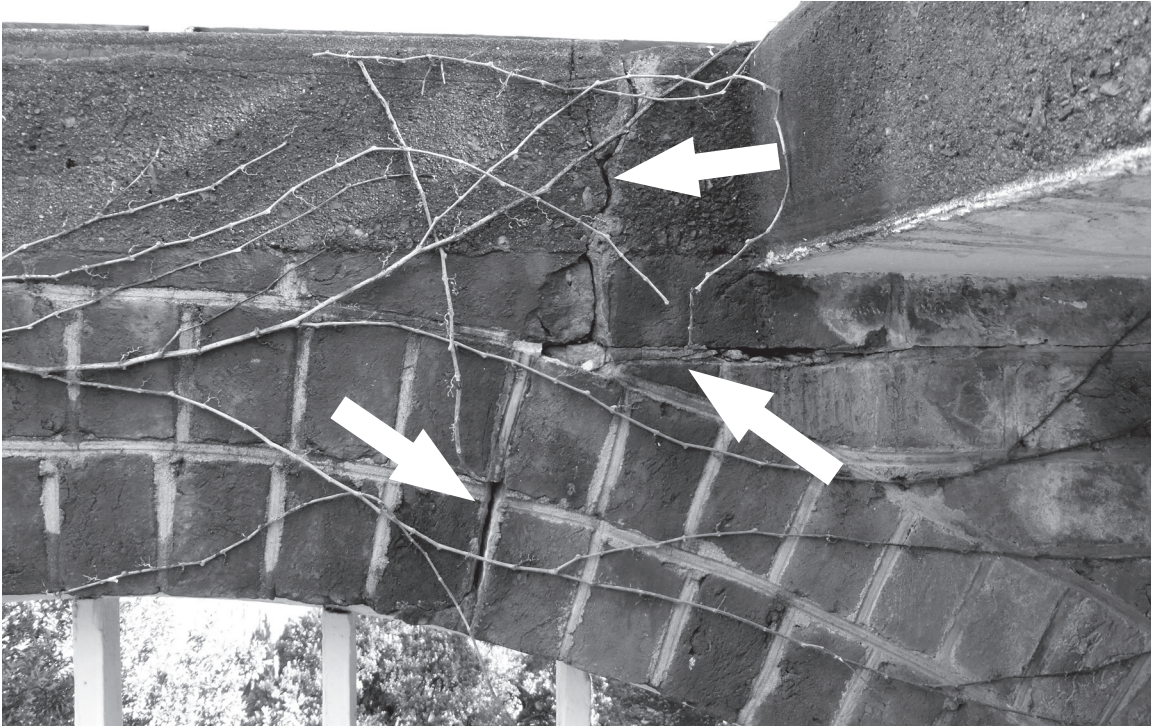
Differential settlement between the pavilion and the east porch has caused cracks in the brick arches on the north and south sides of the porch. The cracks have allowed water to infiltrate the masonry construction, contributing to efflorescence, mortar erosion and brick spalling.

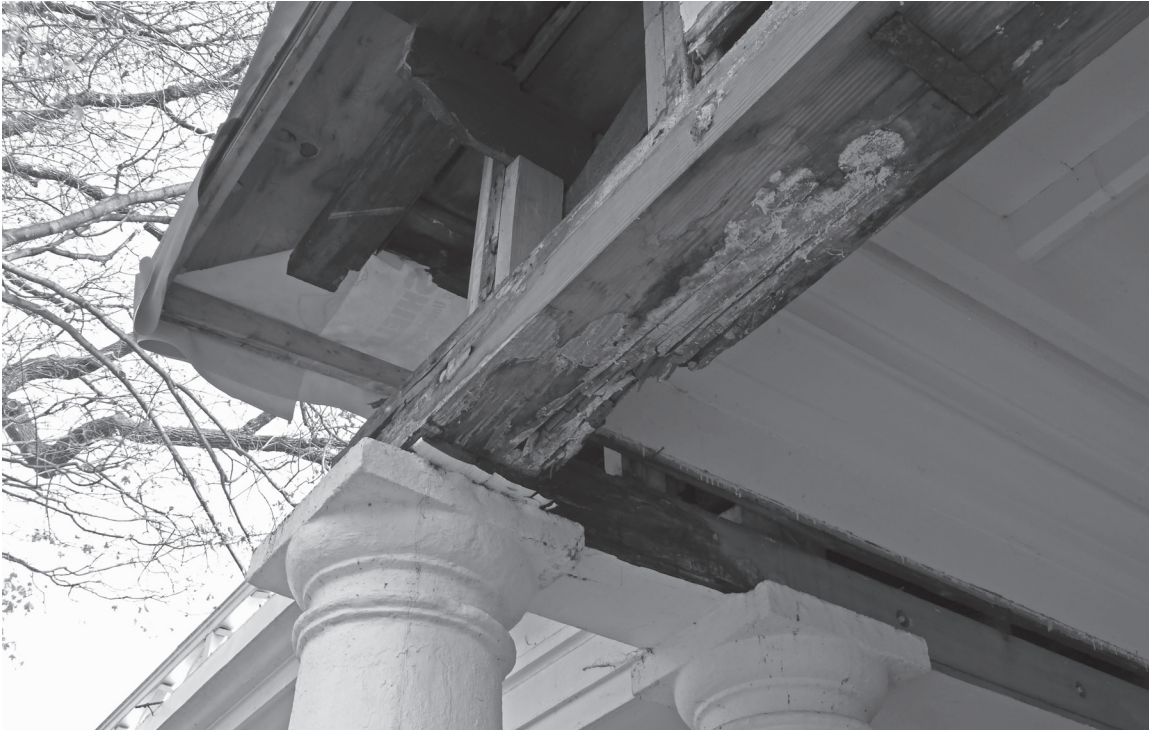
The entablature framing at the northwest corner of the colonnade is rotted. This damage appears to be the result of poor drainage discharge from the colonnade roofing in combination with leaks in the sheet metal roofing.

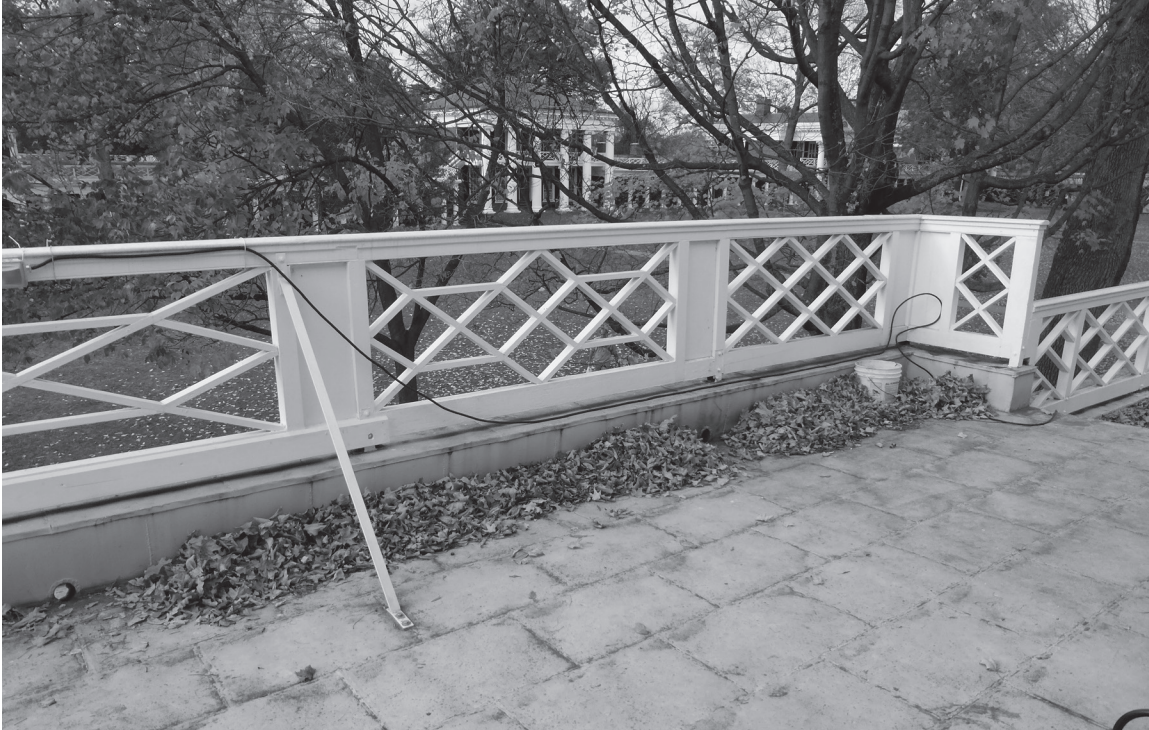
The flat-lock seam sheet metal roofing above the colonnade is compromised by penetrations for the attachment of the railing and railing braces. The scuppers draining to the west are clogged with leaves and debris.

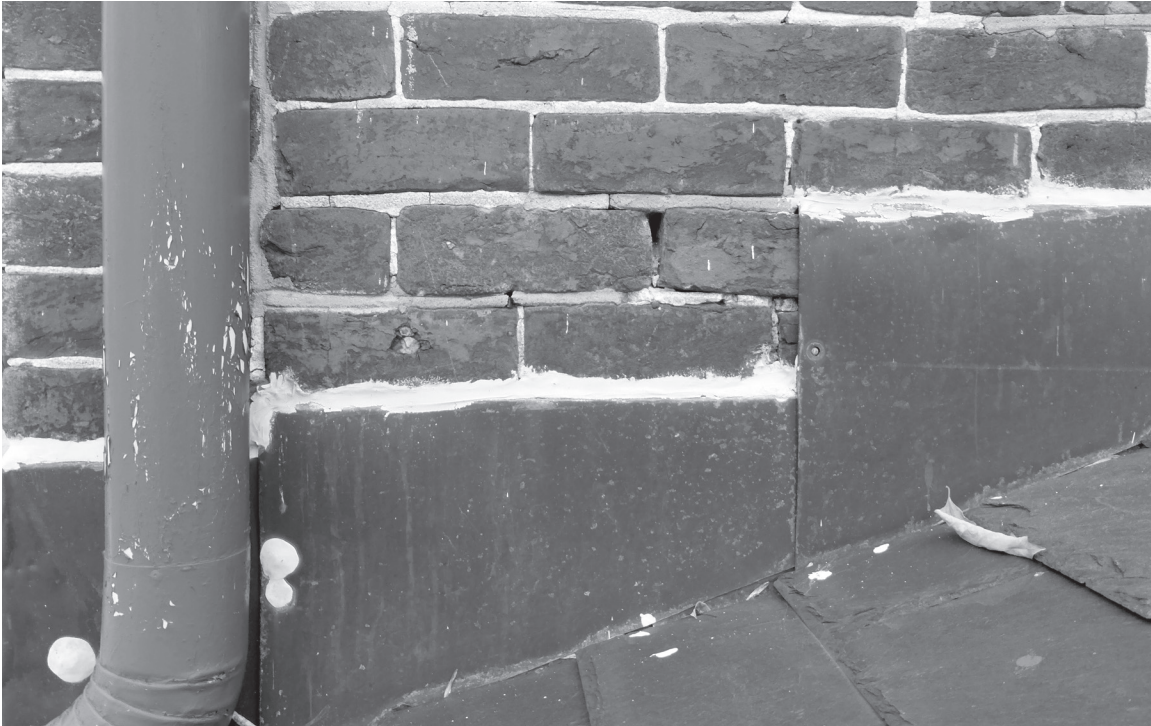
The mortar in the brick wall construction near the second floor, southwest corner of the pavilion has failed; the mortar is eroded, cracked, and missing. An excessive application of sealant at the roof flashing detracts from the appearance of the building construction.

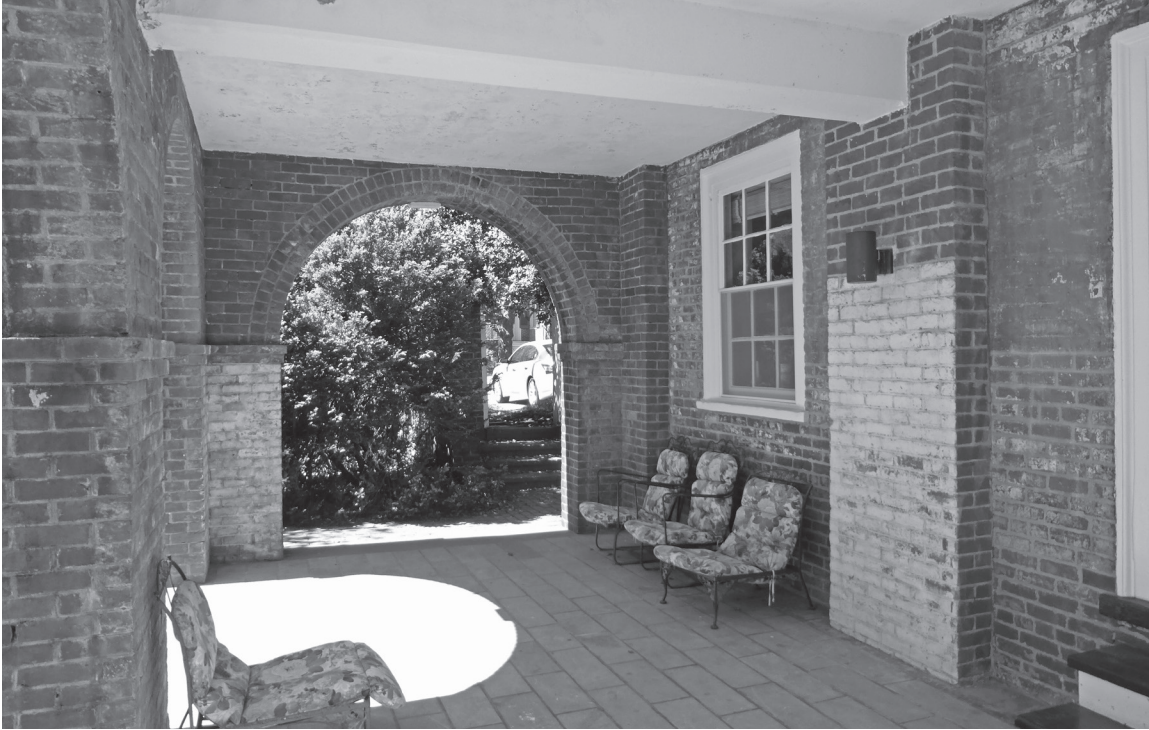
In this view towards the south end of the east porch worn and peeling paint, efflorescence, and algae are visible.

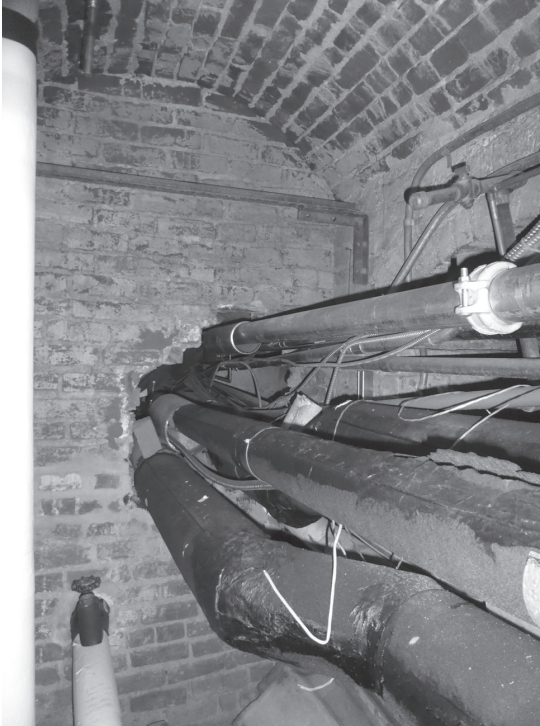
The brick masonry above the opening at the south end of B14 is unsupported.

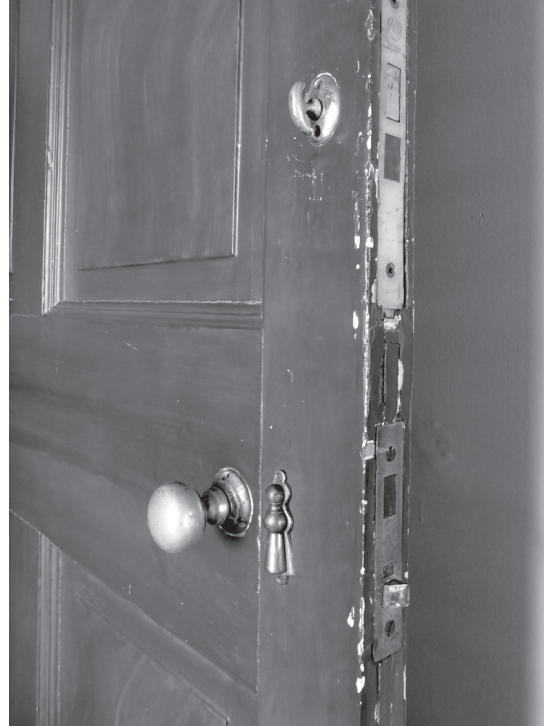
The coatings at the exposed edges of the faux-finish grained doors are chipped and abraded.

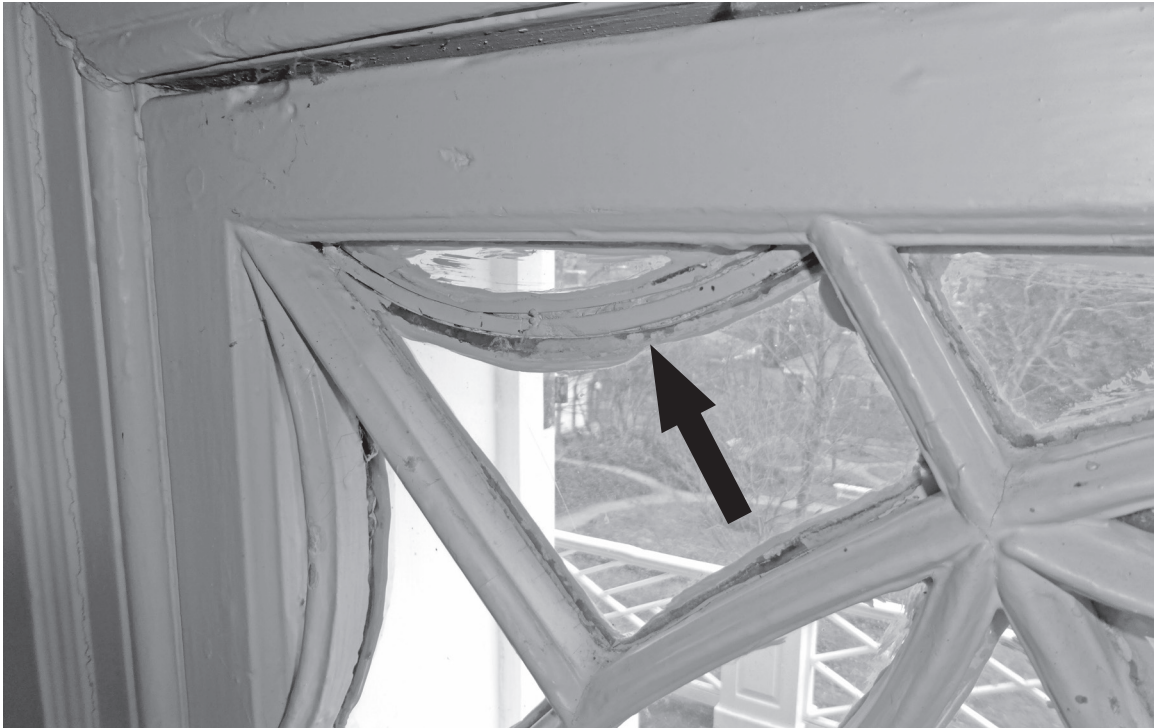
The interior face of the segmental muntin at the first floor east door transom is missing. It is one of three muntins missing at the transom. The build-up of paint coatings has obscured the molding profiles of the sash.

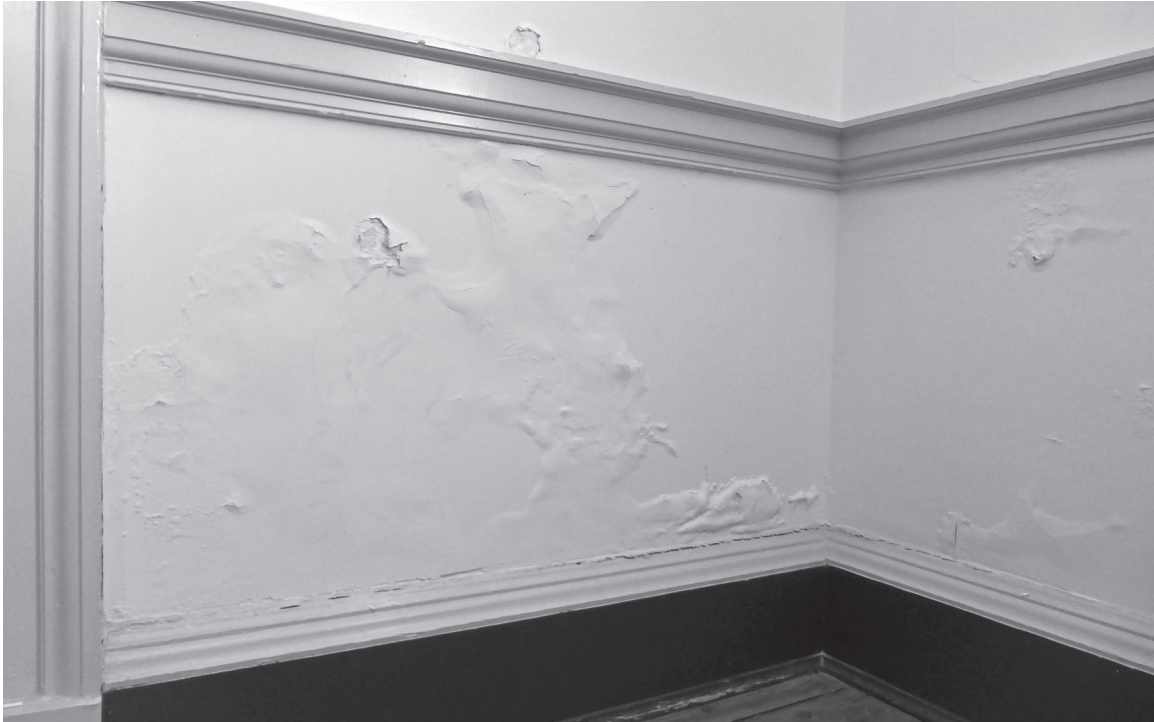
The painted wall plaster in the northeast corner of room 103 is blistered and friable. The damage has been caused by water infiltration that is attributable to a backup in the storm water drainage system at the northeast downspout.
