PAVILION X

EXTERIOR RESTORATION PLAN

E X T E R I O R R E S T O R A T I O N P L A N

MESICK COHEN WILSON BAKER
ARCHITECTS

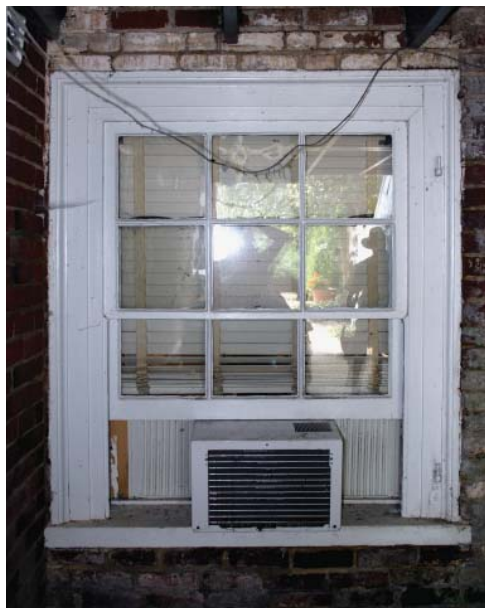
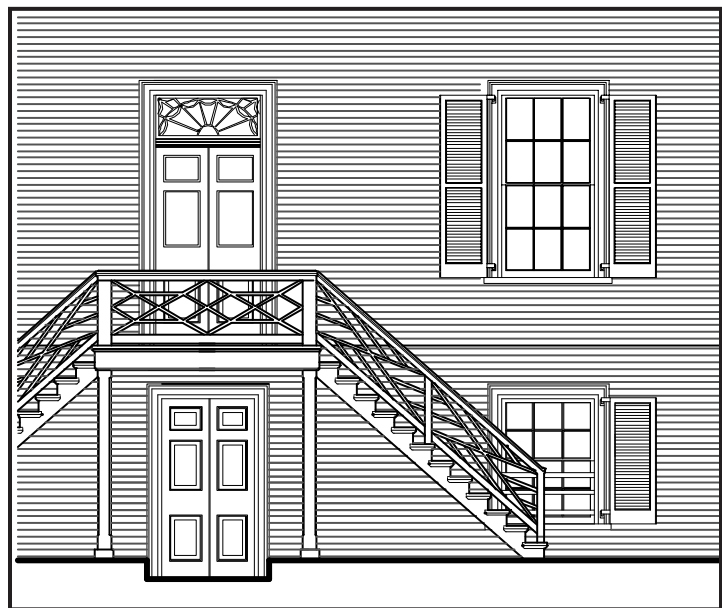
Figure 22 & 23 One set of pintles are located on the right side of the north cellar window on the east elevation. It is believed the rear stair passed in front of a portion of the cellar windows resulting in the condition illustrated above resulting in the need for only one set of pintles.

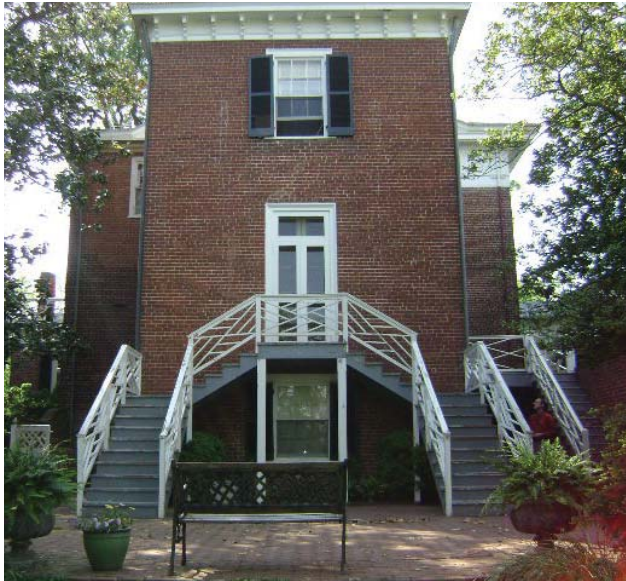
Figure 24 East (rear) elevation of Pavilion X. Paint ghosts support archival documentation indicating a one story porch at this elevation.

The 1877-8 addition appears to have displaced the earlier additions on the building, and some changes have been made to the addition since it was completed. The Sanborn maps show that a wood framed two story porch once existed along half the length of the north elevation, and paint ghosts on the building clearly outline this feature. No record has been found that documents when this was removed. Similarly, paint ghosts reveal that there was once a one story wood framed porch on the east elevation of the addition (Figure 24).

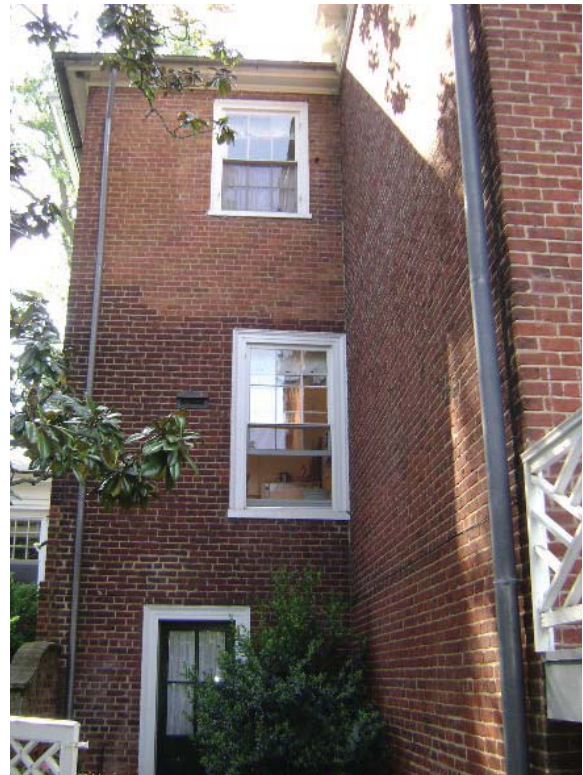
Figure 25 The clear demarcation between nineteenth and twentieth century brickwork illustrates the raising of this addition from one to two floors.

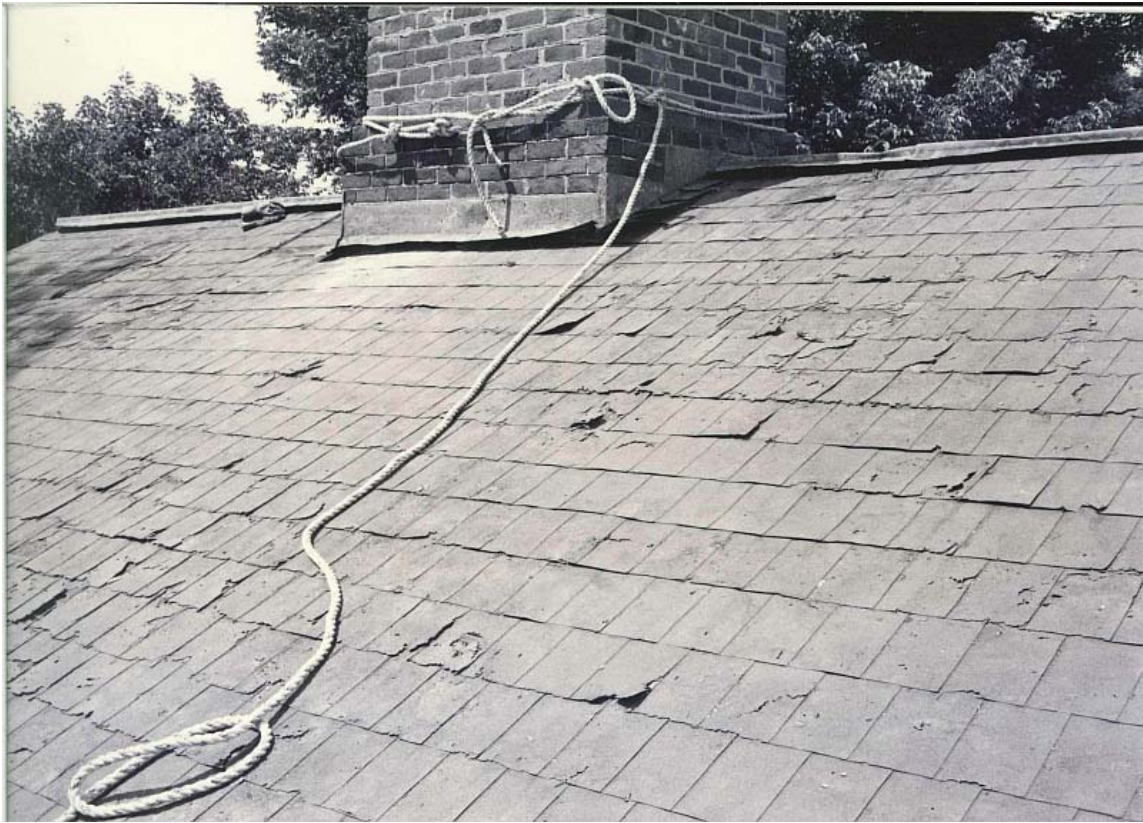
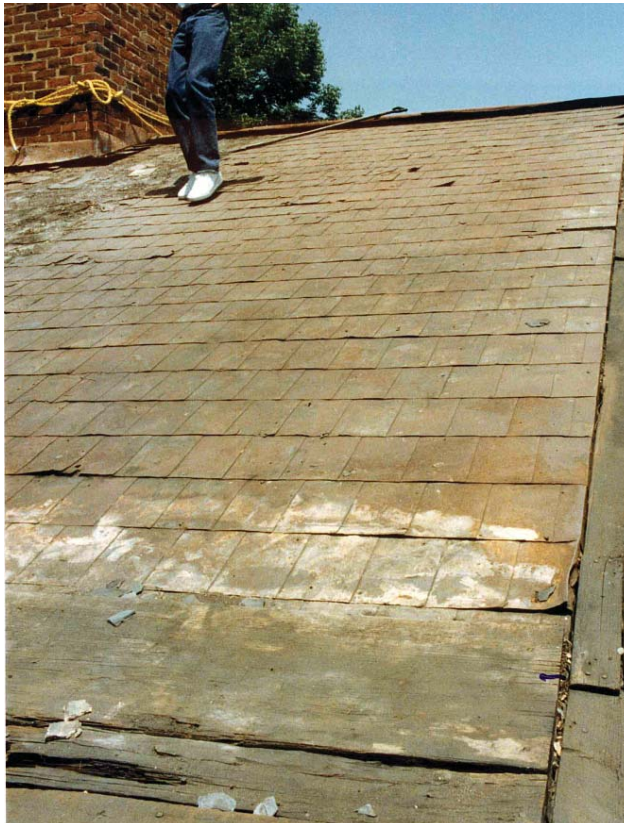
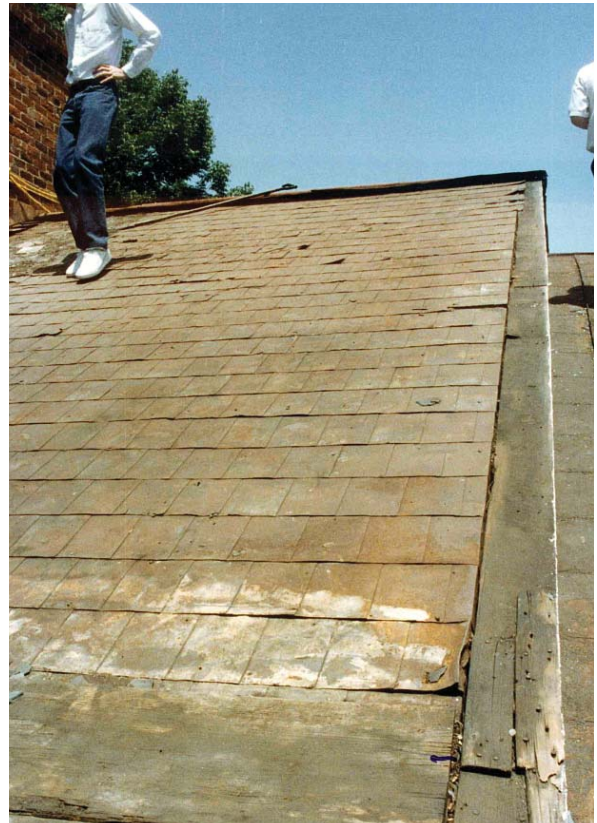
Figures 26, 27, 28 Jefferson's tin plated iron roof uncovered during the removal of the later period standing seam roof. Summer 1987.

In 1987 the later period standing seam roof was removed and it was discovered that the original tin plated iron roof was encapsulated below (Figures 26-28). The earlier roof was carefully recorded and a new terne-coated stainless steel roof was designed to replicate the layout and original appearance of the original roof (Figure 29). The new roof once again encapsulated the historic tin shingles and a plywood separation layer and an EPDM membrane was laid down before the new shingles were installed. It was fortunate that the original roof was not removed when the standing seam roof was applied because very clear evidence survived of the original Philadelphia gutter, the locations of the original downspouts and the iron brackets that once held the enormous parapet up and off the roof (Figures 30-32). In fact, several of these brackets survived in-situ and were simply bent down before the later roof was installed. When the roof was installed, new stainless steel brackets copying the original brackets were fastened to the roof at the same locations in anticipation of the day when the parapet is restored to the building (Figure 33).

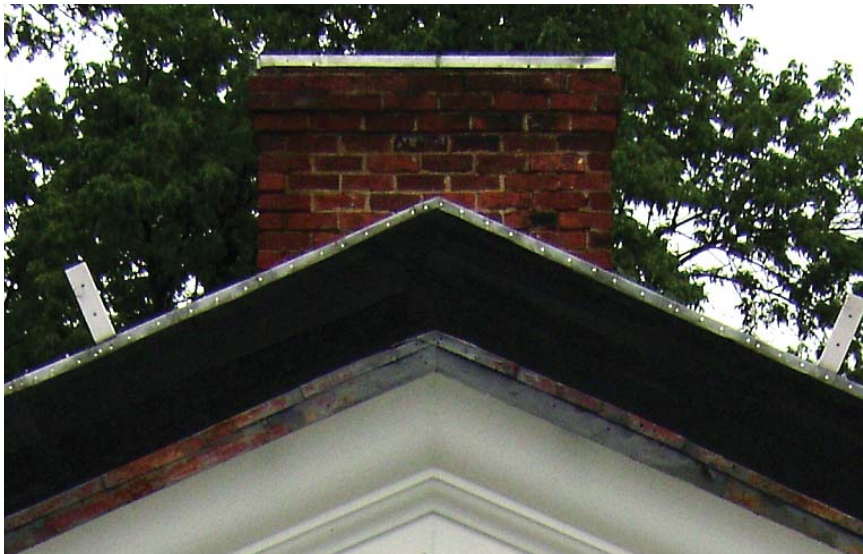
Figure 33 New stainless steel brackets were installed during the 1987 roof restoration in anticipation of restoring the parapet at a later date.

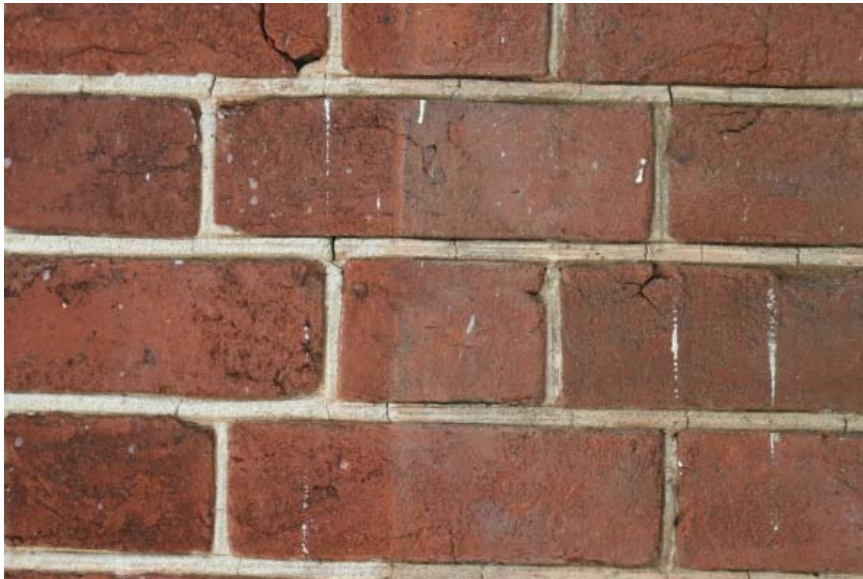
Figure 34 Pavilion X west elevation. Detail of oil struck bricks laid in Flemish bond. Colorwash and penciling still survives in sheltered areas of this elevation.

The brickwork of Pavilion X essentially matches the brickwork of the other pavilions. The front elevation was laid up in Flemish bond using oil struck bricks (Figure 34). These bricks were slightly rubbed to smooth down any obvious imperfections, and laid in lime mortar. A great deal of information regarding the manufacture of these kinds of bricks is found in the Pavilion IV historic structure report, so there is no reason to repeat those findings in this study. However, it should be pointed out that the brickwork along the entire front façade (as well as that of the student rooms) was colorwashed and penciled. The penciling is somewhat cruder on the student rooms. It is obvious that the mason laying the front façade walls had intended to pencil that façade because the joints are cut in or double struck with the trowel to emphasize the penciling. The other facades of the building are laid in running bond using sand struck un-rubbed bricks. The running bond exhibits header bond courses at locations that vary throughout the building. On one elevation they may be four, six and eight courses apart. Alternating stretcher/header bond courses may also be

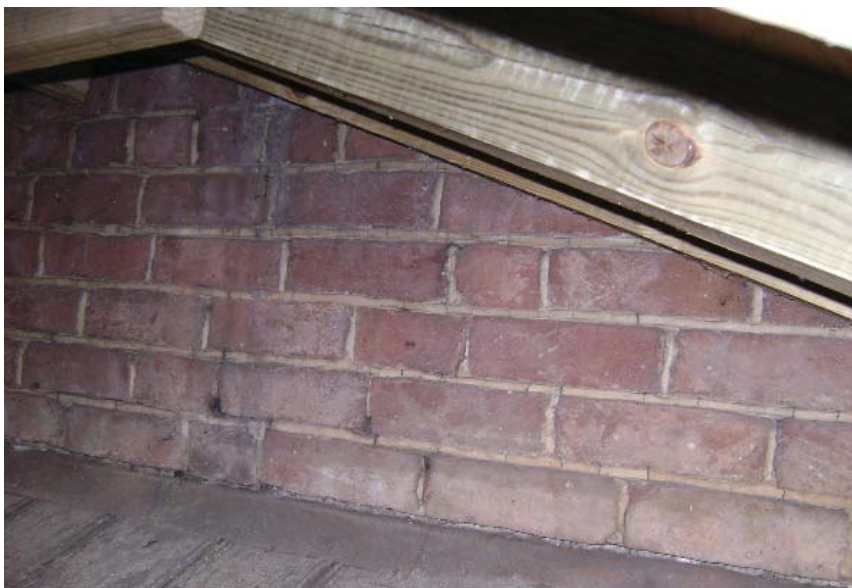
Figure 35 Attic space of student room north of Pavilion X. Portions of encapsulated brickwork survive on the north and south walls providing period examples of the original joint finish and appearance. Note the serrated roof at the bottom of the image.

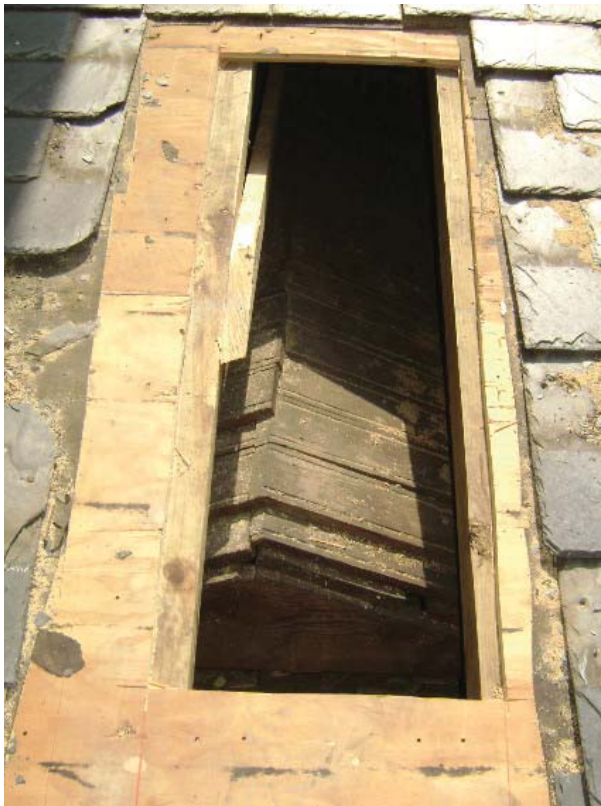
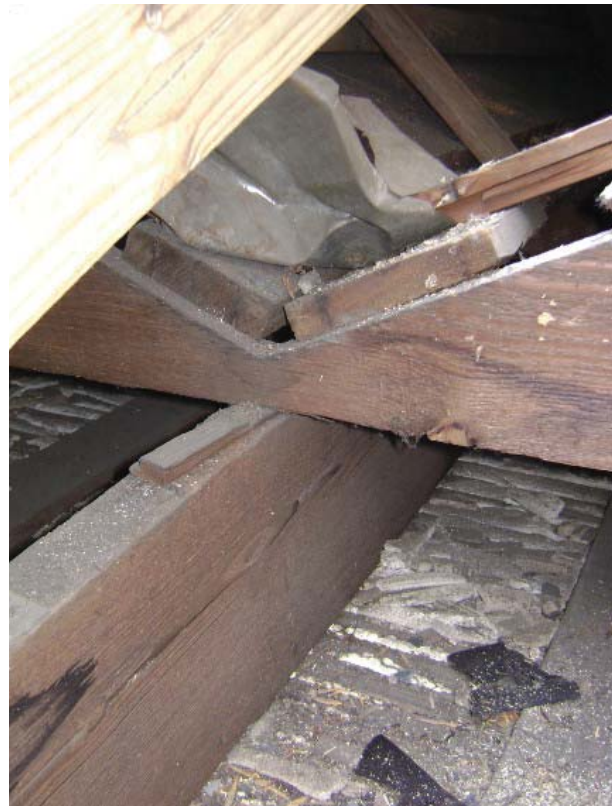
Figures 36 & 37 Details of the “serrated lath” type roof over the student rooms.

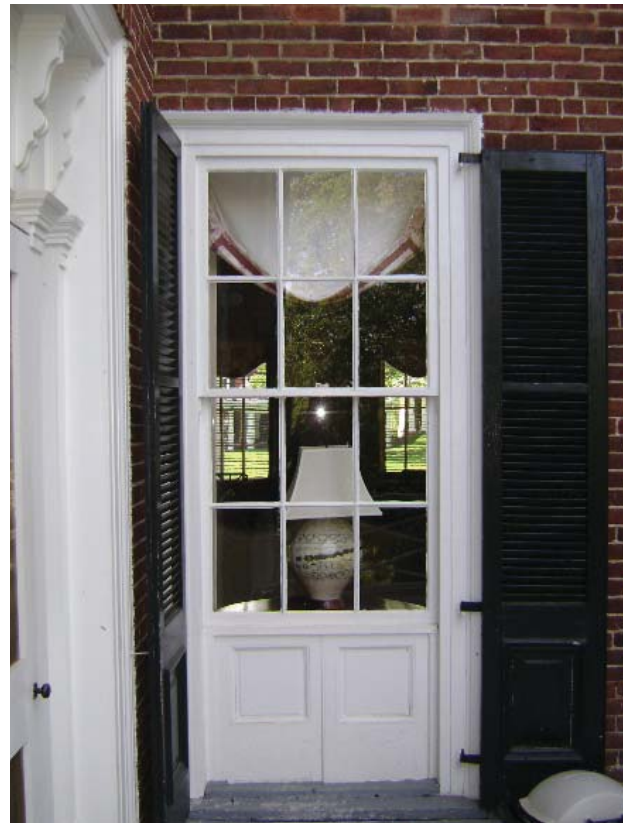
Figure 39a East elevation, north window. This window was modified when the 1877-8 addition was built. The window was turned into a door providing access to a wood porch and later converted back into a window.

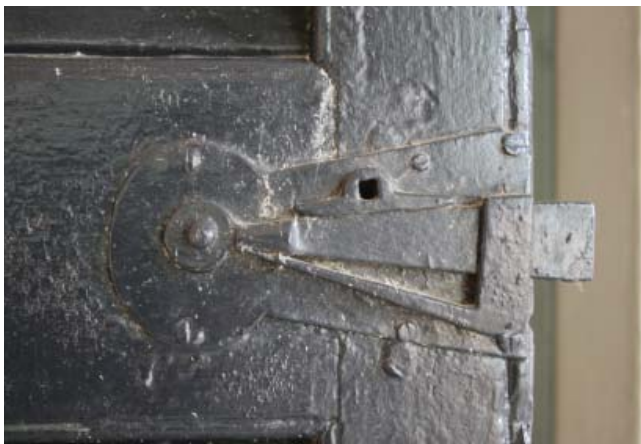
Figure 43 Door blind at No. 13, West Range. Detail of surface mounted plate latch. While ghosts for this type of latch survive on other blinds along the West Range, this example was the only one found remaining.

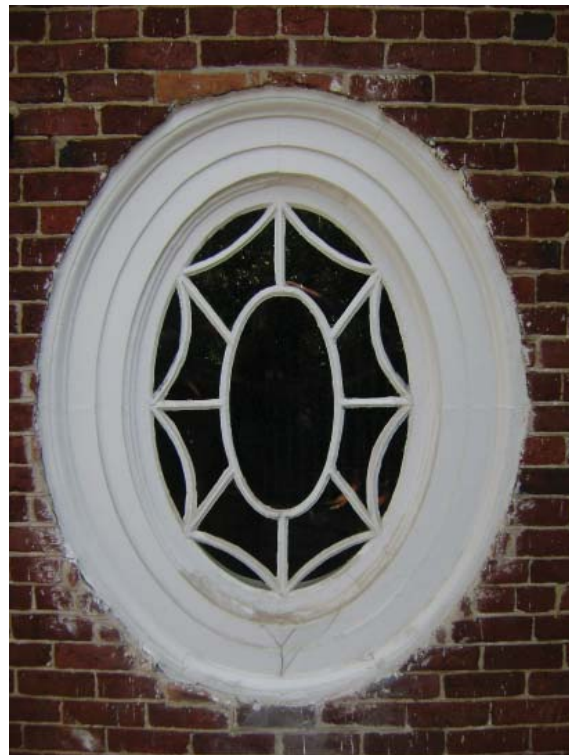
Figure 44 South elliptical window. Note the crude manner in which this window was installed. The elliptical windows disrupt the original fenestration pattern and clearly read as an afterthought.

Because there is no question that these windows were inserted in a somewhat crude manner into the wall of the pavilion, it may be desirable to remove them. The windows can be observed from the path along the south of the building, and they alter the original fenestration pattern in an unhappy way. However, once these windows are removed, all natural light will be blocked from entering the stair hall unless portions of the addition are removed from the east elevation.

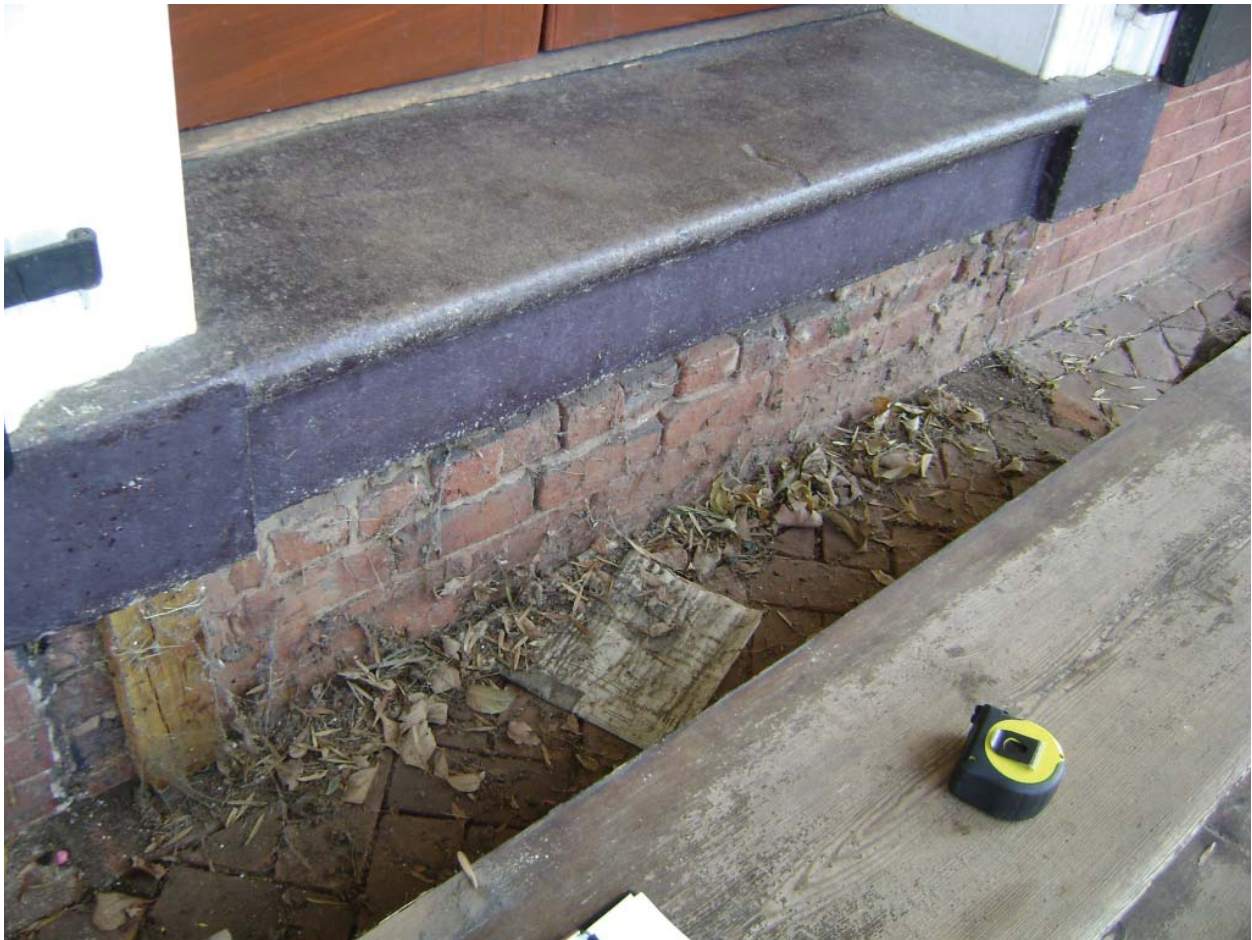
Questions regarding the pavement material and elevation may be linked to the original condition of the steps in front of the main entry door. All of the pavilions along the west side of the lawn have stone steps, yet all those on the east have later period wood steps with the exception of Pavilion IX. If stone steps were constructed along the east, the durability of the stones would have helped to ensure that they would have survived to this day just as those on the west have survived. The lack of evidence for any stone steps points to the strong possibility that, unlike the west, only wood steps ever existed at the pavilions to the east, and it is quite possible that they closely matched those that exist today. The wood steps now in place are clearly modern. The brickwork behind the steps appears as though it is infill; both the materials and workmanship do not match the surrounding brickwork (Figure 46). Examination of entry steps at other pavilions along the east side of the lawn revealed a late-nineteenth century window opening behind the steps at Pavilion VI. It is feasible that a similar condition existed at Pavilion X but was later filled in. Paint lines of what looks like a stair nosing can clearly be seen on the brick to either side of the infill further reinforcing the possibility that wood steps were originally located here.

Figure 46 The brick surface behind the entry steps is made up of later infill suggesting this space may have originally contained an opening of sorts, possibly similar that found behind the steps at Pavilion VI. Paint lines exist on the pavilion walls to either side of the infill suggesting wood steps may have butted against the wall here.

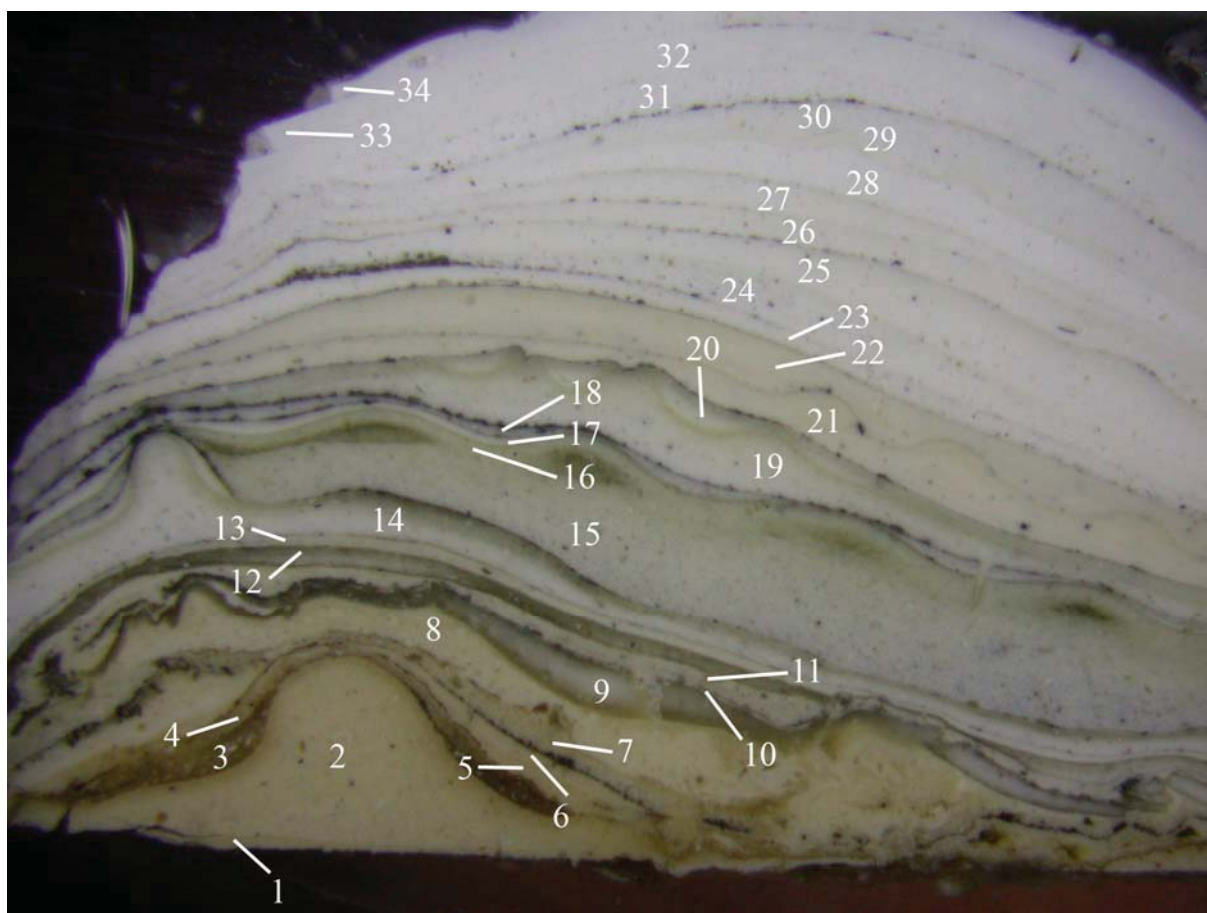
Although the Chinese railing on the balcony has had some newly replaced elements, a large portion of it is original and still contains its complete paint history. Of all the surfaces examined on the Pavilion, the railing appears to have received the most painting activity throughout its life. One sample displayed 23 finishes in 37 total layers. This high number may be due to its easy access, a higher traffic impact or that it simply collected dirt very quickly, or a combination of all three. In contrast, the portico inner cornice displayed a much lower painting activity, probably due to its more difficult access. Although only 15 finishes were found on these surfaces, they included the earliest and latest paint campaigns as found elsewhere. For example, where the Chinese railing displayed three initial campaigns of buff color, the cornice displayed only one.

Sample #28: balcony, Chinese railing

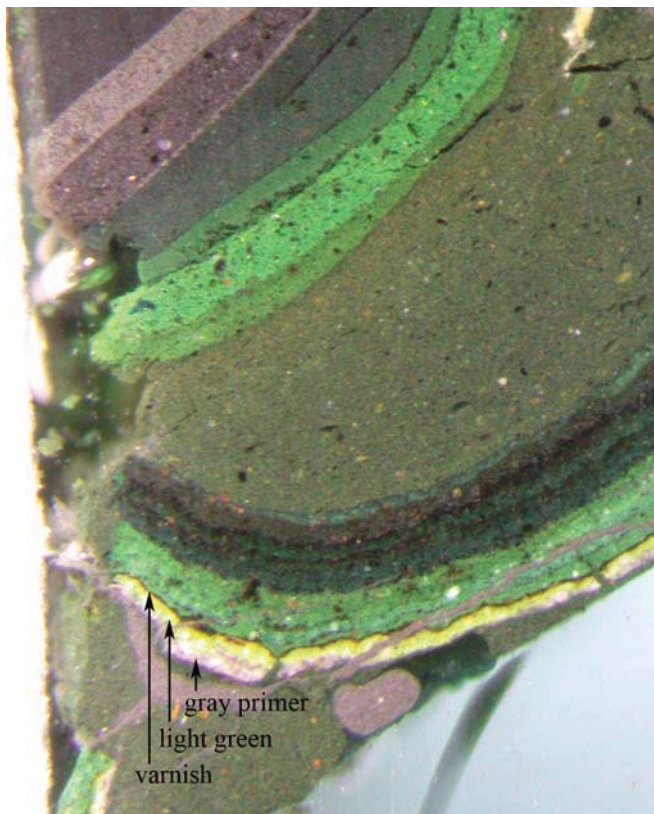
Layers 2-9 in the Pavilion X blind sample are degraded to the point where their true appearance has been lost. This does not appear to be the case in the sample from Room 48. Sampling additional Pavilion X blinds, as well as other student room blinds would help support which form of this early green the reproduction color should take. In any case, it should be a light to medium green, and therefore much different from what is currently displayed. Further analysis, including pigment identification, will be carried out in order to accurately reproduce this color.

Student room #48 blind

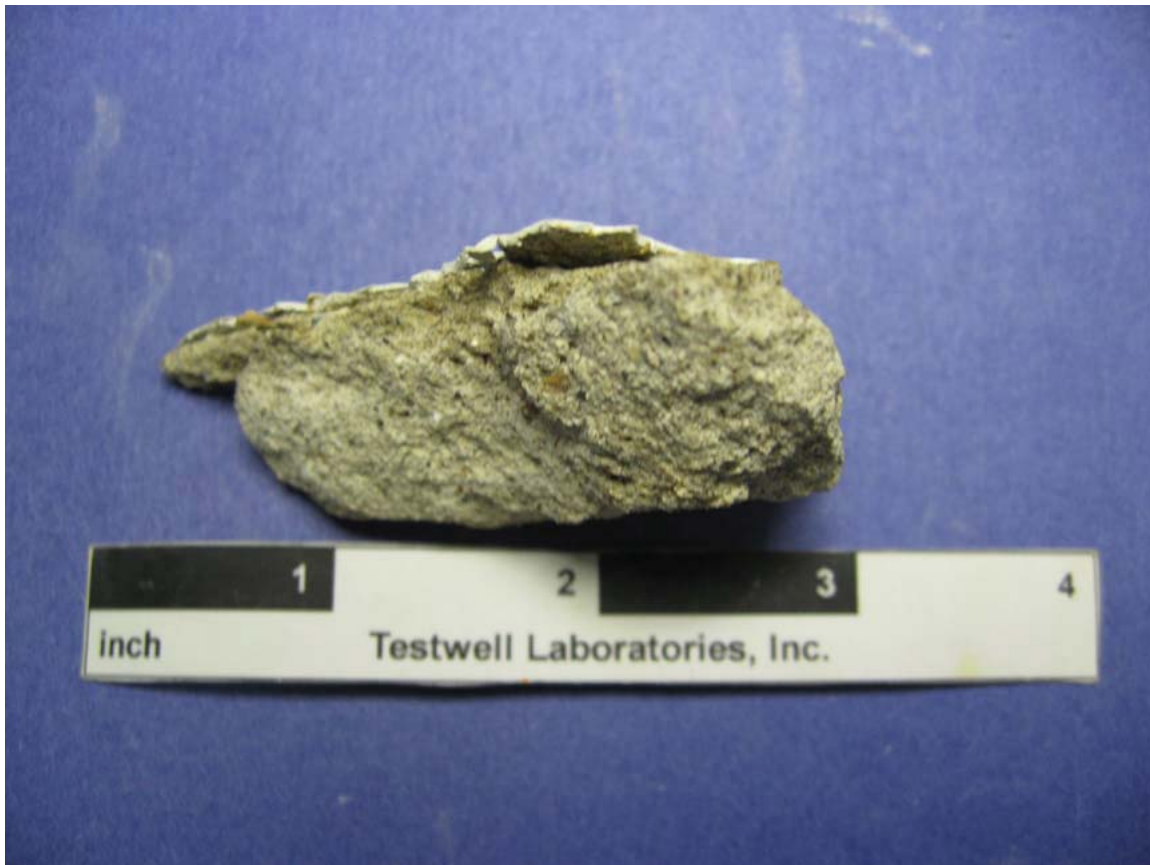
Figure 1: Render sample as received by Testwell Laboratories for mortar analysis. The sample appears homogeneous throughout with no indication of multiple campaigns. The sample is coated with several layers of a light-colored paint.

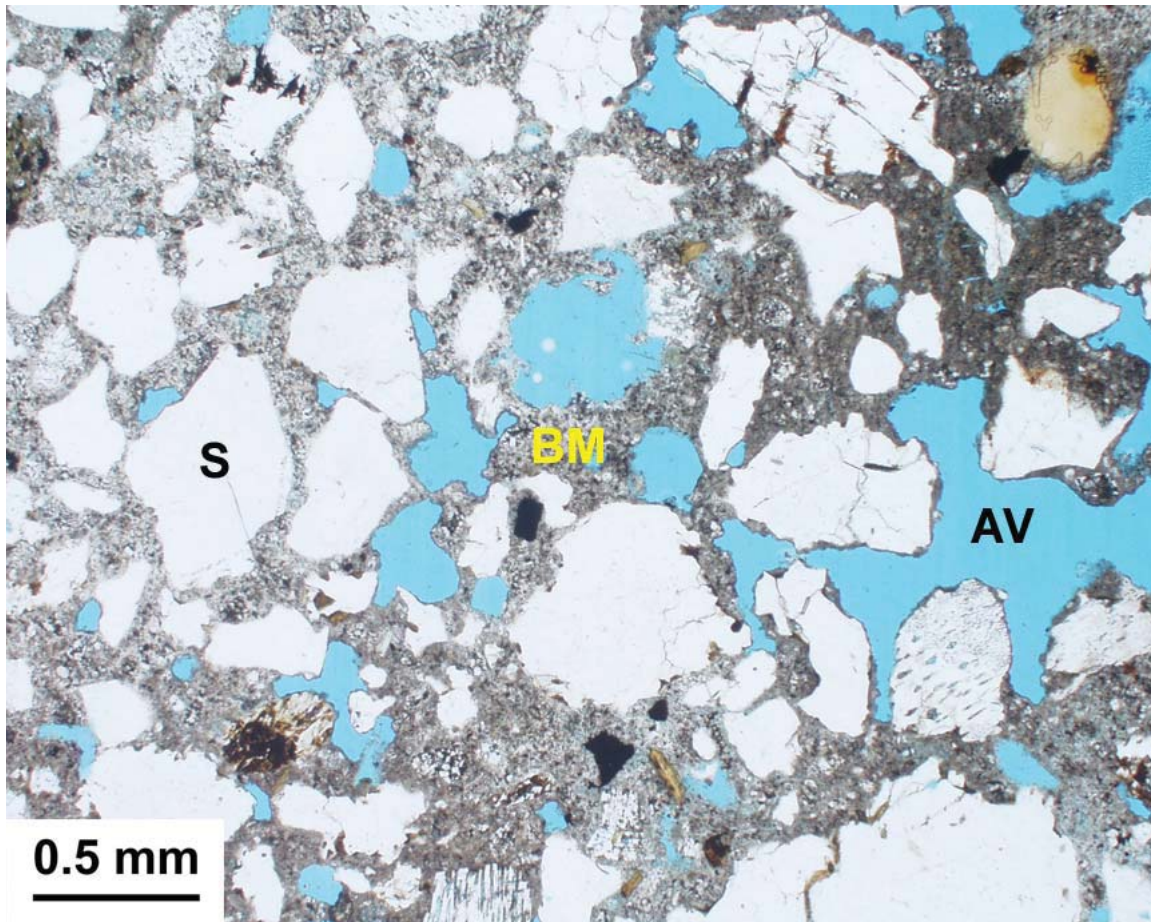
Figure 2: PPL photomicrograph illustrating the overall microstructure of the render sample. The binder matrix (BM) is a moderately dense and homogeneous cementitious matrix. Sand grains (S) are well coated with binder. Air-voids (AV) are found in moderate abundance and tend to be irregular in shape. No significant secondary deposits are observed in air-voids to suggest any significant service life distress.

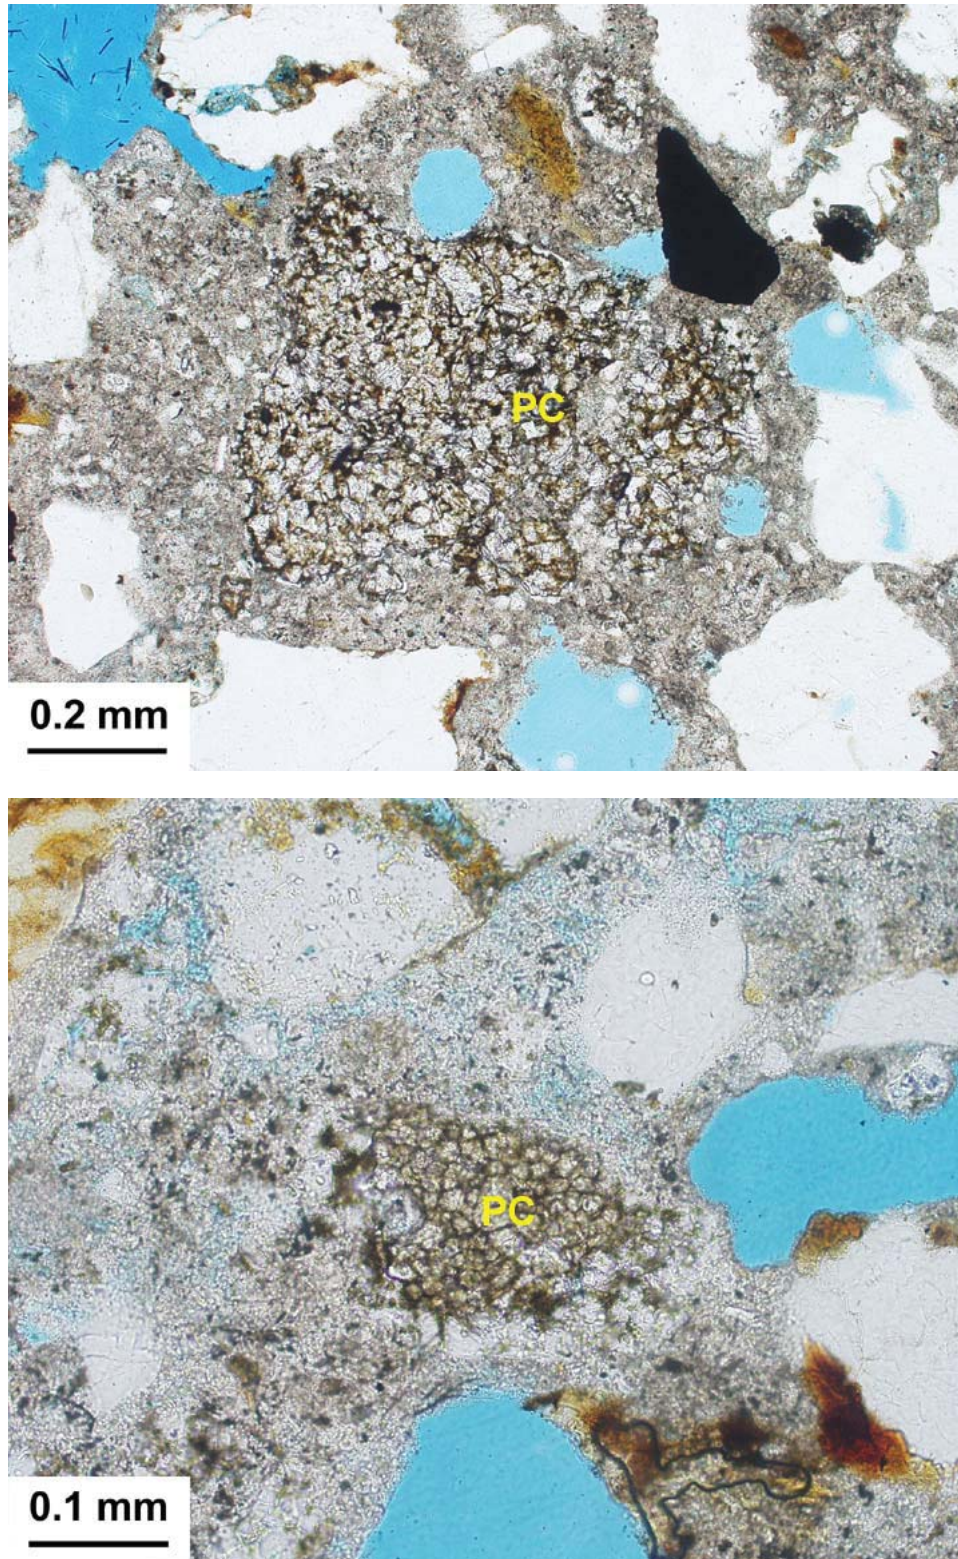
Figure 3: PPL Photomicrographs illustrating portland cement residuals (PC) in the mortar matrix. The top image illustrates a very large grain indicative of coarse cement grinds typical of the early twentieth century. The color of the individual belite crystals tends to be very light. The bottom image shows a belite agglomerate that is finer but exhibits amber belite colors. The variation of belite color is a function of variations in kiln conditions and this range is more typical of earlier cements.

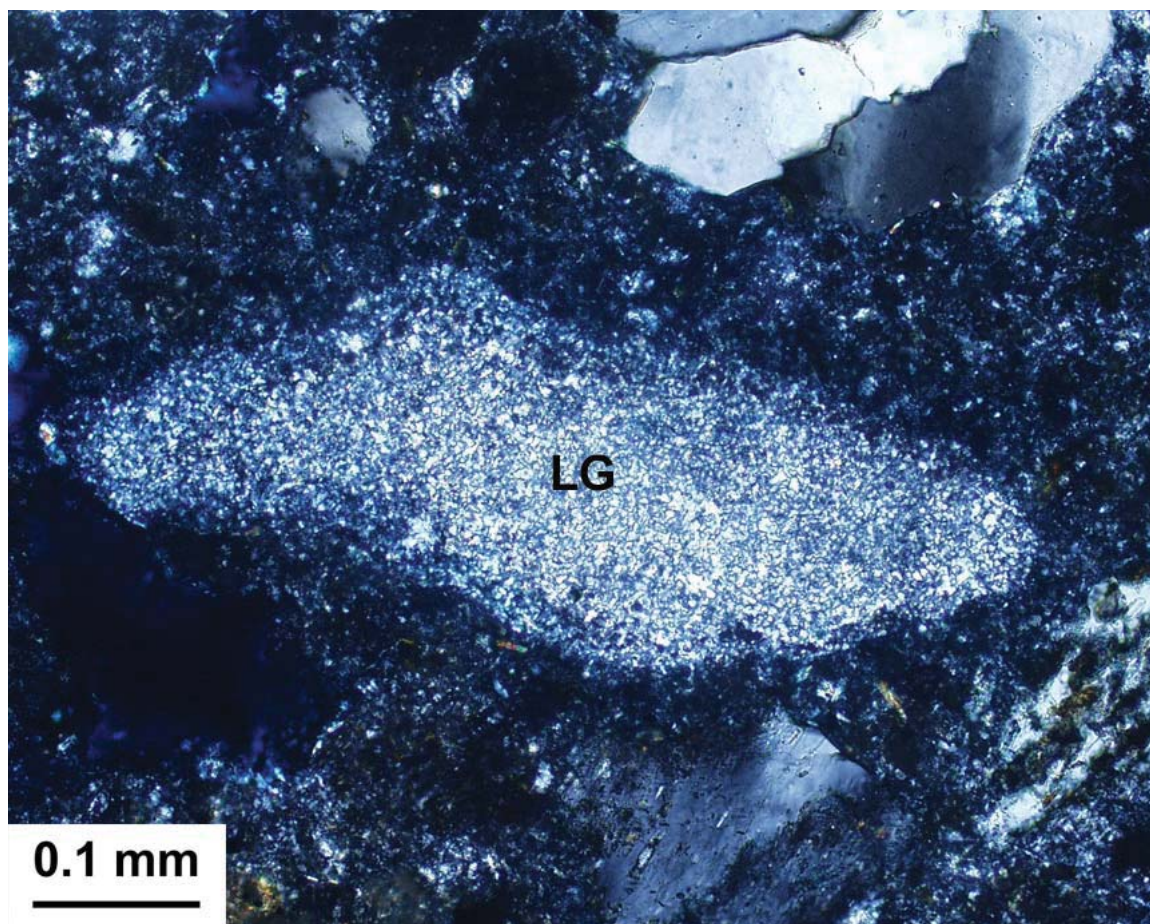
Figure 4: XPL photomicrograph illustrating a larger lime residual in the examined render. While the size is atypical of the much finer grains detected throughout, it better illustrates the internal texture of the lime. The black and white optical colors indicate the lime is not carbonated. The very fine crystallites of lime hydrate are typical of lime produced as a dry hydrate. If the lime was added as a dry hydrate, this would date the mortar after about 1910. If added as a putty, the vintage could be up to twenty earlier given the microtexture of the portland cement residuals.
