# UNIVERSITY CHAPEL HISTORIC STRUCTURES REPORT

**FINAL REPORT**  
**24 JANUARY 2008**

**QUINN EVANS|ARCHITECTS**  
**1214 Twenty-eighth Street, NW**  
**Washington, DC**

**Facilities Management**  
**University of Virginia**

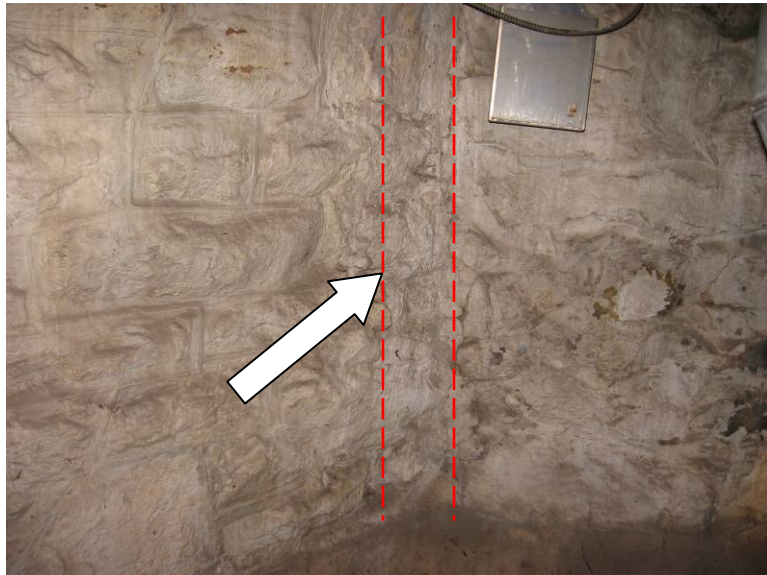
**Figure 2.10**

Photograph of southwest corner of basement room below organ chamber. (QE|A, 2006)

A vertical swath of stone about 12" to 18" wide depicts a condition where a perpendicular stone wall has been demolished.

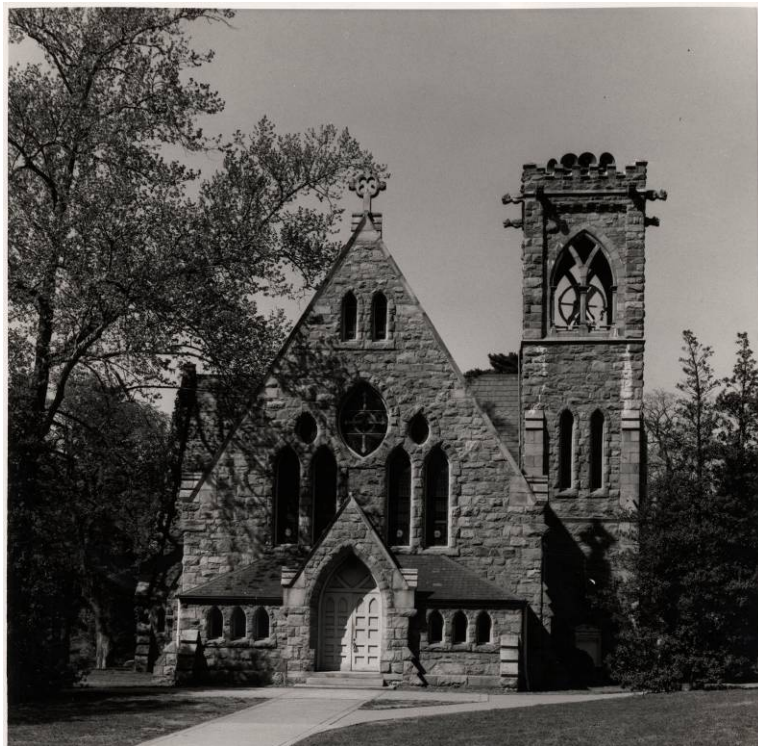
**Figure 2.20**

South façade, 1969, photographer unknown. (Special Collections, University of Virginia Library) (image cropped)

Note the heavy staining, possibly efflorescence, evident on the bell tower in a similar location to where test cleaning was recently done.

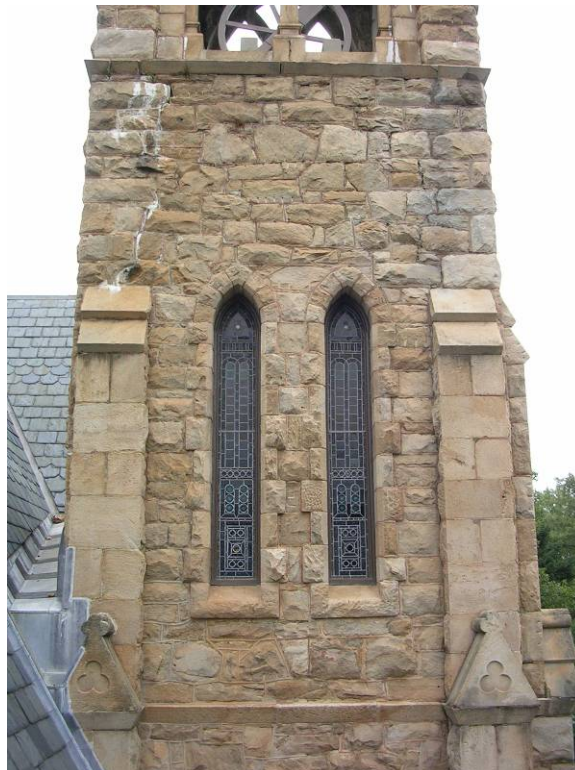
Since this photo was taken the bell tower repair project completed the repointing and removal of the efflorescence.

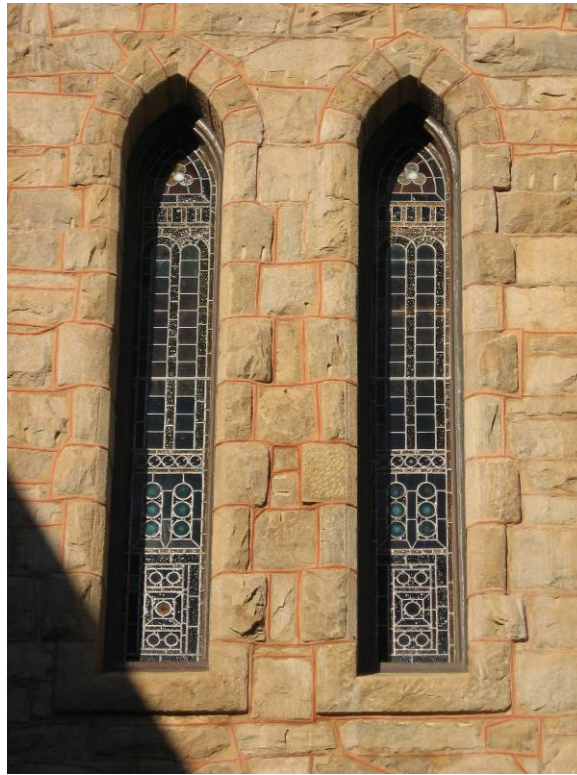
Note the new repointing completed during the 2006 bell tower repair project.

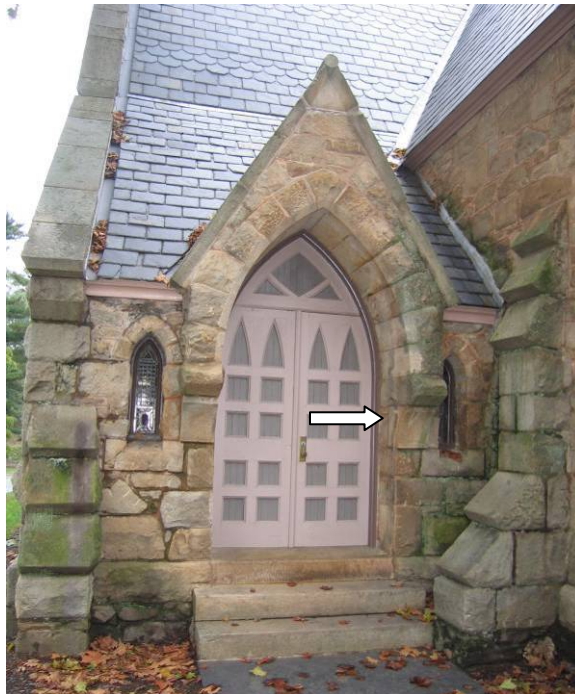
The arrow indicates the spalling location in Figure 4.3.

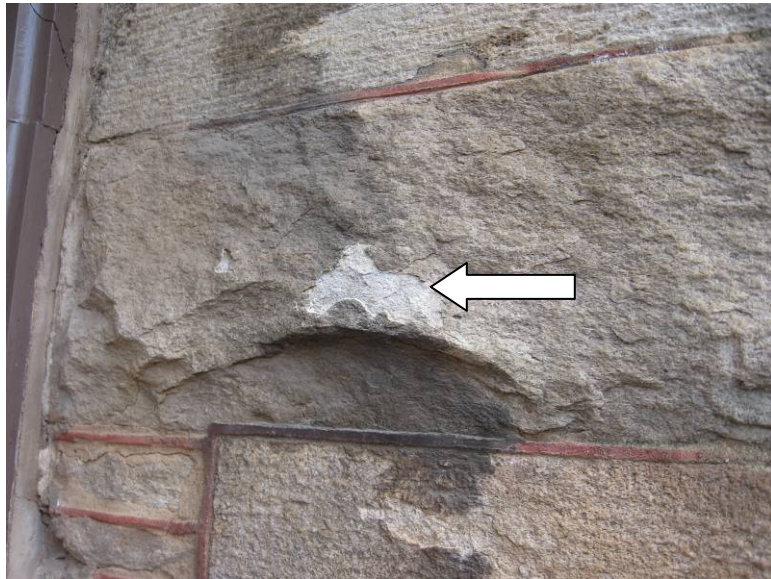
**Figure 4.3**

The lighter color is where the outermost surface of the stone has spalled off.

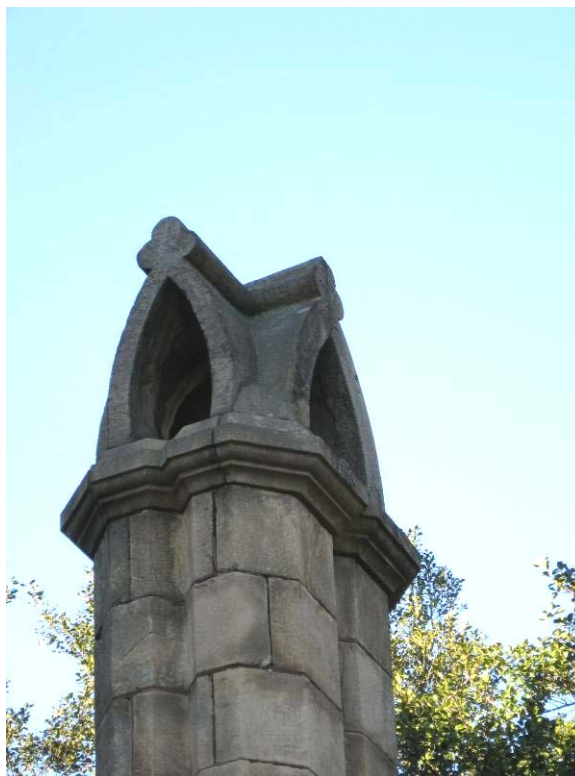
**Figure 4.4**

Note also the darkness and staining of the stone.

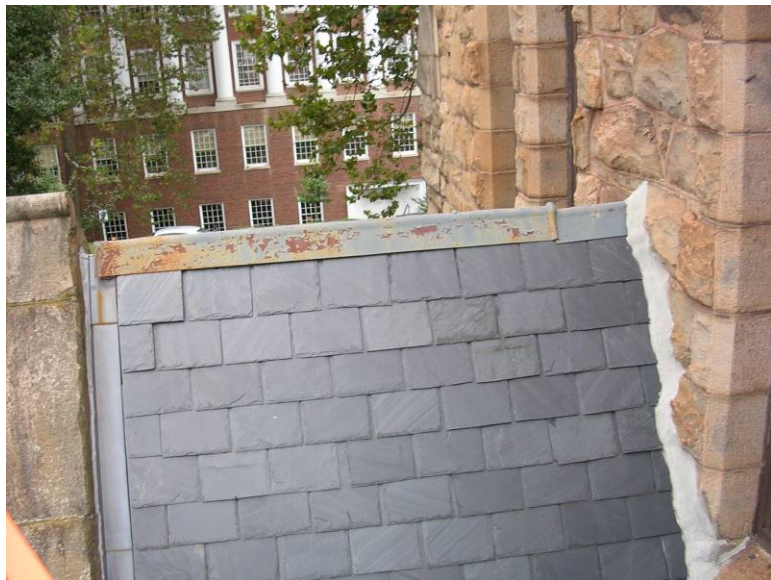
**Figure 4.6**

Rusting rigid cap flashing over  
narthex, south facade. (QE|A,  
2006)

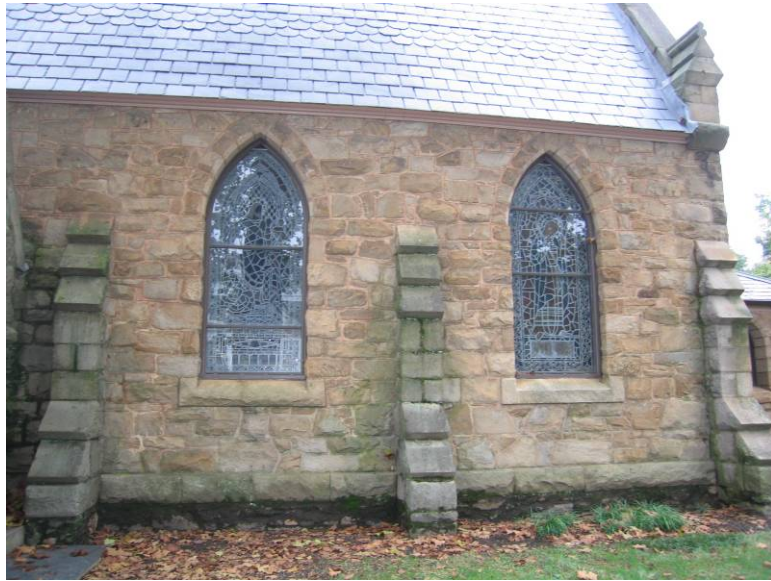
Biological growth and damp stone all along the west façade between the buttresses where there is no gutter nor proper grading. (QE|A, 2006)

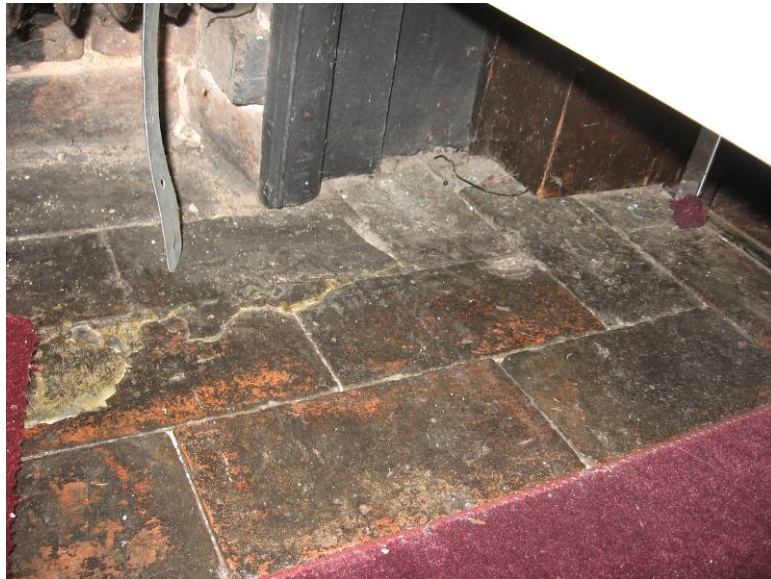
**Figure 4.8**

Possible adhesive remnants on severely worn tile of fireplace hearth in vestry. (QE|A, 2006)

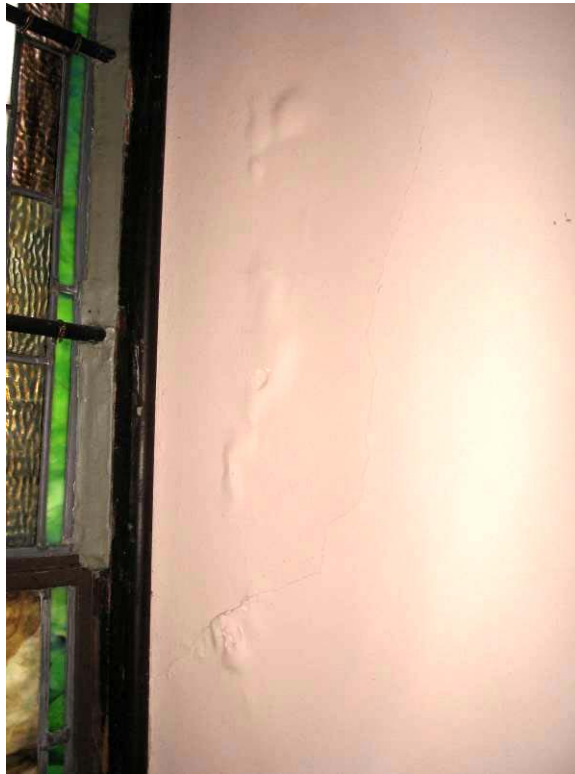
Blistering paint indicating moisture on the right jamb of window #53 in the nave. (QE|A, 2006)

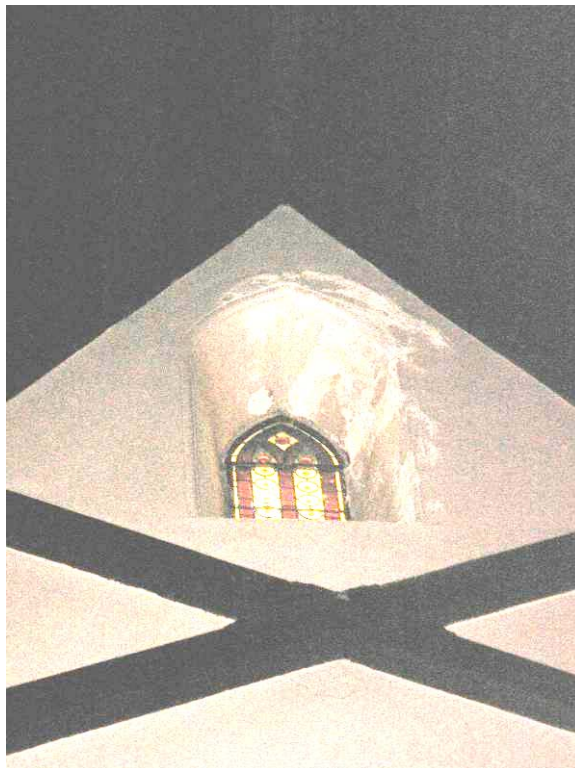
**Figure 4.10**

Damaged plaster around window #55 in the west transept. (QE|A, 2006)

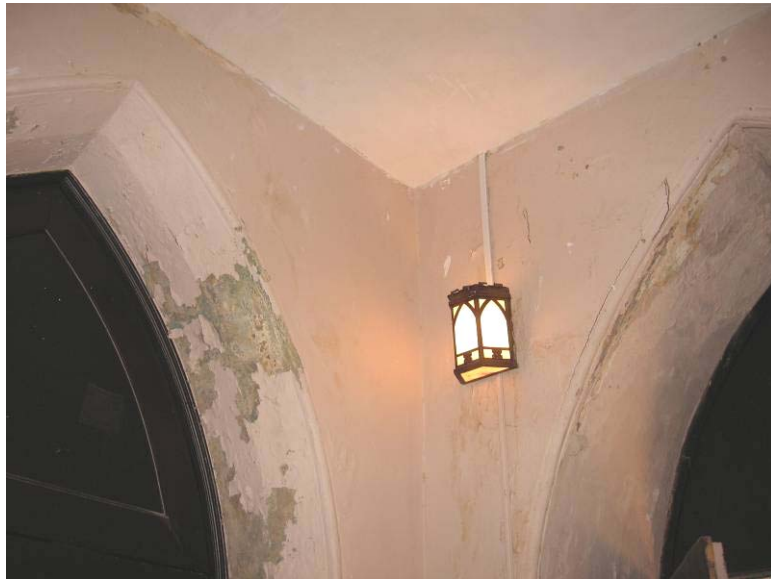
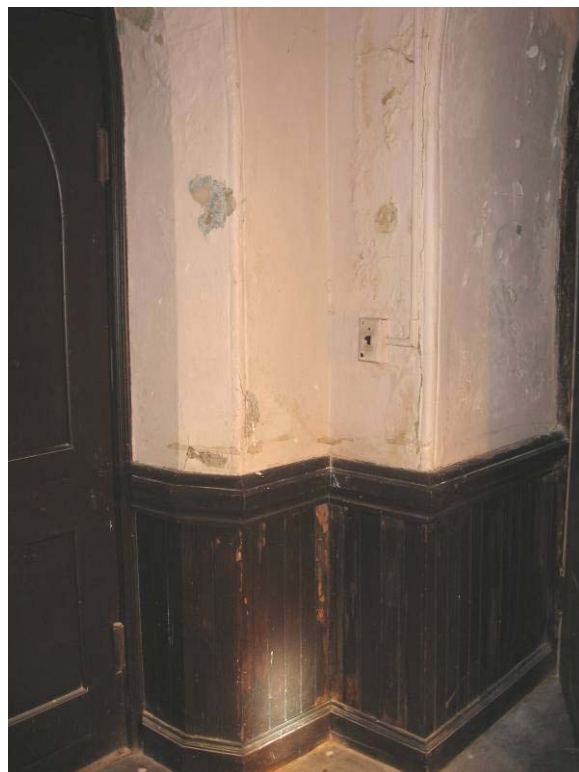
Damaged paint on the north and east walls of the east vestibule of the bell tower.  
(QE|A, 2006)

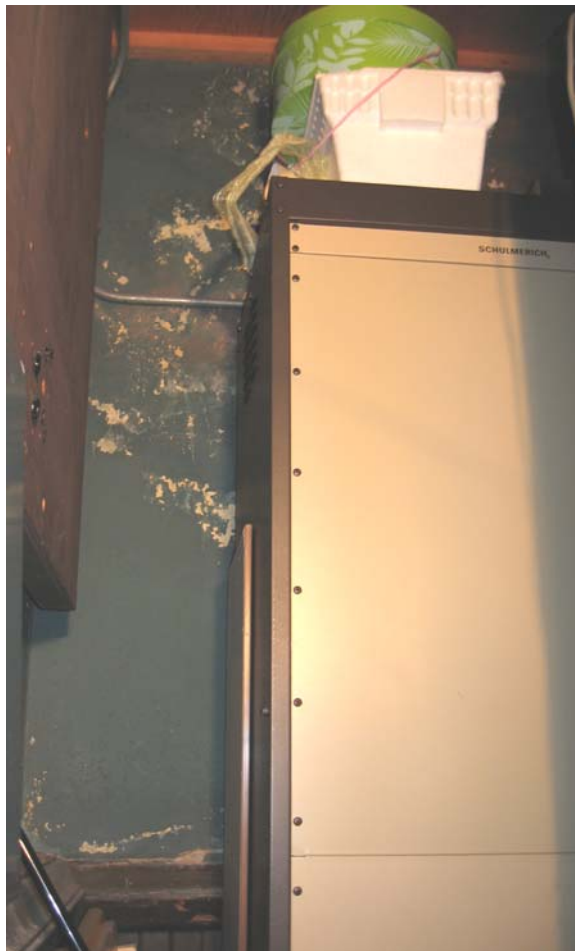
**Figure 4.13**

Damaged green-blue paint along north wall of vestry within closet. (QE|A, 2006)

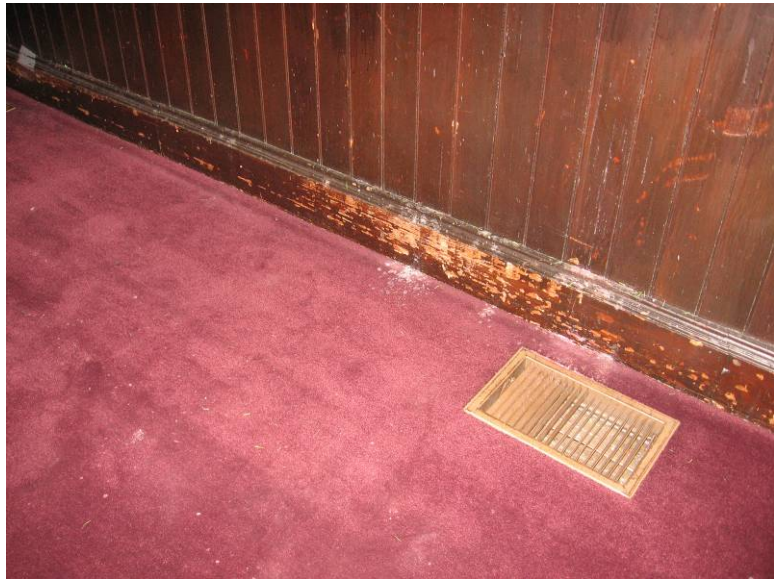
Damaged baseboard with chips in the coating along north wall of chancel. (QE|A, 2006)

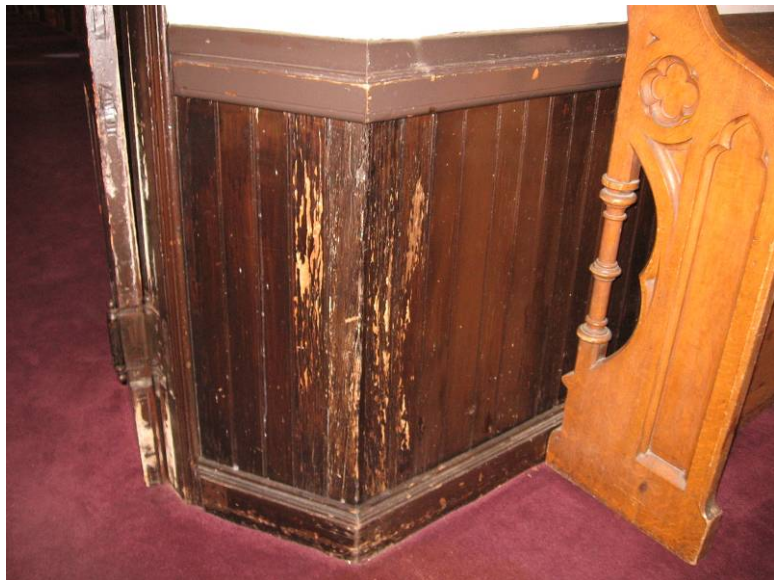
**Figure 4.15**

Damaged wainscot with numerous chips in the coating along north wall of narthex. (QE|A, 2006)

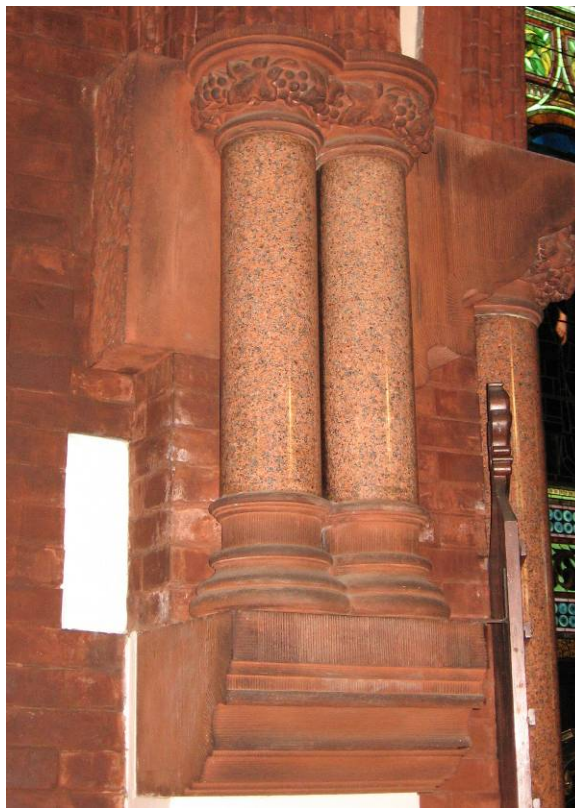
**Figure 4.19**

Soiled and darkened stone capitals, bases, and brackets at west transept columns. (QE|A, 2006)

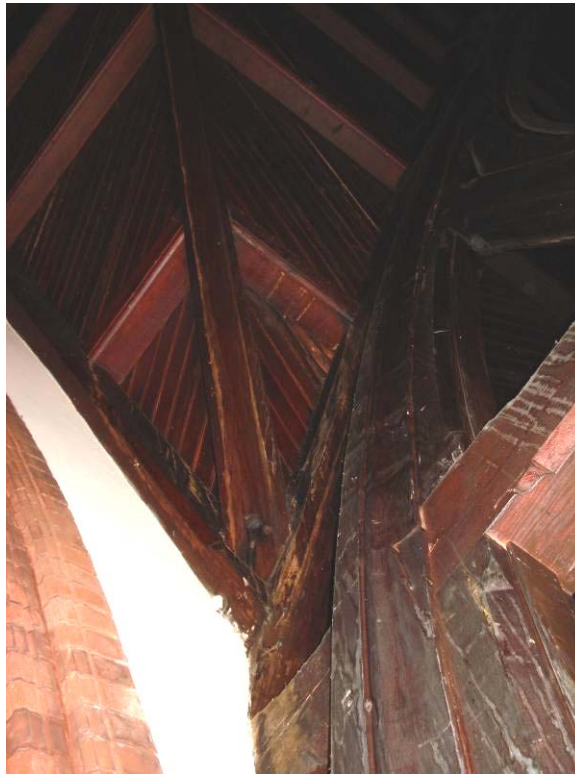
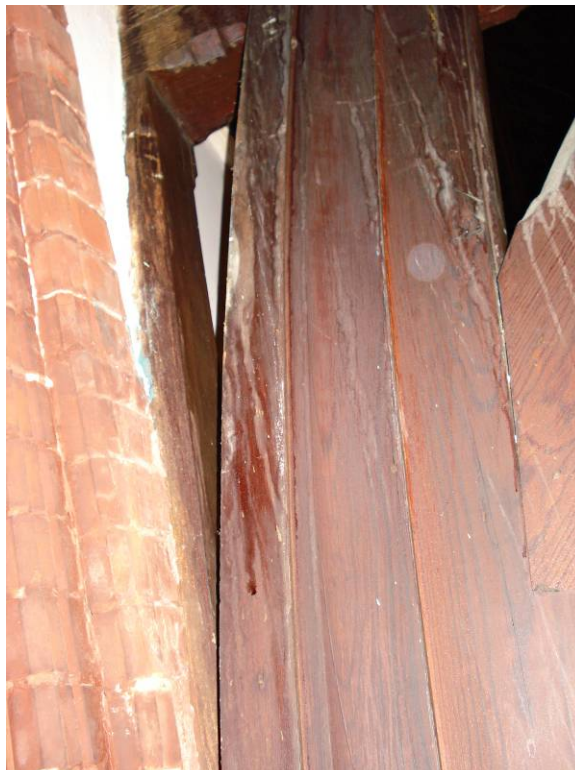
There are also modest water stains on the plaster wall below this location. Flashing is assumed to have been redone in the 1991 roofing project, but it appears that there is still water entering the roof assembly and down onto the walls.

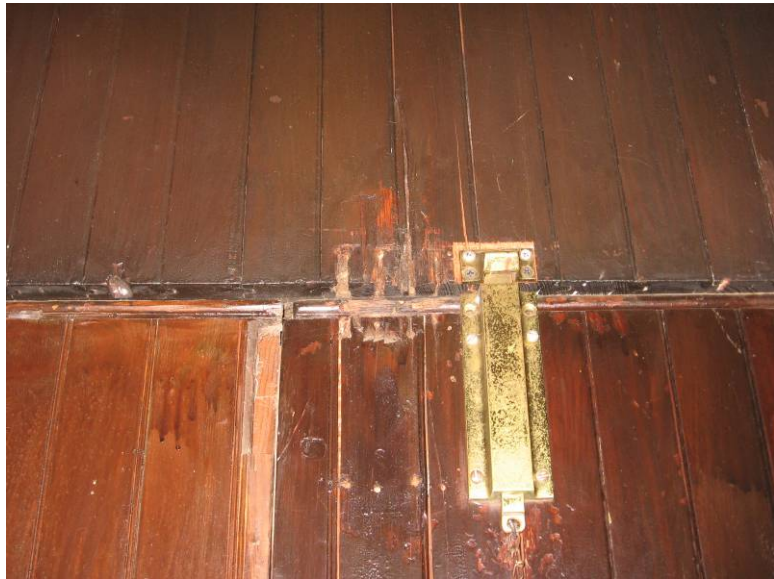
**Figure 4.21**

Damaged door 109a with three different color coatings, inside face in the narthex. (QE|A, 2006)
