PRESIDENT'S HOUSE ON CARR'S HILL

BUILDING ASSESSMENT & SCHEMATIC DESIGN FINAL REPORT

JOHN MILNER ASSOCIATES, INC.
FEBRUARY 28, 2006

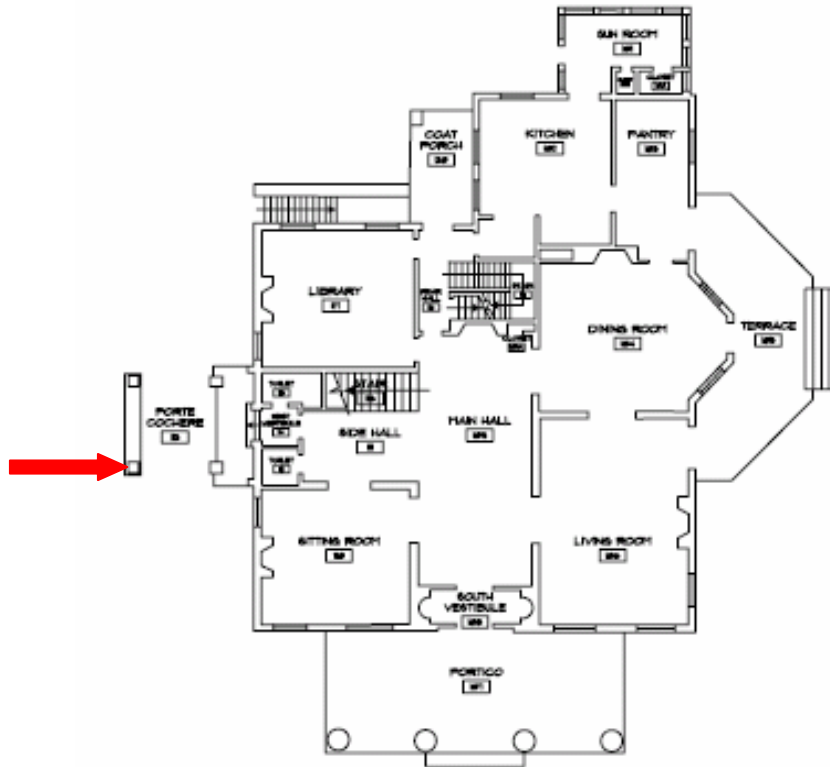
Location of water and brick deterioration (Item 2).

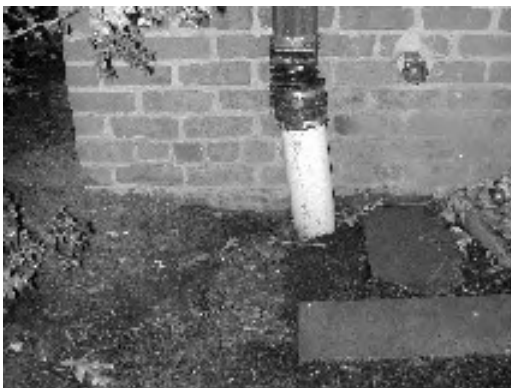
Depressed grade around downspout boot (Item 1).

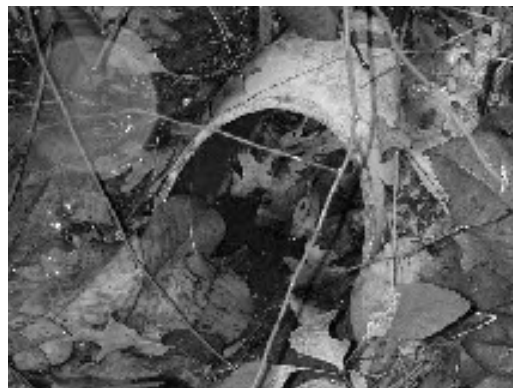
PVC drain pipe at east side of terrace (Item 3).

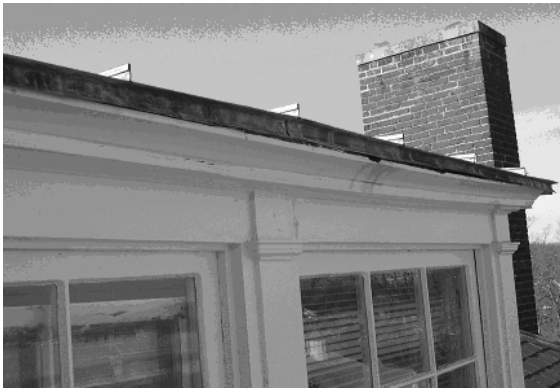
4. Water appears to be getting behind the fascia board and trim at the dormer roof over the third-floor hallway. Flashing should be evaluated to insure that water is diverted away from the building. Wood is rotting. Three slates and the dormer wall have shifted out of place and needs to be refastened.

Water problems at dormer (Item 4).

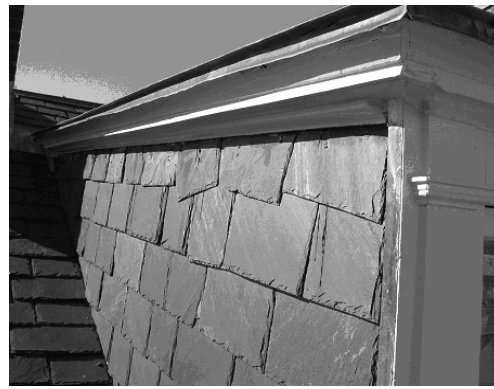
Loose slates at dormer side-wall (Item 4).

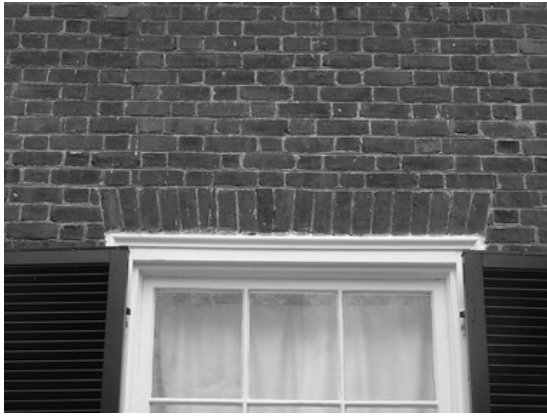
Shallow flat arch at exterior wall openings (Item 3).

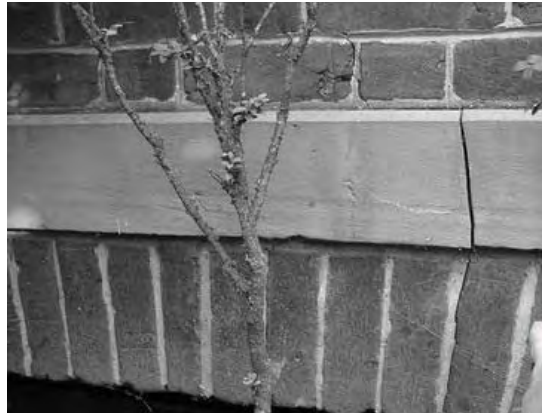
along the west façade, near the southwest corner, where cracking and movement in the jack arch has translated to the stone watertable above.

Flat arch and stone watertable cracking (Item 3).

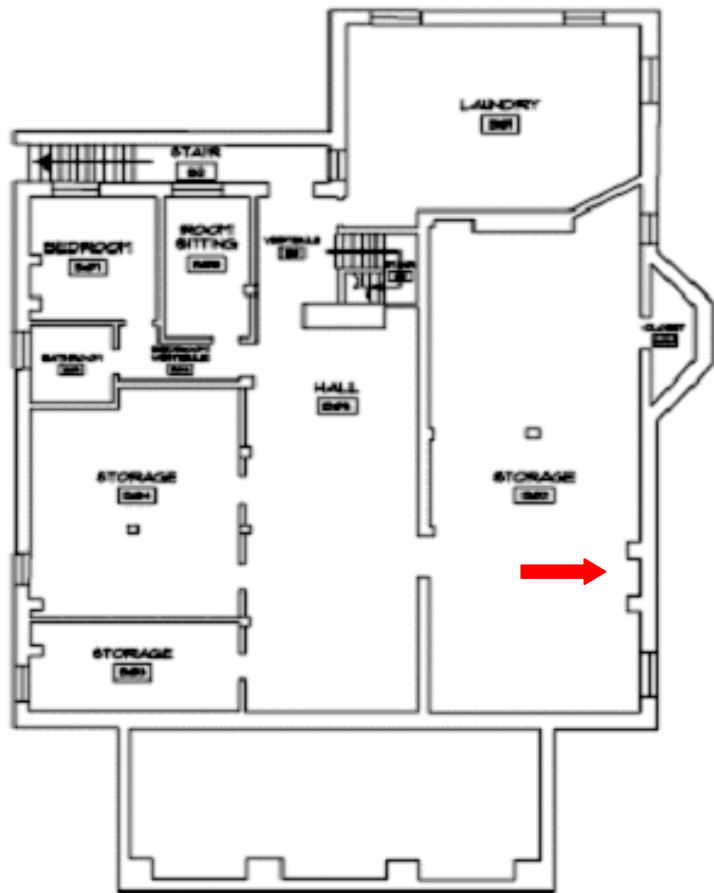
2. Below grade there is an area of high moisture content that appears on the east wall of the basement in the northeast corner of Storage B02 at a location about 24 inches above the floor. It starts about 12 inches south of the angled north wall of the room and extends for about 4 to 5 feet. It is somewhat evident because of a faint orange stain on the plaster surface. There is no apparent reason for this because this wall is immediately under the large terrace on the east side of the house.

Area of high moisture content in wall (Item 2).

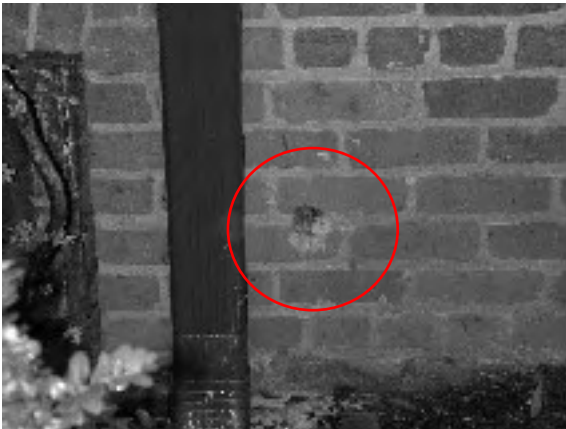
Pipe in wall beside downspout (Item 2).

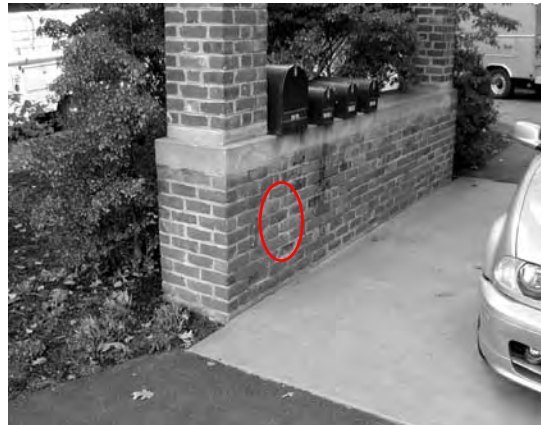
Brick deterioration on porte cochere cheek (Item 3).

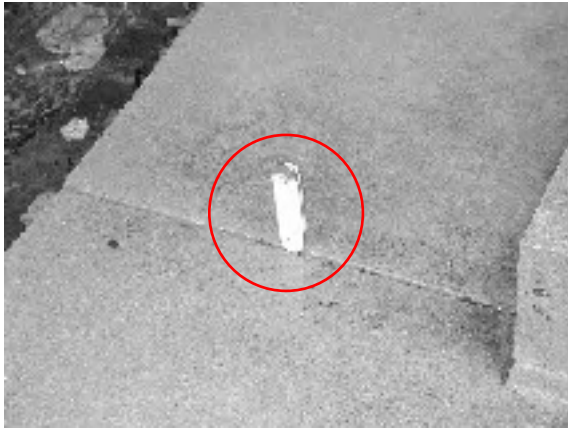
Deteriorated joint in portico steps. Knife blade buried in joint is 4" long (Portico, Item 1).

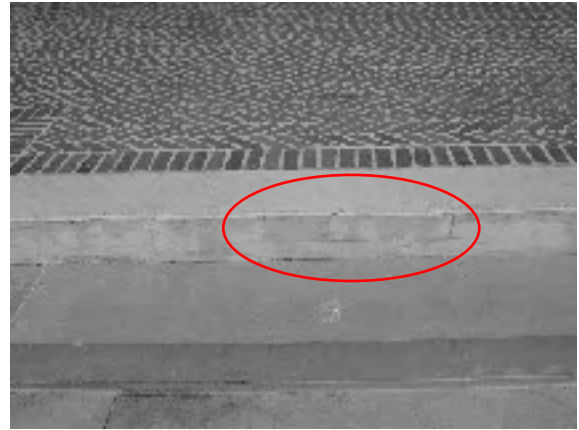
Failing patches in concrete border (Portico, Item 2).

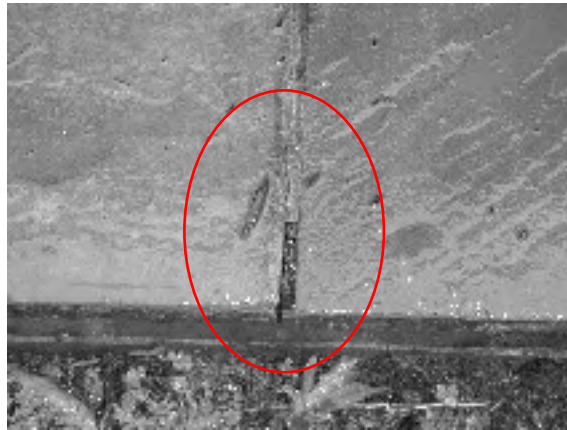
Deteriorating joints in terrace flagstone steps (Terrace, Item 2).

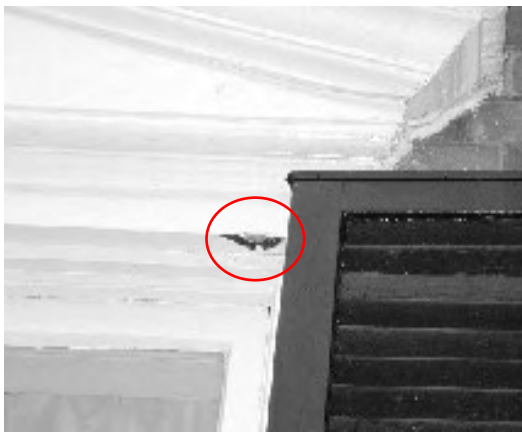
Deterioration at window head (Item 2).

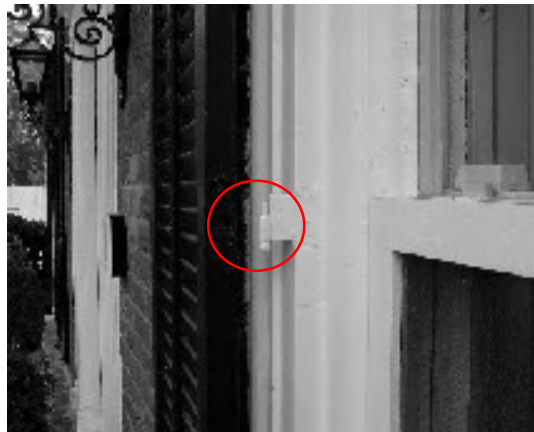
Missing piece of shutter hinge (Item 3).

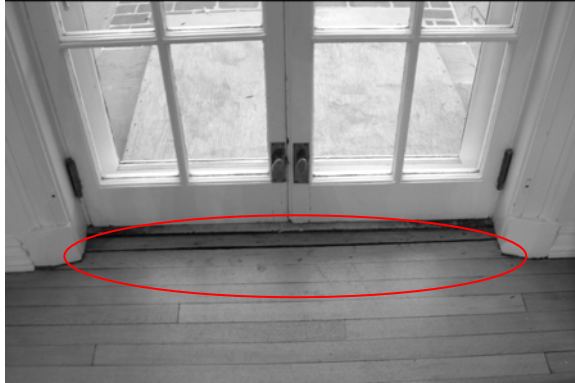
Wide gaps at floorboards (Item 2).

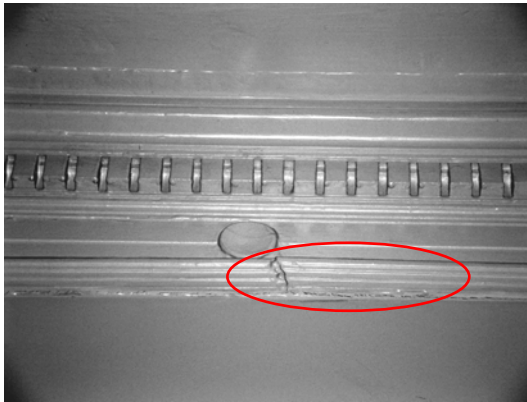
Uplifted picture rail (Item 1).

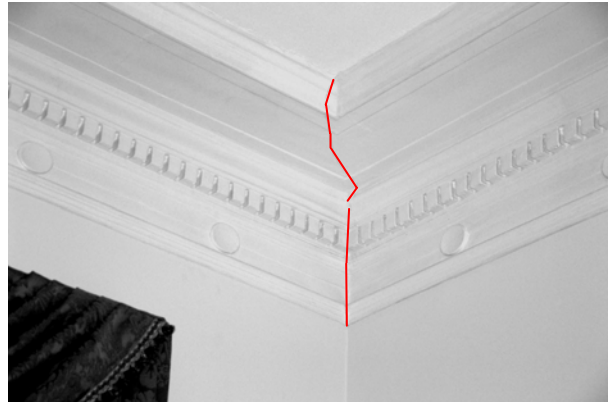
Plaster crack in crown molding (Item 11).

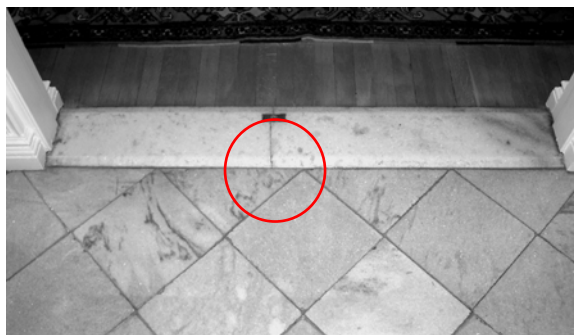
Cracked marble threshold (Item 2).

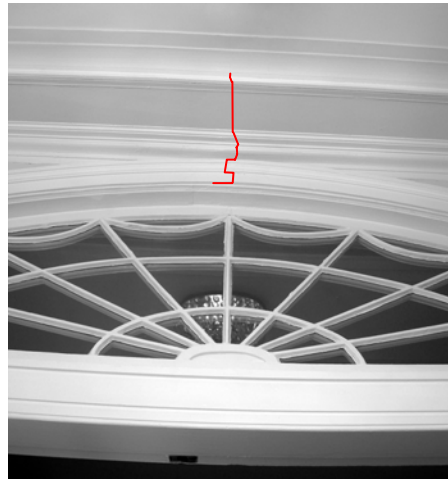
Separation of wood joints and cracked plaster (Item 3).

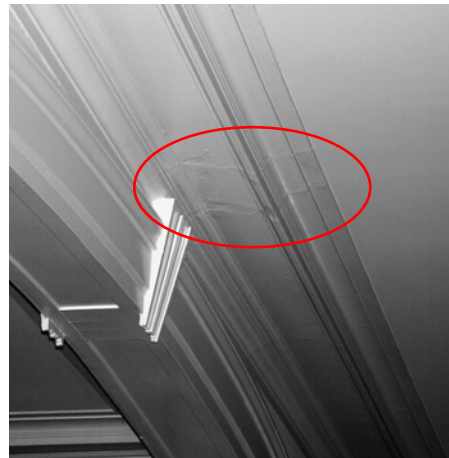
Previous plaster repair (Item 8).

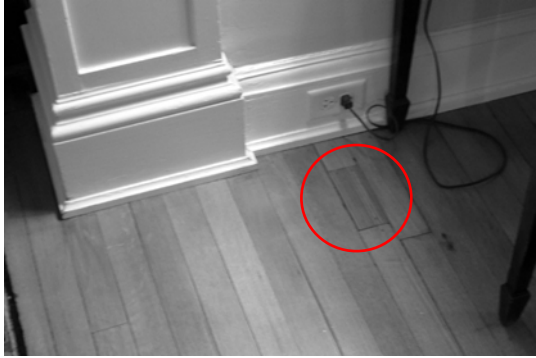
Wood patch (Item 3).

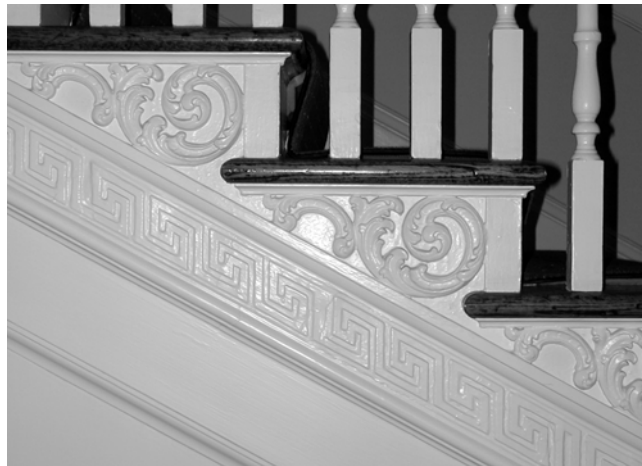
Paint build-up on face string (Item 14).

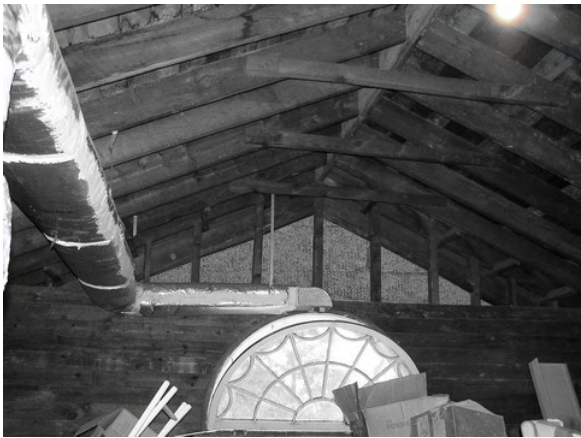
The roof rafters are depicted in the original McKim, Mead & White drawings as “2 x 8 rafters at 20” inches on center.” The exact dimensions, however, are generally somewhat smaller than the full 2” x 8”, but larger than modern standards for sawn lumber. This relationship of true dimensions to nominal sizes indicated on the historic drawings proved consistent with most measured framing members, including hip and valley beams. One significant difference between the as-built framing and original design drawings was found near the south portico, where a central post below the portico ridge, indicated on the original drawings as 4” x 6”, was apparently not constructed. The portico ridge framing was also constructed differently, with the original drawings indicating a “2 x 12 *ridge beam*,” but the as-built condition presenting two 1” x 10” *ridge boards*, which serve only to provide a horizontal connection between the rafter at the ridge and do not function as a spanning member between posts or walls (Photo 3).

Photo 3: The roof structure above the portico (Room 304) with the absence of the 4x6 post indicated in the original drawings.

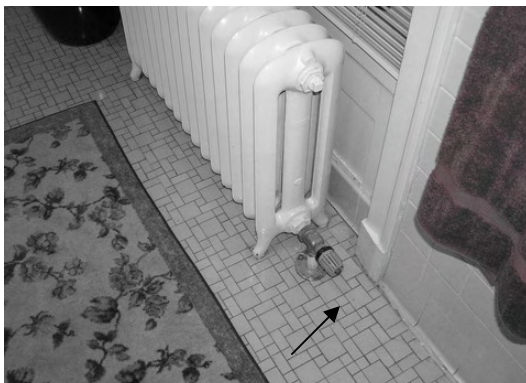
Some small movement in the tile finish of the bathroom in Room 219 was observed (Photo 7). Looking at this portion of the wall from the exterior porch (Room 218), some additional distress in the form of cracking in the exterior masonry wall was found (Photo 8). Smaller-scale cracking in the masonry was also observed in this wall from the first-floor level, which is apparently associated with the functioning of the flat arch, or *jack arch*, over the first-floor window below (Photo 9). The jack arch was measured as only 7 inches deep for a 4'-1" clear span, with a very shallow *skewback*, or projection of the upper portion of the arch over the bearing face of the masonry opening. The original drawings indicate that behind the jack arch, which is shown to only occur in the outer wythe of brick, there is likely to be a segmental brick arch consisting of two brick wythes. The segmental arch has a physical rise to its makeup which affords it significantly greater spanning capacity. It may be that additional loads are being introduced over the window opening from the porch-floor framing which are overstressing the masonry assembly, particularly in the outer wythe which has a limited spanning capacity.

Photo 7: Tile movement below the window in Room 219.

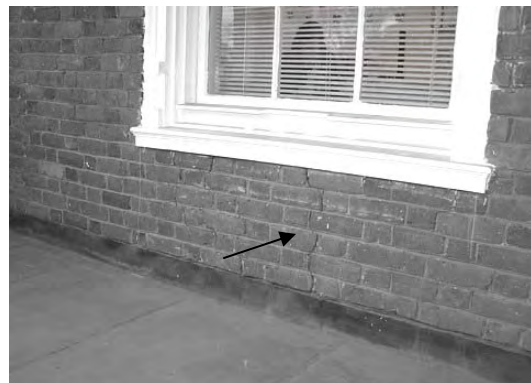
Photo 8: Exterior cracking in brick masonry beneath the window in Room 219.

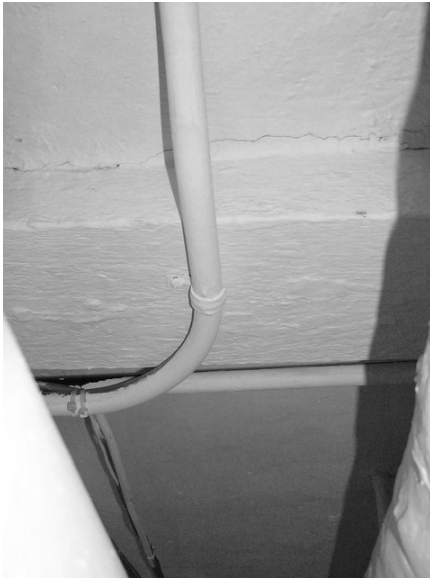
Photo 13: Paint cracking between first-floor girder and ceiling indicative of movement.

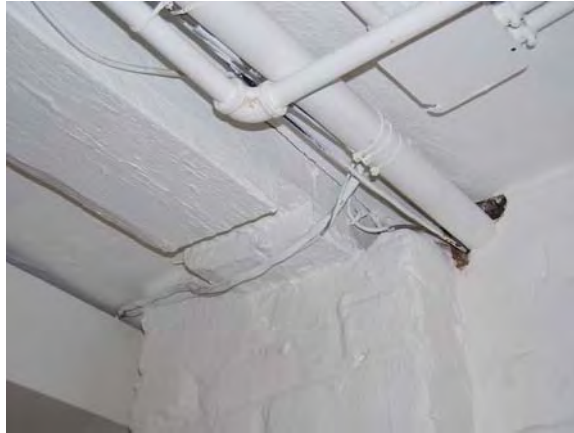
Photo 14: The bottom of the beam in Room B02 is notched near the support.

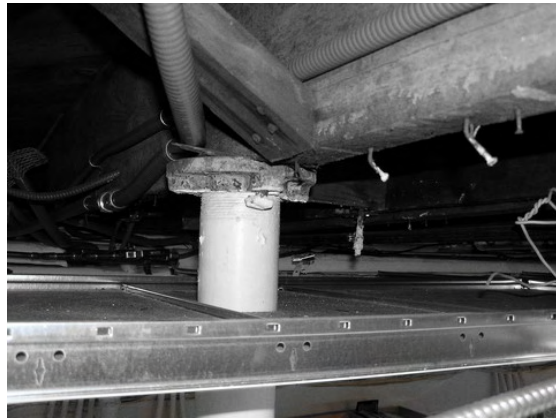
Photo 18: Pipe column tenuous top connection.

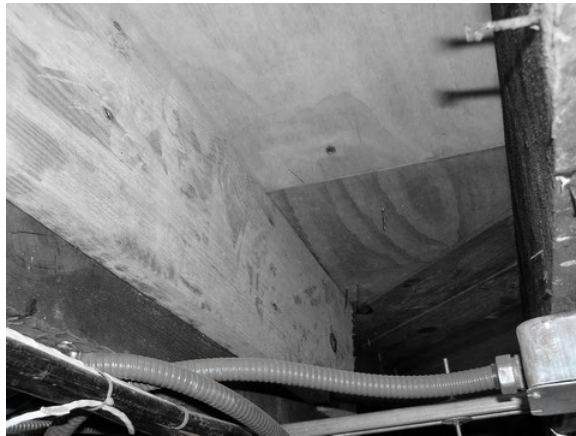
Isolated areas of past deterioration were observed in the laundry room, toward the northeast corner of the house. Here it appears that some wood floor framing around the lightwells, including the edge joist, a sill, and some floorboards had suffered from moisture intrusion and limited termite damage. The deterioration appears to have been addressed with new wood sistering and localized floorboard replacement (Photo 19).

Photo 19: In Room B01 a new wood sister and plywood floor replacement address apparent deterioration over the window in the northeast corner.

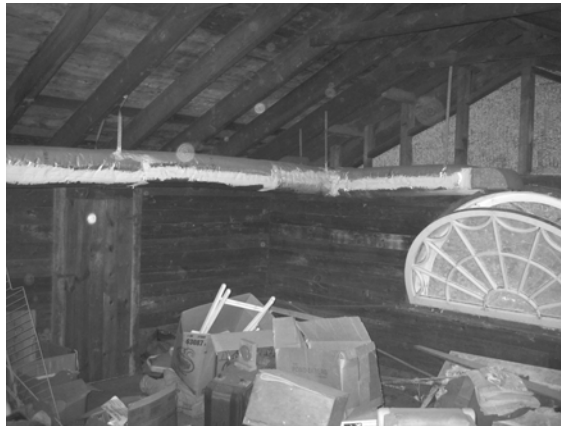
6. The outside air intake duct for the air handlers that serve the second and third floors (located in the attic) is not directly connected to a permanent opening to the exterior, but instead relies upon an operable arched window in the front portico. Air drawn into the open intake duct is likely a mixture of recirculated attic air and outside air. The open window allows uncontrolled temperature and humidity fluctuations in the attic, with possible damage to stored materials, and uncontrolled infiltration of unconditioned air into the third floor. In addition, no balancing dampers exist in the outside air branch ducts to each of the two air handlers. Technically, this outside air intake is not required by building codes since the house has operable windows in occupied spaces. However, if deemed desirable, a permanent exterior intake louver should be installed to allow the window to be closed and balancing dampers should be installed in each of the outside air intake ducts to the air handlers.

Outside air intake duct in Attic 304 (Item 6).
