UNIVERSITY OF VIRGINIA

THE ROTUNDA

HISTORIC STRUCTURE REPORT

JOHN G. WAITE ASSOCIATES, ARCHITECTS PLLC

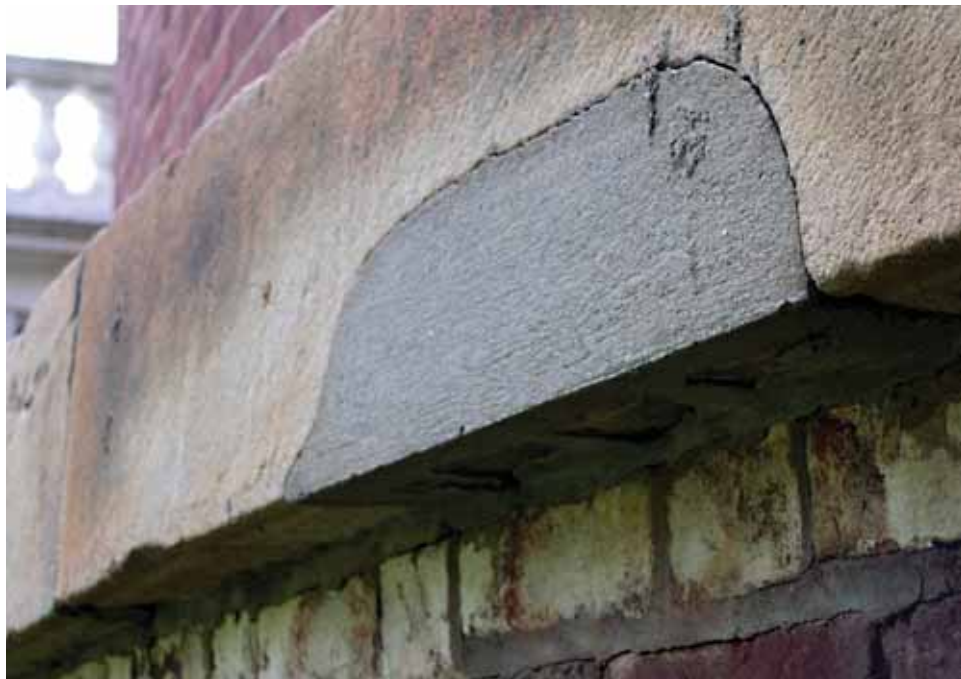
Rotunda, East Elevation. The sandstone water table is chipped and broken at its outer face, overhanging edge, and butted joints. A large brick-and-mortar repair to the sandstone beneath the center window has failed. [JGWA, 2006]

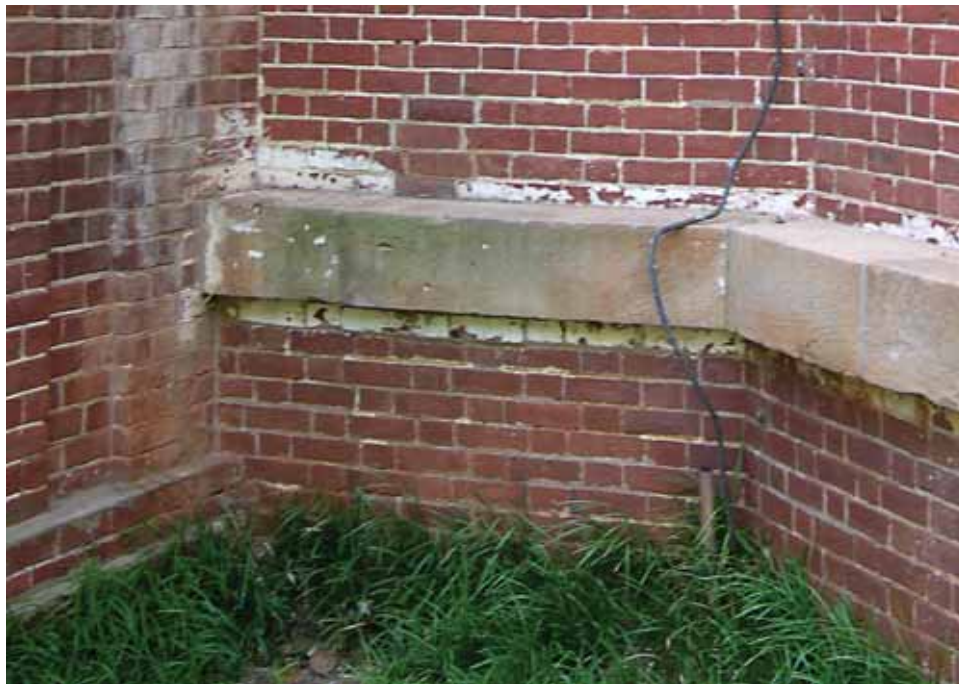
Rotunda, East Elevation. Evidence of paint coatings remains on the brickwork above and below the stone water table at the south end of the wall. The lightning down-conductor cable has been pulled loose from the wall, and there are lime-run (calcium carbonate) deposits on the brickwork. [JGWA, 2006]

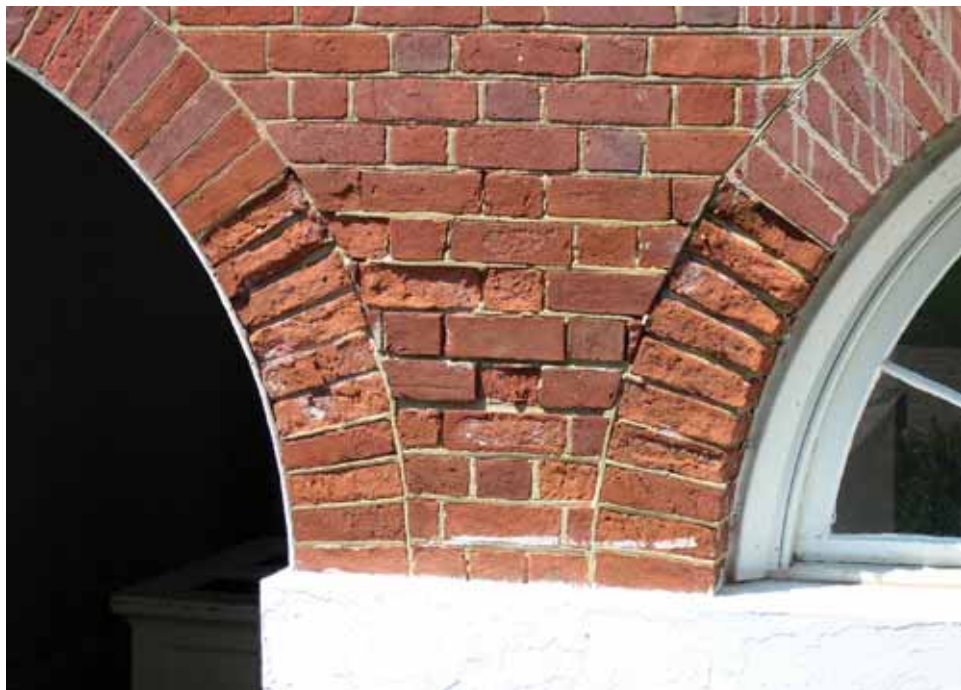
Southeast Wing, South Elevation. The brickwork has been grit-blasted, leaving an eroded surface. The brick is spalling in isolated locations, and there are lime-run (calcium carbonate) deposits on the brickwork beneath the marble cornice. [JGWA, 2006]

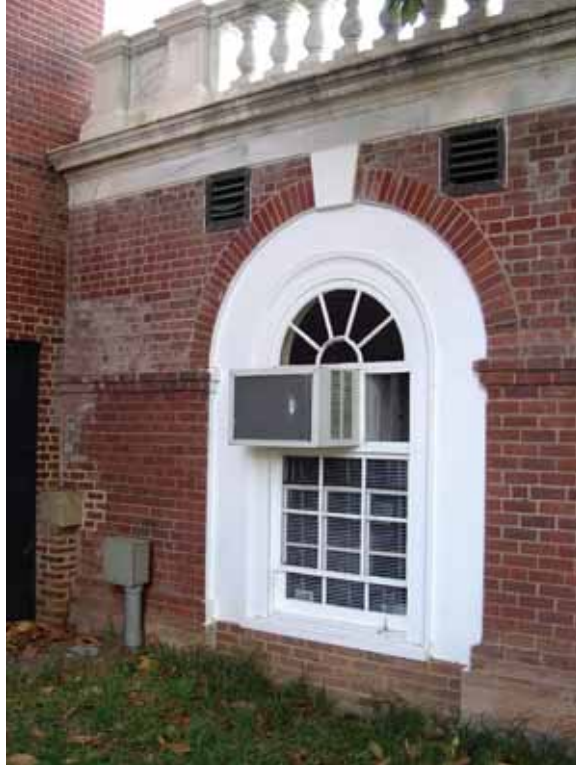
Northeast Wing, South Elevation. The window air-conditioning unit and electrical conduit at the west end of the wall detract from the historic character of the courtyard. [JGWA, 2006]

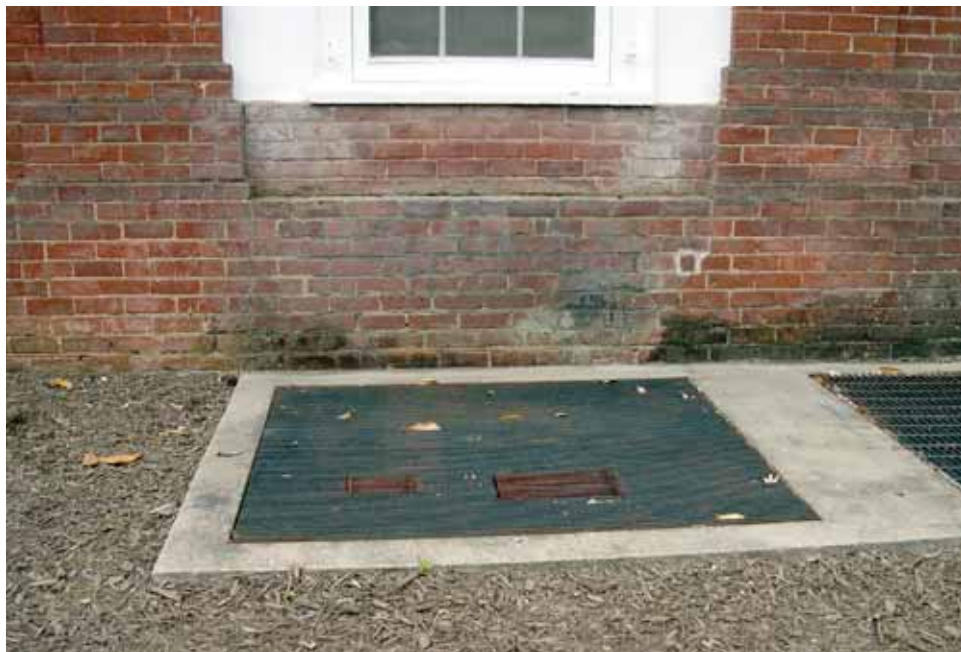
Northeast Wing, North Elevation. The painted surfaces have chalked and stained the brickwork. There is dark biological staining on the brick near the rusted areaway grates. [JGWA, 2006]

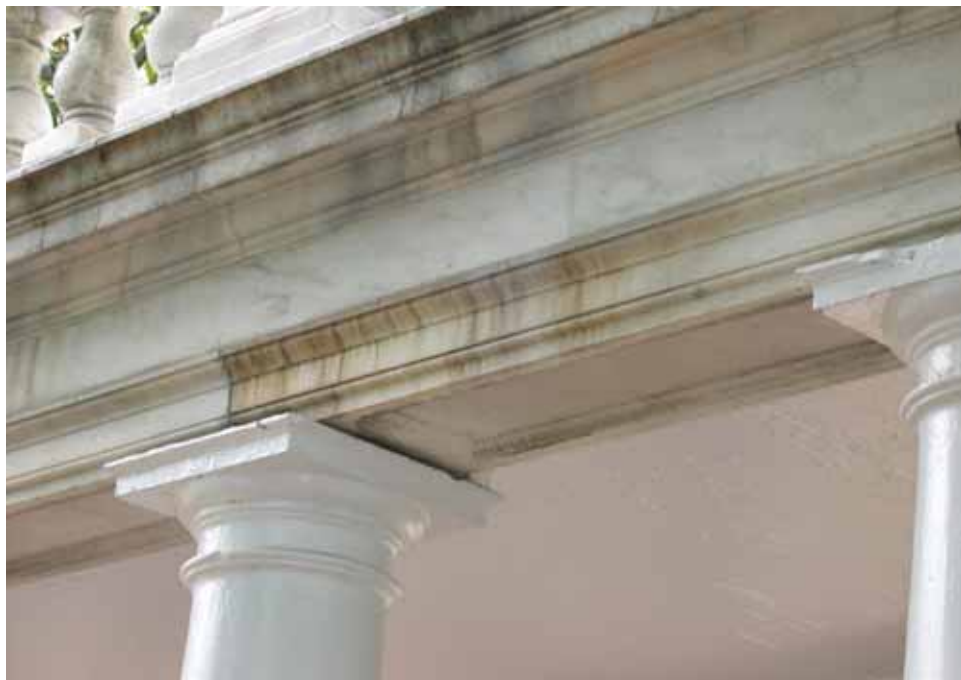
East Colonnade, East Elevation. The marble entablature and soffit have been soiled and stained by rainwater run-off, originating in the terrace construction above. [JGWA, 2006]

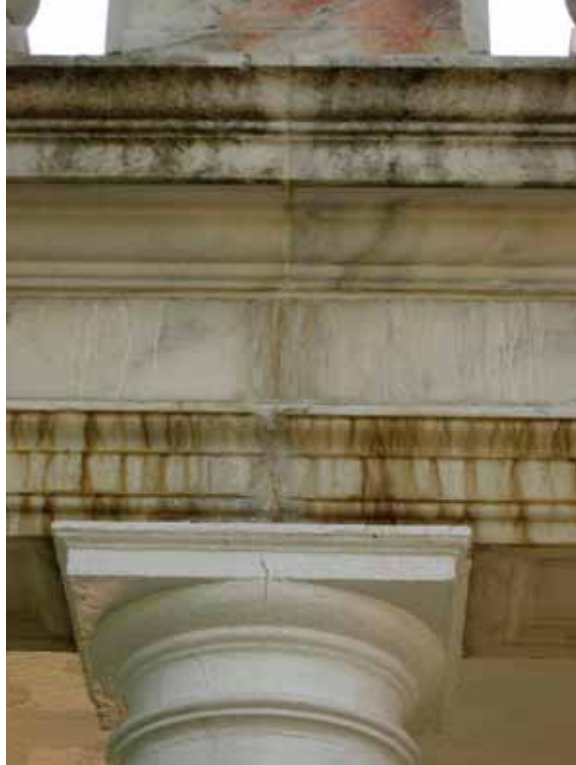
West Colonnade, West Elevation. There are lime-run (calcium carbonate) deposits at the vertical joints in the marble entablature, and rust colored staining on the architrave. This deterioration has resulted from water percolating through the terrace construction above. [JGWA, 2006]

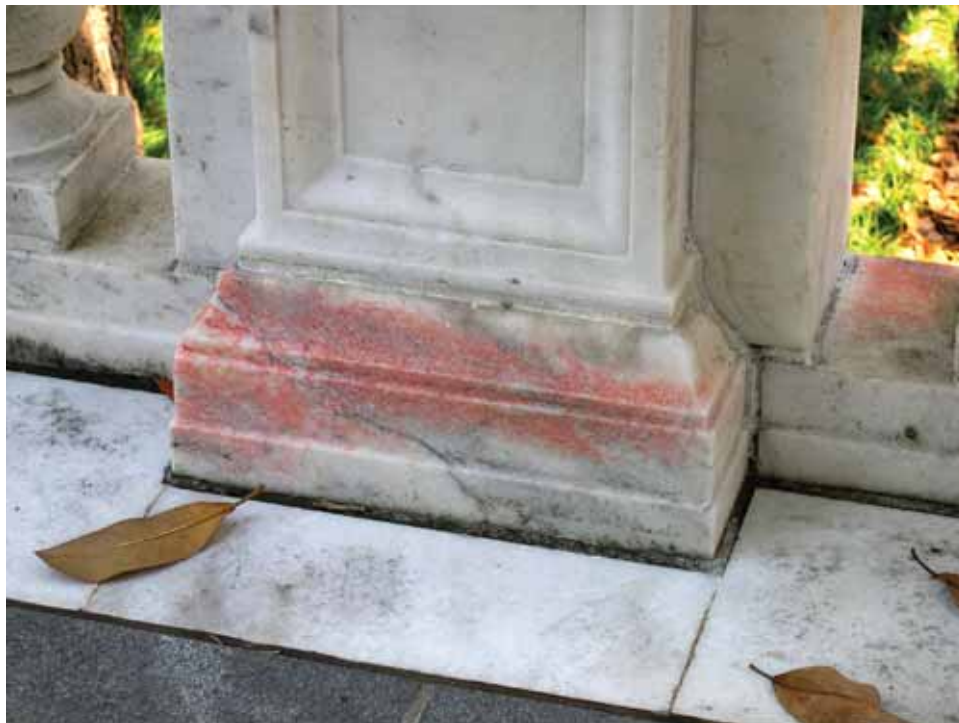
West Terrace. There is vivid orange “staining” along the bottom rails of the marble balustrades; this appears to be subsurface biological growth. [JGWA, 2006]

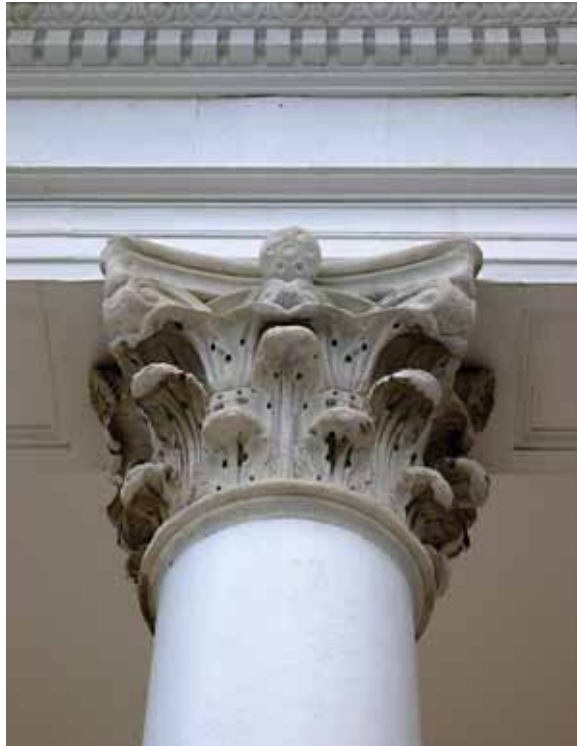
South Portico. The outer, exposed surfaces of the marble capitals are eroded. There are yellow-brown to black gypsum deposits on the inner, protected surfaces of the capitals. [JGWA, 2006]

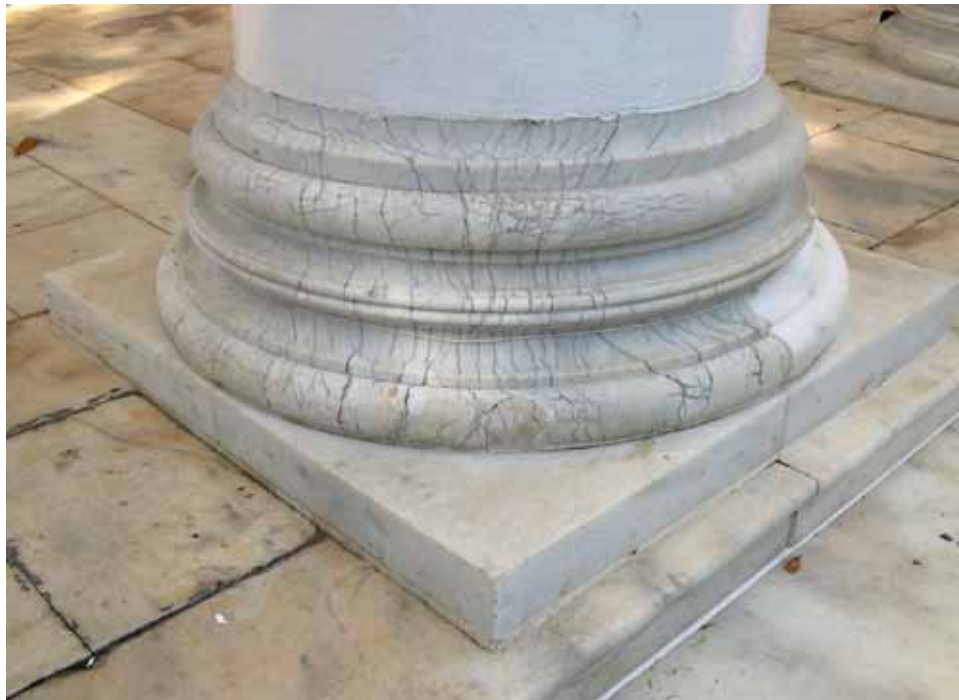
South Portico. The marble column bases have networks of cracks. [JGWA, 2006]

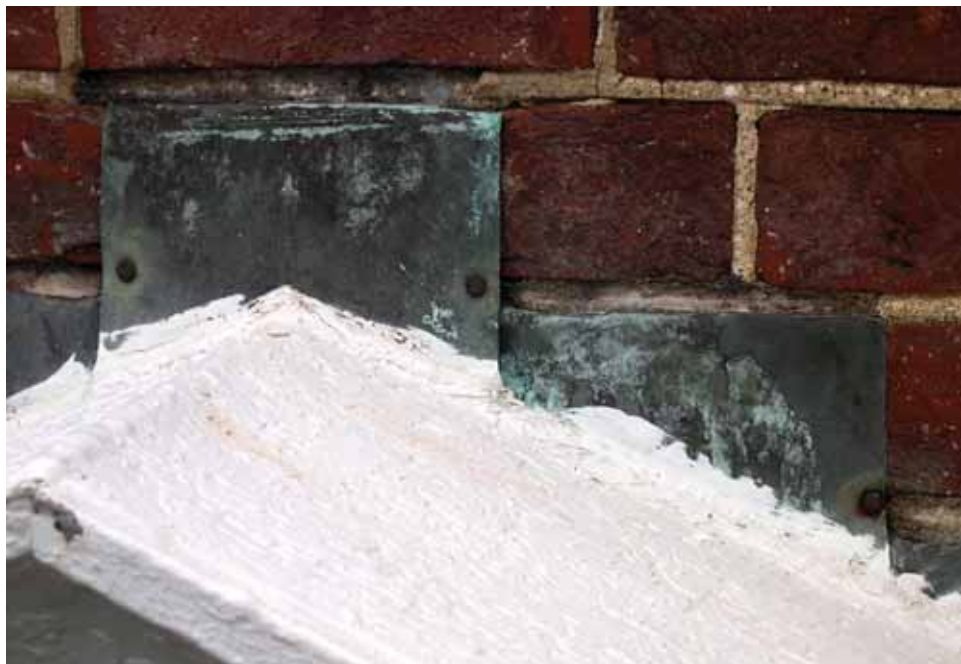
Rotunda, West Elevation. The copper step flashing above the pediments of the first floor windows is nailed into the masonry with ferrous cut nails. Galvanic corrosion is attacking the nails. [JGWA, 2006]

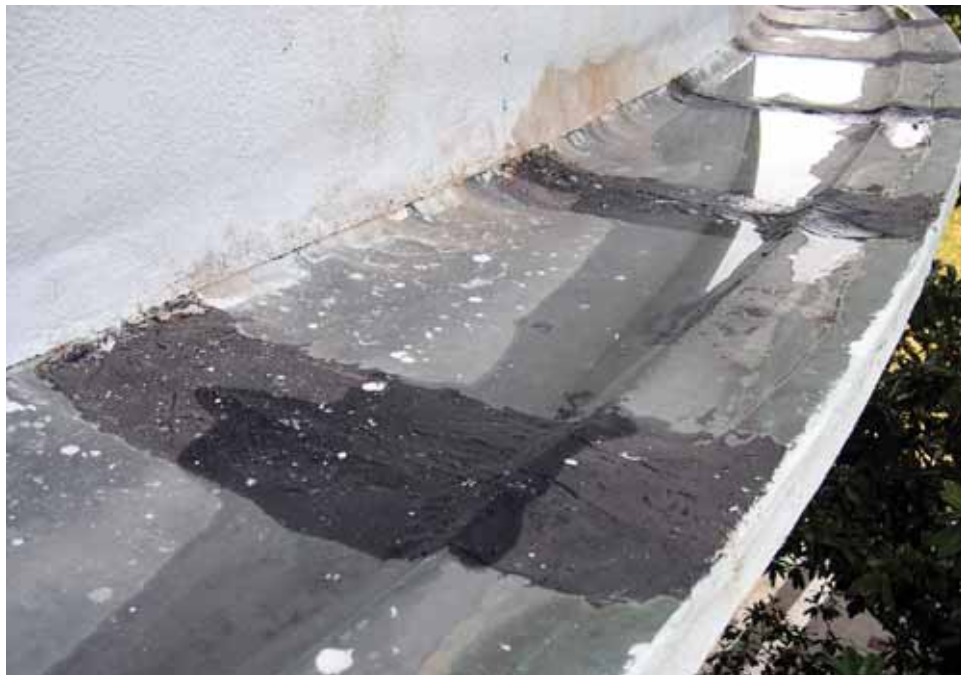
Rotunda, West Elevation. The seams in the copper sheet metal gutter above the intermediate cornice have been repaired with fiber-reinforced elastomeric seam tape. The tape is failing from long-term exposure. [JGWA, 2006]

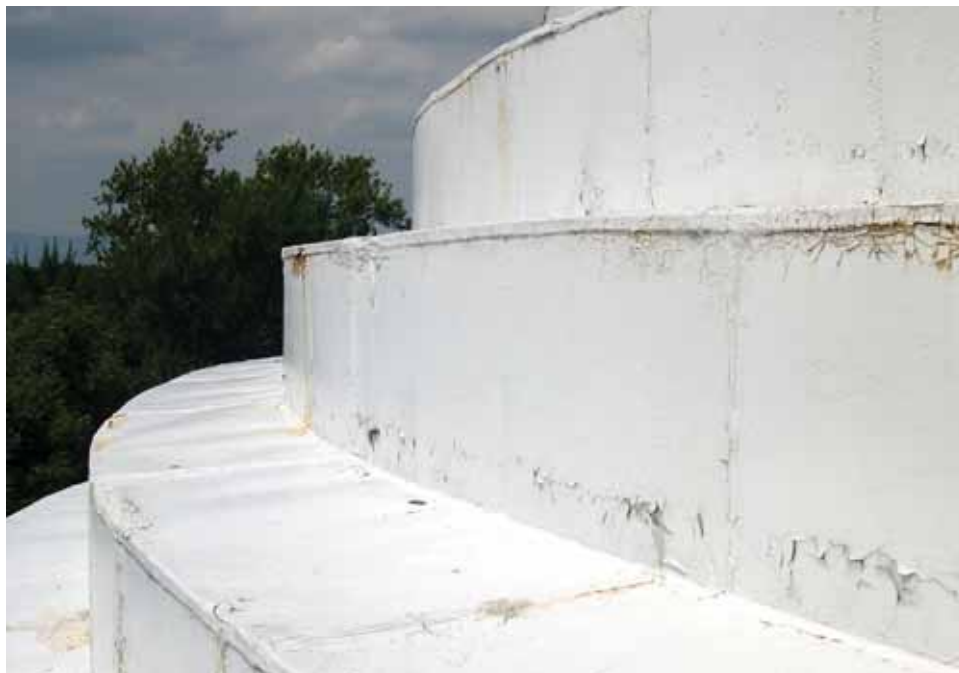
Rotunda, Roof. The painted finish on the terne-coated sheet metal roofing of the dome is crazed and rust stained; this condition is pronounced on the north elevation. [JGWA, 2006]

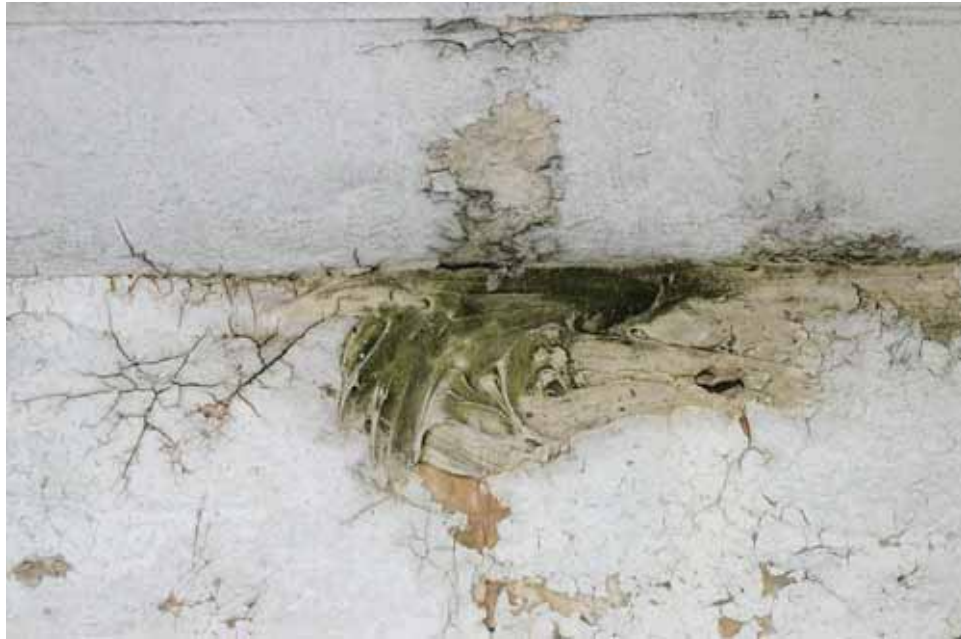
Rotunda, Roof. Inadequate attempts have been made to cover areas of exposed sheet metal on the steps at the base of the dome with smeared sealant. The sealant is supporting the growth of algae.[JGWA, 2006]

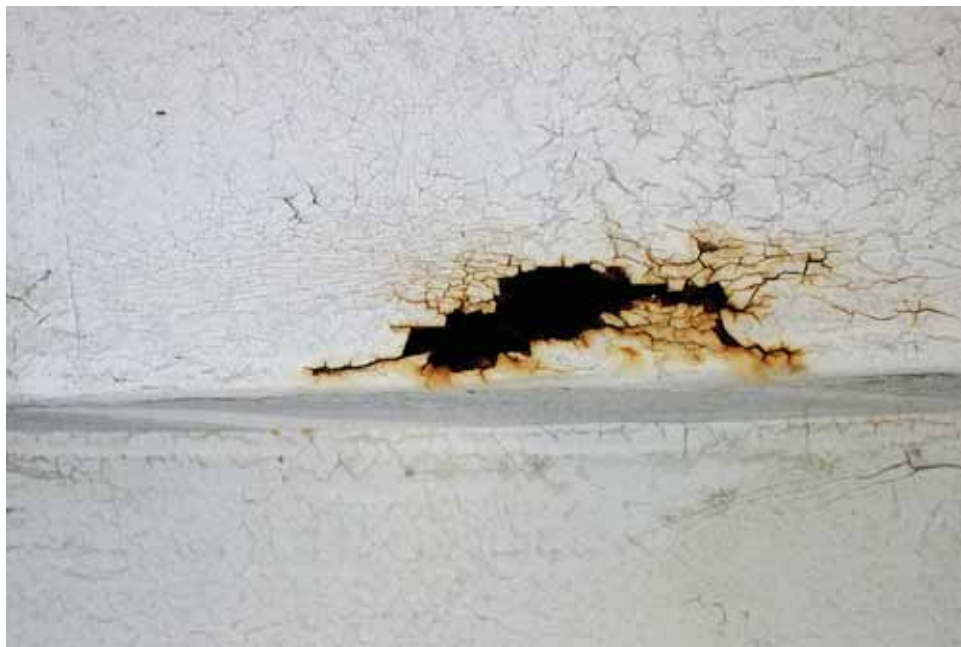
Rotunda, Roof. The painted finish on the terne-coated roofing of the dome is crazed and peeling; the underlying sheet metal is rusting through. [JGWA, 2006]

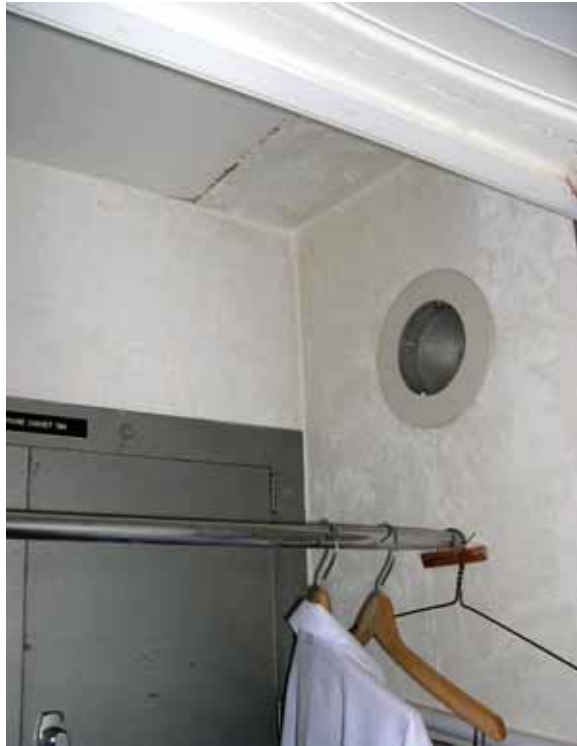
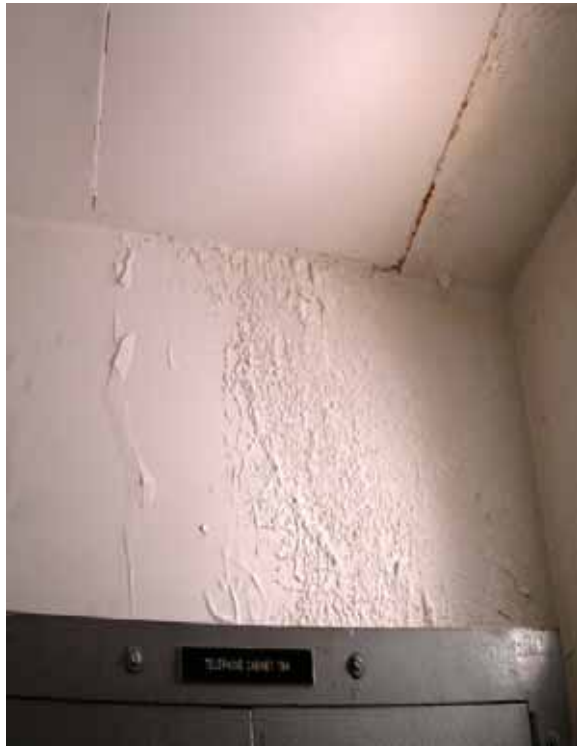
The plaster on the ceiling and upper southeast wall surfaces of the northeast closet (101B) in the ground floor stair hall is water damaged. The plaster is friable, and the painted finish is peeling. [JGWA, 2006]

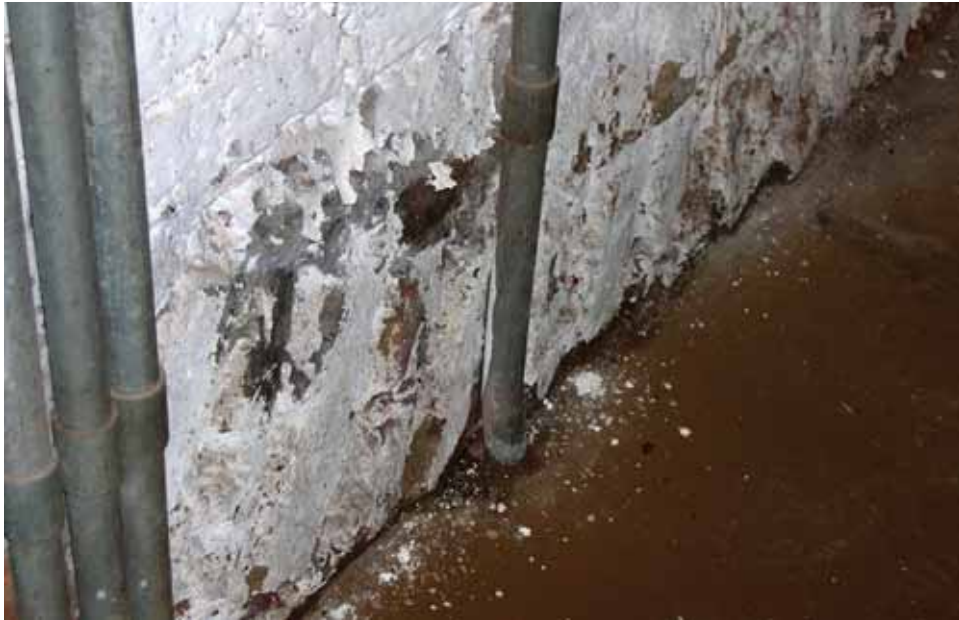
There is rising damp in the masonry construction of the north and east walls of Mechanical Room (108). The painted wall finish is peeling, and efflorescence has formed on the masonry. [JGWA, 2006]

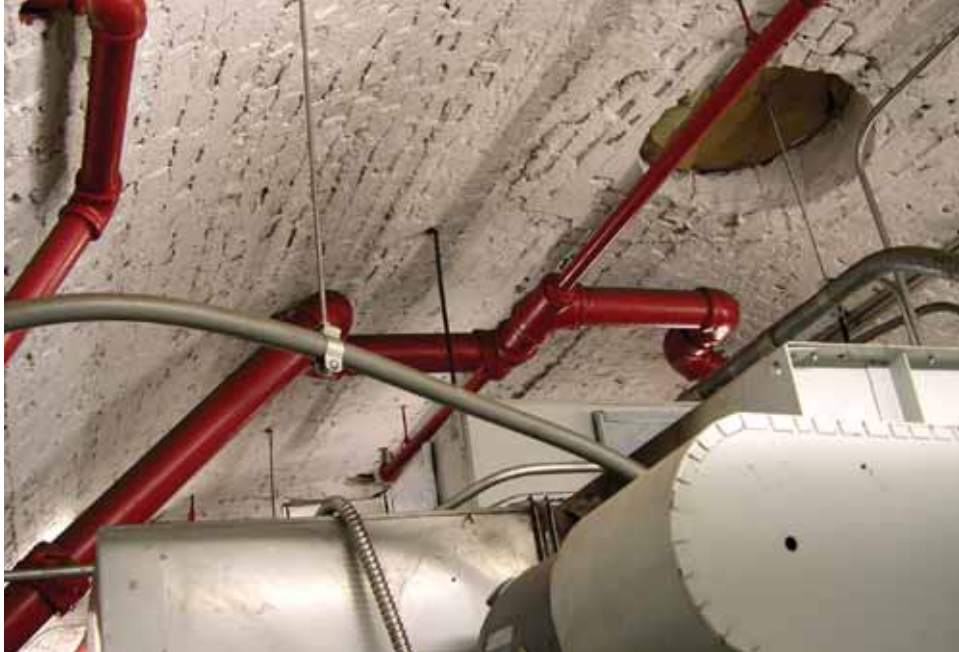
The clearance space for mechanical, electrical, telephone, and sprinkler equipment in Mechanical Room (108) is inadequate and does not meet current building codes. [JGWA, 2006]

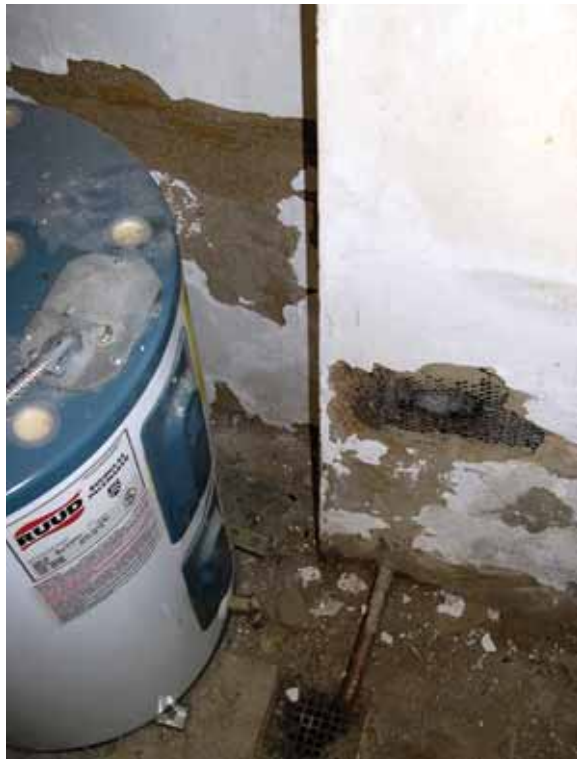
Rising damp has caused the wall plaster in Closet (T102B) to deteriorate, exposing the metal lath and brown coats of plaster. [JGWA, 2006]

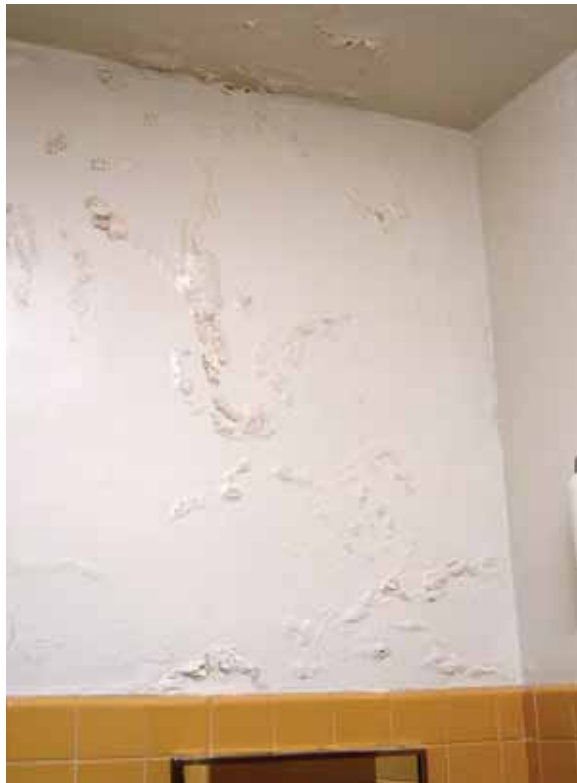
*The plaster wall and ceiling
surfaces in the northeast
corner of the Men's Toilet
Room (T113) are badly
blistered. The plaster is
friable, and the painted finish
is peeling as a result of water
infiltration. [JGWA, 2006]*

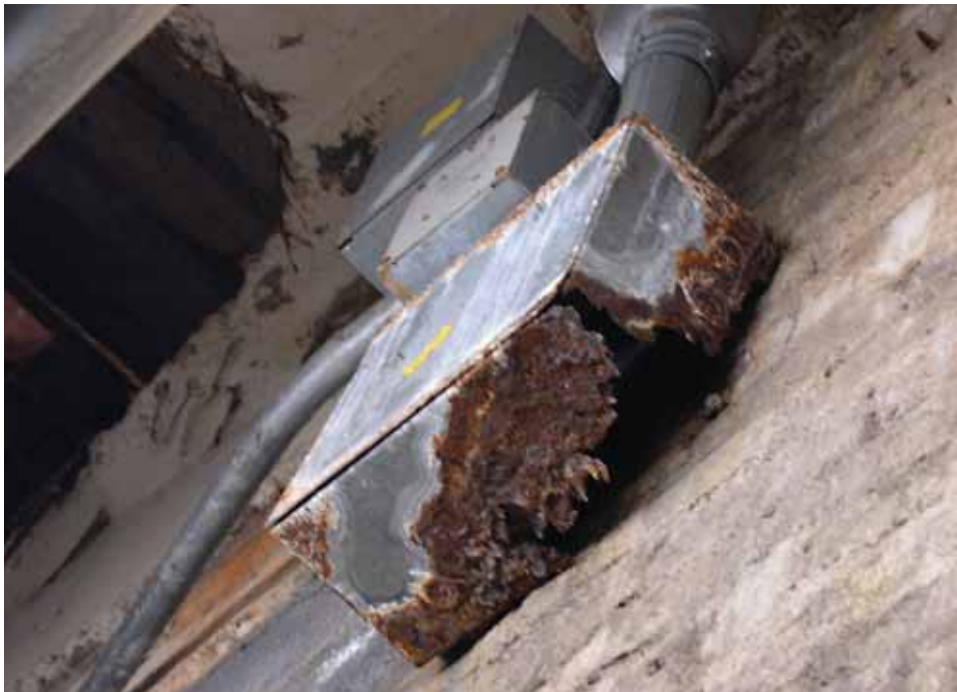
Significant problems with water infiltration in the Mechanical Room beneath the north portico have lead to advanced deterioration of equipment and fixtures. [JGWA, 2006]

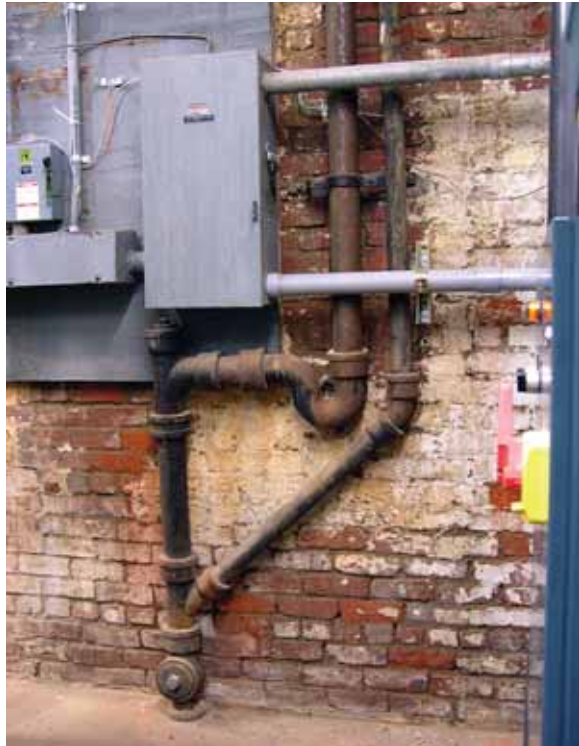
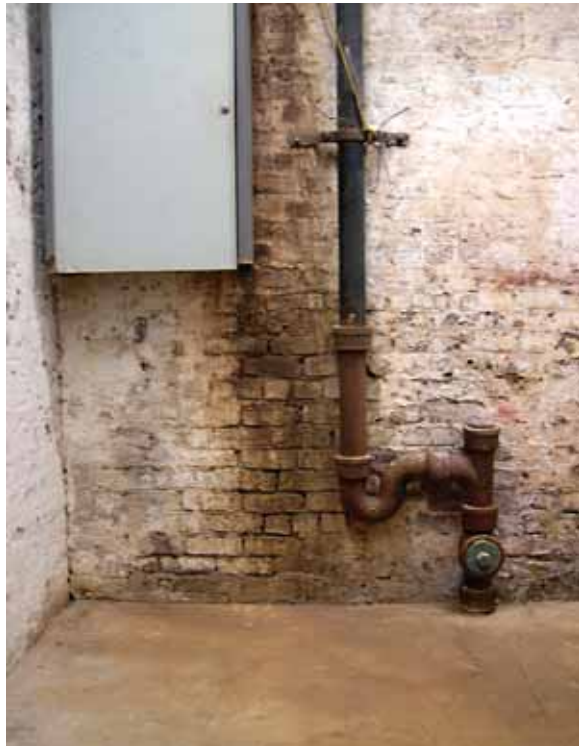
*Years of water infiltration and rising damp in the masonry walls of the Mechanical Room beneath the north portico have eroded the mortar and caused the brick to spall.
[JGWA, 2006]*

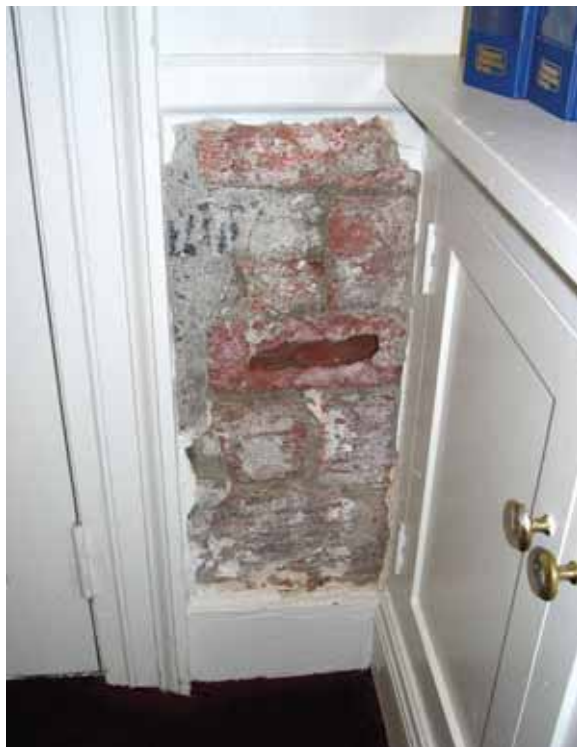
The plaster finish is missing from the south wall of the office of the Vice President for Student Affairs (124), west of the door opening and below the chair rail. The hollow clay tile wall construction is exposed. [JGWA, 2006]

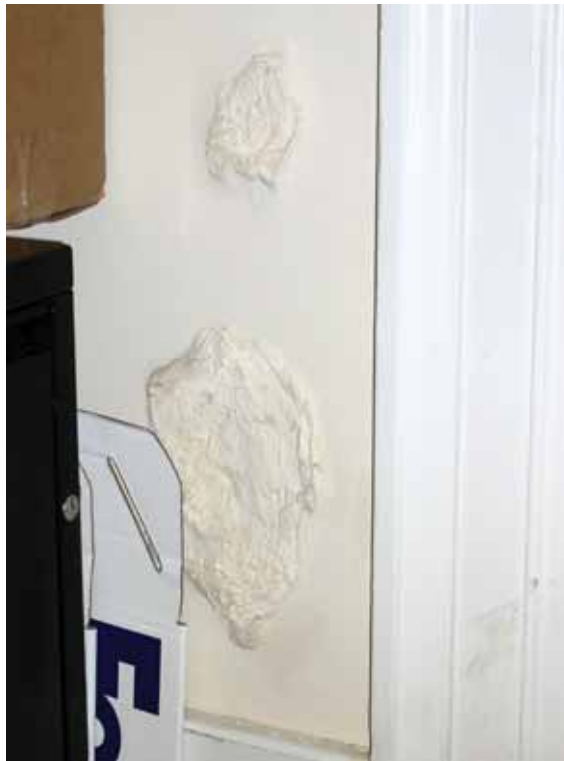
The wall plaster on the south elevation of room 154, to the east of the door opening, is friable. Water infiltration has caused the plaster to "bloom." [JGWA, 2006]

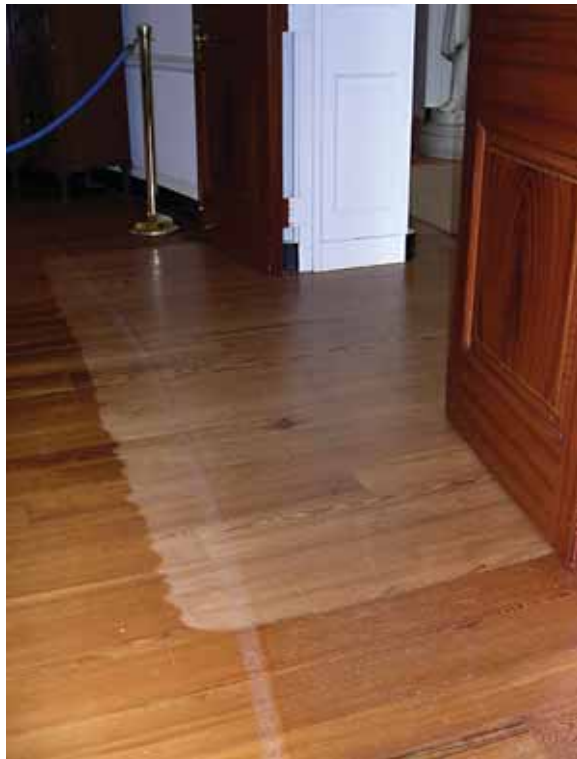
Floor sanding in the Center Hall (C202/C203) was continued through the east entry of the President's Reception Room (Upper West Oval Room 201). This refinishing work and the perimeter abrasion from a large oval rug have caused discoloration and uneven wear in the heart pine flooring. [JGWA, 2006]

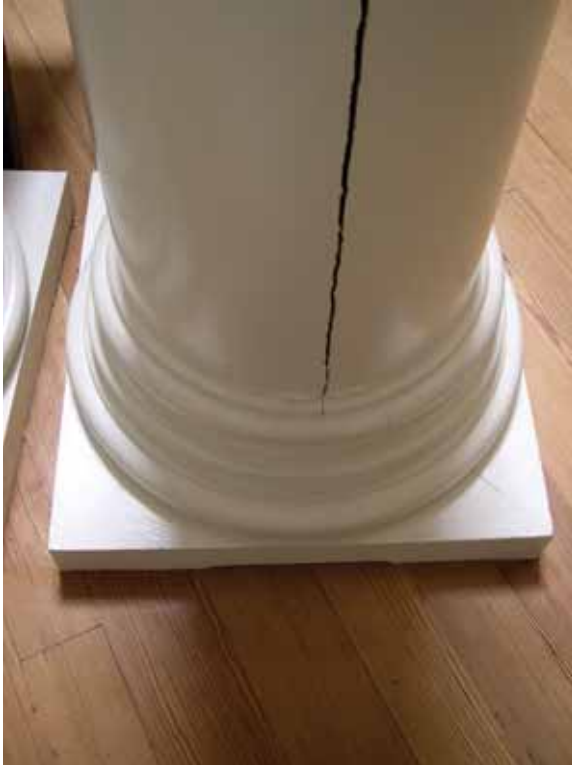
One column in each pair of columns encircling the Dome Room (301) has two vertical cracks, opposed 180 degrees from one another. The cracked wood columns have structural steel columns within them. [JGWA, 2006]

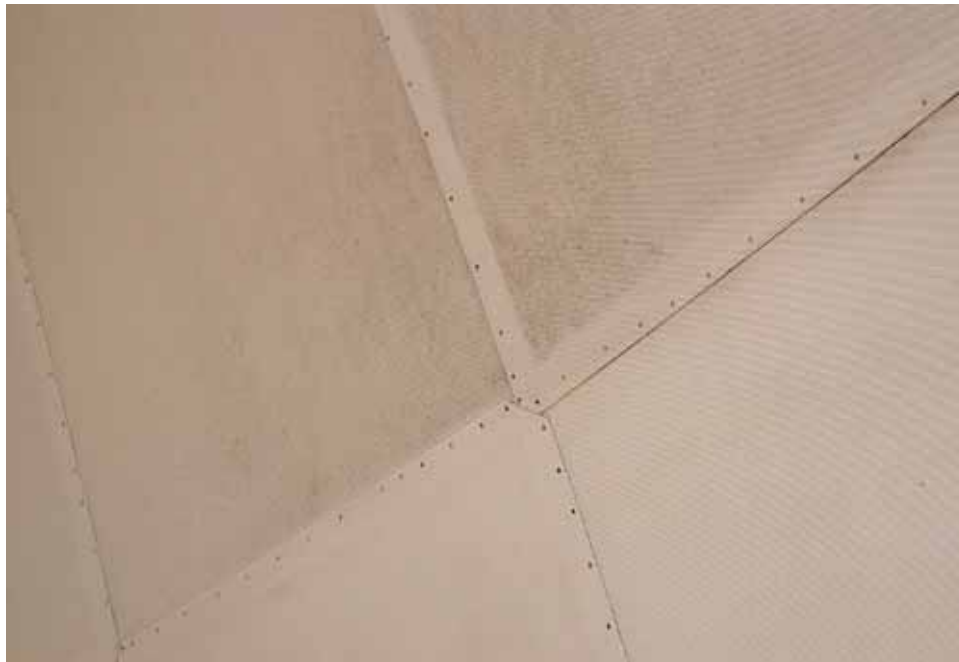
Some of the vinyl-coated, perforated metal acoustic ceiling panels that line the dome are discolored. Mold was growing on the surface of individual panels prior to the December 2006 mold remediation project. Many of the rivets used to fasten the ceiling panels are rusted. [JGWA, 2006]

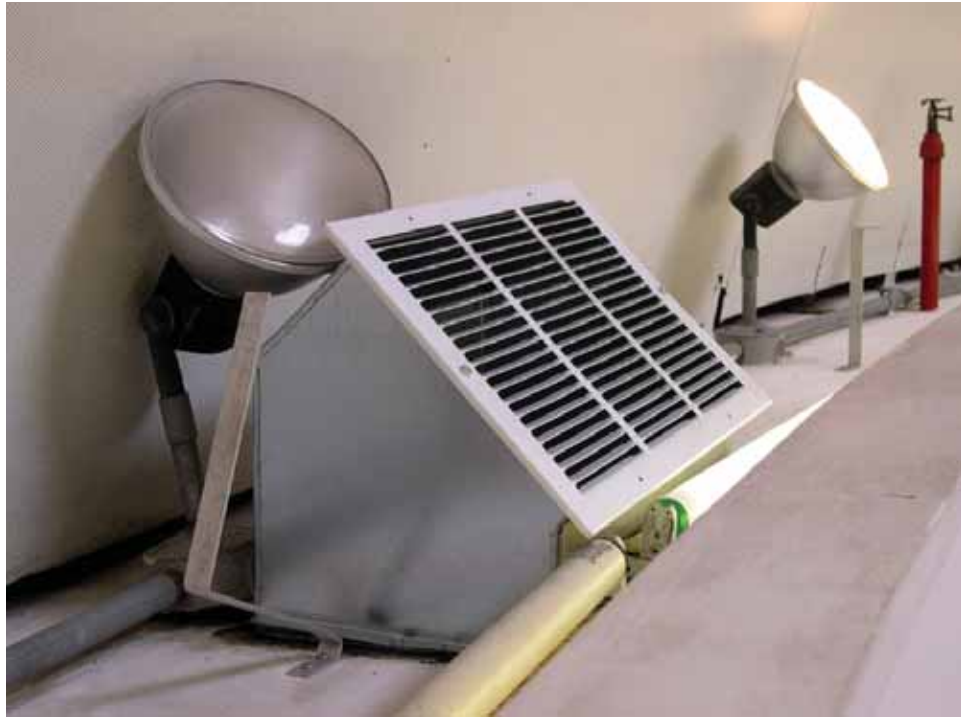
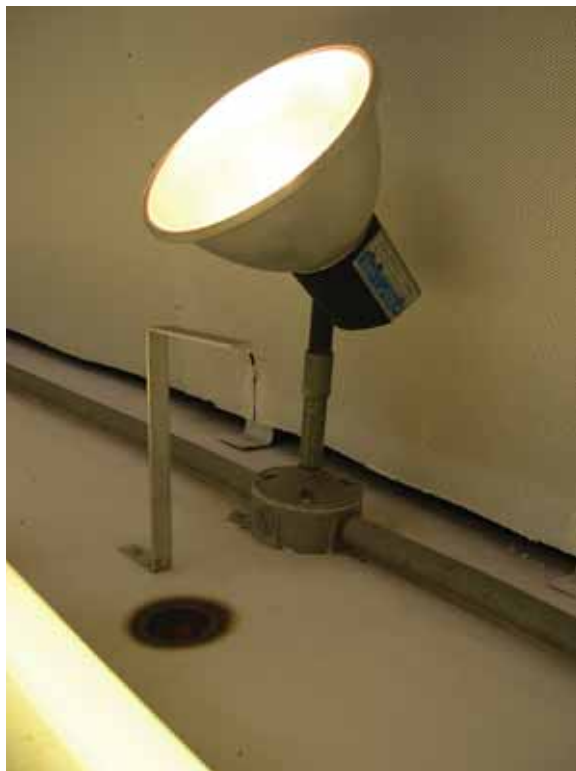
Several of the perimeter spotlights at the base of the dome are not illuminated. Others have been removed or displaced by the installation of HVAC grilles. [JGWA, 2006]

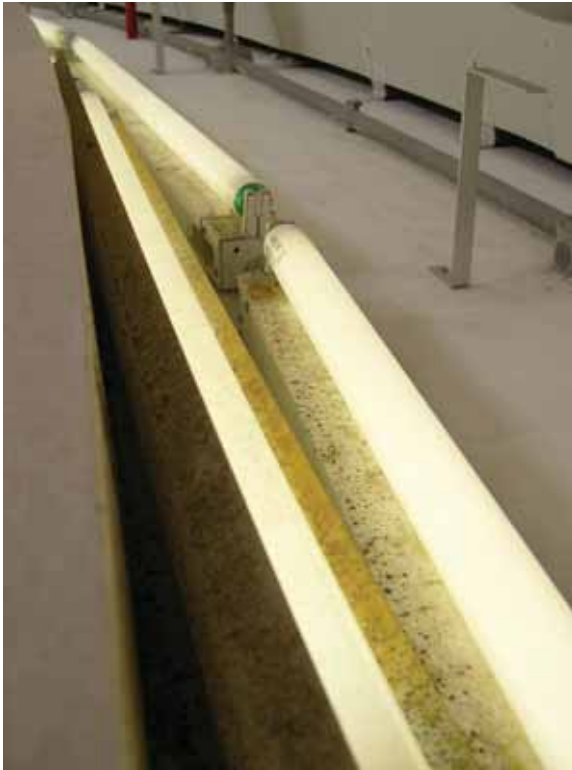
The fluorescent strip lighting fixtures at the base of the dome were removed in December 2006 as part of the mold remediation project. Exposed conductors protruding from conduit remain; these conductors may present an electrical shock hazard. [JGWA, 2006 (top), 2007 (bottom)]

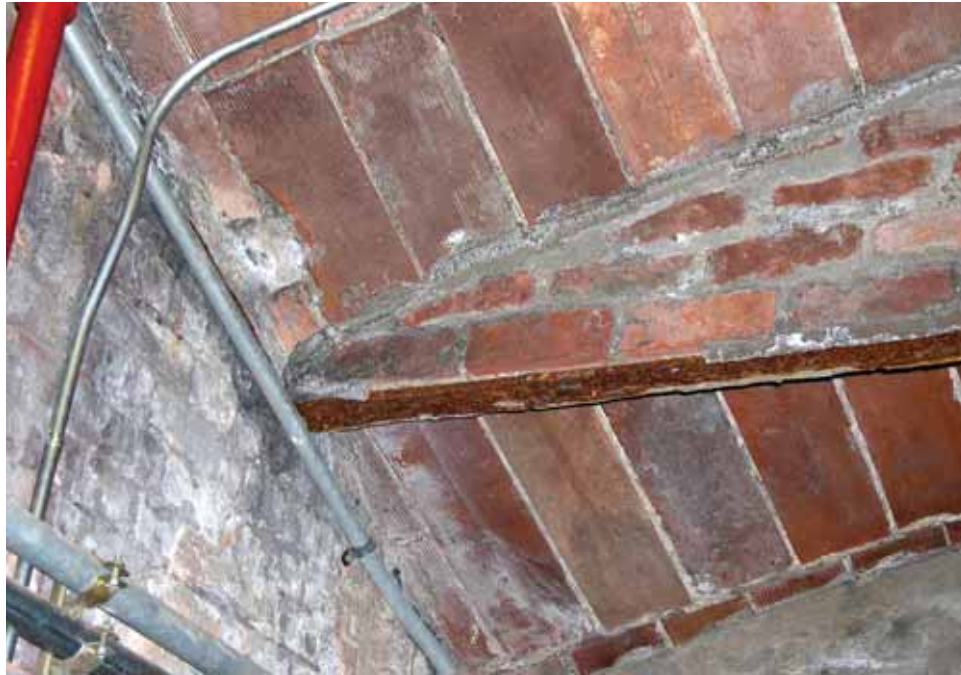
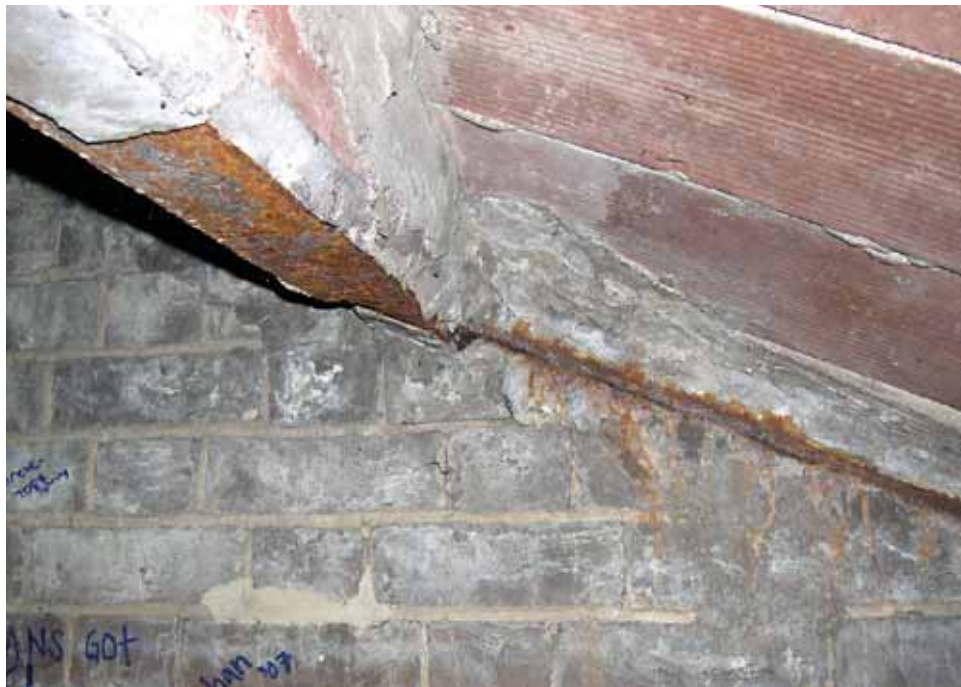
The steel plates and ledgers for the ribs of the tile vaulting in the North Portico Attic (401) are rusting; minimal delamination of the steel is occurring. [JGWA, 2006]

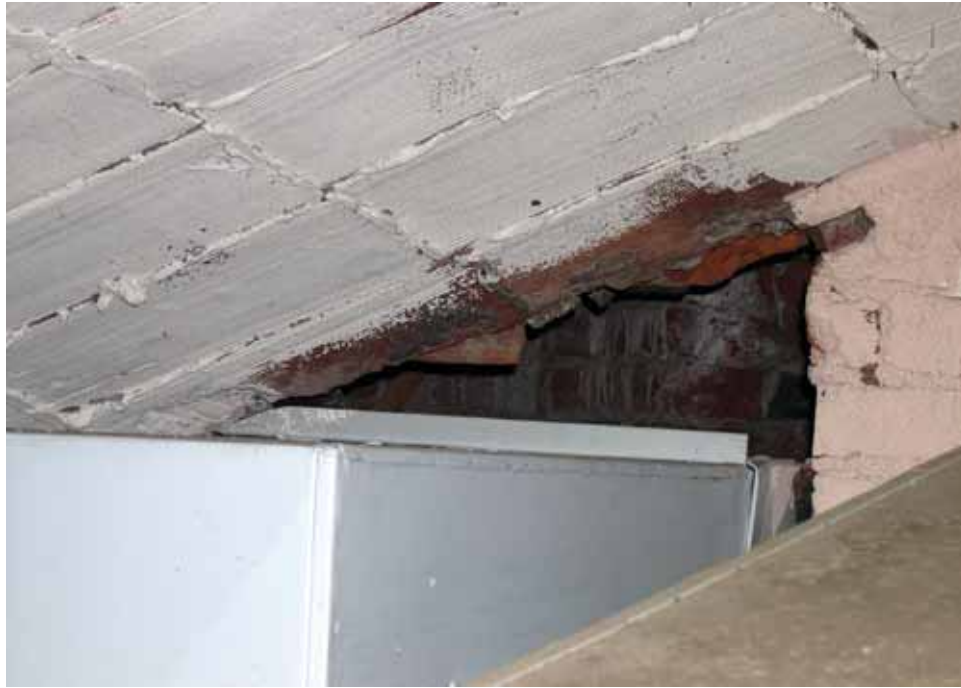
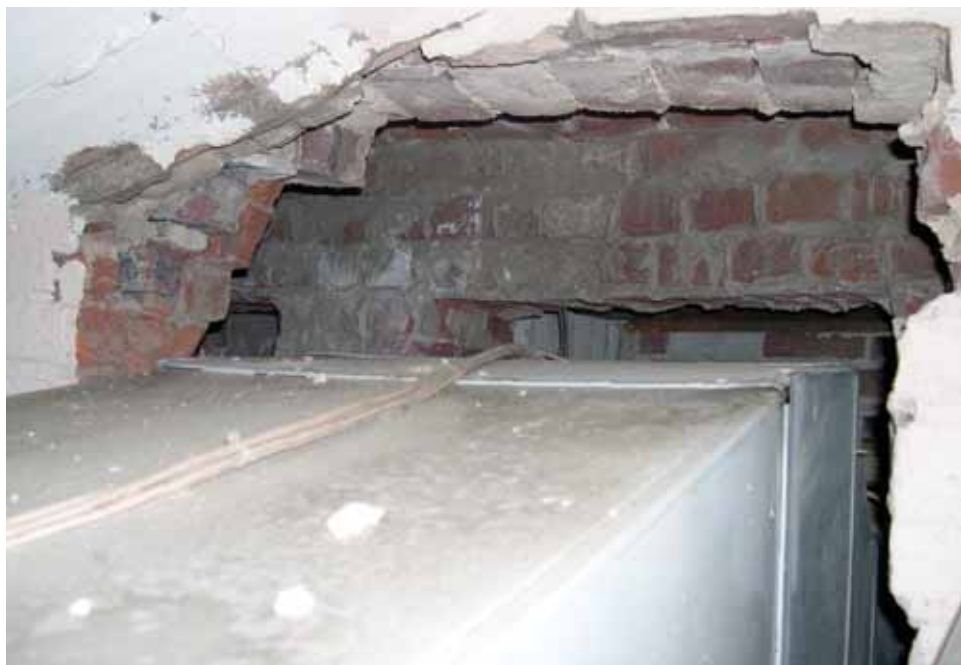
Large duct penetrations have been made in the north wall of the South Portico Attic (402) without providing lintels to support the brick construction above. [JGWA, 2006]

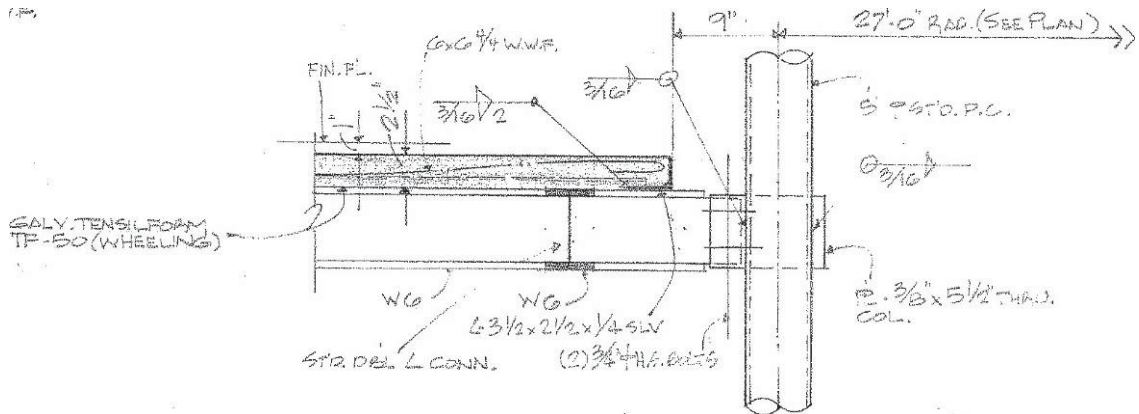
Figure 29: Section X/S.8 from the 1972 Structural drawings shows the connection of the W6 beam in the middle gallery to the column inside the cracked wood casing.
