H I S T O R I C S T R U C T U R E R E P O R T

THE MEWS

UNIVERSITY OF VIRGINIA

DLR GROUP
2021

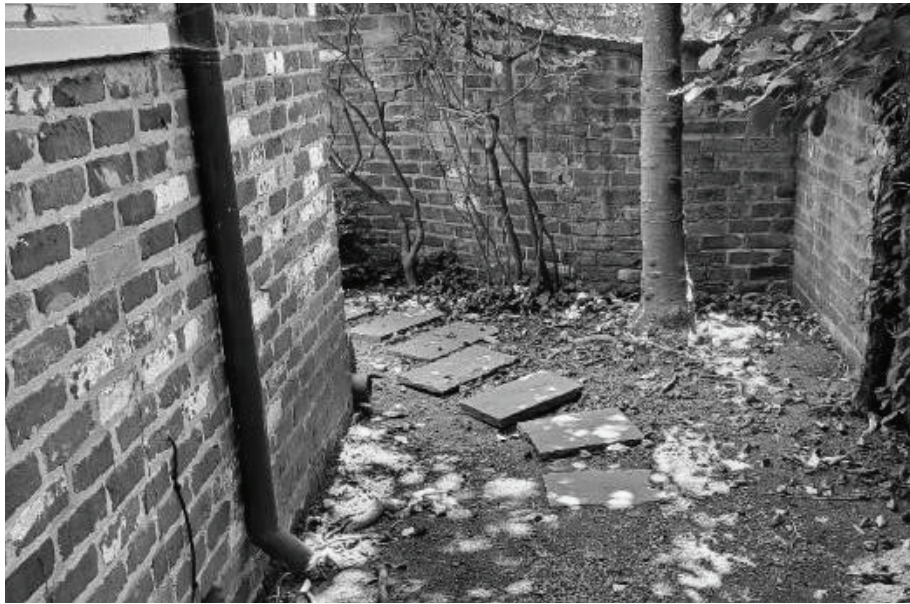
Figure 51. The pipe sticking out at the corner is the roof leader from the main roof. The leader coming down the face of the building is from the second-floor patio. Note the sweetbay magnolia and climbing hydrangea along the back wall.

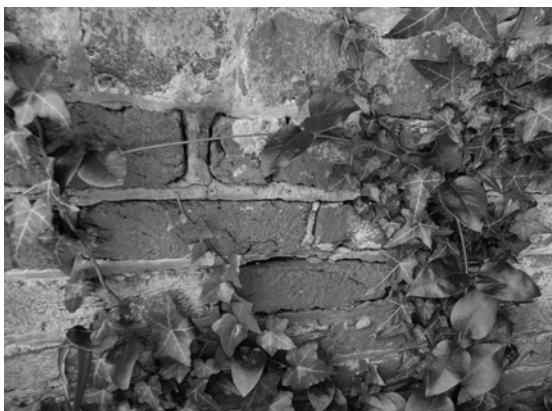
Figure 69. View of heavy brick and mortar deterioration and spalling at the base of the garden wall facing Mews Alley. This wall is directly adjacent to the small walled garden area on the west side of the Mews that is noted for a lack of drainage and retention of excessive moisture.

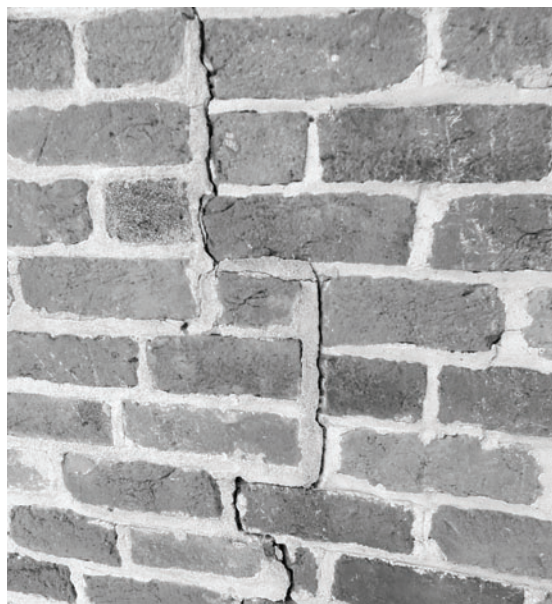
Figure 70. Detail view of the hairline cracking that marks the division between the garden wall and where the brick was toothed into the Mews building's masonry wall. Similar cracking takes place along the division of the one-story west addition and the two-story construction.

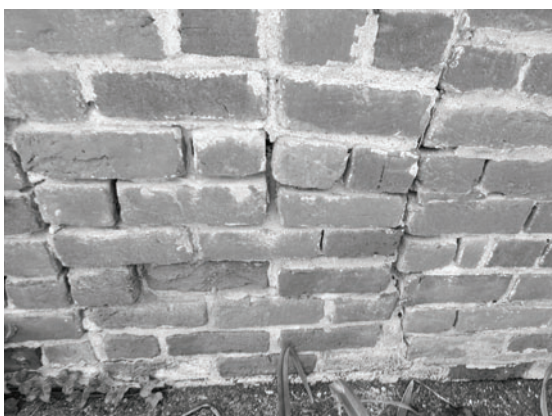
Figure 71. View of severe brick and mortar deterioration and spalling at the base of the masonry wall facing Mews Alley. Inadequate drainage from the alley appears to be the major contributing factor.

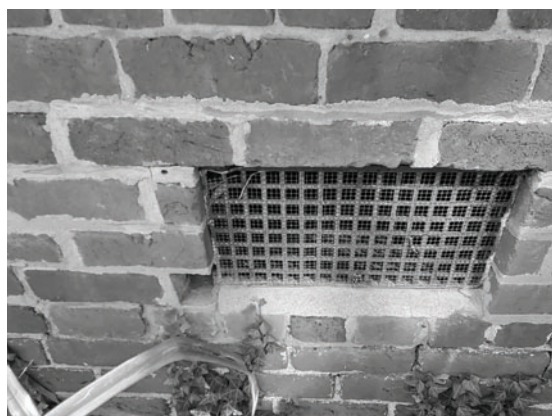
Figure 72. Missing brick, an off-color brick replacement, and heavy mortar deterioration are evident surrounding the crawl space vent. Previous repairs include repointing that extended the mortar past the edge of the brick. The mortar used for repointing also appears to be a much harder mix than the surrounding mortar and may not be compatible with the historic soft brick.

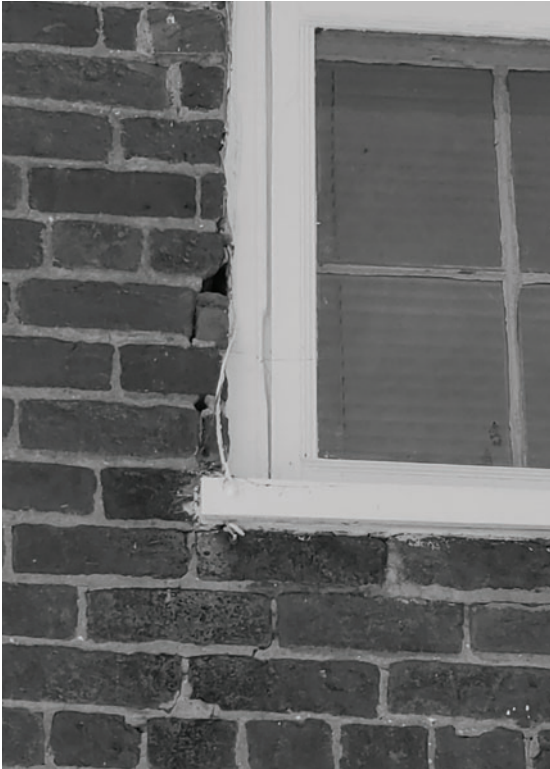
Figure 73. Loss of brick and an inadequate attempt at repair are evident along the frame of the second-story window.

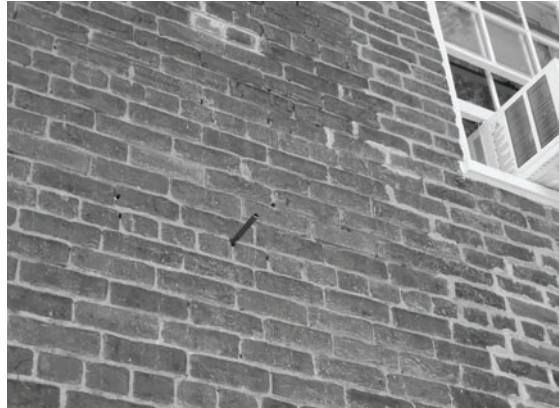
Figure 74. A small pipe is protruding from the north wall approximately 10 feet above the alley pavement. The image also illustrates the numerous voids evident in the grout in this section of wall.

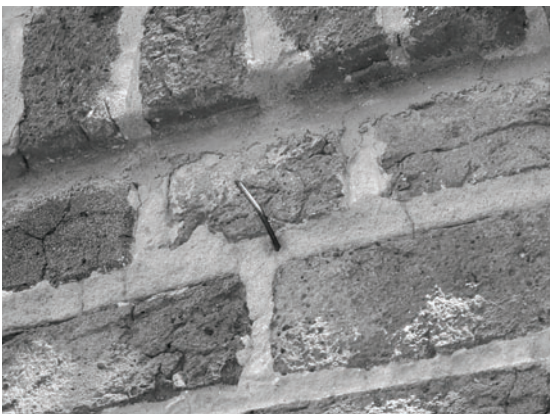
Figure 75. As a general note, there are a variety of fasteners, nails, and screws remaining in the mortar and (to a lesser extent) the bricks themselves. Damaged mortar at multiple locations appears to be the result of removal of fasteners without subsequent mortar repair.

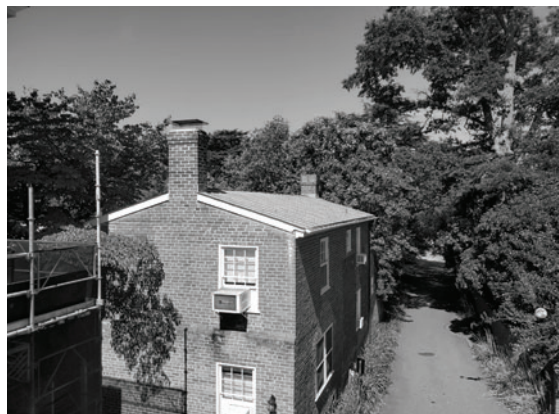
Figure 76. A view of the Mews's roof from neighboring Pavilion III shows the terne-coated stainless-steel sheet-metal roof in good condition with only minimal oxidation evident near the fireplace chimney flashing. Gutters appear sound and free of debris.

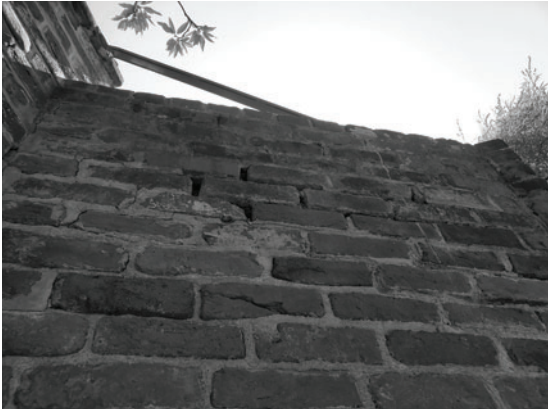
Figure 77. A view of the west wall of the exterior stair shows heavy grout deterioration. Overall, the exterior stair shows the worst grout deterioration found on the Mews. Decorative tiles that were included in the stair construction are in good condition.

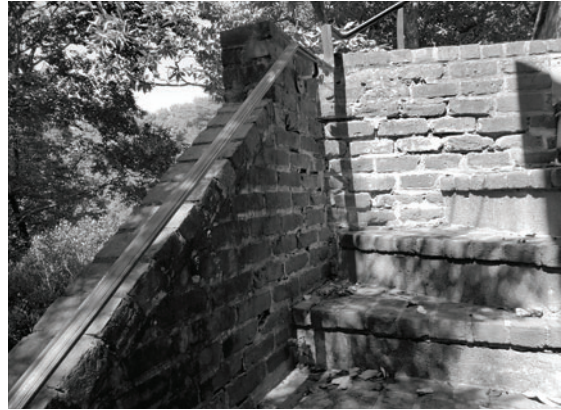
Figure 78. A view of the interior side of the west wall of the exterior stair shows heavy grout deterioration. The exterior stair shows grout deterioration on both faces of the masonry wall.

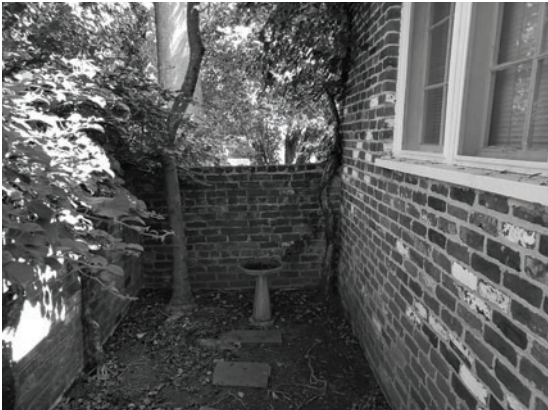
Figure 79. The building rain leaders drain to the small enclosed garden area on the west side of the Mews without any evident path for the water to exit the area. Moisture is evident on the exterior as well as the interior crawl space along the adjacent wall.

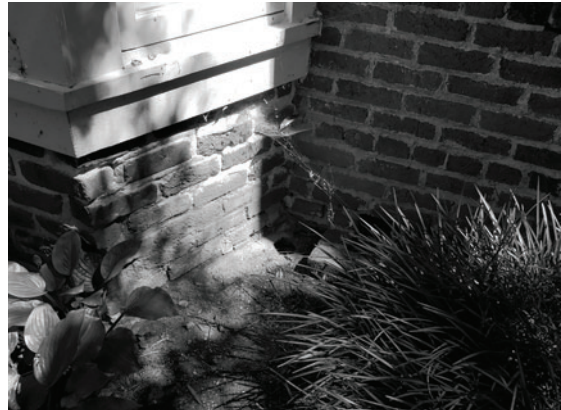
Figure 80. Mortar and brick deterioration are evident, with the increase in moisture along the east side of the bay window where the grade and landscaping prevent proper drainage away from the foundation.

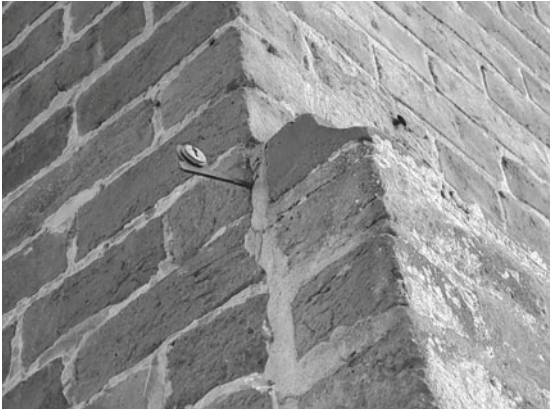
Figure 81. Excess mortar has been smeared on the face of the masonry. Also, a variety of fasteners, nails, and screws are evident across the building. The image shows a brick veneer that was added to the east facade after the removal of an addition on the east end of the building.

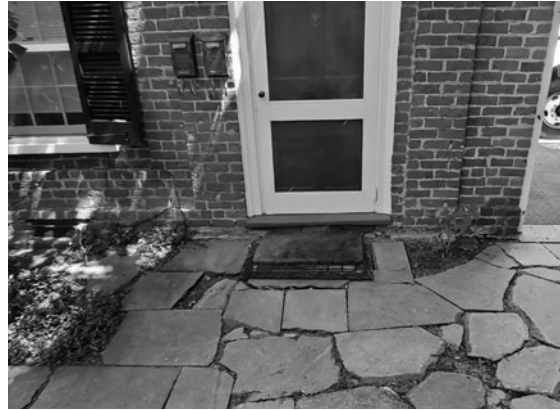
Figure 82. The existing pavers and landscaping adjacent to the south side of the Mews make for both an unequal walking surface and a collector of moisture along the perimeter of the building.

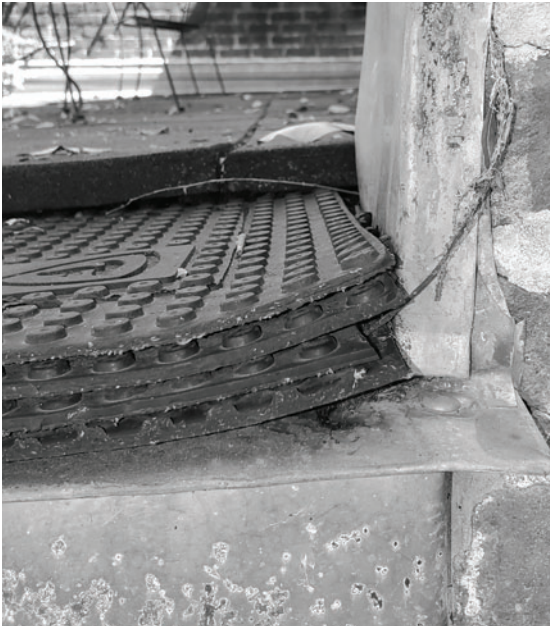
Figure 83. The stair transition at the top of the exterior stair constitutes a tripping hazard. Four layers of a Firestone rubber mat have been stacked on the roof with an additional layer of rubber roof pavers placed for a surface layer. The composition and condition of the substrate beneath the rubber mat was not readily evident.

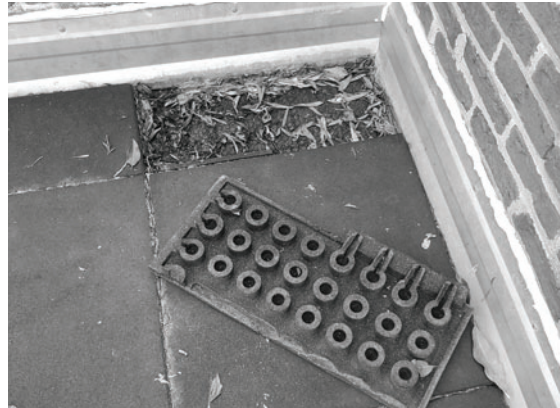
Figure 84. The space between the rubber roof pavers and rubber roof sheet material are collecting debris and moisture. Because the roof pavers are interlocking and are not mechanically fastened, they would allow for the cleaning and removal of the organic materials accumulating beneath the pavers.

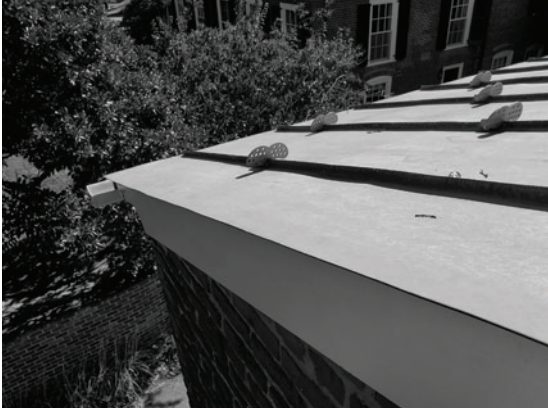
Figure 85. A view of the Mews's roof from the roof deck shows the terne-coated stainless-steel sheet-metal roof in good condition with only minimal oxidation evident near the fireplace chimney flashing. Gutters appear sound and free of debris. Snow and ice stops are in place and appear to be secure.

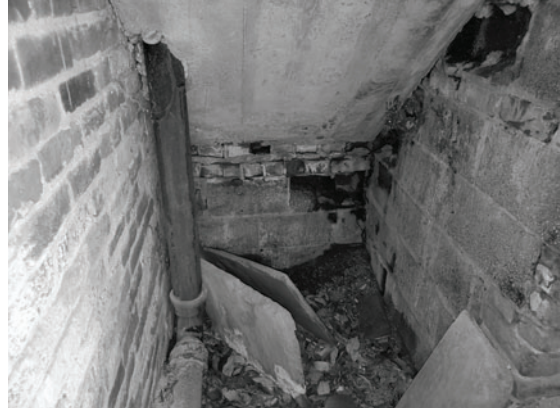
Figure 86. The area beneath the exterior stair is full of debris and illustrates the need for comprehensive maintenance on the exterior stair. A roof leader passes beneath the stair before daylighting in the enclosed garden area just west of the building. This space might provide one of the few appropriate exterior locations for mechanical equipment, if necessary.

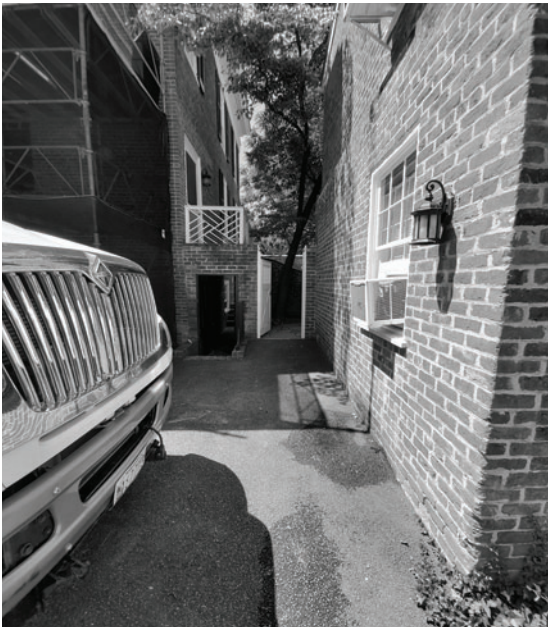
Figure 87. Window air conditioners provide an unwanted source of moisture at several locations around the perimeter of the building. There is no transition between the asphalt paving and the masonry wall on the east side of the building.

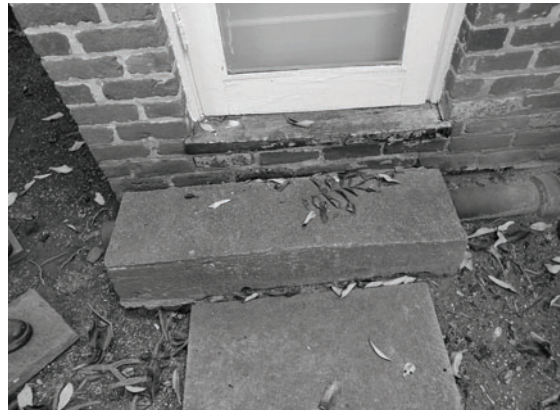
Figure 88. A single concrete step at the southwest kitchen door does not provide an equal stepping transition between the garden pavers and the kitchen entry level. The step does not appear to be directly attached to the masonry.

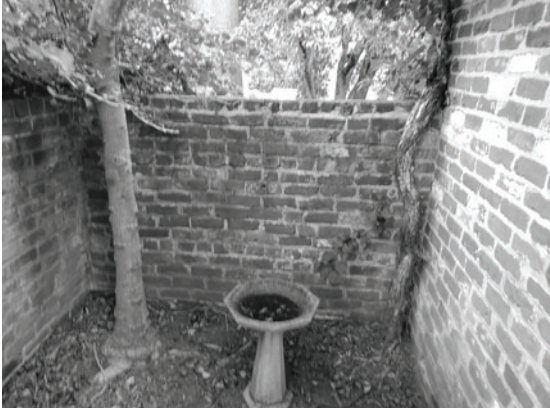
Figure 89. The interior side of the Mews Alley wall has several areas where cracking seems to indicate ongoing settling in the foundation of the wall. A variety of mature plants are growing in close proximity to or directly on the wall itself.

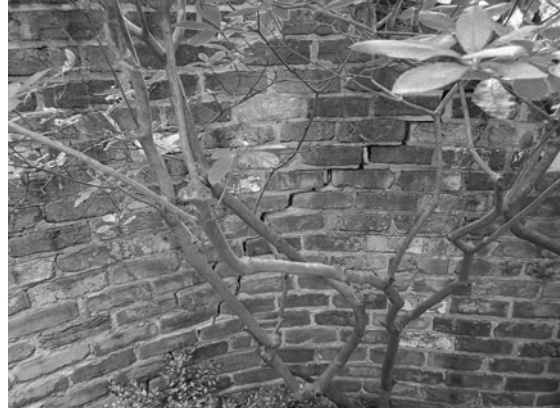
Figure 90. The low exterior wall that separates the Mews from the larger garden area has several areas where cracking seems to indicate ongoing settling in the foundation of the wall. A variety of mature plants are growing in close proximity to or directly on the wall itself.

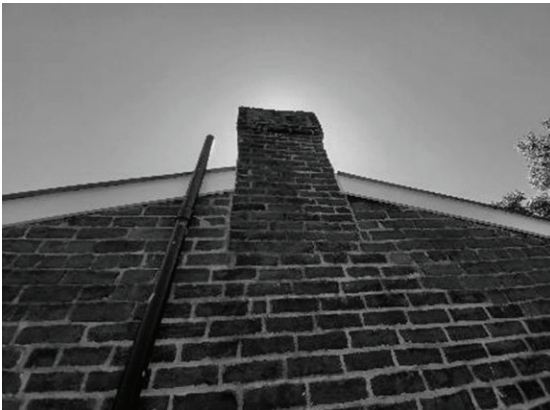
Figure 91. Detail view of unsecured exterior PVC vent pipe that exits through the second-floor patio and roof. The pipe is not firmly secured to the building.
