THE HISTORIC REFECTORY BUILDING at the UNIVERSITY OF VIRGINIA

A Historic Structure Report

John Milner Associates, Inc. Alexandria, Virginia

February 2009

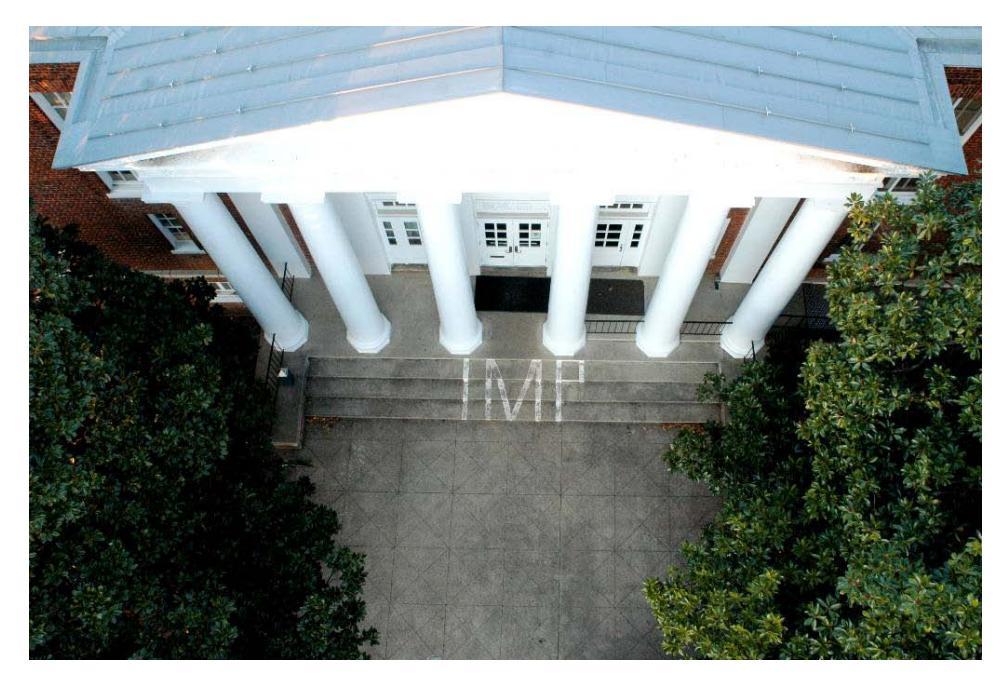
The South plaza is an uninviting concrete pad with little site furnishing. It is flanked by two large planting areas with very large trees.

**Recommendations:** Site drainage system requires redesign and additional capacity to handle existing downspout discharge and provide for general site drainage at paved areas. The location of trees and plantings must be carefully reconsidered.

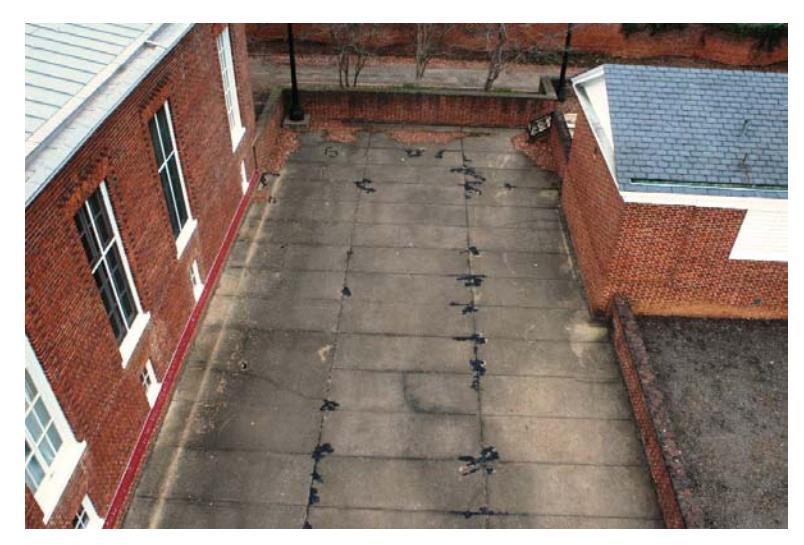
The areaway is an inhospitable zone with most of the equipment that once occupied it long since removed.

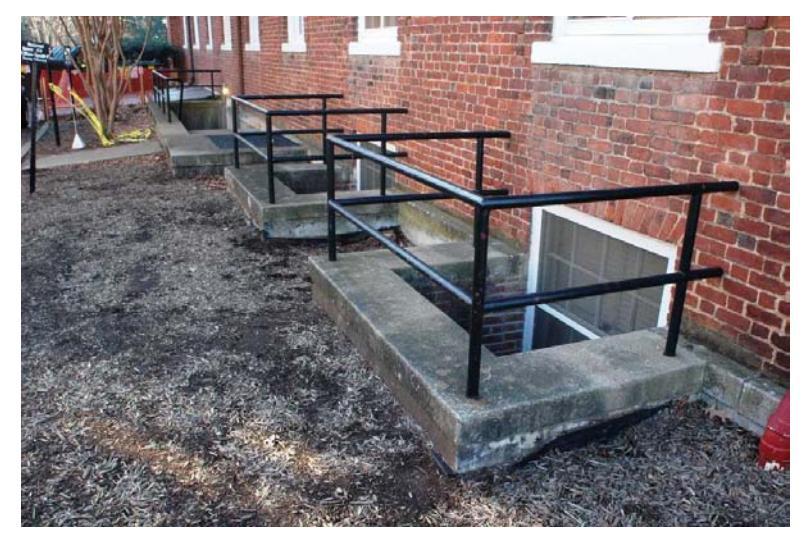
**Existing Conditions:** In general, foundations were found to be stable and in excellent condition. The absence of appropriate rainwater management at the base of the building is cause for concern as this will result in extensive damage over time. Foundation waterproofing appears to be compromised along the north wall. Wetting and continual ground contact has resulted in biological soiling of most visible masonry surfaces near grade.

**Recommendation:** Install new subsurface drainage system to handle site water and roof runoff. Later construction and grading conceals a large portion of the foundation so EXISTING CONDITIONS SURVEY – ARCHITECTURAL

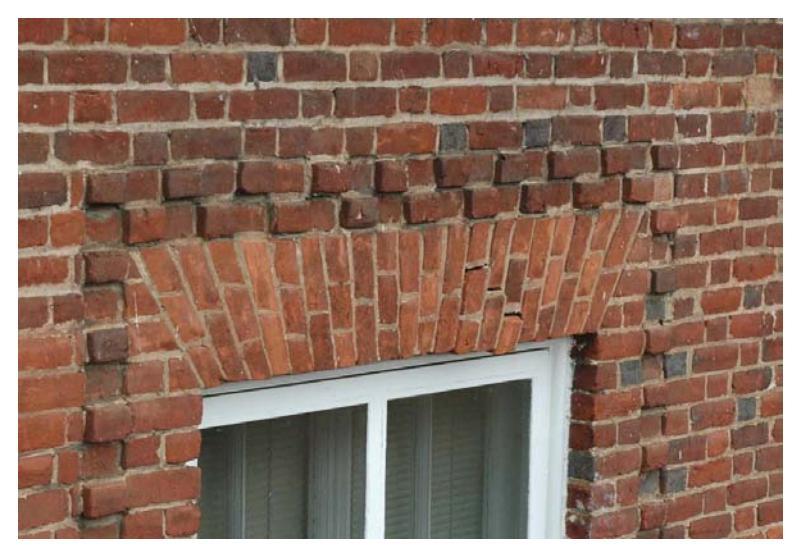
Rusticated artistic brick surrounds are typical at all principal windows. Note minor displacement of brick voussoirs at jack arch.

**Recommendations:** See structural evaluation. 100% repointing is advisable due to poor past pointing, mortar loss and mortar weakness.

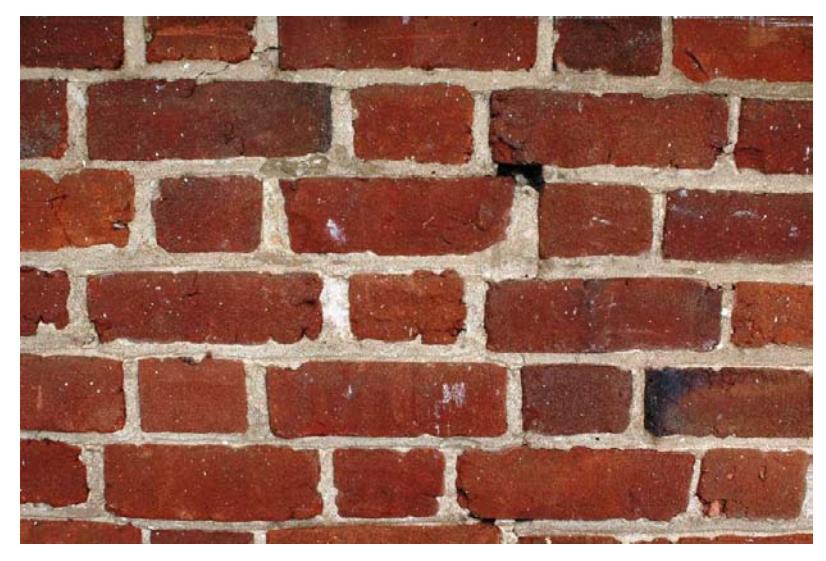
Mortar is an extremely soft lime mortar with frequent voids and cracks.

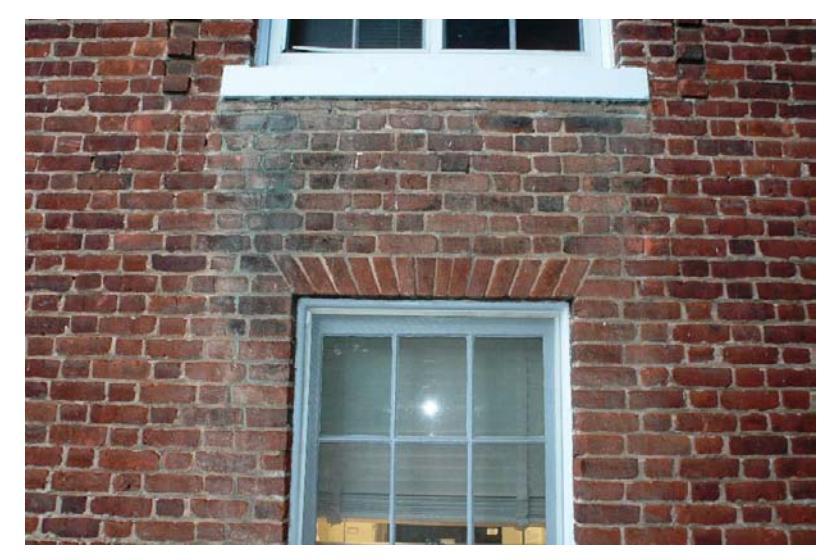
Typical staining beneath the windows.

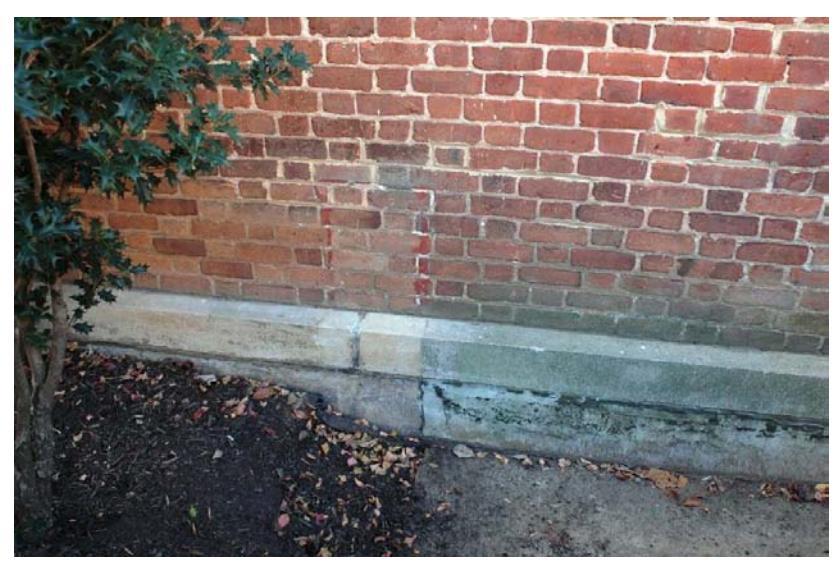
Scar from a previous retaining wall at the rear of the building.

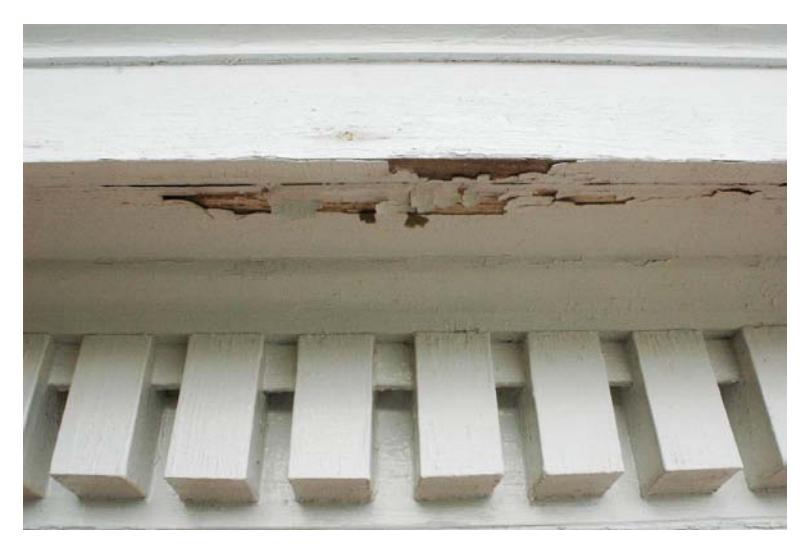
Localized paint failure may be due to gutter seam problems in the built-in gutter above.

**Recommendations:** Cornice requires general minor refurbishment to replace damaged areas, replace perimeter caulking, and restore painted finishes.

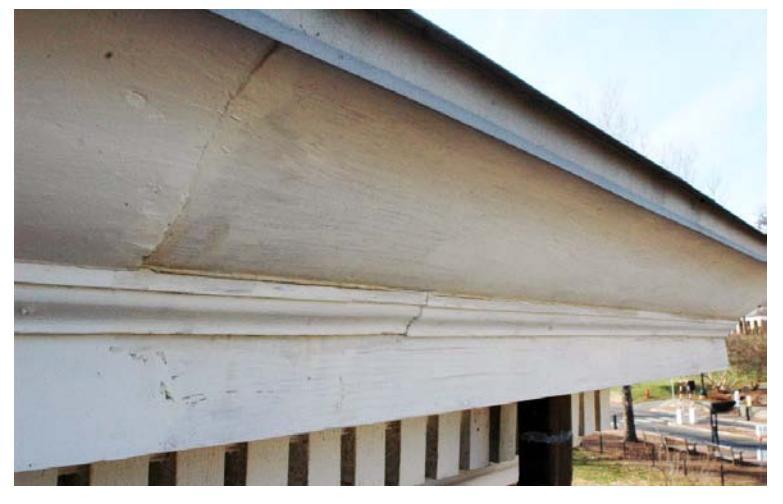
Upper cornice moldings were replaced as part of the gutter repair and were not adequately painted at that time (appears to have a single coat of primer and no finish coat).

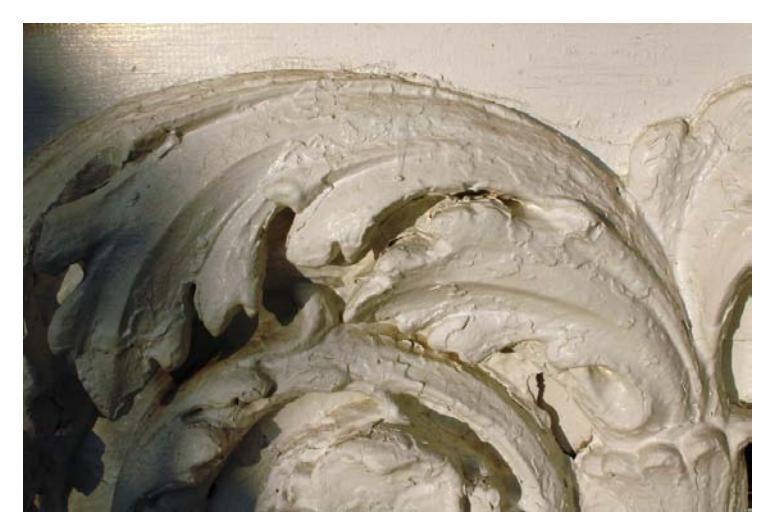
Ornamental features including molded ornament and dentils have been repainted many times without proper removal of previous, alligatored layers, resulting in loss of detail.

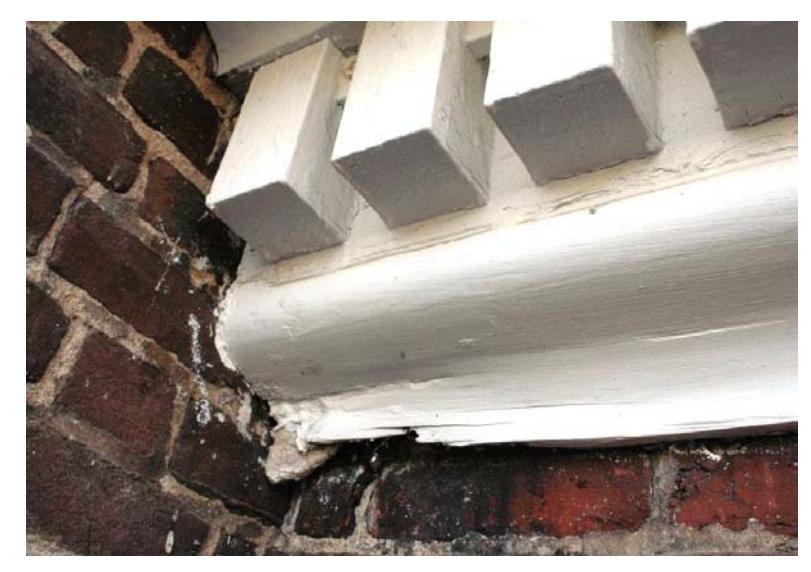
A few locations exhibited rot or other damage; such deterioration will escalate if left untreated.

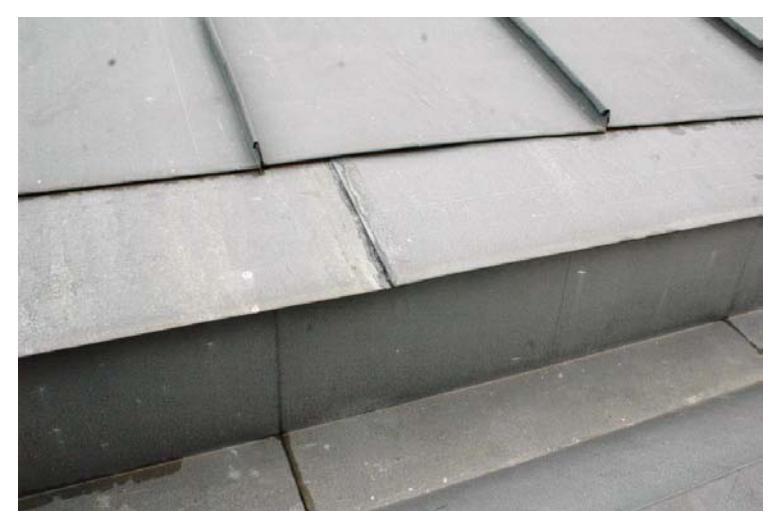
**Existing Conditions:** The roof is in good condition with no active leaks observed. Soldered seams at the metal gutter liner were typically cracked along the seams, which often indicate that joints were not properly soldered.

Soldered seams at the roof perimeter and in the gutter liner have failed.

**Recommendation:** All seams in the gutter liners should be examined (including cutting one or two seams) to see whether or not the cracking is superficial and if the gutter is water-tight. Assume re-soldering of all seams is required. Remove coatings from the pediment cornice flashing and assess the underlying copper flashing (it may be more cost effective to simply replace the flashing during any future renovations)

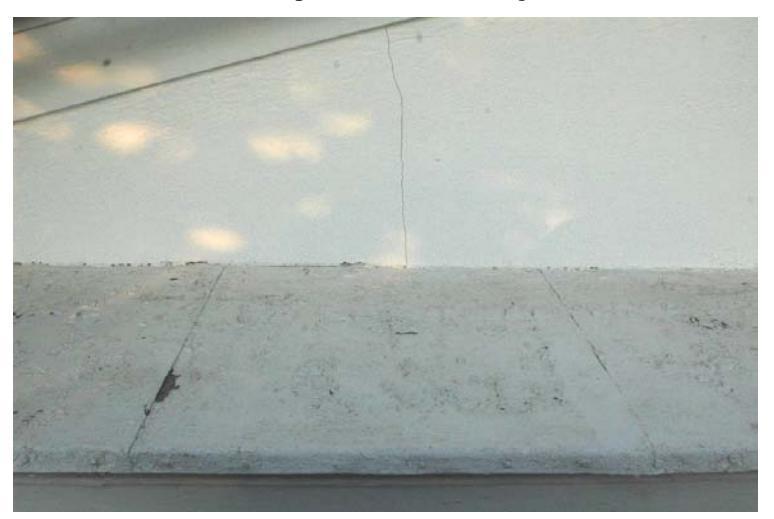
The pediment cornice flashing was not replaced during the 2001 re-roofing, has open seams, and is heavily over painted (note also crack in the stucco above).

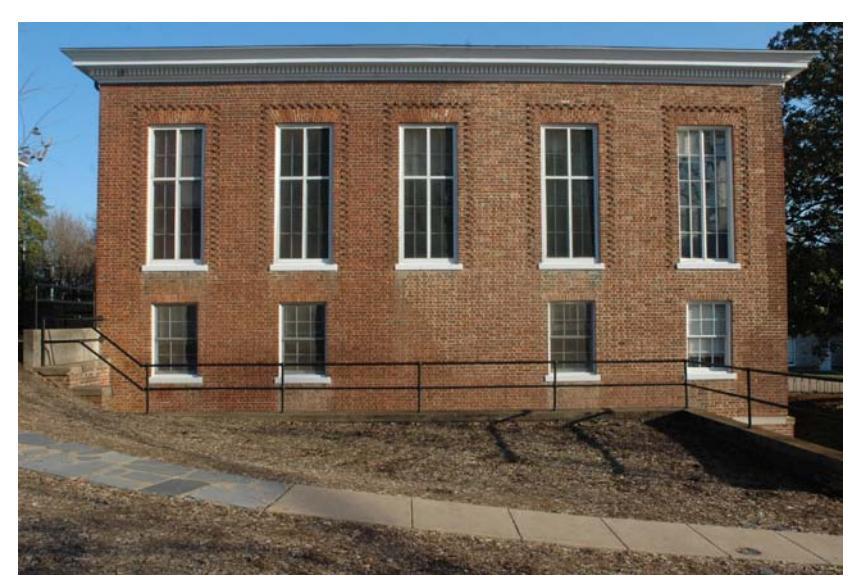
West Elevation

**Condition:** In addition to the alterations noted, the west elevation has been poorly repointed and basement level masonry has numerous deficiencies.

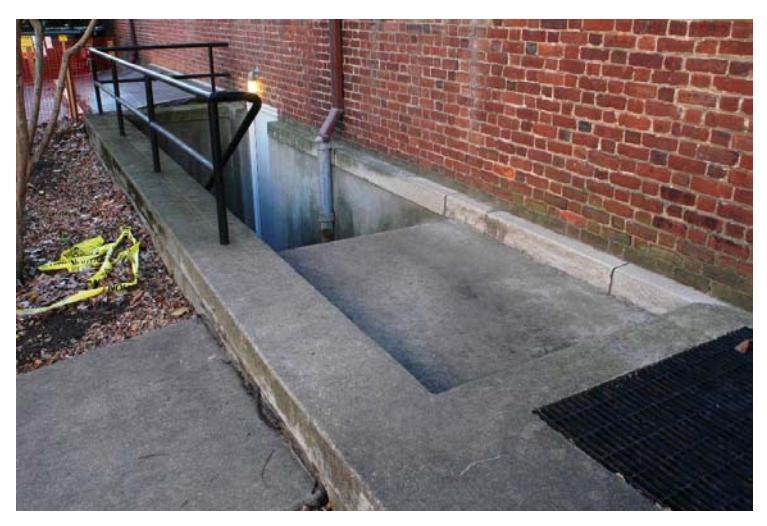
Rear entrance at north elevation

**Condition:** The north façade has significantly displaced masonry associated with the interior truss deficiencies (see structural section) and extensive microbial staining.

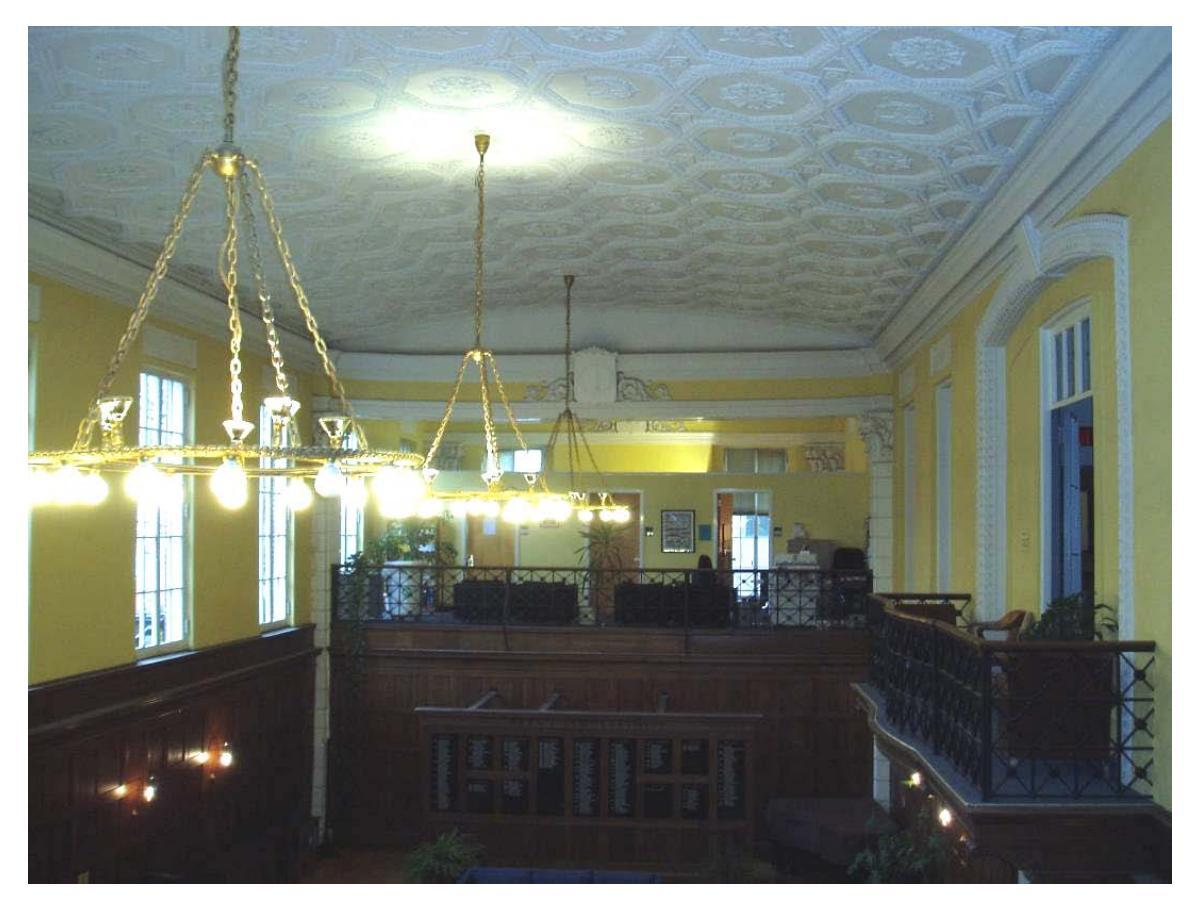
The east mezzanine obscures the Great Fireplace centrally located on the far east building wall

The addition of the east mezzanine can be fairly easily reversed. The 1959 drawings indicate that the wood wainscot from the north and south walls at this end of the original space was re-used on the new east wall of the Great Room. This historic fabric should be able to be pieced back into its original location. In general the wainscoting has been altered, patched and repaired in numerous places throughout the years. As wood is a very forgiving material, this too can be reversed by good carpentry craftsmanship. The original wood flooring in a herring bone pattern is still in place and in relatively good condition. Historic photographs show that this floor was originally stained a darker color to complement the rest of the wood in the space.

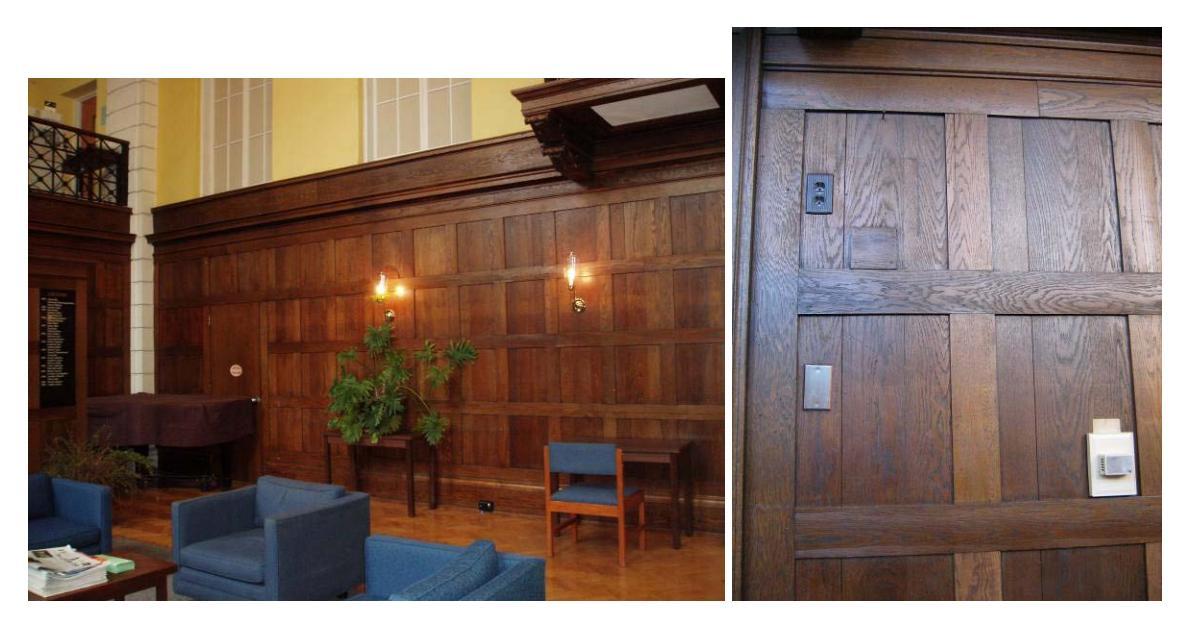
The majority of the over-sized historic wainscot is still intact but does show signs of previous repairs and patching. Electrical accessories have been installed in a random fashion over the years and should be consolidated to more discrete locations.

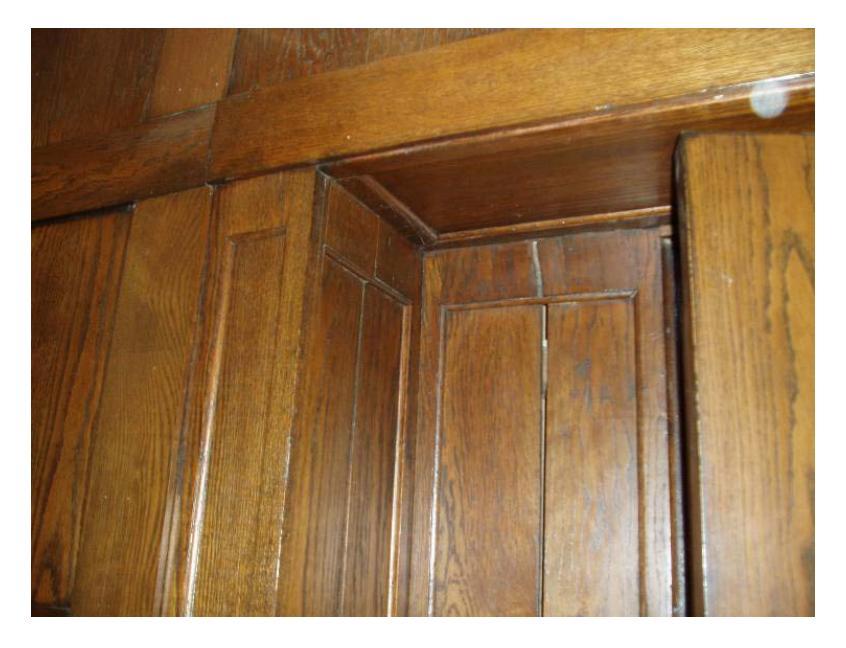
The doorway at the west end of the Great Hall originally contained double swinging doors; but has been altered to accommodate a single door.

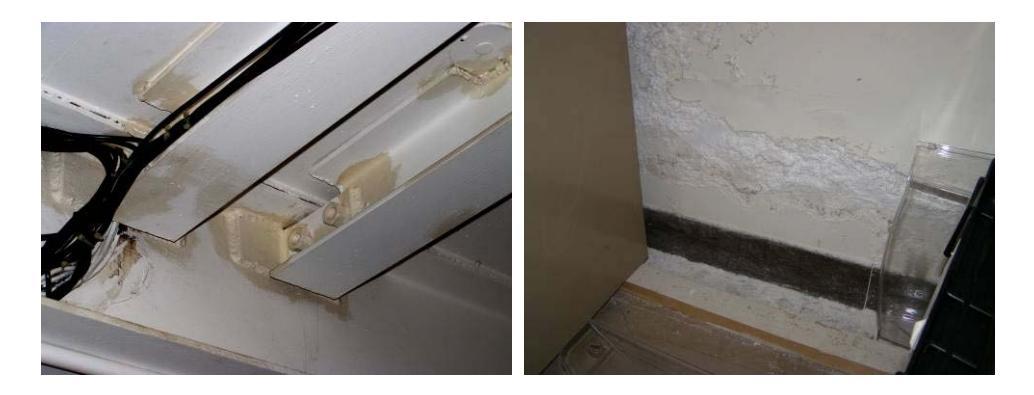
**Figure 5:** W5 steel beams spanning from west wall to steel beam. **Figure 6:** Plaster deterioration along exterior wall (both north and west)

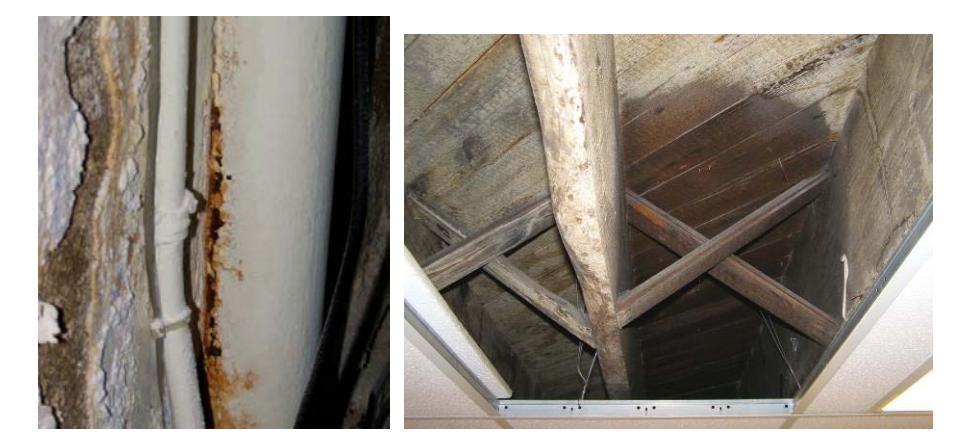
Figure 7: Rust at steel post fully developed thru wall thickness, also note plaster deterioration.Figure 8: First floor joists, bridging, and diagonal subfloor boards

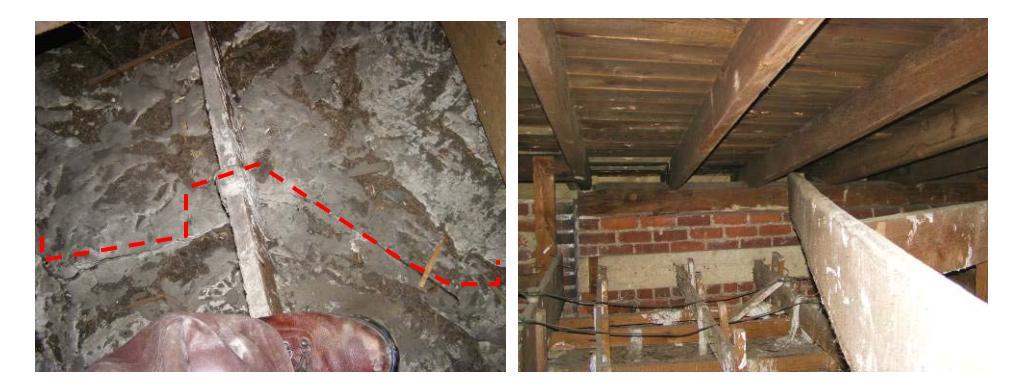
**Figure 23:** Crack as seen from attic space **Figure 24:** Rafters framing into sill at top of western exterior masonry wall. Note varying levels of ceiling joists/framing.

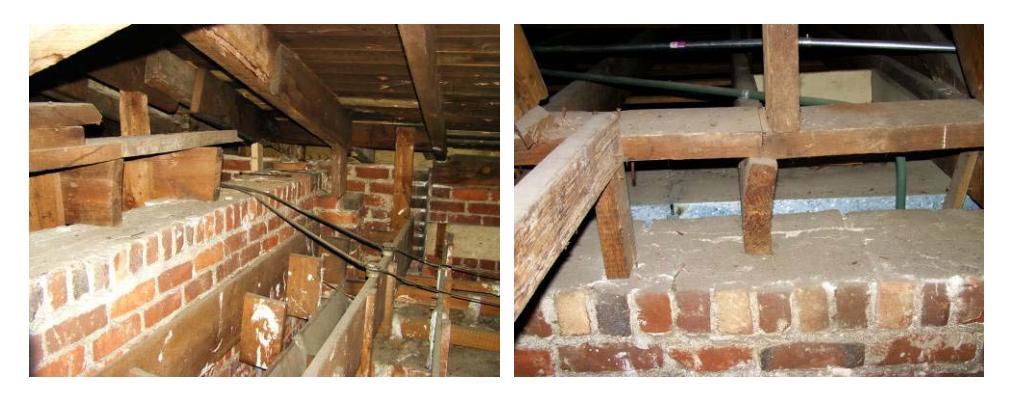
**Figure 25:** Corridor load-bearing brick masonry wall (left) and western Exterior wall beyond. Note rafters spanning from hip rafter to sill plate, ceiling joists (left) and suspended plaster ceiling over Dining Hall (right). **Figure 26:** Buckling ceiling joists (southern bay) at interior wall.

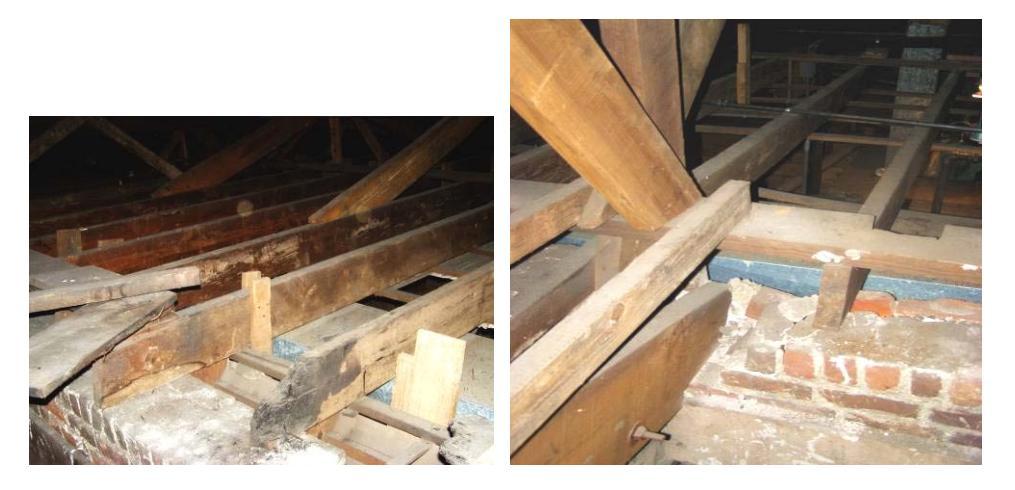
Figure 32: Localized joist bearing deterioration due to fire. Note lack of bridging and locking. Figure 33: Compromised truss bearing due to loss of masonry at interior corridor wall.
