HOTEL A

HISTORIC STRUCTURE REPORT

MESICK • COHEN • WILSON • BAKER ARCHITECTS 2012

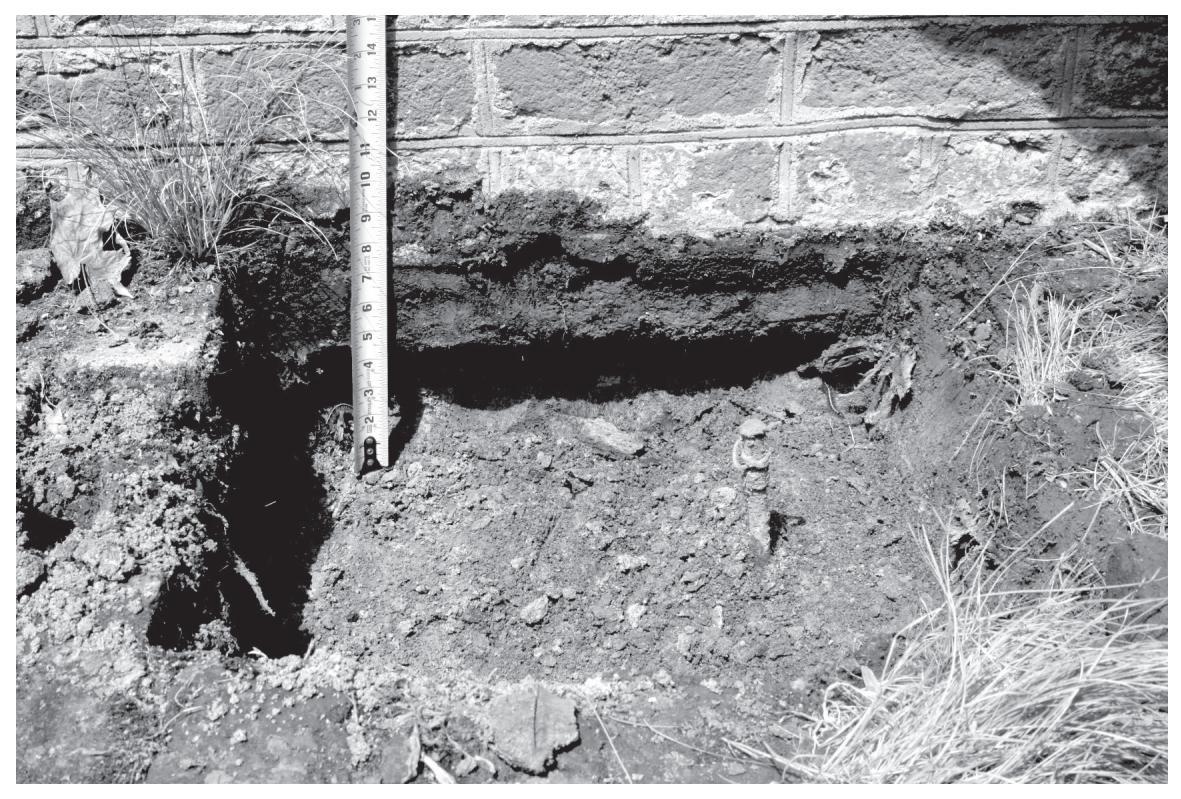
Exterior brick walls are built on top of grade without footings

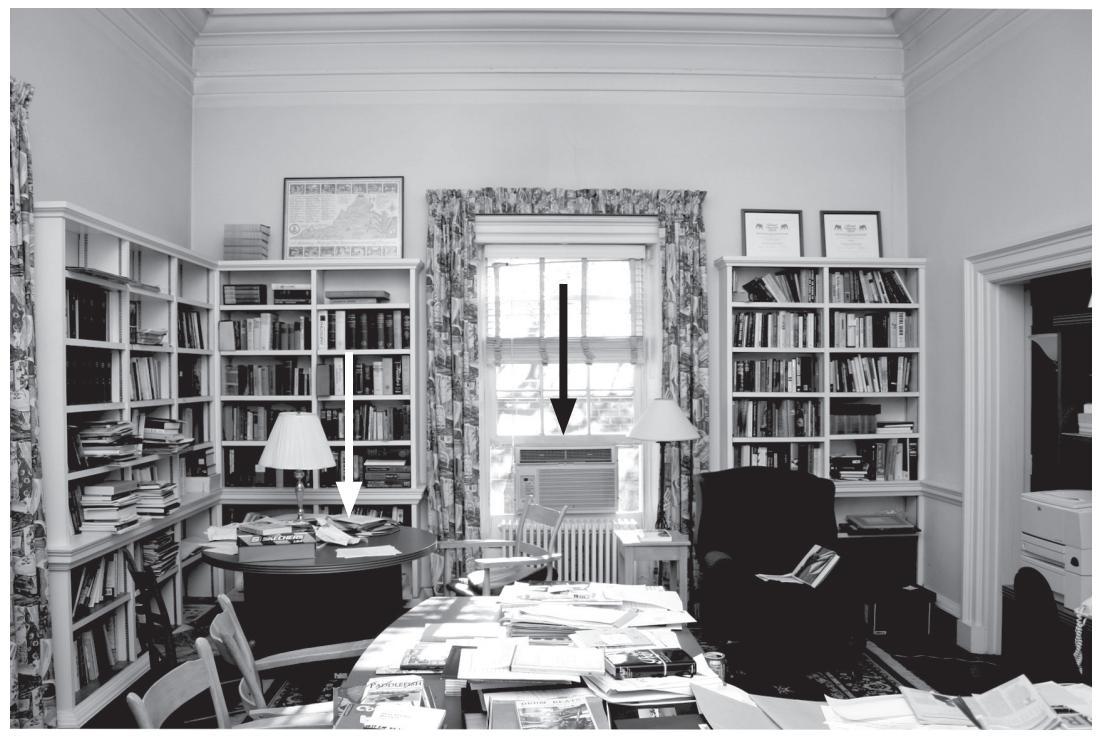
Representative example of office conditions at Hotel A. The space has a very high volume of loose papers which can act as kindling to allow the fire to grow very quickly. Note the paper items that are close to the tabletop lights and the air conditioner, placing easily ignited materials near potential ignition sources. This volume of combustibles could support a fire of one to two hours duration.

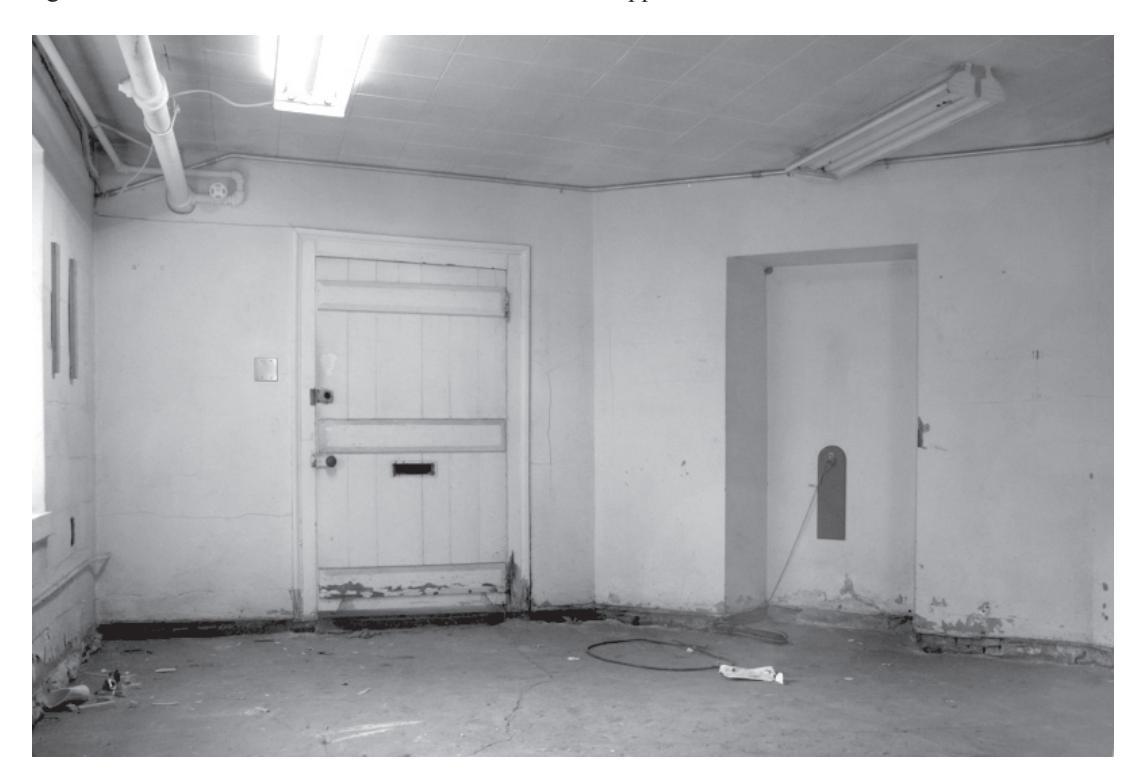
This photo shows a portion of the basement where the quantity of fuels and fire risk are low but this may change if use is altered.

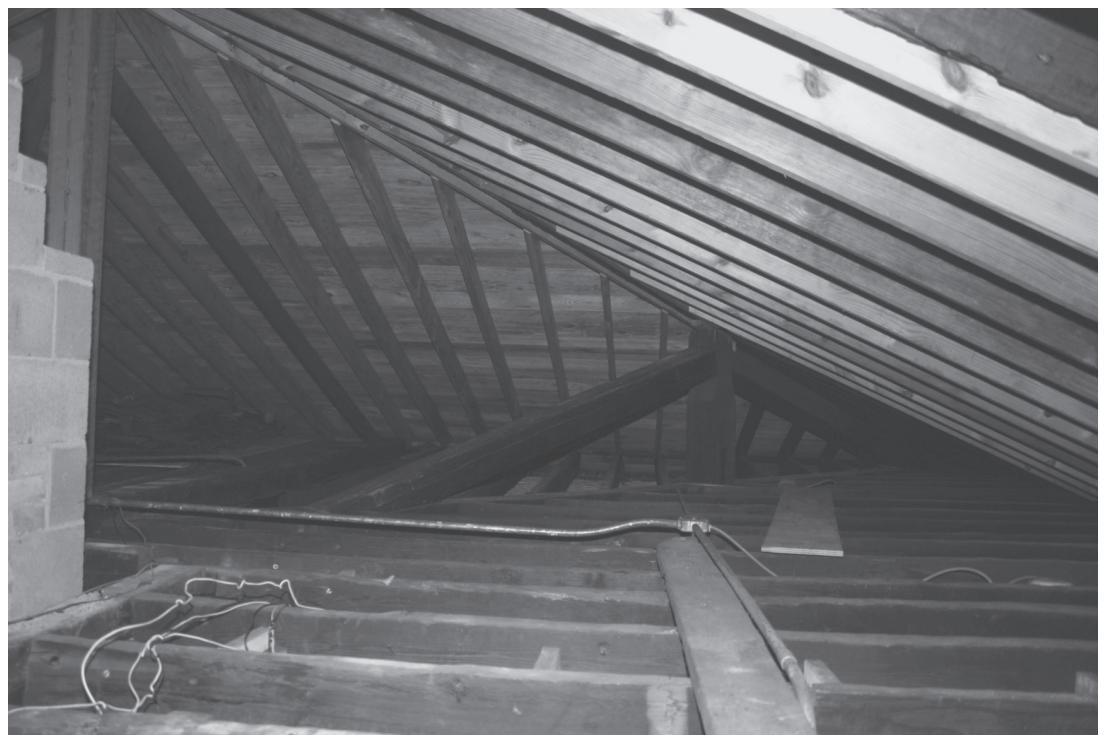
This photo illustrates the sizable quantity of combustible materials that have been used for the building's attic and roof construction. Once a fire reaches this level it can rapidly spread to involve the entire space, as illustrated by the charred roof members which survived earlier fire.

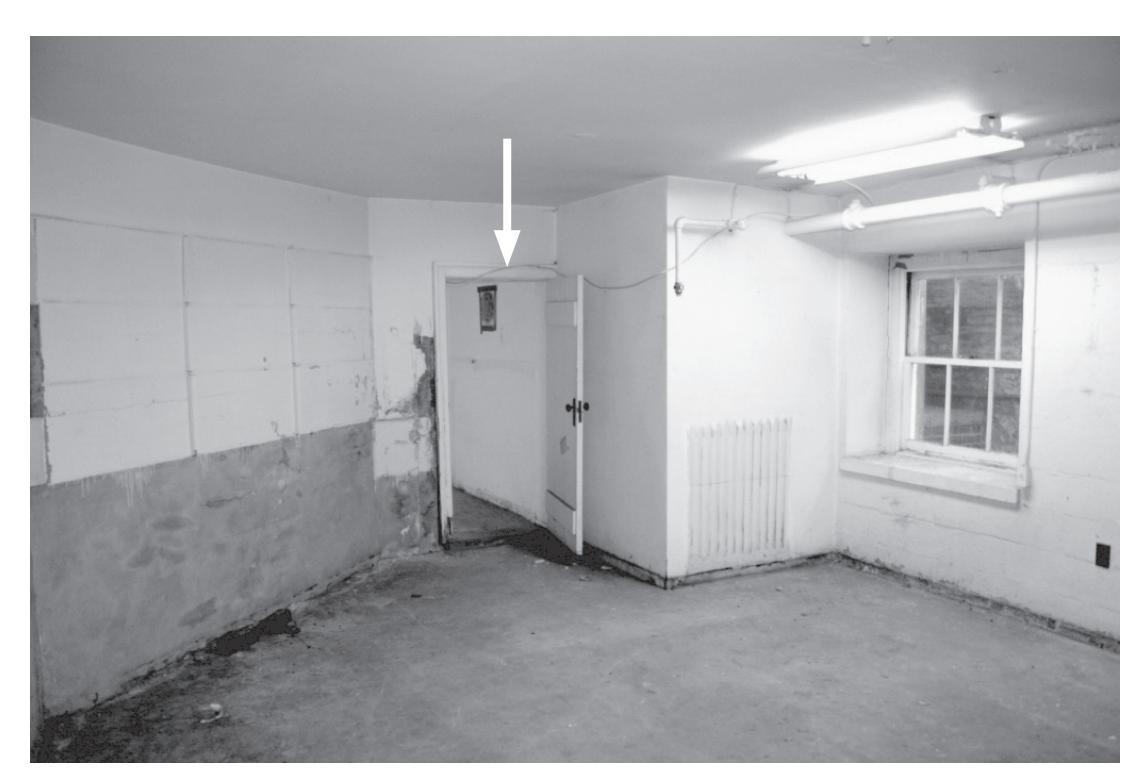
This photo shows an extension cord routed through the door opening. This practice could lead to a damaged cord, increasing the potential for fire.

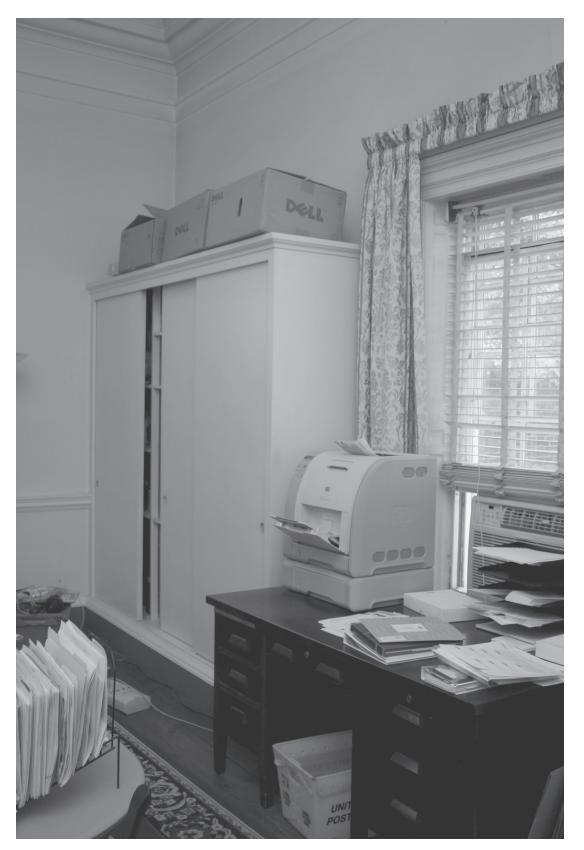
Printers like that shown in this photo are subject to breakdown over time and can lead to a fire ignition. A policy of turning off all office appliances when then building is closed should be implemented.

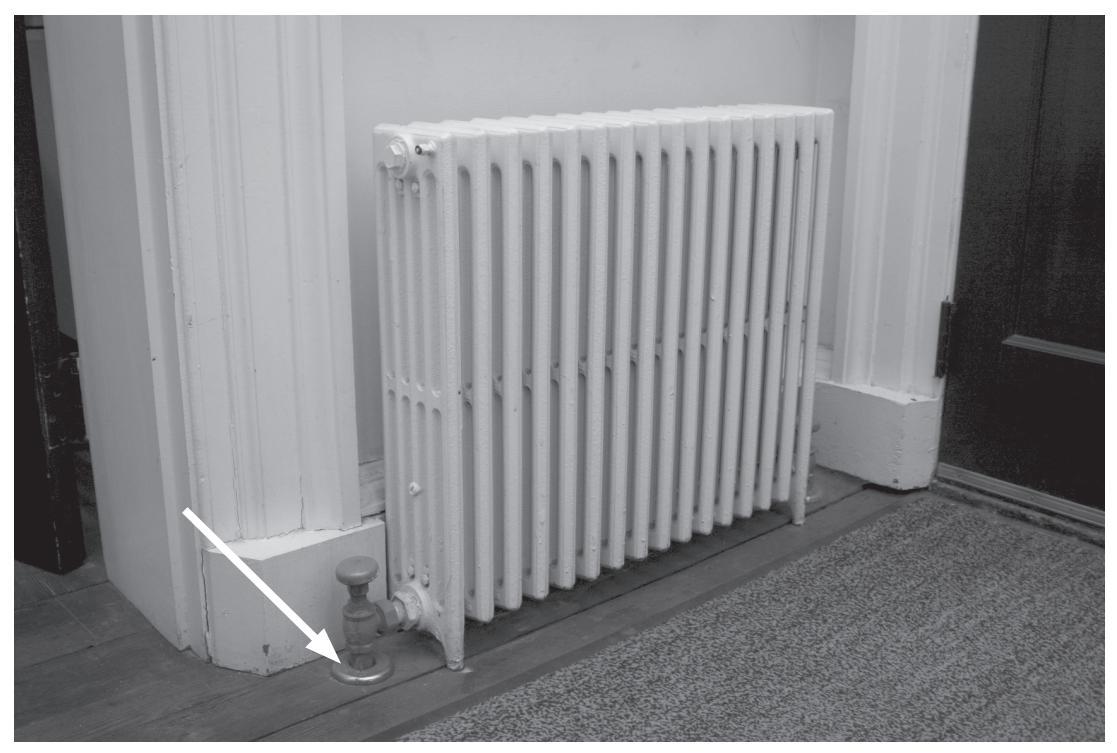
Penetrations in the floor by the radiator provide an opening for fire to spread from the lower level to this floor.
