THE THOMAS H. BAYLY BUILDING AT THE UNIVERSITY OF VIRGINIA

HISTORIC STRUCTURE REPORT.

November 8, 2013

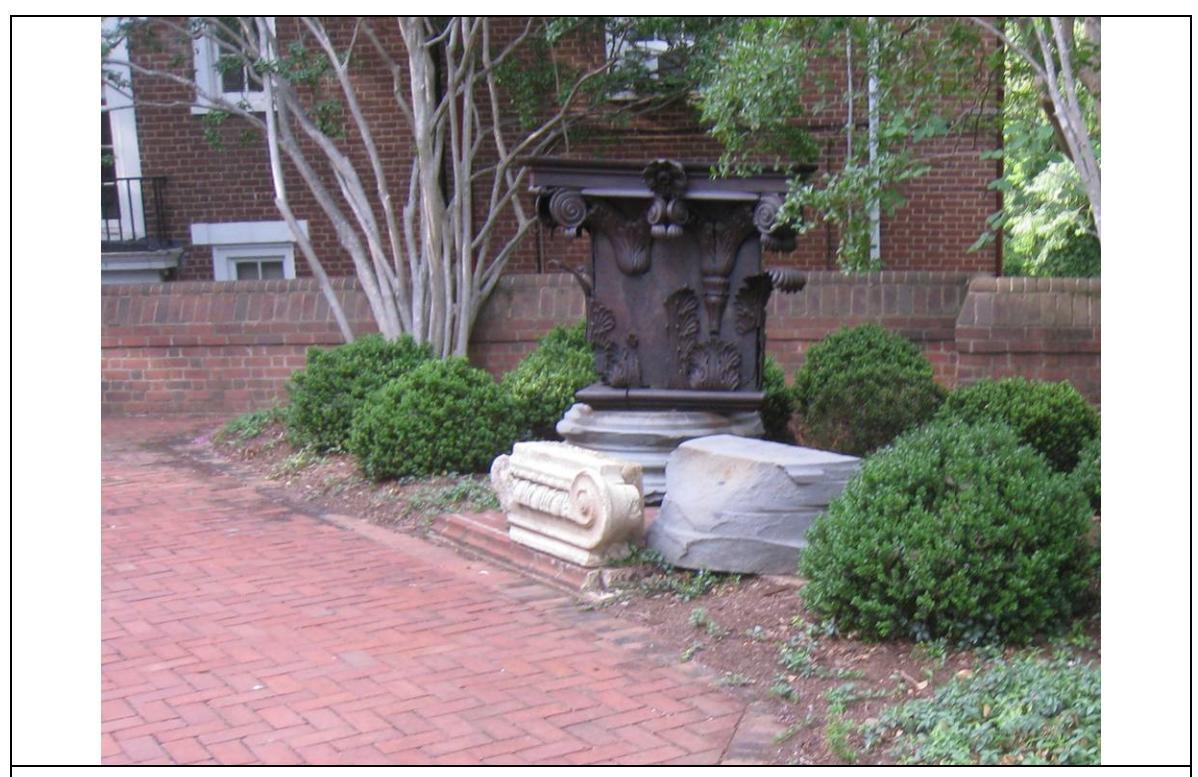
Figure 1.2.1-7: Missing brick coping and mulch flow at the brick pads with architectural fragments on the upper terrace. Photograph by Heritage Landscapes, June 2012.

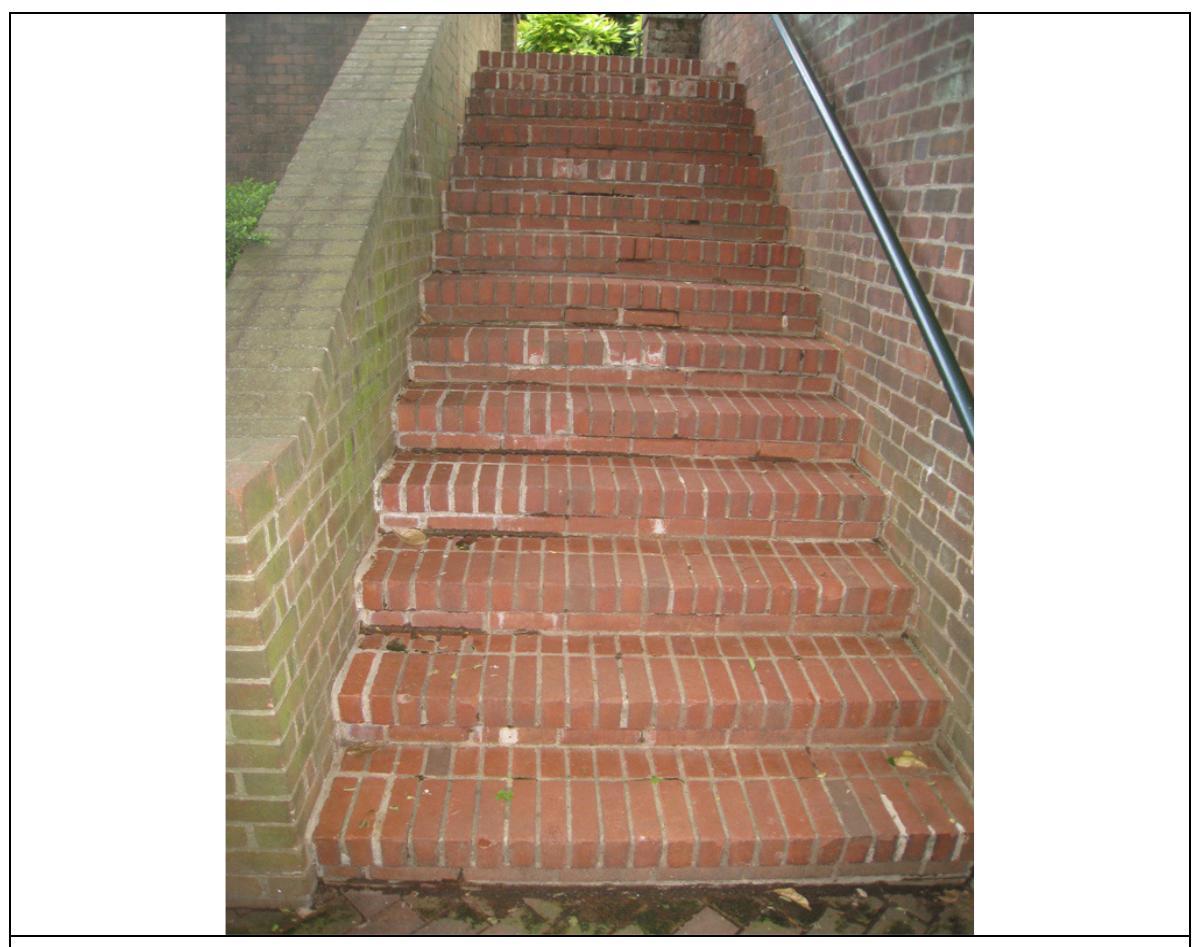
Figure 1.2.1-8: Water infiltration is evident as well as a partial bright mortar repointing at the brick steps at the west end of the South Garden. Photograph by Heritage Landscapes, June 2012.

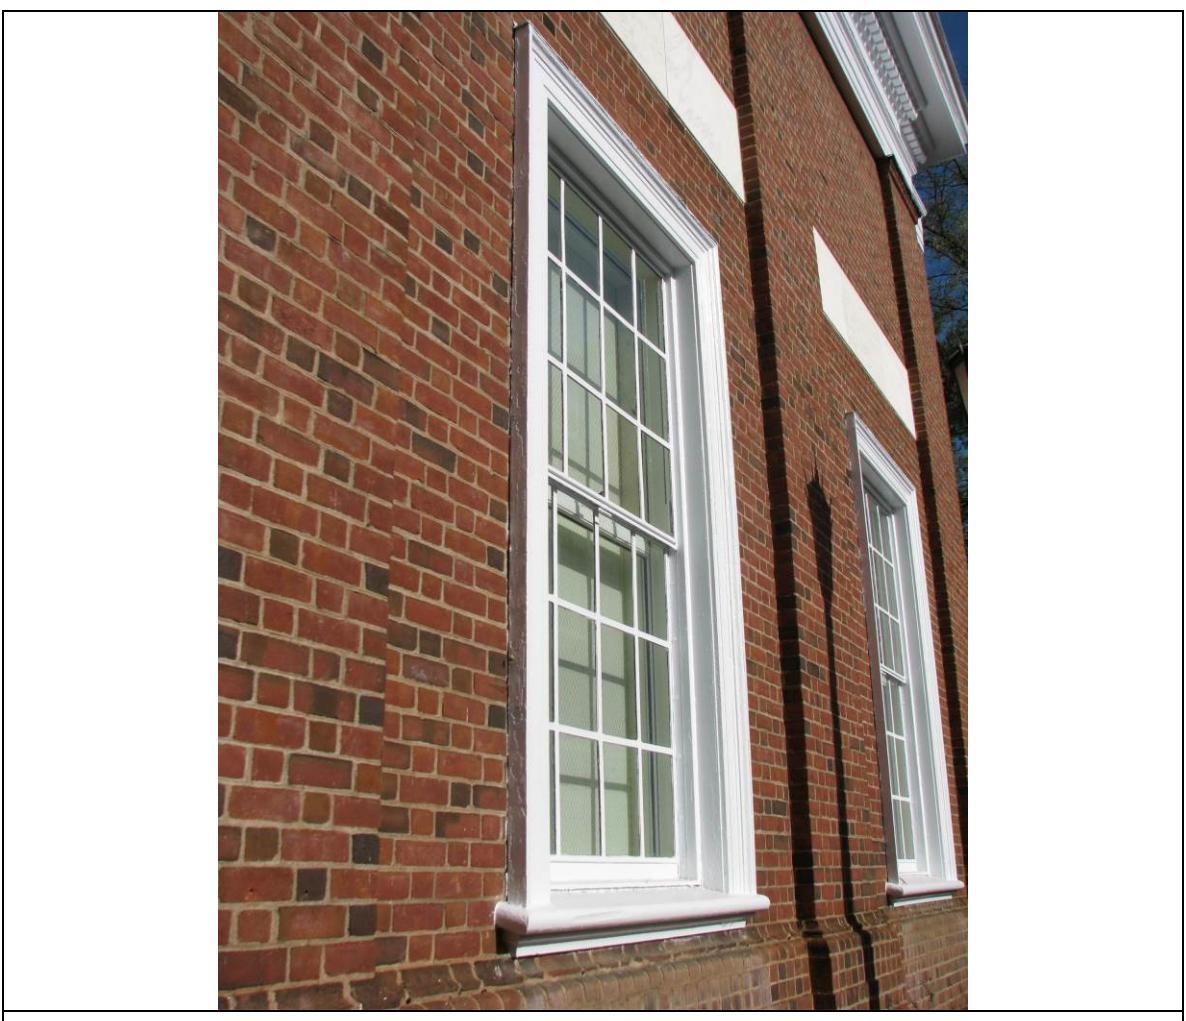
Figure 1.2.3-1: Open vertical joint, typical at windows. Photograph by John Milner Architects, November 2012.

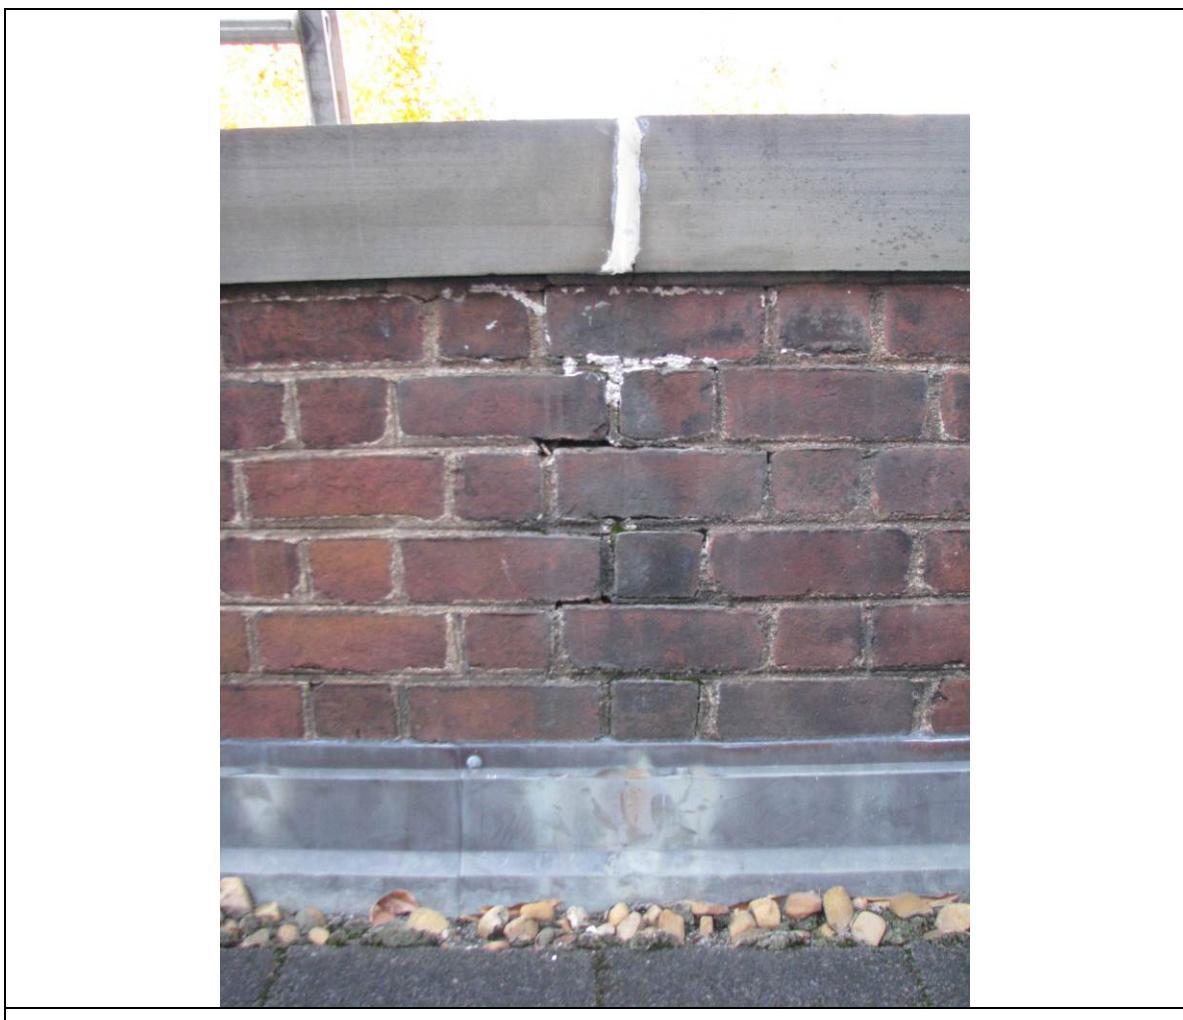
Figure 1.2.3-2: Open joints at West Terrace parapet, below inappropriately sealed coping joint. Photograph by John Milner Architects, November 2012.

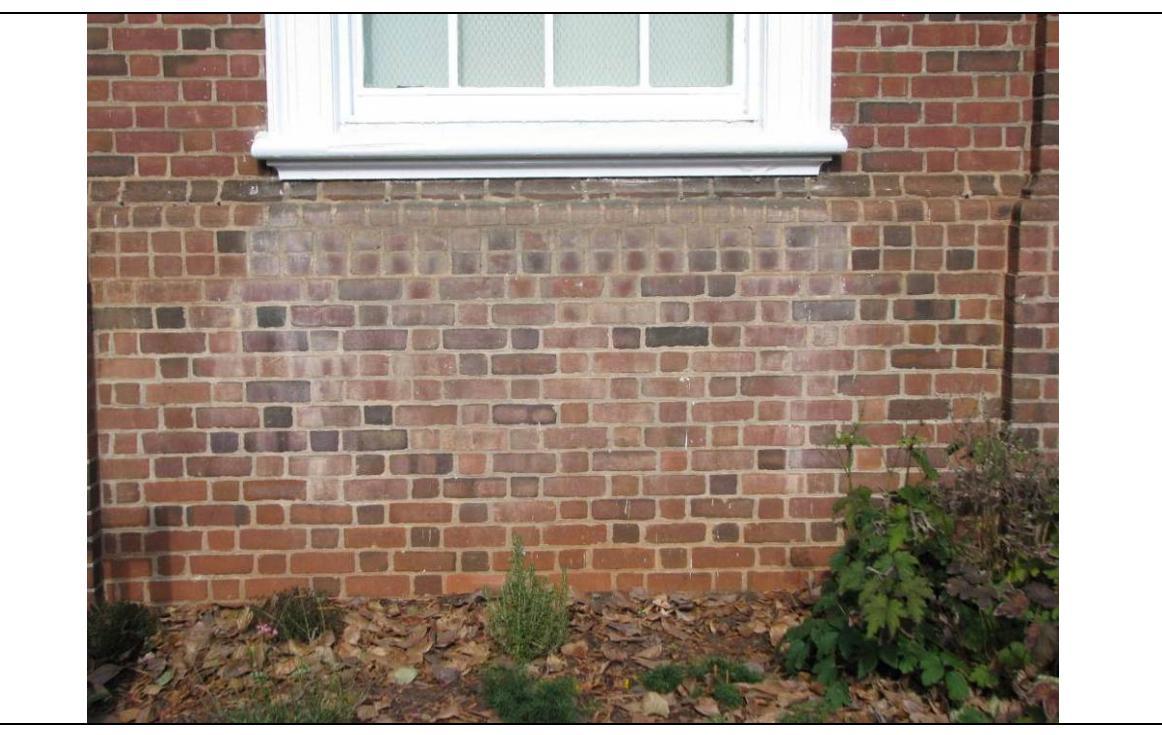
Figure 1.2.3-3: Stained brickwork, typical below windows. Photograph by John Milner Architects, November 2012.

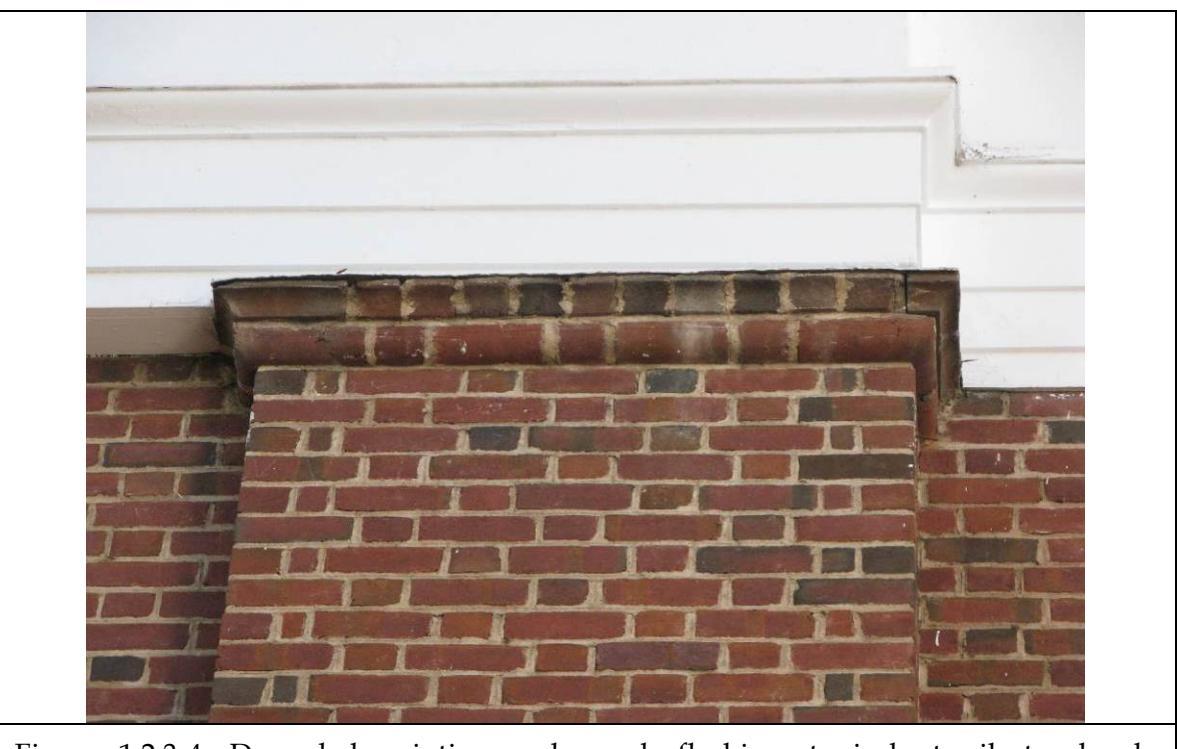
Figure 1.2.3-4: Degraded pointing and rough flashing, typical at pilaster heads. Photograph by John Milner Architects, November 2012.

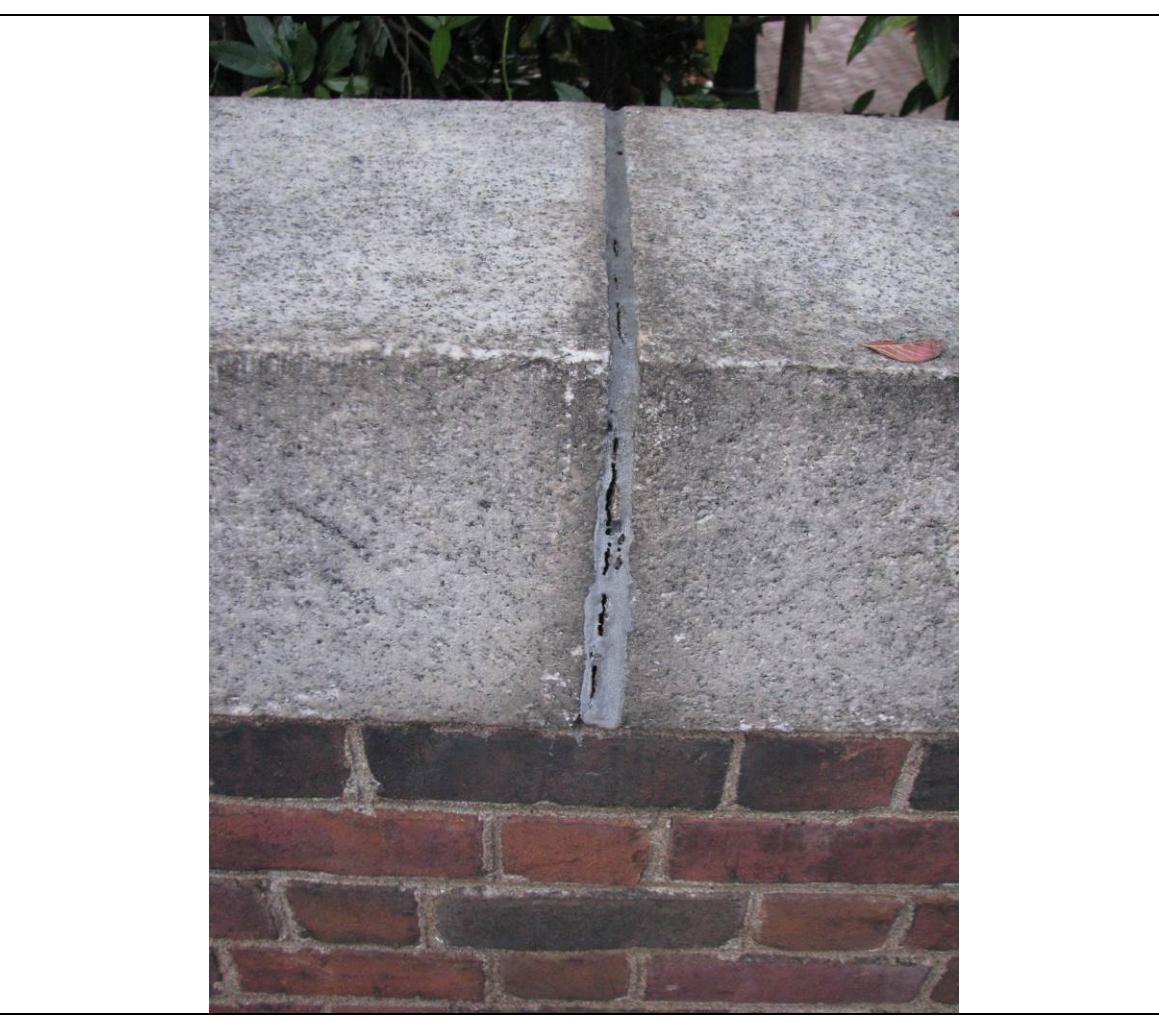
Figure 1.2.3-11: Failed sealant, typical at granite course. Photograph by John Milner Architects, November 2012.

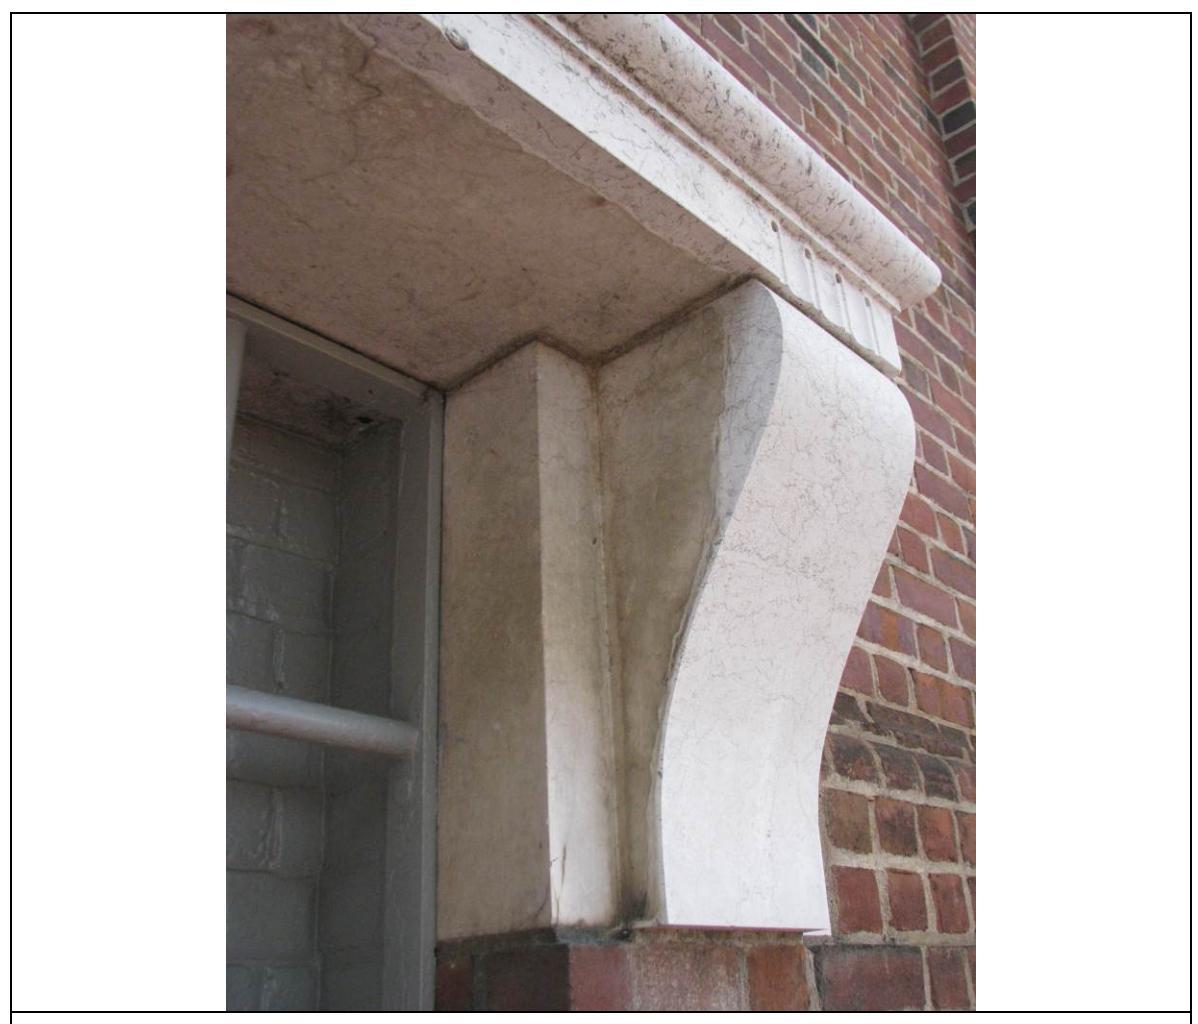
Figure 1.2.3-12: Aggressively and incompletely cleaned marble window sill and bracket, typical at East facade. Photograph by John Milner Architects, November 2012.

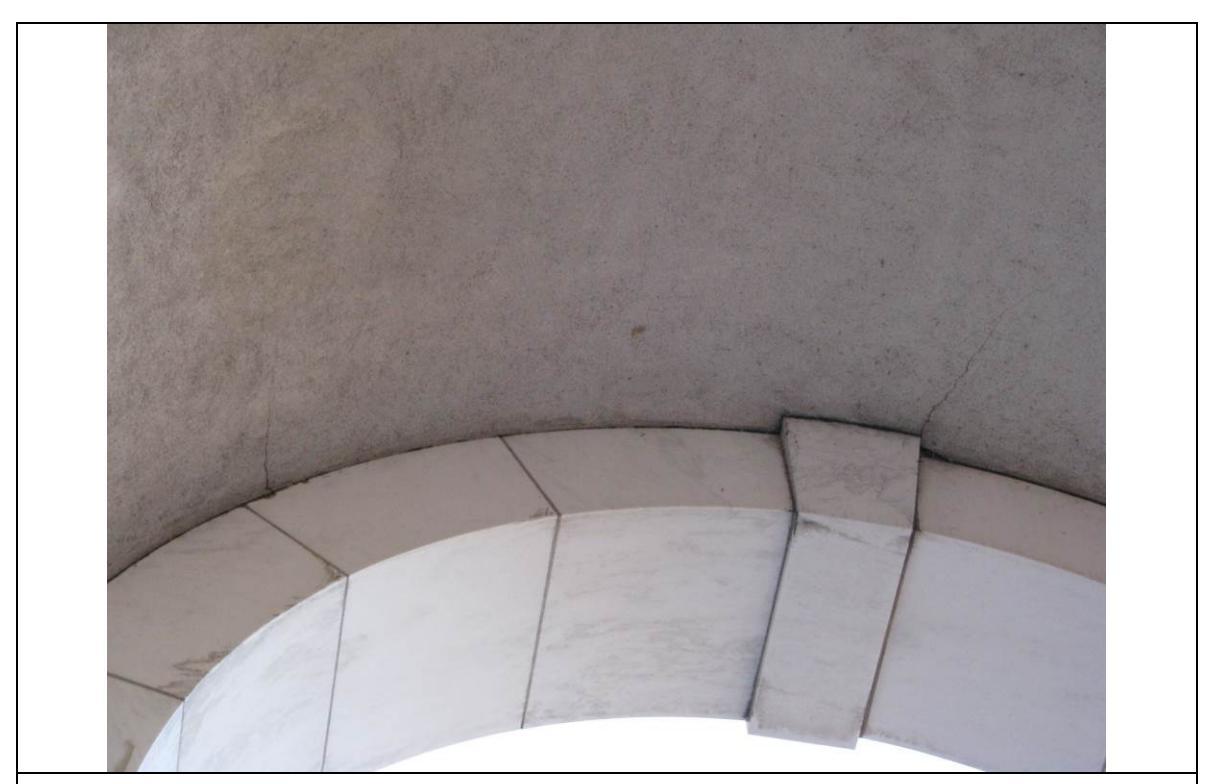
Figure 1.2.3-14: Hairline cracks at perimeter of Portico ceiling. Photograph by John Milner Architects, November 2012.

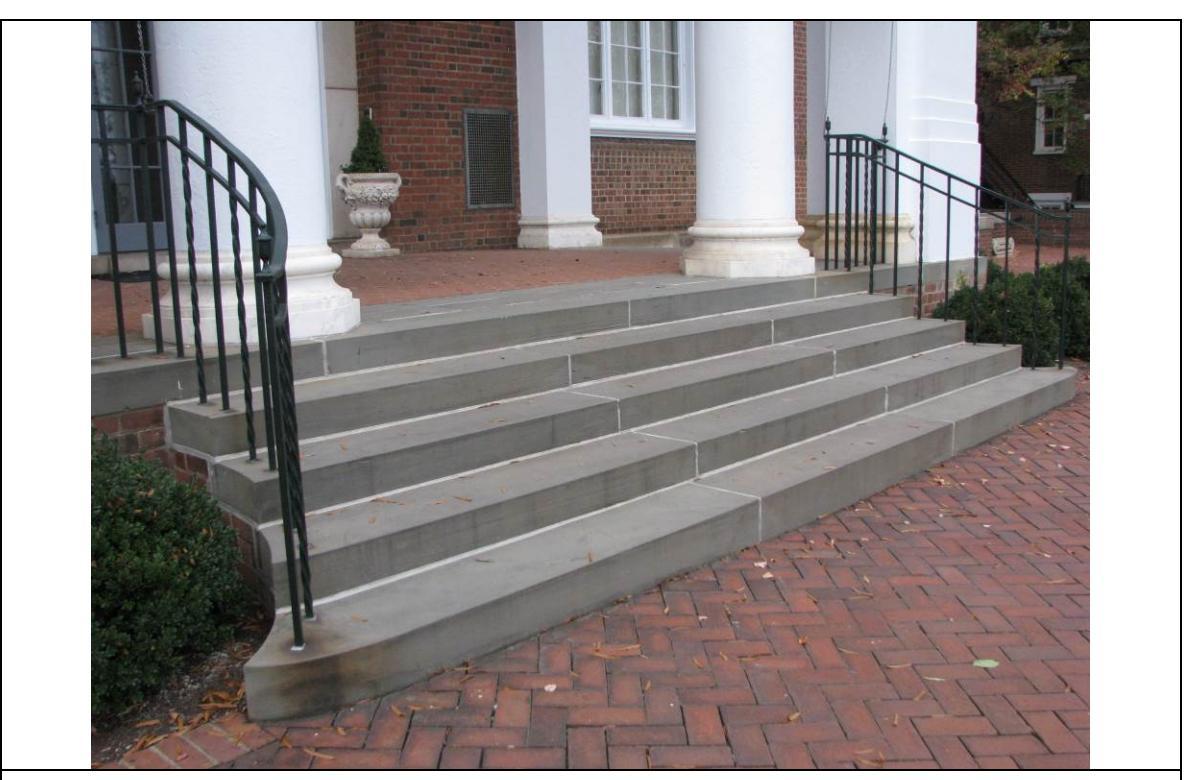
Figure 1.2.3-15: Iron stains at handrail anchor points. Photograph by John Milner Architects, November 2012.

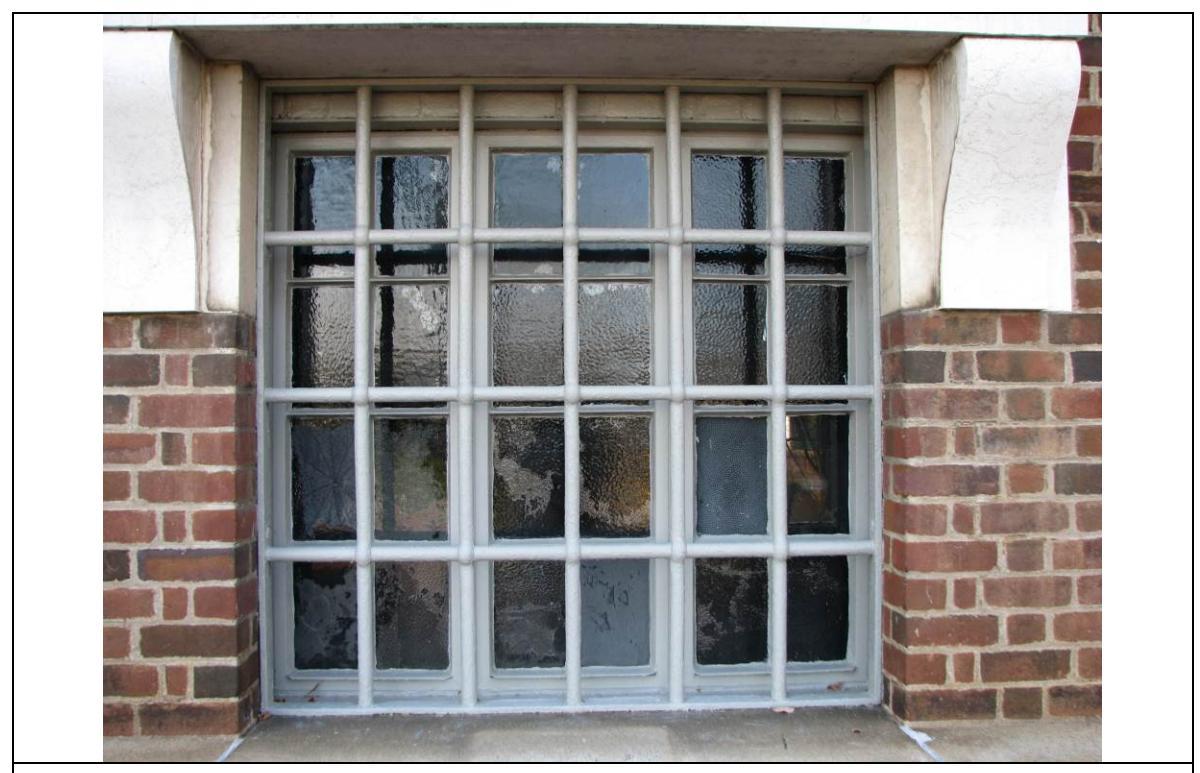
Figure 1.2.3-16: Cracked window panes. Photograph by John Milner Architects, November 2012.

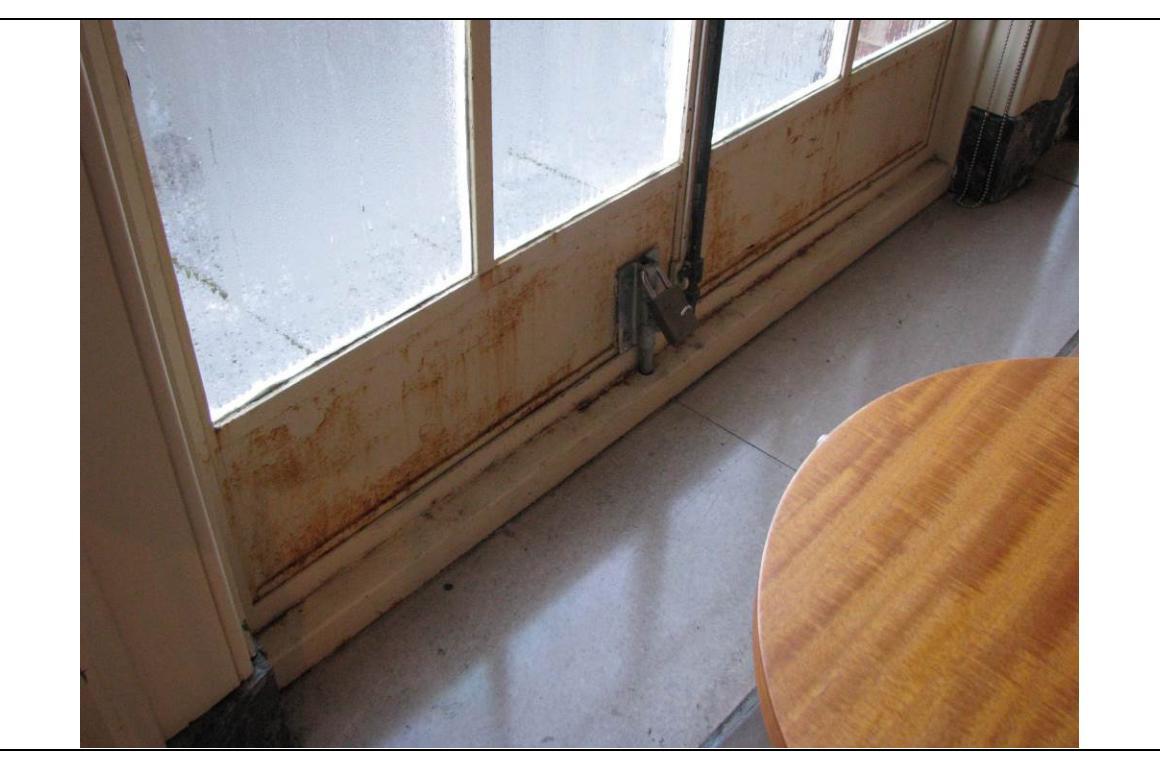
Figure 1.2.3-17: Rusted bottom rail, typical at West Terrace doors. Photograph by John Milner Architects, November 2012.

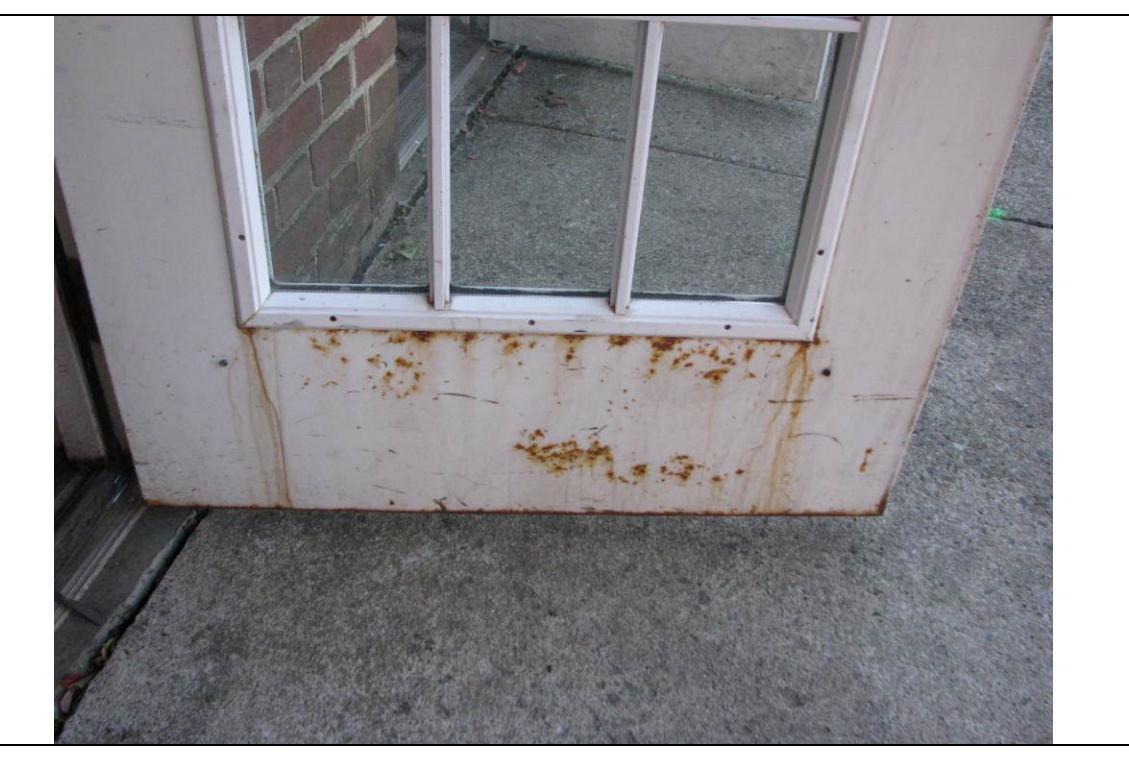
Figure 1.2.3-18: Rusted bottom rail at Annex door. Photograph by John Milner Architects, November 2012.

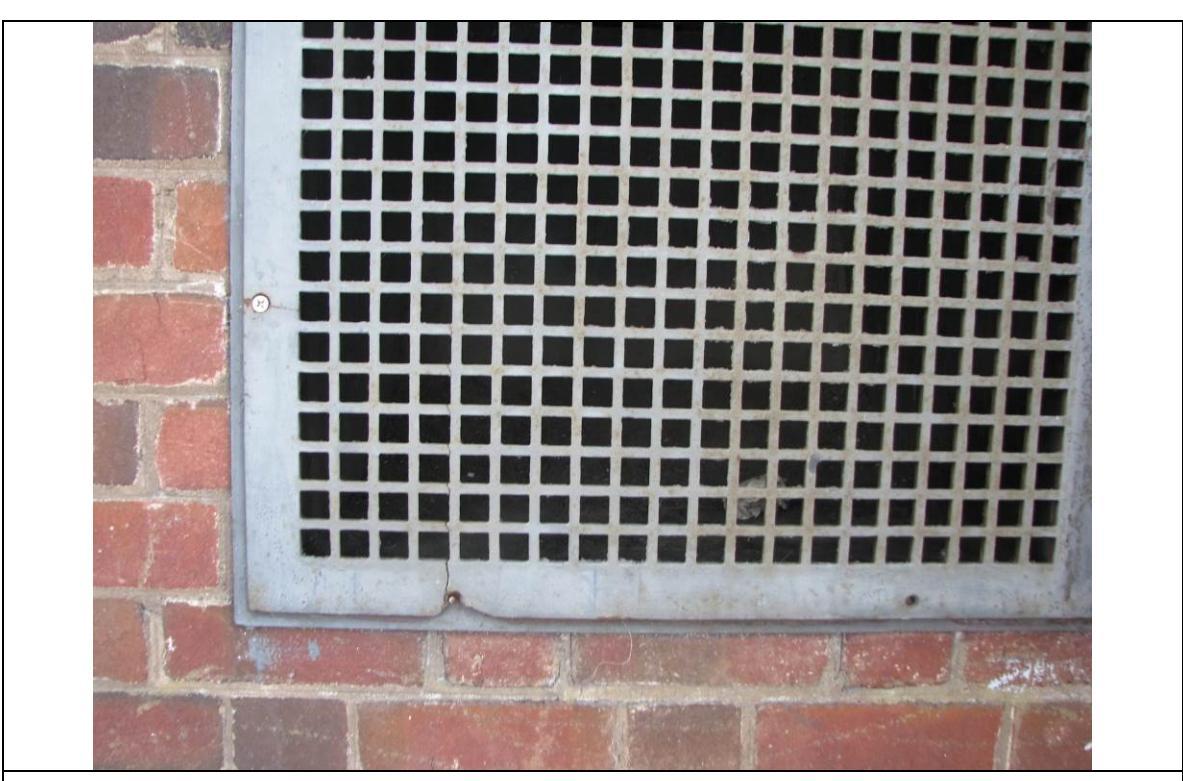
Figure 1.2.3-19: Damaged grille with inappropriate fasteners at East facade. Photograph by John Milner Architects, November 2012.

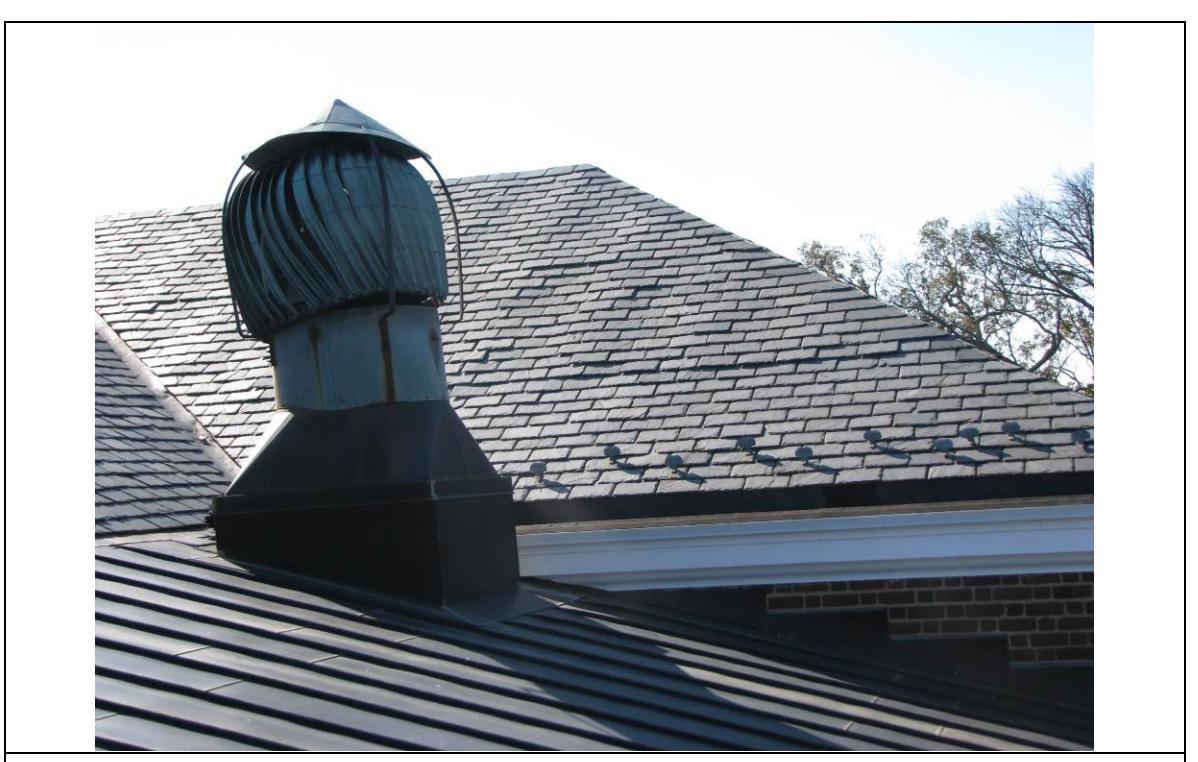
Figure 1.2.3-20: Damaged ventilator. Undulating roof surface (typical) visible beyond. Photograph by John Milner Architects, November 2012.

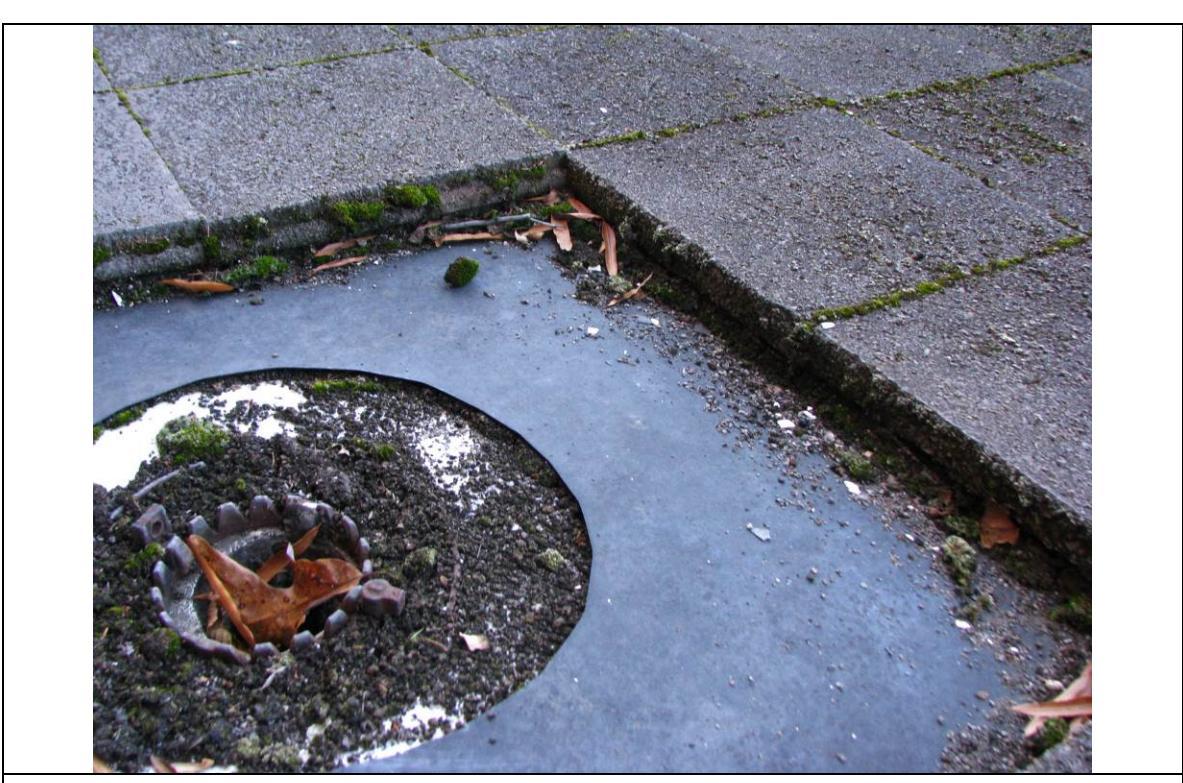
Figure 1.2.3-23: Unprotected terrace drain. Photograph by John Milner Architects, November 2012.

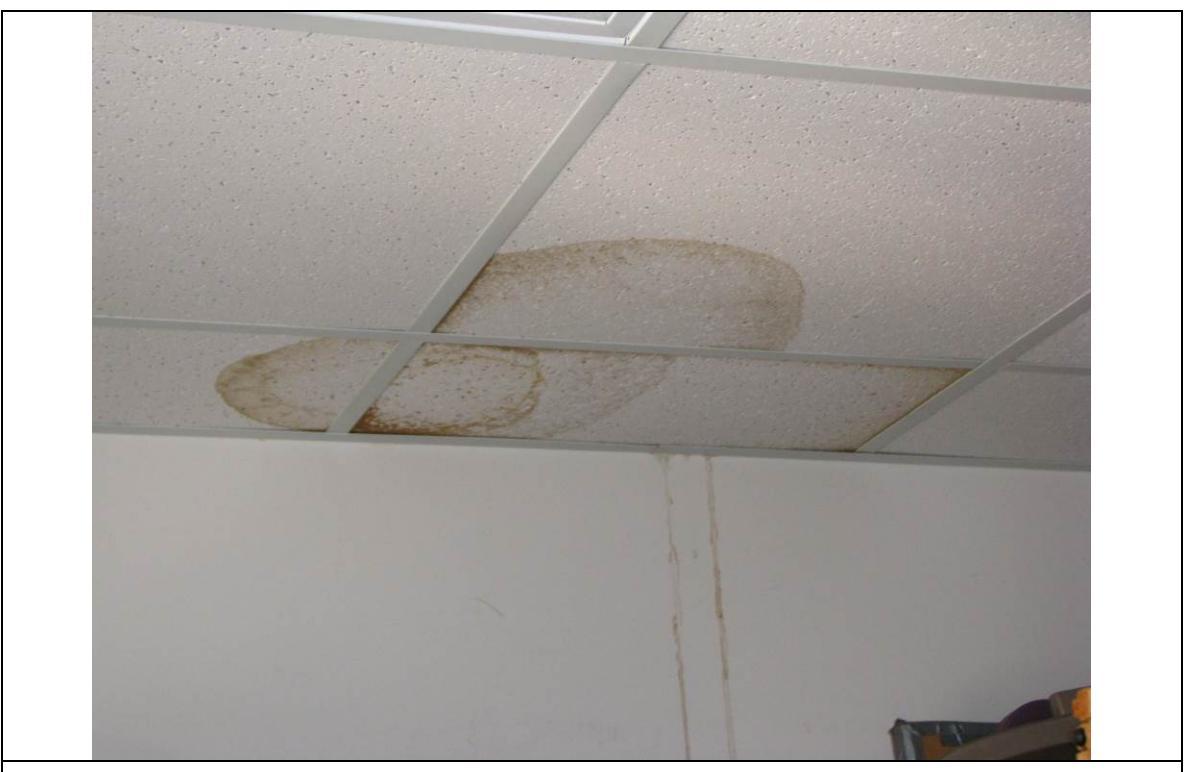
Figure 1.2.3-25: Water stains below southwest addition roof. Photograph by John Milner Architects, November 2012.

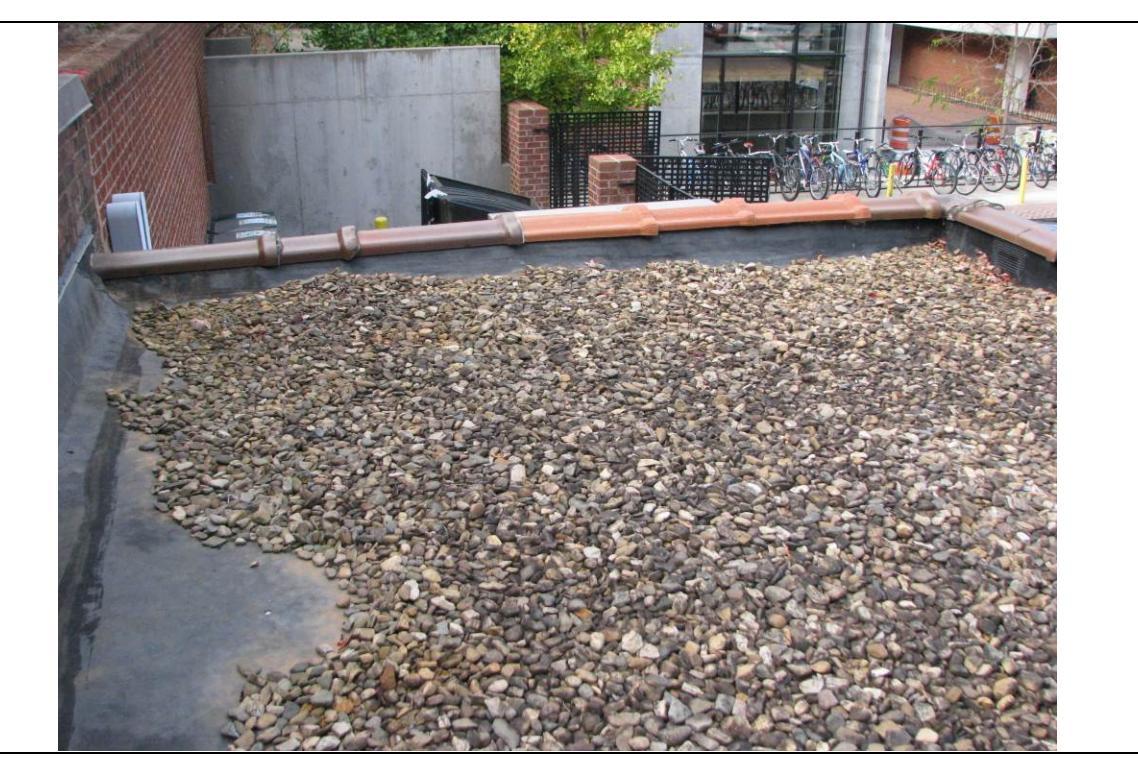
Figure 1.2.3-26: Sprung membrane and inappropriate coping patch at roof of Annex. Photograph by John Milner Architects, November 2012.

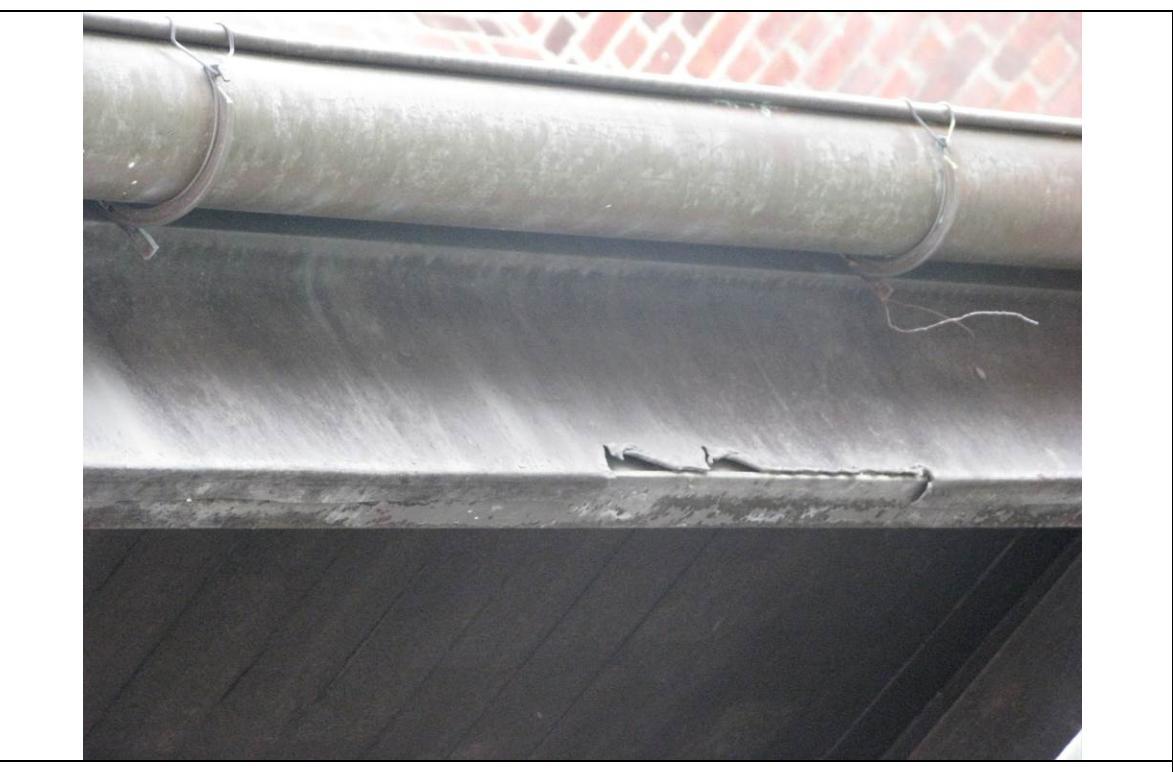
Figure 1.2.3-28: Damaged metal fascia at West canopy. Photograph by John Milner Architects, November 2012.

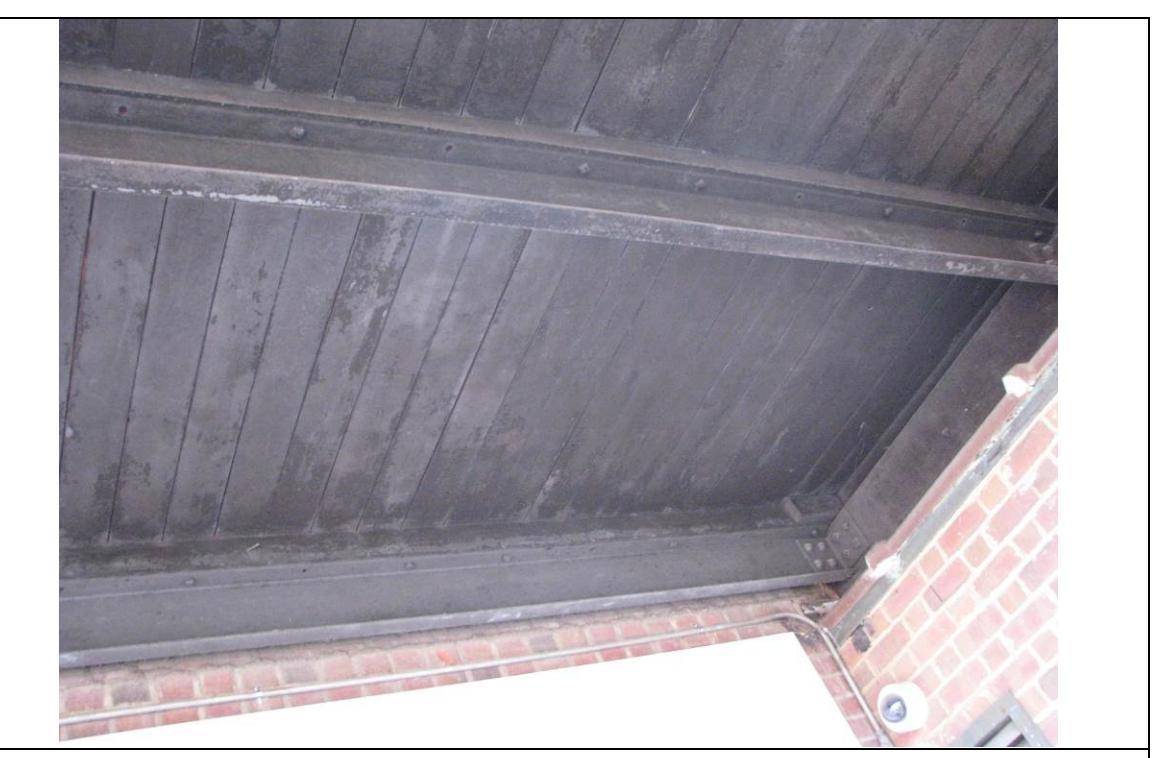
Figure 1.2.3-29: Degraded paint at underside of West canopy. Photograph by John Milner Architects, November 2012.

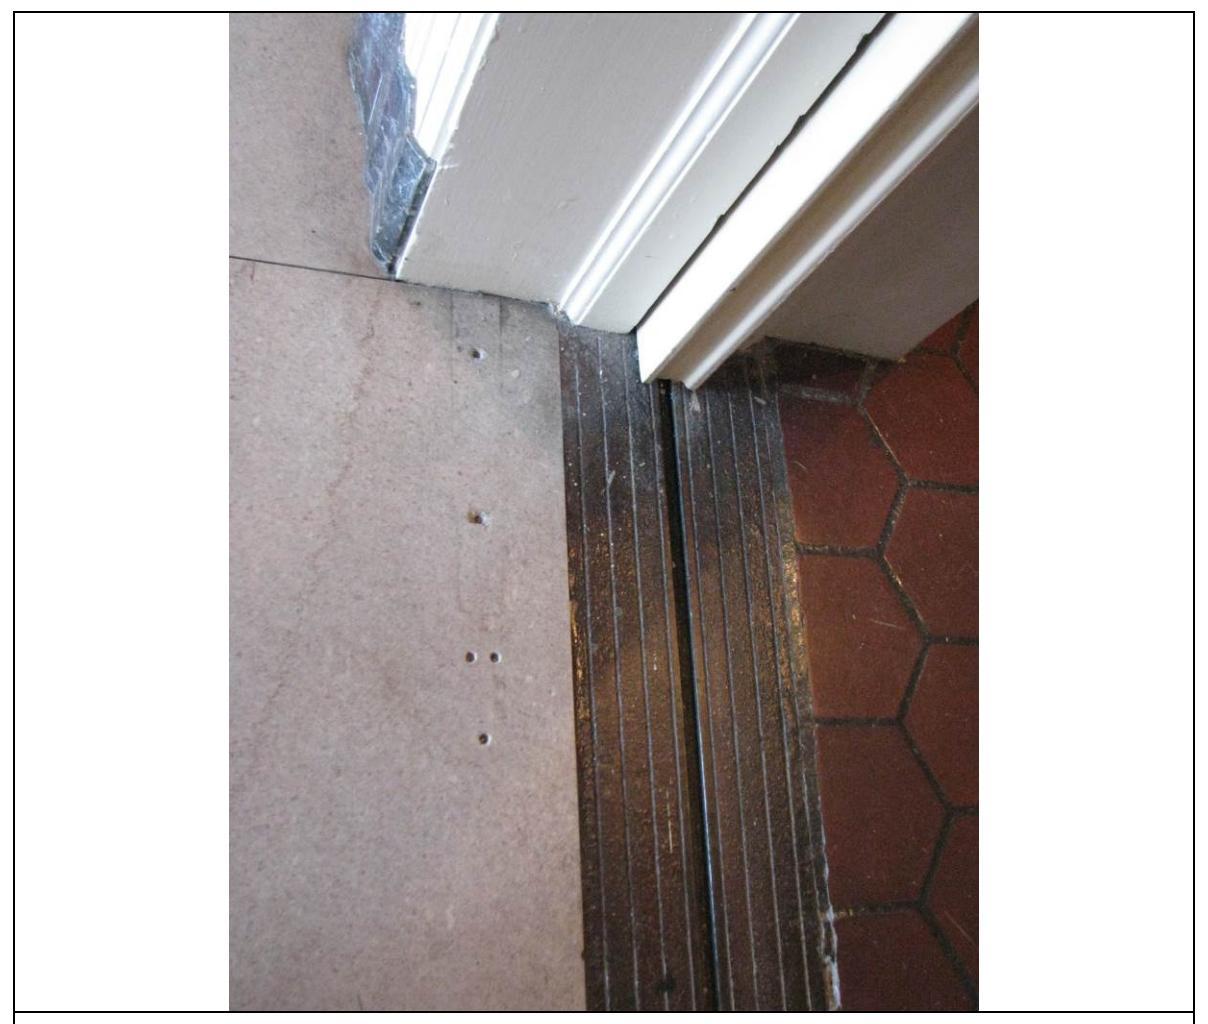
Figure 1.2.3-31: Hardware damage at Tennessee Tavarnelle marble flooring. Photograph by John Milner Architects, November 2012.

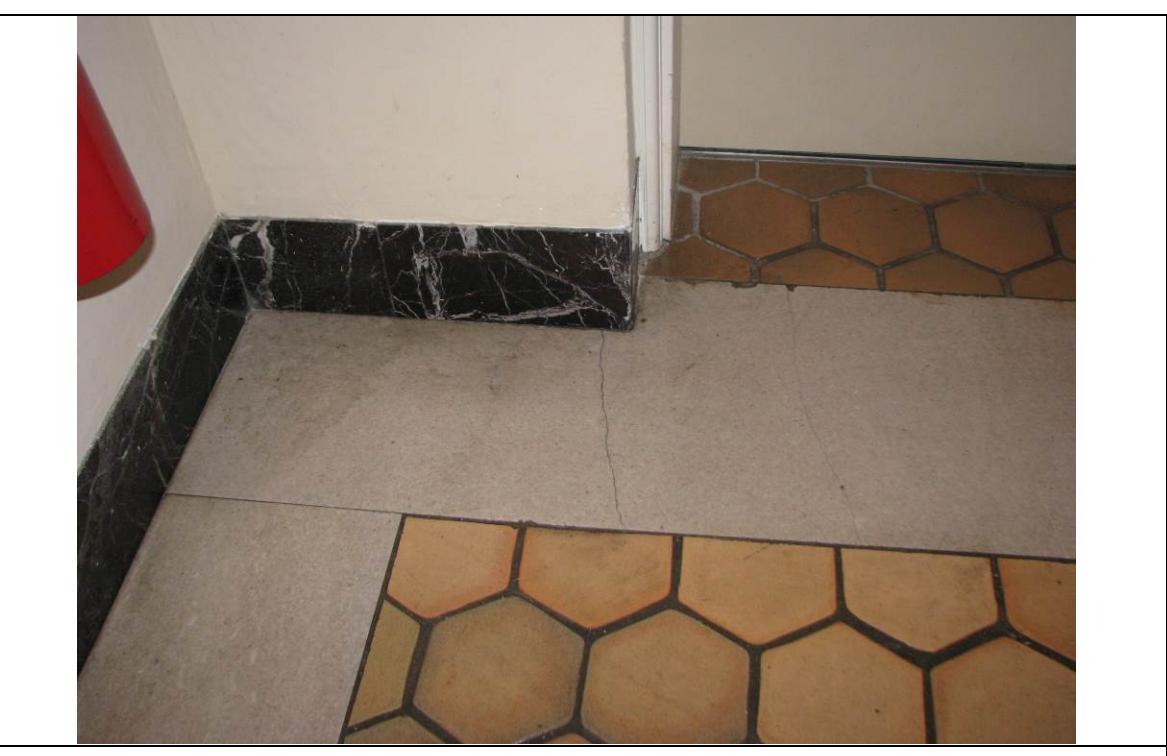
Figure 1.2.3-32: Hairline cracks in Tennessee Tavarnelle marble border. Photograph by John Milner Architects, November 2012.

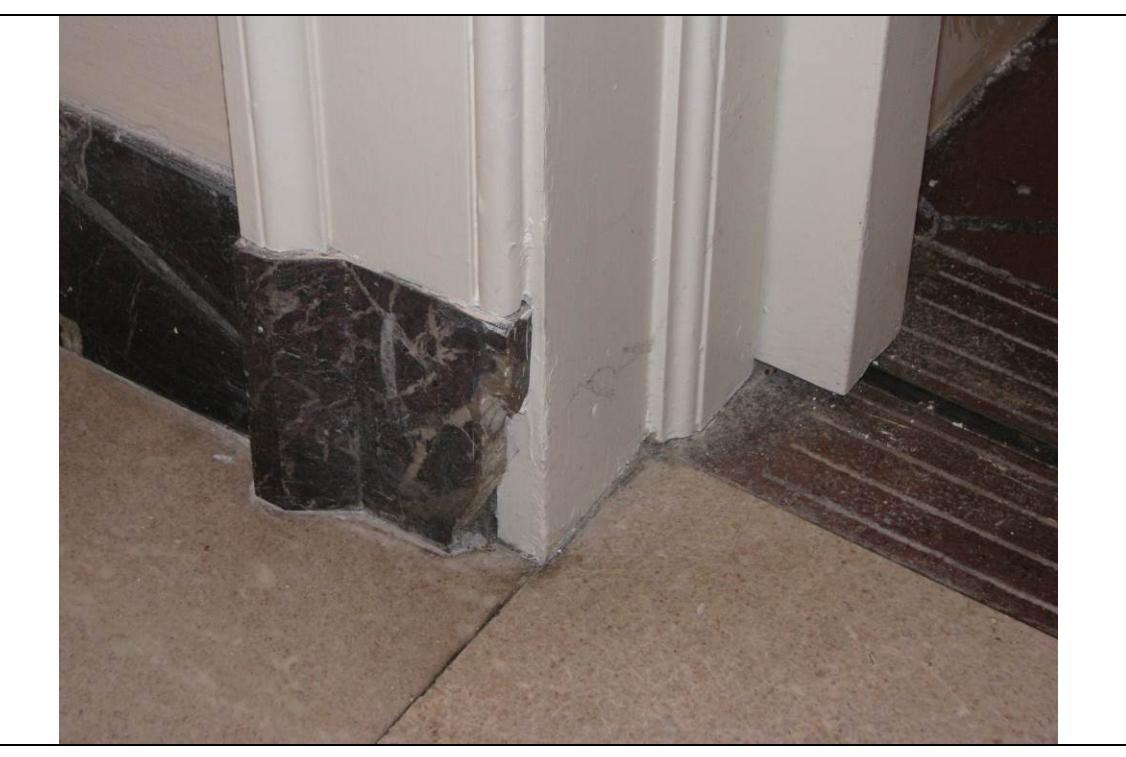
Figure 1.2.3-33: Broken Levanto marble wall base. Photograph by John Milner Architects, November 2012.
