THE THOMAS H. BAYLY BUILDING AT THE UNIVERSITY OF VIRGINIA

HISTORIC STRUCTURE REPORT.

November 8, 2013

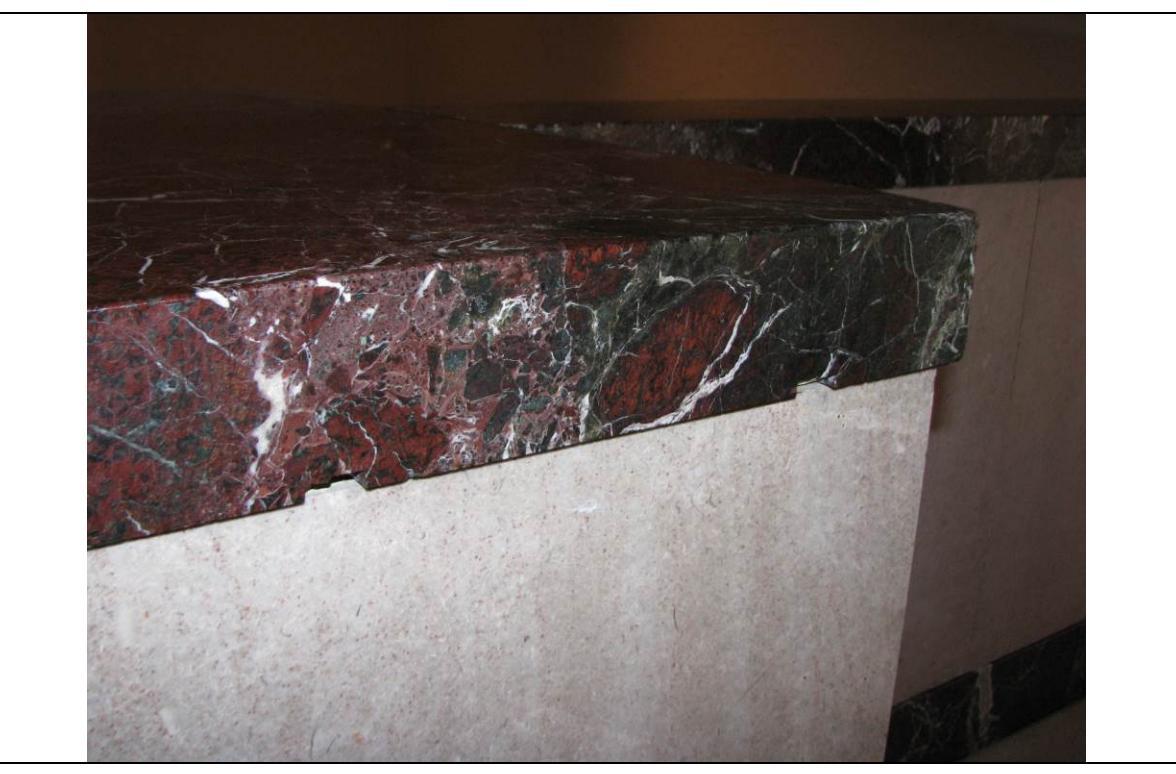
Figure 1.2.3-34: Chipped Levanto capstone at stair wall. Photograph by John Milner Architects, November 2012.

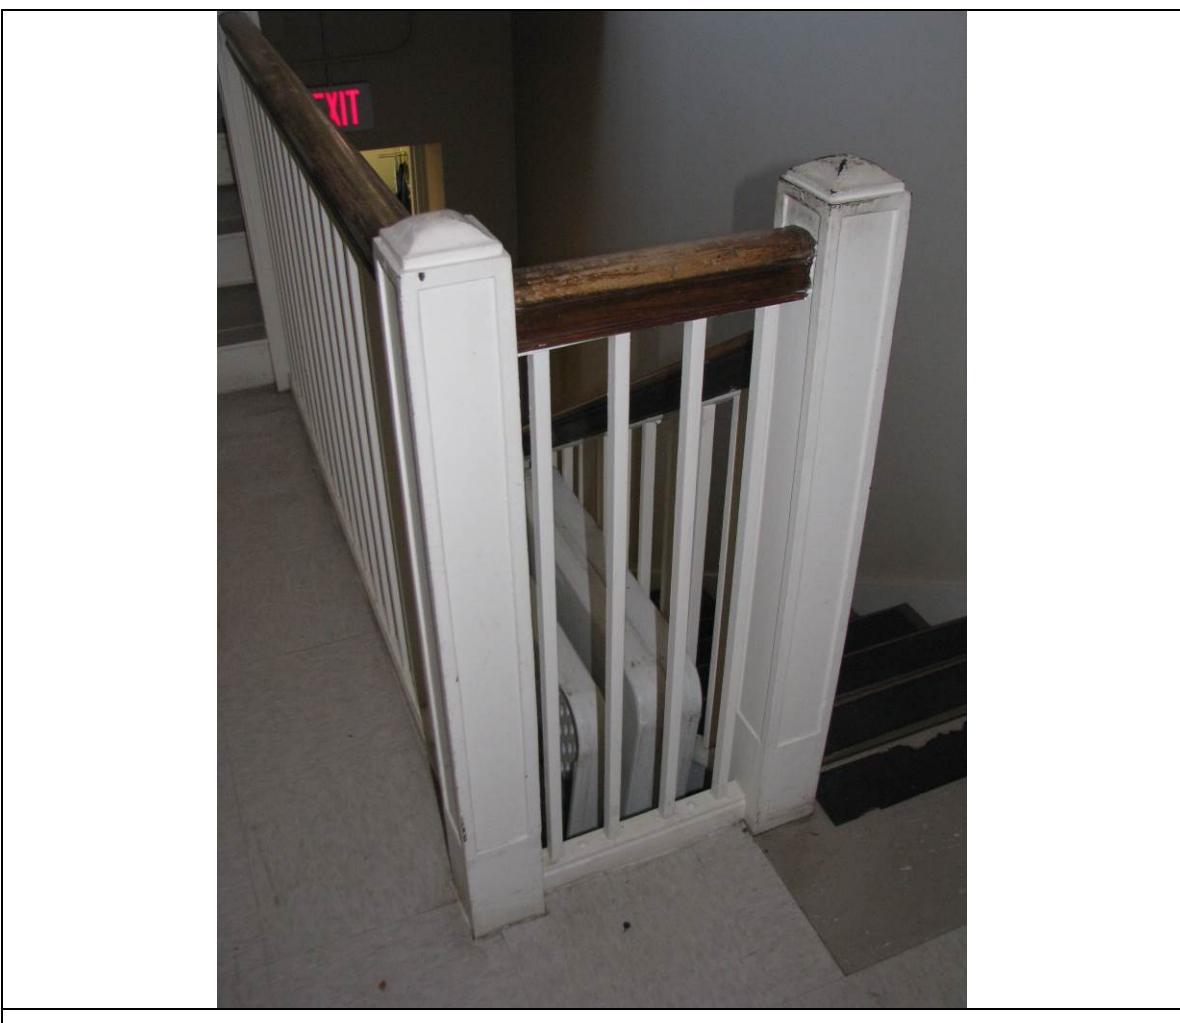
Figure 1.2.3-36: Worn railings and newels at secondary staircase. Photograph by John Milner Architects, November 2012.

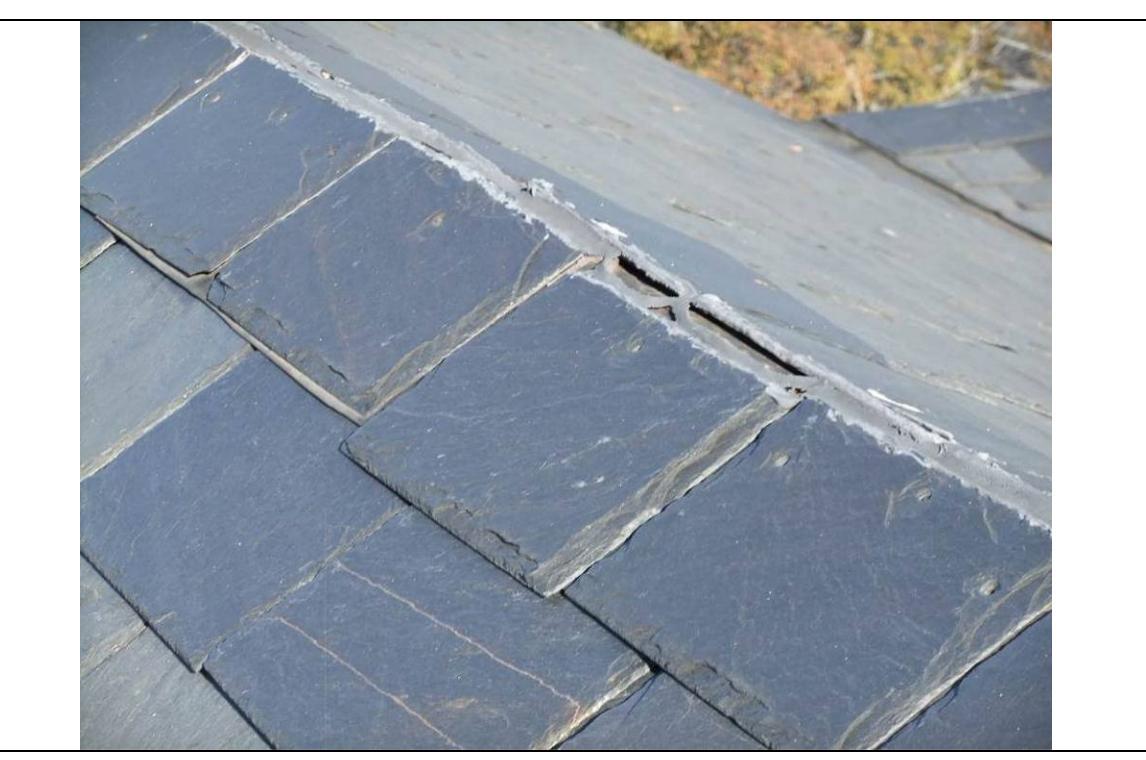
Figure 1.2.4.1-9: Localized slate deterioration at apex of roof. Photograph by Robert Silman Associates, November 2012.

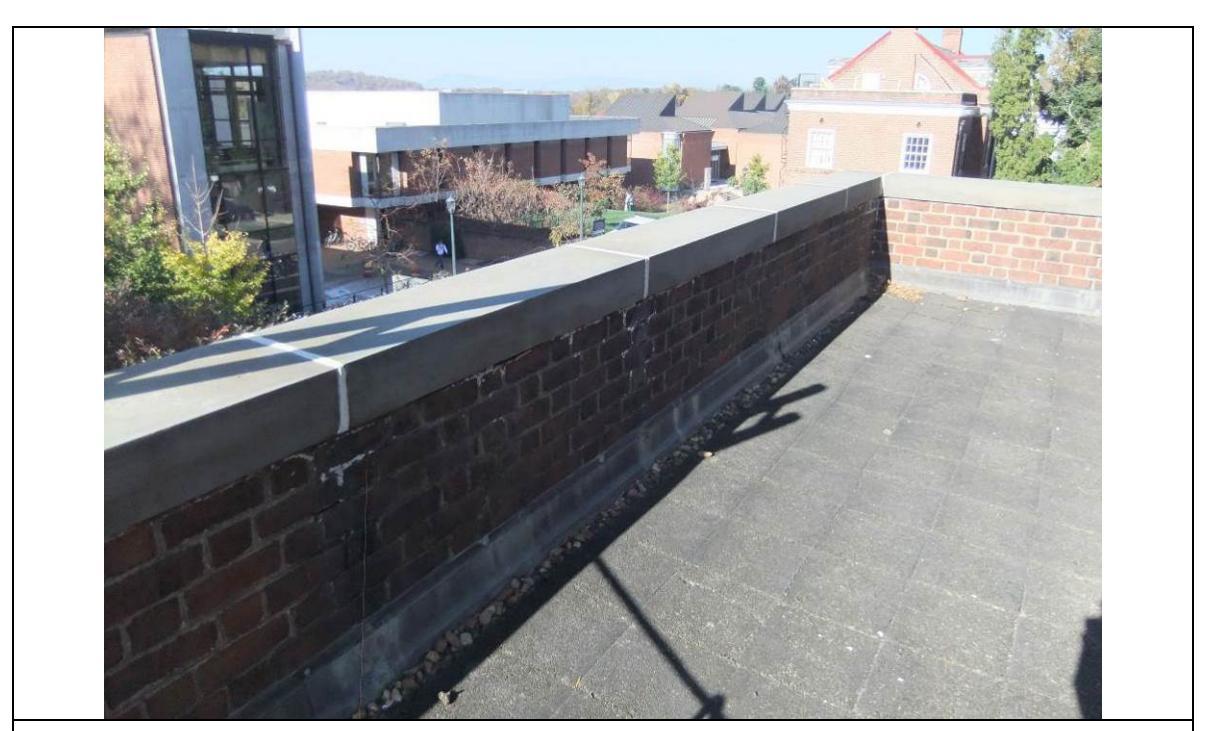
Figure 1.2.4.1-11: Parapet of West Terrace. *Note*: Biological growth, caulking of head joints, and loss of mortar at bed joints. Photograph by Robert Silman Associates, November 2012.

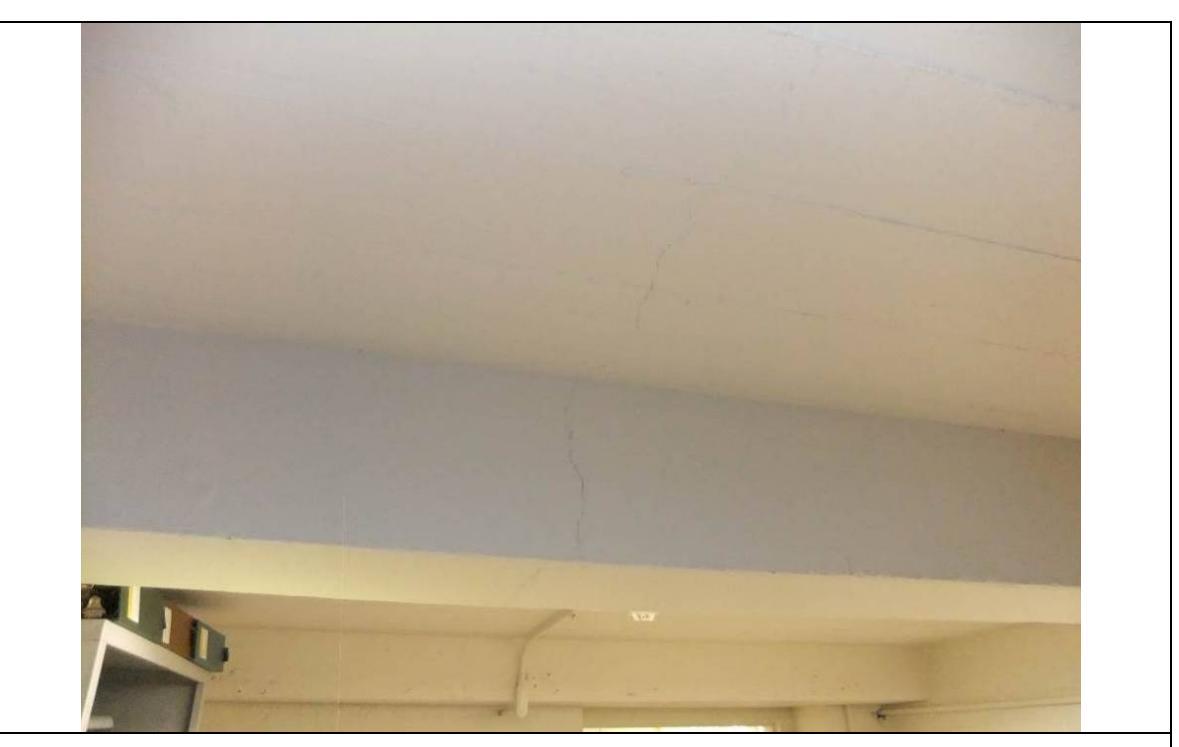
Figure 1.2.4.1-14: Crack in underside of first-floor slab and beam encasement in existing storage room adjacent to elevator. Photograph by Robert Silman Associates, November 2012.

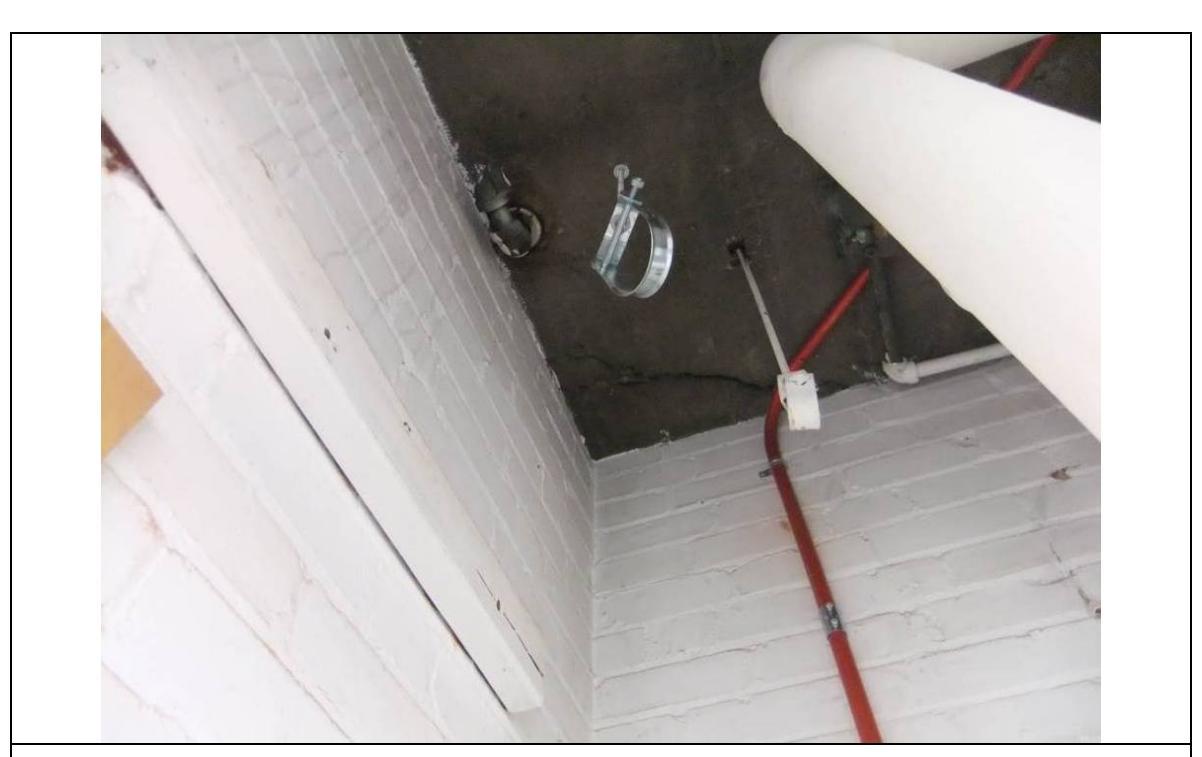
Figure 1.2.4.1-15: Crack in underside of first-floor slab in northeast mechanical room above trench access hatch. Photograph by Robert Silman Associates, November 2012.

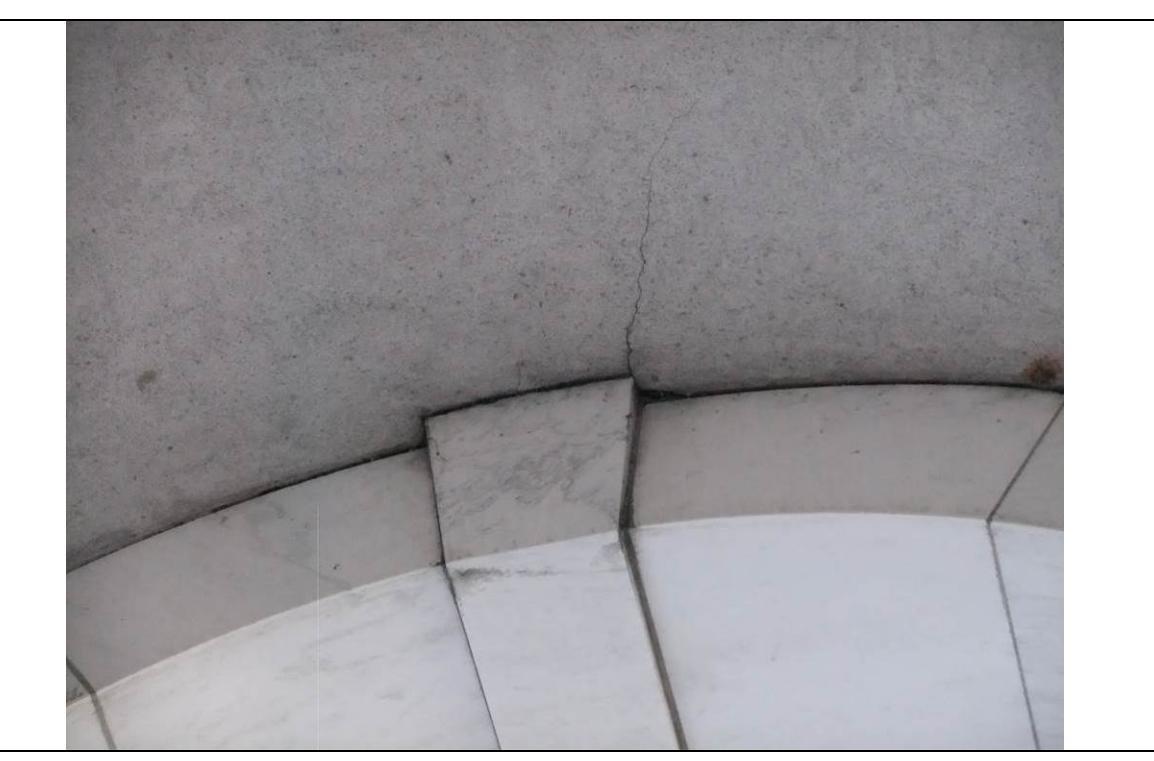
Figure 1.2.4.1-17: Localized cracking at top of hung stucco ceiling at east Portico. Photograph by Robert Silman Associates, November 2012.

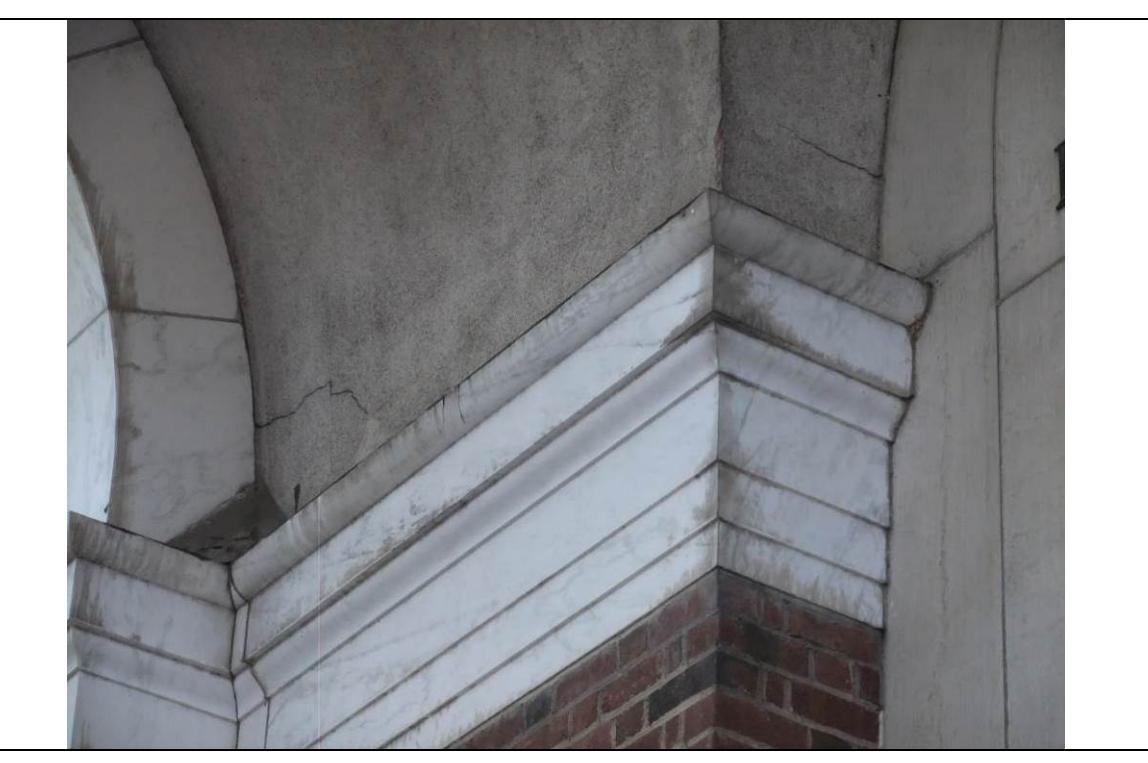
Figure 1.2.4.1-18: Localized cracking at base of hung stucco ceiling at east Portico. Photograph by Robert Silman Associates, November 2012.

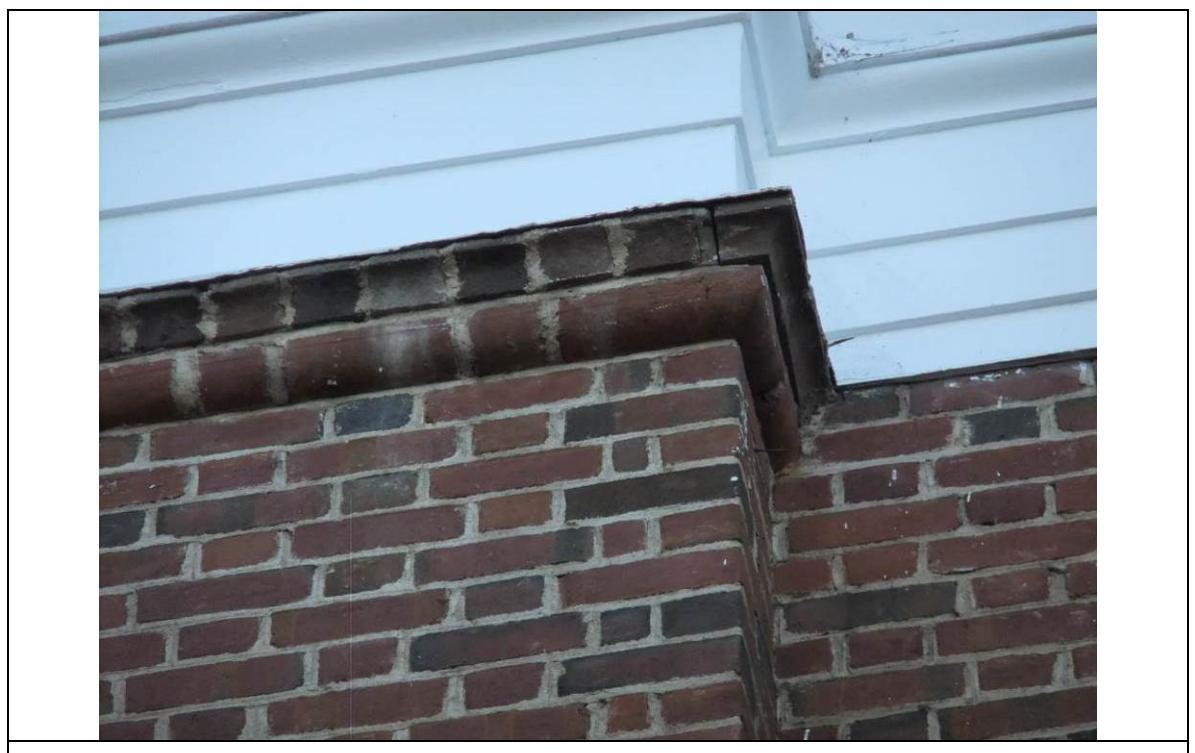
Figure 1.2.4.1-19: Localized loose brick and open mortar joints at top of pilasters. Photograph by Robert Silman Associates, November 2012.

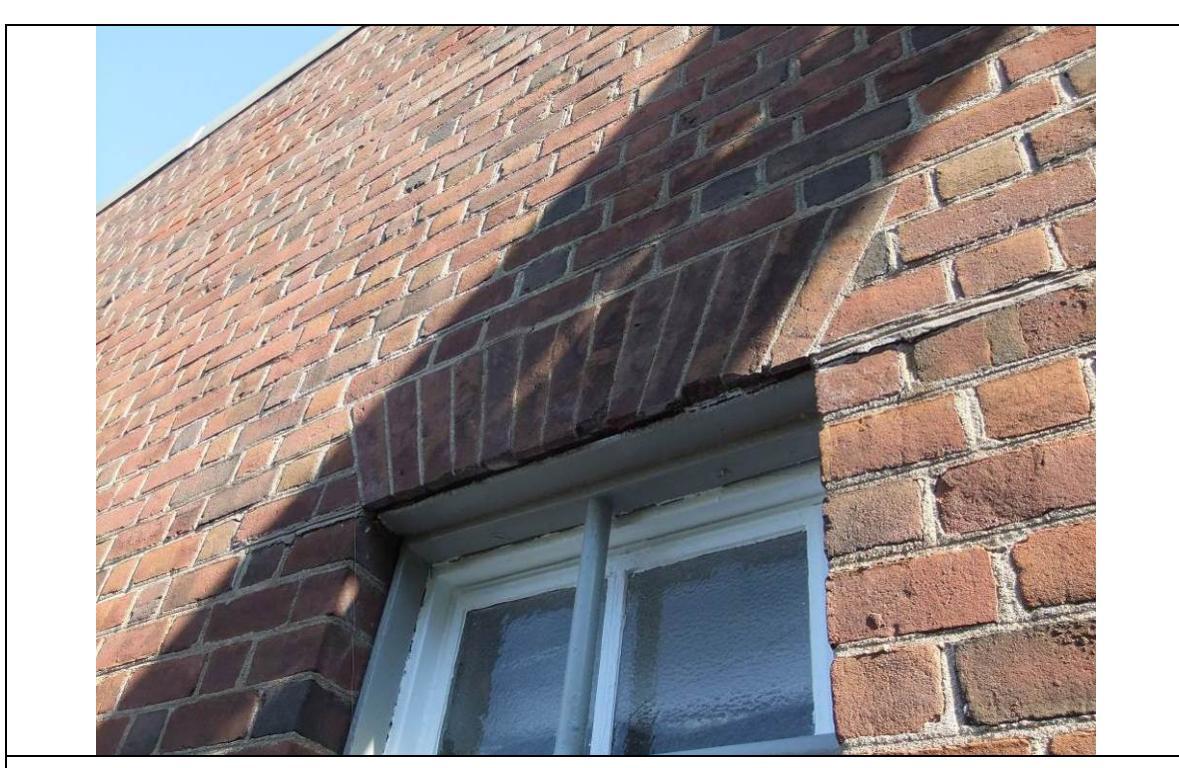
Figure 1.2.4.1-21: Deterioration of brick flat (jack) arch due to rust jacking of steel lintels along West elevation. Photograph by Robert Silman Associates, November 2012.

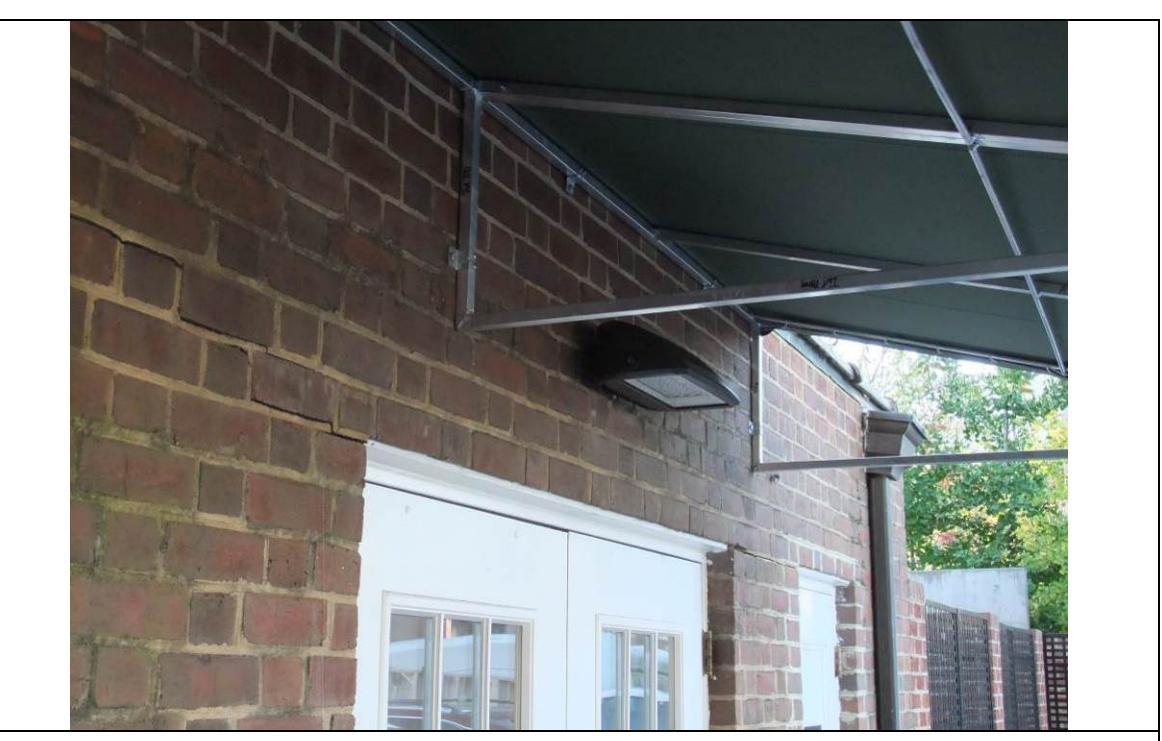
Figure 1.2.4.1-22: Horizontal cracking of brick masonry above wall penetrations (along single-story addition at northwest corner) due to rust jacking of steel lintels. Photograph by Robert Silman Associates, November 2012.

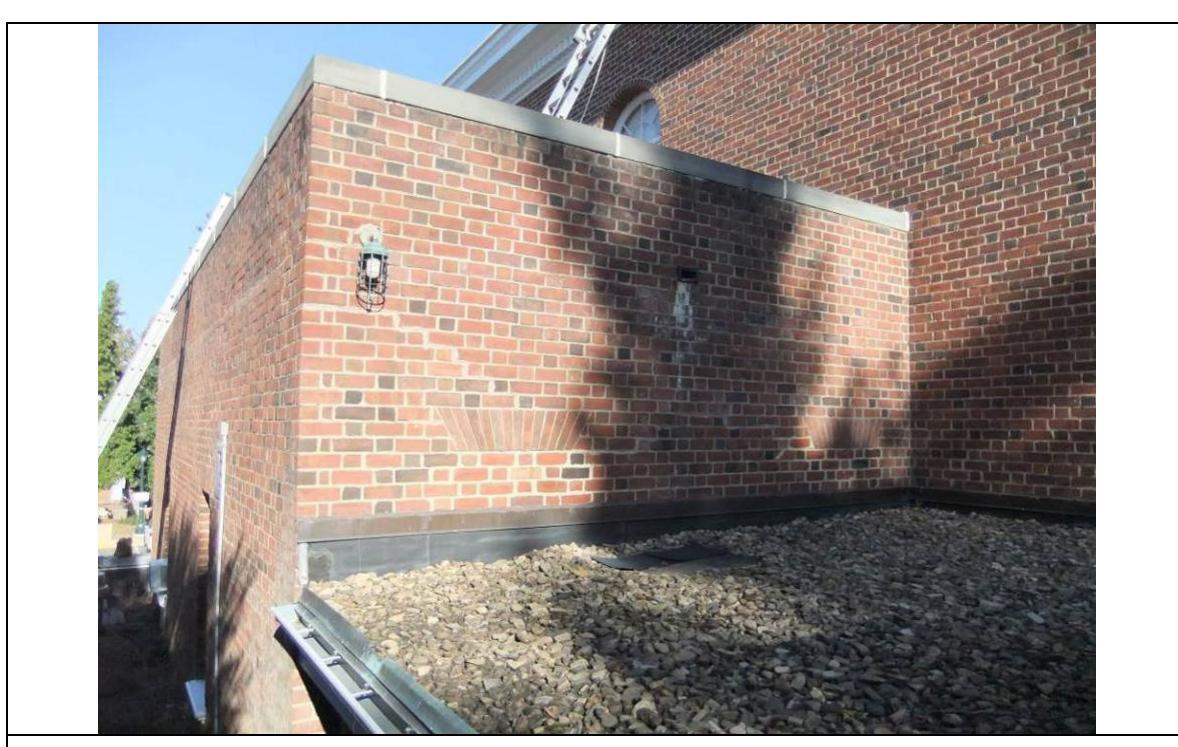
Figure 1.2.4.1-23: Infilled masonry openings and previously repaired diagonal and horizontal cracking. Photograph by Robert Silman Associates, November 2012.

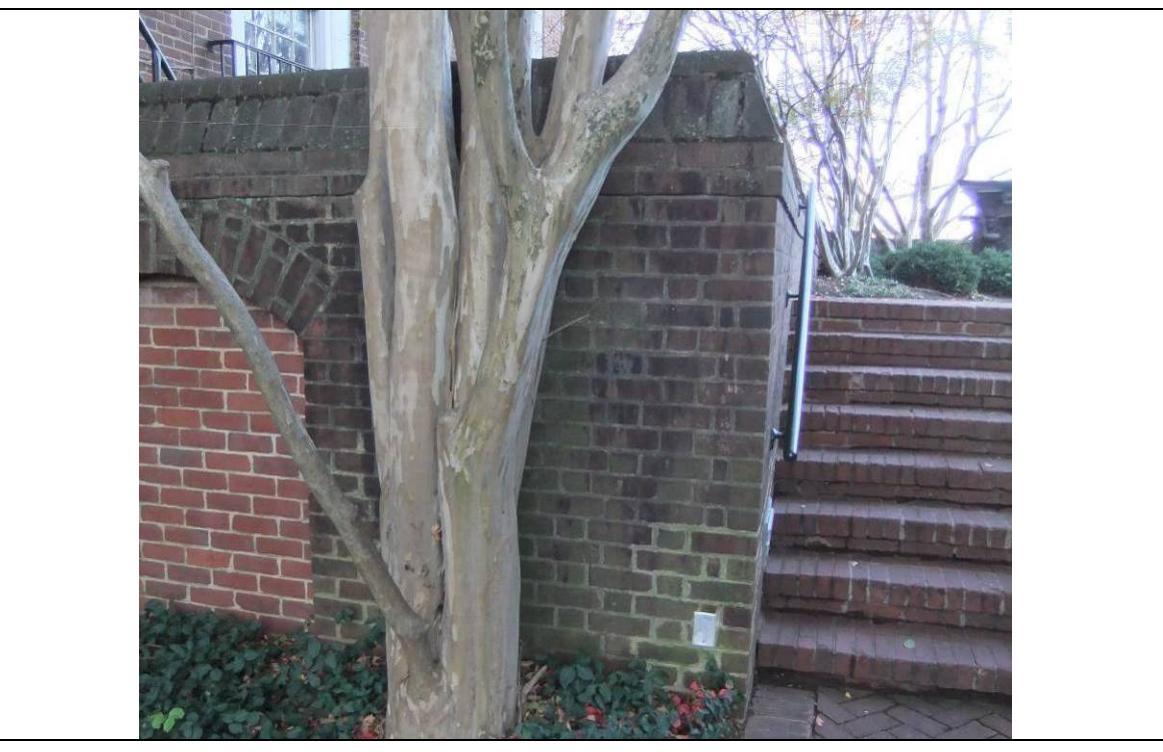
Figure 1.2.4.1-24: Existing brick-masonry retaining wall at northwest corner of site exhibiting localized vertical cracking due to proximity of tree-root and underlying root-system encroachment. Photograph by Robert Silman Associates, November 2012.

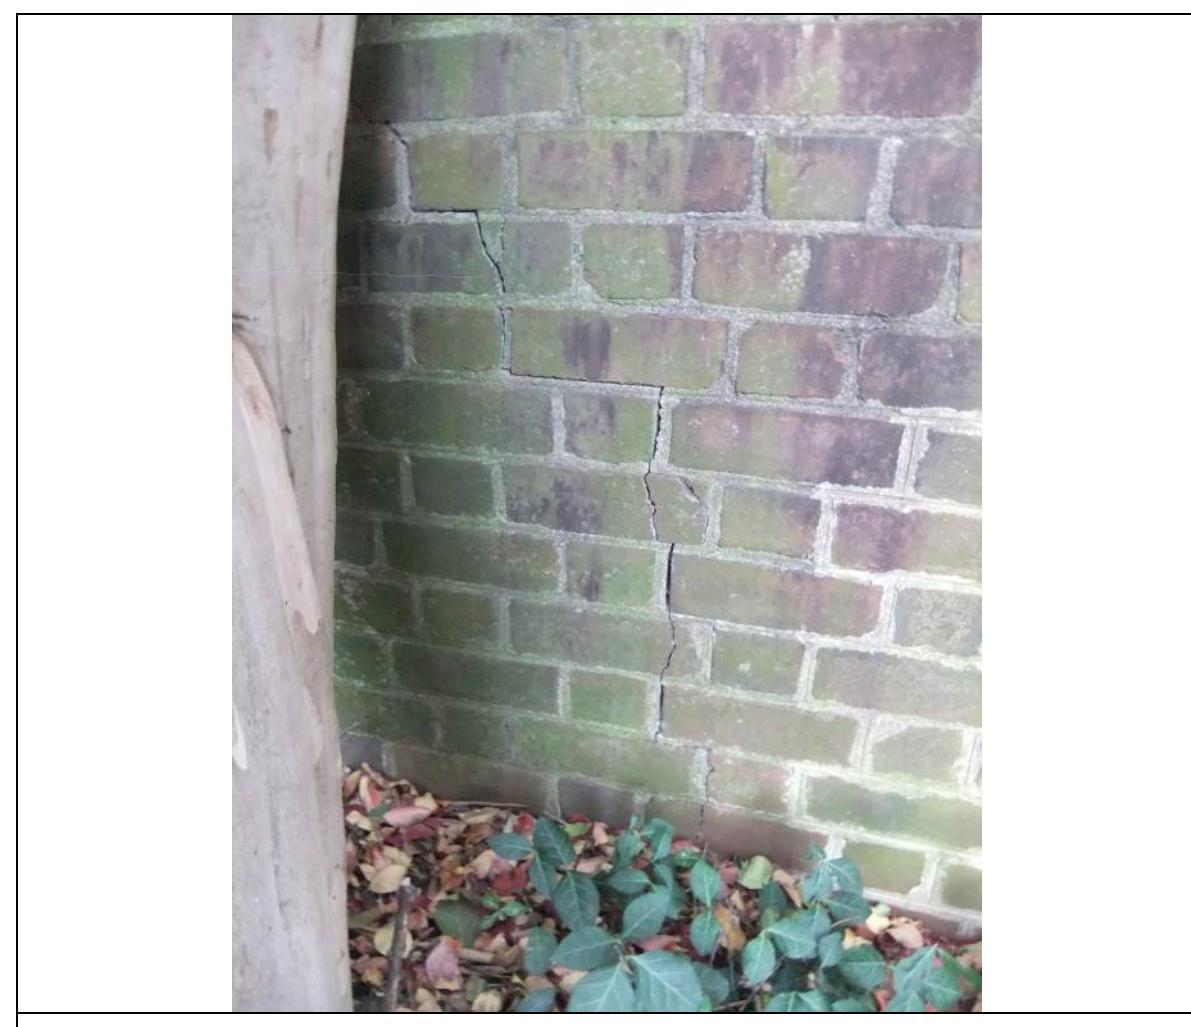
Figure 1.2.4.1-25: Existing brick-masonry retaining wall at northwest corner of site exhibiting localized vertical cracking due to proximity of tree-root and underlying root-system encroachment. Photograph by Robert Silman Associates, November 2012.

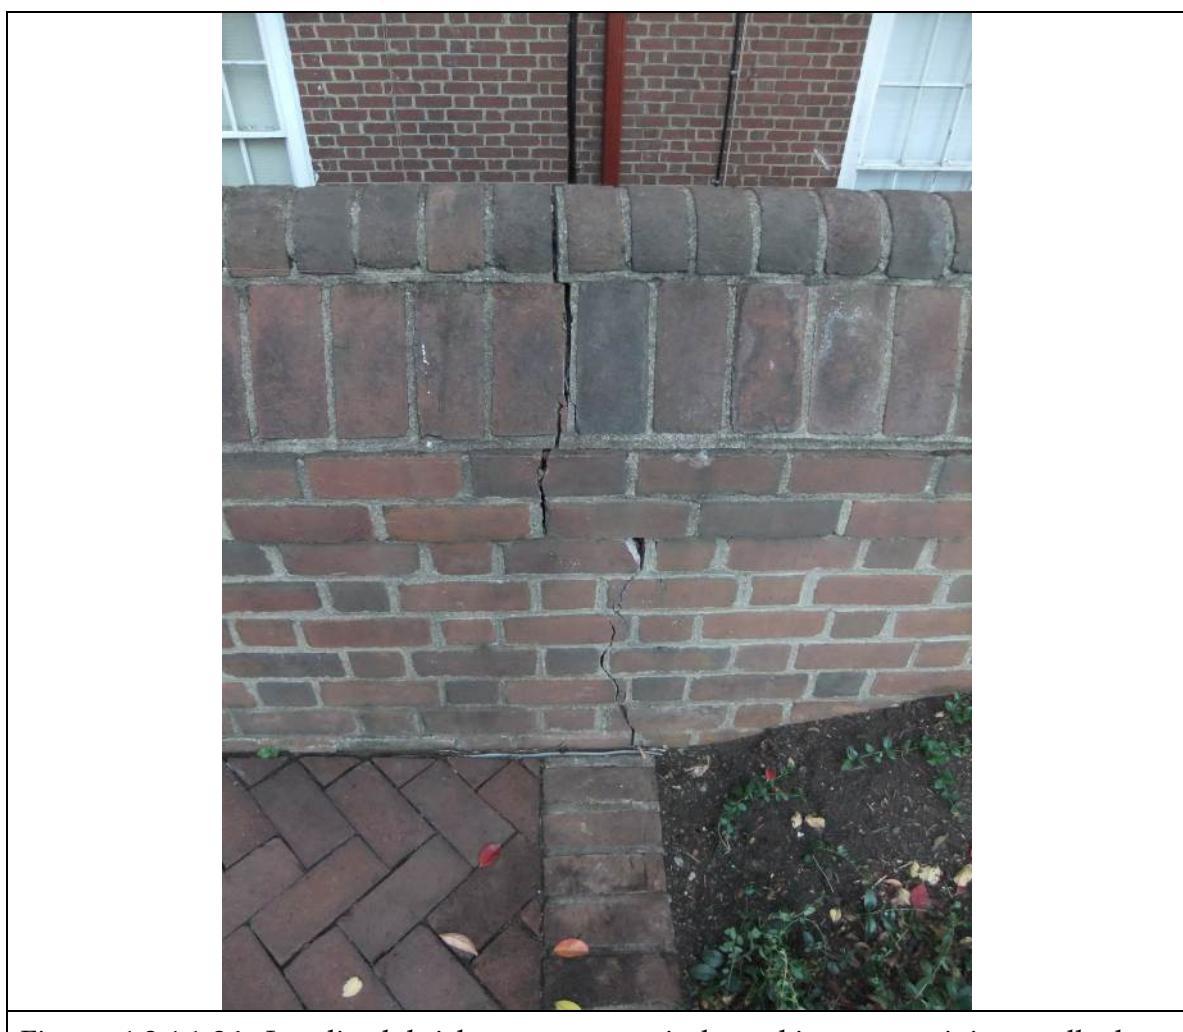
Figure 1.2.4.1-26: Localized brick-masonry vertical cracking at retaining wall along northern boundary of site. Photograph by Robert Silman Associates, November 2012.

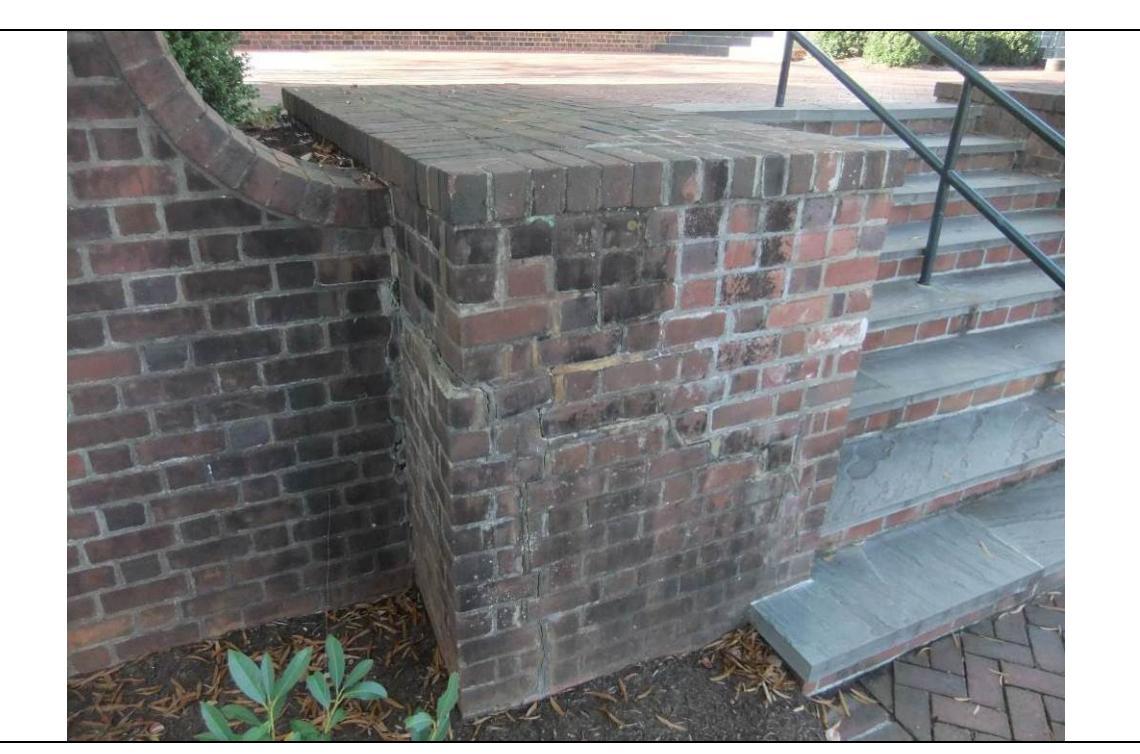
Figure 1.2.4.1-28: Brick-masonry cracking and displacement of pier abutment due to retaining-wall movement. Photograph by Robert Silman Associates, November 2012.

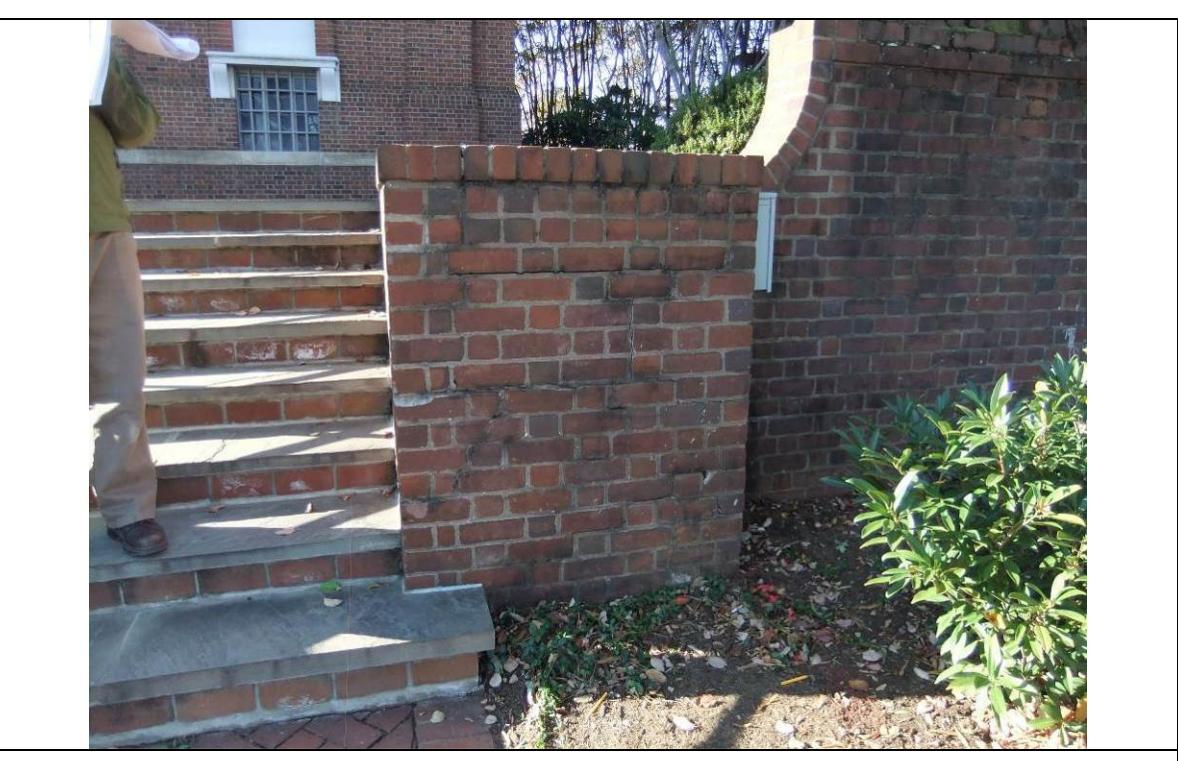
Figure 1.2.4.1-29: Horizontal cracking and displacement of brick at pier abutment due to retaining wall movement. Photograph by Robert Silman Associates, November 2012.

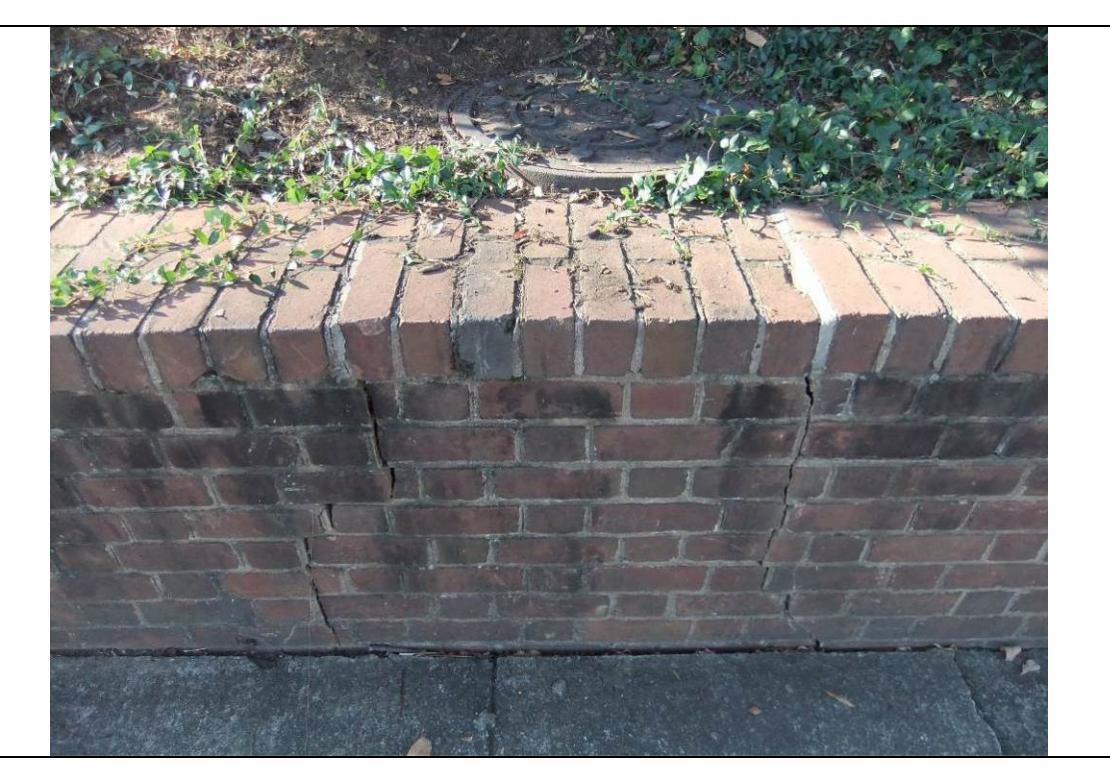
Figure 1.2.4.1-31: Vertical cracking in brick-masonry site wall locally at existing sanitary and water lines. Photograph by Robert Silman Associates, November 2012.

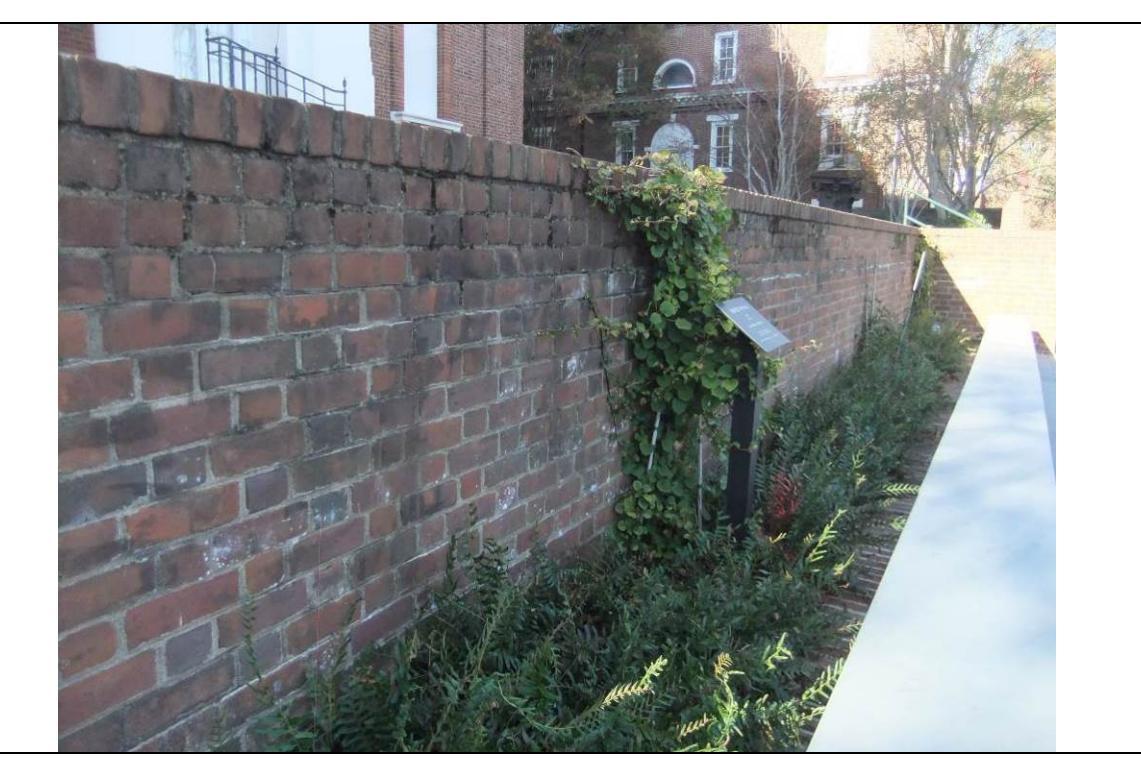
Figure 1.2.4.1-32: Biological growth and efflorescence in brick-masonry retaining wall. Photograph by Robert Silman Associates, November 2012.

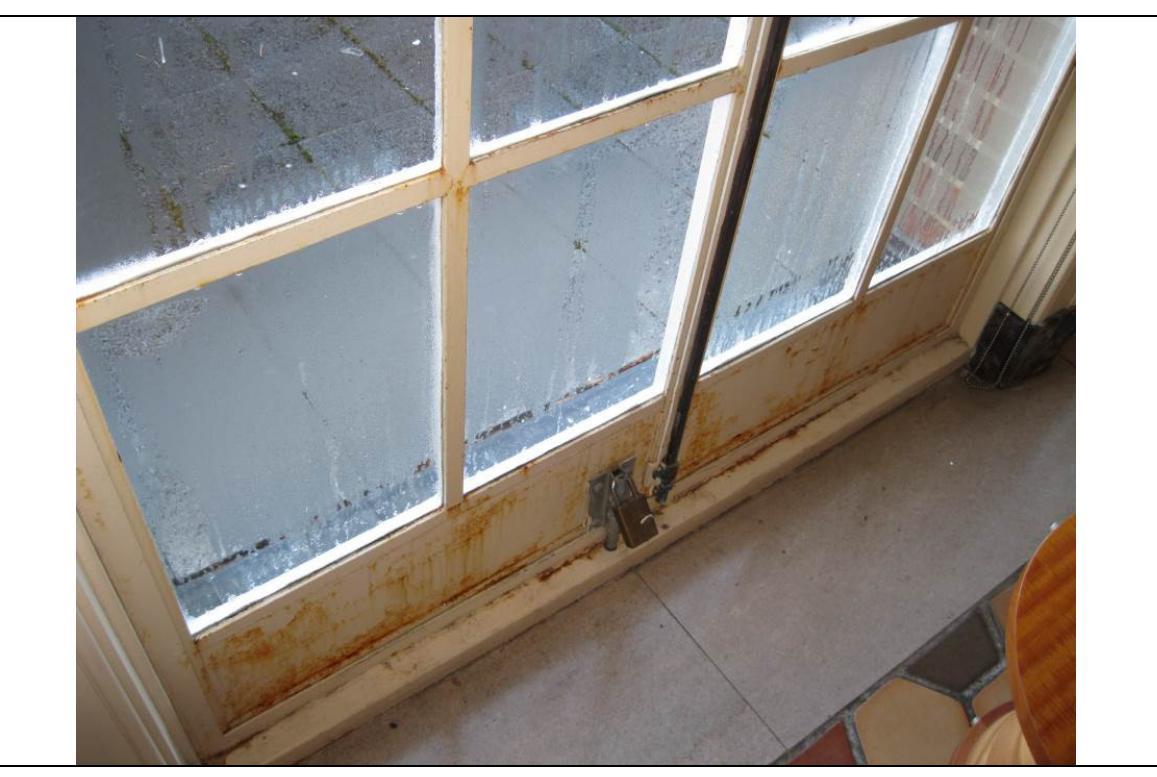
Figure 1.2.4.2-1: Single-glazed door on second floor with condensation. Photograph by T. Newbold, December 2012.

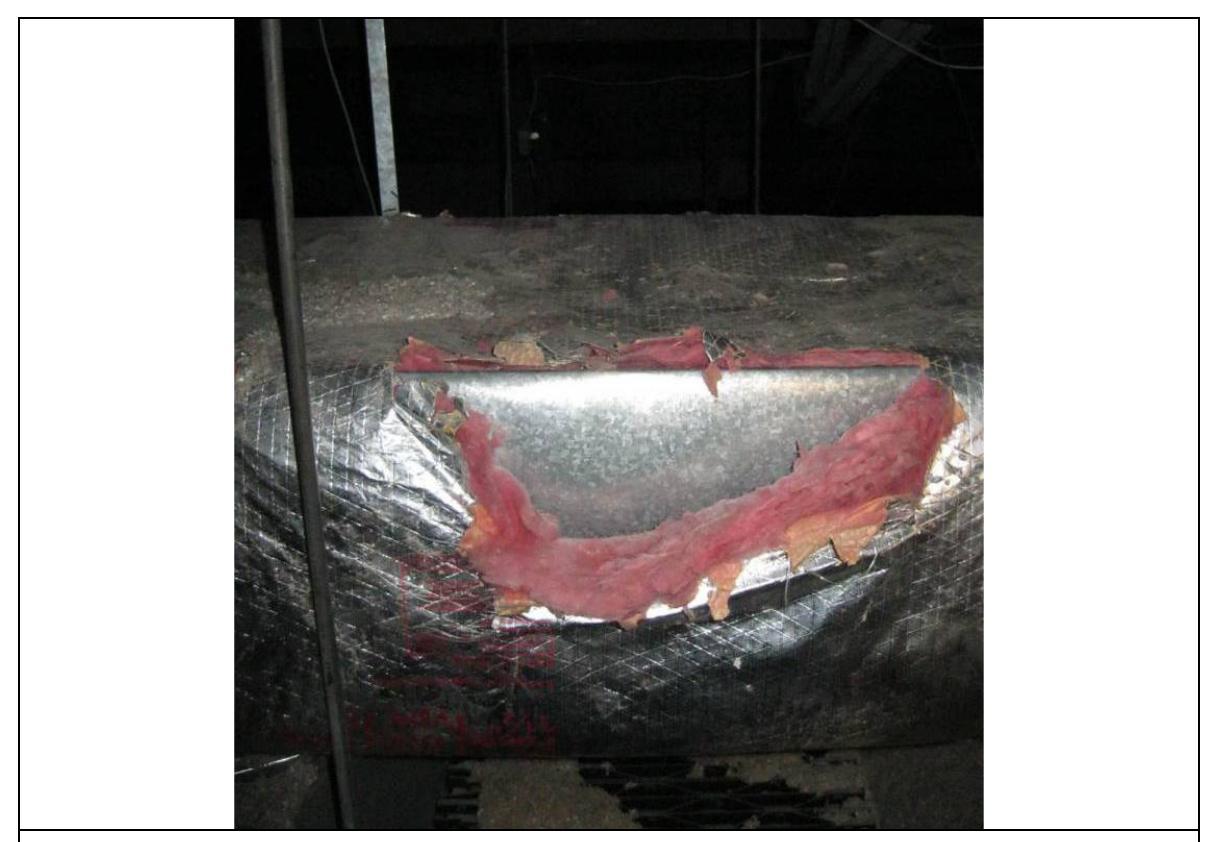
Figure 1.2.4.2-4: Damaged insulation on ductwork in attic. Photograph by T. Newbold, December 2012.

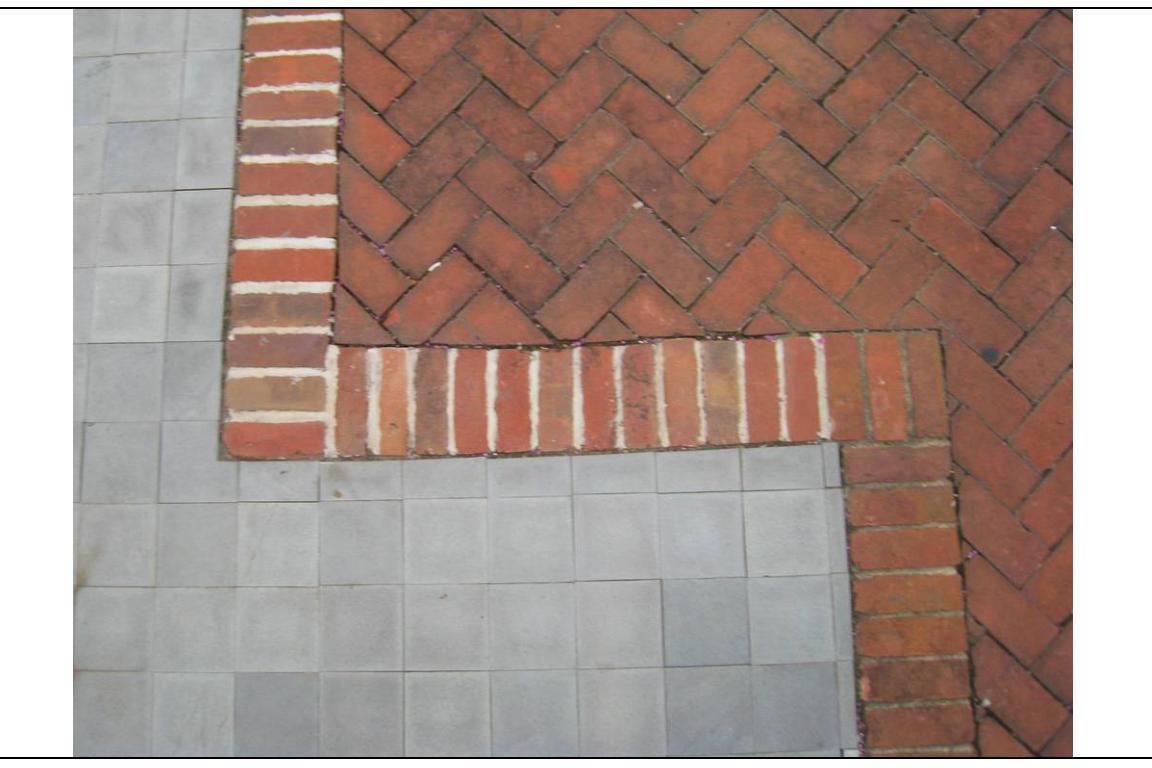
Figure 1.3.1-15: Brick-framed bluestone pavers fill the original island planting beds in the brick surface of the upper terrace. Note the recent bright mortar repair. Photograph by Heritage Landscapes, June 2012.
