ALDERMAN LIBRARY

UNIVERSITY OF VIRGINIA

Historic Features Survey

Final Submission
13 March 2015

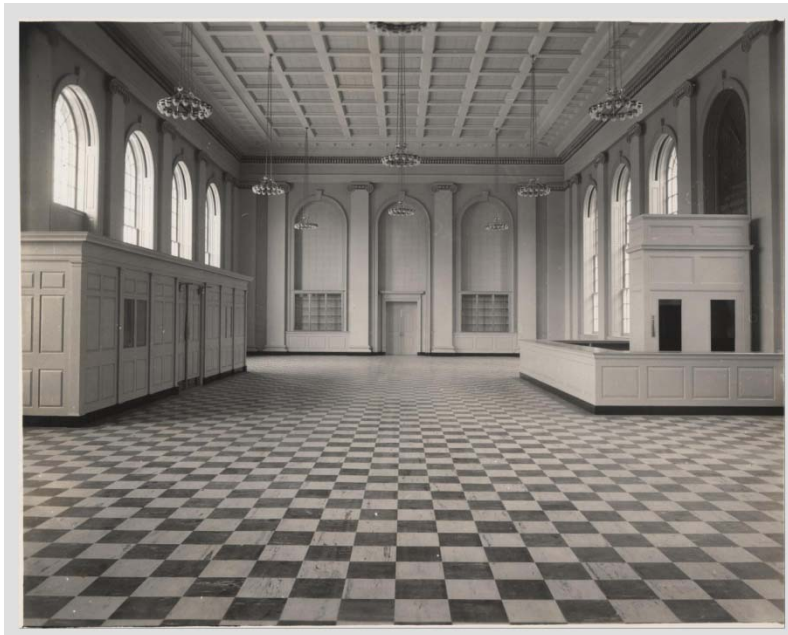
Figure 2- 22. West view of Memorial Hall. note the coat room on the left flanking the vestibule. On the right is the control desk and book conveyor delivery system. [UVa Special Collections, Print 2162447]

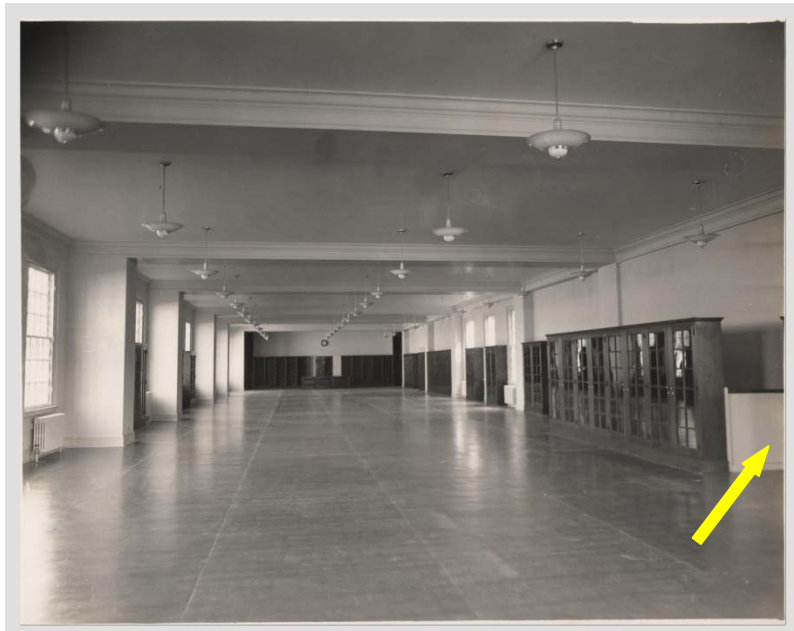
Figure 2- 23. South view of the Manuscripts Room before the installation of the McGregor Room. Note the doors to the vault on the south wall and the stairs to the first floor on the west wall (see arrow). [UVa Special Collections, Print 2162412]

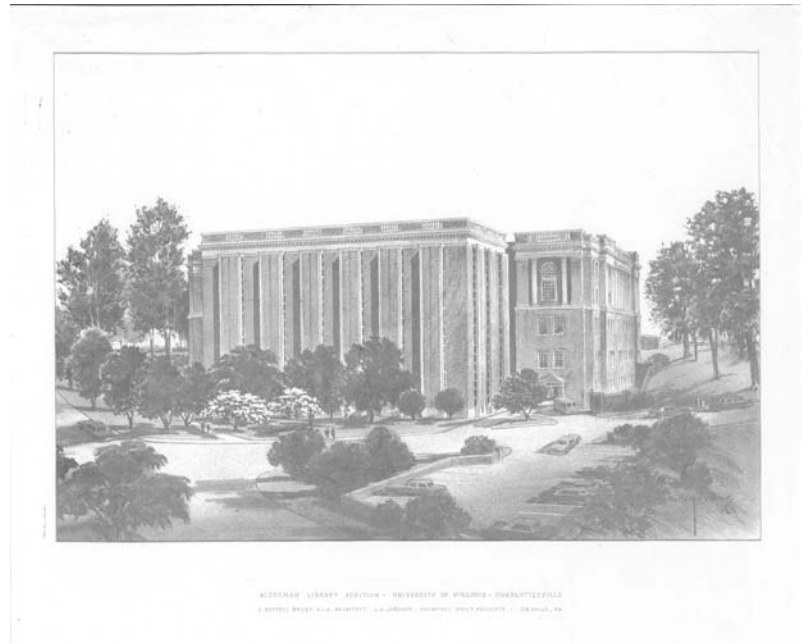
Figure 2- 33. North view of proposed addition by J. Russell Bailey in 1963. [UVa Facilities Management]

in brick. A light colored cornice and parapet, mimicking the 1936-38 design, wrapped the perimeter of the building. These features were not included in the construction drawings. The recessed bays were changed to marble panels, the cornice was stripped of ornamentation, and the parapet was removed.³⁰

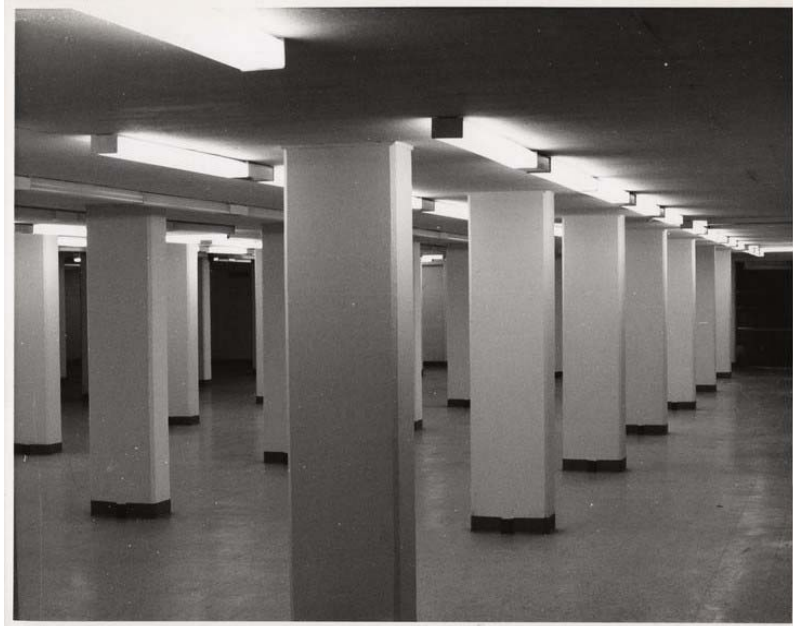
Figure 2- 34. View of columns in the New Stacks prior to the installation of book shelves. [UVa Special Collections]

The interior of the addition was defined by the use of columns rather than a structural book shelf system such as that used in the Old Stacks. (See Figure 2- 34.) The columns catered to the prescribed layout of shelves. Single occupancy desks were placed at the perimeter where light and air could be enjoyed through operable windows.

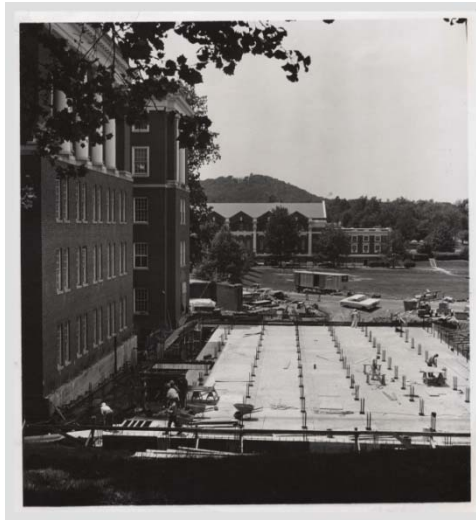
Figure 2- 35. West view of the addition's foundation on the north side of Alderman Library [UVa Special Collections, Print 2162489]

Construction commenced directly on the north elevation of Alderman Library. (See Figure 2- 35.) Upon opening in 1967, the New Stacks were already at capacity. The \$1.4 million addition was used exclusively for book storage and carrel space. A struggle immediately developed to continue to phases 2 and 3 of the library expansion. At this time, America was becoming more suburban and the university campus followed suit. "Instead of the tight control of the Board of Architects, new bureaucratic layers tended to disperse the decision making, and in the end, nobody had an overall vision."³³

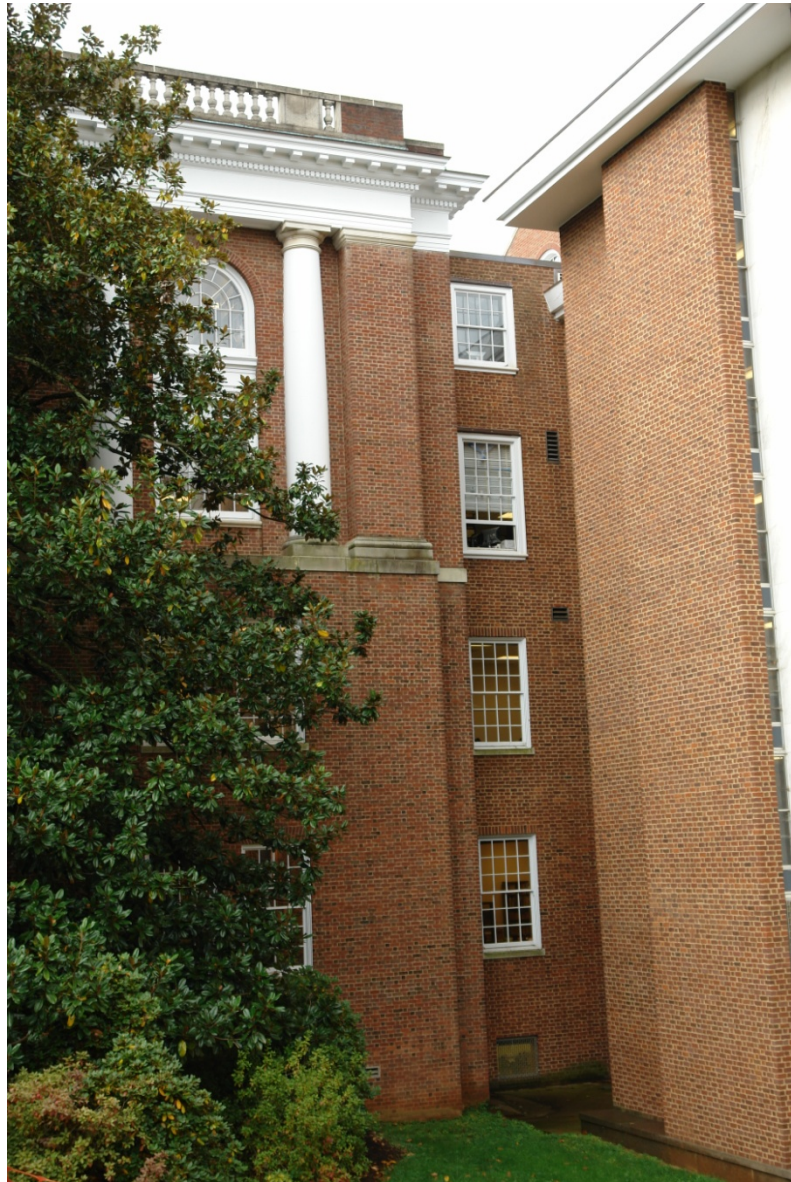
Figure 4- 7: Southwest view of the north elevation where the addition intersects with the original building. [QEA, 2014]

centerline of the engaged columns. The parapet ends in a brick wall with a cast stone cap at the ends of the balustrade and at the hyphens.

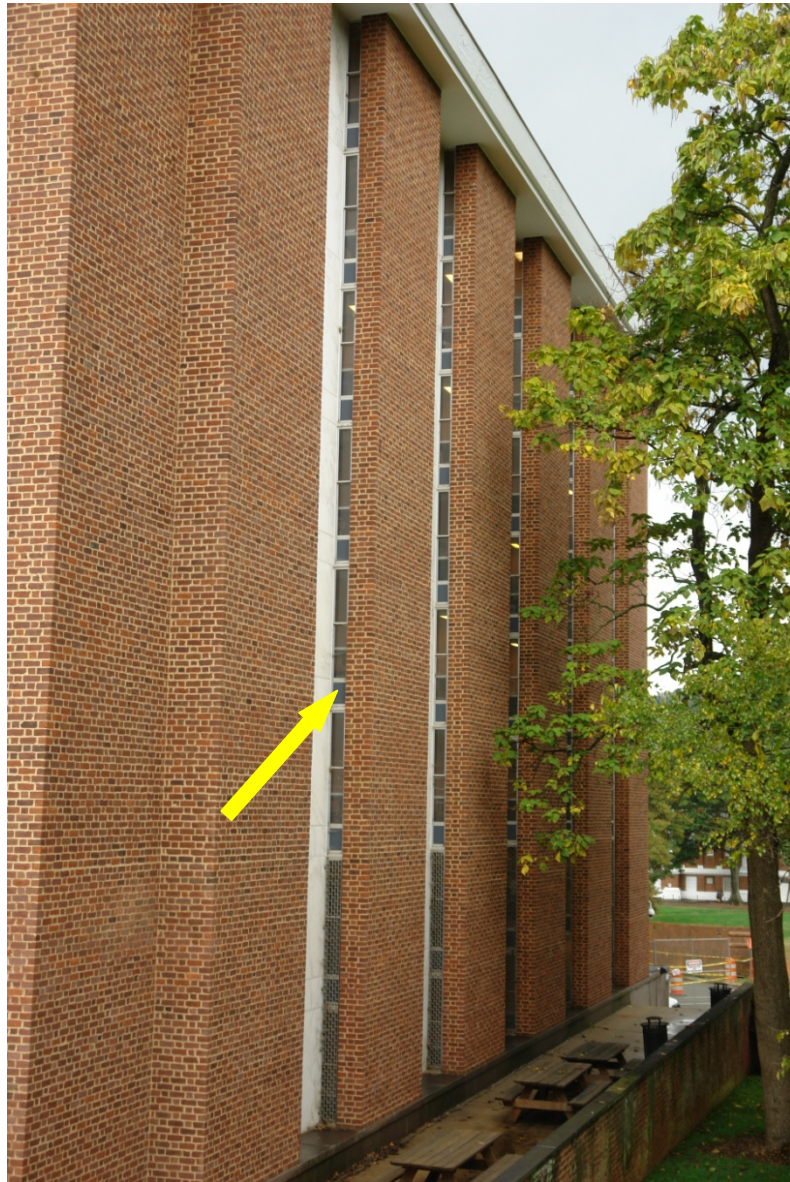
Figure 4- 10: West view of the addition's north elevation. Note the slender windows at the recessed marble panels. The arrow highlights a location of Glasweld used at the floor lines. [QEA, 2014]

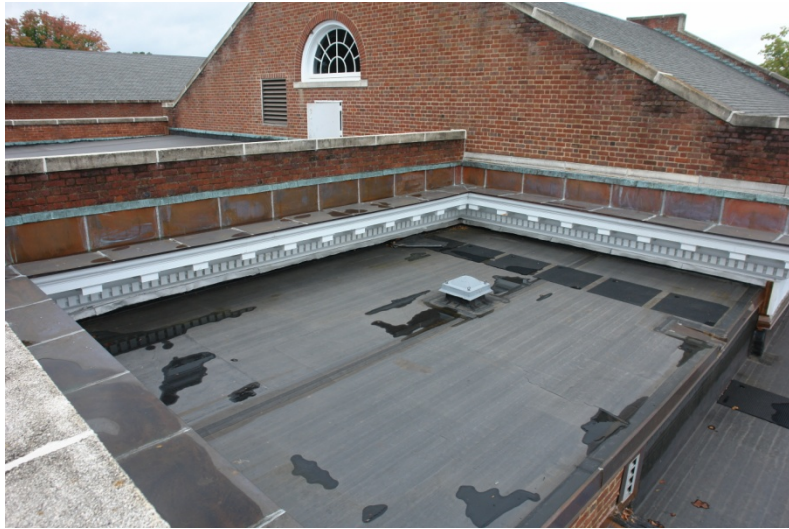
Figure 4- 12: Southwest view of the northeast 1967 infill roof and the east gable wall of the north Old Stacks block. [QEA, 2014]

The slate, single gable roofs over the north and south blocks have parapet end walls. A fanlight is on the east and west gable walls of both sides of the gable walls. Two varying dark colors of slate were observed. The end wings and hyphens have a flat roof. All of the roofs have been replaced with the exception of the slate roofs which are original to 1936-1938 construction.

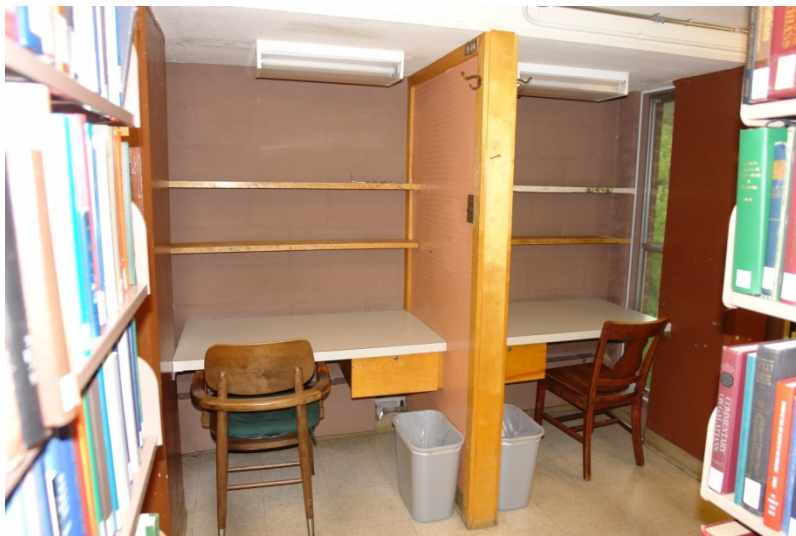
Figure 4- 54. A typical study desk in the New Stacks. Note the operable window at the corner of the desk. [QEA, 2014]

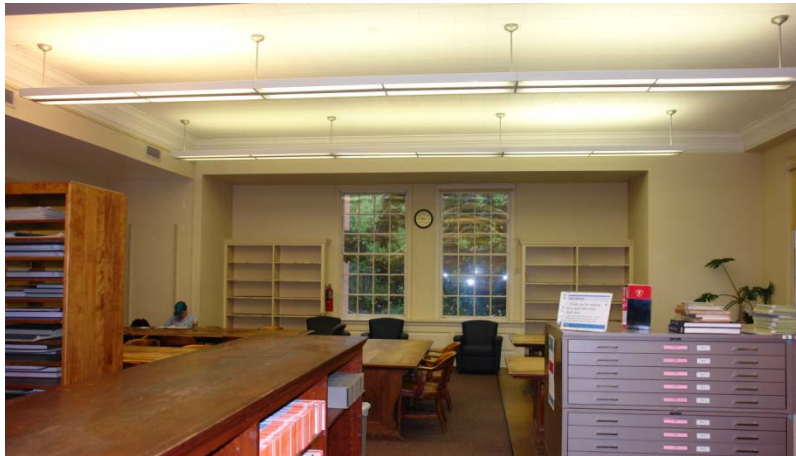
Figure 4- 60. North view of the Map Room. Note built-in shelves along the north wall. [QEA, 2014]

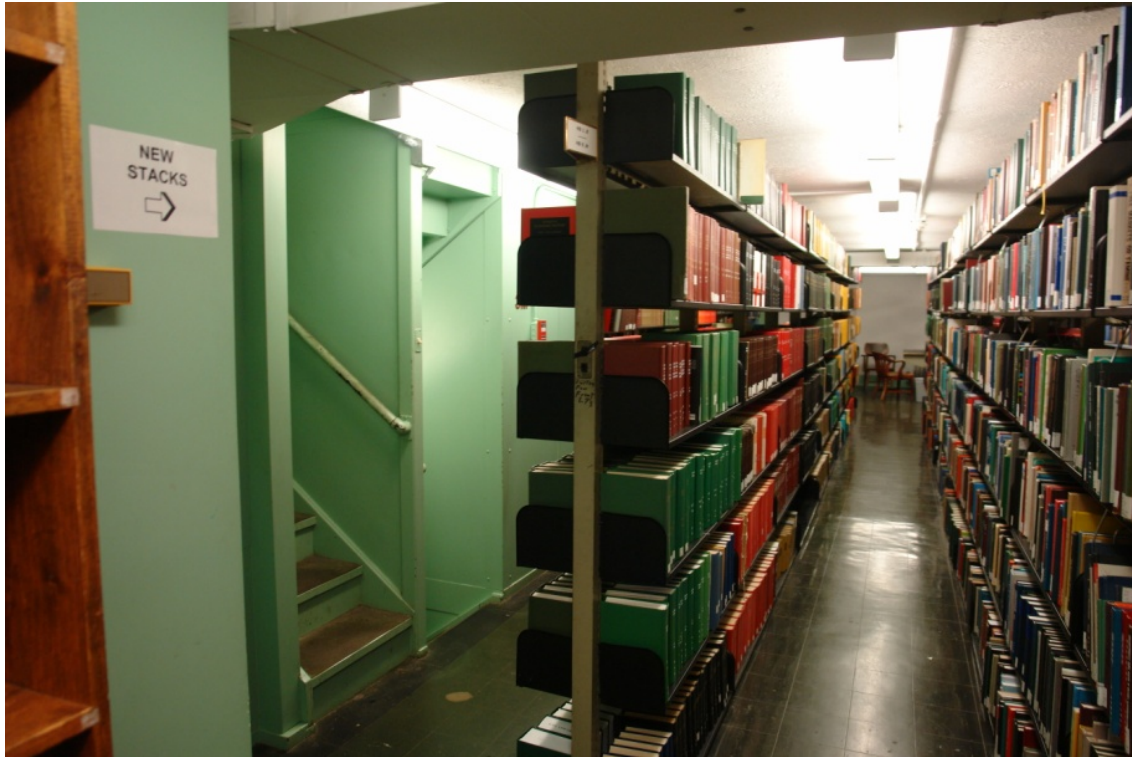
Figure 4- 112. North view of the submarine stairs in the Old Stacks. [QEA, 2014]
