# OAK LAWN

HISTORIC STRUCTURE REPORT &  
CULTURAL LANDSCAPE REPORT

JOHN G. WAITE ASSOCIATES, ARCHITECTS  
LIZ SARGENT HISTORIC LANDSCAPE ARCHITECTURE  
2025

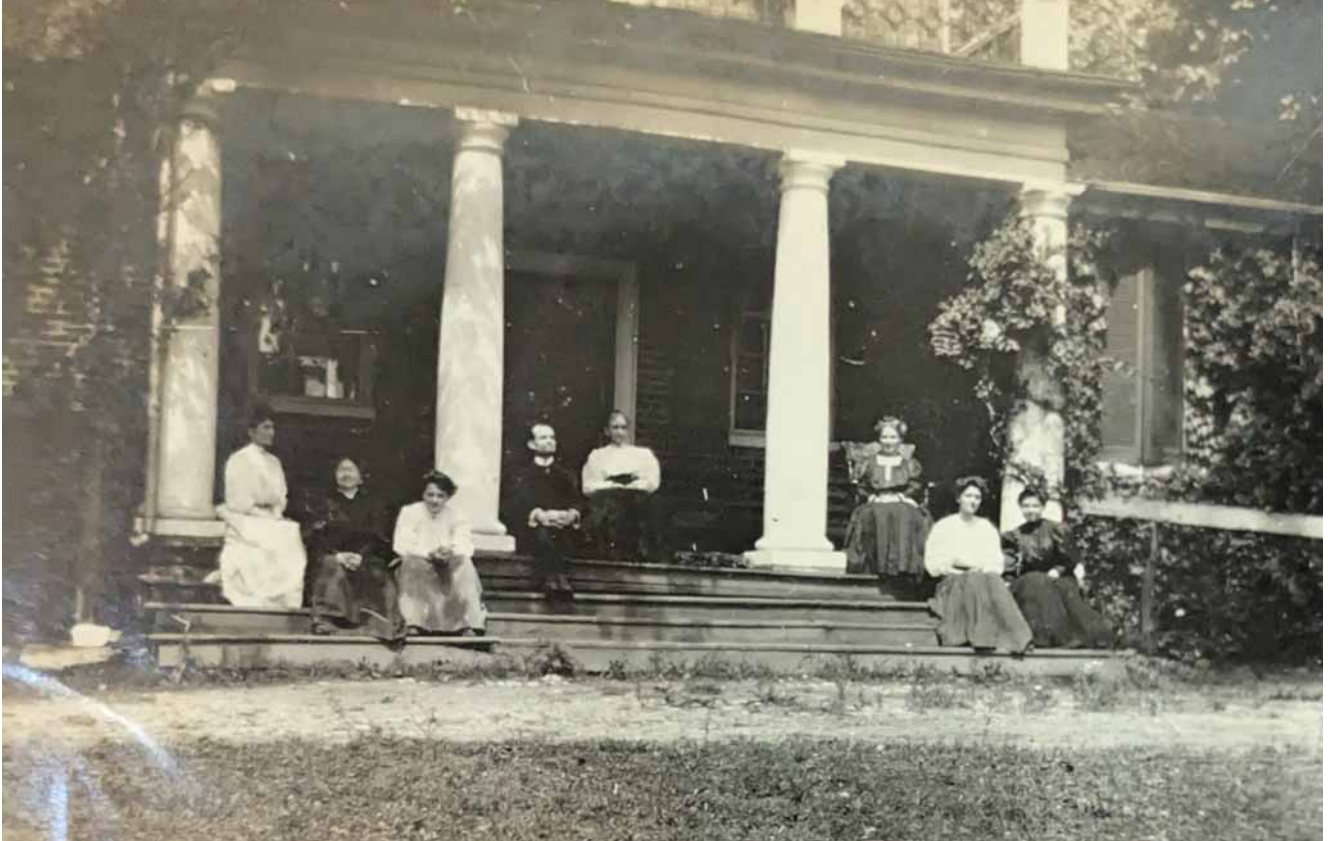
*Figure 1. Sarah (Sallie) Fife (between the center two columns) with her family on the front steps of Oak Lawn. The photo is annotated with the family names: "Daisy, Katherine, Ella, James, Mother [Sallie], Cousin Sammy, Madge, Nanny." Note that the front steps extend the full width of the porch. Courtesy of the Fife Family.*

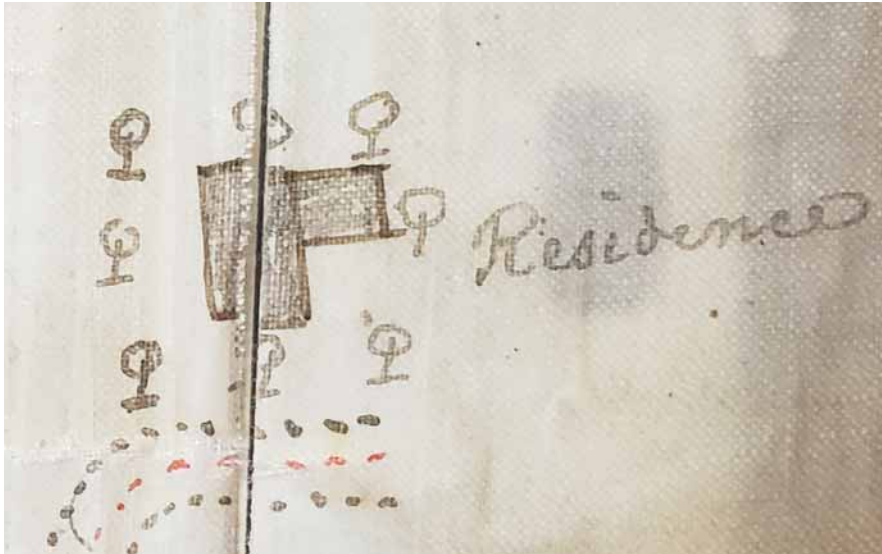
*Figure 18. Detail, Plat of Fife Lots, showing Oak Lawn residence. J. T. E. Simms, June 1886. Clerk's Office, Albemarle County Courthouse, ACDB 88:176-177.*

on the west and 9<sup>th</sup> St. SW on the east. The plat also depicted the Oak Lawn residence and a curvilinear entrance drive leading to its north façade (Figure 16 - Figure 18).<sup>151</sup>

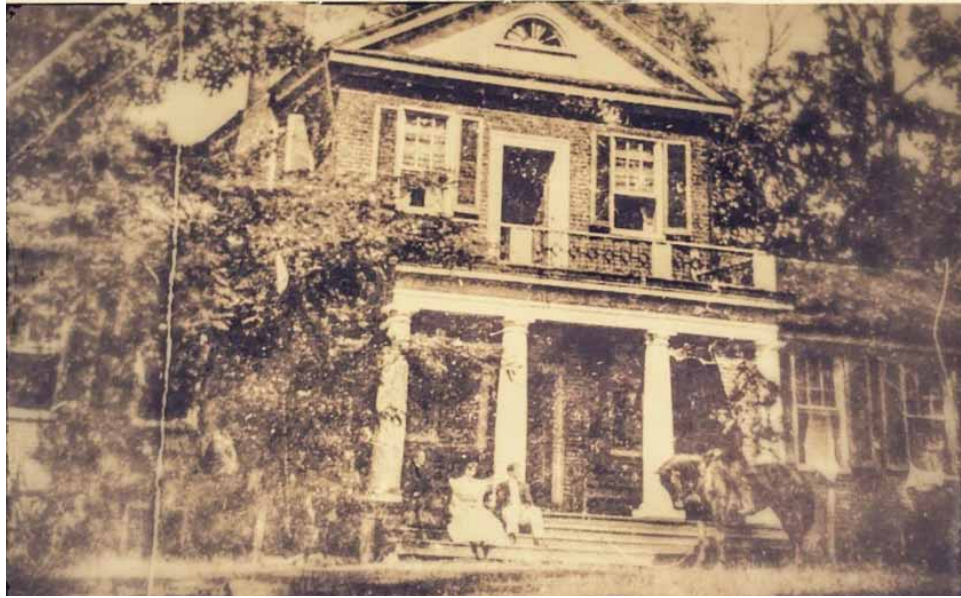
*Figure 27. Undated view of the main house from the southeast. This early view shows a second version of the porch balcony, where cast-iron railings extending between the original wood panels have replaced the original wood railings. Courtesy of the Fife family.*

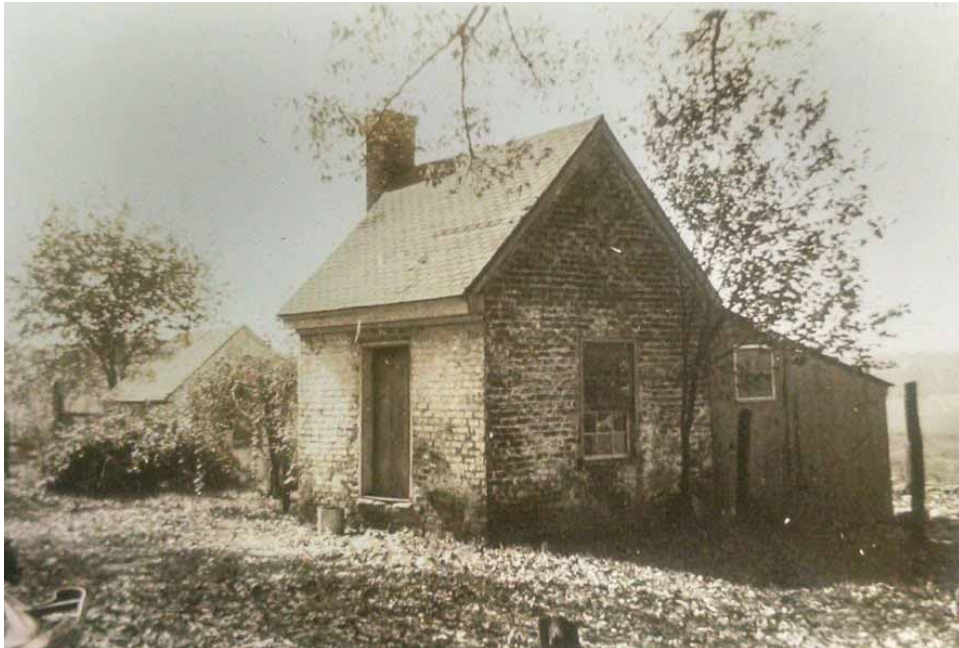
*Figure 30. The Cook's House, with a framed addition to the west, and another outbuilding to the south. Courtesy of the Fife family.*

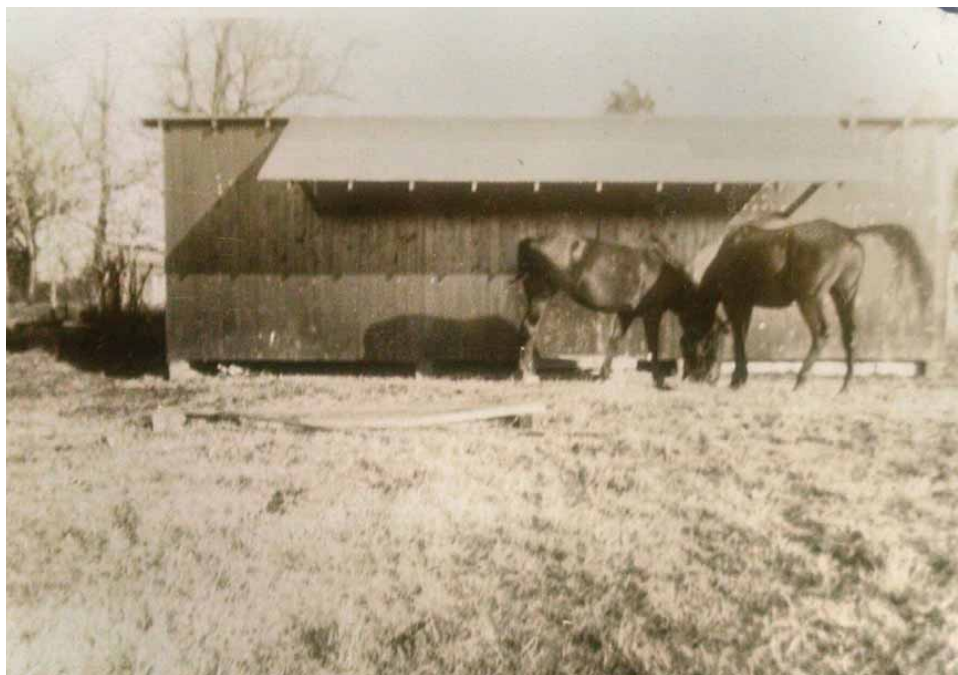
*Figure 33. View looking east showing a barn formerly located along the current western boundary of Oak Lawn. Courtesy of the Fife family.*

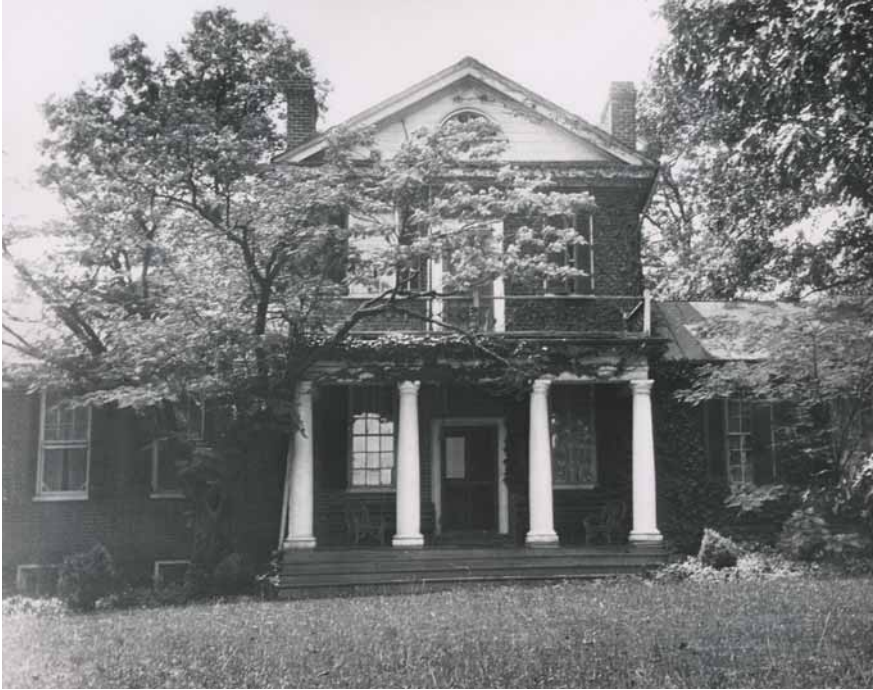
*Figure 41. East façade of Oak Lawn showing columned front porch. The balcony balustrade now consists of cast-iron railings extending between narrow posts. A. Hench, June 3, 1937. University of Virginia, Special Collections Library, UVA Prints #16531.*

A series of four black and white photographs of Oak Lawn taken by Atcheson L. Hench, a Professor of English at the University of Virginia, document the primary residence and its immediate vicinity in June of 1937. The photographs show the east, south and west façades of Oak Lawn. Vegetation, including small trees and shrubs surround the residence. The formal east façade with columned porch has English ivy growing on the brick walls. What appears to be a gravel road winds up to the front porch. In the east yard is a well-maintained yard of sod. The south yard shows the western brick kitchen addition and southern frame porch connecting the kitchen and primary residence. Josephine McDaniel is shown working adjacent to what appears to be a pile of vegetative debris in front of the frame porch. The western façade and yard is shaded by large oak trees and what appears to be a barbed wire fence separates the domestic core from the adjacent western fields. (Figure 41 through Figure 44).

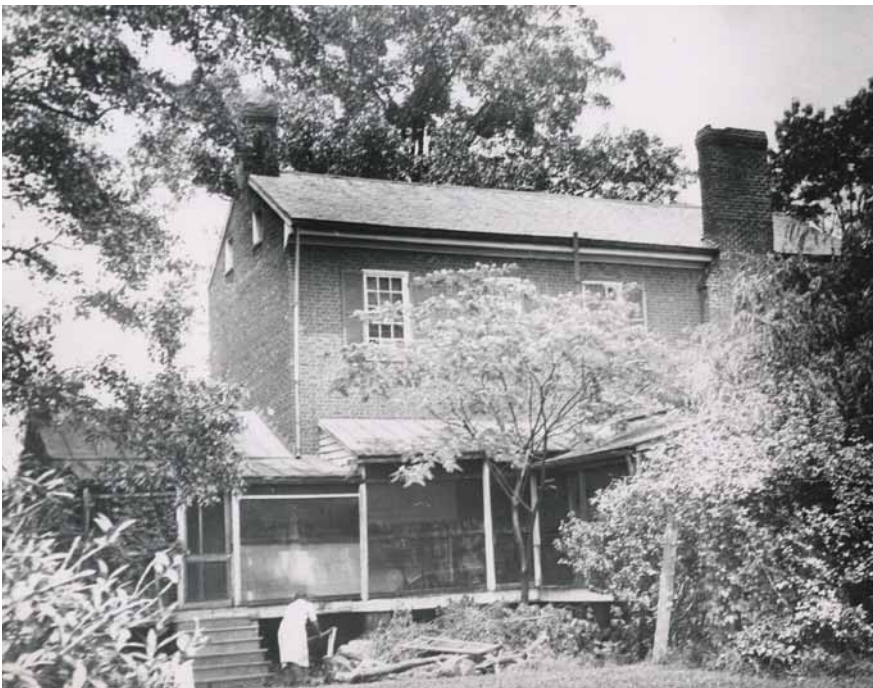
*Figure 42. South façade of Oak Lawn showing screened porches and western kitchen addition. A. Hench, June 3, 1937. University of Virginia, Special Collections Library, UVA Prints #16354.*

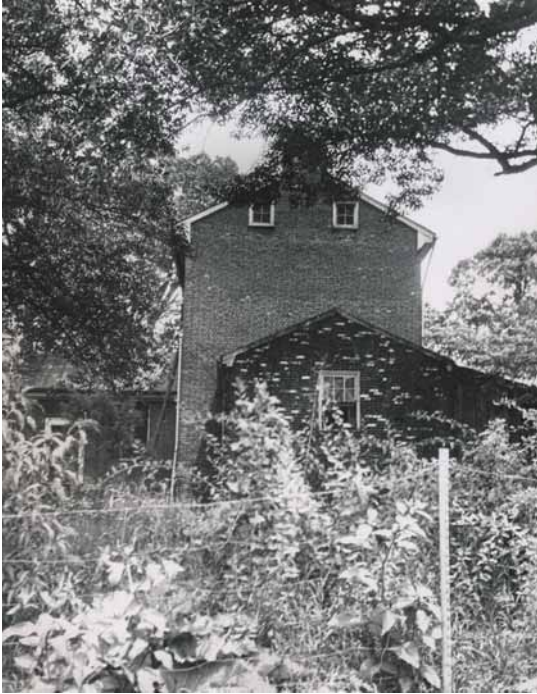
*Figure 43. West façade of Oak Lawn showing western kitchen addition. A. Hench, June 3, 1937. University of Virginia, Special Collections Library, UVA Prints #16353.*

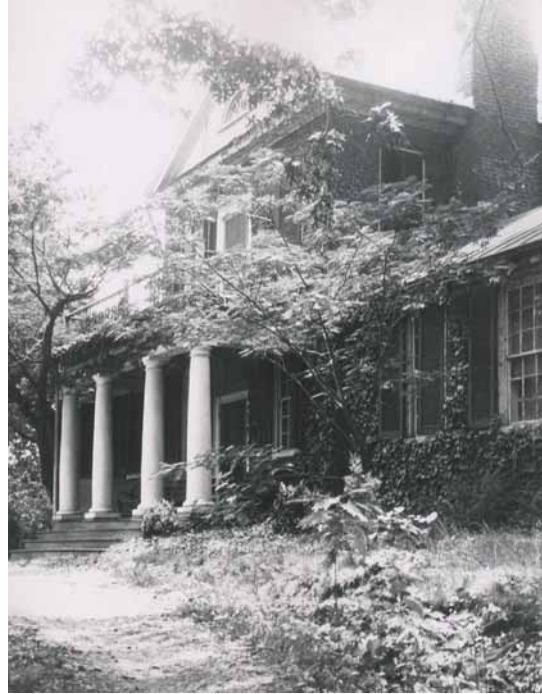
*Figure 44. View southwest showing ivy covered east façade of Oak Lawn. A. Hench, June 3, 1937. University of Virginia, Special Collections Library, UVA Prints #16352.*

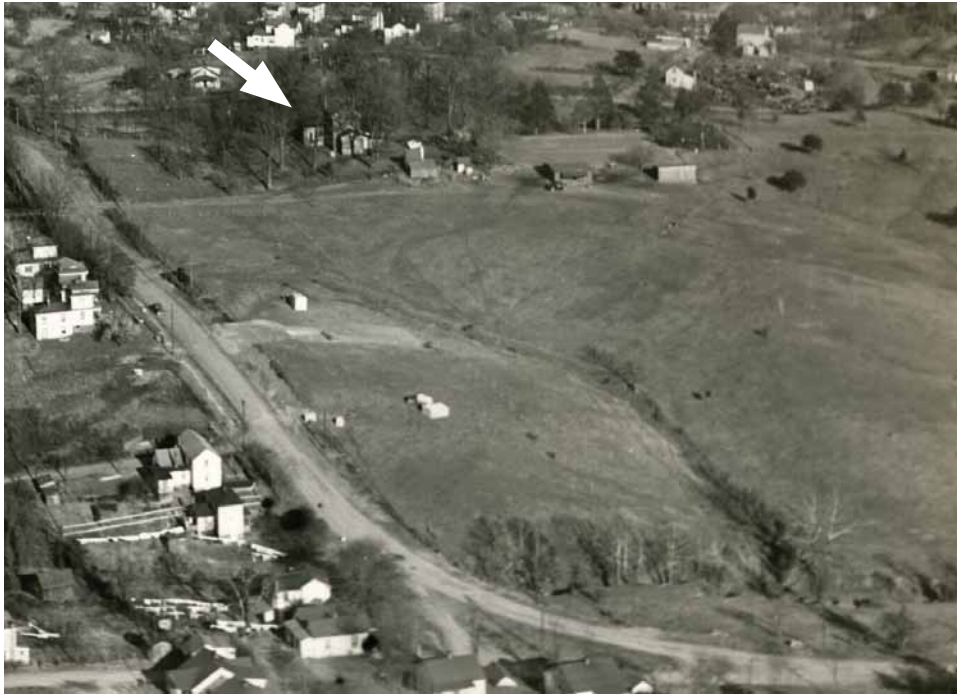
Figure 49. (Above) Detail, oblique aerial photograph, circa 1940, showing the Oak Lawn residence (at top) and several outbuildings and structures west and southwest of it. University of Virginia, Special Collections Library, UVA Prints #16191.

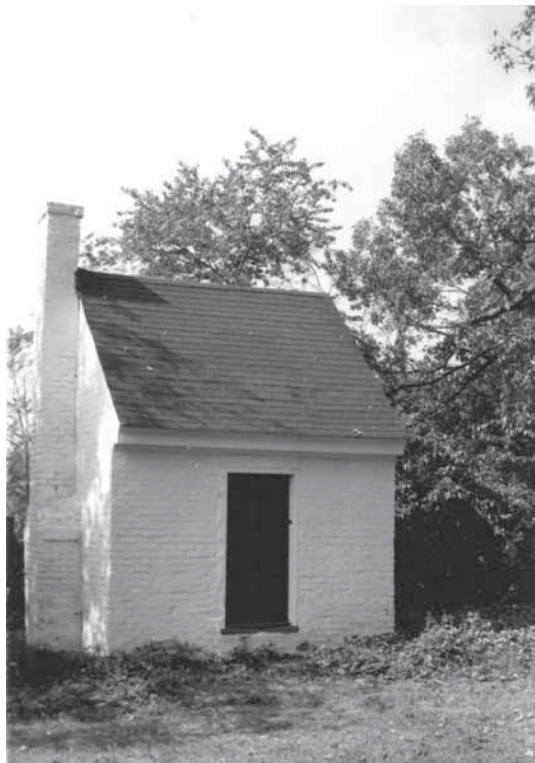
*Figure 58. (Left) East elevation, Smokehouse [Cook's House], Oak Lawn. E. Magruder, 1967. VDHR Library and Archives, 104-0031.*

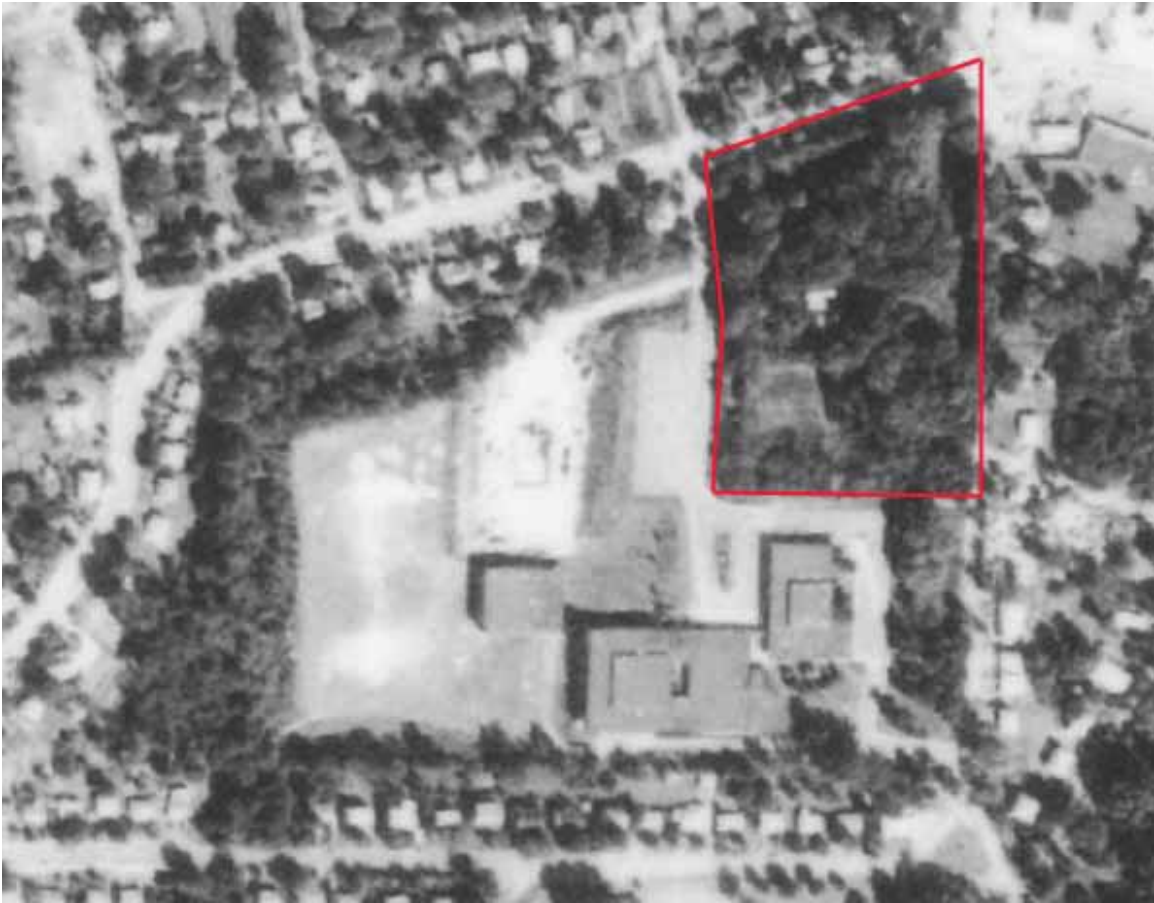
*Figure 63. Detail, 1974 aerial photograph, showing the red-circled Oak Lawn residence.*

An aerial photograph taken in 1974 shows the mature Buford Junior High School facilities, and the heavily wooded Oak Lawn property (Figure 63).

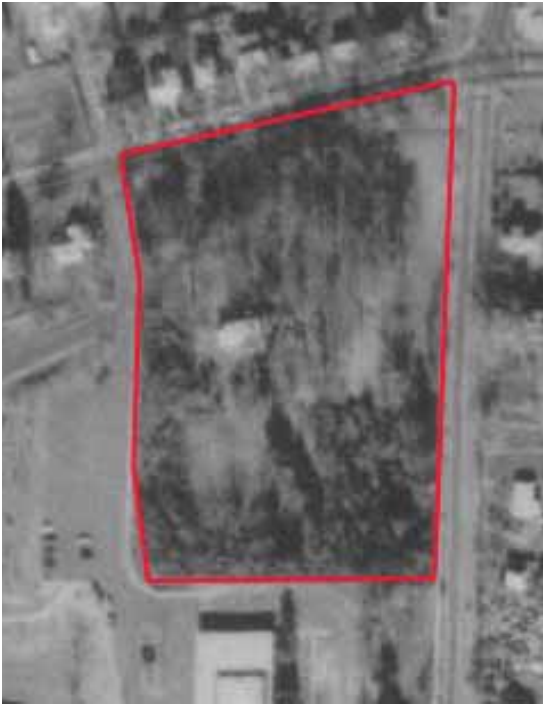
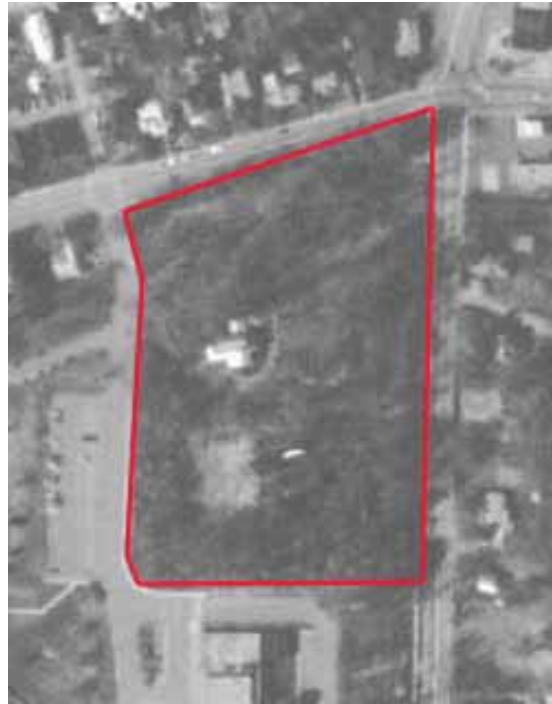
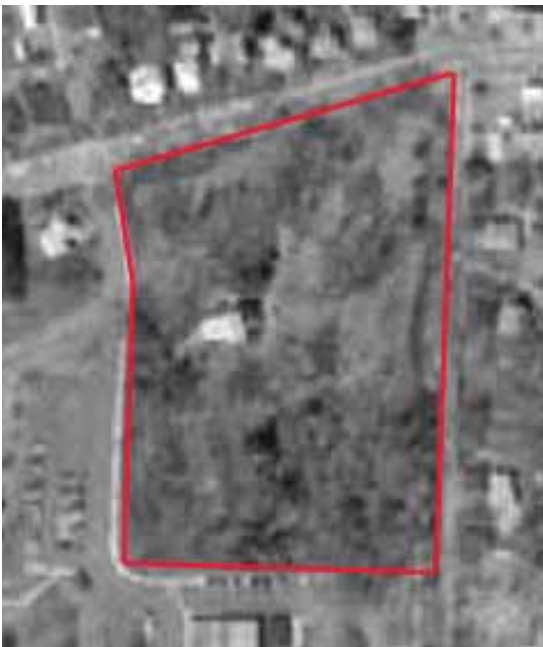
*Figure 65. Aerial photographs showing Oak Lawn surrounded by woods in 1980 (above left); 1990 (above right); and 1996 (left).*

Three aerial photographs of Oak Lawn taken between 1980 and 1996 document the wooded nature of the property. The only open and sodded areas within the 5.20-acre parcel appeared to be portions of the east and south lawns (Figure 65).

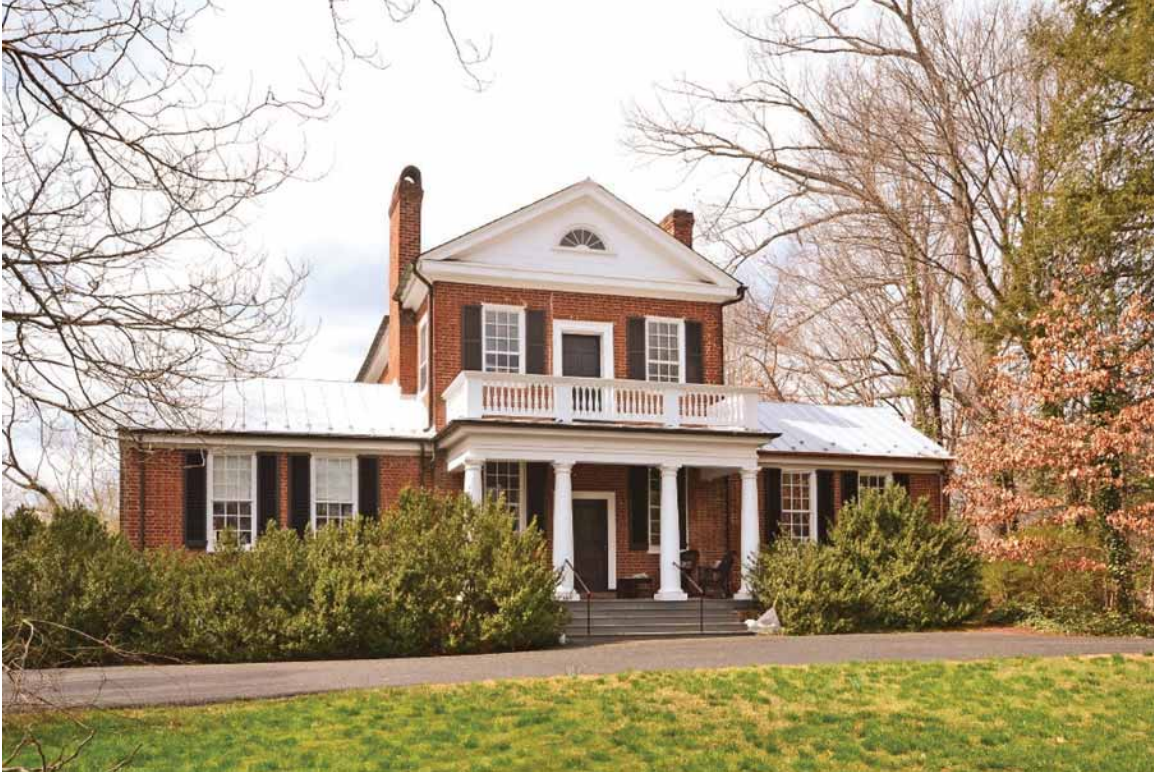
*Figure 67. View toward the principal façade of Oak Lawn, 2022. Virginia Department of Historic Resources.*

Oak Lawn is a historic estate in Charlottesville, Virginia. Before being sold to the University of Virginia in 2023, the property was owned by only a handful of families. The last private owners, Francis Fife and wife Nancy O'Brien, followed several generations of Fifes residing on the property after 1847. The centerpiece of the property is a stately brick home built in 1822 by the previous owner, Nimrod Bramham. The house, which reflects a Jeffersonian Palladian style of architecture, is considered one of the finest houses in Charlottesville (Figure 67).<sup>217</sup>

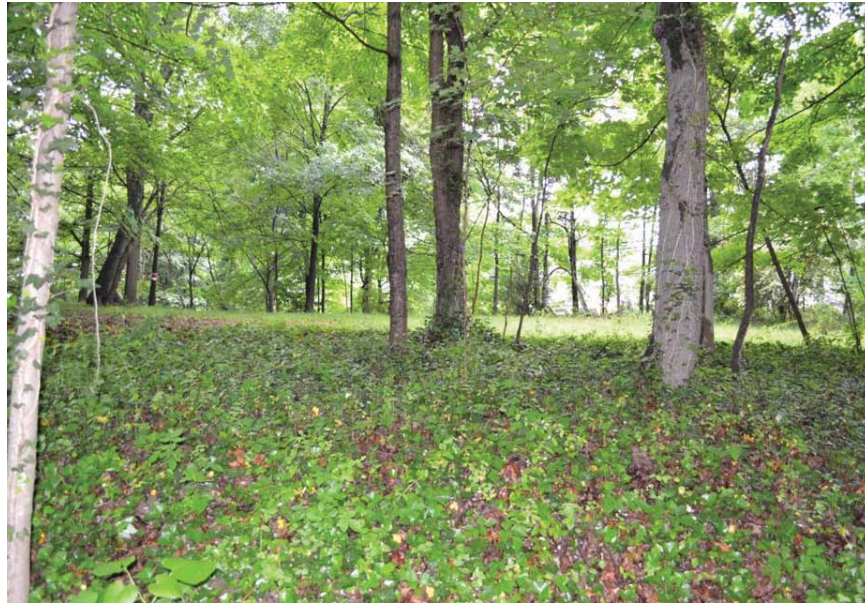
*Figure 80. Successional woodland with extensive stands of English ivy covers much of the ground plane. LSHLA, 2024.*

Native woodland plant communities are present that include older native deciduous oak and hickory trees, along with younger successional overstory and understory trees and shrubs (Figure 80). There are also several areas that have been planted with evergreen screen trees and ornamental species. Areas of successional woodland growth is heavily impacted by colonization by invasive species such as Norway maple (*Acer platanoides*), tree-of heaven (*Ailanthus altissima*), mimosa (*Albizia julibrissin*), mulberry (*Morus alba*), autumn olive (*Elaeagnus umbellata*), Chinese privet (*Ligustrum sinensis*), wisteria (*Wisteria sinensis*), English ivy (Figure 81), and periwinkle.

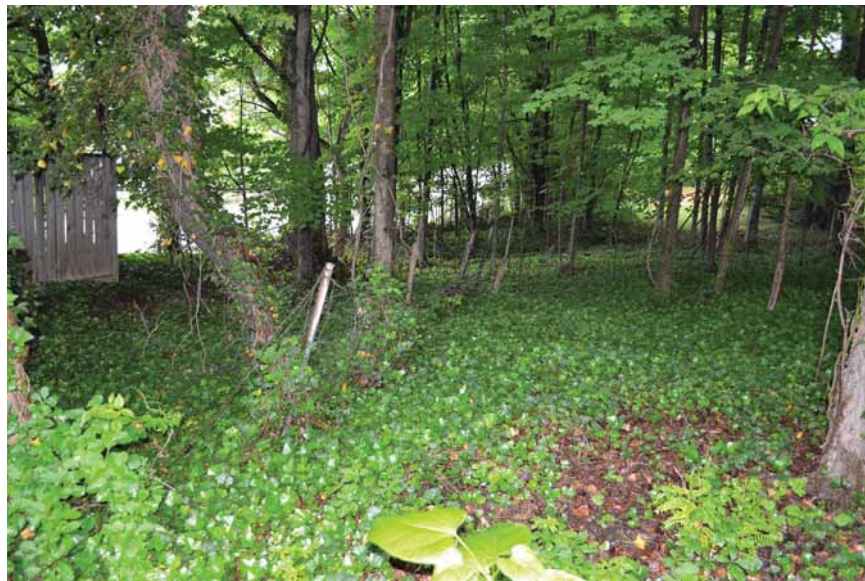
*Figure 81. English ivy covers much of the ground plane in the woods around the main house. LSHLA, 2024.*

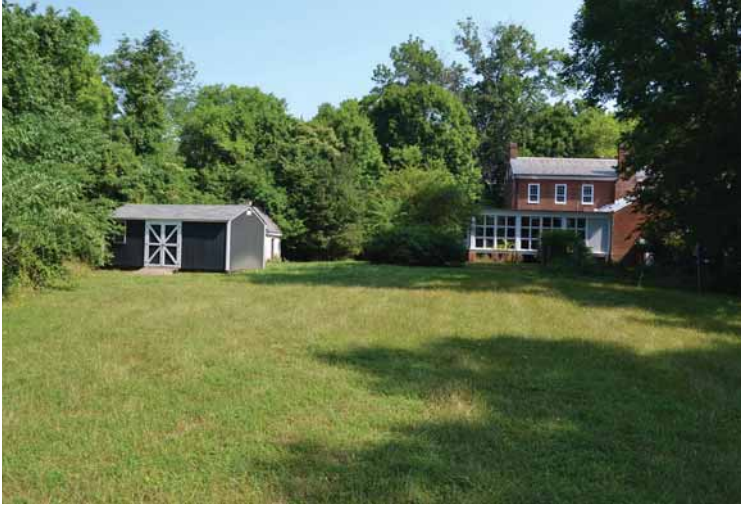
*Figure 82. The lawn panel south of the main house is relatively level. LSHLA, 2024.*

sloped terrain east of the lawn panel that forms the yard south of the house (Figure 82) has been modified into a series of terraced landforms (Figure 83). Grading of the steeply sloped terrain northeast of the house is evident in association with the driveway as it approaches the house (Figure 84). Slopes mapped across the property range from 2 to 25 percent.

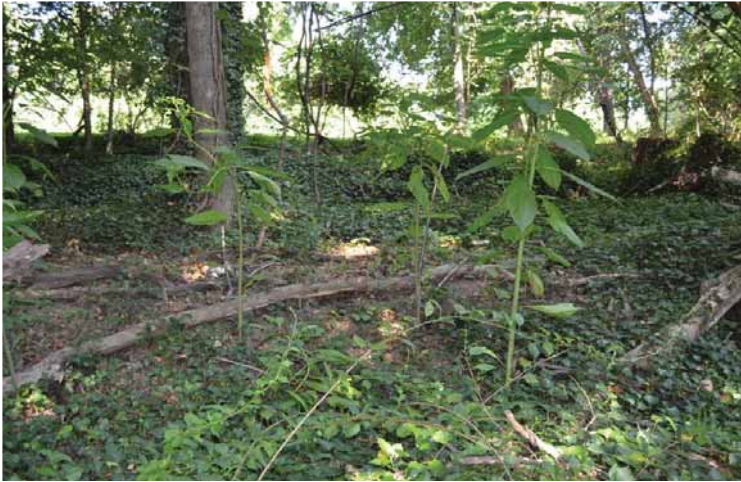
*Figure 83. The terraced garden area descends from the south lawn toward Ninth Street SW. LSHLA, 2024.*

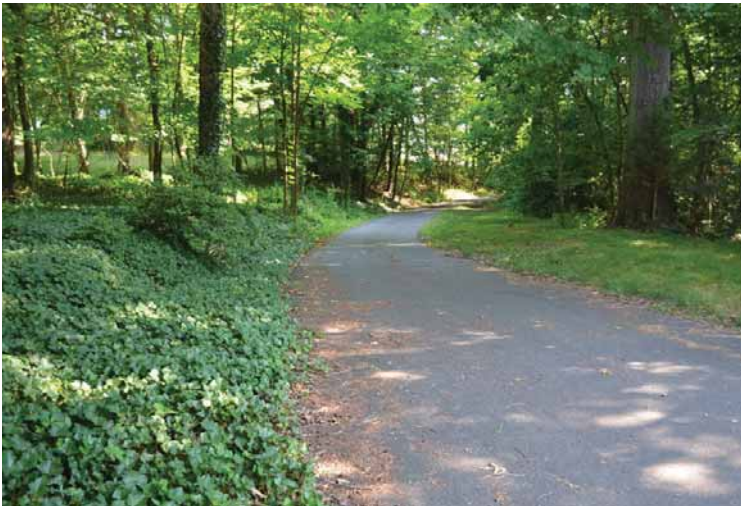
*Figure 84. A steep slope edges the driveway as it approaches the main house that is the result of grading to level out the road corridor. LSHLA, 2024.*

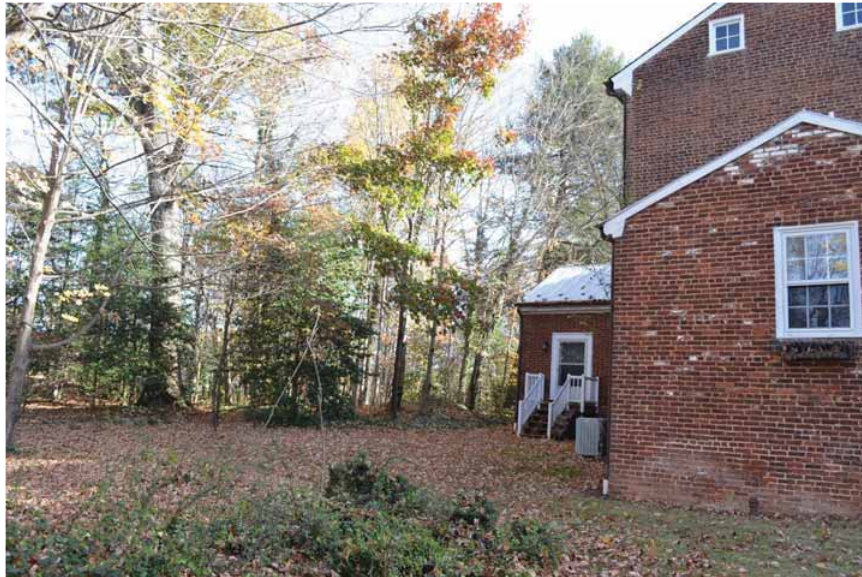
*Figure 105. View toward a large oak north of the main house that is the only apparent survivor of the oak grove that suggested the initial name for the property. LSHLA, 2024.*

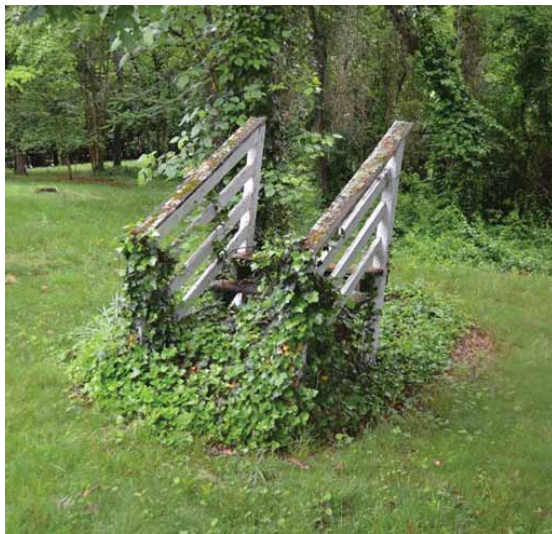
*Figure 108. The wooden stair located adjacent to the driveway southeast of the dwelling. LSHLA, 2024.*

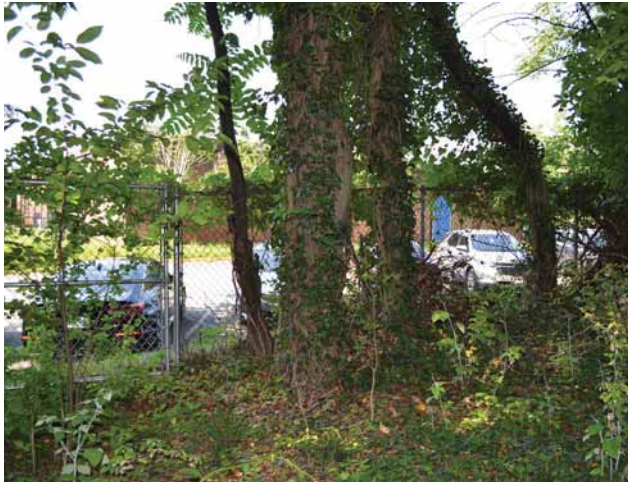
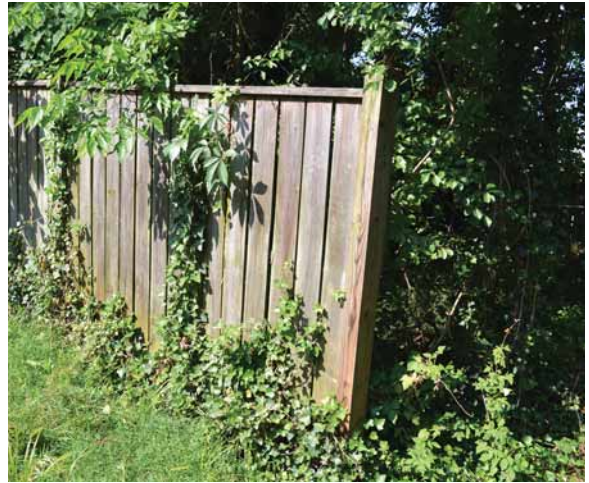
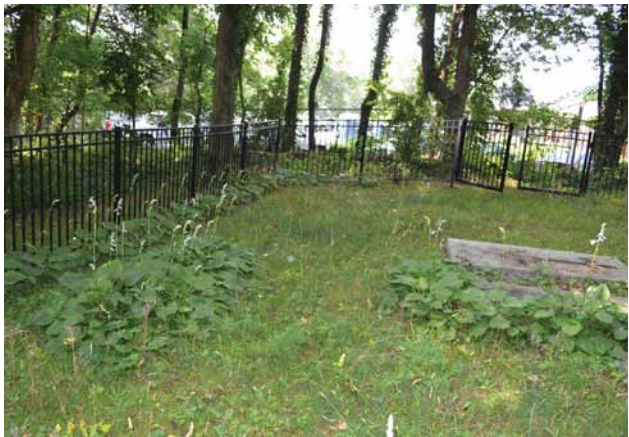
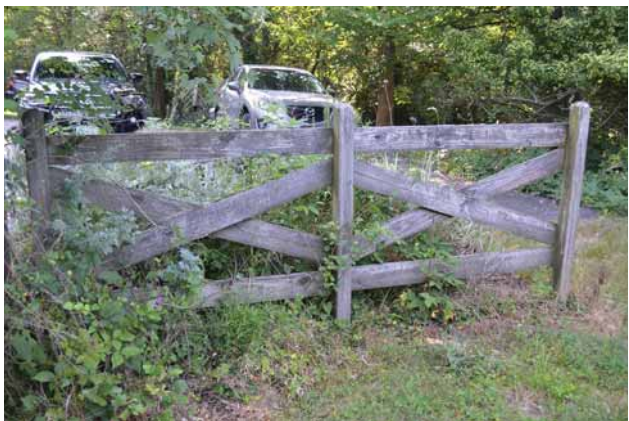
*Figure 110. (Above left) The chain link fencing along the southern property boundary.*

*Figure 111. (Above right) The privacy fencing that edges a portion of the western property boundary.*

*Figure 112. (Center left) The metal picket fencing that encloses the Fife family cemetery.*

*Figure 113. (Lower left) The post and board fencing that edges the arbor to either side. All images LSHLA, 2024.*

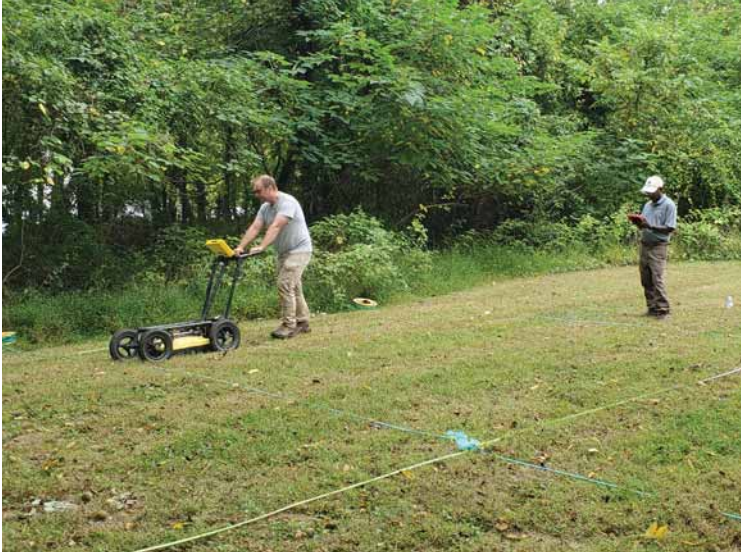
*Figure 126. GPR survey at Oak Lawn, September 2023. Rivanna Archaeological Services.*

Little archaeological research has occurred at Oak Lawn until recently. Prior to the University of Virginia's purchase of the Oak Lawn property in September of 2023, Rivanna Archaeological Services, LLC in association with NAEVA Geophysics, Inc. conducted a Ground Penetrating Radar (GPR) survey of a limited, approximately 0.12-acre, area surrounding the northern side of the Bramham-Bibb family cemetery and the northern and eastern side of the Fife family cemetery. The goal of the GPR survey was to determine the presence or absence of human graves outside of and adjacent to the fenced enclosure of the Fife cemetery, and the visible boundaries of the adjacent Bramham-Bibb family cemetery to the west (Figure 126).

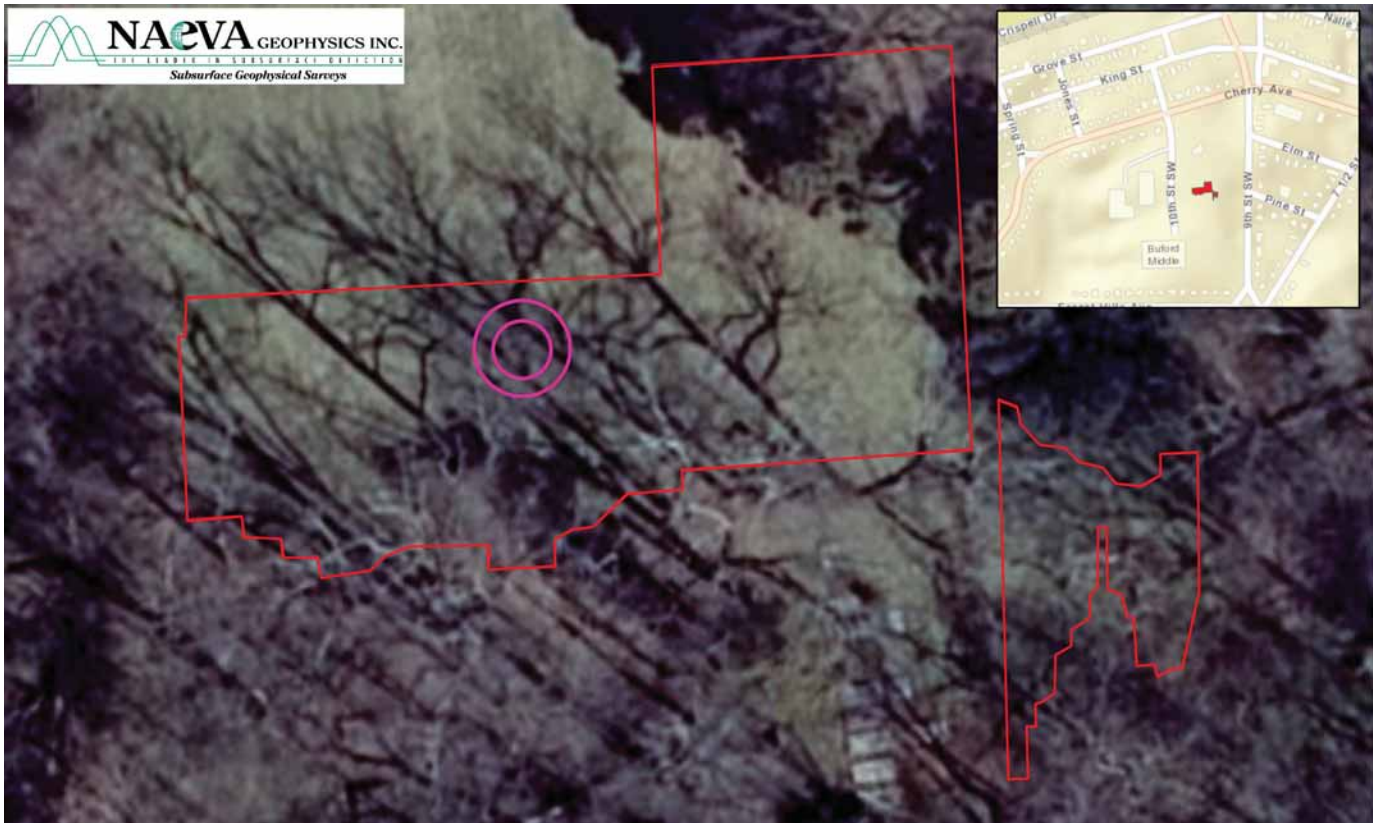
*Figure 127. Plan showing the red-outlined GPR survey area north and east of the Bramham-Bibb and Fife family cemeteries at Oak Lawn and the circular shaped remains of a tree.  
NAEVA Geophysics, Inc., September 2023.*

Wherever possible, the GPR project area extended out at least 30 feet from the fenced enclosure or visible boundary of the burial grounds. The survey was limited, however, to the close-cropped turf and areas that were unobstructed. The GPR survey did not extend into the formal cemeteries themselves, or their overgrown and vegetated boundaries. Transects were conducted at 0.5-meter intervals in a north-south orientation. No GPR-identified grave anomalies were identified within the project area during the survey. A large, circular-shaped feature, believed to represent the location of a former tree, was identified north of and within 25 feet of the Bramham-Bibb family cemetery (Figure 127).

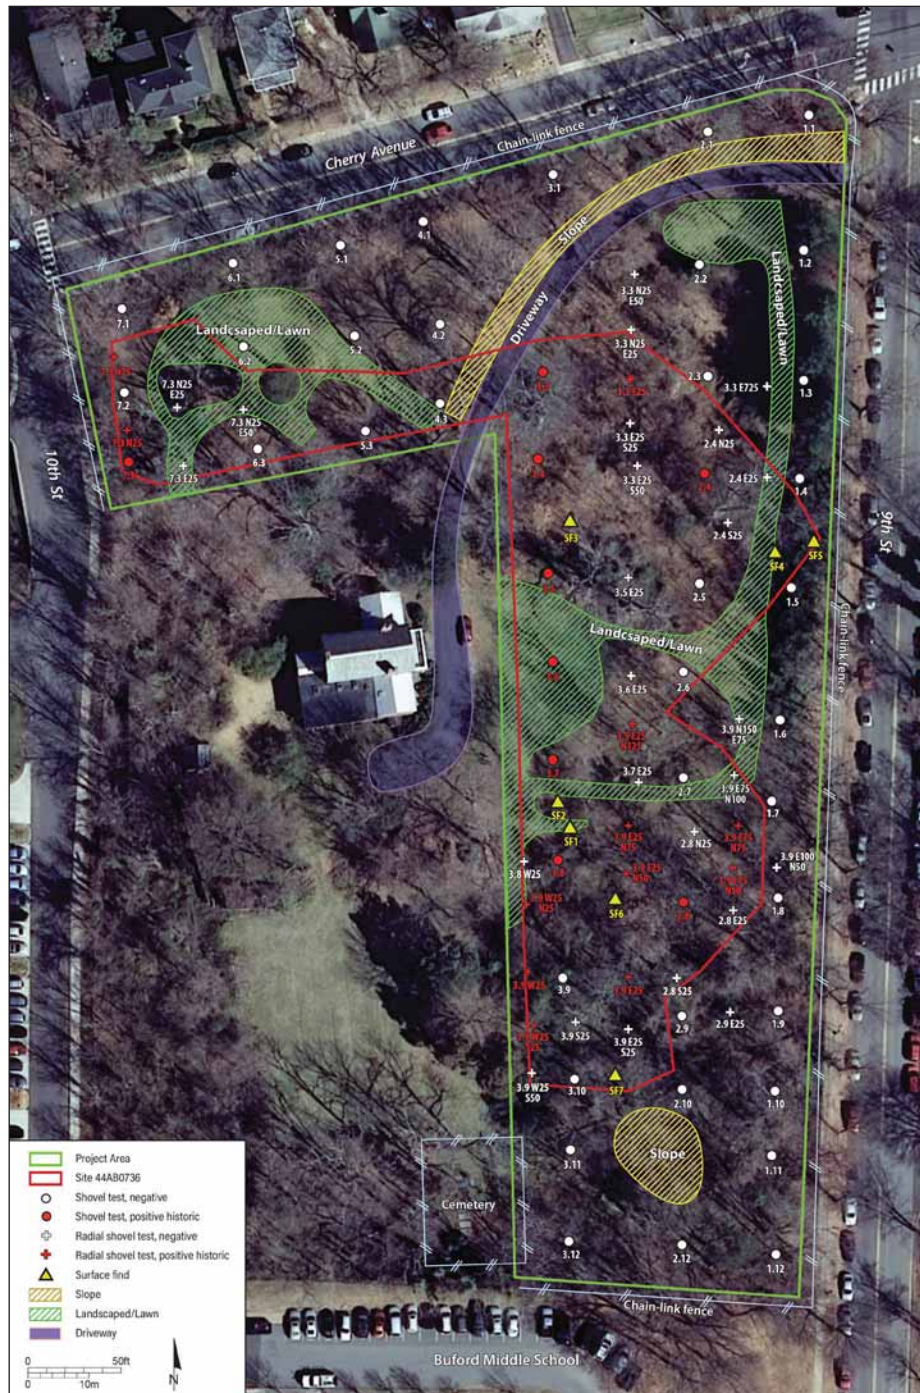
Figure 128. Map showing the Oak Lawn Phase I survey project area and location of excavated positive and negative shovel test pits. Chronicle Heritage, December 2023.

Based on the recovery of seventy-five artifacts from twenty-one shovel test pits and limited surface finds, an approximately 1.25-acre archaeological site, 44AB0736, was identified. Artifacts recovered from the survey included architectural materials (brick, nails, pane glass), domestic ceramics (pearlware, whiteware, yellow ware, ironstone salt-glazed stoneware, hard-paste porcelain), as well as mold-blown and machine-made container glass, and animal bone. A single probable quartz flake was also recovered from the survey. The artifacts were found to generally conform to the known occupation of the Oak Lawn property by the Bramham-Bibb and Fife families. Across much of the Phase I project area (Figure 128), stratigraphy was characterized by the presence of natural soils as well as disturbed soils associated with the construction of fences, roads, and gardening. No subsurface features were identified during the Phase I investigations.

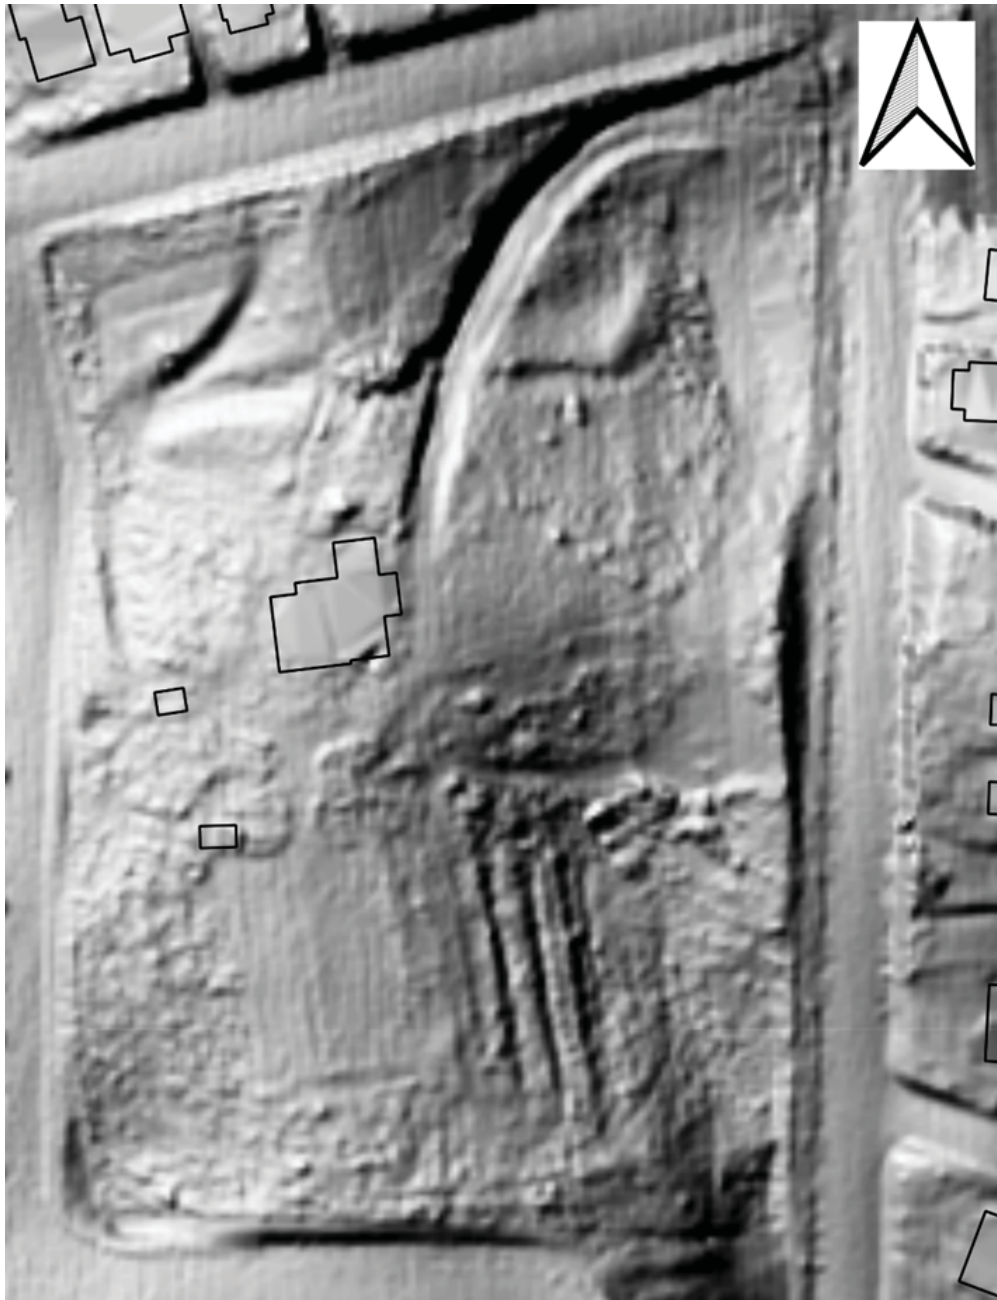
*Figure 133. A LiDAR survey of the property shows the topographic modifications of the graded driveway and terraced gardens.*

**TERRACED GARDENS.** Located to the east of the level lawn south of the Oak Lawn dwelling, a portion of the declining terrain has been graded to form four terraced garden spaces oriented north-south and separated by sloped banks (Figure 133). The terraces are heavily presently

**MISSING TOPOGRAPHIC FEATURES.** A LiDAR survey of the property (Figure 133) appears to show a section of a former road and part of the driveway in the northwest corner of the property that is missing today. It is possible that the missing road was an internal lane on the Oak Lawn property associated with outbuildings or fields.

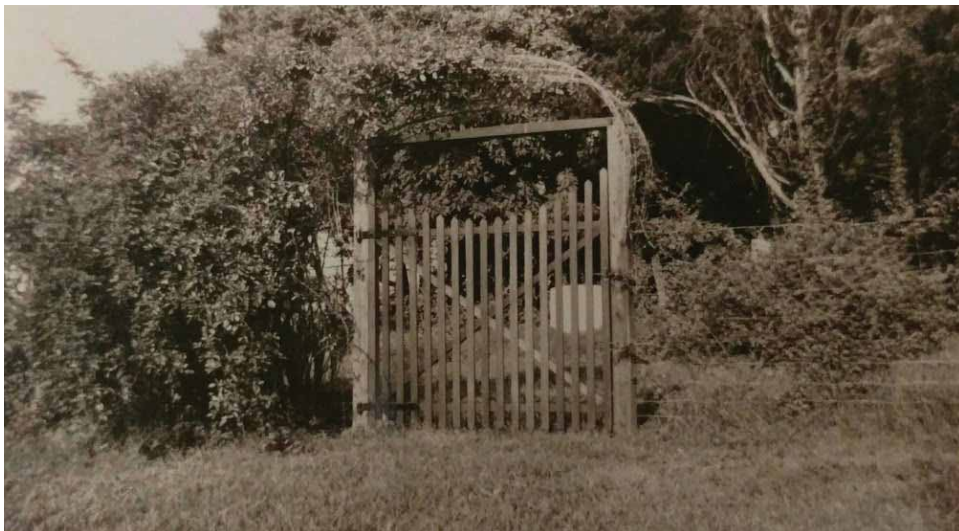
*Figure 135. The former Fife family cemetery fence and gate, circa early twentieth century. The fencing is strings of barbwire, likely to restrict access by cows and horses. A large shrub arches over the gate. Courtesy of the Fife family.*

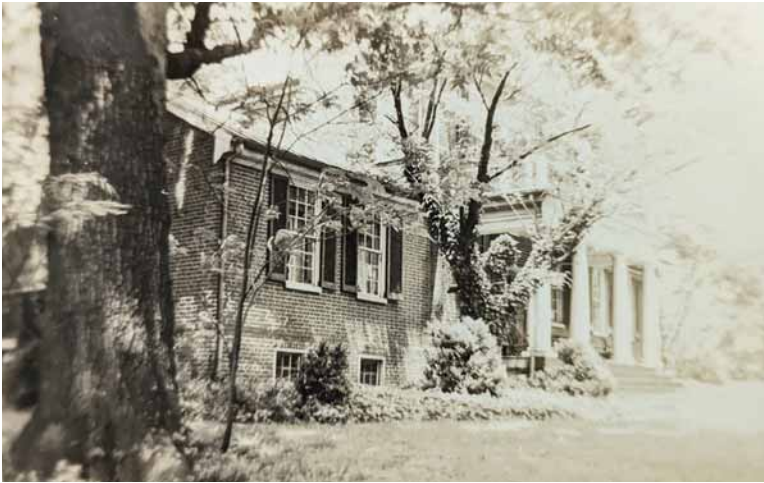
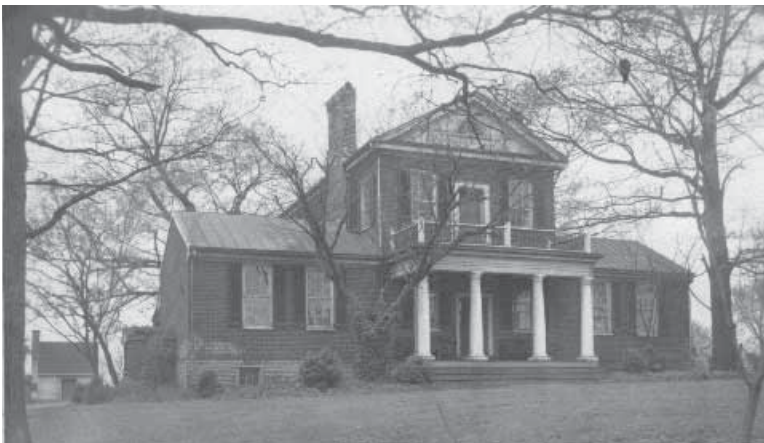
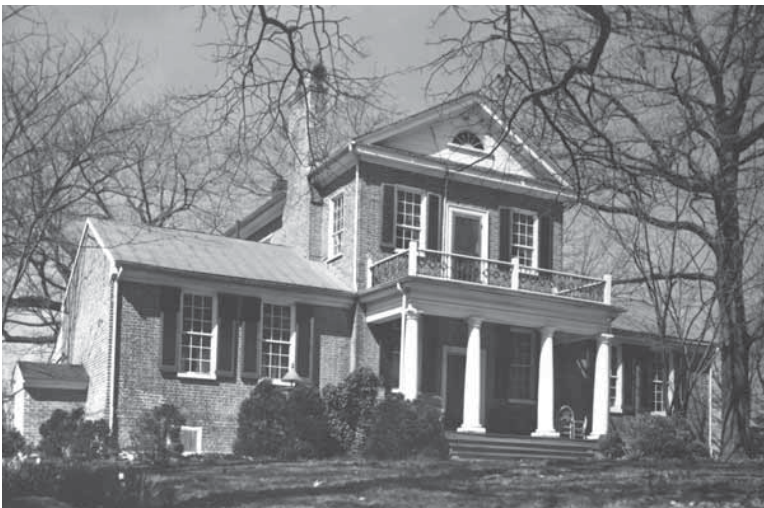
*Figure 143. (Above left) View of Oak Lawn circa 1930s showing small boxwoods and ivy present as foundation plantings. Missing today are a small tree adjacent to the left side of the porch and a larger tree in the foreground of the photo.*

*(Center left) The principal façade in 1940 with boxwood plantings around the foundation.*

*(Lower left) By 1964, the tree to the left of the porch had been lost, while the other plantings remained similar. A bed of daffodils appears to the left in the photo. All images courtesy of the Fife family.*

**BOXWOOD FOUNDATION PLANTINGS.** Several large American boxwoods (*Buxus sempervirens*) are located to either side of the front porch and around the southeastern corner of the main house. Several historic photographs of Oak Lawn illustrate the presence of boxwood edging the principal façade of the main house beginning in the 1930s (Figure 143). The shrubs, however, are much smaller than those present today. Boxwood continues to be present along the principal façade and at the southeast corner of the building today and contributes to the significance of Oak Lawn.
