# OAK LAWN

HISTORIC STRUCTURE REPORT &  
CULTURAL LANDSCAPE REPORT

JOHN G. WAITE ASSOCIATES, ARCHITECTS  
LIZ SARGENT HISTORIC LANDSCAPE ARCHITECTURE  
2025

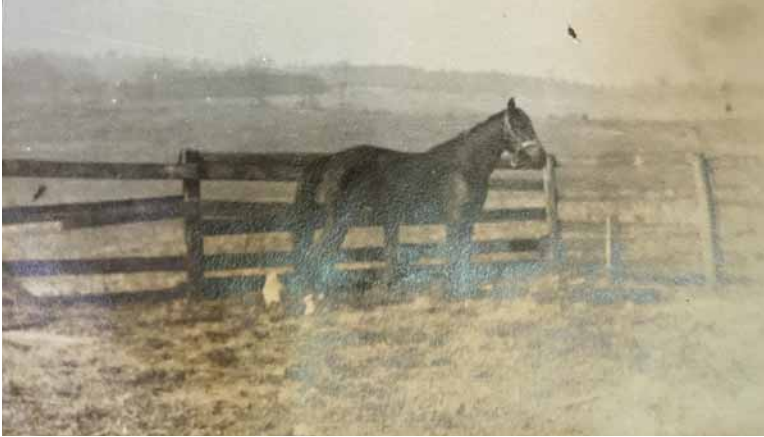
*Figure 149. (Upper left) Wood post and board fencing at Oak Lawn in an undetermined location.*

**MISSING FENCING.** Several historic fence types appear to have been used on the property historically over time, all of which are missing today. Historic fencing is visible in several family photographs of the property provided by the Fifes. These photographs indicate that fields and pastures were contained by wooden post and rail fencing (Figure 148). Post and board fencing appears in photographs of a barnyard with a horse (Figure 149). Board and wire fencing appears in several photographs of the house placed along the foundation, potentially to protect plantings from livestock (Figure 150). Historic photographs of other properties in the region similarly show fencing protecting the area around the house, suggesting that the potential for farm animals to be in the vicinity of the residential precinct may not have been unusual.

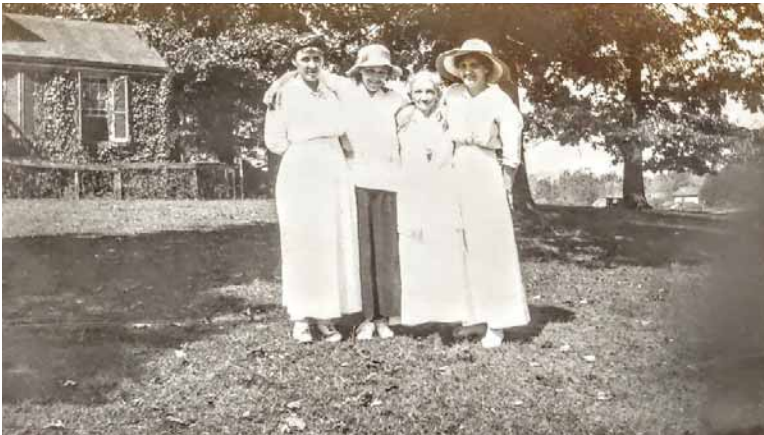
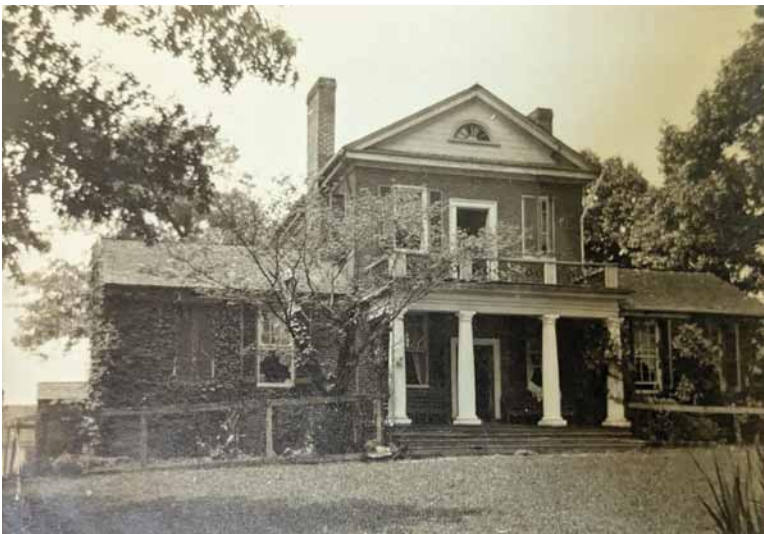
*Figure 150. (Center and lower left) Views toward the main house showing fencing around the base potentially to protect against livestock. Pictured in the center photograph are Sarah Gildersleeve Fife (Robert Herndon Fife's first wife), Ella Fife, Sallie Fife, and Madge Fife. All images courtesy of the Fife family.*

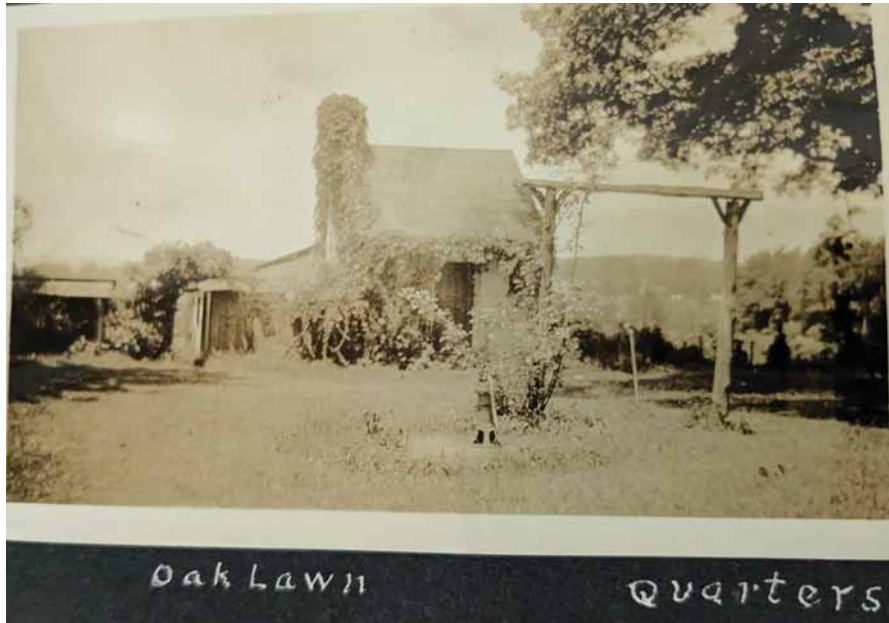
*Figure 151. View of buildings in the environs of the main house referencing "Quarters" and showing an arched structure that appears to have been used to train ornamental plantings. Courtesy of the Fife family.*

**MISSING FEATURES.** Little is known about additional small-scale features present on the property historically except for where ground photographs illustrate the presence of wooden trellis and arch near the house that appears to have been used to train ornamental plantings (Figure 36 and Figure 151), a yard hydrant indicated on the Nichols map behind the log barn, and a concrete birdbath that appears to be a more contemporary feature (Figure 152).

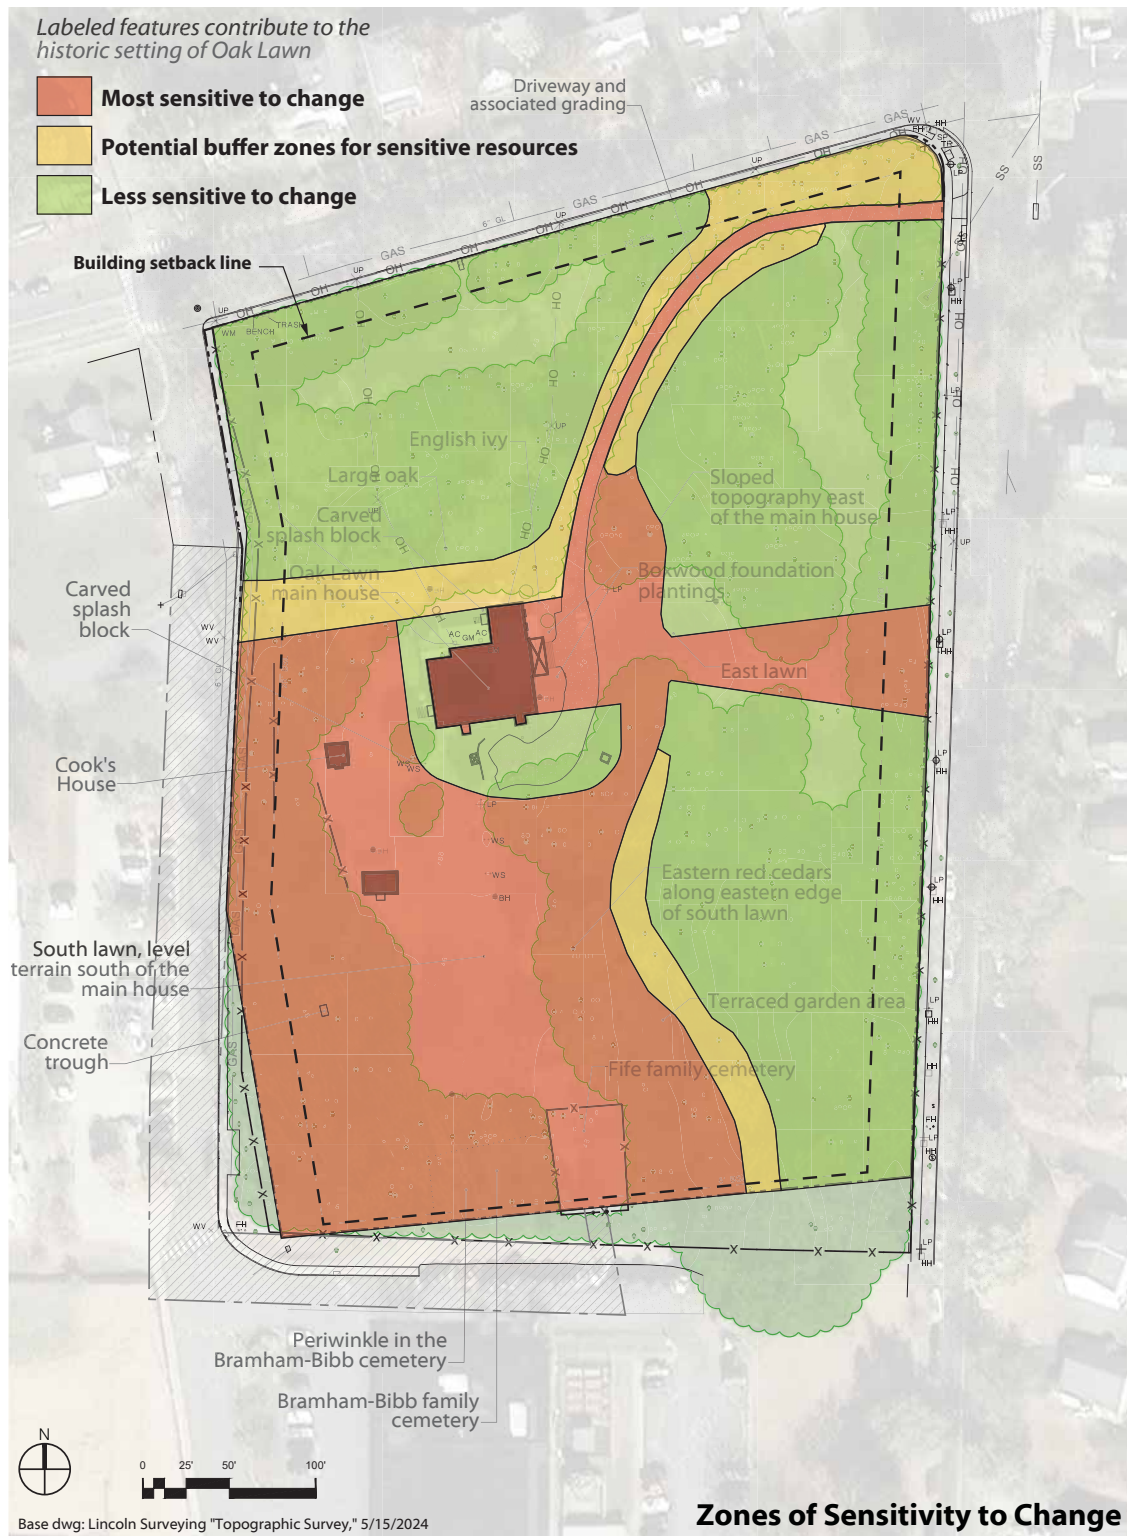
Figure 153. Zones of Sensitivity to Change. LSHLA, 2024.

*Refer to Figure 153, Zones of Sensitivity to Change*

Based on these parameters, goals for treatment of the Oak Lawn property as it is considered for adaptive reuse include protection and maintenance of features contributing to the National Register significance of the property, establishing sufficient buffer land between the historic features and proposed new features that the heritage values are neither overshadowed nor lost due to new programming, and establishing management and maintenance protocols to care for the individual needs of contributing features, such as the grave markers in the two family cemeteries, the topographic signature of the garden terraces, historic views, and control of invasive vegetation. The treatment plan also considers appropriate locations for the siting of new program that respects the contributing features while accommodating desired adaptive use, with the understanding that determinations about what the new program will require in terms of space have not yet been made. In support of these efforts, the CLR provides an identification of zones of sensitivity to change to guide the most suitable areas for considering future development of the property.

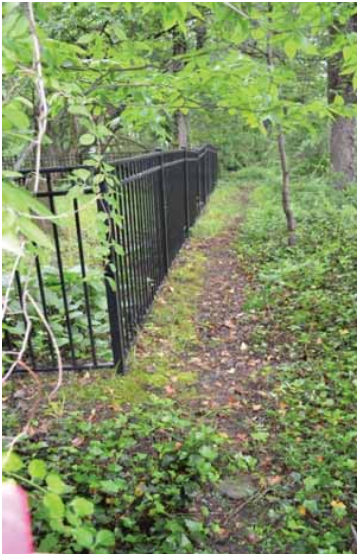
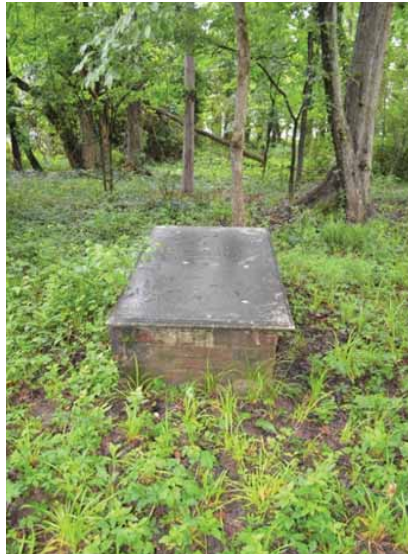
*Figure 155. The Fife family cemetery is enclosed by decorative black metal fencing. A similar fence should be considered to enclose the Bramham-Bibb family cemetery to protect it from access and define the area of care and maintenance (left image). The extent of the cemetery should be further investigated prior to determining the location of a fence enclosure (right image). LSHLA, 2024.*

- Conduct an archaeological investigation of the Bramham-Bibb family cemetery to determine the limits of the burial ground and whether extant fieldstones mark burials (Figure 155). While a previous GPR survey verified that there are likely no burials in the turfed area immediately north of and adjacent to both cemeteries, the extent of the Bramham-Bibb family cemetery remains unclear. Defining the Bramham-Bibb family cemetery to accurately understand where there are graves, and where there are not, is a primary recommendation, given the as of yet undefined Bramham to Fife reservation, and the possibility of fencing and formally defining it in the future to aid in the maintenance of the cemetery (see recommendations to follow).

- Consider enclosing the Bramham-Bibb family cemetery using a simple, contemporary, compatible fencing material similar to that which encloses the Fife family cemetery (Figure 155). Fencing would support appropriate care of the burial ground.

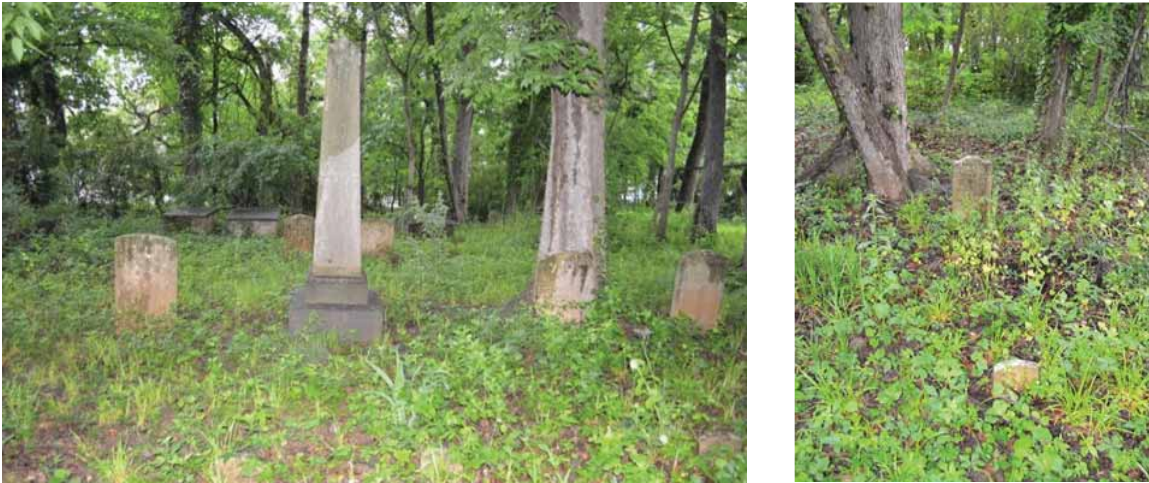
*Figure 156. Condition issues of concern apparent within the Bramham-Bibb family cemetery include staining and biological growth associated with the markers (left) and encroachment of trees and tree roots (right). LSHLA, 2024.*

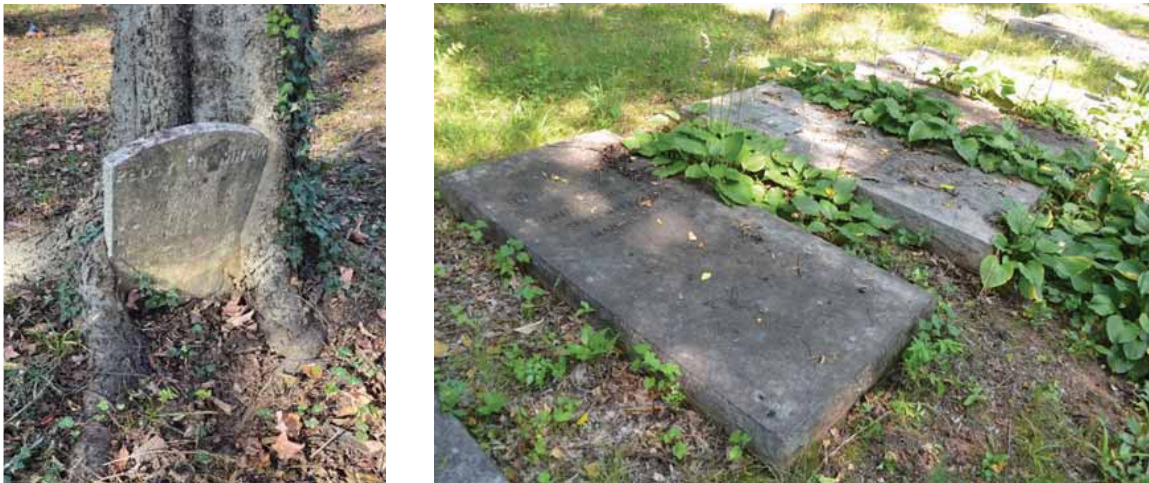
*Figure 157. Tree growth has engulfed one of the headstones in the Bramham-Bibb family cemetery (left), while a ground hog has burrowed beneath one of the vaults in the Fife family cemetery (right), threatening the stability and condition of these grave markers. LSHLA, 2024.*

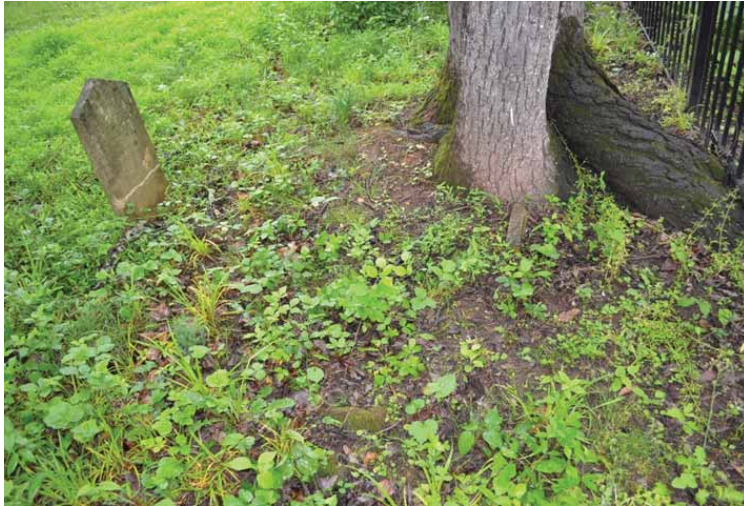
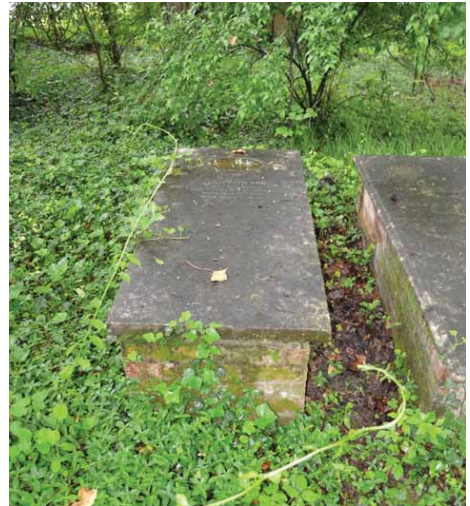
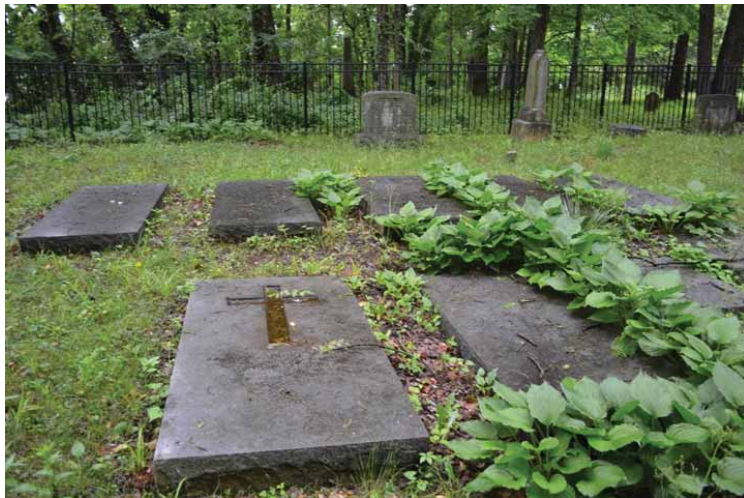
*Figure 158. (Above left) Tree growth has already displaced and damaged a grave marker within the Bramham-Bibb family cemetery, while another is located in close proximity to the tree trunk and associated roots as shown in this photograph. The tree may be a candidate for removal in order to safeguard the burial markers and the adjacent Fife family cemetery fence.*

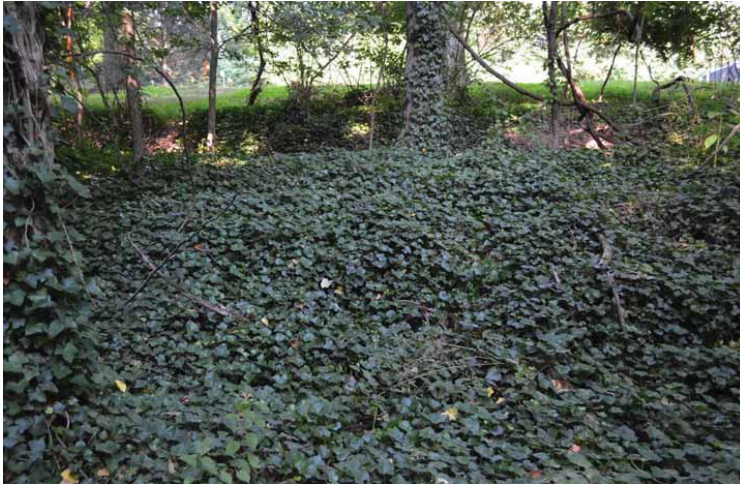
*Figure 161. (Left) English ivy has colonized many parts of the property and is one of the invasive species recommended for control measures.*

*Figure 162. (Below left and right) English ivy is also growing on the trunks of trees (left) and on the walls of the Cook's House (right). All images LSHLA, 2024.*

- Prepare a prioritized program of tree care and vegetation management.
- Consider implementing efforts to control invasive species immediately, particularly English ivy (Figure 161 and Figure 162). Consult an archaeologist prior to initiating control measures to ensure that the work does not disturb potential archaeological resources.

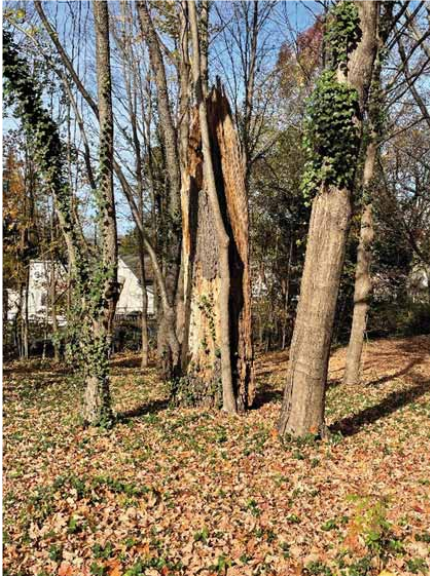
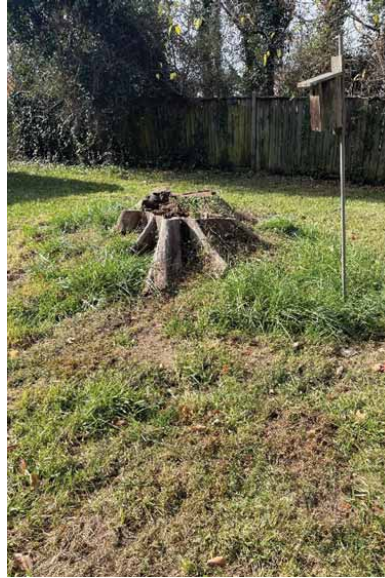
*Figure 163. Dead and diseased trees will likely require removal for the safety of visitors and protection of historic resources (left), while stumps near the house should be removed under the guidance of an archaeologist (right). LSHLA, 2024.*

- Utilize hand-pulling or small tools to remove unwanted vegetation in close proximity to historic features.
- Address pruning and hazard tree and limb removal needs that have been identified through evaluation by an arborist, particularly where removal protects historic resources (Figure 163).

- Avoid using chemicals for vegetation control in the vicinity of historic materials that can be absorbed by stone and brick and cause deterioration.
- Consider removing the stumps that are present in the vicinity of the main house (Figure 163). Evaluate stump removal options with an archaeologist to ensure that the process avoids impact to potential archaeological resources. Backfill any holes created by stump removal to ensure that the ground is level upon completion of the process.

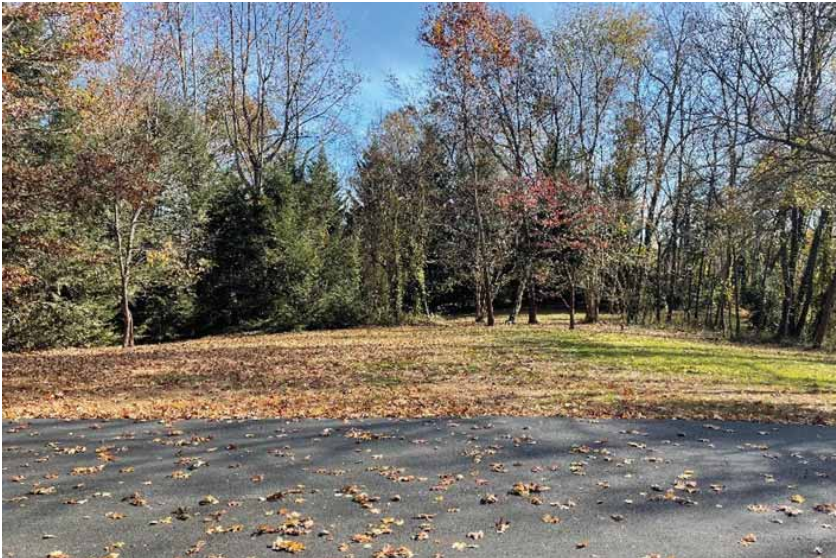
*Figure 164. The view east from the principal façade of the main house is partially blocked by trees. A reciprocal view between the road and house is recommended to be established through the removal of some of the trees visible in the photograph. LSHLA, 2024.*

- Manage and maintain vegetation to establish a clear sight line between the principal façade of the main house and Ninth Street SW, which is part of a historic viewshed (Figure 164). Tree growth is currently encroaching on the view.

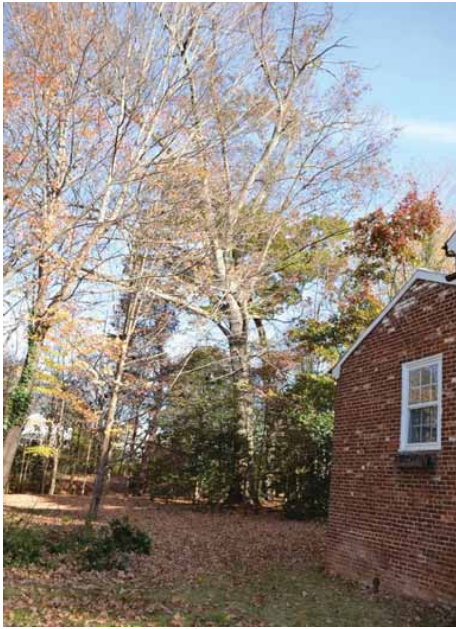
*Figure 165. (Left) View northeast from the west façade of the main house toward a large oak recommended for protection should construction occur on the Oak Lawn property.*

Vegetation at Oak Lawn associated with ornamental and cultural uses includes turf lawn associated with the east and south lawns (Figure 97) and linear areas that parallel Ninth Street SW (refer to Figure 86), foundation plantings that include mature boxwood along the principal façade and the south façade of the main house (Figure 98), planting beds along the foundation of the 1997–1998 southwest addition (Figure 99), planting beds at the base of the arbor and post and rail fencing to either side (Figure 100), vines trained on the arbor (Figure 101), hosta plantings in the Fife family cemetery (Figure 102), periwinkle in the Bramham-Bibb family cemetery (Figure 103), and evergreen screen plantings along Ninth Street SW composed of Leyland cypress (*Cupressus x leylandii*) and white pine (*Pinus strobus*) (Figure 104). There are also several mature shade trees, including a mature oak north of the house that recalls the historic name for the property (Figure 165)

- Protect existing vegetation that is desirable to remain, especially the oak north of the main house (Figure 165), in areas that may be impacted by new construction or programming related to adaptive use of the property (Figure 166), and closely monitor protected vegetation throughout the disturbance period. Tree roots typically extend well past the drip line of the tree. At a minimum, the area within the drip line should be protected from soil compaction from heavy equipment, which will inhibit air and water penetration to the root zone and threaten the health of the tree.

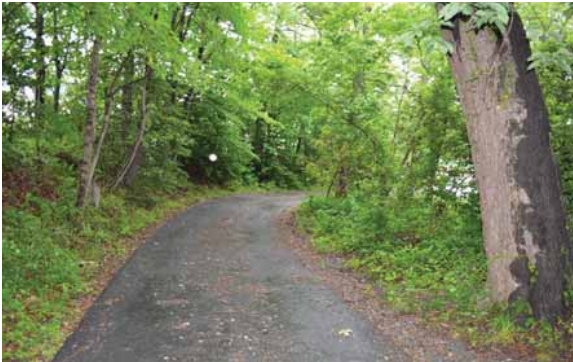
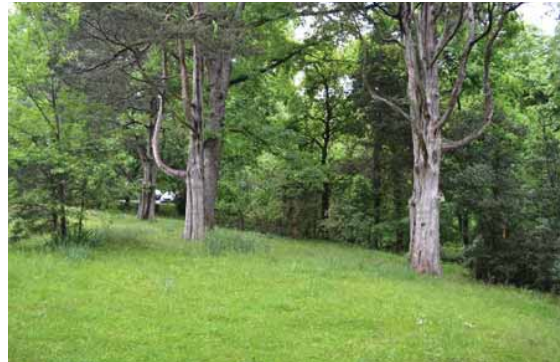
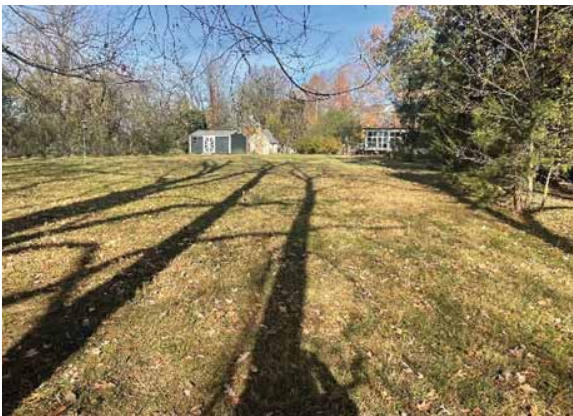
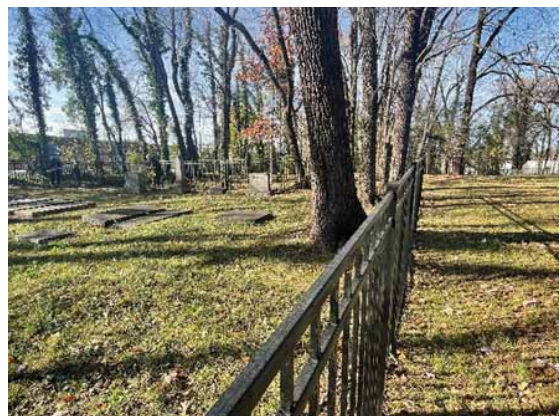
*Figure 166. (Center images) Large trees on the property should be considered for protection during any new construction.*

*Figure 167. (Lower images) Turf grass extends south of the house to the environs of the two family cemeteries (left) and is the principal ground cover within the Fife family cemetery. Turf care within the cemetery should be undertaken in such a way as to protect the grave markers from damage. All images LSHLA, 2024.*

- Manage and maintain the turf grass associated with the east and south lawns. Plant an alternative ground cover in areas of deep shade, including beneath large trees, where turf is currently missing or not likely to thrive (Figure 167).

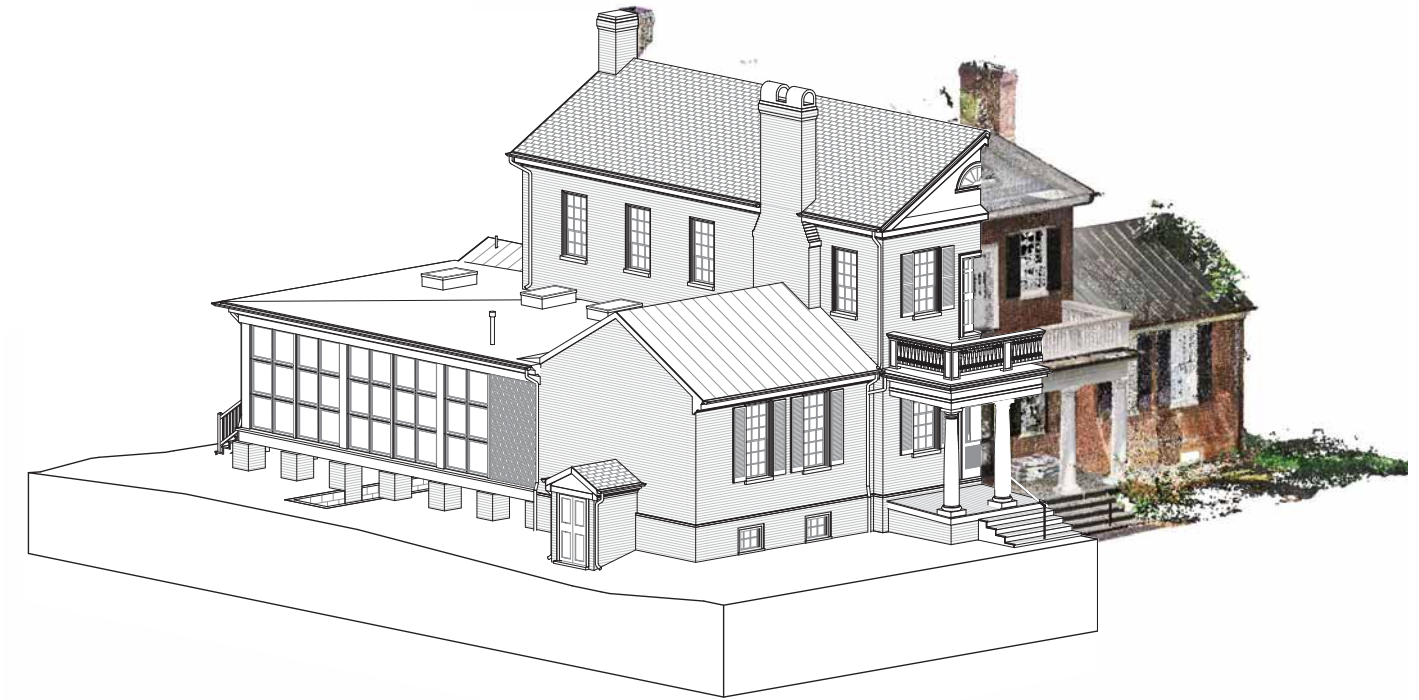
*Figure 179. Point cloud image superimposed on 3D model. The measured drawings relied on laser scanning and on hand measurements. JGWA, 2024.*

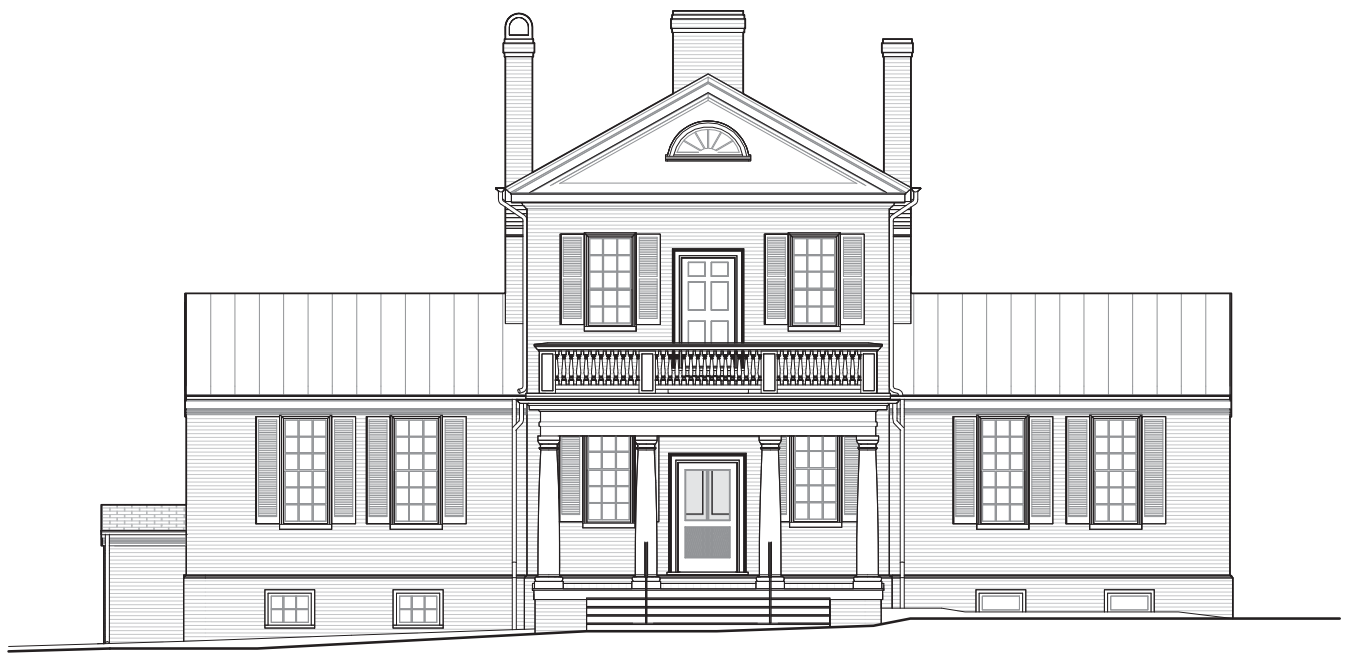
*Figure 181. Oak Lawn east elevation. JGWA, 2024.*

Windows: The two circa 1822 first-story windows flanking the main entrance are framed by 3" wide plain two-fasciae architraves trimmed with an interior bead, set inside the masonry openings, and hold 9/9 wood sash. Iron pintles support pairs of louvered wood shutters at each opening; the shutters fasten with ring latches. The iron bean strap hinges average 1' 5" long.

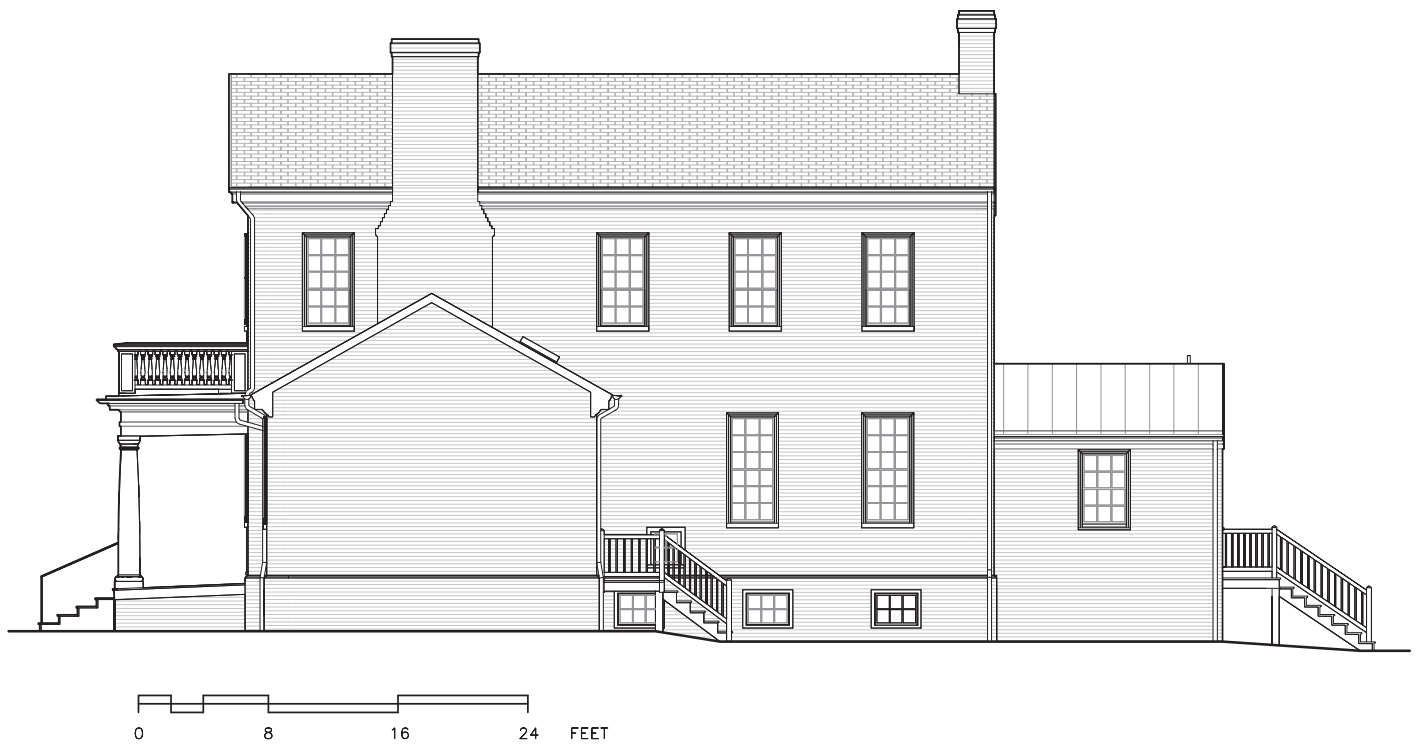
*Figure 182. Oak Lawn north elevation. JGWA, 2024.*

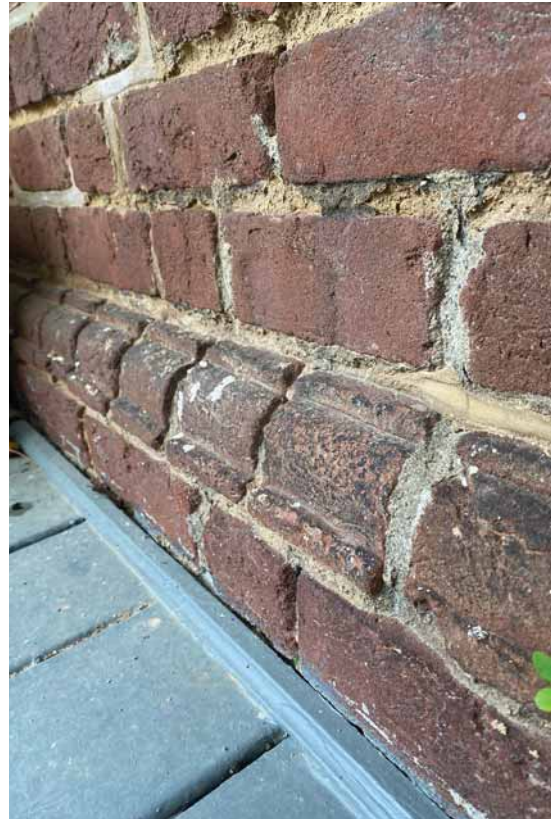
*Figure 186. A molded brick course trims the top of  
the water table. JGWA, 2024.*

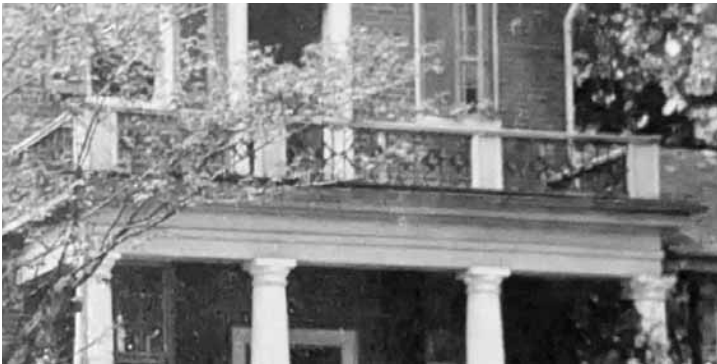
*(Above left) The first porch railing, circa 1822, likely matched the wood Chinese-style railings at the Lawn, seen in this detail of Pavilions VII and IX from Benjamin Tanner's 1826 engraving. Albert and Shirley Small Special Collections Library, University of Virginia.*

Above the entablature, a 1997–1998 wood railing includes bands of turned balusters set between paneled plinths, capped by a molded handrail. This is the last of a series of railings on this porch (Figure 188).

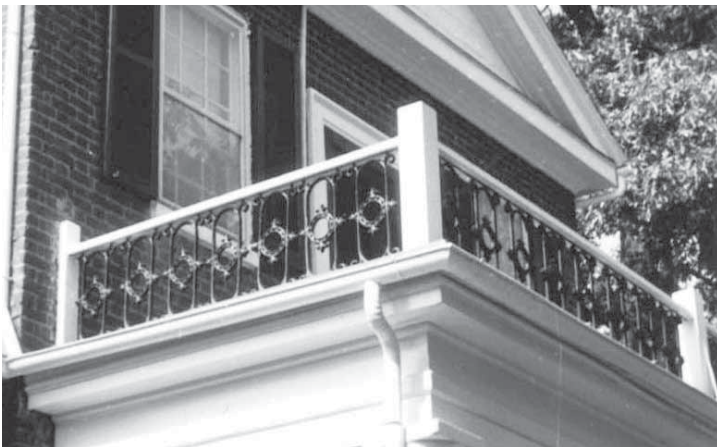
*(Center left) The earliest railing to appear in photographs included cast-iron railings extending between panels centered over the porch columns. Detail from an undated photograph, courtesy of the Fife family.*

*(Below left) As early as the 1920s or early 1930s, the railing was modified or replaced, with cast-iron panels between wood posts. On the east side of the railing, there were three posts, with one post centered over the porch. Detail from E. Magruder, 1967. VDHR Library and Archives, 104-0031.*

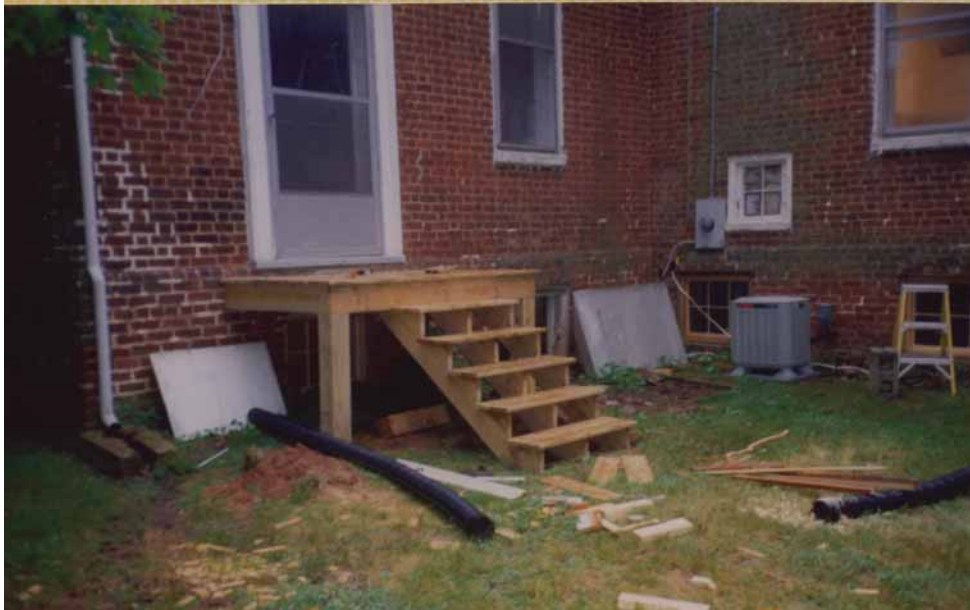
*Figure 197. View from the northwest during the 1997–1998 work. Courtesy of Nancy O'Brien.*

The doorway in the first story's north bay holds an original stile-and-rail door with four vertical recessed panels. Slightly angled rowlock bricks form a flat-arched lintel above the opening. While there must have been a wood stair to the door when originally built, by the first half of the twentieth century the entrance was no longer in use and there was no porch or stair (Figure 196). A stair was installed later in the twentieth century and was subsequently replaced by the existing 1997–1998 wood steps and porch.

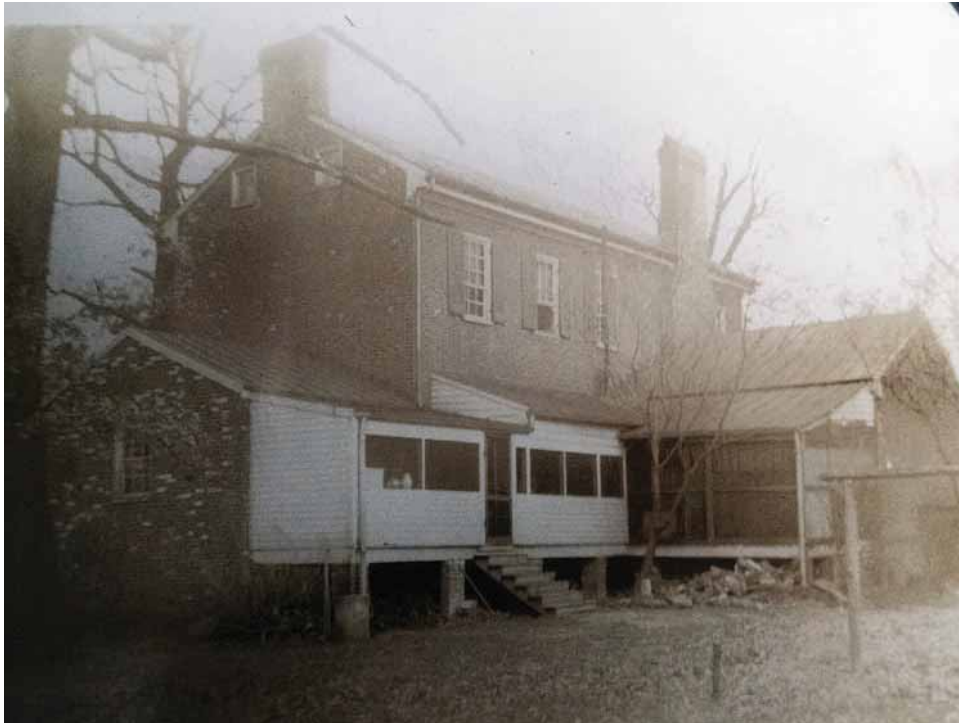
*Figure 201. The southwest porch after it was partially covered in clapboard. Courtesy of the Fife family. .*

Historic photographs document that at some point in time, after 1937 but prior to 1967, the screened-in porch abutting the southern façades of the dining room and kitchen addition was enclosed as a sleeping porch (Figure 200 and Figure 201). This entailed the construction of clapboard siding and horizontally set screens in the southern and western façades of the porch. The western porch abutting the western façade of the southern wing may also have been screened-in at this time but did not possess clapboard siding.

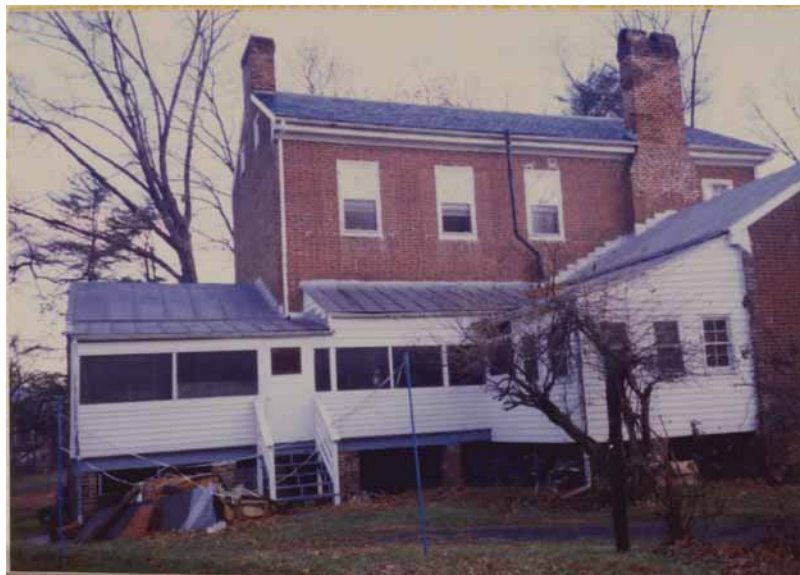
*Figure 204. The southwest porch before the 1997–1998 work. Courtesy of Nancy O'Brien.*

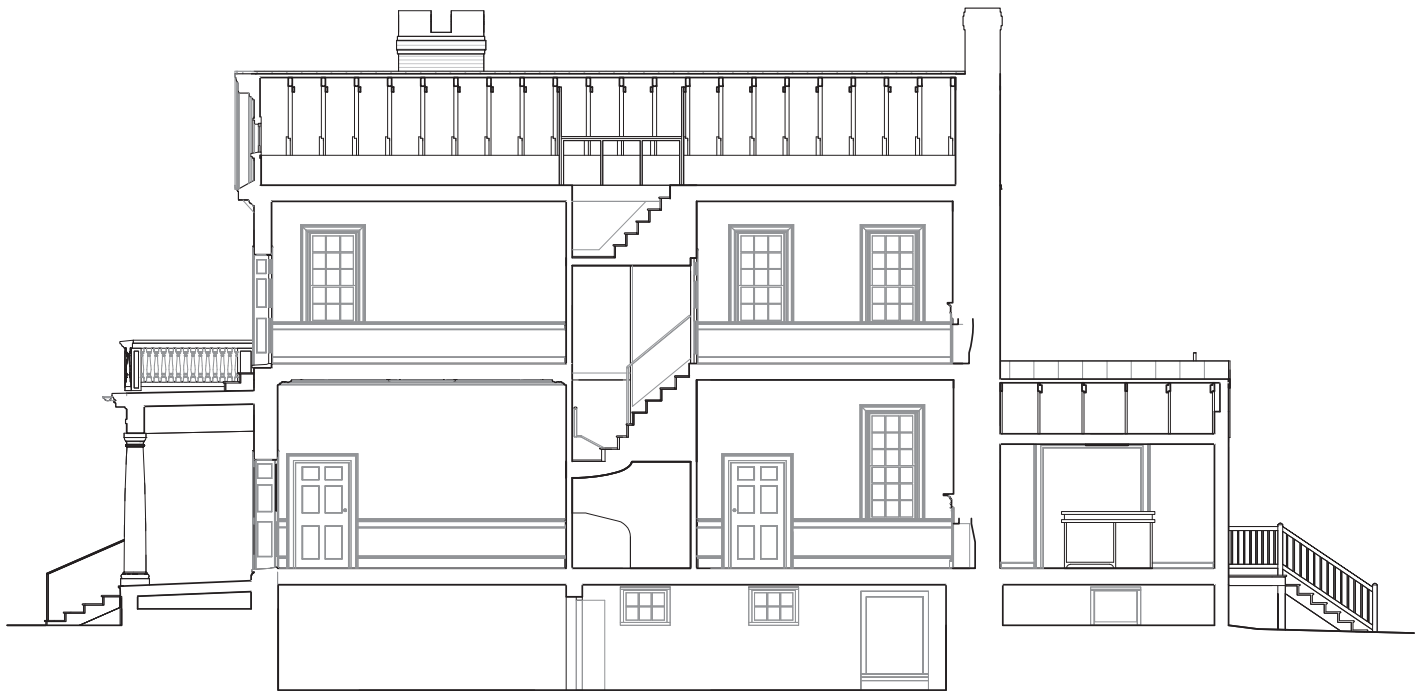
Figure 206. Oak Lawn, section facing south. JGWA, 2024.

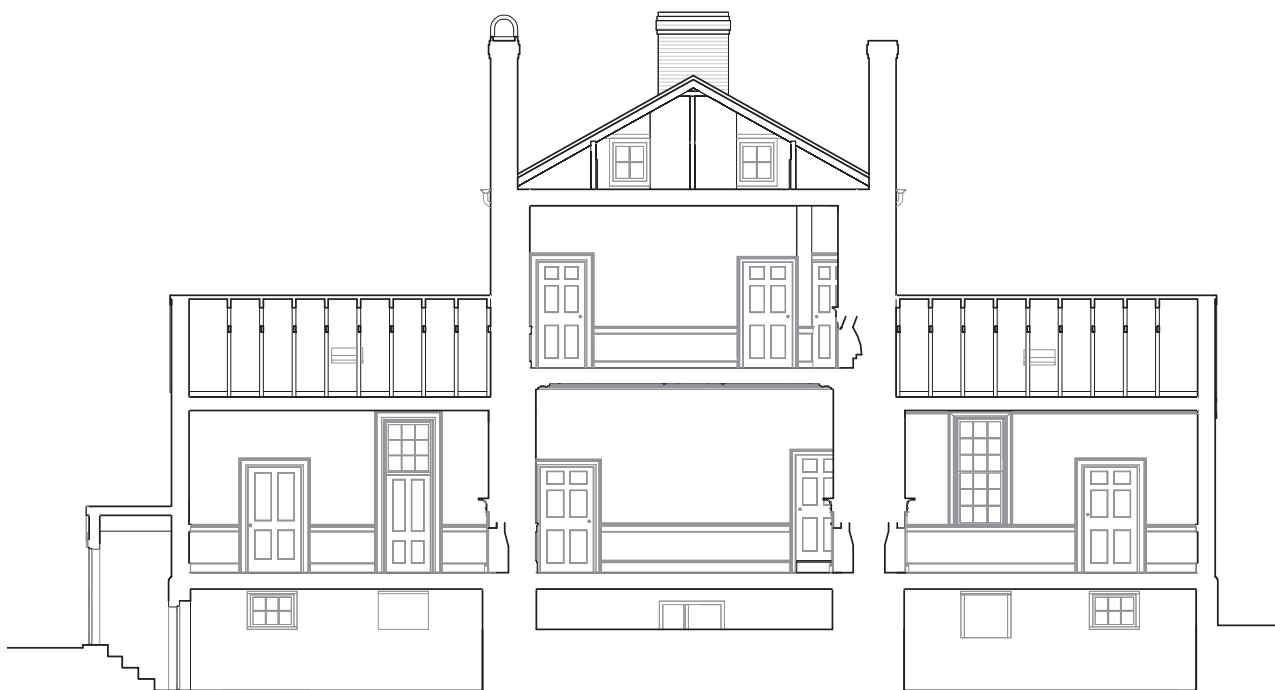
Figure 207. Oak Lawn, section facing west. JGWA, 2024.

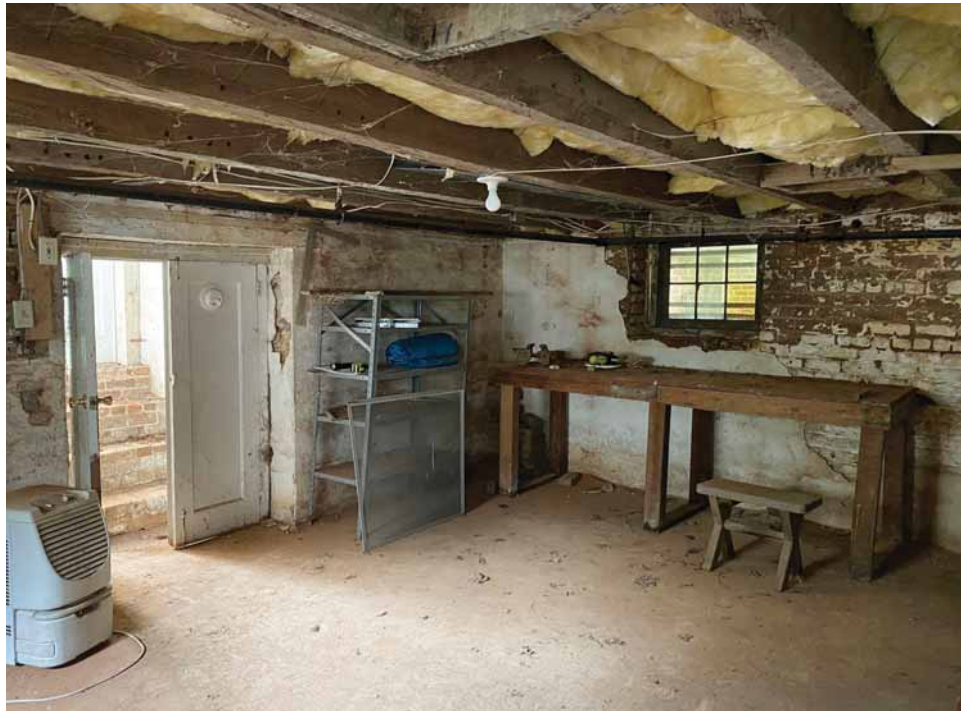
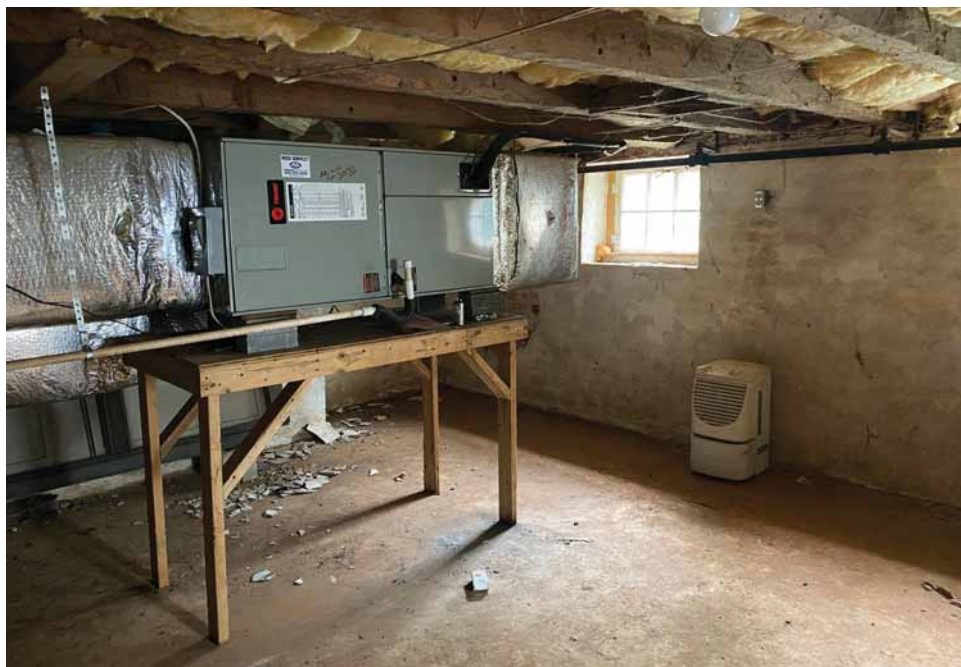
*Figure 210. The south basement room (001), looking southwest (upper image) and northeast (lower image). JGWA, 2024.*

Windows: The pairs of masonry openings in the east and west walls have wood lintels and frames fitted with six-light casement sash. The east frames and sash were replaced in 1997–1998. Each of the six-light casement sash have 8" x 10" panes and 3/4" wide muntins. The sash hardware includes a pair of butt hinges and a hook-and-eye on each sash; the east sash have stainless-steel hinges, while the hardware on the original southwest sash is older and rusted. Horizontal bars extend across the exterior of the southwest opening; a heating duct fills the northwest opening.

Fireplace: The chimney foundation on the north wall has an arched firebox that has been infilled with brick and plastered over. Rowlock bricks form the arch.

Lighting/electrical: The room is lit by an incandescent porcelain utility fixture mounted to one of the ceiling joists. Other fittings include a surface-mounted receptacle and switch near the south doorway, and a surface-mounted receptacle on the east wall.

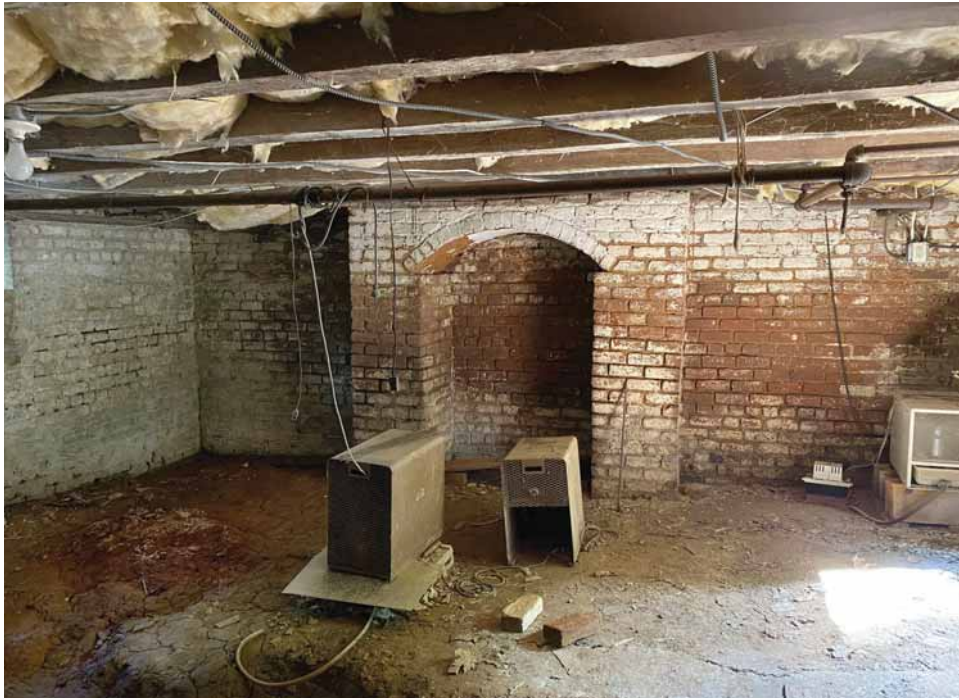
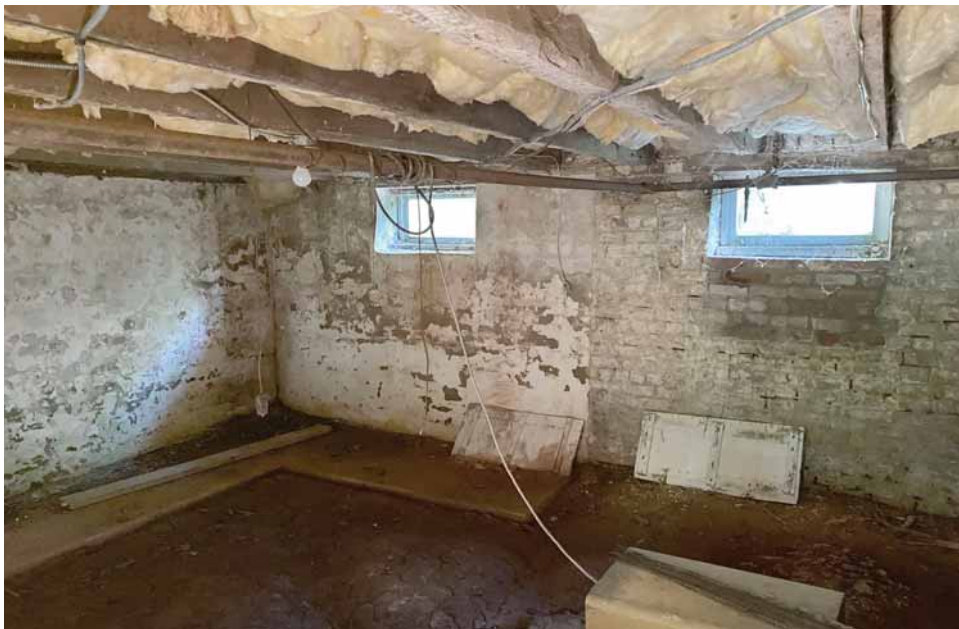
*Figure 211. The north basement (002), looking south (upper image) towards the arched support for the fireplace above; and northeast (lower image). Note the brick infill below the windows, indicating their original size. JGWA, 2024.*

The 19' 8" x 17' 10" cellar below the north room (103) includes two window openings in the east wall, a window in the west wall, and a partial-height doorway high in the west wall. A chimney foundation projects from the south wall. Remnants of whitewash on the brick and lath and plaster on the ceiling joists indicate that this room was used historically.

The chimney foundation for the fireplace in 103 projects from the south wall. Engaged brick piers support a segmental arch.

Windows: The two east window openings and the single east window opening have plain wood frames (replaced in 1997–1998). The east windows have been truncated; they originally matched the east windows in the south basement (001). The openings are fitted with 1997–1998 single-light sash; the west opening has an older six-light sash with 9-1/2" wide x 11" high panes and 5/8" muntins.
