# OAK LAWN

HISTORIC STRUCTURE REPORT &  
CULTURAL LANDSCAPE REPORT

JOHN G. WAITE ASSOCIATES, ARCHITECTS  
LIZ SARGENT HISTORIC LANDSCAPE ARCHITECTURE  
2025

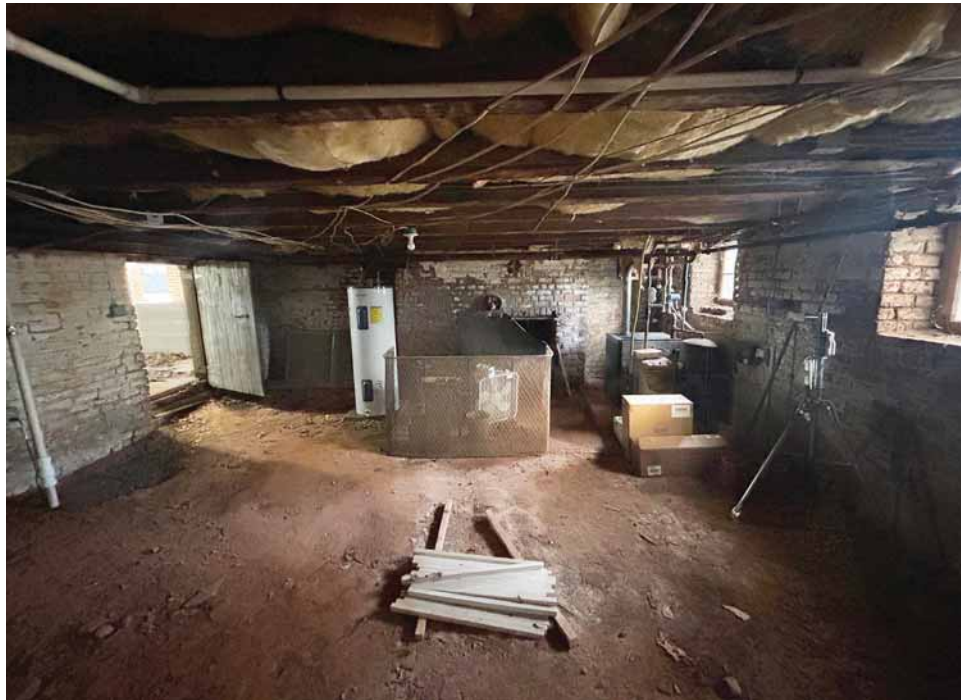
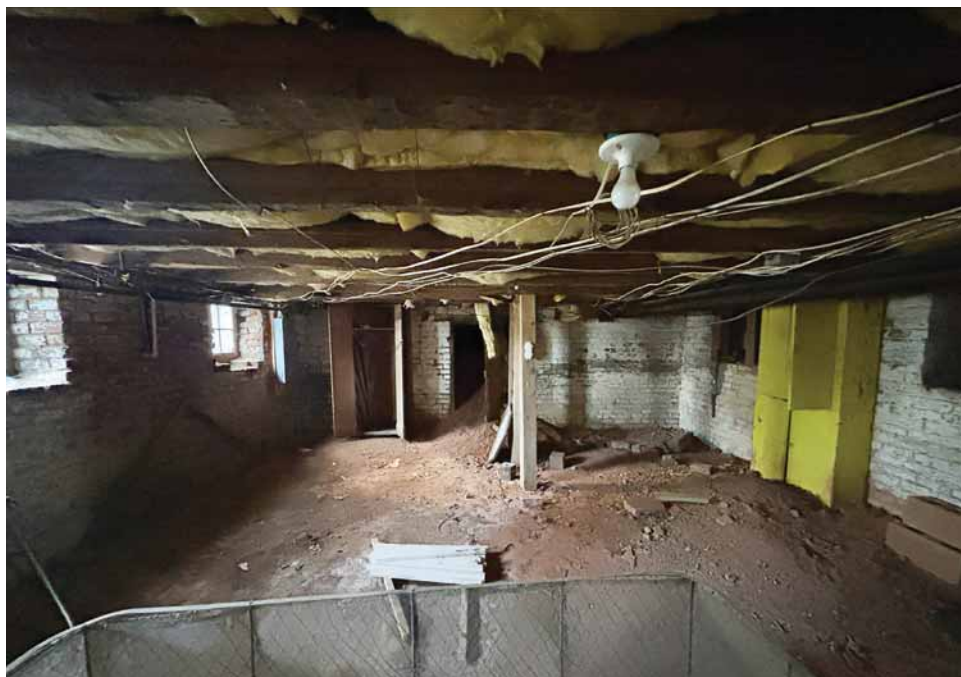
*Figure 212. The west basement (003) looking west (upper image) and east (lower image).  
James Zehmer, 2025.*

Heating: A concrete platform in the northwest corner holds a *Utica Gas Boiler* (DV200A), a *Whirlpool* dehumidifier, and an *Amtrol Extrol* expansion tank.

Lighting/electrical: The space is lit by an incandescent porcelain utility fixture mounted to one of the joists. Other electrical elements include an electrical panel at the east end of the north wall; an Argo connector, switch, and duplex receptacle on a plywood panel mounted to the west end of the north wall (to service the nearby boiler, expansion tank, and dehumidifier); a switch and duplex receptacle near the south doorway.

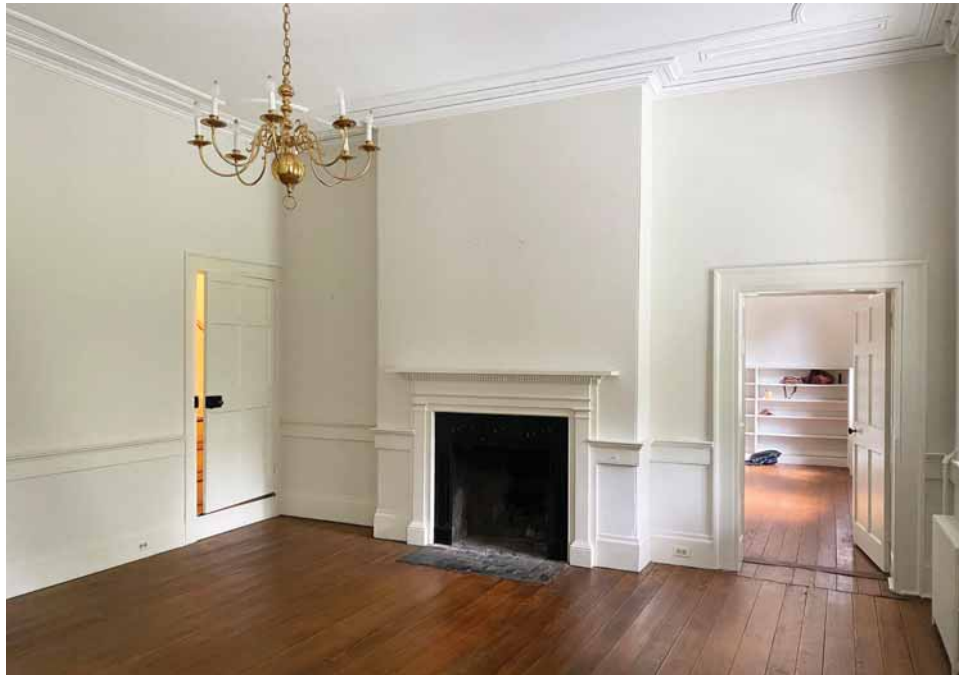
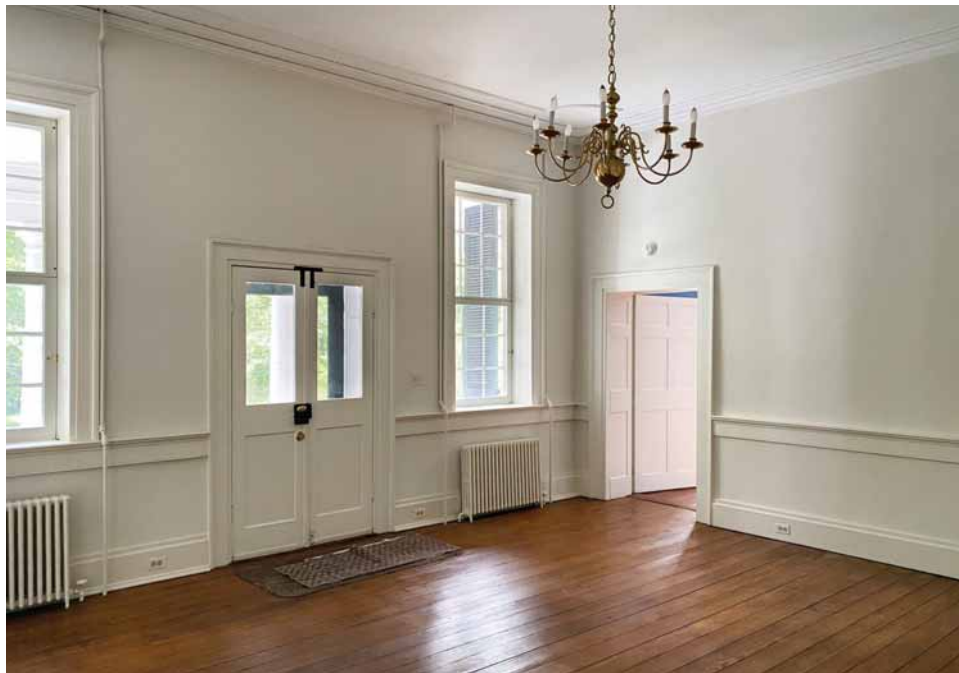
*Figure 220. Entrance Hall (101), looking northwest (upper image) and southeast (lower image). JGWA, 2024.*

Fireplace: The original 8' 3" wide plastered brick chimney breast projects 1' 1-1/2" from the north wall. The brick firebox is lined with metal. The brick surround is covered by a post-1847 cast-iron surround, painted black. Tall rectangular panels of vertical beads embellish the sides of

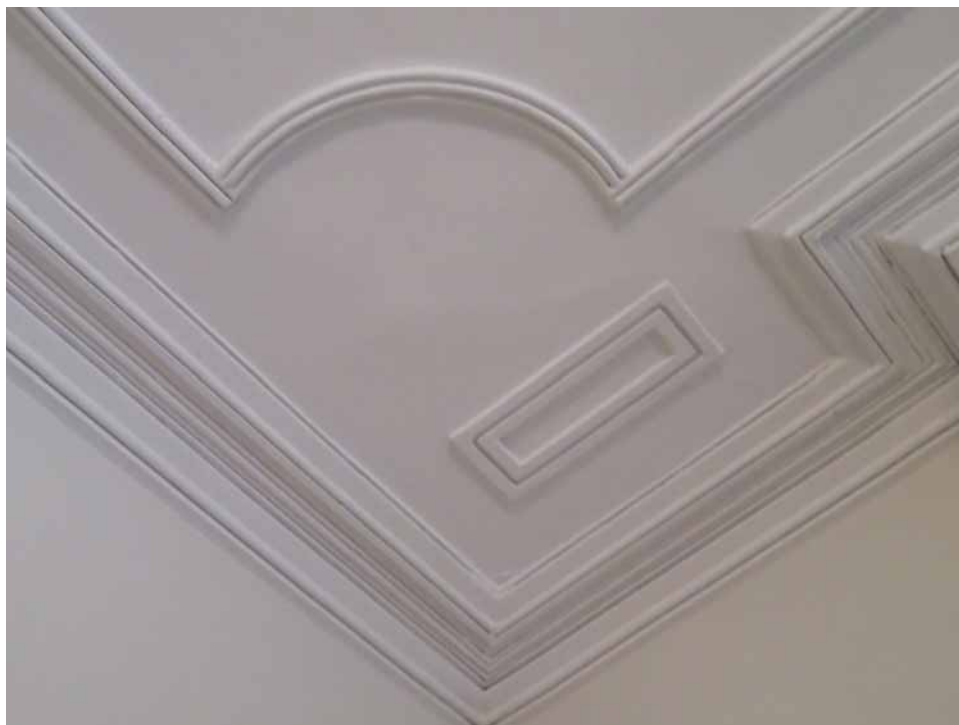
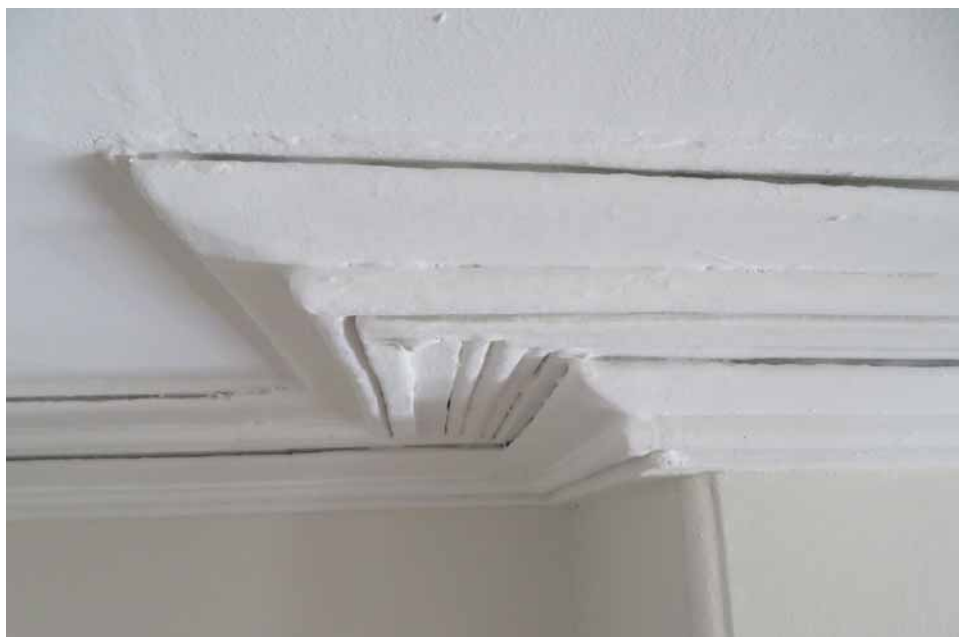
*Figure 221. The ceiling and cornice in the Entrance Hall (101). JGWA, 2024.*

Ceiling: The ceiling is 11' 6-1/2" above the floor. With the exception of the cornice and the central medallion, the plaster was replaced in the 1997–1998 work.

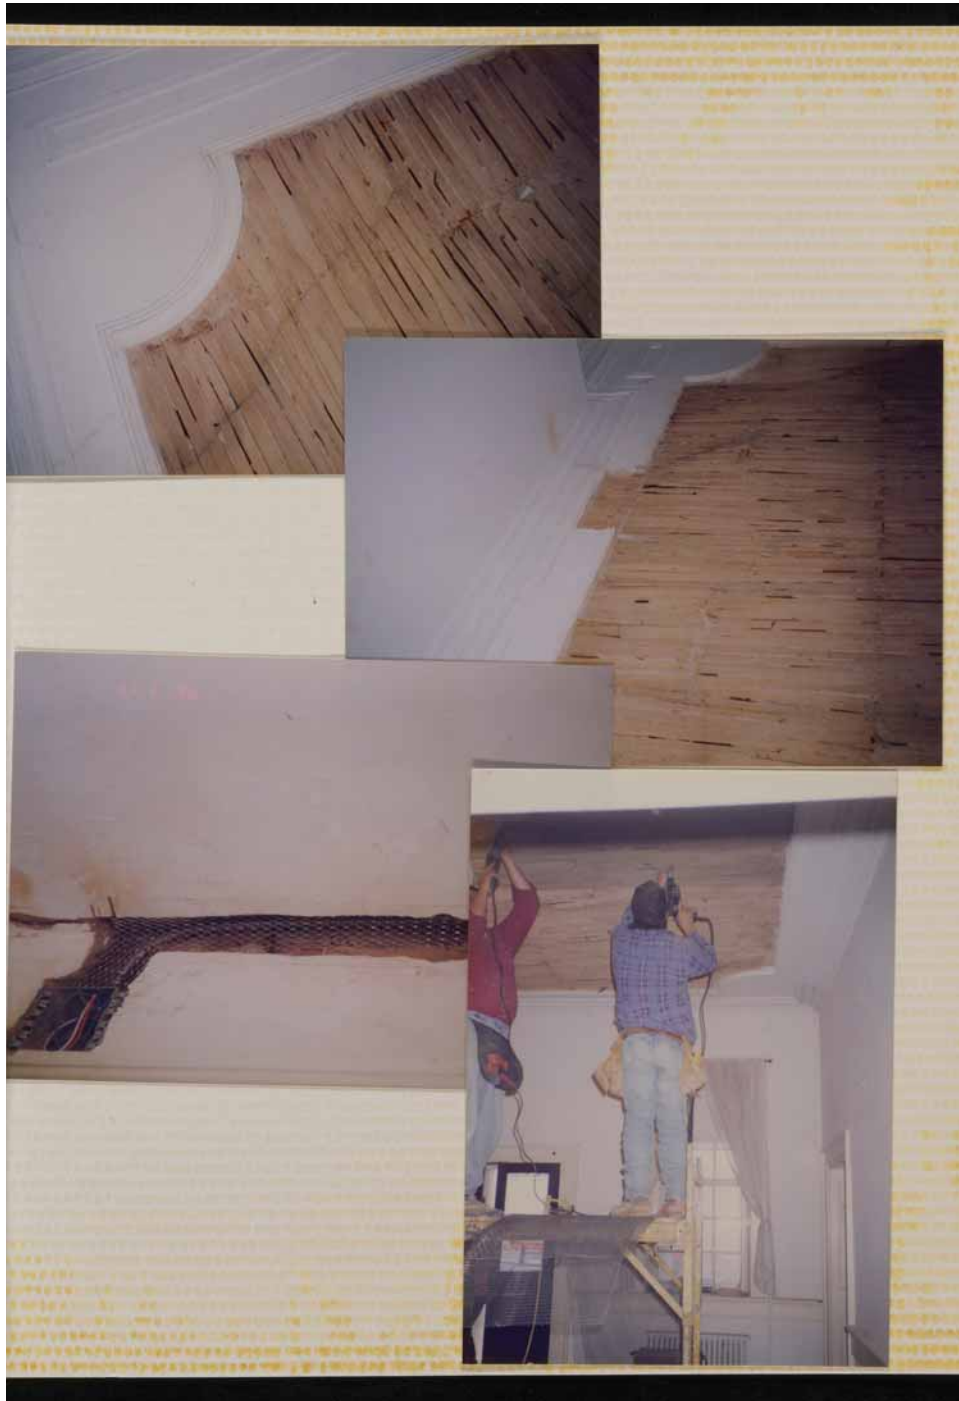
*Figure 223. Work on the entrance hall (101) ceiling in the 1997–1998 restoration.  
Courtesy of Nancy O'Brien.*

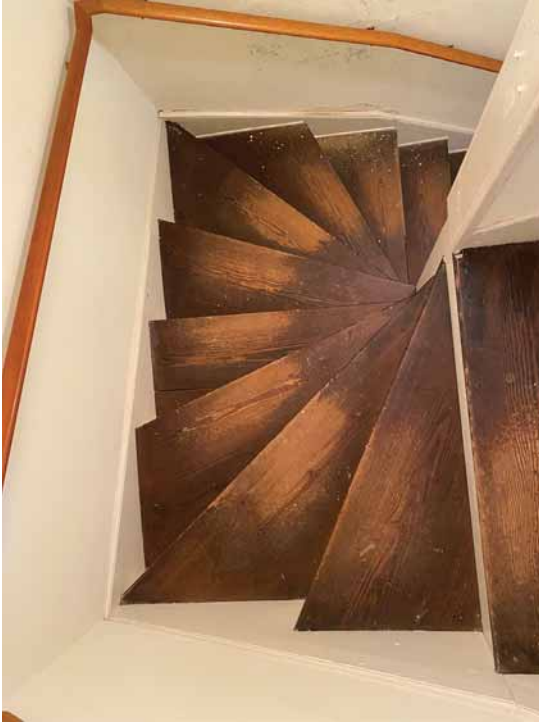
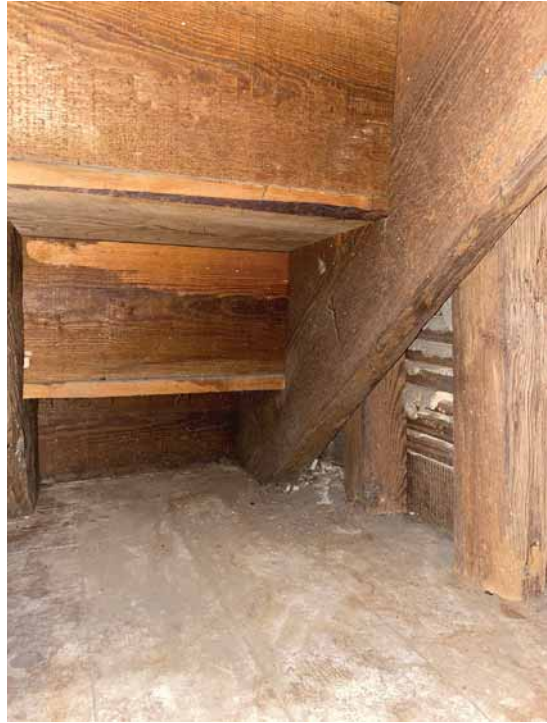
*Figure 225. (Above) The north stair (C101). JGWA, 2024.*

*Figure 226. (Left) The north stair after removal of the plaster and lath, 1997–1998. Courtesy of Nancy O'Brien.*

Walls: Wood-framed walls retain some plaster and wood lath; it is intact on the lower run of the stairs. Other areas were replaced with a gypsum board finish in 1997–1998. The finishes in this stair were replaced in the 1997–1998 campaign.

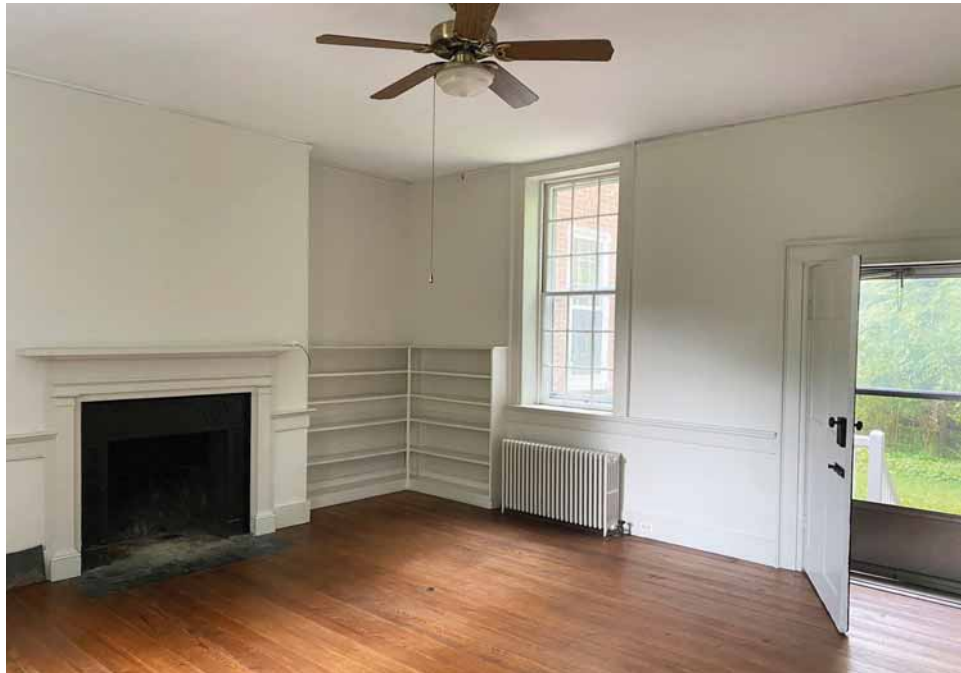
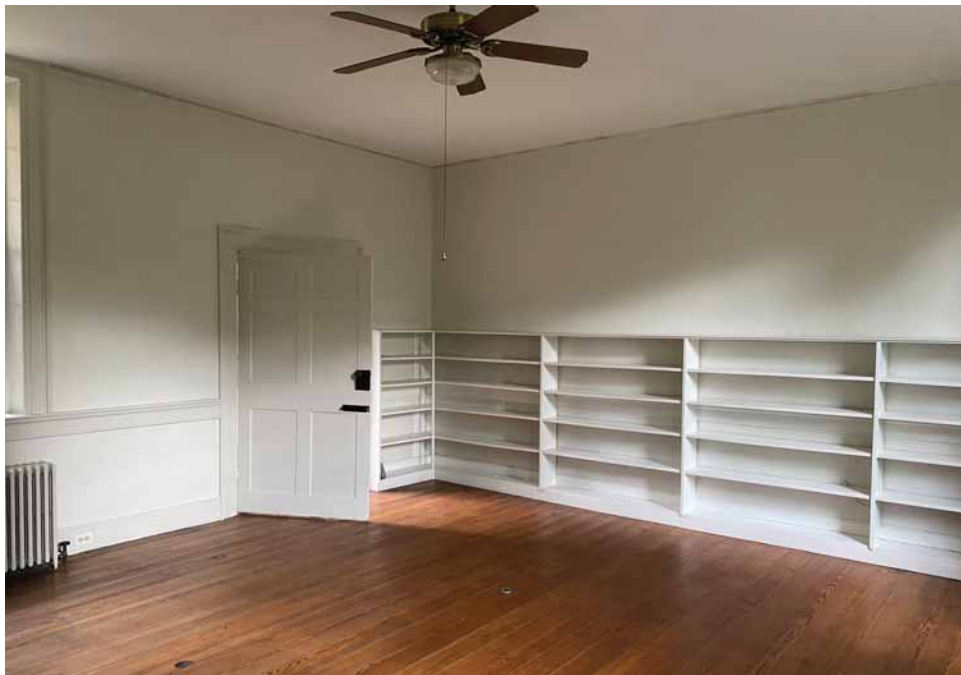
*Figure 227. The north room (103), looking southwest (upper image) and northwest (lower image). JGWA, 2024.*

The 1822 4' 8" wide brick hearth projects 1' 8" from the surround.

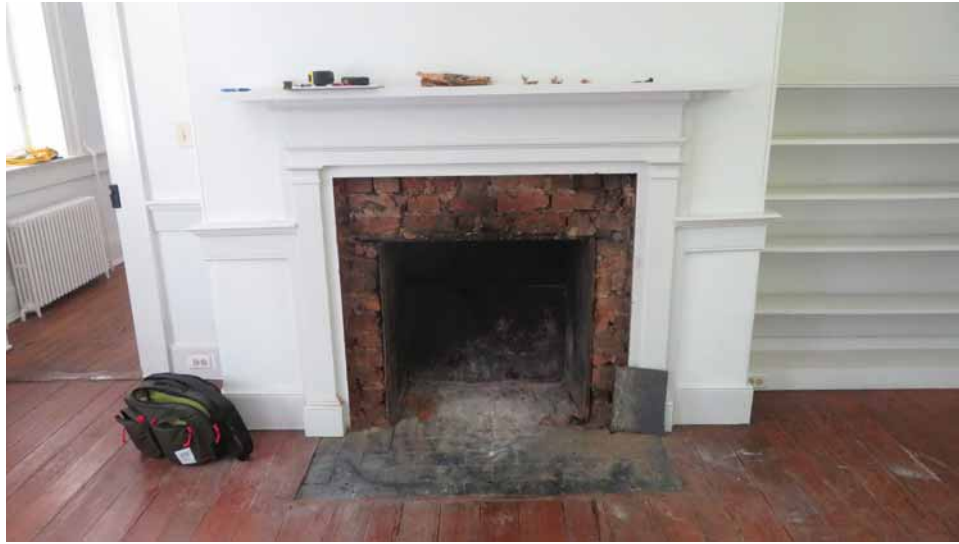
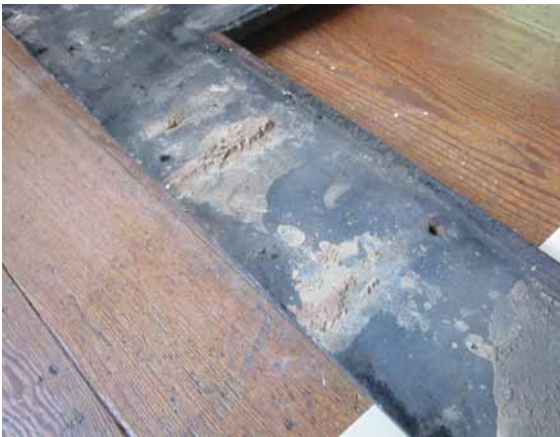
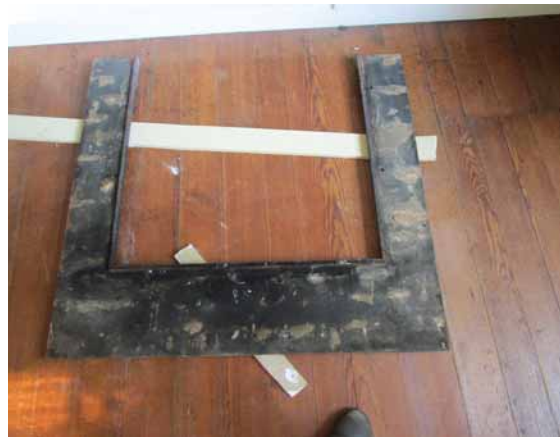
*Figure 228. The fireplace in the north room (103) after removal of the cast-iron mantel.  
JGWA, 2024.*

In 2024, a probe removed the cast-iron insert from the fireplace in the north room (103). The outline of an earlier, larger, firebox could be seen. That firebox measured 4' 4" wide and 3' 7" high: the same height as the cast-iron insert, but 5" wider. The outline of the mantel in Room 104 can be seen in a construction photograph from 1997-98 (Figure 231). This image shows a bare brick wall behind the current mantel. The earlier mantel was likely large enough to cover this entire area.

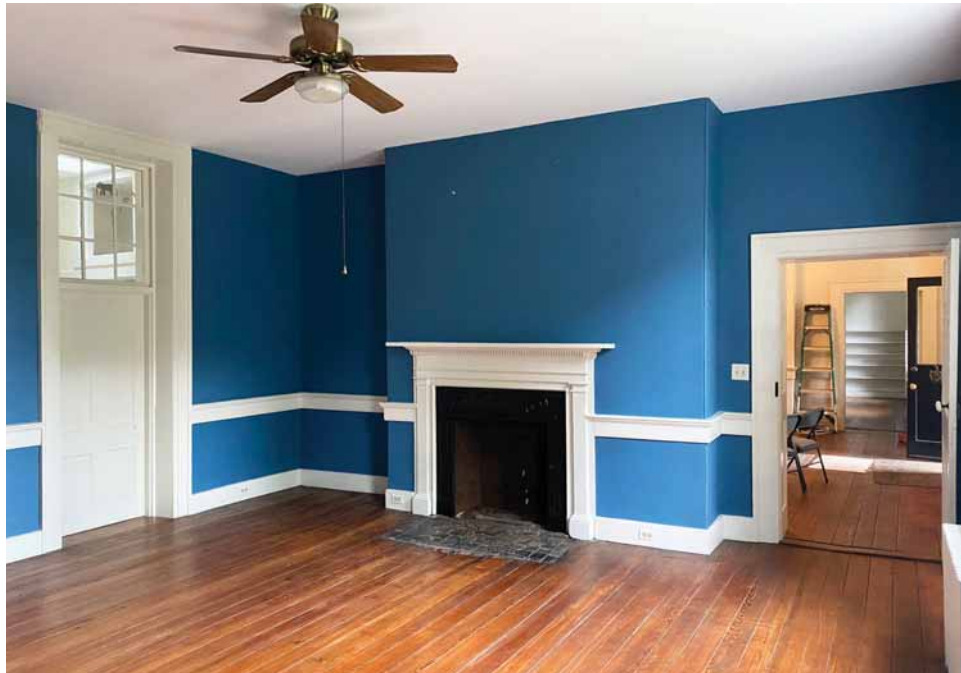
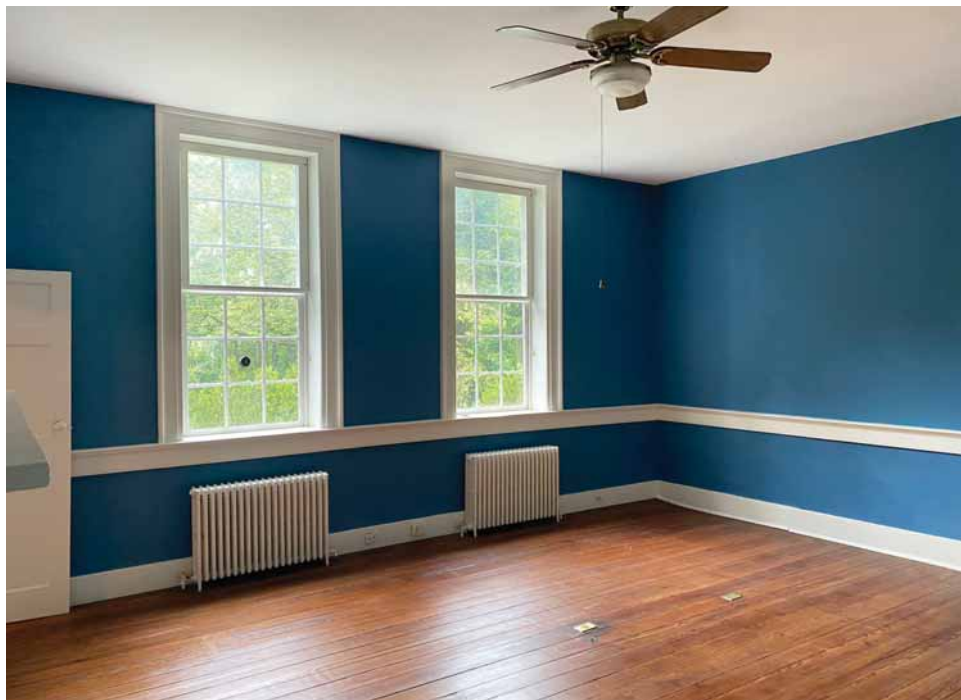
*Figure 230. The south room (104), looking northwest (upper image) and southeast (lower image). JGWA, 2024.*

The post-1847 wood mantel is similar to the one in 101: a plain wood fascia with a flush interior bead borders the surround, and simple pilasters flanking the fascia extend from molded

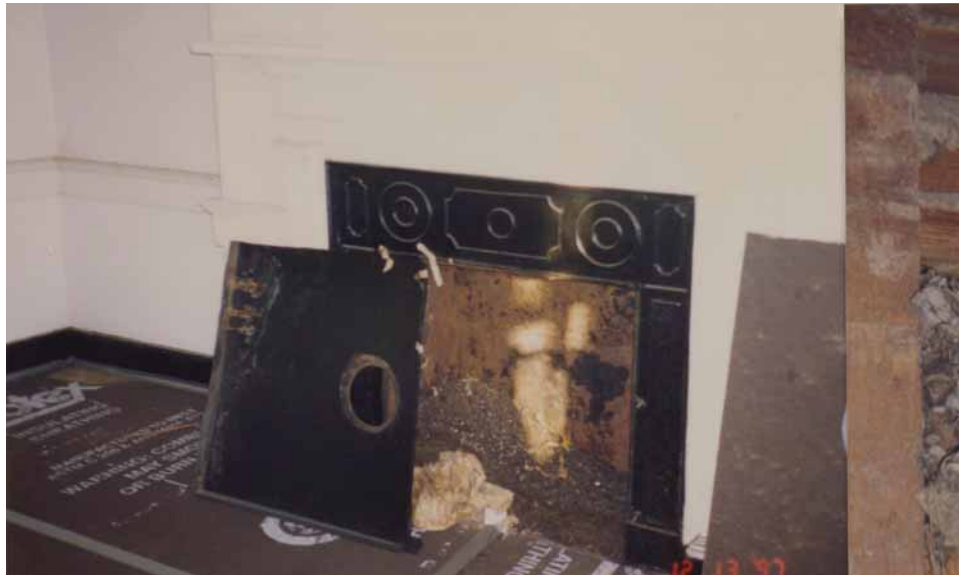
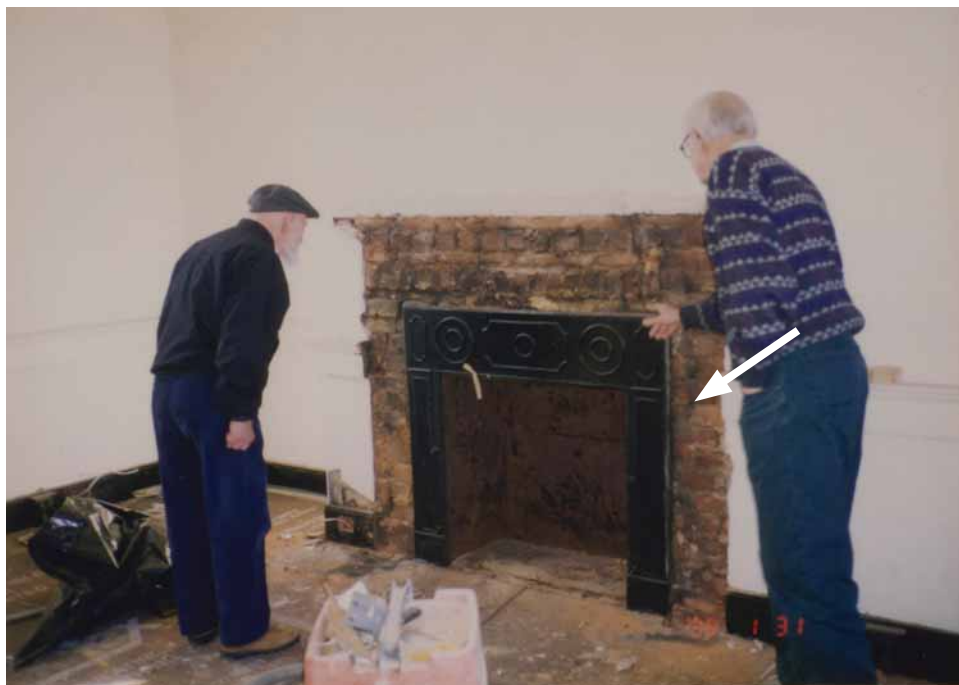
*Figure 231. Removal of the fireplace mantel in the south room (104) during the 1997–1998 work. The arrow marks the outline of the original firebox. Courtesy of Nancy O'Brien.*

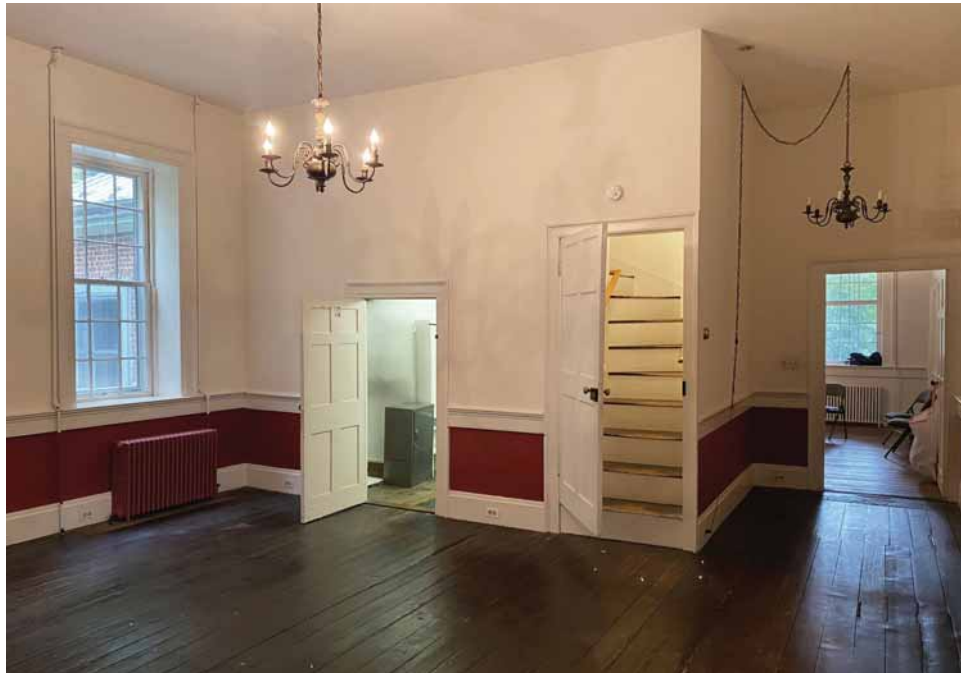
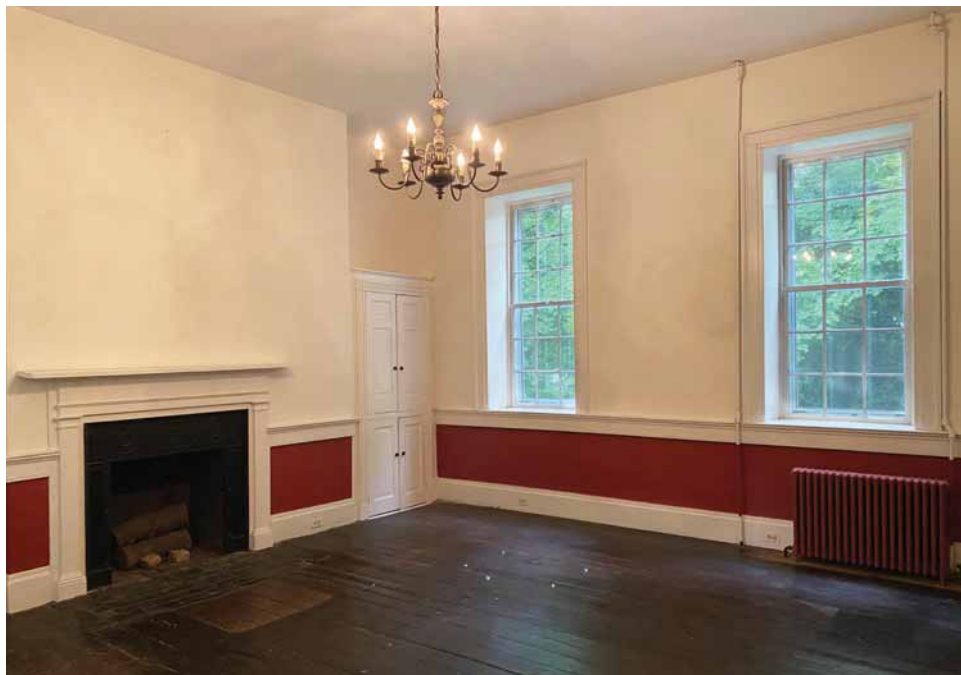
*Figure 232. The west room (105), looking east (upper image) and northwest (lower image).  
JGWA, 2024.*

Windows: The two window openings in the north wall and the opening in the south wall are framed by 6" wide two-fascia architraves; the sills extend out to the chair rail. Each original opening is fitted with 9/9 wood sash with 10" x 12" panes and 3/4" muntins.

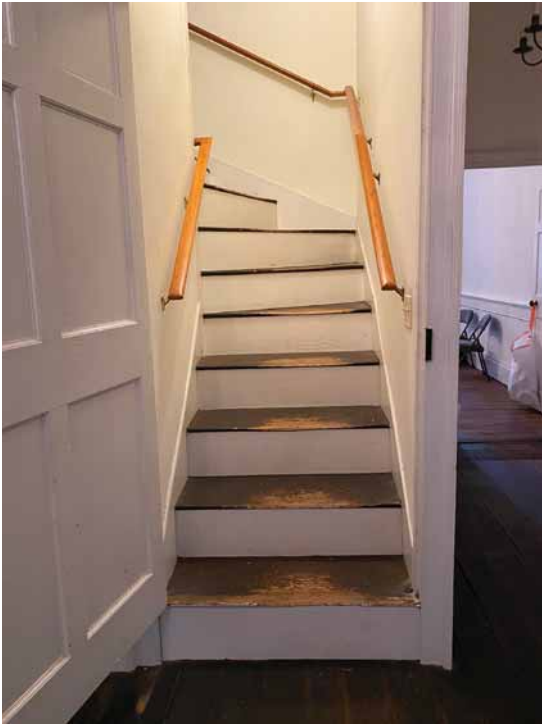
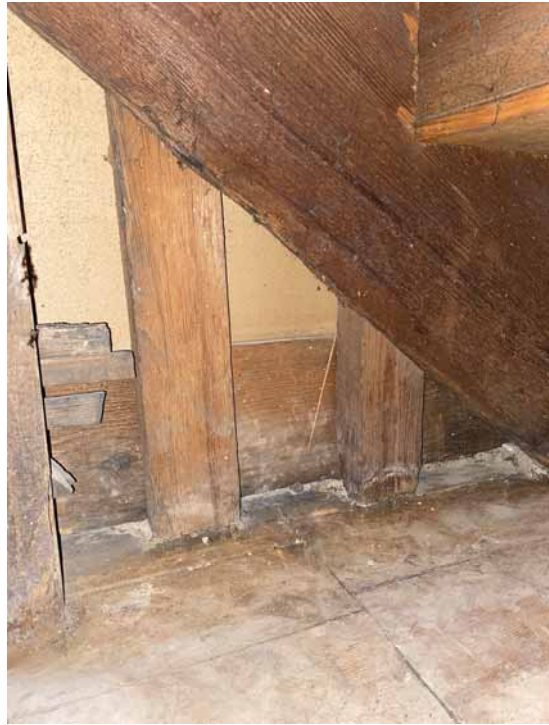
*Figure 234. The south stair (C105), looking east (upper left) and in the space below the stair (above). JGWA, 2024.*

The south stair is a mirror image of the north stair (C101). Access to the stair is provided by doorways in the west walls of the stairwell at the first and second-floor levels. In the 1997–1998

Walls: Wood-framed walls are mostly finished with painted gypsum board. The finishes in this stair were replaced in the 1997–1998 work, after the plaster was removed to facilitate running conduit and HVAC piping to the attic.

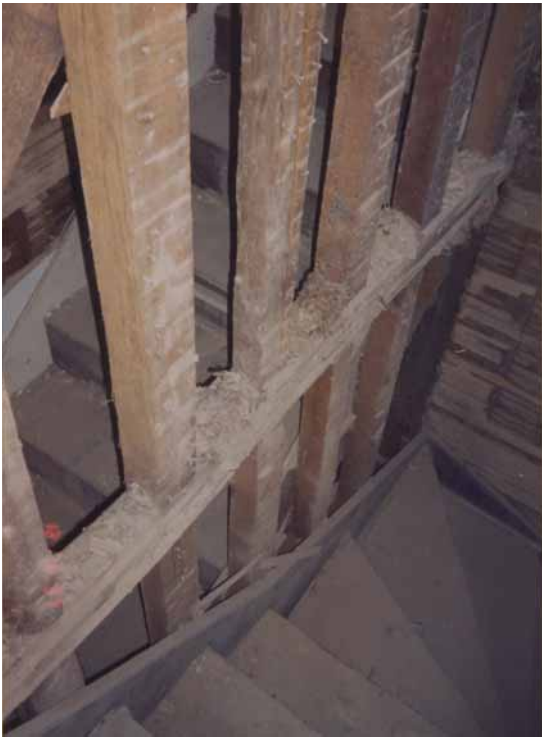
*Figure 235. (Left) The wall between the south stair (C105) and the attic stair (C204) after the lath and plaster were removed, 1997–1998. Courtesy of Nancy O'Brien.*

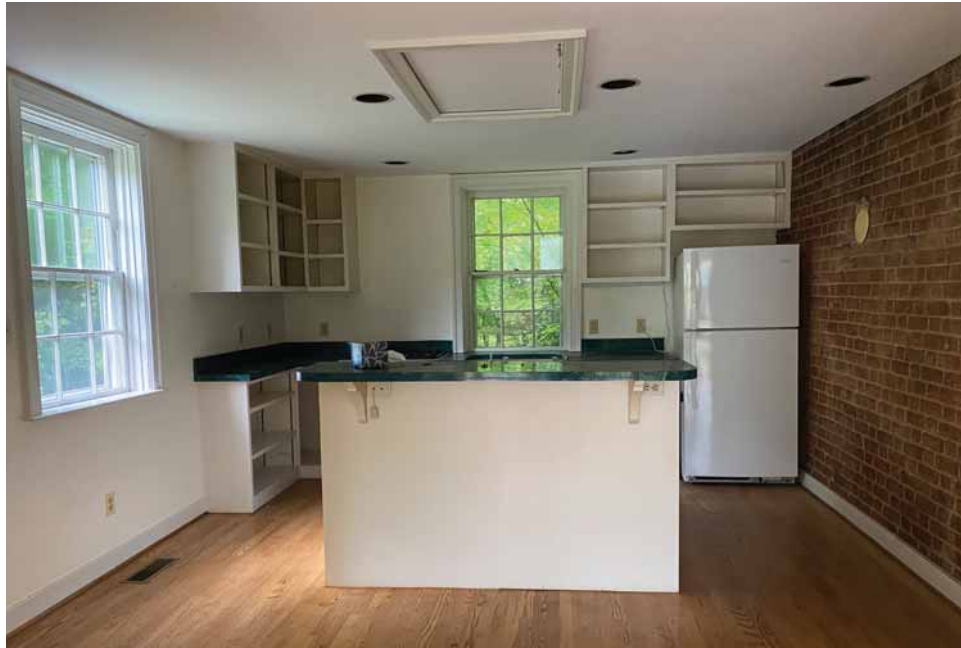
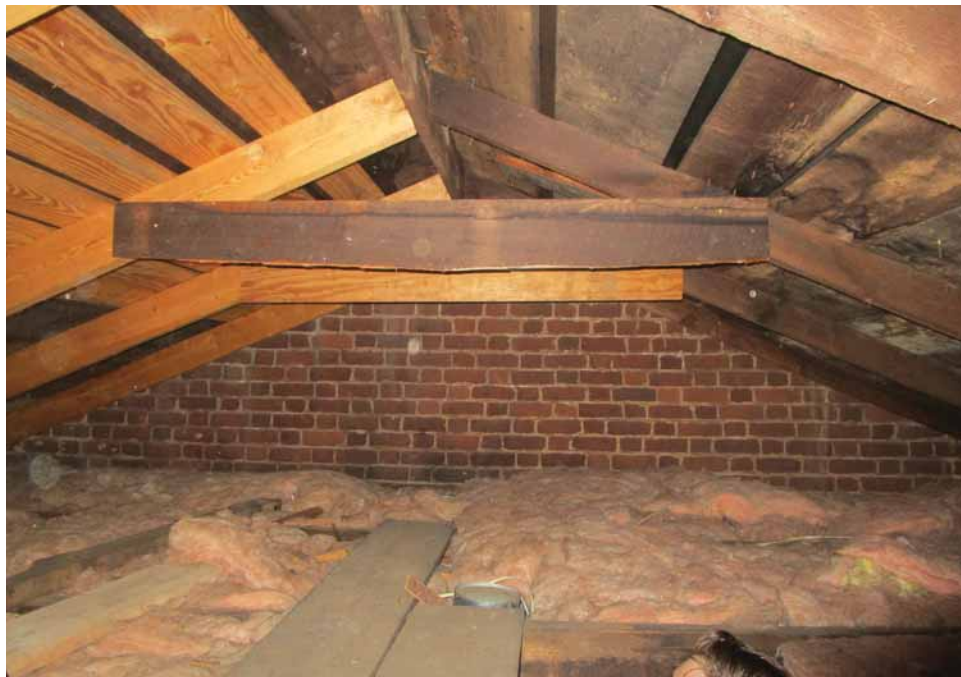
*Figure 238. The kitchen (108), looking north (upper image); and the attic above the kitchen, looking east (lower image). JGWA, 2024.*

The 16' 4" x 13' 2" one-story circa 1900 kitchen addition at the west end of the house includes circa 1900 window openings in the north and west walls; a circa 1900 doorway in the east wall; and a large 1997–1998 doorway to the south. The south opening replaced a circa 1900 doorway.

Doors: The circa 1900 east doorway is trimmed with a circa 1900 beaded board reveal and a 4-7/8" wide single-fascia architrave with a quirked ogee outer molding. The large 1997–1998 south opening that replaced the circa 1900 south doorway has a 5" wide single-fascia architrave with a simple cyma outer molding.

Heating: A thimble in the east wall served a wood-burning cooking stove; the Fife family remembers the stove in that location into the mid twentieth-century.<sup>308</sup> There is a modern floor register near the north window. Photographs of the kitchen before the 1997–1998 work show a cast-iron radiator in front of that window.

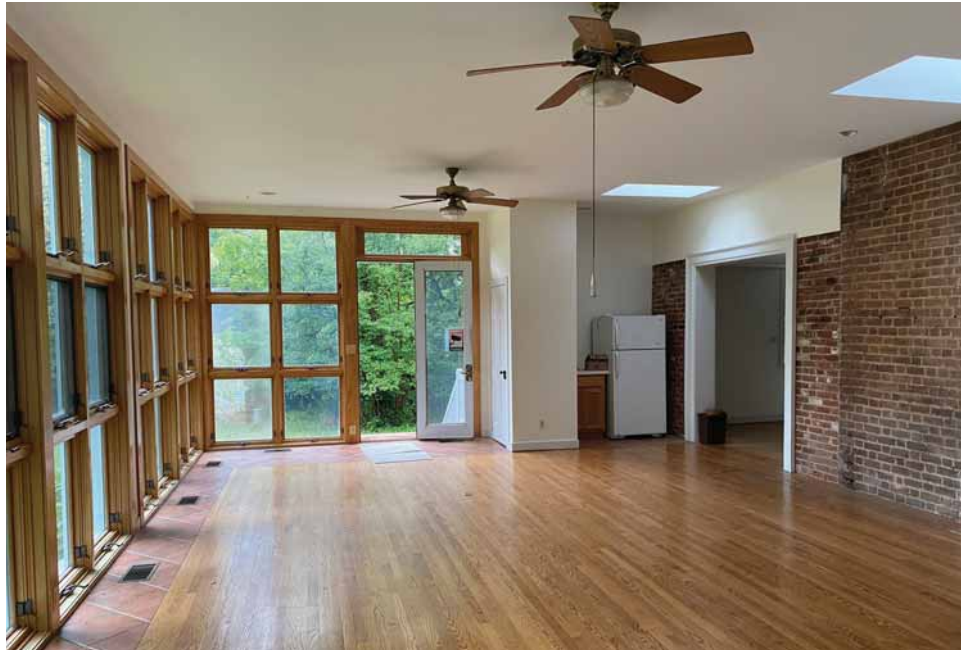
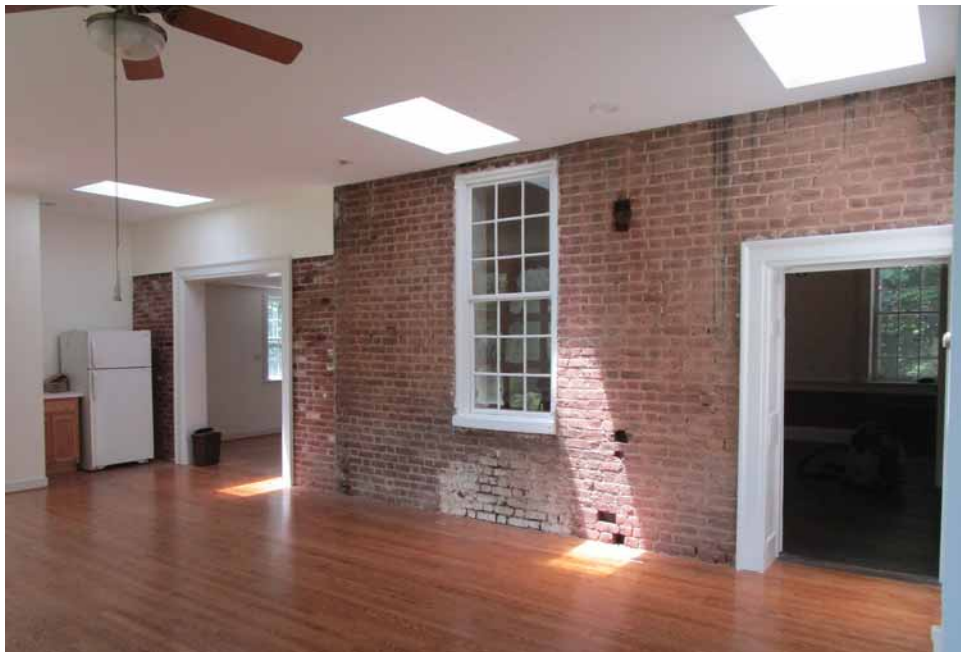
*Figure 239. The southwest addition (109), looking west (upper image) and northwest (lower image). The pockets or cavities in the north wall are evidence of the first southwest porch.  
JGWA, 2024.*

The 1997–1998 remodeling replaced enclosed southwest porches with this spacious, light-filled room. Natural light is provided by window walls to the south and west and by three skylights. The 29' 4" x 20' 0-1/2" space includes three openings in the north wall: a wide 1997–1998 doorway that replaced the 1910 door to the kitchen; and the original window and doorway to the dining room. At the east end of the room is a closet and a doorway to the bathroom, both dating to the 1997–1998 work, as well as an original exterior entrance into 104.

Floor: 2-1/4" wide tongue-and-groove floorboards are laid east/west. Along the window walls, in the southeast corner of the room (where there is a wood-burning stove) and in the passage to the bath, the floor is covered in 1' 1-1/4" square quarry tiles.

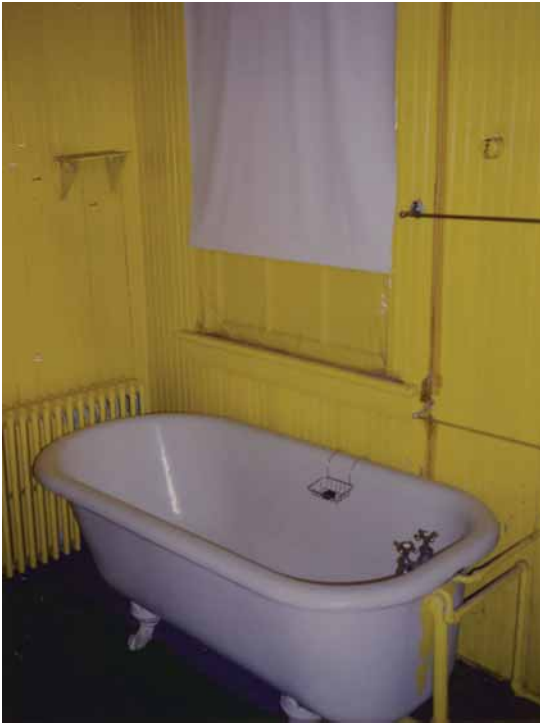
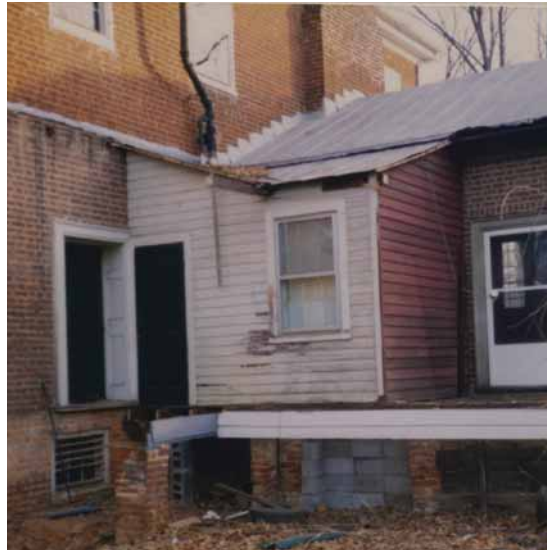
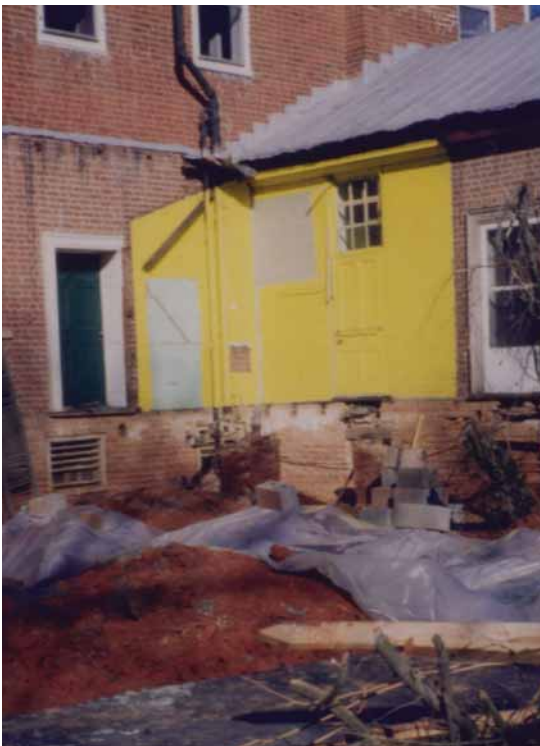
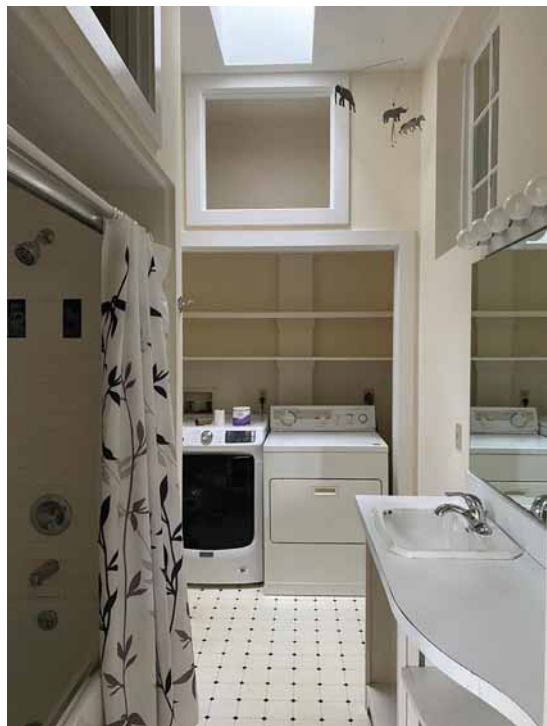
*Figure 240. The 1910 first-floor bathroom (upper images), and after demolition (left). Courtesy of Nancy O'Brien.*

*Figure 241. (Above) First-floor bathroom (T110), looking north. JGWA, 2024.*

This bathroom was demolished and a new bathroom constructed in the 1997–1998 campaign. All of the finishes, unless otherwise noted, date to that work.

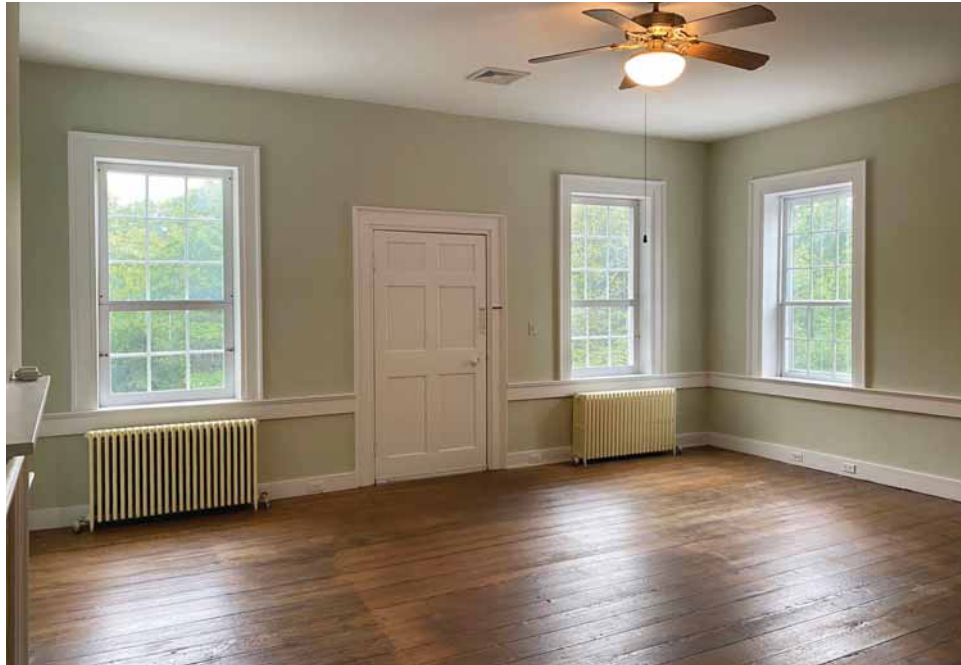
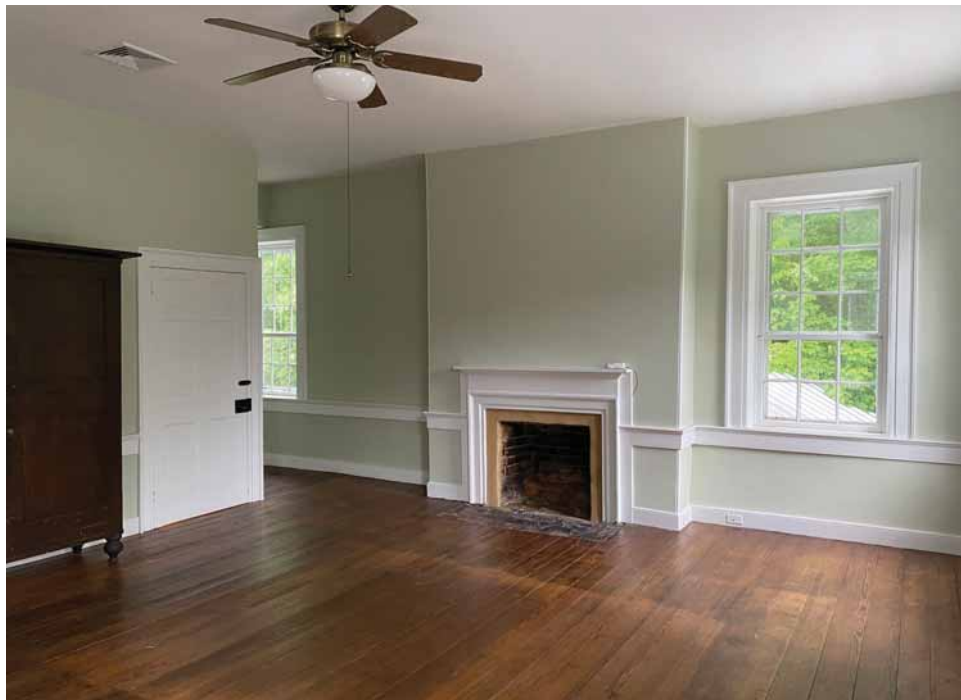
*Figure 243. East bedroom (201), looking southeast (upper image) and northwest (lower image). JGWA, 2024.*

The 20' 2-1/2" x 18' 0-1/2" room at the east end of the second floor is accessed via the north stairway (C101). The room includes three doorways in the west wall, an east exterior doorway to a balcony, pairs of window openings in the north and east walls, and one window opening in the south wall. A chimney breast with fireplace projects from the north wall. When a bathroom was first installed on the second floor (now T206), it replaced a closet or dressing room to the southwest.<sup>311</sup>

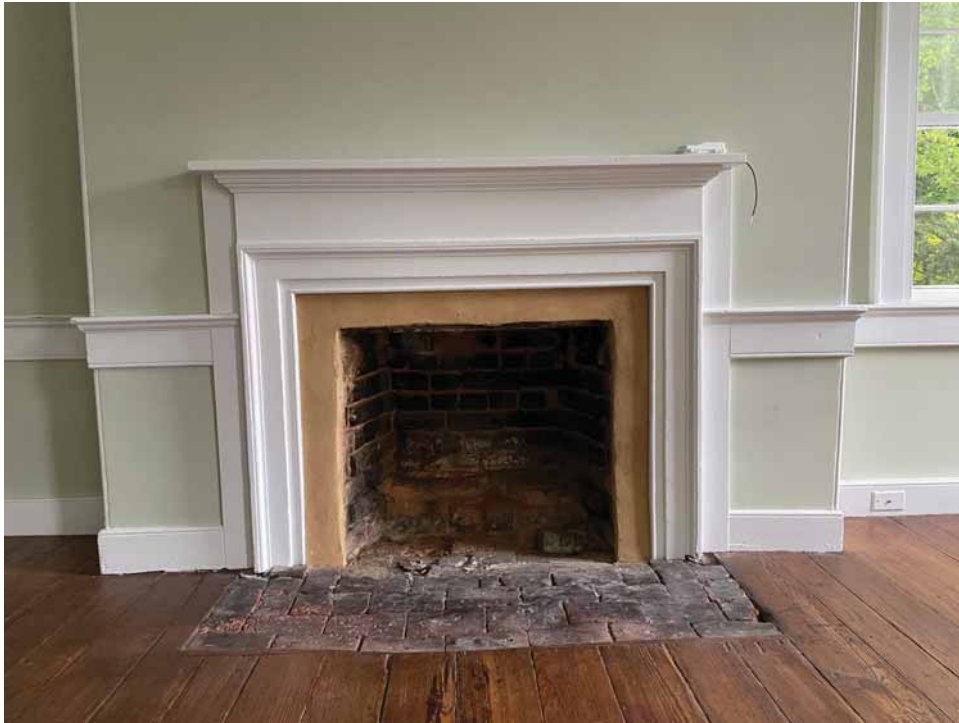
*Figure 244. The fireplace mantle in the east bedroom (201). JGWA, 2024.*

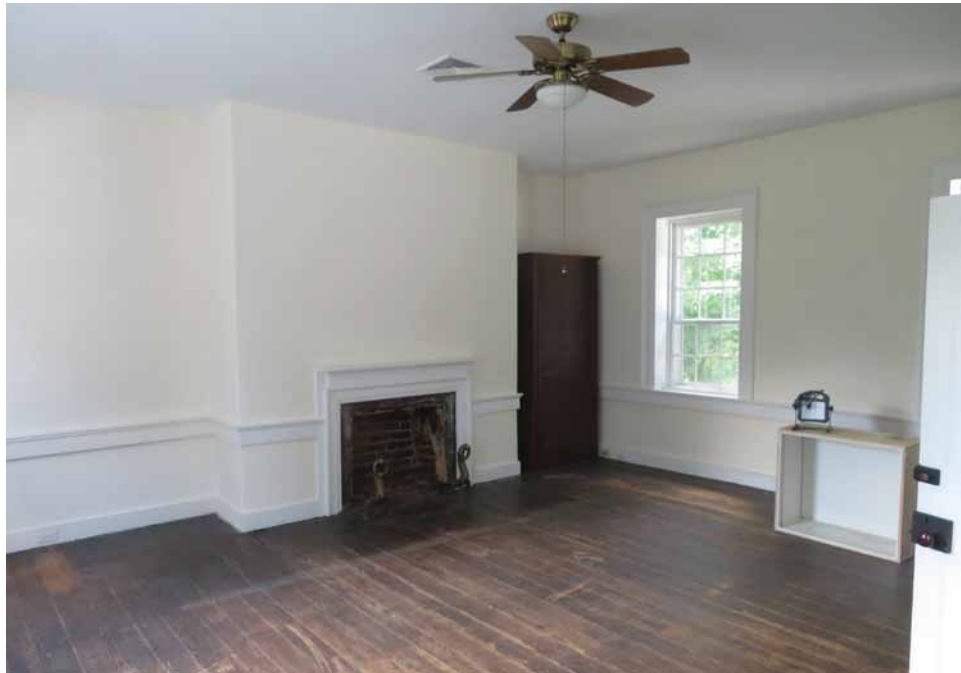
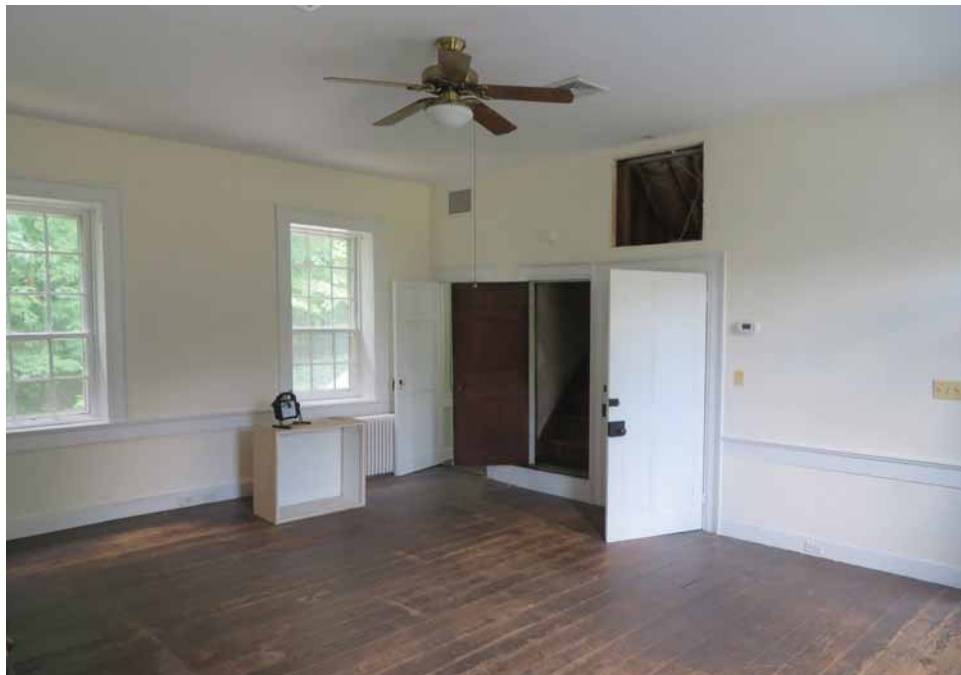
*Figure 245. The second-floor west bedroom (205), looking northwest (upper image) and northeast (lower image). JGWA, 2024.*
