# OAK LAWN

HISTORIC STRUCTURE REPORT &  
CULTURAL LANDSCAPE REPORT

JOHN G. WAITE ASSOCIATES, ARCHITECTS  
LIZ SARGENT HISTORIC LANDSCAPE ARCHITECTURE  
2025

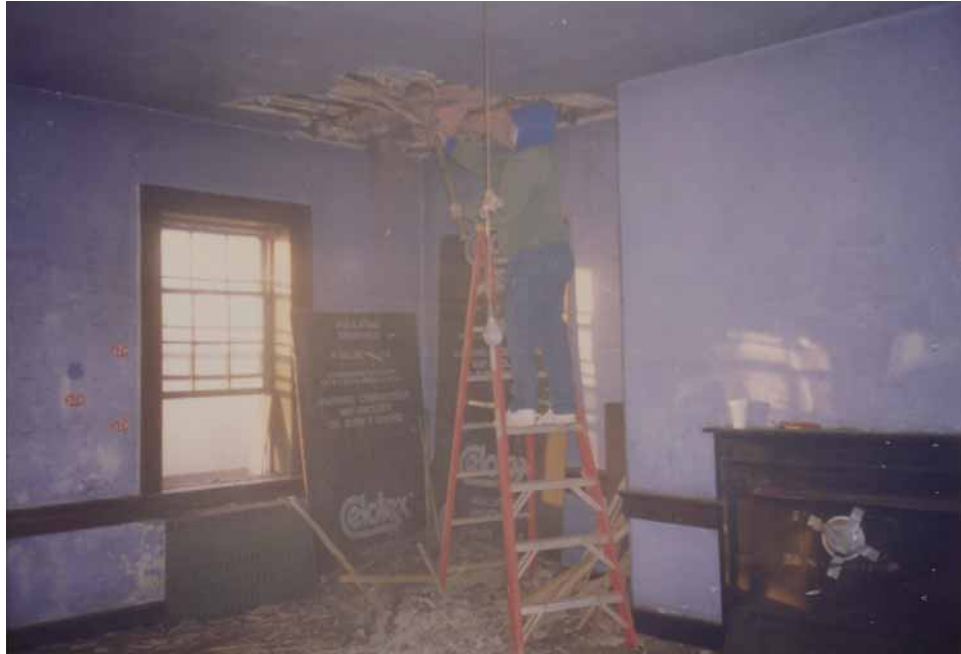
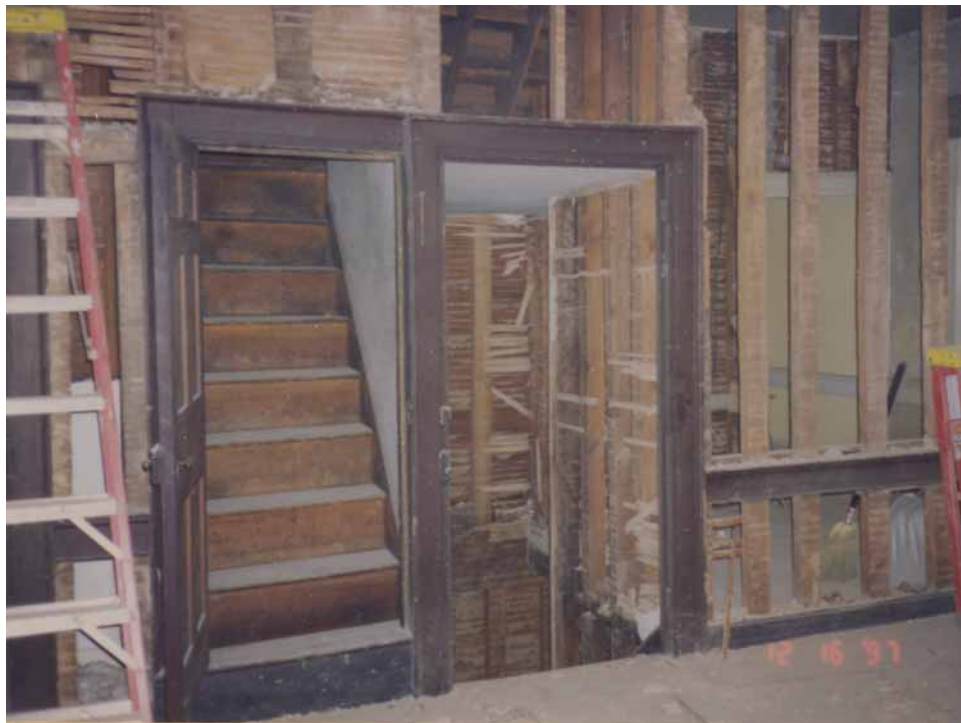
*Figure 246. The west bedroom (205) during the 1997–1998 work. Courtesy of Nancy O'Brien.*

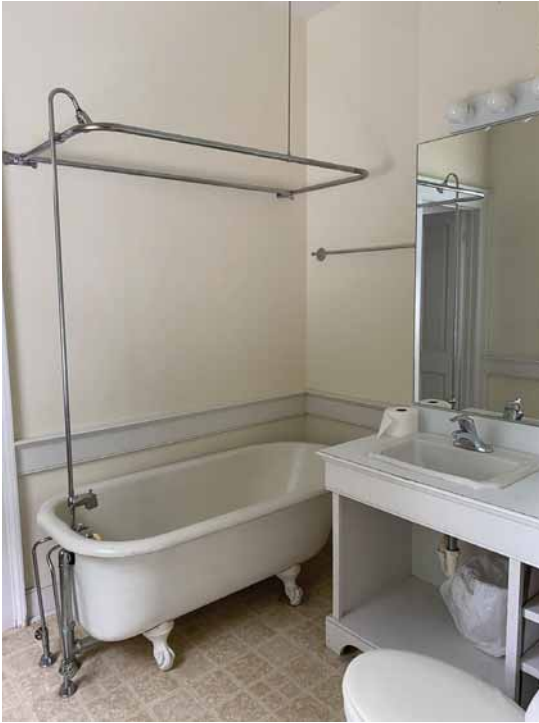
*Figure 247. The second-floor bathroom (T206), looking northwest. JGWA, 2024.*

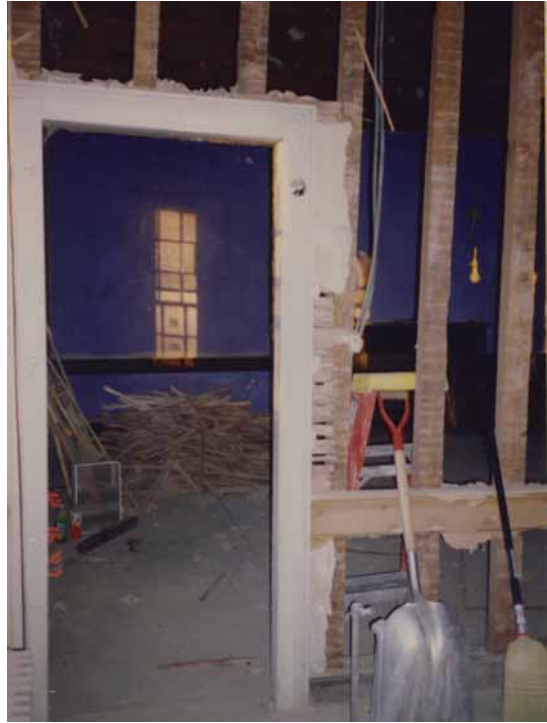
*Figure 248. The second-floor bathroom (T206) during the 1997–1998 work, after the lath and plaster were removed. Courtesy of Nancy O'Brien.*

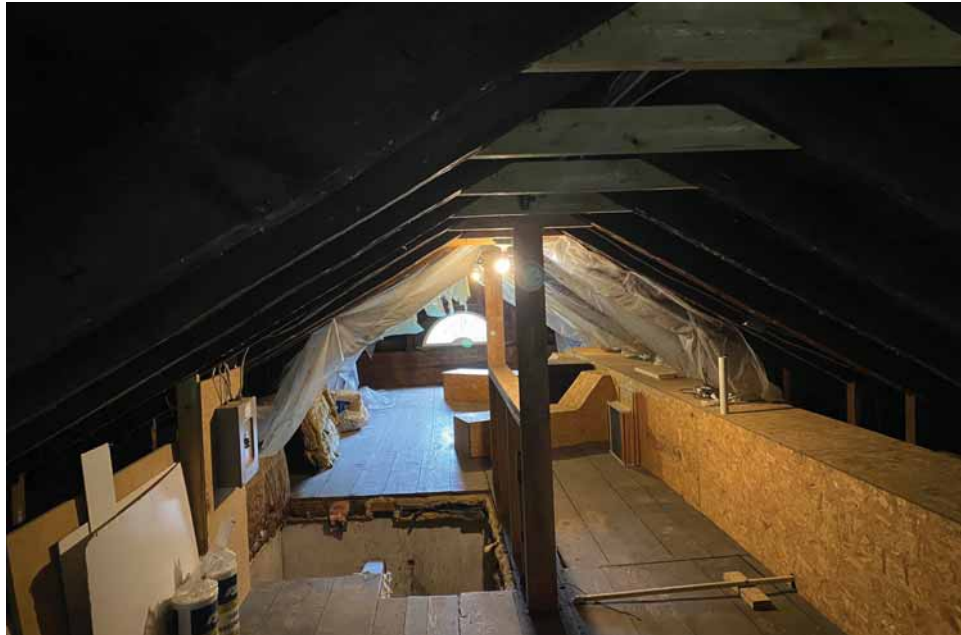
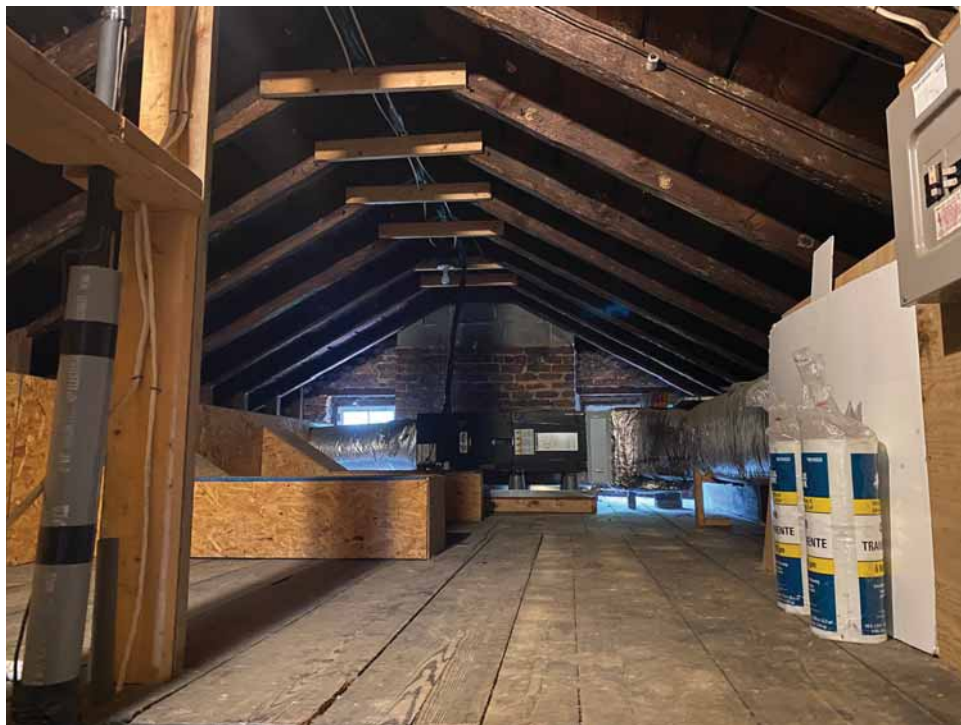
*Figure 250. The central attic (301), looking east (upper image) and west (lower image).  
JGWA, 2024.*

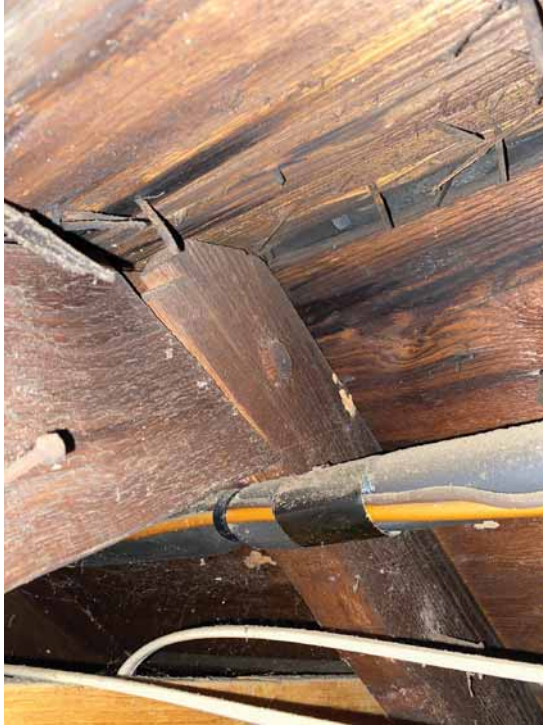
*Figure 251. (Left) The rafters meet at mortise-and-tenon joints at the peak of the gable. JGWA, 2024.*

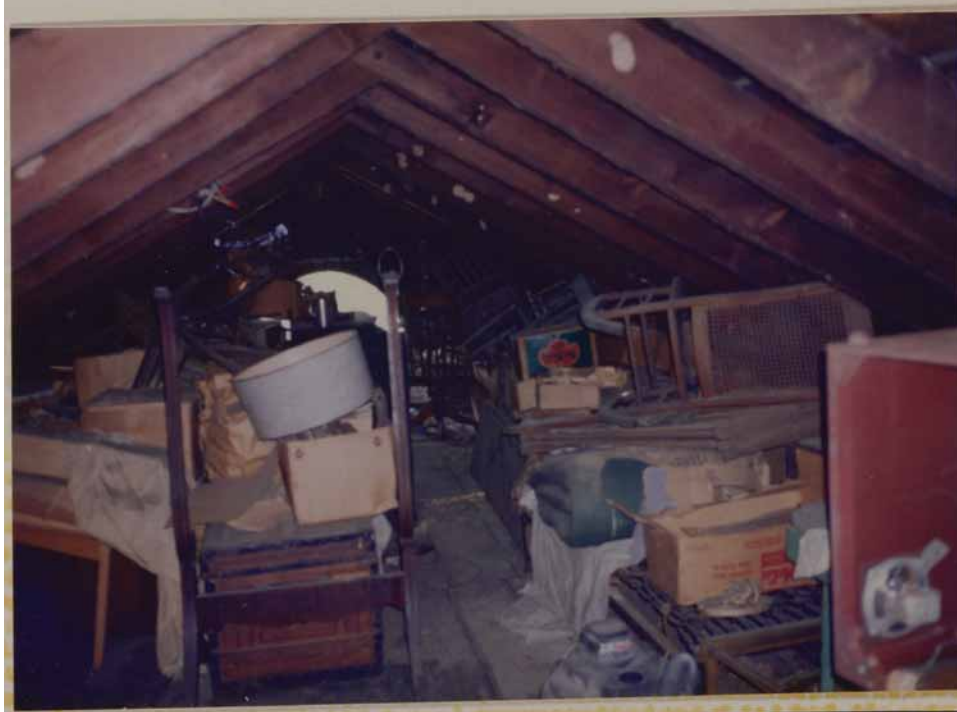
*Figure 252. (Below) The central attic (301) in 1997. Courtesy of Nancy O'Brien.*

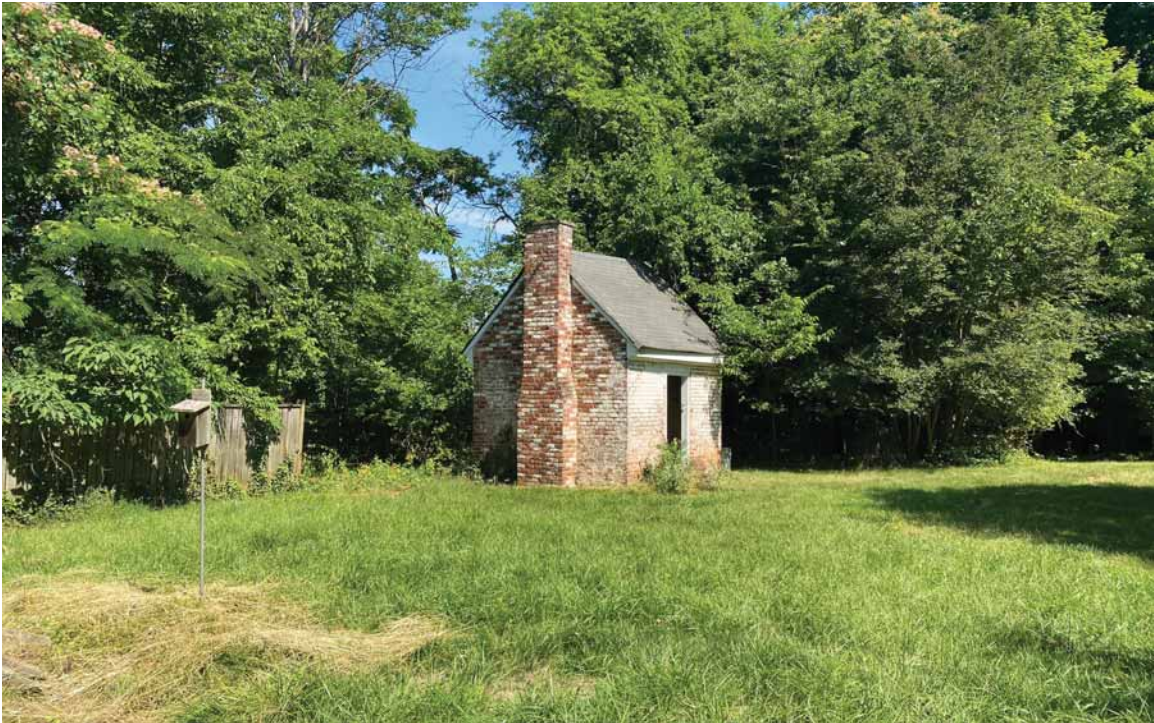
*Figure 253. The Cook's House from the southeast. JGWA, 2024.*

The walls of the Cook’s House are brick, laid in a common bond. Below the roofline, the bricks are laid with one header course every three stretcher courses. The header courses are spaced further

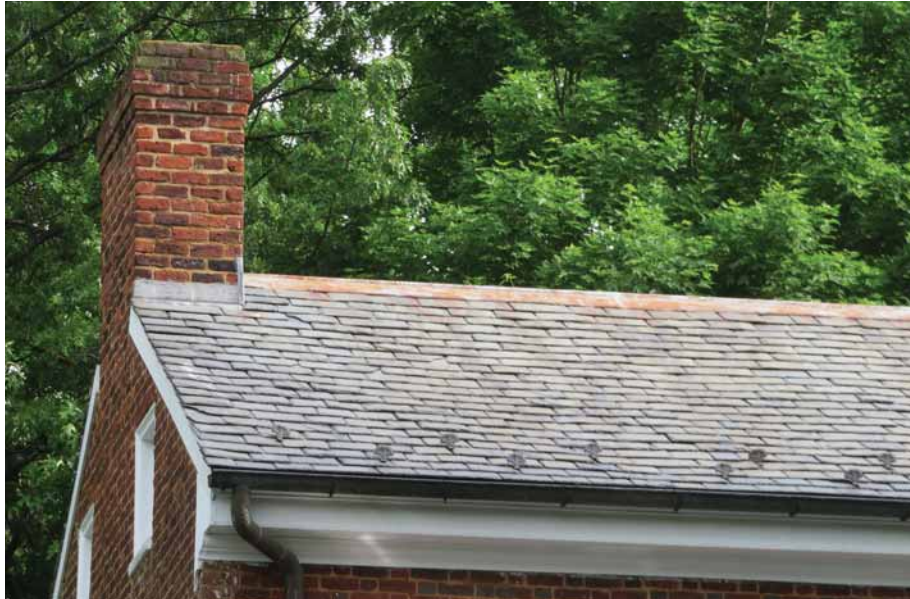
*Figure 255. Slate shingles cover the central section of the roof, which shows signs of its age through missing, broken, and displaced slate. Regular maintenance has countered some of the age-related deterioration. JGWA, 2024.*

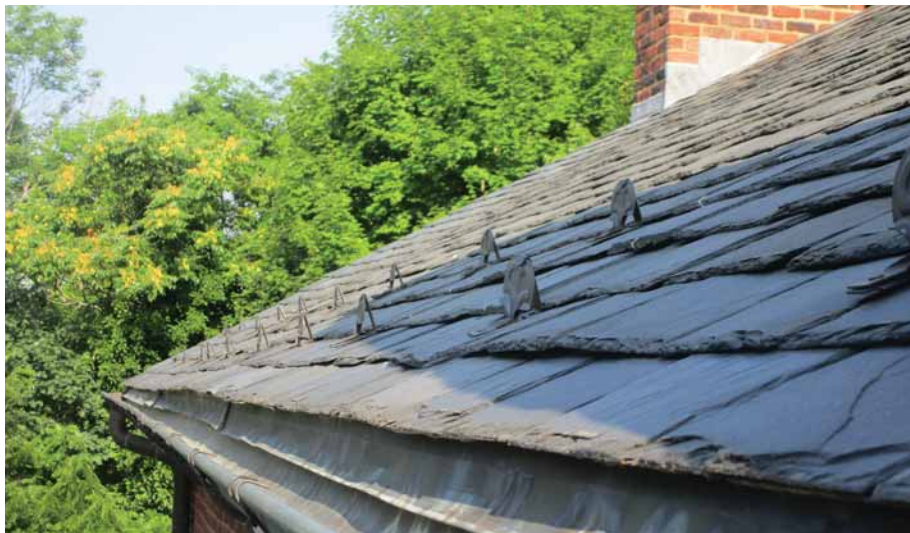
*Figure 256. Roof accessories, such as snowguards, flashings, and hung quarter-round gutter are generally in sound condition. Copper hooks used to secure replacement slates can be seen in numerous locations. JGWA, 2024.*

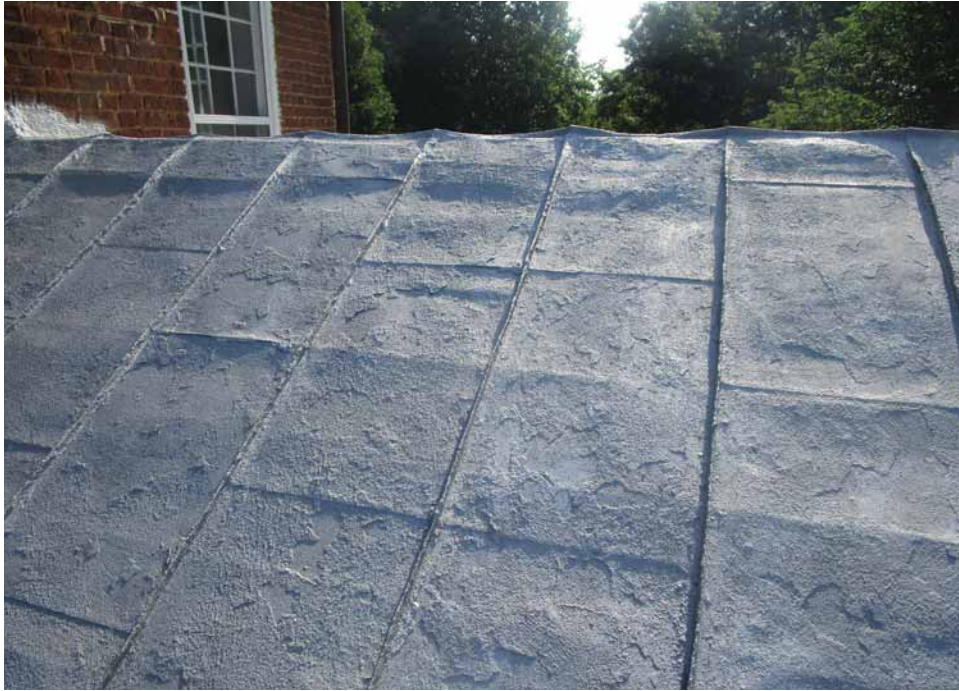
*Figure 257. (Above) The standing-seam sheet-metal roofs of the north and south wings are of different ages and conditions. The roof on the south wing has several coats of aluminized roof coating. Some of this has chipped, and some areas of rust staining exist. JGWA, 2024.*

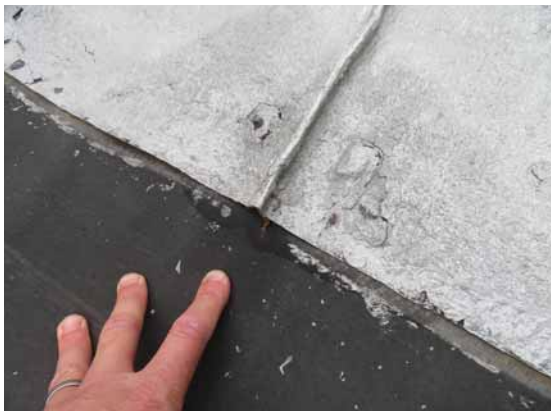
*Figure 258. (Left) Where the nearly flat membrane roof over the 1990s additions meets the gable roof of the south wing, the preexisting roofing was lifted to provide an overlap. The older metal roofing was then refastened by nailing through the face of the sheet metal. The membrane roofing is no longer fully adhered at this junction. JGWA, 2024.*

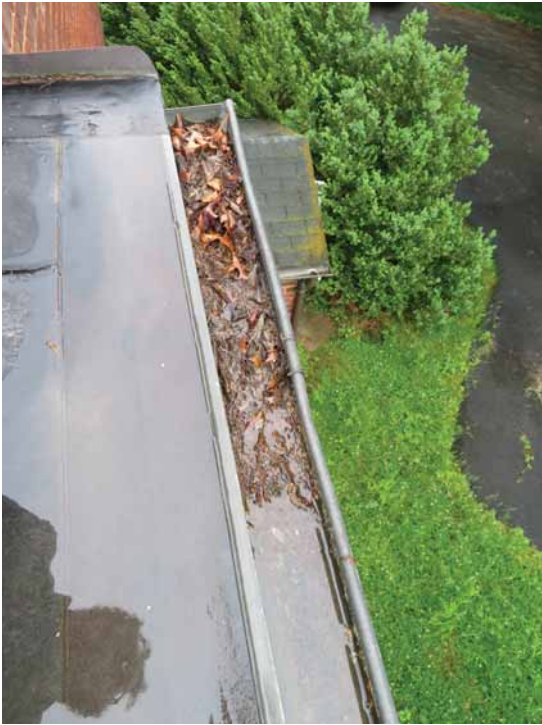
*Figure 259. Clogged or nearly clogged gutters exist at all sides of the building. The sheet-metal gutter to the left of this image is intended to prevent water from running down the brick wall below; however there is water damage on the brick below. The asphalt roof on the entrance to the south basement is nearing the end of its service life. JGWA, 2024.*

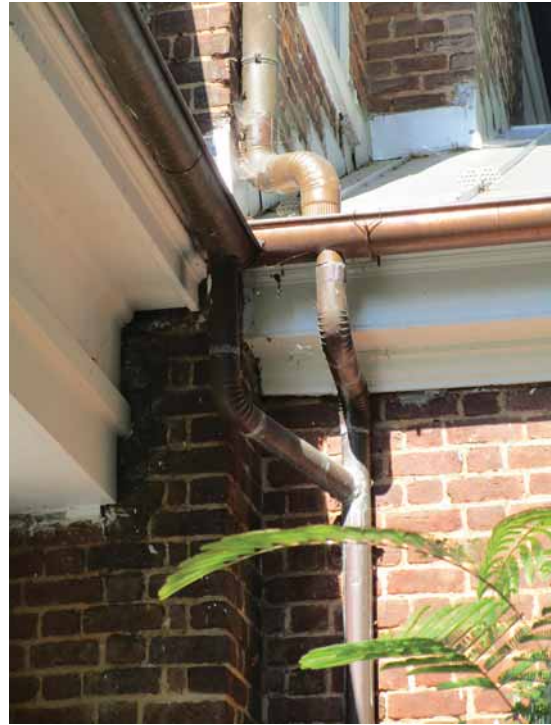
*Figure 260. Many of the gutter downspouts on the house follow a circuitous route to the ground. In this location, north of the east porch, three gutters drain into one downspout. JGWA, 2024.*

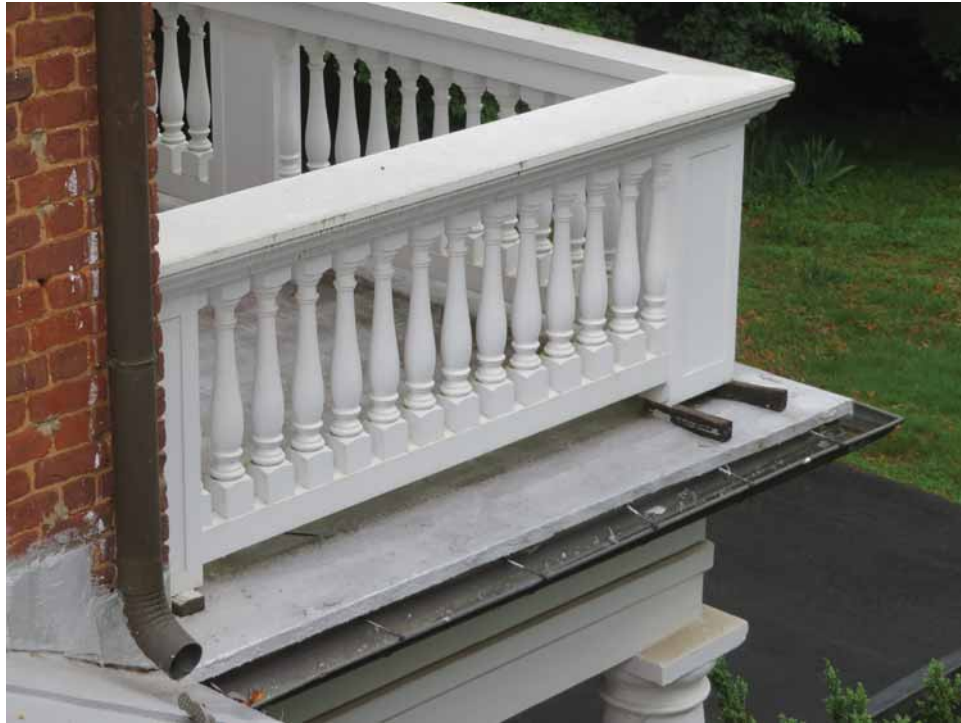
*Figure 261. (Above) The rooftop balustrade on the east entrance porch was constructed in 1997–1998. Because it lacks a drip edge, there is surface staining and some biological growth on the painted surfaces below the cap rail. The plinths rest on exposed pressure-treated blocking. JGWA, 2024.*

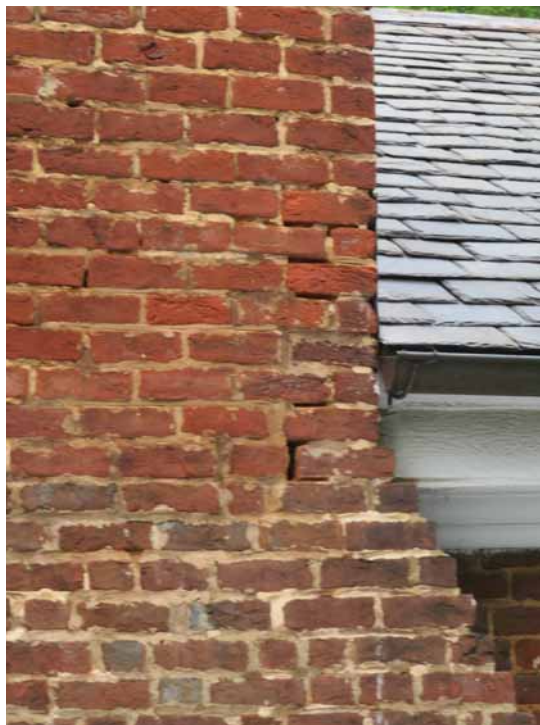
*Figure 262. (Left) Much of the pointing at Oak Lawn is in good sound condition, but there are areas of deteriorated mortar, such as at the chimneys, near grade level, and near gutter downspouts. Because of the size of the flues, the brick construction at the chimneys is only one wythe thick. As a result of this thinness, mortar failure in these areas is common. JGWA, 2024.*

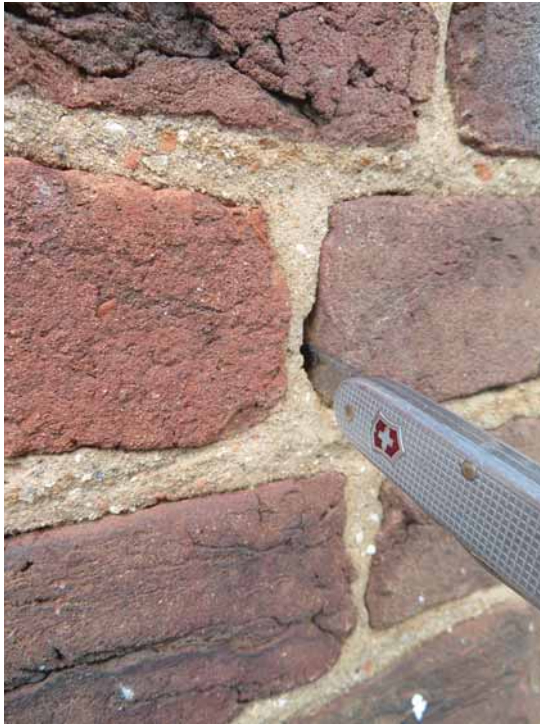
*Figure 263. (Left) Head joints, the vertical joints at the small ends of individual bricks, are often not filled as well as the bed joints below each brick during construction. When the surface joint in these locations fails, a void often exists behind the surface. JGWA, 2024.*

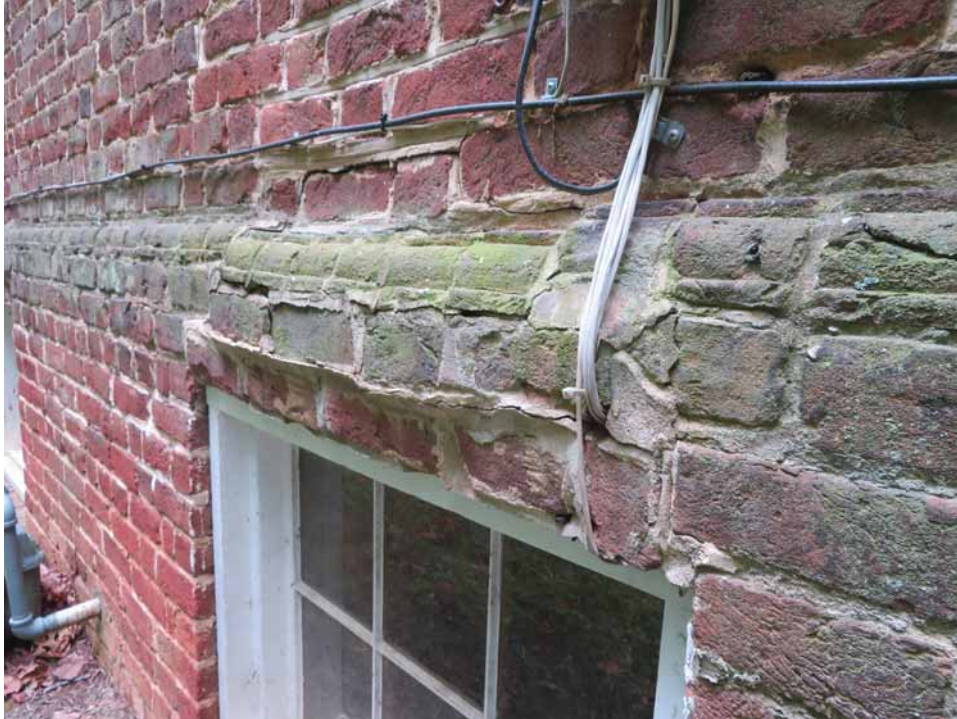
*Figure 264. (Below) In many instances, there is displacement of the bricks where the molded brick water table passes over the basement windows. This condition is most advanced at the westernmost window on the north side of the main block of the house. JGWA, 2024.*

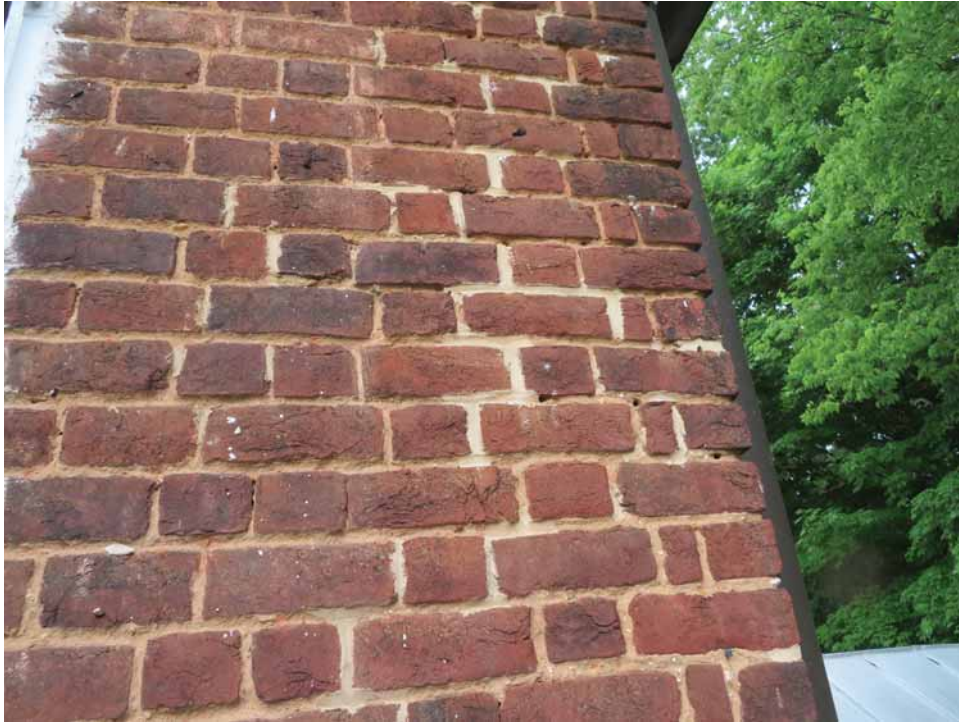
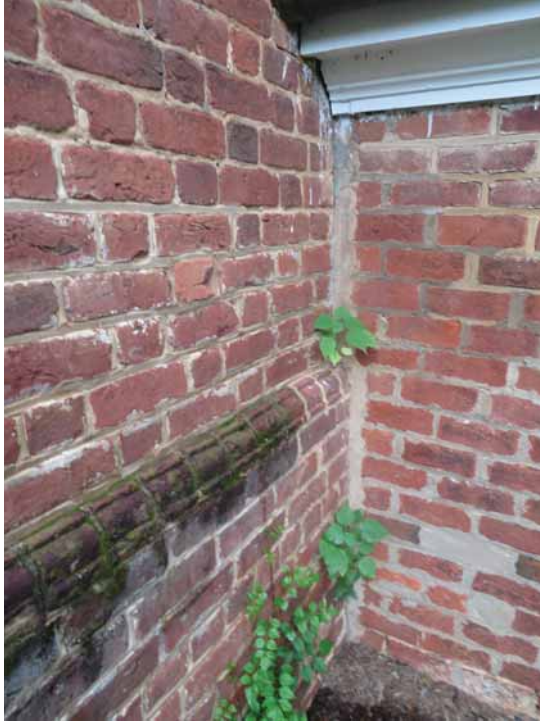
*Figure 265. (Above) While much of the original mortar remains intact, the softness of the lime mortar makes it both resilient and susceptible to isolated areas of failure. Many of these have been repointed with a mix of different mortars, but each area of new mortar stands out to some extent because of color, texture, or poor workmanship. JGWA, 2024.*

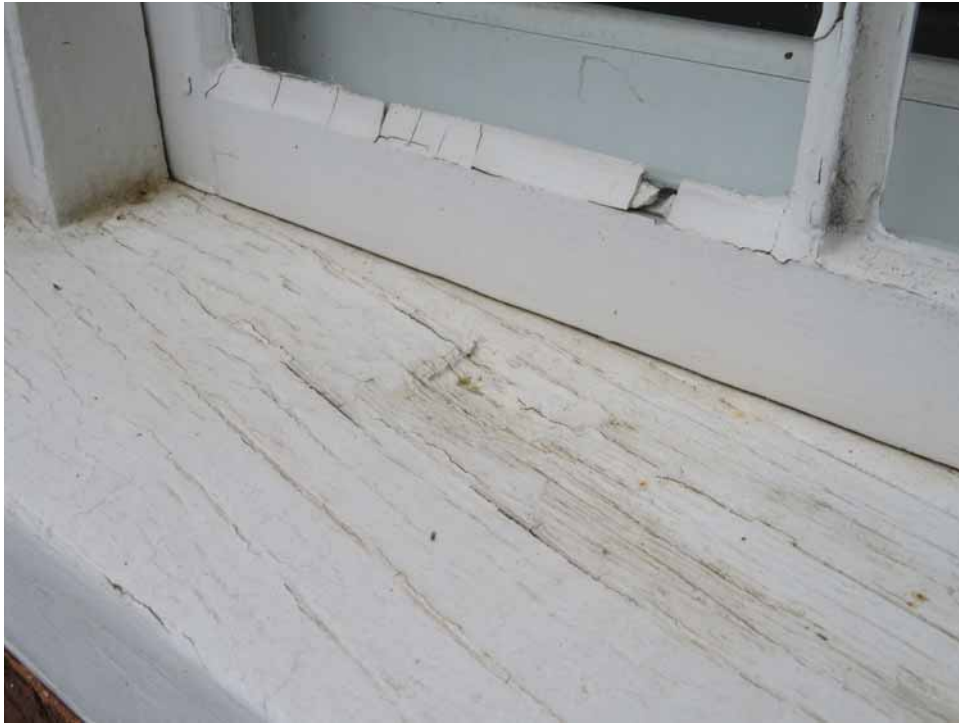
*Figure 267. (Above) Failing glazing compound surrounding individual panes of glass and checked wood and cracked paint at the sills are common problems at the original windows. These problem conditions are most advanced where regular and rapid cycles of heating and cooling take place. JGWA, 2024.*

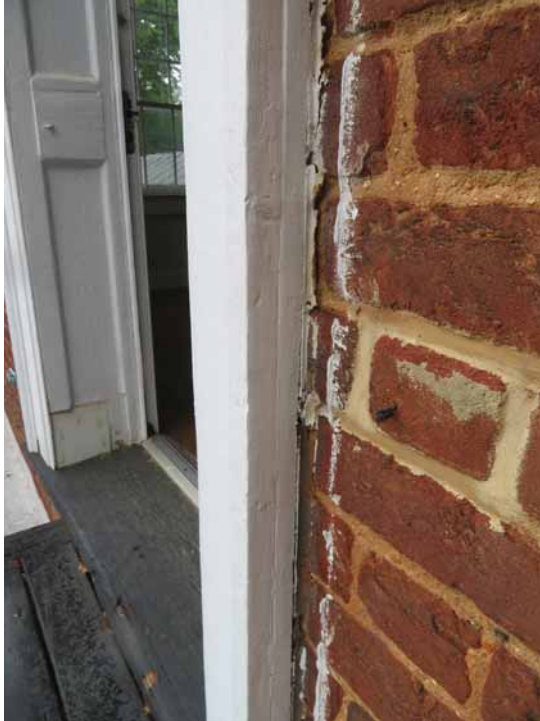
*Figure 268. (Left) Overpainting, where paint projects onto the face of the brickwork, is a common problem at the window and door openings at Oak Lawn. The wood trim elements at the east door on the second-floor level are damaged, missing, and raised out of position. JGWA, 2024.*

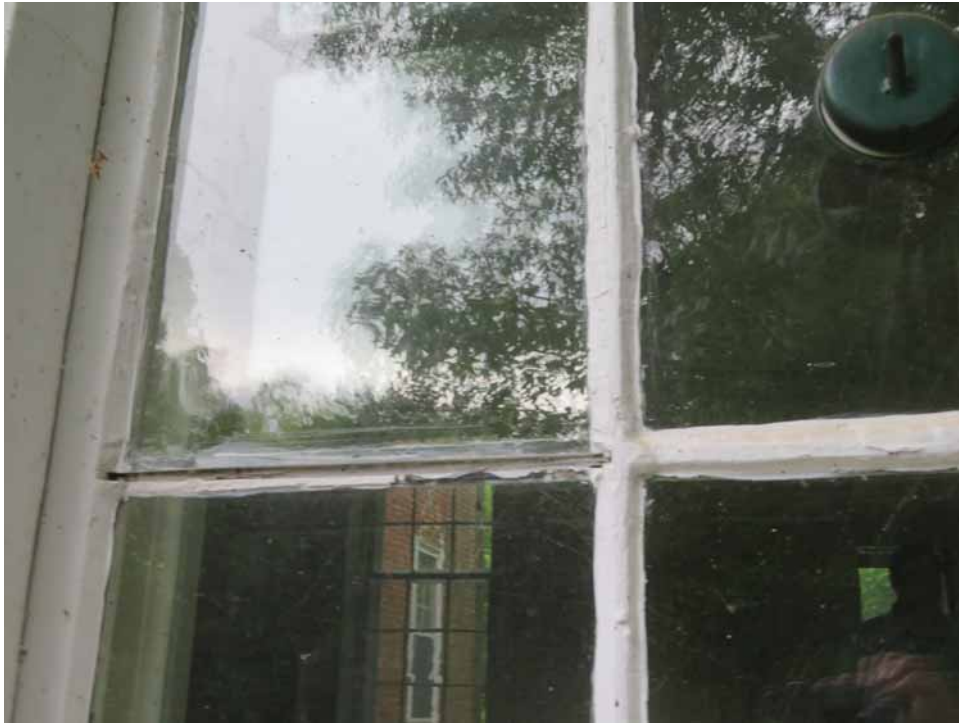
*Figure 269. (Above) The loss of the outer flange of the muntin at this window on the north side of the central block of the house leaves the glass poorly supported and the joint unsealed. JGWA, 2024.*

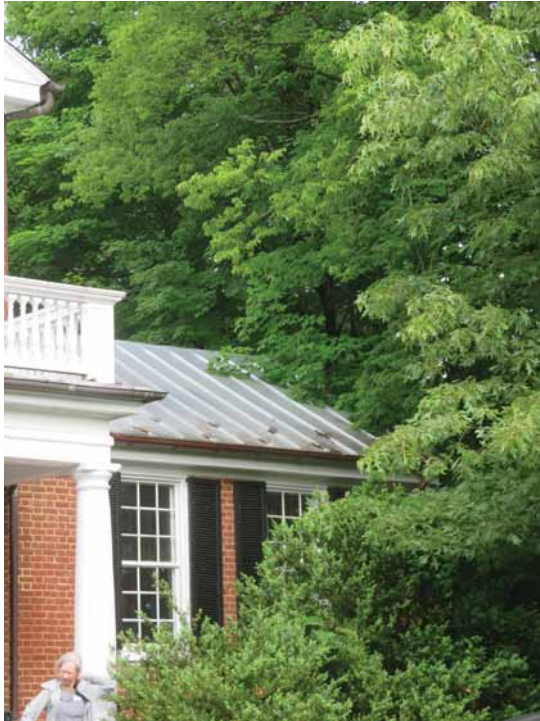
*Figure 270. (Left) The north end of the north wing is extremely overgrown, with tree branches coming in direct contact with the building in several locations. This is likely similar to the conditions that led to the replacement of this roof, while the corresponding roof on the south side of the building was still in sound condition. JGWA, 2024.*

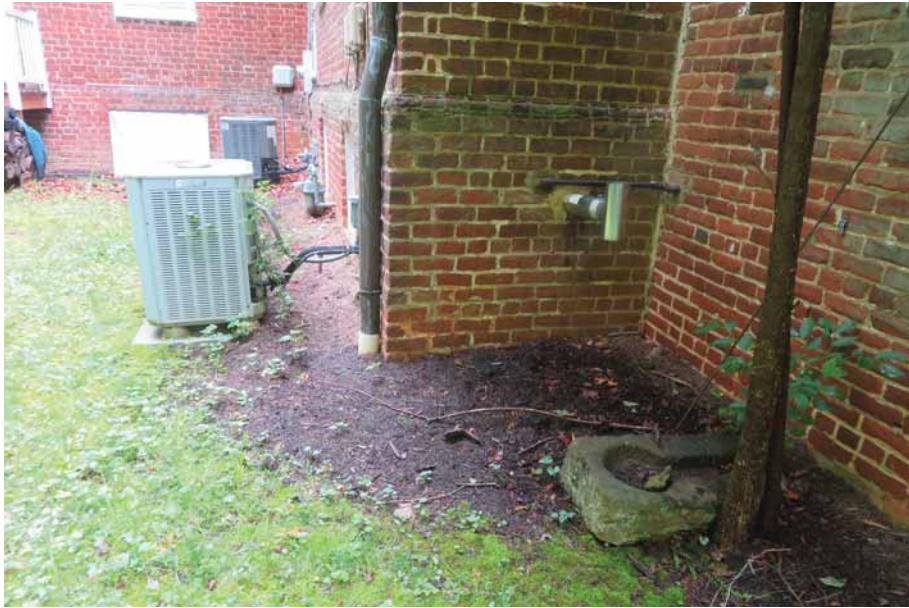
*Figure 271. The north side of the central block of the house is a repository for numerous pieces of mechanical, electrical, and telecommunications equipment. It is also the exit point for the direct vent of Oak Lawn's boiler. JGWA, 2024.*

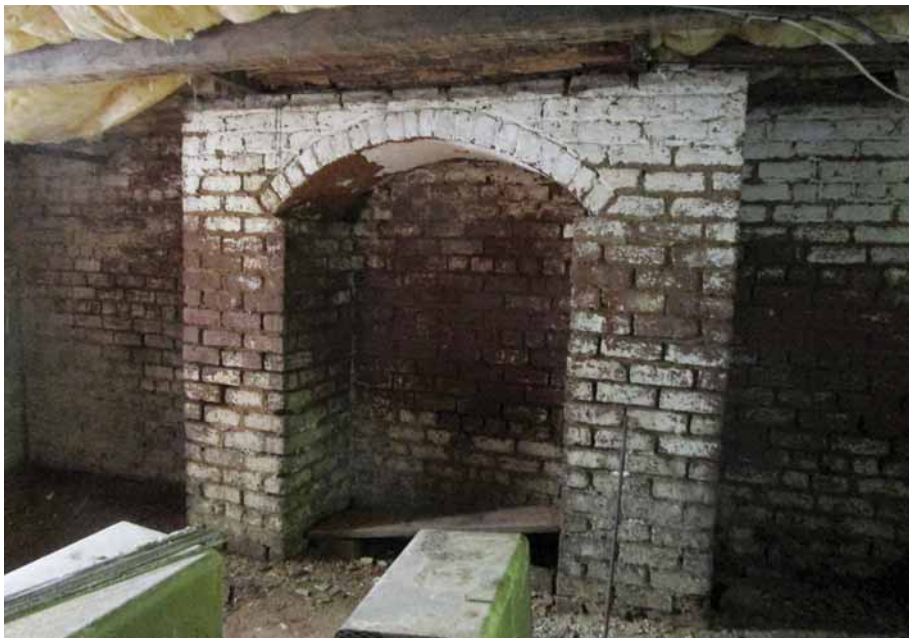
*Figure 272. Evidence of rising damp can be seen across the midsection of the hearth support in Room 002 where the limewash has fallen away from the deteriorated face of the brick. There are also deteriorated mortar joints in this section of the wall. JGWA, 2024.*

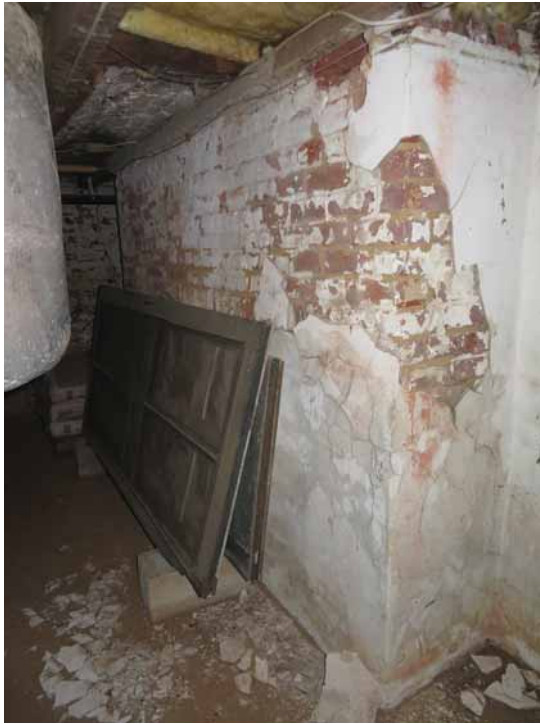
*Figure 273. (Left) The cementitious render that was applied to much of the brick wall surface in the south basement (001) has fallen away in sheets where it has trapped rising moisture. In these locations, the brick is more damaged than in areas where only limewash was applied to the brick surfaces. JGWA, 2024.*

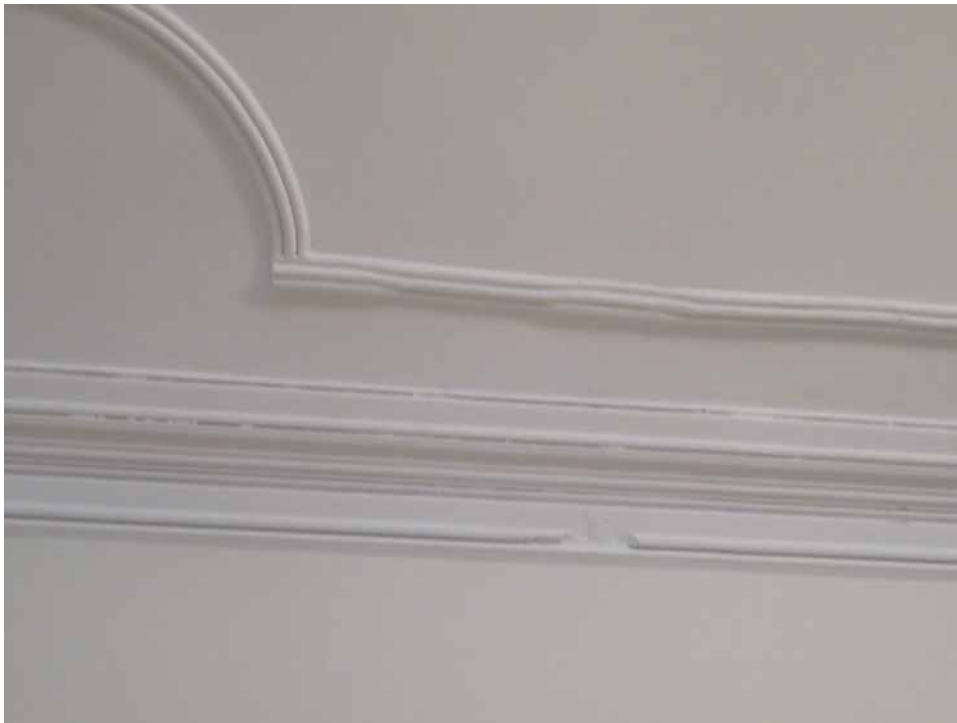
*Figure 274. (Below) The plaster ceiling in the entrance hall (101) has been renewed and repaired on numerous occasions. Buildup of paint coatings has obscured some of the details and shadow lines. In some areas cracking of the plaster has resulted from movement and uneven support. JGWA, 2024.*

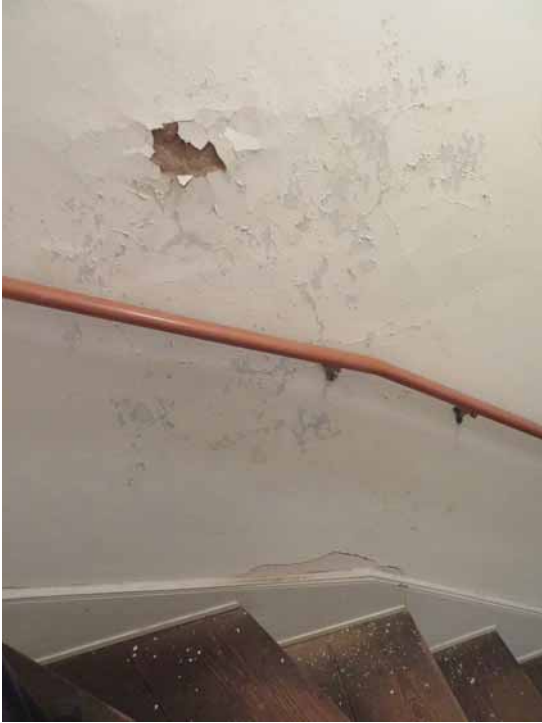
*Figure 275. The north wall of the north stair (C101) is in extremely deteriorated condition. This is the result of moisture ingress from the exterior where the north wing and main blocks of the building meet and roof water runs down the face of the exterior wall. JGWA, 2024.*

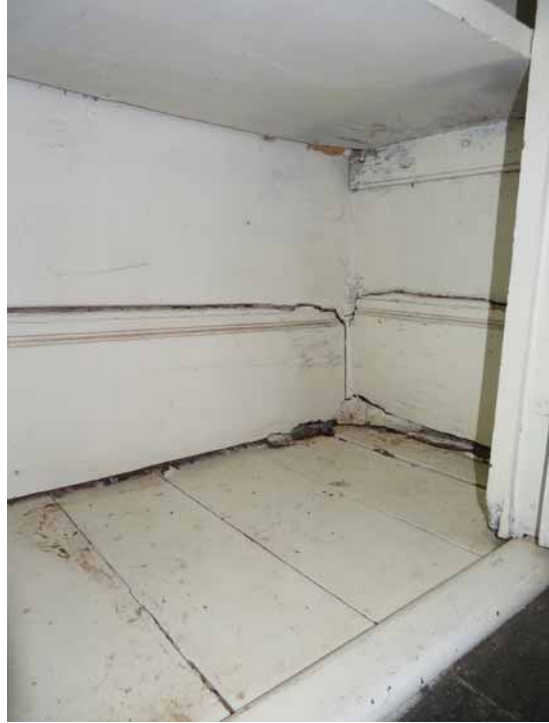
*Figure 276. The floorboards under the built-in cupboard in the northwest corner of the west room (105) have dropped out of position, as has the baseboard above. This condition is a result of moisture-based deterioration adjacent to a failed roof leader. JGWA, 2024.*

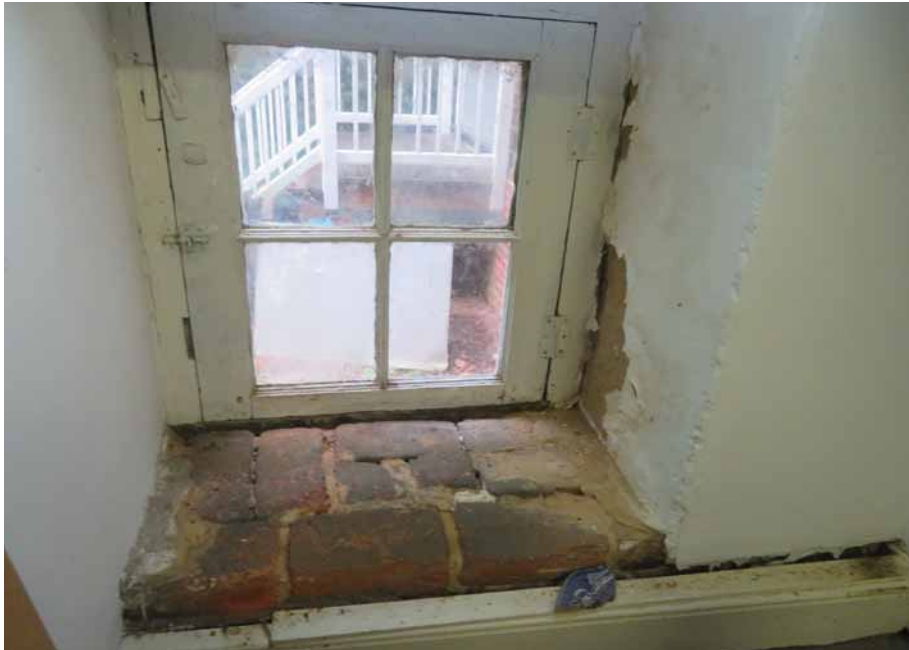
*Figure 277. The plaster failure on the east side of the small window in the storage room under the stairs (106) is the result of moisture ingress. In this location, overflow from the roof has caused an area of staining on the exterior face of the wall and related damage on the interior. JGWA, 2024.*

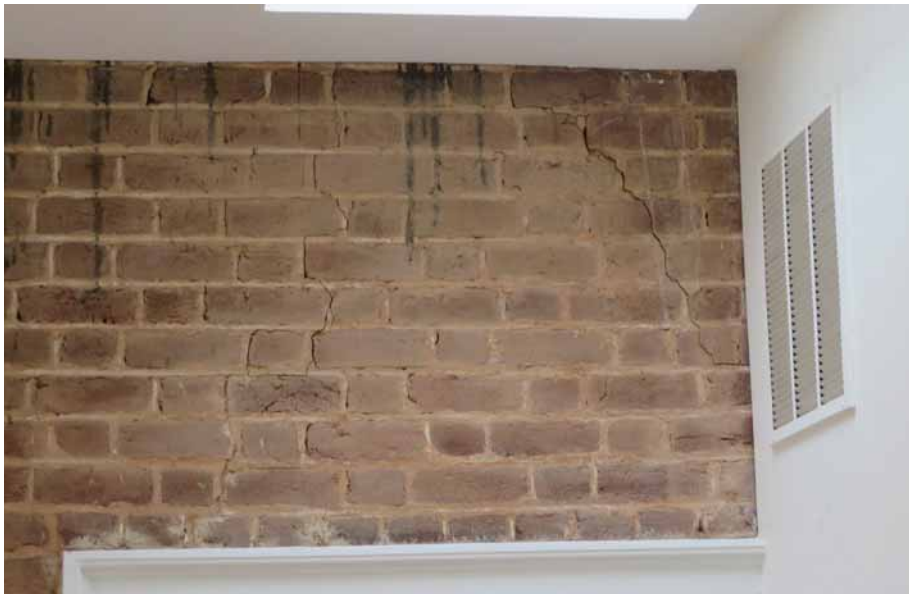
*Figure 278. Settlement cracks can be seen in the well-preserved exposed brickwork above two of the doorways in the southwest addition (109). In the image, one of the cracks is over the doorway to the west room (105). JGWA, 2024.*

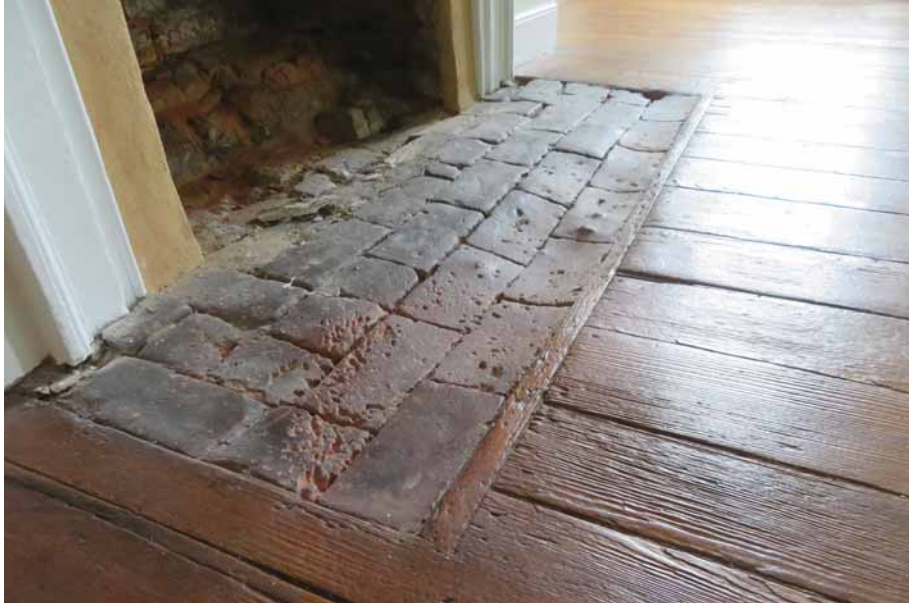
*Figure 279. The brick thresholds of each fireplace are worn and the mortar joints eroded, but in the east bedroom (201) this condition is particularly severe. The wood flooring adjacent to the hearths is often similarly worn. JGWA, 2024.*

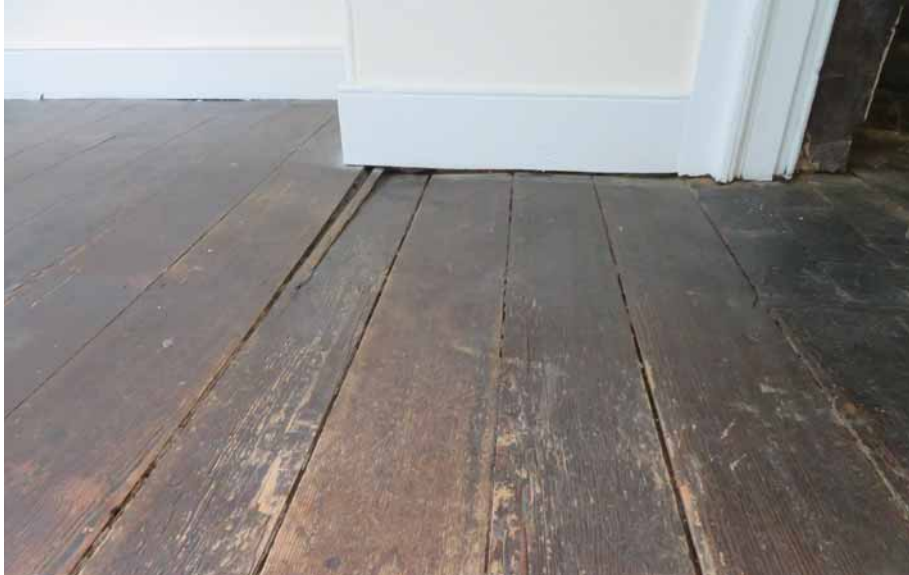
*Figure 280. The west end of the floor boards to the south of the fireplace in the west bedroom (205) have dropped out of position. This condition is likely the result of moisture-based deterioration where the roofs above the kitchen and the southwest addition merge. JGWA, 2024.*

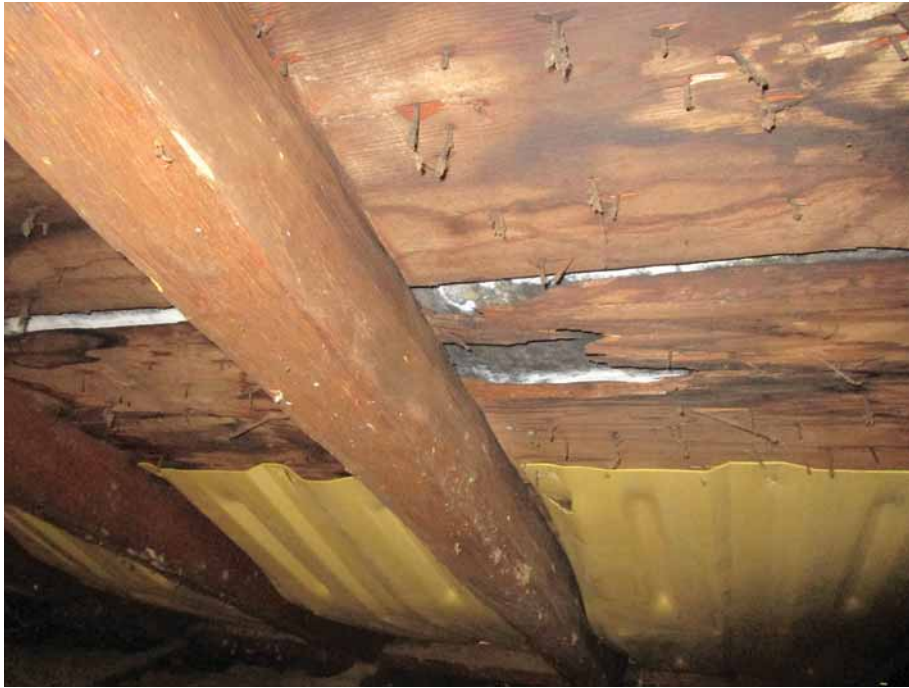
*Figure 281. Rotted roof sheathing was left in place in some locations when the roof of the north wing was replaced. In other areas extensive repairs to framing and decking were undertaken. JGWA, 2024.*

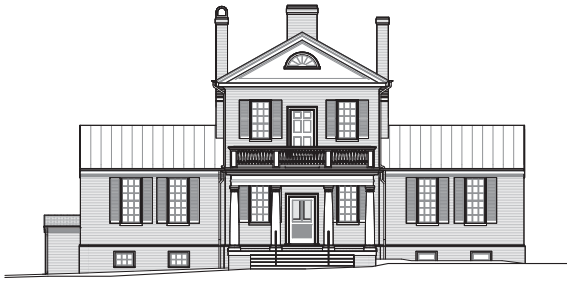
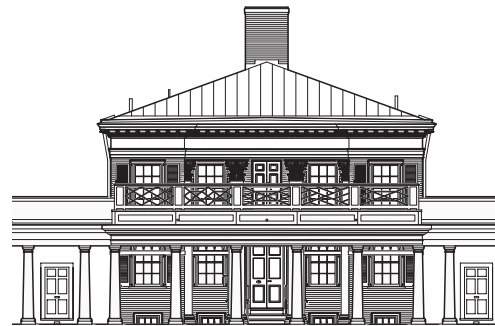
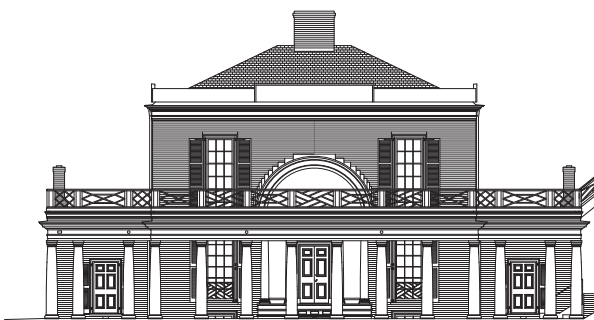
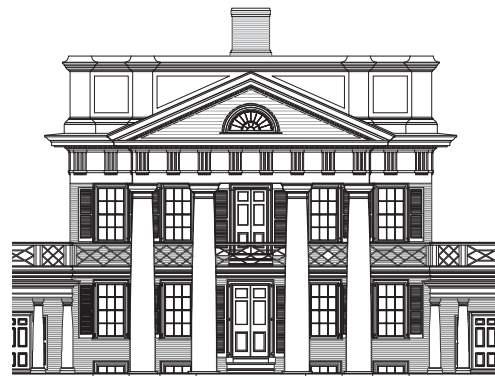
Figure 282. The front elevation of Oak Lawn and selected pavilions from the University of Virginia. Drawings taken from historic structure reports and the Historic American Building Survey.

time of Oak Lawn's construction or Bramham's business records from the period have not yet been found to establish a definitive connection between Dinsmore and Bramham or Oak Lawn, there is considerable physical evidence of similarities in the design and construction of Oak Lawn and the University of Virginia buildings. Similarities in exterior character, design, style, and material to the Pavilions and Hotels at the University of Virginia (Figure 282 and Figure 283) are as follows:
