# OAK LAWN

HISTORIC STRUCTURE REPORT &  
CULTURAL LANDSCAPE REPORT

JOHN G. WAITE ASSOCIATES, ARCHITECTS  
LIZ SARGENT HISTORIC LANDSCAPE ARCHITECTURE  
2025

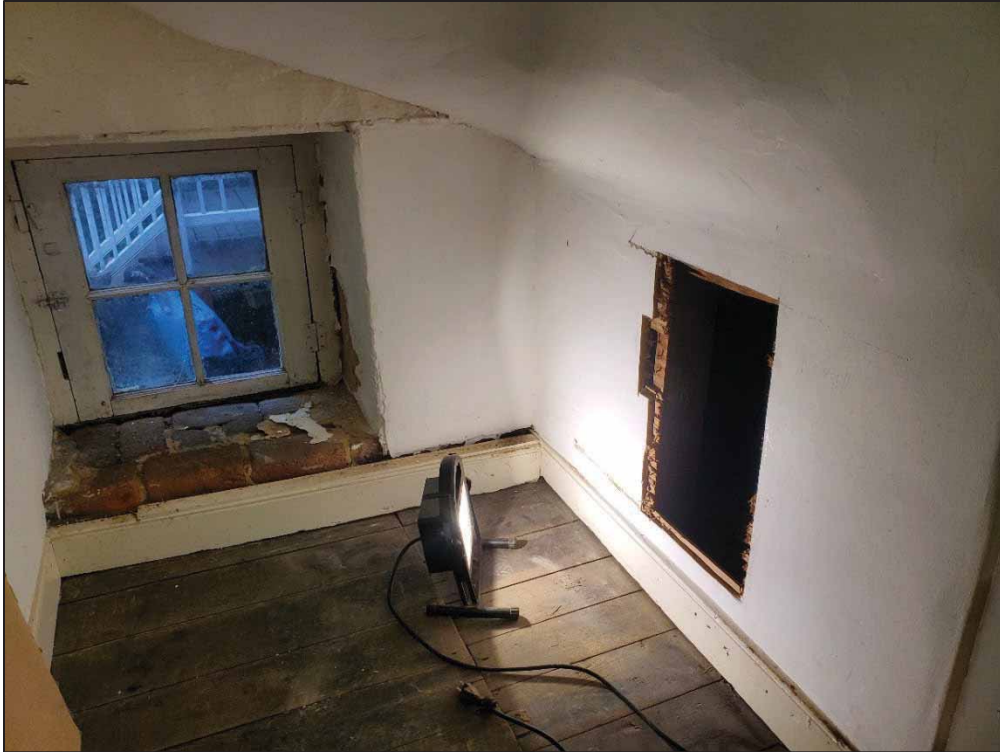
Figure 2: First floor, Oak Lawn, showing northern stairwell and probe cut into formerly sealed space.

On June 18, 2024, Rivanna Archaeological Services, LLC staff collected the materials within the first floor northern and southern stairwell spaces. Debris and material culture was collected manually with short shovels, and dustpan and trowel. Materials were placed in plastic buckets and boxes and brought back to Rivanna Archaeological Services, LLC offices for screening and processing. Screening of all collected sediment took place outdoors. Sediment was screened through 1/4-inch wire mesh to ensure consistent recovery. Material culture collected was bagged by provenience (e.g. northern stairwell vs. southern stairwell) (Figures 2 through 6).

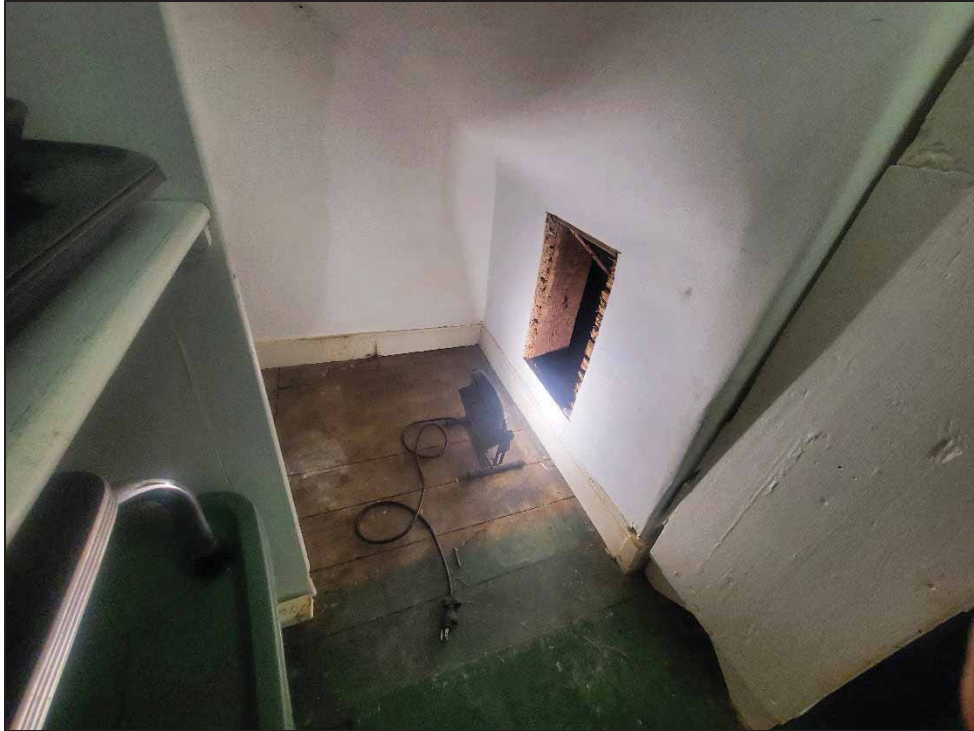
Figure 4: First floor, Oak Lawn, showing southern stairwell and probe cut into formerly sealed space.

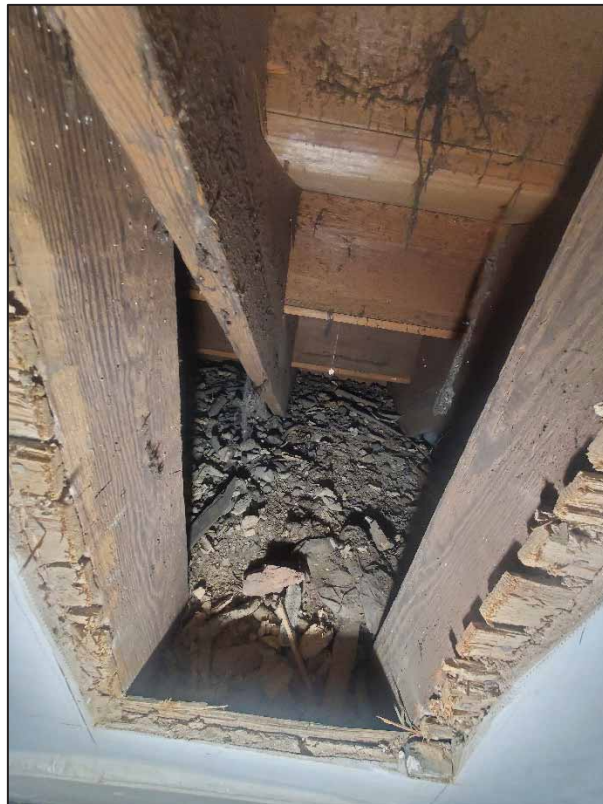
Figure 5: Interior of southern stairwell showing sediment and debris on floor.

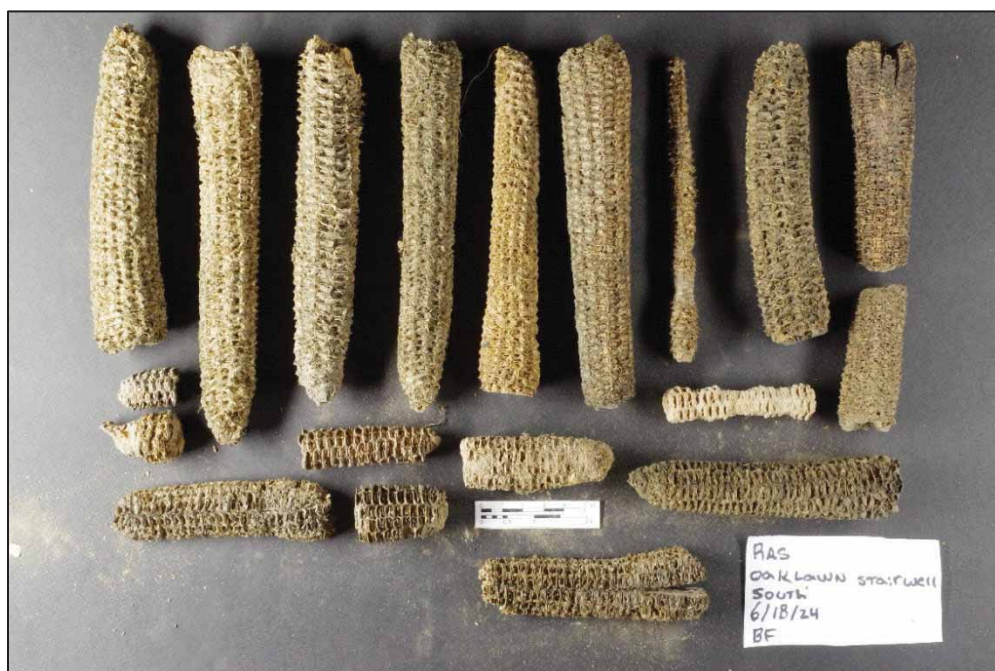
**Figure 7: Corn cobs recovered from the south stairwell.**

The most prolific category of item recovered from both stairwell spaces were organic materials such as fruit pits, nuts, nut shells, corn cobs, and animal bone. These items would all likely have been food items that were found both in the Oak Lawn residence and its adjacent grounds and brought back to the nest for consumption. The array of food items is remarkable and to a great degree reflects what would have been available to rats. The acorns, walnuts, and other mast items would clearly have been foraged from the adjacent land surrounding Oak Lawn. The sheer quantity of peach pits, certainly fruit gathered from the Oak Lawn vicinity, speaks to the presence of a modest-sized orchard likely in some proximity to the primary residence. Corn cobs too, document the presence of agricultural fields just beyond the domestic core, and possibly the presence of a nearby purposefully built granary or a structure which had a secondary purpose of storing grain. Several of the corn cobs showed evidence of rodent gnawing. Pistachio shells, however, likely speak to foraging from within the Oak Lawn residence. Not grown regionally, historically pistachios would likely have been imported into the United States,<sup>3</sup> purchased locally, and stored within the Oak Lawn residence (Figures 7 through 10).

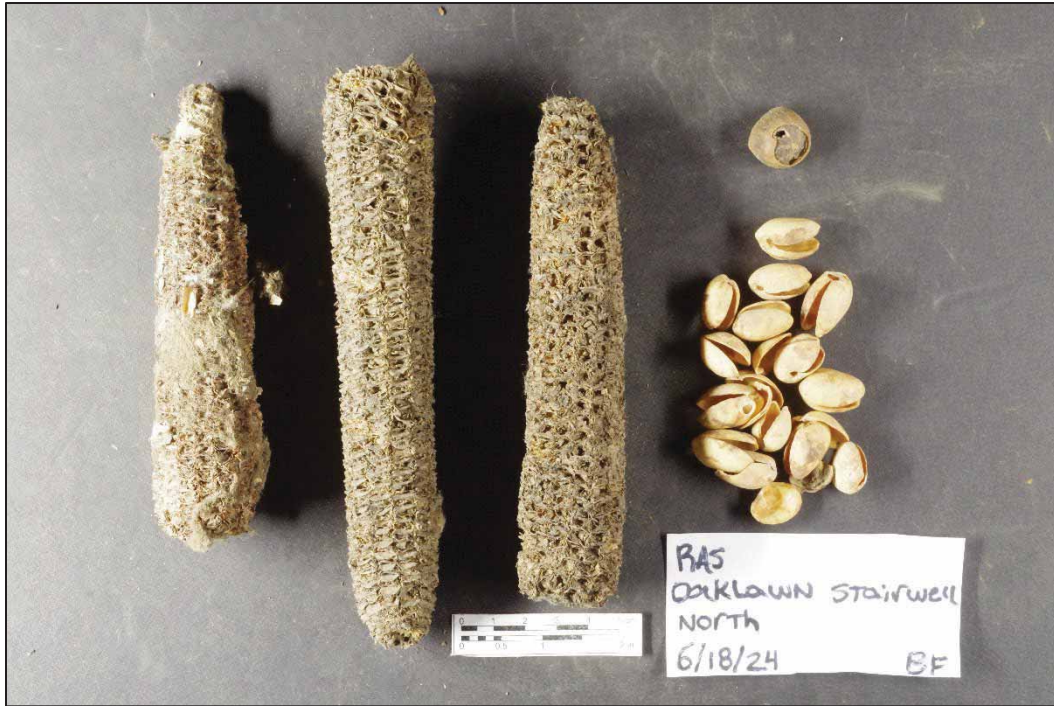
Figure 8: Corn cobs, acorn, and pistachio nuts recovered from the north stairwell.

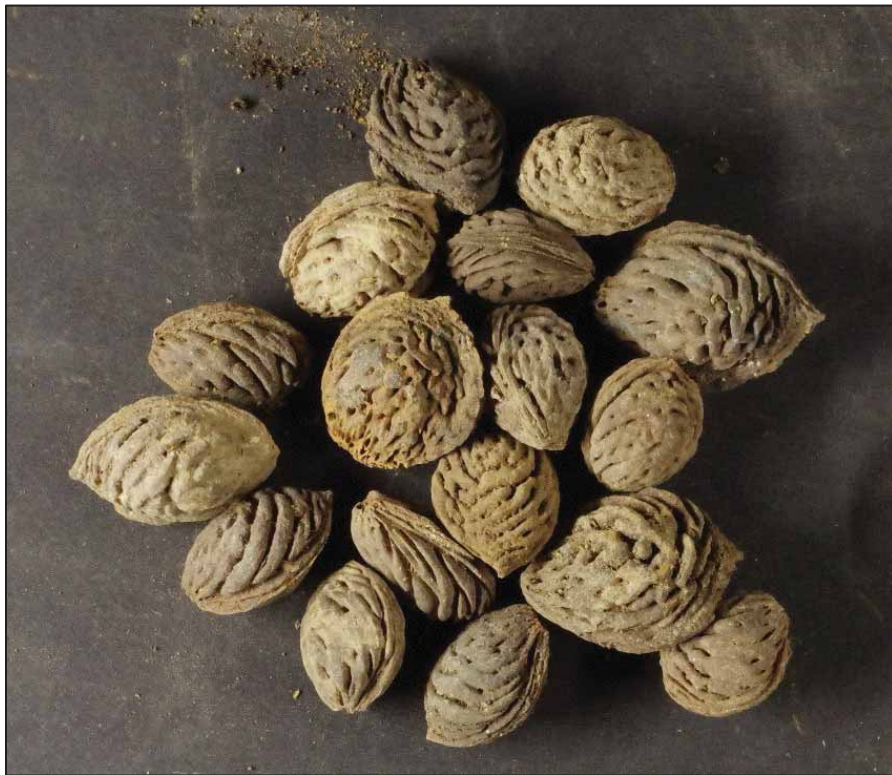
Figure 9: A sample of peach pits recovered from the stairwell spaces.

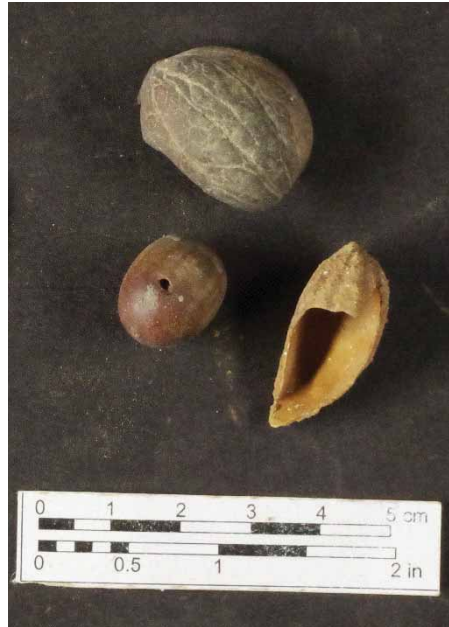
Figure 10: A sample of nuts recovered from the stairwell spaces.

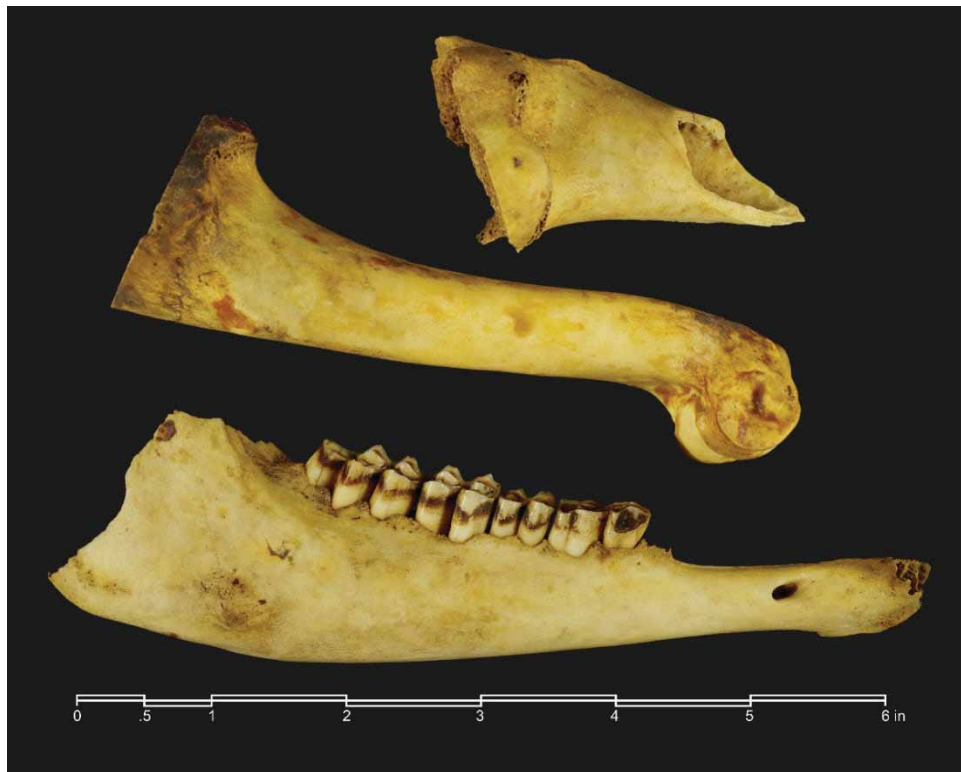
Figure 11: Butchered animal bone showing a medium mammal humerus (top), a sheep/goat humerus (middle), and a sheep/goat mandible (bottom) recovered from the south stairwell space at Oak Lawn.

In the case of animal bone, the samples recovered from the stairwell spaces were nearly exclusively medium to large mammals. For those animal bones that could be identified as to species, limited quantities of pig and sheep/goat bone were recovered. A single small rodent skeleton, mostly articulated, was also recovered from the south stairwell space. Most of the medium to large mammal bone recovered from the rat nests likely represent salvaging from an exterior refuse pile. Several of the animal bone exhibited sawn ends documenting that it had been butchered and likely disposed of following consumption. While much of the bone could have contained residual meat, a large majority of the bone also exhibited rodent gnawing, possible the result of rats needing to wear down their teeth (Figures 11 and 12).

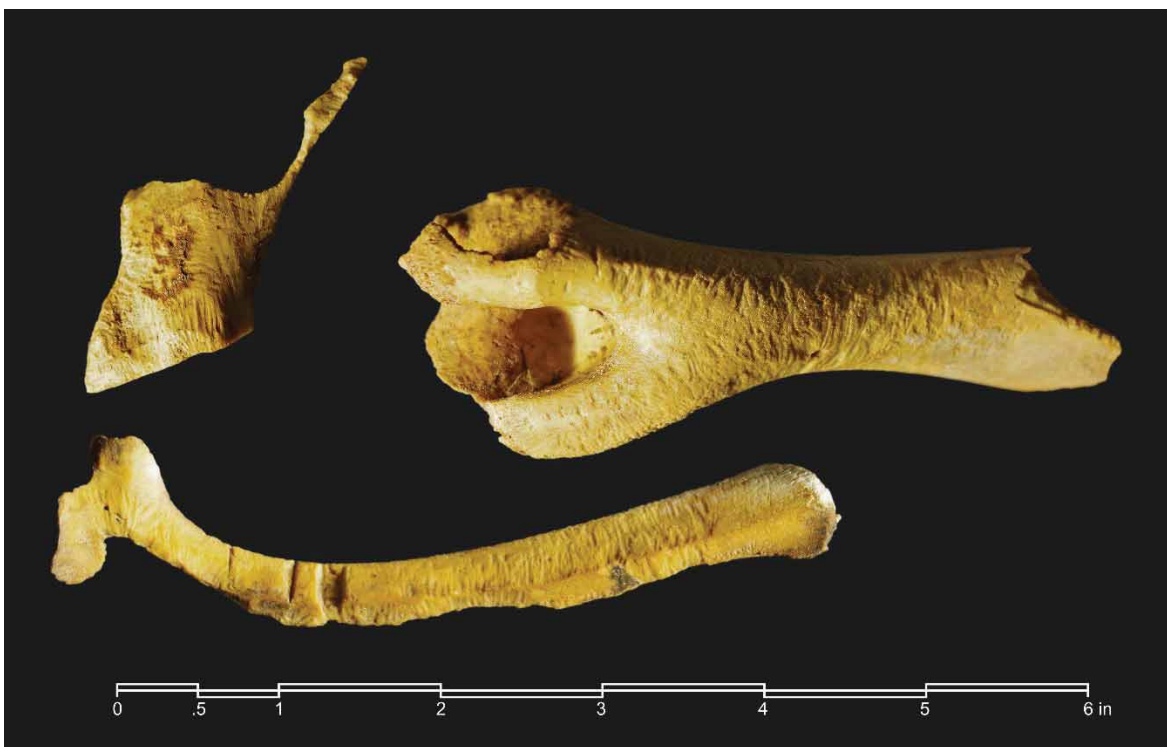
**Figure 12: Animal bone recovered from the Oak Lawn stairwell spaces. Note the significant rodent gnawing scars on each bone.**

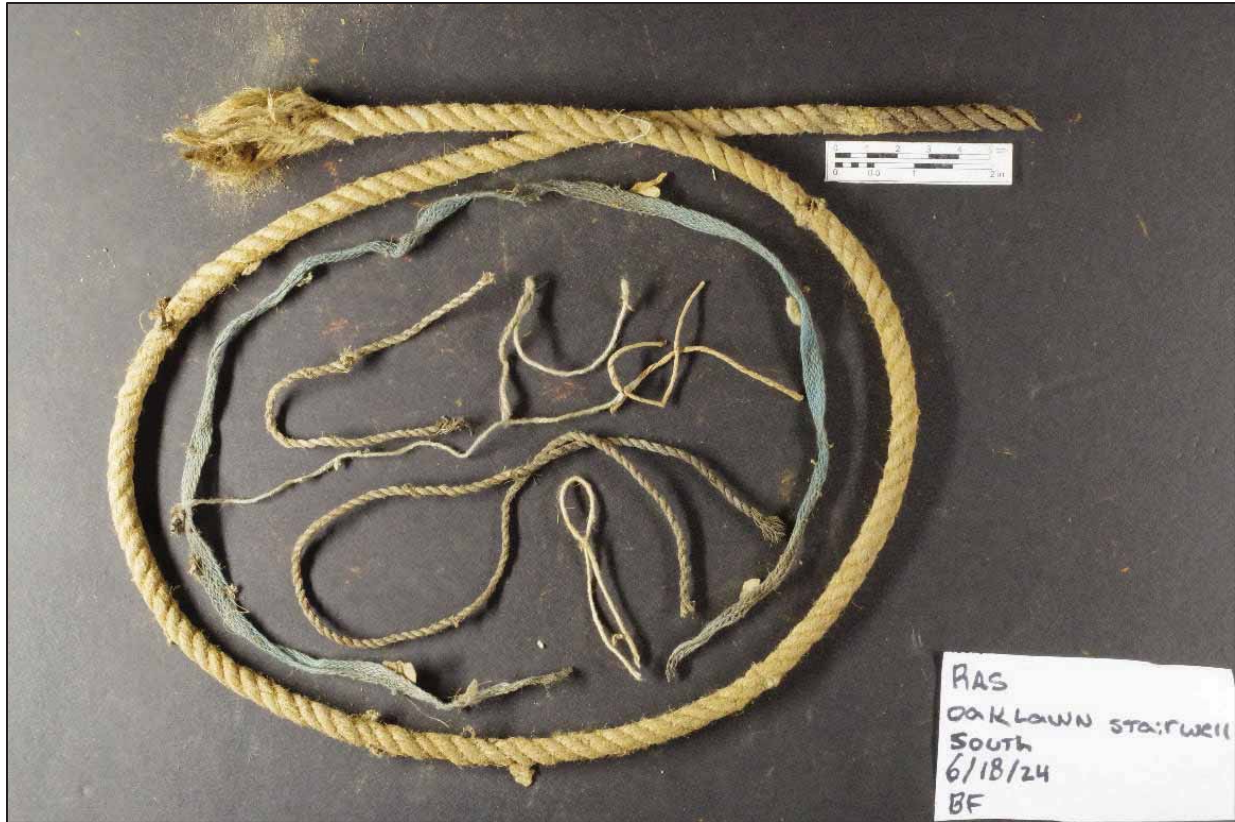
Figure 13: Rope and string recovered from the south stairwell space.

Soft items likely used for nesting such as cloth, newspaper, string, and other paper-based items were also recovered. Rope and string of all different diameters and lengths were found in the stairwell spaces. Cloth too, mostly crumpled into wads, was recovered both stairwell spaces. A remnant red woven cloth bag, with a black printed label noting its contents, ‘Landreth’s Xtra Early Peas,’ a product that was introduced by the company in 1822. The bag and its peas were likely produced in the ca. post-1886 period as a copyright date of 1886 appears on the bag.<sup>4</sup> Less preserved were fragile, small pieces of newspaper and other paper products. One piece of newspaper noted that J. A. Broadus was selected to give the introductory sermon in a gathering in Savannah. J. A. Broadus was John Albert Broadus (b. 1827 – d. 1895), a Baptist minister and President of the Southern Baptist Theological Seminary. Broadus attended the University of Virginia and became pastor of the Baptist Church in Charlottesville. The newspaper would have to have been published sometime in the second half of the nineteenth century and before Broadus’ 1895 death. The recovery of three cardboard dairy milk bottle plugs or caps, items that were not produced until 1889 at the earliest and became relatively widespread by the turn of the century, document that rats were present in these spaces in the early twentieth century (Figures 13 through 18).

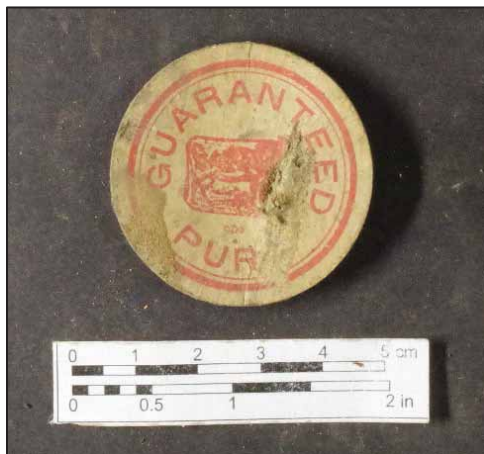
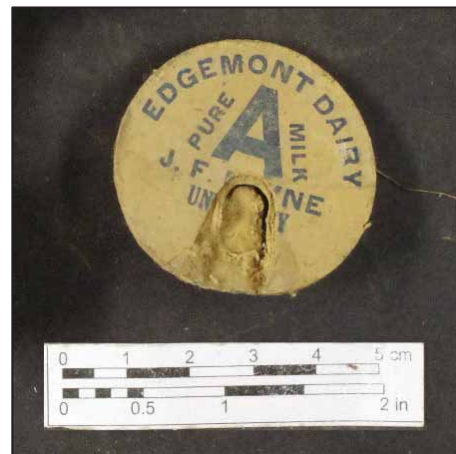
Figures 17 and 18: Cardboard dairy milk bottle caps recovered from the south stairwell.

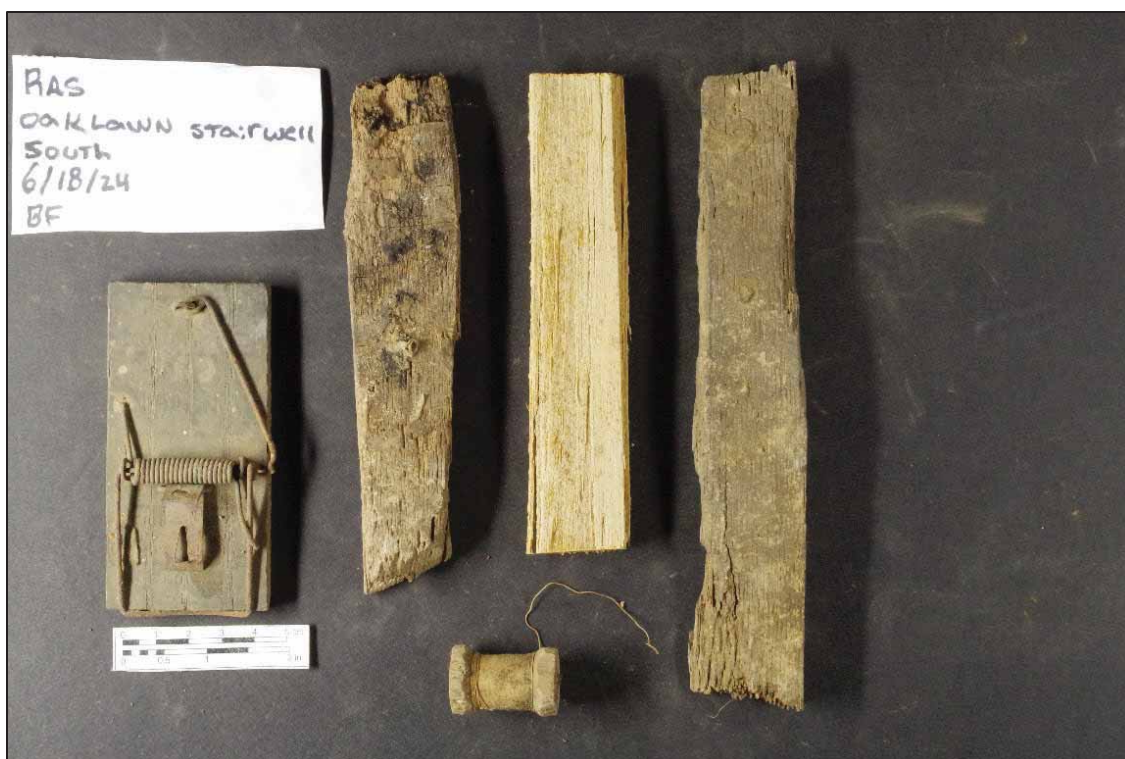
Figure 19: Wood lathing, a mouse trap, and a wooden spool recovered from the south stairwell.

Softer organic items that were not food included wood and architectural composites such as render and plaster. Much of the wood recovered from both stairwell spaces was lathing. Combined with the remnant render tabs, the lathing pieces may not represent items collected by rats but could have come from a construction episode, or perhaps during a remodeling. However, even though not collected, lathing may have been utilized by rats for gnawing. Other items, such as a wooden spool and soft wood mouse trap, were likely collected by a rat (Figures 19 and 20).

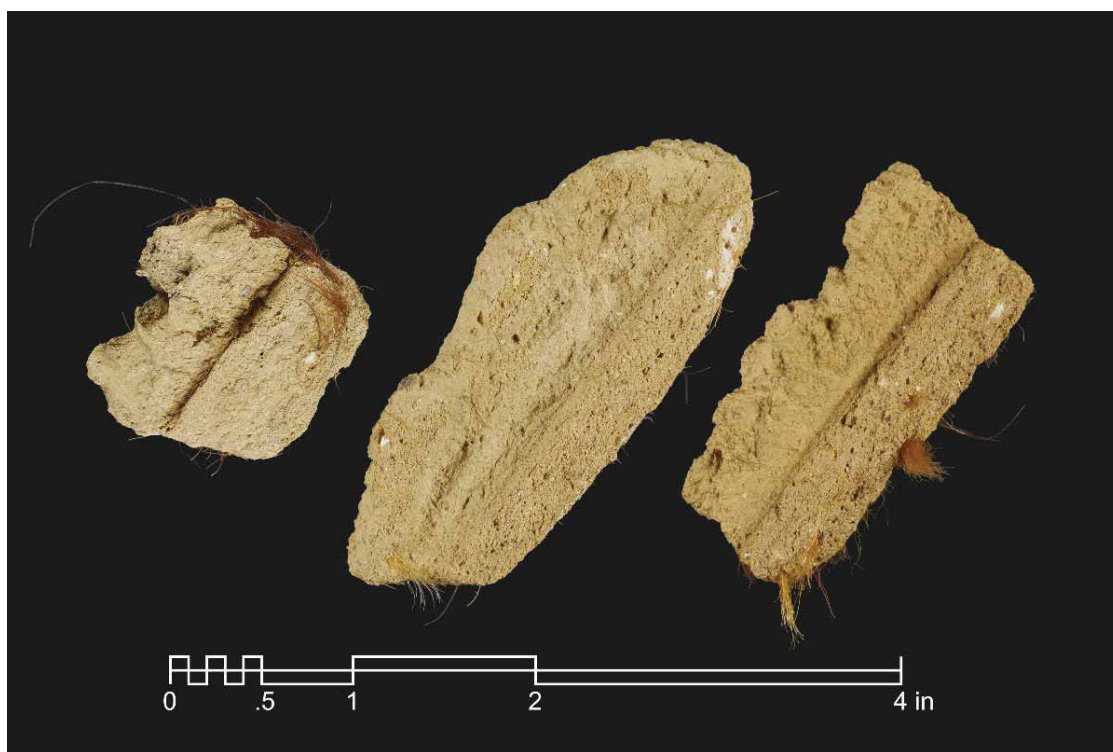
Figure 20: Lathing render tabs showing detail of hair amendments.

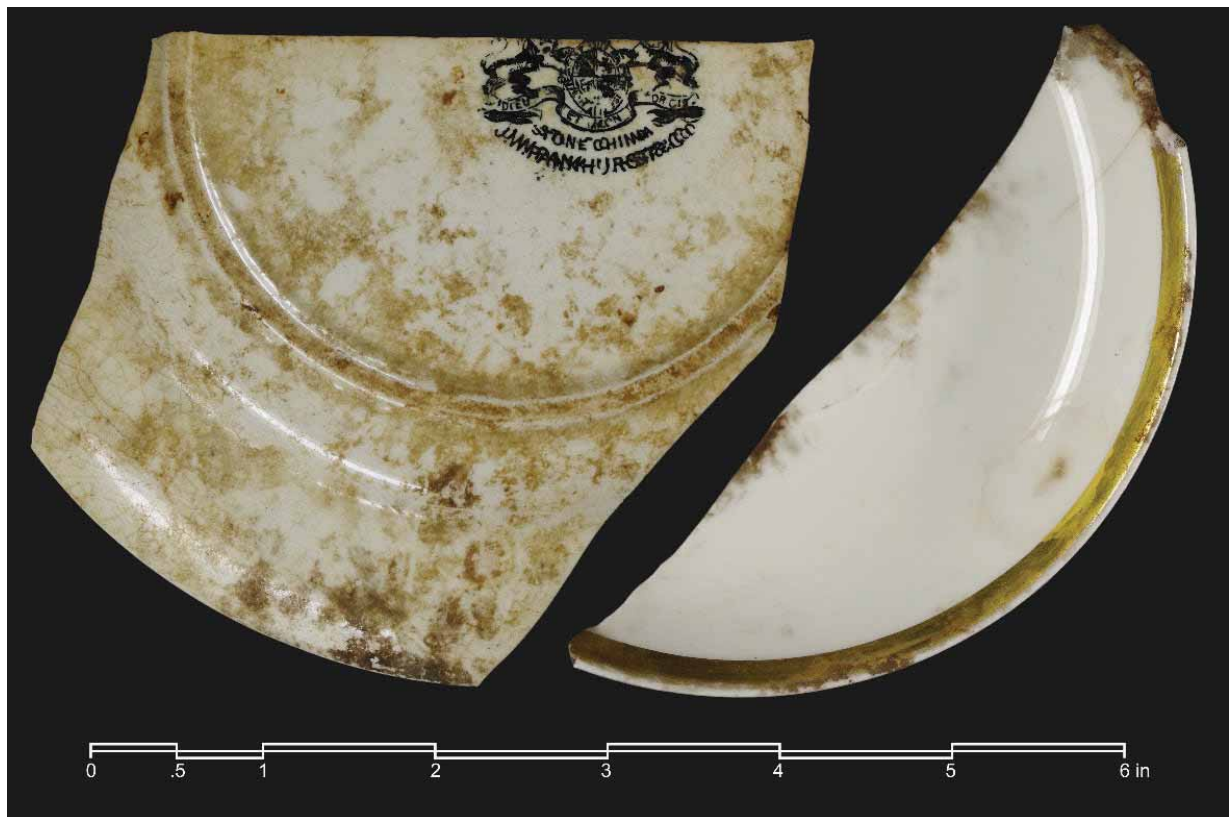
Figure 21: Ironstone ceramic plate (left) and European hardpaste porcelain ceramic (right) recovered from the south stairwell space.

Objects that possessed no obvious use to rats, such as ceramic, glass and metal were also recovered from both stairwell spaces. Ceramics recovered from the stairwell spaces were limited in number but included both ironstone (n = 5), a refined earthenware produced from 1840 onwards, and European hardpaste porcelain (n = 1), also commonly available on the American market from the mid-nineteenth century onwards. Glassware was more numerous and included fragments of bottles, jars, tableware, and lighting. Of note, a complete small pharmaceutical bottle manufactured for the Charlottesville-based pharmacy of 'F. M. Wills' (1850 – 1912), portions of a clear press-molded, ribbed, hurricane lamp shade, and a paneled tumbler and larger paneled drinking glass were recovered. Because they have no overtly functional value to rats (e.g. food, gnawing, nesting), it is not yet clear why these hard objects appear in the rat nests. However similar ceramic, glass and metal objects have also been found in other rat nests in historic homes (Figures 21 through 25).<sup>5</sup>

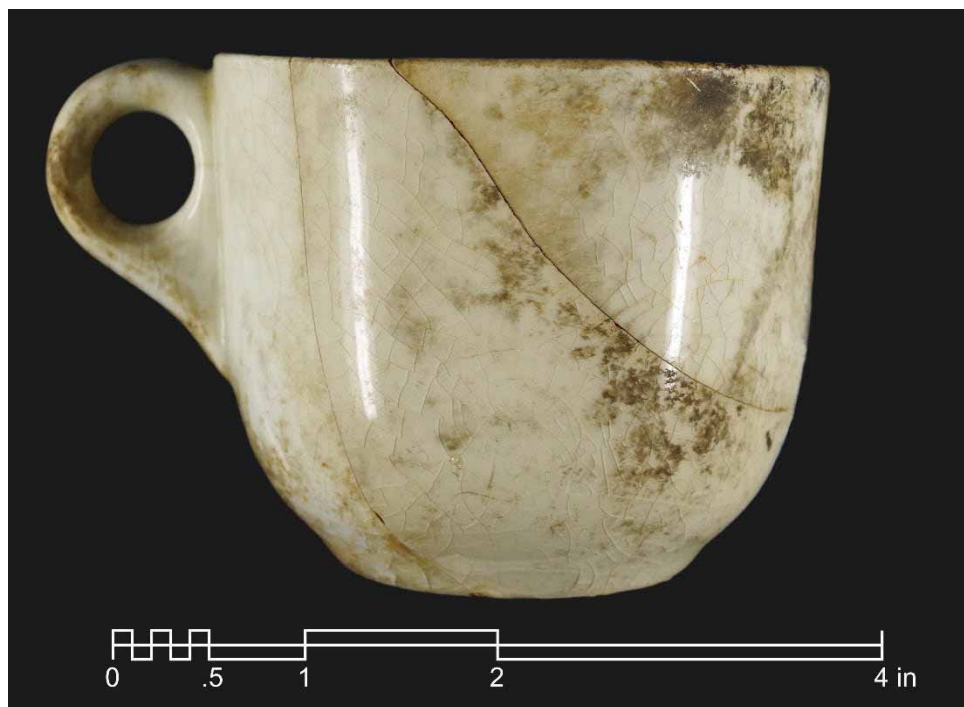
Figure 22: Ironstone ceramic cup recovered from the south stairwell space.

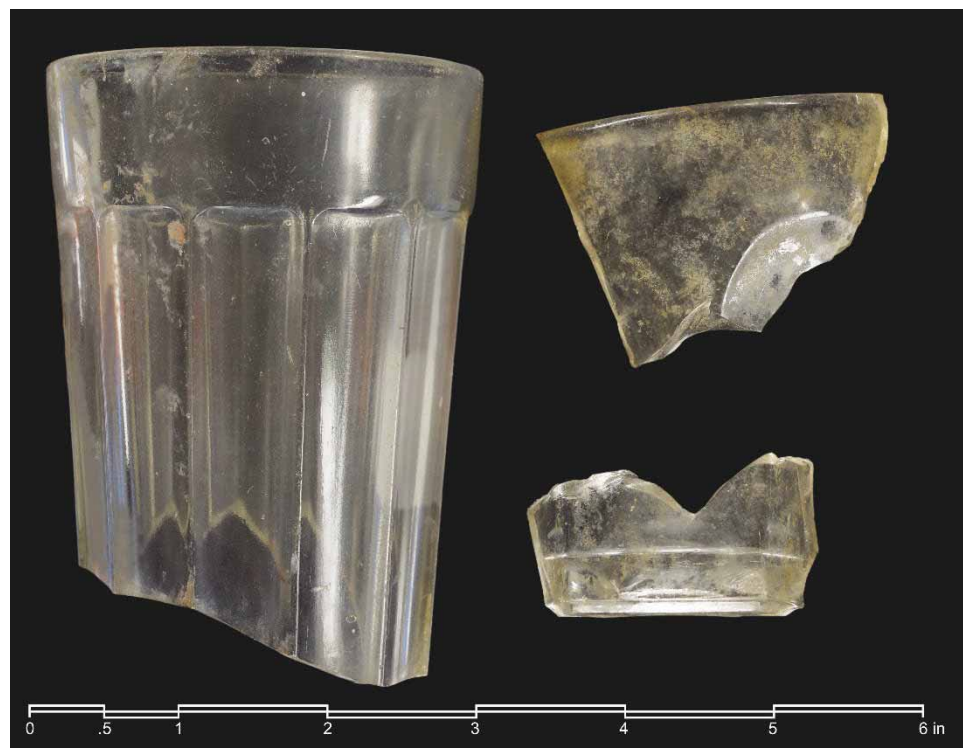
Figure 23: Tableware glass recovered from the south stairwell space.

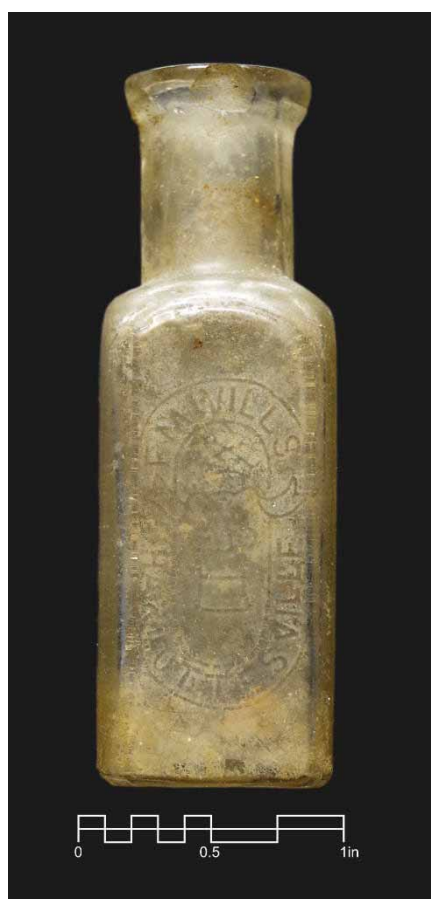
Figure 25: Embossed pharmaceutical bottle produced for F. M. Wills, a local pharmacy, recovered from the south stairwell space.

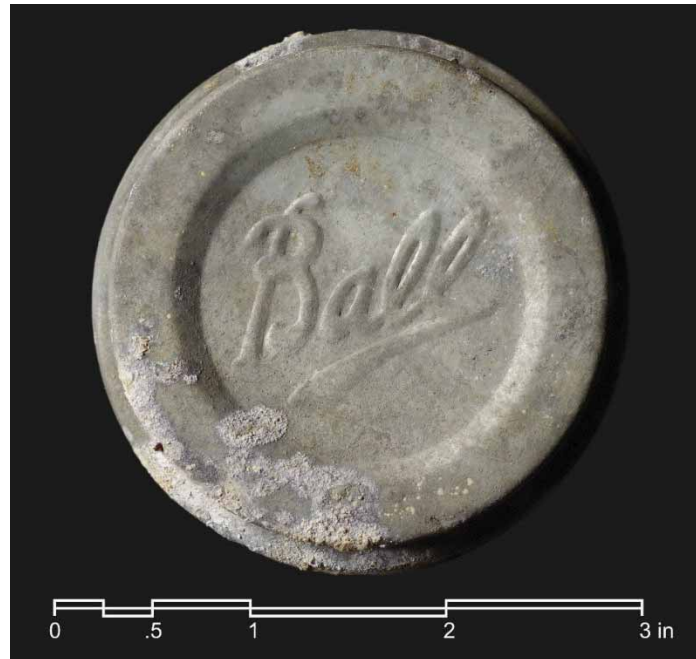
Figure 26: Zinc, stamped Ball screw top lid to canning jar recovered from south stairwell space.

A limited number of metal objects, predominantly light in weight, were also recovered from the stairwell spaces. These metal objects included screw caps, crown bottle caps (1892+), and zinc canning jar lids (1858+) and their porcelain lid liners (1870s+), and most of a second quarter of the twentieth century Maxwell House 'vita fresh' coffee can (Figures 26 through 29).

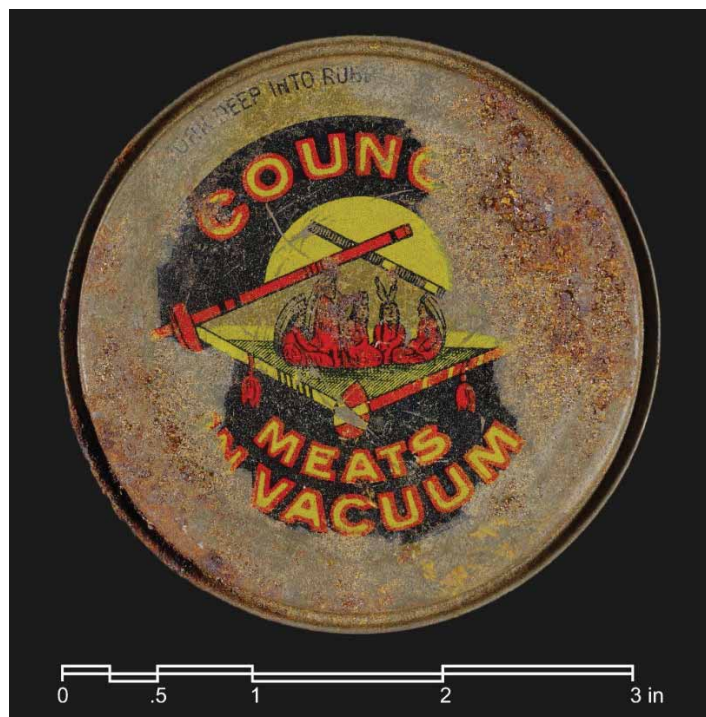
Figure 27: Stamped metal cap to jar, ca. 1919-1921, recovered from the south stairwell space.

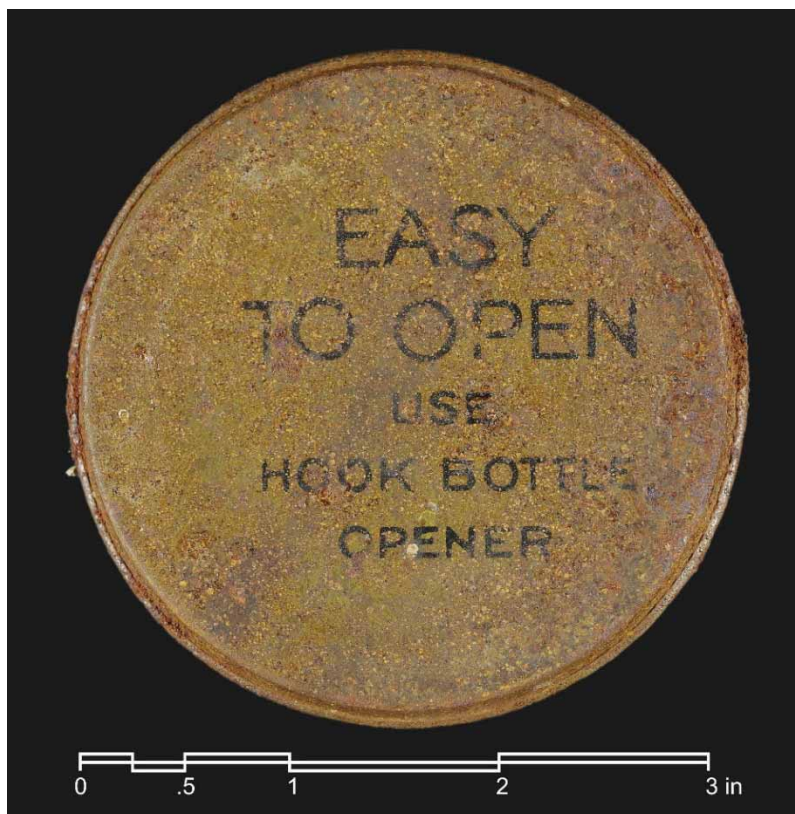
Figure 28: Stamped metal cap to jar, ca. late nineteenth century, recovered from south stairwell space.
