THE ROTUNDA

APPENDIX D

# UNIVERSITY OF VIRGINIA ROTUNDA

## MEP/FP FINDINGS & RECOMMENDATIONS Feb 12<sup>th</sup> 2007

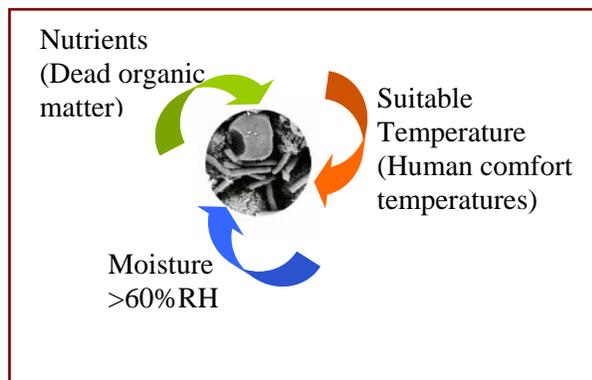
Mold growth generally results from a combination of mold spores, food sources in the form of organics and dust, temperatures between 65°F and 90°F, and relative humidity above 65%. Since mold spores, favourable temperatures, and food sources exist in most buildings, controlling relative humidity is the only means available to avoid microbial growth problems. The potential factors contributing to mold problems are outlined below:

- The air-handling unit, AC#1, serving the Dome Room has a chilled-water cooling coil for dehumidification and cooling. It is likely that the chilled water supply temperature during moderate outdoor conditions is not low enough to provide adequate dehumidification. Relative humidity levels in the Dome Room (301) may exceed 60%~70% for extended periods.
- Mold spores are in relative abundance during mild seasons.
- Any source of water leakage and infiltration of moisture must be investigated.
- Abundant vegetation on the campus provides the necessary mold spores. This combined with relatively high humidity levels can result in microbial growth problems.

- It is also likely that the current air distribution is suspect. The cold air supply at the dome perimeter mixes with the rising warm and humid air in the upper gallery zone leading to surface condensation on railing surfaces. This promotes conditions conducive to microbial growth. This may be checked by measuring the temperature and humidity profile three feet on either side of the upper gallery railing.
- Infiltration of untreated air due to the buoyancy effect inherent in the Rotunda's design must also be investigated. Untreated air with high moisture content will raise the relative humidity in the space. When untreated outdoor air comes in

contact with cold surfaces (cold air from perimeter dome supply) it can cause condensation, promoting conditions for mold growth.

As noted in the analysis above, stable and low relative humidity is the most effective means available to control microbial growth in buildings. The proposed desiccant technology utilizes a wheel coated with a hygroscopic substance that absorbs water to remove moisture. The desiccant, which can be silica gel, lithium chloride or a molecular sieve, is infused into an inorganic composite material that resembles the honeycombs of a beehive, and this is formed into a wheel. The wheel rotates slowly between the outdoor air and the reactivation or regenerating air stream. Moisture extracted from the outdoor air is removed from the desiccant by the heated regenerating air stream. The function of drying the air is totally separated from cooling the air with the cooling medium to meet the space cooling load.
