THE HISTORIC REFECTORY BUILDING at the UNIVERSITY OF VIRGINIA

A Historic Structure Report

John Milner Associates, Inc. Alexandria, Virginia

February 2009

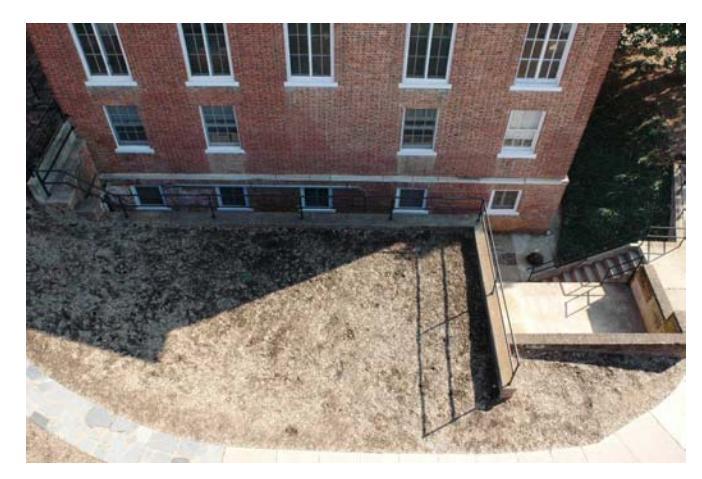
Flanking the portico to the west is a low areaway and drainage swale that was cut into the site

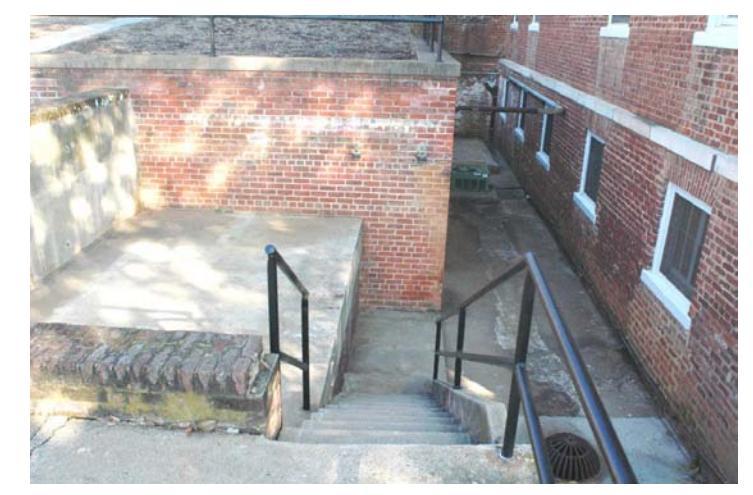
The west side is steeply sloped and is graded to cover an underground mechanical vault. The current site arrangement is a significant alteration from the original site plan and creates an awkward arrangement of low walls and sub-grade structures.

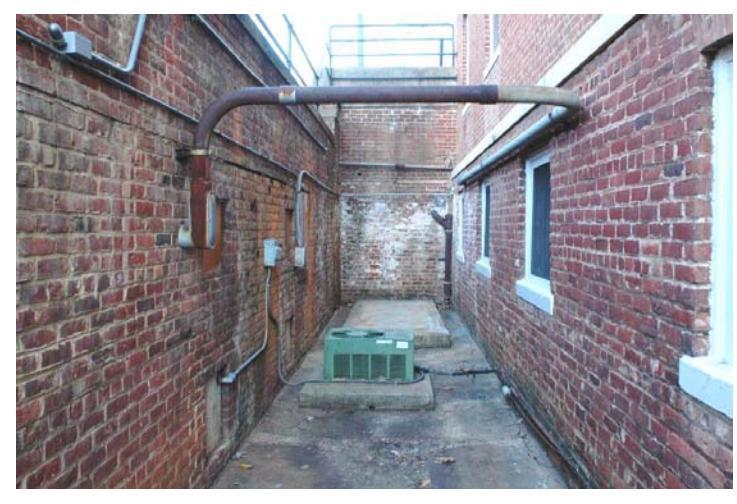
The west side is dominated by a narrow areaway between the west façade and the mechanical vault added in 1959. The function of this area has significantly changed since its original construction.

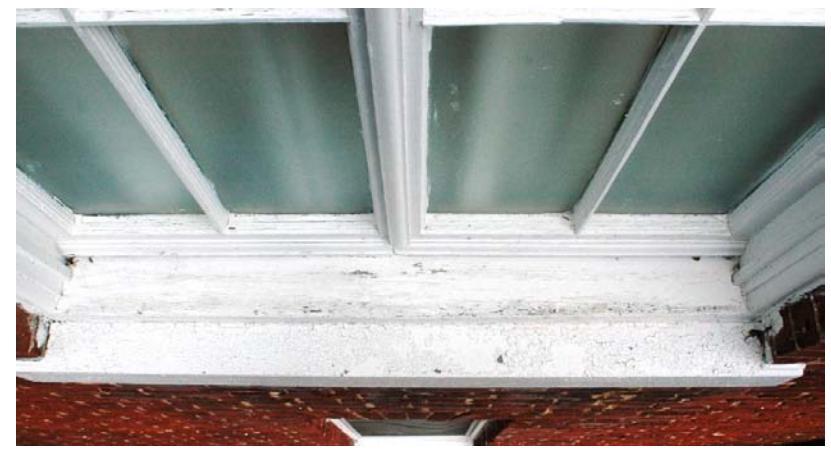
Window sills have a wood sill over a painted masonry sill (paint has typically failed).

**Recommendations:** Many of the large windows require removal, stripping of painted finishes, selective repair/replacement of rotted rails and muntins, and refinishing. All windows require general refurbishment to replace cracked panes, replace perimeter caulking, and restore painted finishes.

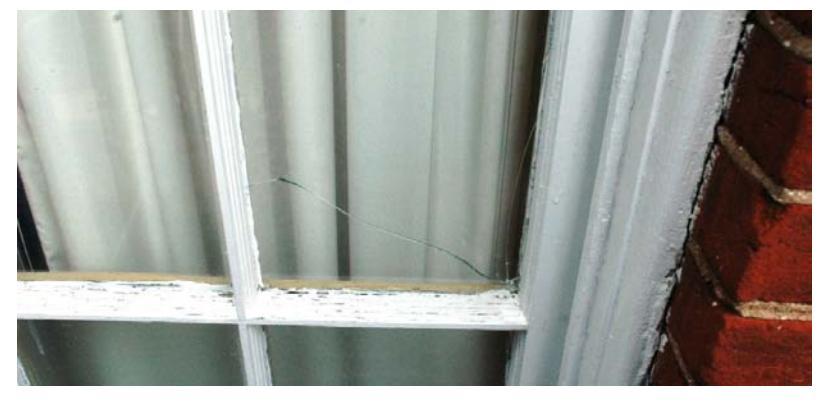
Most of the larger casements have at least one or two broken panes of glass and rot at rails and muntins in selected locations.

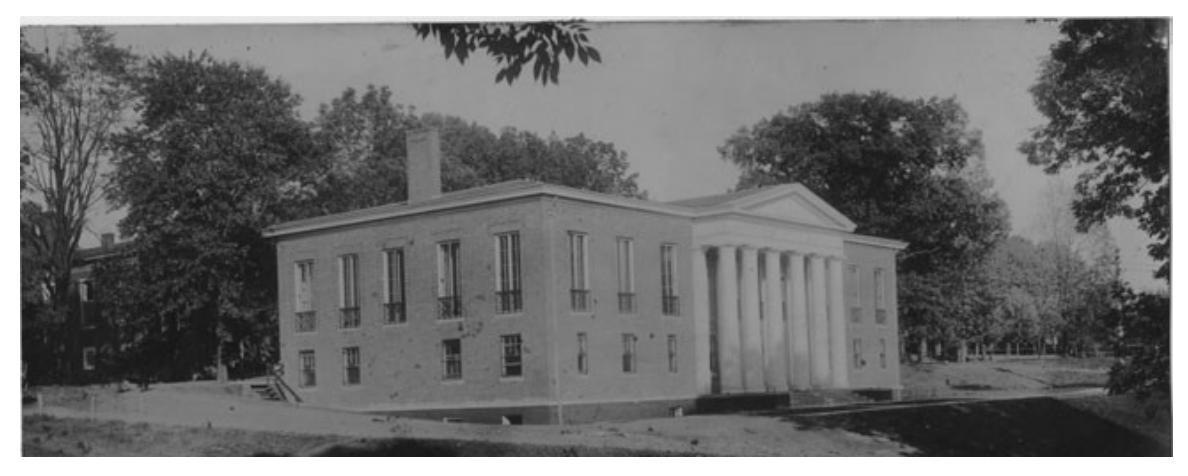
**Condition:** In addition to the alterations noted, the west elevation has been poorly repointed and basement level masonry has numerous deficiencies.

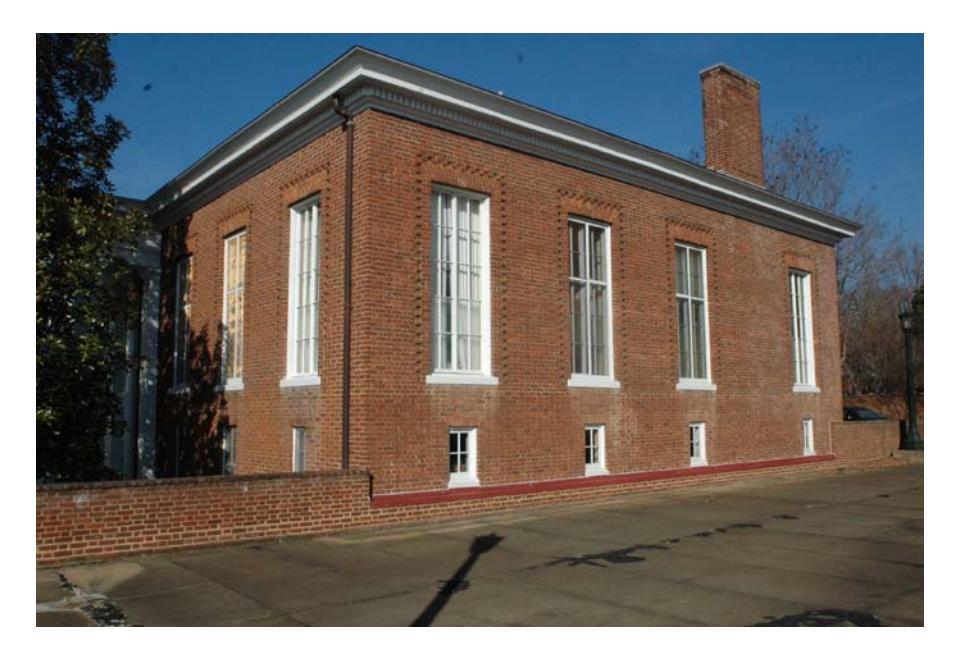
This photo shows a current view of the East Elevation from the roof of the adjoining Annex. Note small windows at plaza level are not original.

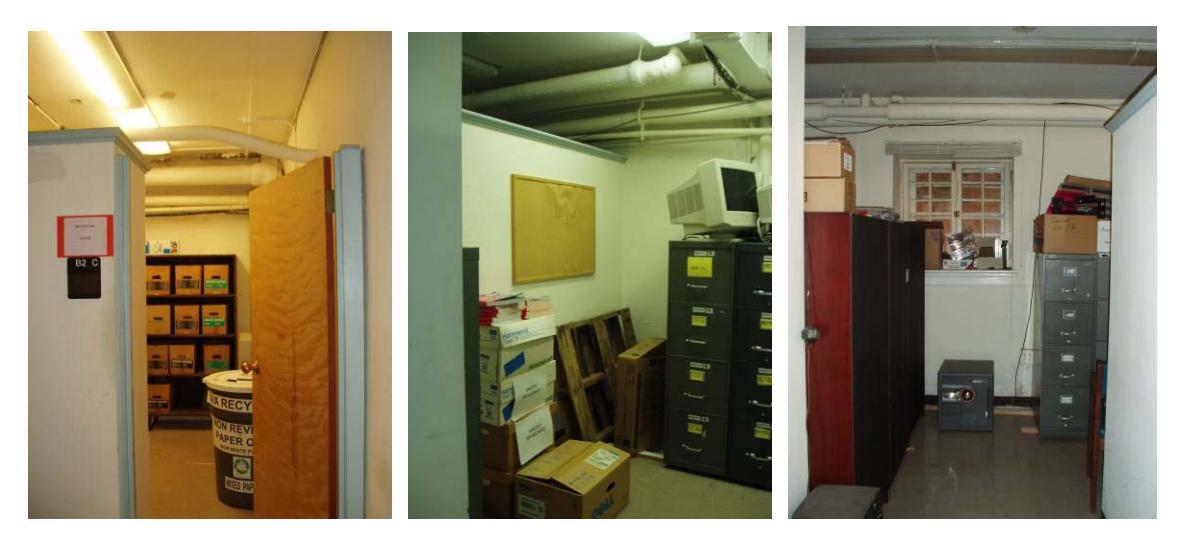
Typical Basement offices with partial height walls and exposed utilities at the ceiling

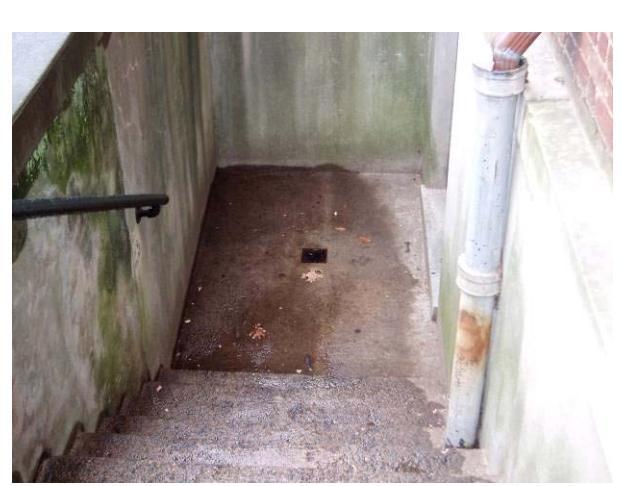
Flooring throughout the basement is either vinyl composition tile or carpet. The former is in relatively good condition, but carpeting is old and worn especially in areas that are taking on moisture. This is especially true at the west end of the building where the walls have evidence of significant rising damp. The plaster is blooming and bubbled up all along the lower interior part of the wall at the west end and the northwest corner. Another area where moisture penetration is obvious is under the exterior stair at the rear of the building in what is now a closet. It is obvious that subgrade drains at the back of
the building are not draining as they should. Water is backing up and penetrating the structure.

Floor drain and downspout at the exterior stair on the north side of the building

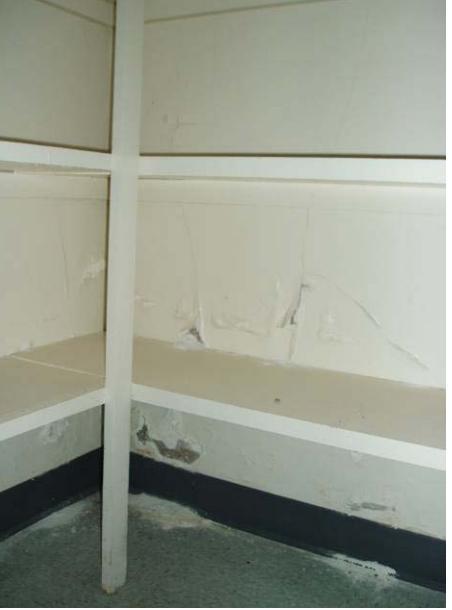
Plaster deterioration on closet walls below the exterior north stair

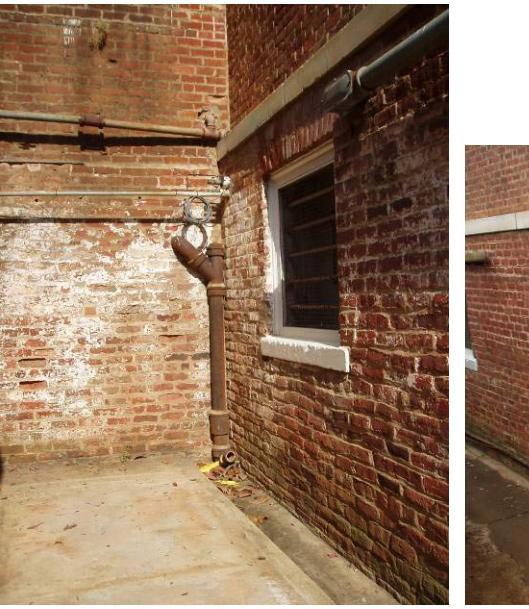
Poor drainage at the northwest corner of the building has caused deterioration in the walls

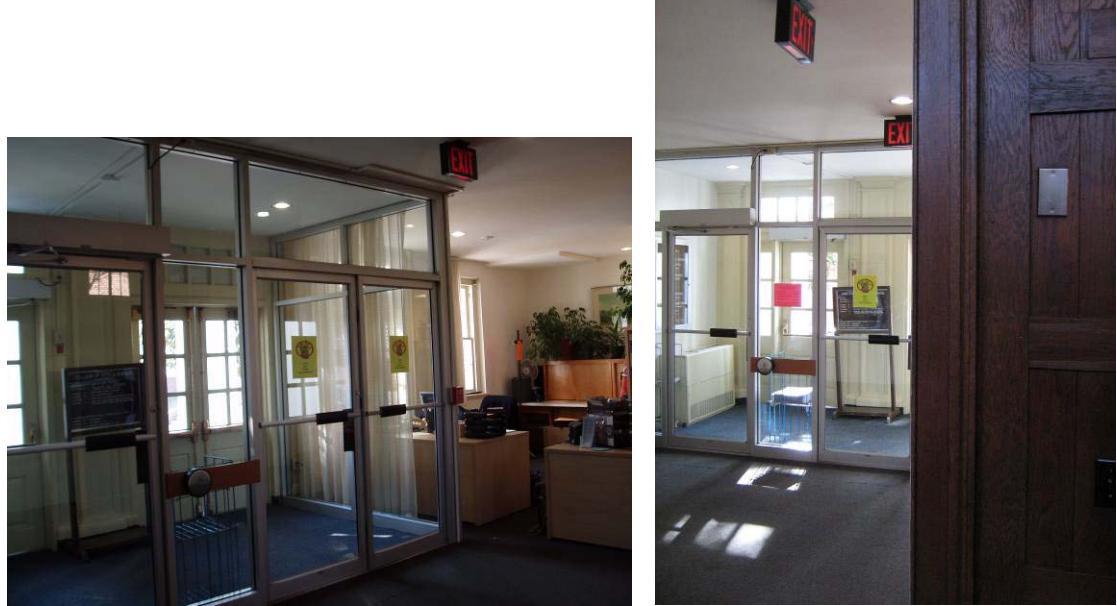
Addition of an internal air lock further diminished the once open Entrance Hall

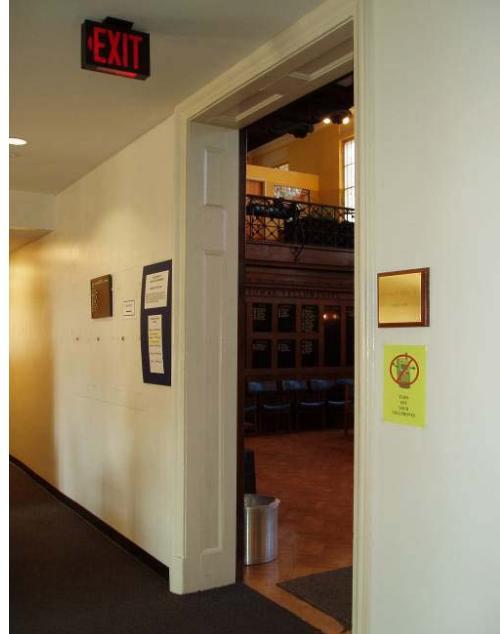
Now all that remains is the paneled jamb and profiled casing.

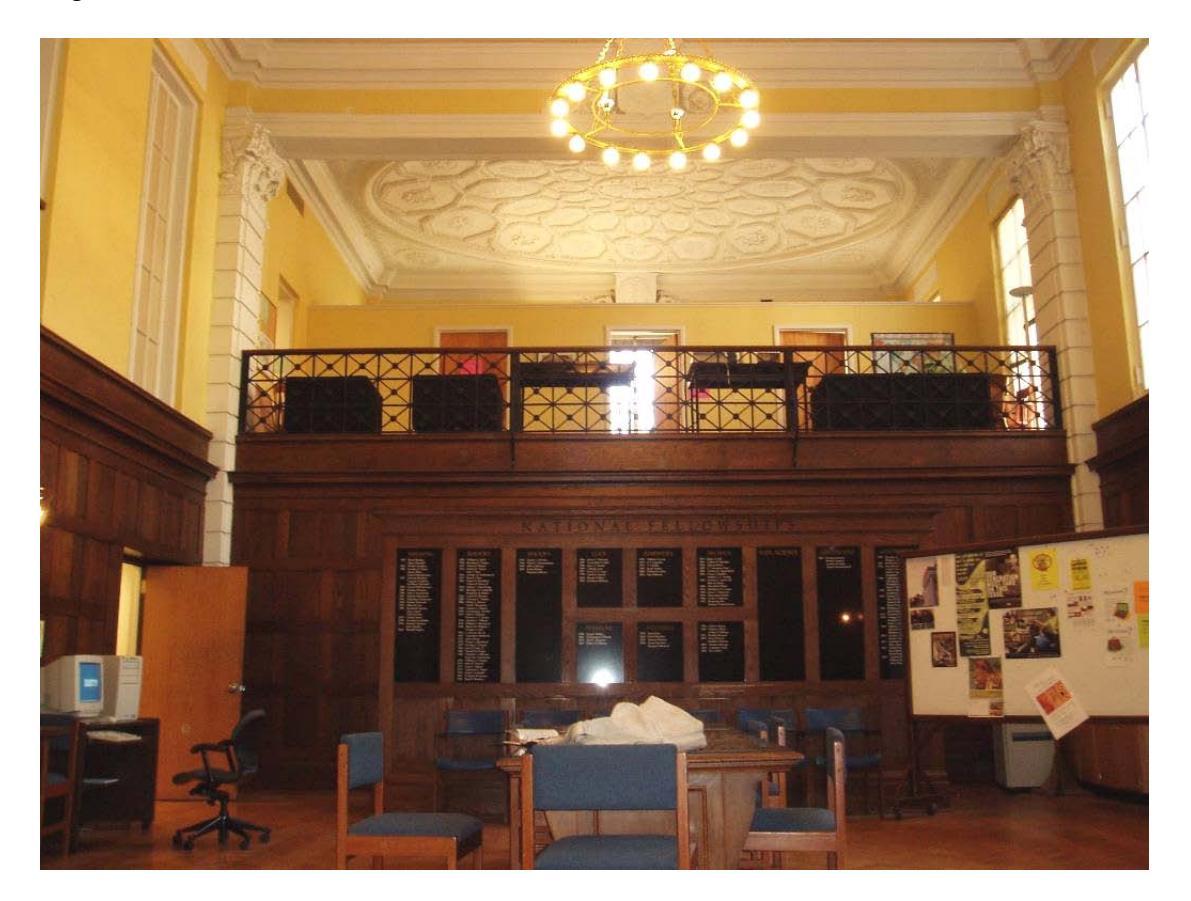
The west mezzanine is part of the original design, but an intermediary partition wall has been added within the main Refectory space to hide folding chairs and tables when not in use.

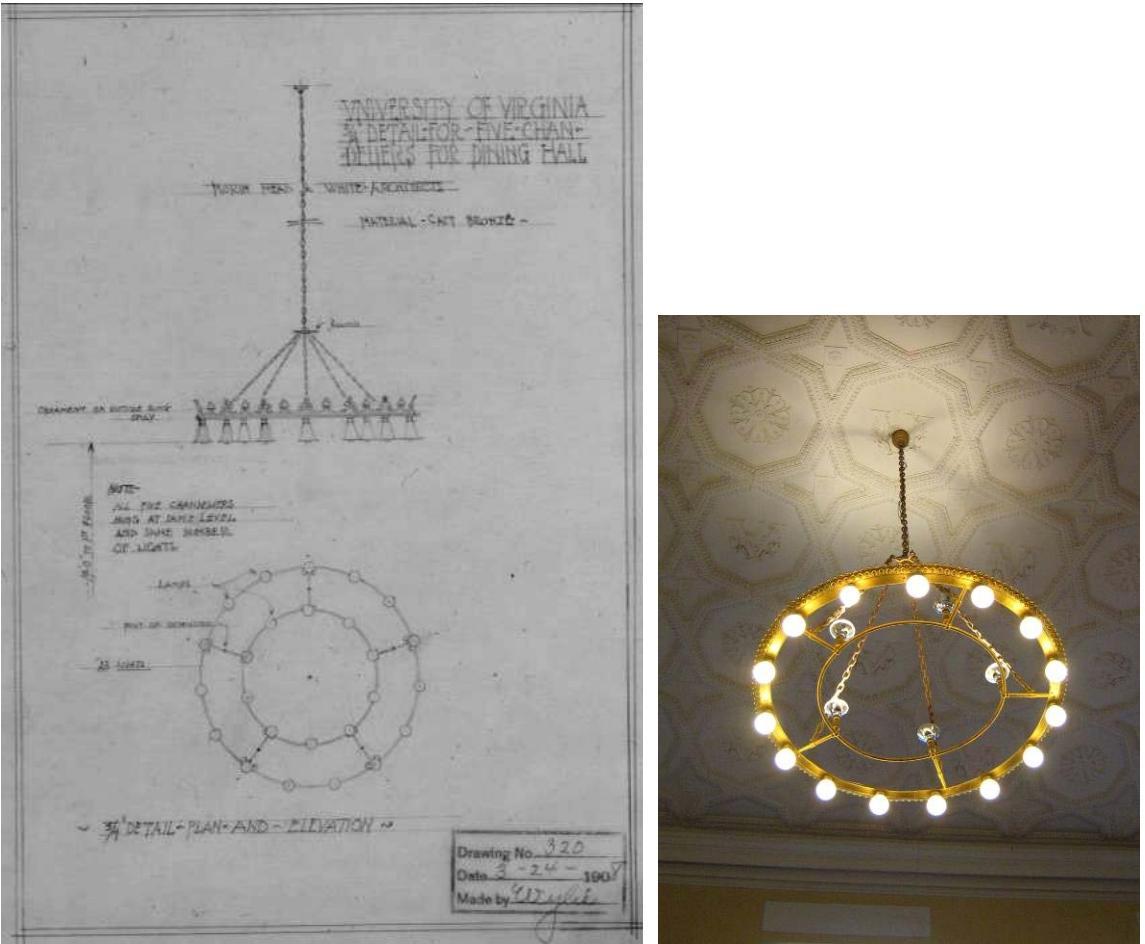
The existing chandeliers were designed specifically for this space (historic drawing courtesy of the New York Historical Society), but have been altered over time, turning the inner tier of lamps into up-lights with spot lamps in them.

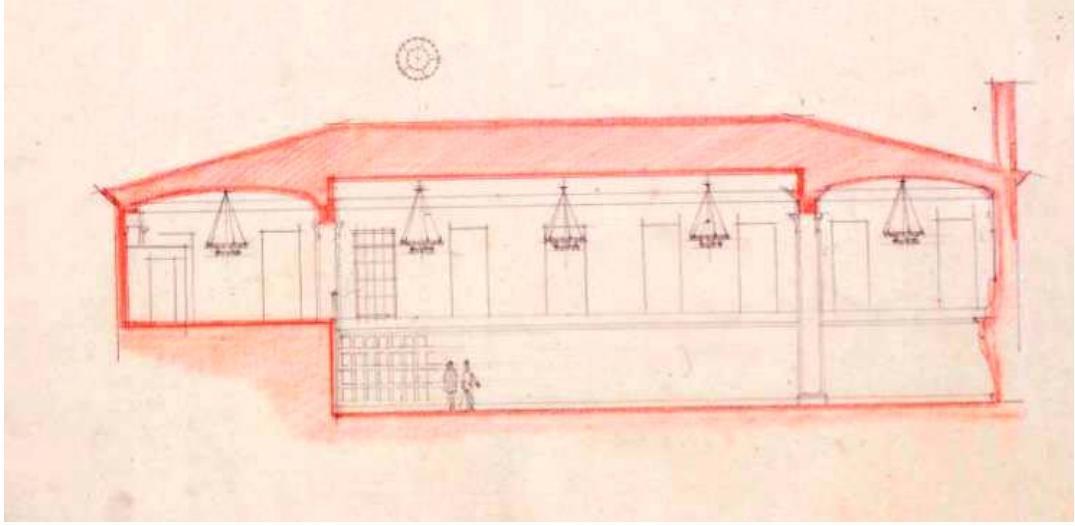
An original drawing (courtesy of the New York Historical Society) calls for five of these; currently only three remain.

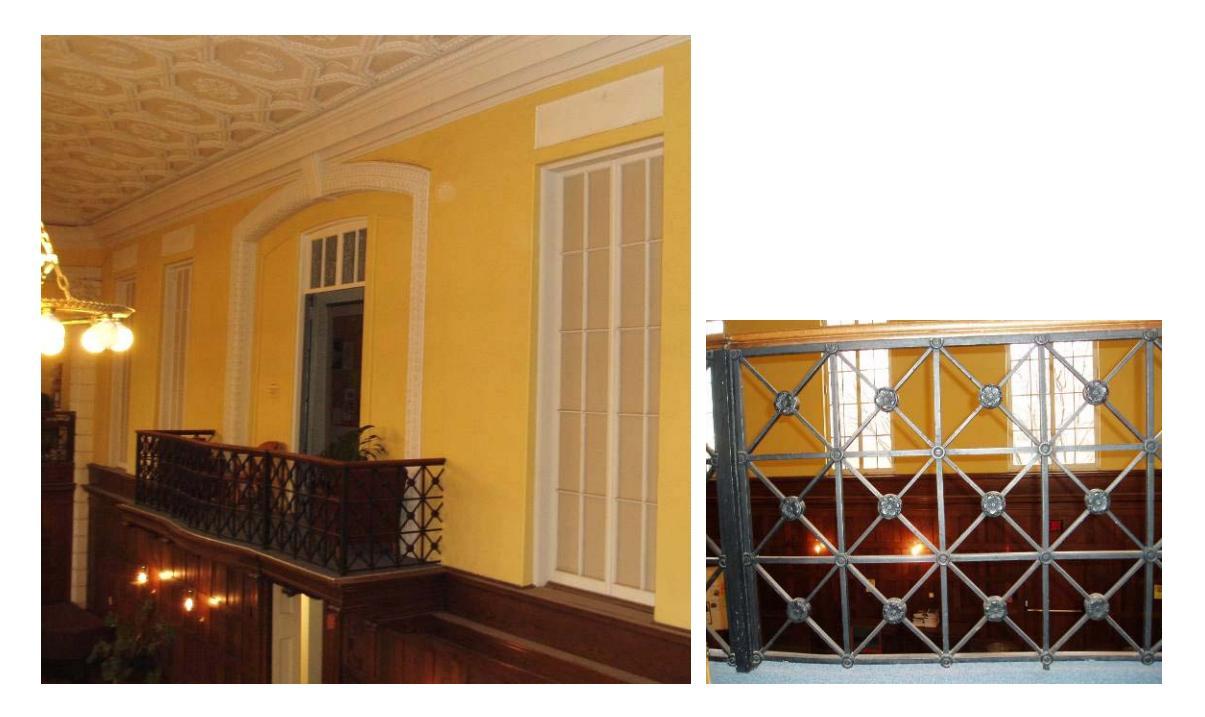
Another significant loss to the character of this great space is the repetitive rhythm of the grill work which used to fill the lower part of all the clerestory windows around the room. Today only the balcony and the mezzanine retain their original wrought iron railings with the repetitive "X" pattern.

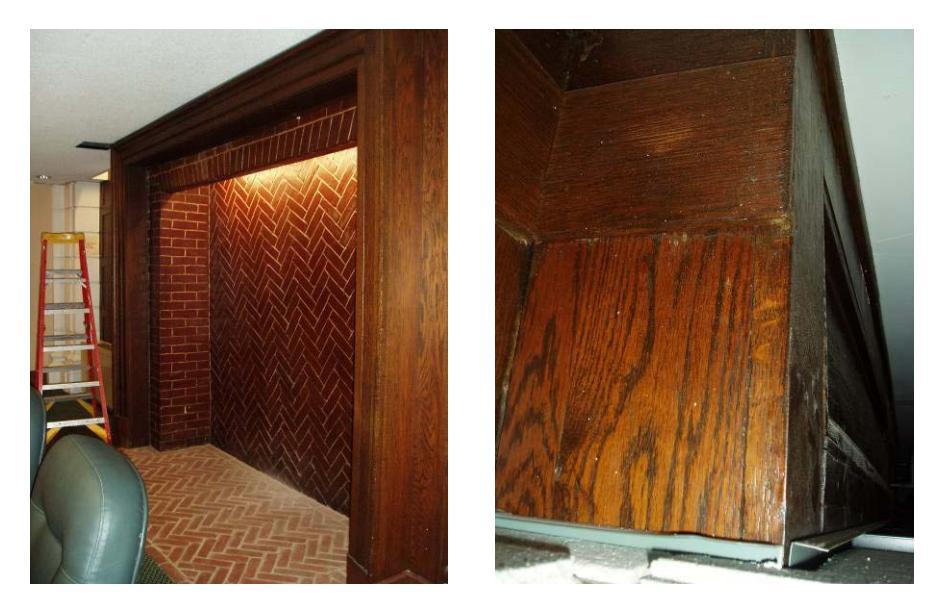
The dropped ceiling under the added west mezzanine obscures the upper part of the Fireplace Surround. The photo on the right shows what remains above the ceiling.

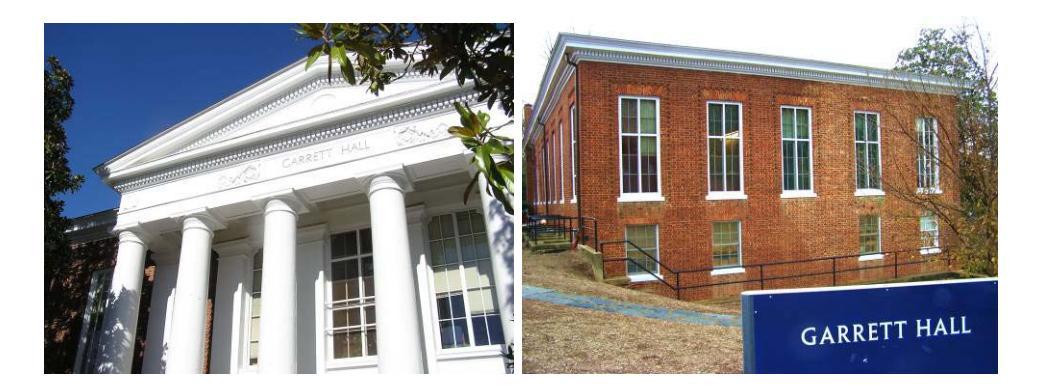
Figure 1 (left): Garrett Hall Main South Entrance Figure 2 (right): Garrett Hall west wall

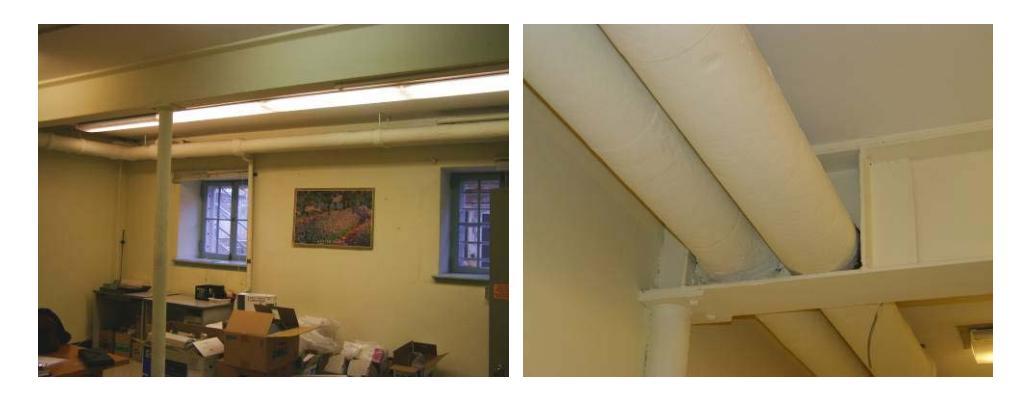
**Figure 3:** Basement room, SW corner. Note 3<sup>1</sup>/<sub>2</sub>" pipe column & beam **Figure 4:** Pipes run through stiffened web penetrations in steel beam.

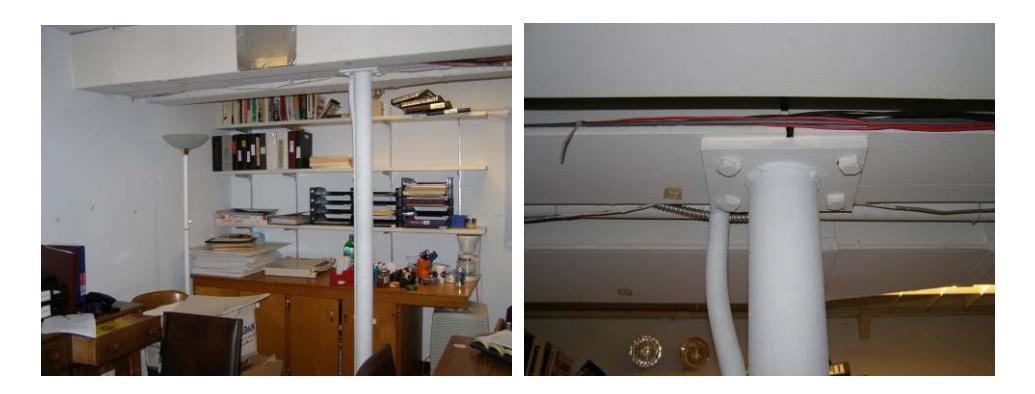
In the remainder of the building, the first floor framing consists of wood joists spanning north-south and spaced at 16" o.c. Figure 8 shows the typical first floor framing. Diagonal subfloor boards were also observed; this arrangement tends to offer greater stiffness than an orthogonal board layout for the floor diaphragm. In the northern portion of the building, the joists are 2"x11!/2" and span between masonry walls with an additional line of interior support. Per the 1907 drawings, this was originally a line of wood girders supported on masonry piers, but it was replaced with a row of 12 WF 31 steel girders supported on 3!/2" diameter steel pipe columns in the 1959 renovation. Steel posts and girders continue eastward along a central line of framing until the east masonry wall. Fulldepth blocking between floor joists was observed at the steel girder while bridging occurs at their mid-span. Figure 9 shows the steel post in a basement office and the top plate is visible in Figure 10.

Figure 9: Steel post in basement office. Figure 10: Close-up of post top plate

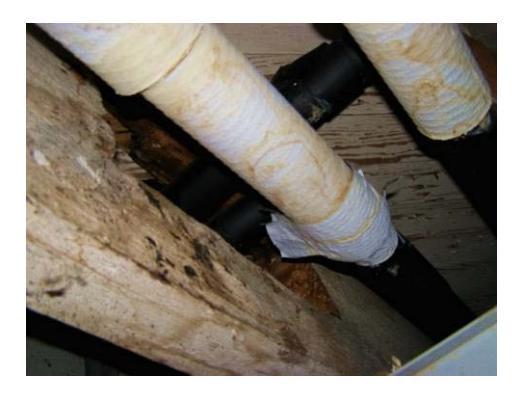
In the southern portion of the building, the joists are  $3"x11\frac{3}{4}"$ , which matches the existing drawings. Figure 11 shows first floor framing as observed from the women's bathroom in the basement. This photo shows a significant notch in one of the joists to allow space for pipes. The notch measures 14" long by 7" deep and occurs near mid-span. No apparent adverse effects were observed related to the notching, such as excessive deflection or the propagation of cracks. Most likely, any adverse impact in the form of cracking was lessened by placing the notch at the compression (top) face rather than the tension (bottom) face of the member. <u>RSA recommends that a sister be installed to reinforce the joist locally.</u>

Figure 11: 1<sup>st</sup> floor framing from women's bath. Note notch in joist.

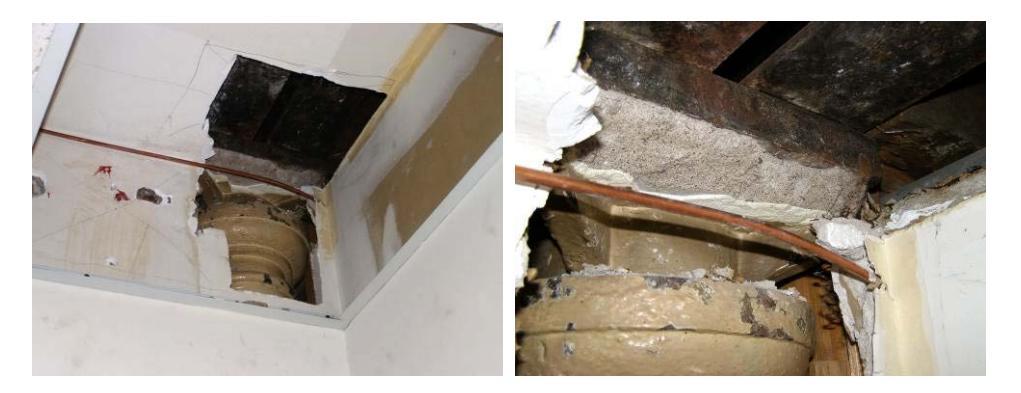
Figure 12: Probe at cast iron column Figure 13: Close-up of cast iron column and steel beams

The 6" outside diameter column was found to support a pair of steel beams which span to the column from both east and west sides (see Detail 1/SSK-4). On the west side, (2) 10"x28# were exposed, measured, and found to match the original drawings. The paired beams framing in from the east side were not accessible, but are indicated on the drawings to be (2) 12" I x 31.5#. The increase in beam size corresponds to the greater span for the eastern beams. Figure 13 shows a close-up of the top of the cast iron column and the  $10\frac{3}{4}$ "x $10\frac{3}{4}$ "x $1\frac{1}{2}$ " bearing plate which supports the steel beams.

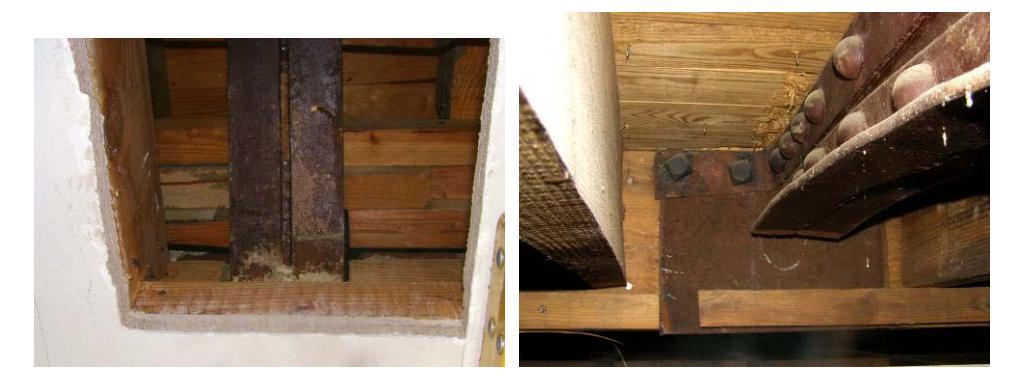
Figure 14: Probe at front corridor ceiling (C108), viewed from below. Note bottom flange of Hall north bracket. Figure 15: Second floor Hall framing.

Figure 14Figures 14 and 15 show the exposed bracket still in place and now supporting the in filled floor. Forming the cantilevered brackets are two (2) 2<sup>1</sup>/<sub>2</sub>"x2"x5/16" steel angles attached to the 3/8" coped web plate with rivets. The brackets frame into posts made of 2-10"x15" steel channels placed back-to-back and connected with rivets to form an I-shape. Brackets occur on either side of the interior masonry wall and were found to match the 1907 drawings.

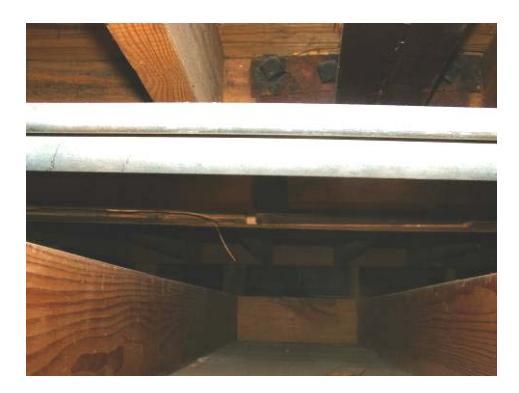
Figure 16 shows the ceiling framing added later below the bracket. Ceiling joists measure 1<sup>1</sup>/<sub>2</sub>"x5<sup>1</sup>/<sub>4</sub>" @ 14" o.c. Two layers of 3/8" gypsum ceiling attach to these joists. Second floor joists in this area measure 1<sup>3</sup>/<sub>4</sub>"x7" @ 12" o.c. Hangers (2x2) are used to attach the ceiling joists to the floor joists. See Detail 2 on SSK-4 for additional information. No additional information was found regarding the framing changes; however, all findings and assumptions and provided on SSK-2.

Figure 16: Ceiling and second floor framing at bracket.

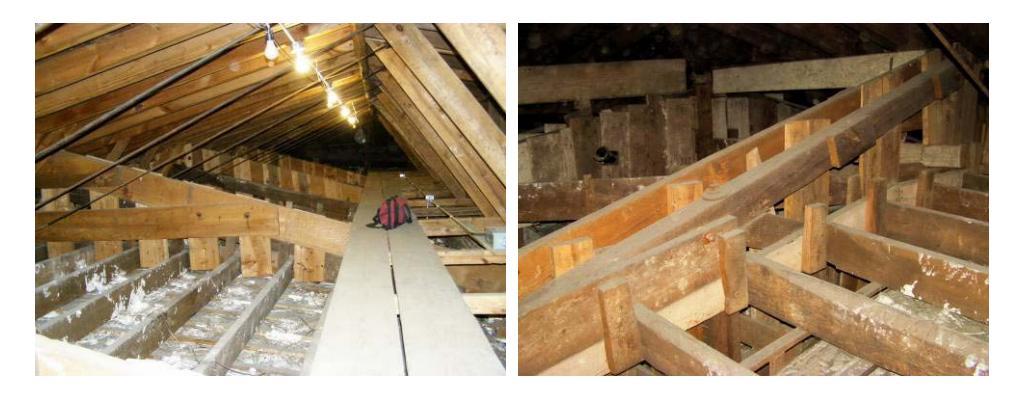
These rafters have an additional support at mid-span, where a purlin spans between a series of roof trusses. The purlin is 6"x8" and has been sistered since the original construction. The trusses are typically type "Truss A" (see SSK-3 and 4) with type "Truss C" below the two ends of the roof ridge (Figure 17 & 18). Truss A is a King-Rod truss with a curved bottom chord supporting the joists for the original vaulted ceiling. The northeast and northwest corners have a different ceiling profile, discussed below. The ends of Truss A are pocketed into the north exterior and interior brick walls (see Figure 19). "Truss C" is also a King-Rod truss; however, the bottom chord is straight and there are two additional vertical tension rods at the truss quarter points. Figure 20 shows a portion of Truss form 'C' which, over the course of its life, has been outfitted with several reinforcement strategies.

Figure 17: View of attic and roof framing, facing east (Truss A at left). Figure 18: Part of Truss C, northern partition of attic.

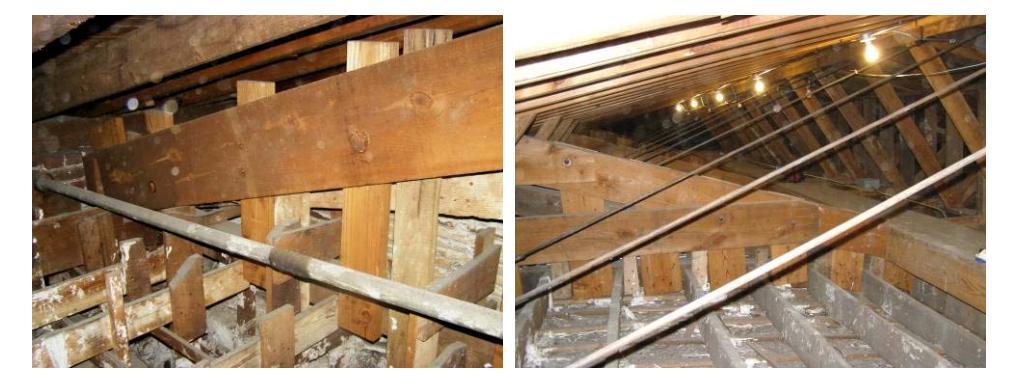
**Figure 19:** Truss 'A' top chord embedment in north load-bearing masonry wall beyond. Note timber hangers for suspended ceiling below.

**Figure 20:** Looking east at northern trusses 'A' and 'C'. Note ceiling Joists span between trusses and support plaster ceiling over Dining Hall (bottom). Trusses have been reinforced with sheathing boards. Additional modifications include installation of steel/iron tie rods (foreground) and diagonal braces (right).

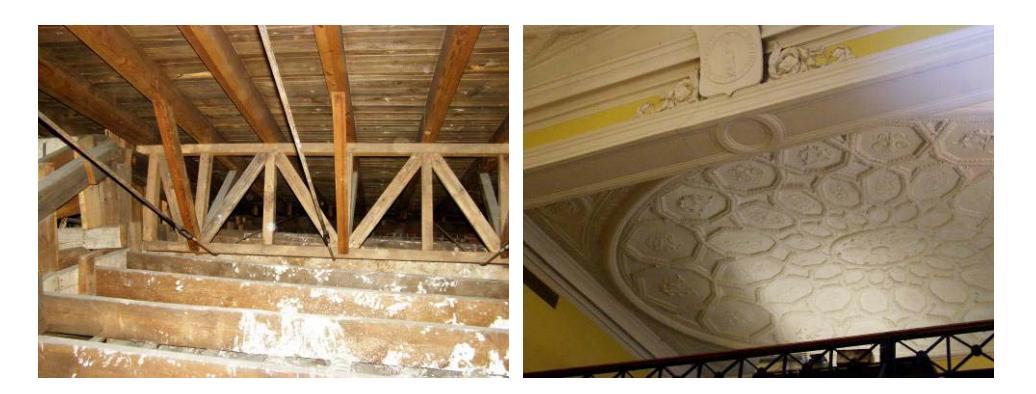
To further reinforce the north side rafters near the purlin support point, a knee wall truss was built running in the east-west direction (Figure 21). A 5/8" diameter steel tie rod has been installed, connecting to the south rafter near the roof ridge and to the north rafter at the north eave as well as to the bottom of the knee wall truss, providing it vertical support. In addition, the knee wall has two

Figure 21: Knee wall truss, northern portion of attic. Figure 22: Decorative plaster ceiling.

At the northeast and northwest corners of the building, decorative plaster ceilings hang from the attic framing (Figure 22). Ceiling joists in this area measure  $\frac{3}{4}$ "x5" at 19" o.c. with  $\frac{3}{4}$ "x3½" perpendicular nailers at 16" o.c. Metal lath and plaster are attached to this ceiling framing. Significant cracks were noted in the plaster ceiling, visible both from below and from above in the attic space (Figure 23). The primary crack originates at the north wall and proceeds in a southwesterly direction to the center of the plaster ceiling. This crack will likely require repair.

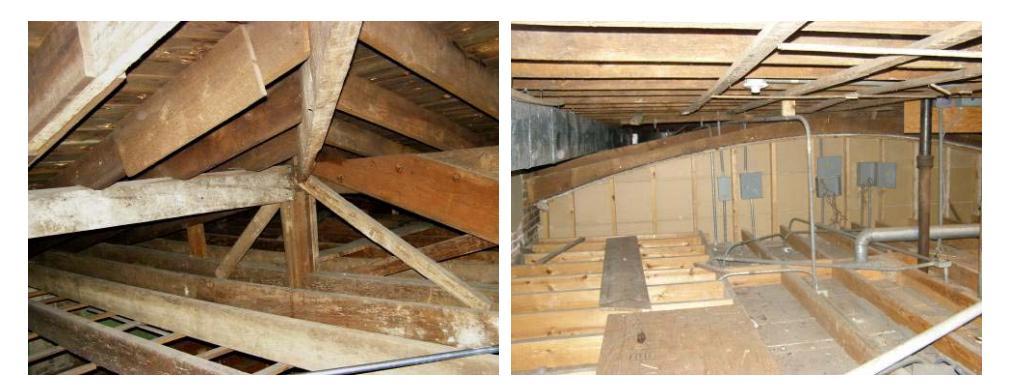
**Figure 27:** Hip rafter over Truss B in area above Staff Office 202. **Figure 28:** Looking east at vaulted ceiling spanning southern bay, note two layers of ceiling joists.

In addition to the original rafters, three trusses of type "Truss B" also exist in the southern attic space. Two occur below the hip rafters and another to the west of the portico roof (see Figure 27). These have flat bottom chords and the rafter is truncated where the trusses intersect with the hips.

On the southern side, the central bay above the original hall has a vaulted ceiling. In the adjacent spaces, a secondary (low) flat ceiling has been installed below the original ceiling joist (see Figure 28). This is hung from the original (high) ceiling joists with wood hangers (Figure 29). The space between these ceilings is currently used for mechanical equipment and distribution systems (Figure 30).

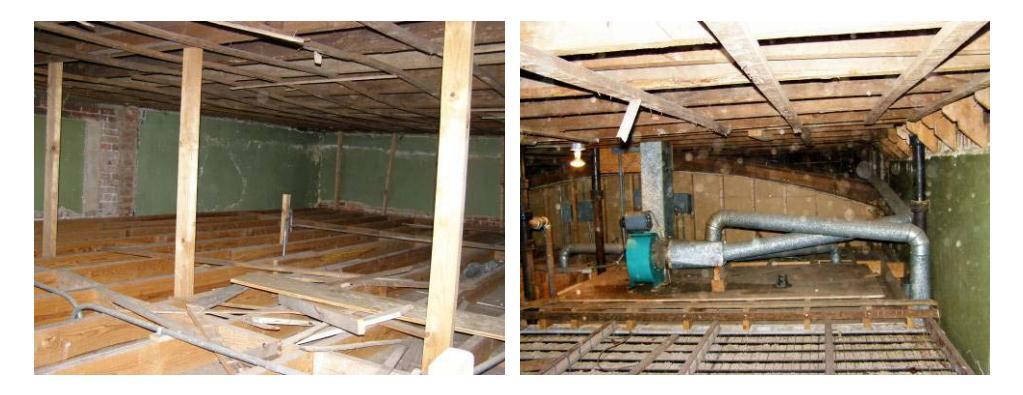
Also visible in the upper right corner of Figure 30 are secondary wood members for ceiling attachment at the interface of historic ceiling framing and masonry wall.

**Figure 29:** Hangers connect upper and lower ceiling joists. **Figure 30:** Mechanical unit between layers of old and new ceiling joists.

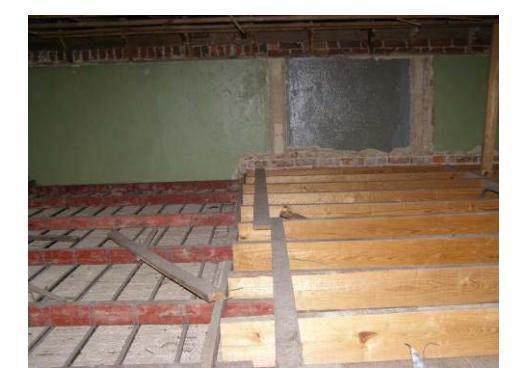
The ceiling framing, shown in Figure 31, changes as it crosses over the CMU wall defining the stairway (C201). Over the stairway, the framing consists of small steel channels with wire lath and plaster. On the other side of the wall, ceiling joists are wood. The change may have been due to different periods of construction or due to differing fire rating and combustibility requirements over the stairway.

Figure 31: Change in ceiling framing over stairwell renovation.

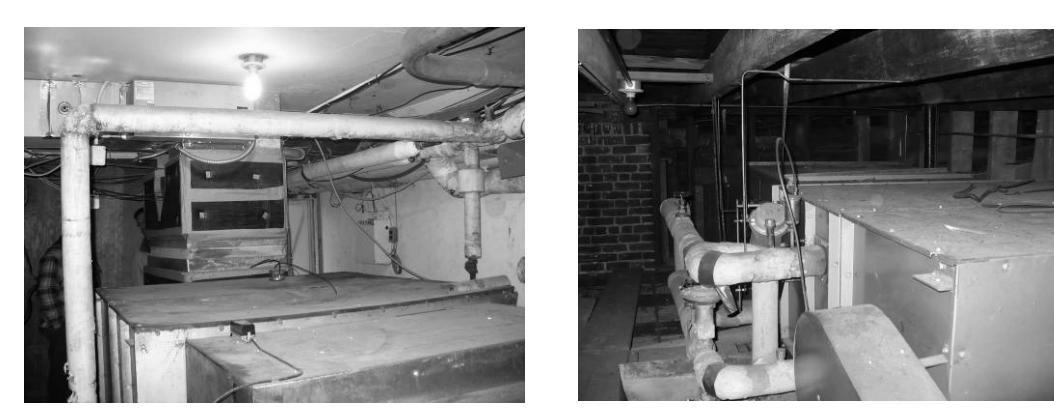
Air Handler in Basement

2. Remove the air handler that serves the Basement. Remove air handler located above the east stairwell (originally intended to distribute conditioned outside air to occupied spaces, but is no longer functional). Remove associated ducts.

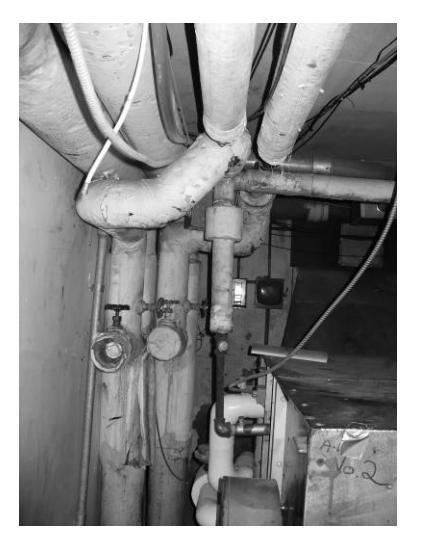
HVAC piping at Basement air handler

3. Remove all heating / chilled and dual-temperature water piping throughout the building, excluding that in the main mechanical vault. Some of the piping within the building has ACM insulation, so asbestos abatement will be required.

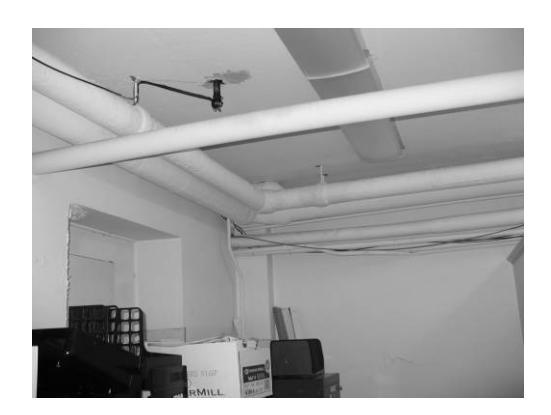
HVAC piping at ceiling of Basement

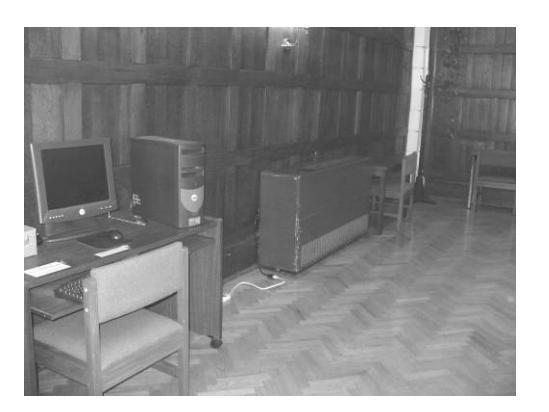
Unit ventilator in Main Hall

4. Remove all unit ventilators on all floors and associated dual-temperature water piping.

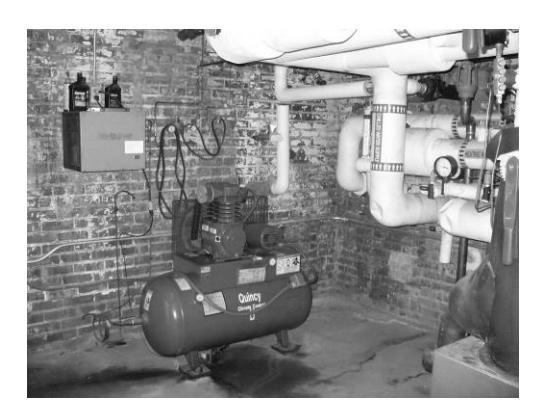
Air Compressor in main mechanical vault

5. Remove all pneumatic controls for the HVAC system.

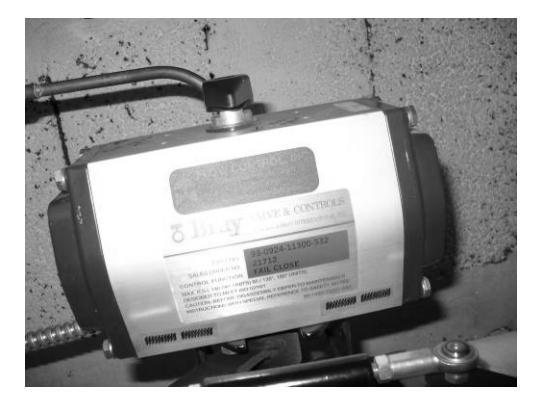
Pneumatic control in main mechanical vault

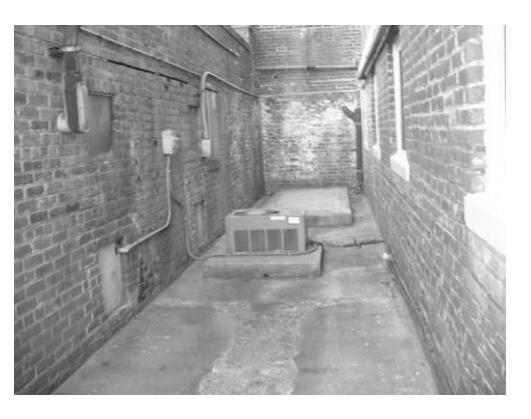
Outdoor condensing unit for IT closet

6. Remove the split system air conditioner serving the IT closet.

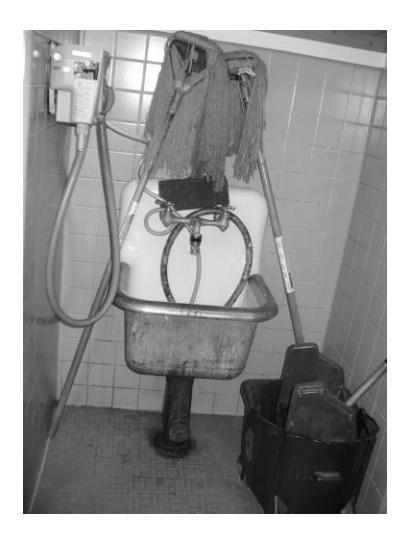
The current plumbing systems have outlived their expected service lives and do not comply with current water consumption and accessibility standards.

Service sink in Basement

1. The existing plumbing facilities should be removed – including fixtures, piping and water heater. Sub-slab drainage piping should be scoped with video equipment to evaluate its suitability for reuse in the renovation work.

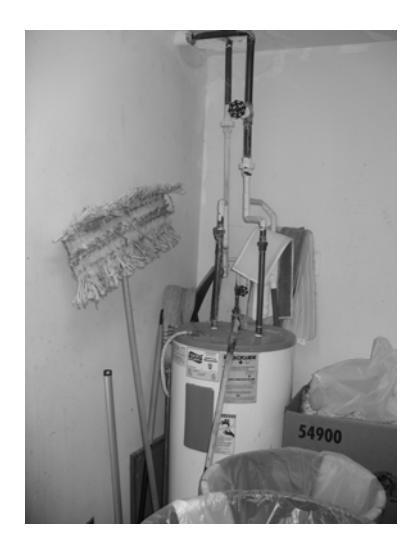
Water heater in Basement

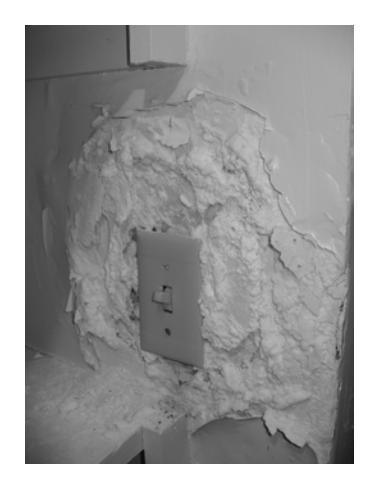
While the electrical systems appear to provide adequate service for the functions that take place in the building, some of the wiring and fixtures / equipment are antiquated and do not meet modern efficiency standards. Parts for some of the panels are no longer manufactured. A considerable amount of exposed conduit is routed along the basement ceilings and walls, and surface raceways are installed along walls on other floors.

Wall switch in deteriorated wall

- 1. The existing electrical systems should be removed in their entirety.
- 2. Major renovations should include replacement of all electrical service and distribution equipment and wiring within the main building. New panels should be fed from the existing switchboard in the annex and located in the main mechanical room (200A to serve existing and new equipment loads), and on each floor level (200A to serve lighting, receptacle and equipment loads).

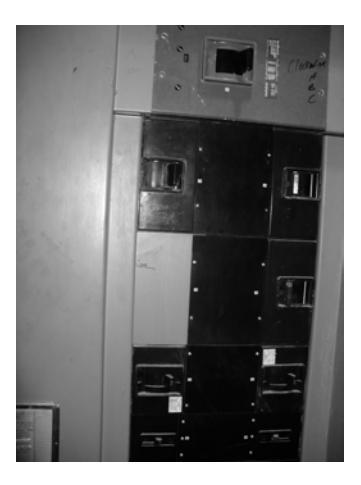
Outdated panel in Basement corridor

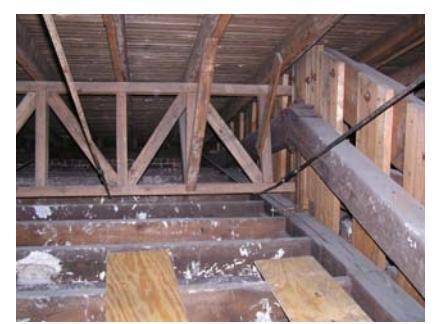
Photo 3: Reinforced Roof Trusses over original refectory hall

with regular sistering of roof rafters, substantial sistering of truss members, and the addition of an intermediate truss system consisting of tension tie rods which support an east-west truss which runs over the centerline of the original double-height dining room; the east-west truss creates a central support line for the roof rafters (Photo 3 and Figure 1). The substantial sistering amounts to an increase in roof dead load from the original.

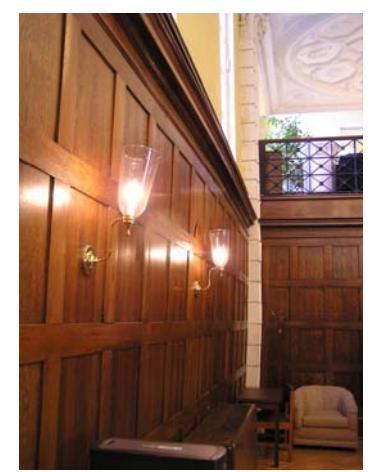
Of primary concern is the apparent inward deflection of the north wall (Photos 4 & 5). The area of most pronounced inward movement is between the chimney on the east side and the stairwell near the middle of the north elevation. Significant cracking is present on the interior finishes on the north wall, with an increased frequency of cracking toward the east side (Figure 2). Most pronounced is a pattern of horizontal cracking, which is consistent with the inward bending of the wall as the interior masonry surface would be in tension and the exterior face in compression. Photos 6 & 7 illustrate the cracking at the east pilaster, both in the

Photo 4: Interior face of North wall, with 1<sup>st</sup> floor level wood paneling – Area of inward bowing.

Figure 3 illustrates a repair concept for consideration while information is being gathered in the next phase of investigation. In this approach, below-grade buttresses would be constructed to brace the north wall and provide sufficient increase in capacity to resist the lateral soil forces. Careful consideration must also be given to the treatment of the exterior face of the foundation wall, maximizing the ability to quickly transport water in the soil away from the foundation wall while minimizing the potential for water infiltration. The concept depicted shows buttresses down to foundation level, with bracing of the north wall along two lines -- one at the first floor level and the other just below the current grade.

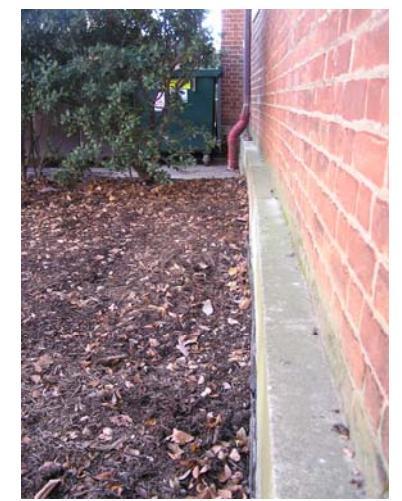
Photo 5: Exterior face of North wall – Area of inward bowing.

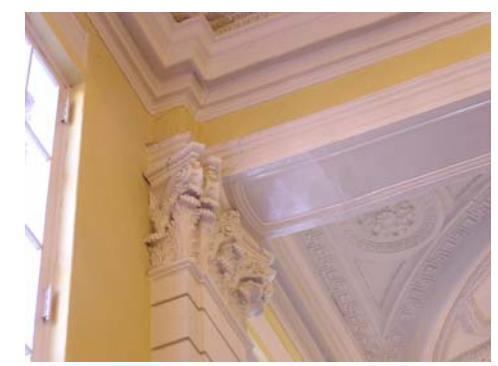
Photo 6: East Pilaster – Cracking at Capital
capital plaster as well as in the wall paneling of the first floor partition wall which abuts the pilaster. As depicted in Photo 8, some cracking was noted in the plaster ceiling, however this was not surveyed in detail during this site visit.

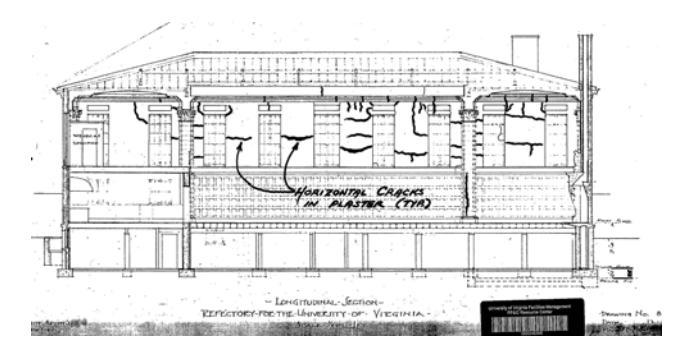
Figure 2: E-W Building Section w/ Interior Face Cracking of North Wall

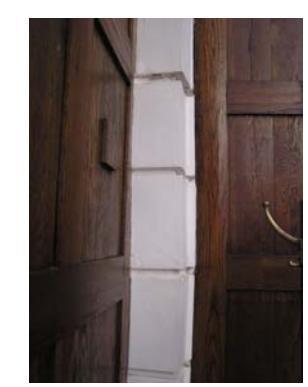
**Photo 7:** East Pilaster – Buckling wood paneling at inward-bowing wall

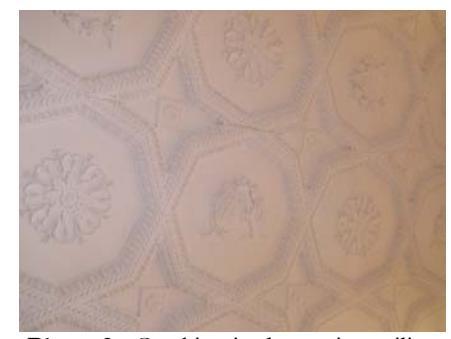
Photo 8: Cracking in decorative ceiling plaster
