THE HISTORIC REFECTORY BUILDING at the UNIVERSITY OF VIRGINIA

A Historic Structure Report

John Milner Associates, Inc. Alexandria, Virginia

February 2009

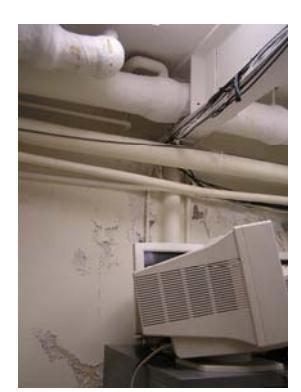
The presence of sustained moisture in a masonry wall is always a concern when that wall is subjected to freeze-thaw cycling. It is apparent from observation of the basement level finishes that the north wall has been susceptible to moisture infiltration (Photo 9). The sustained presence of moisture often results in the decomposition of masonry walls by breaking down the binder in early mortar and also by imparting stresses if the wall is subjected to freeze-thaw cycling.

Photo 9: Water damage at Basement walls

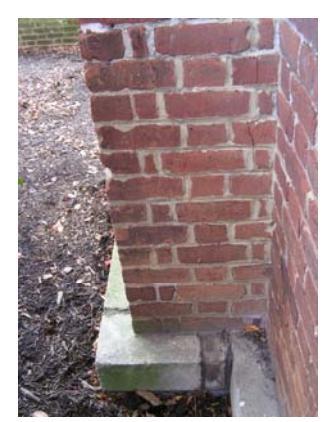
RSA observed minimal cracking in the exterior masonry of the north wall, however some cracking and shifting was apparent on both the east and west ends of the bowing area. Photo 11 shows some cracking of masonry at the base of the east chimney, while Photo 12 shows some separation between the stairwell wall and the building wall.

Photo 11: Cracking at east chimney

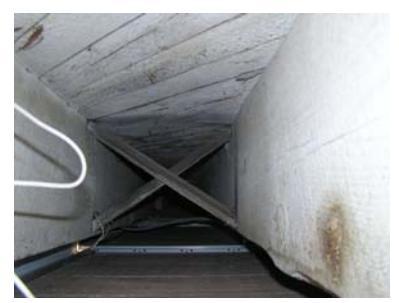
The first floor consists of wooden joists spanning in the north-south direction. The first floor plays an important role in bracing the north wall. Given its wooden construction, the rigidity of this diaphragm may be somewhat limited, however stiffness is gained by the presence of diagonal subfloor boards (Photo 13).

Photo 13: First Floor Framing – Note cross-bridging and diagonal subfloor boards
