HOTEL A

HISTORIC STRUCTURE REPORT

MESICK • COHEN • WILSON • BAKER ARCHITECTS 2012

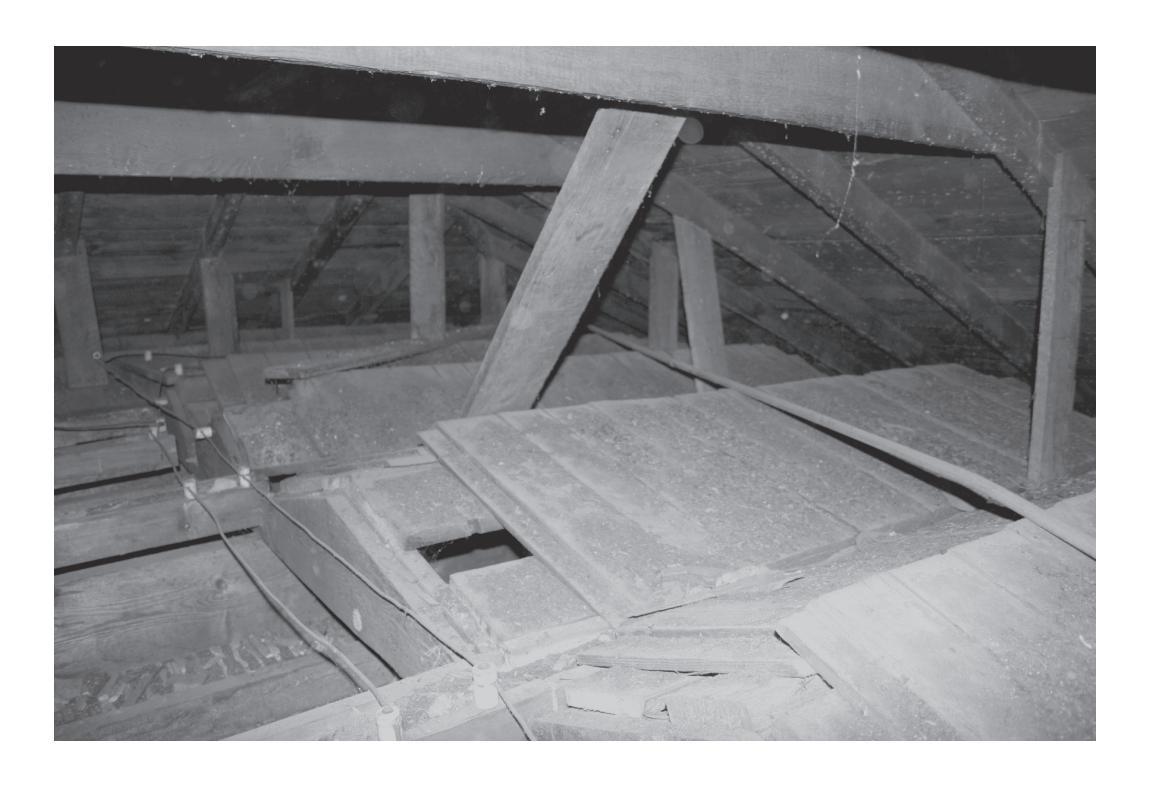
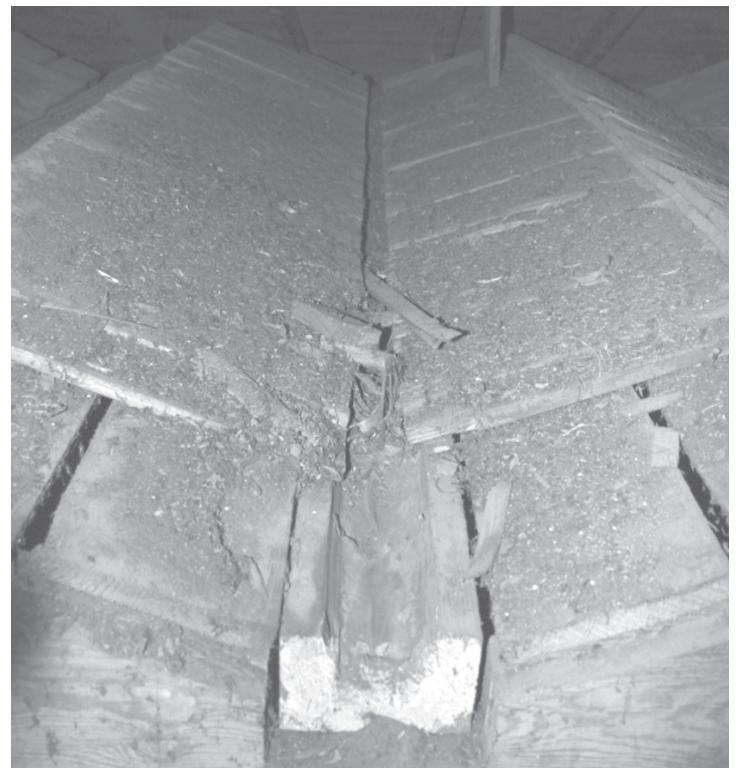
Details of serrated roof located above student rooms between Hotels *A* and *C*. This type of serrated roof was originally used above the student rooms and arcade at Hotel *A*.

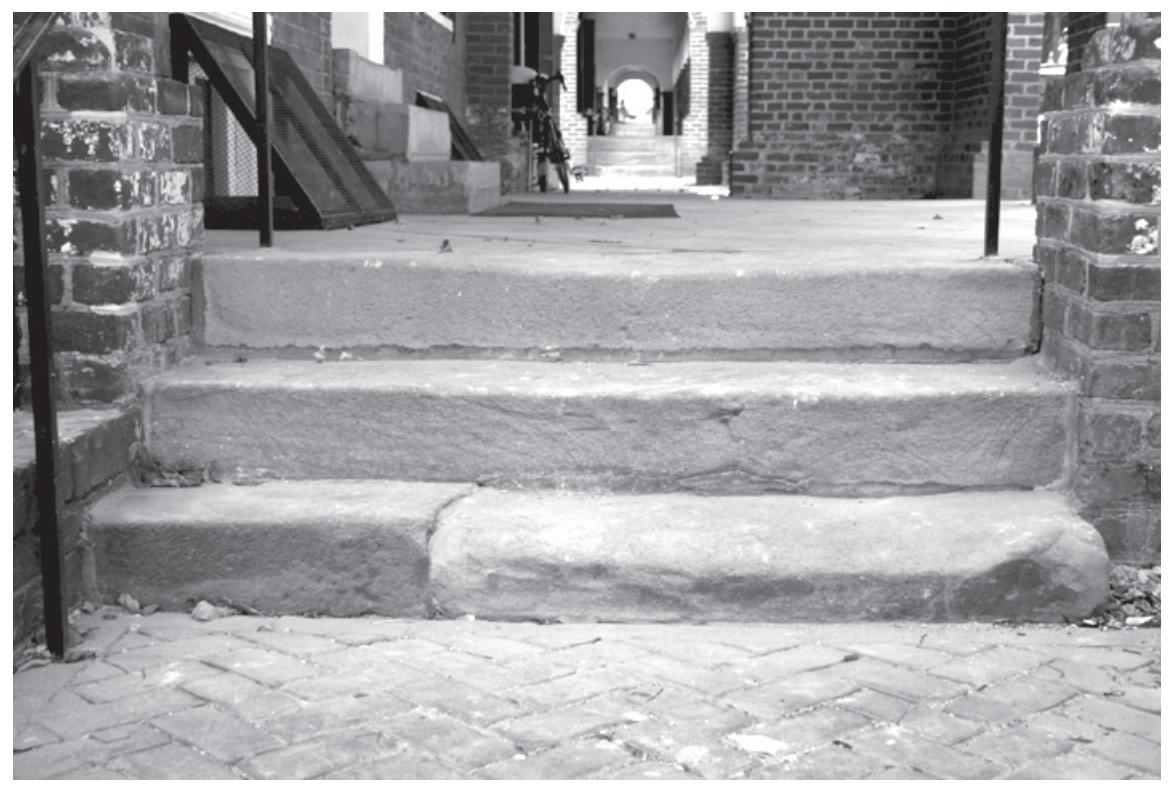
North steps of arcade

The tread of the bottom stone step at the north end of the arcade is severely worn and presents a tripping hazard. Some select bricks adjacent to this step are also deteriorated and should be replaced in combination with replacing or reworking the step. In the case of brick as well as stone, efforts should be made to match the original materials as closely as possible.

Replace the bottom stone step at the north end of the arcade.

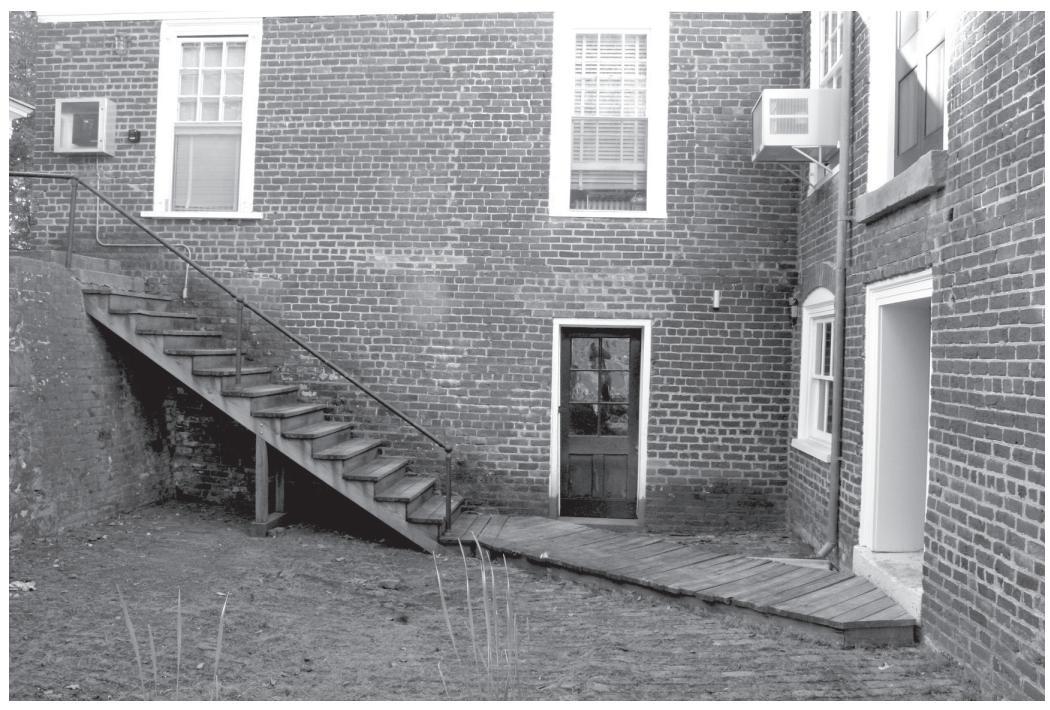
View of service area and east wall of student rooms

The majority of the brickwork on the east façade of the student rooms is in fair condition. The brick is significantly eroded; the surfaces here are extremely pitted and pocketed. This condition may have been brought on either by the fire in the Hotel and student rooms or

by treatments performed on the brick as a result of the fire. The surfaces may have been aggressively cleaned either by sandblasting, by chemicals, or a combination of both. While this condition is unsightly, it is not adversely affecting the building.

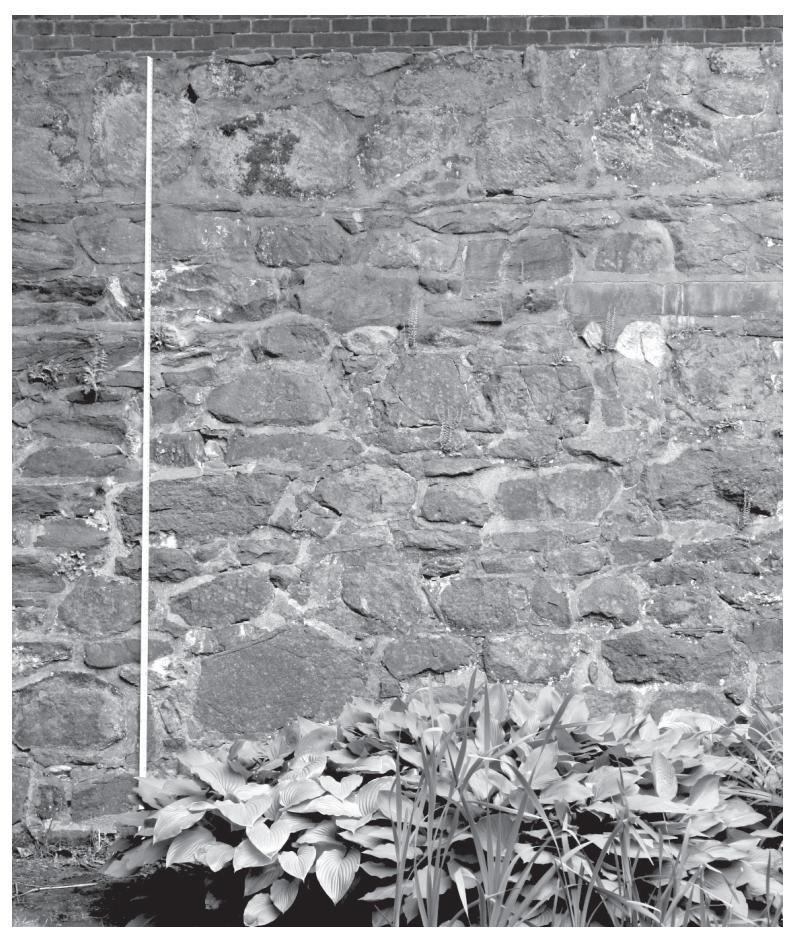
East Wall of service area

The cellars of the Hotel and student rooms suffer considerably from moisture-related issues. The building is essentially constructed within an excavated pit surrounded by retaining walls on three sides. A test pit dug in the service area adjacent to the south wall of the Hotel revealed two significant details: the soil here appears to be undisturbed clay and secondly, the Hotel is simply built immediately on top of this clay, and its foundations extend below grade only about five inches.

Historically, moisture must have migrated into the cellar walls, both interior partitions, and exterior walls, as well as throughout the floor areas. This may have been a chronic problem throughout all the cellars; however, it must have been especially bad in the east portion of the Hotel's cellar. Measures to correct this problem can still be seen in the cellar here. The brick paving that would have originally covered the cellar floors has been replaced (or covered) by a concrete topping slab over which a wood floor system was installed. Concrete block has been laid up against the insides of the exterior walls of the Hotel and painted over in an attempt to prevent water from migrating through. These attempts at arresting the water issues appear to have had little, if any, success and have done nothing to solve the root cause of the problems.

Given the conditions that exist, there is no simple solution to remedy the moisture infiltration problems plaguing the Hotel. In order to prevent moisture from entering the Hotel, actions must be taken to control and manage the runoff entering the areaway and service area around the building, in addition to preventing what water that does enter this zone from migrating into the Hotel. Ideally, a perimeter drainage system would collect runoff from the leaders and ground and channel it away from the building; however, the topography makes it difficult to remove this water. Designs for a perimeter drainage system should include a catch basin to collect the runoff for removal away from the site.

In order to prevent water from migrating into the Hotel, a foundation should be installed under the north, east, and south walls of the building. By waterproofing the foundation and integrating a through-flashing and/or damp proof course, water would be prevented from migrating into the building and brickwork.

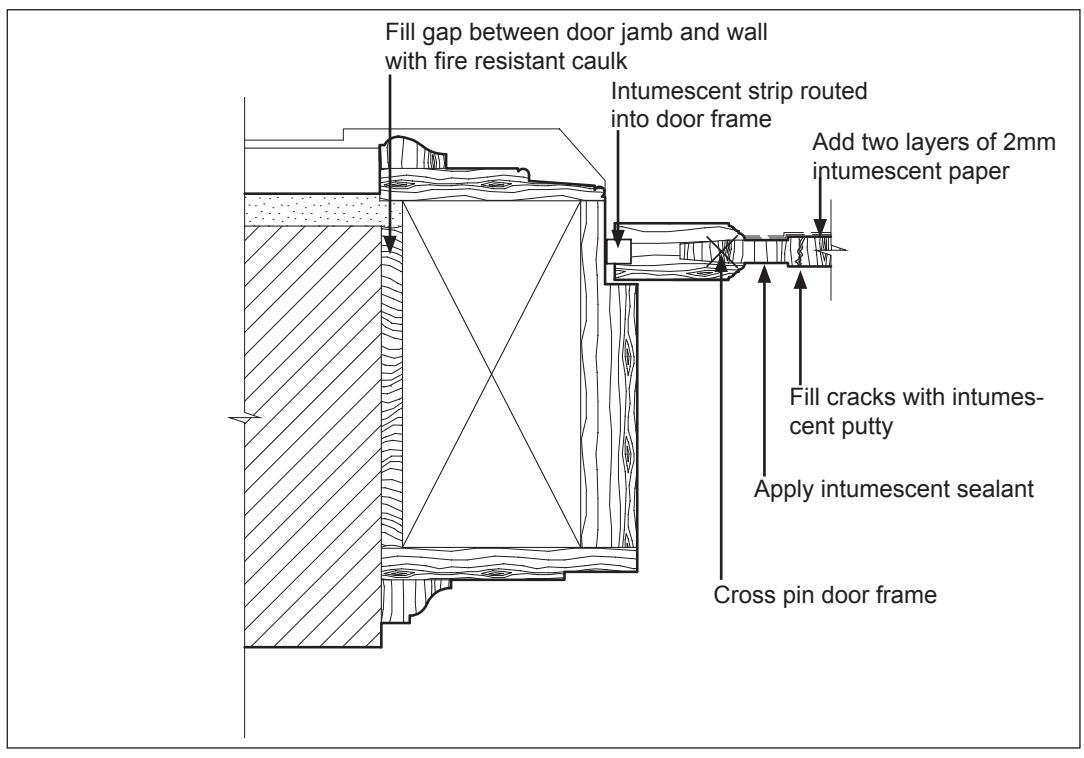
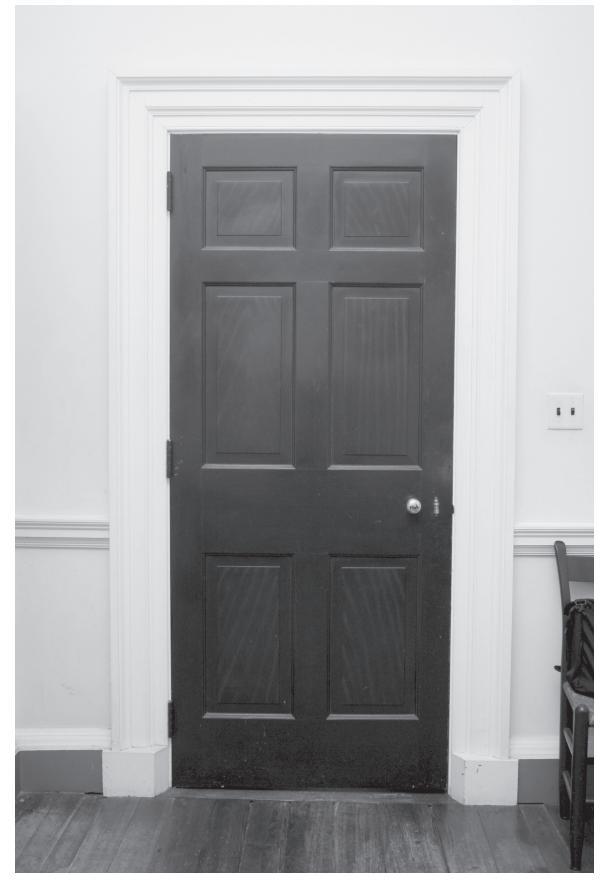
At present, Hotel A is constructed with non-combustible exterior walls and a series of non-combustible interior partitions. Ceilings are plaster on wood framing. The plaster on masonry walls effectively have an unlimited fire resistance rating while the plaster on wood walls can be expected to achieve a minimum of one hour fire resistance. There are,

Interior period door fire resistance improvements.

Example of interior door that can be upgraded using the English Heritage techniques.

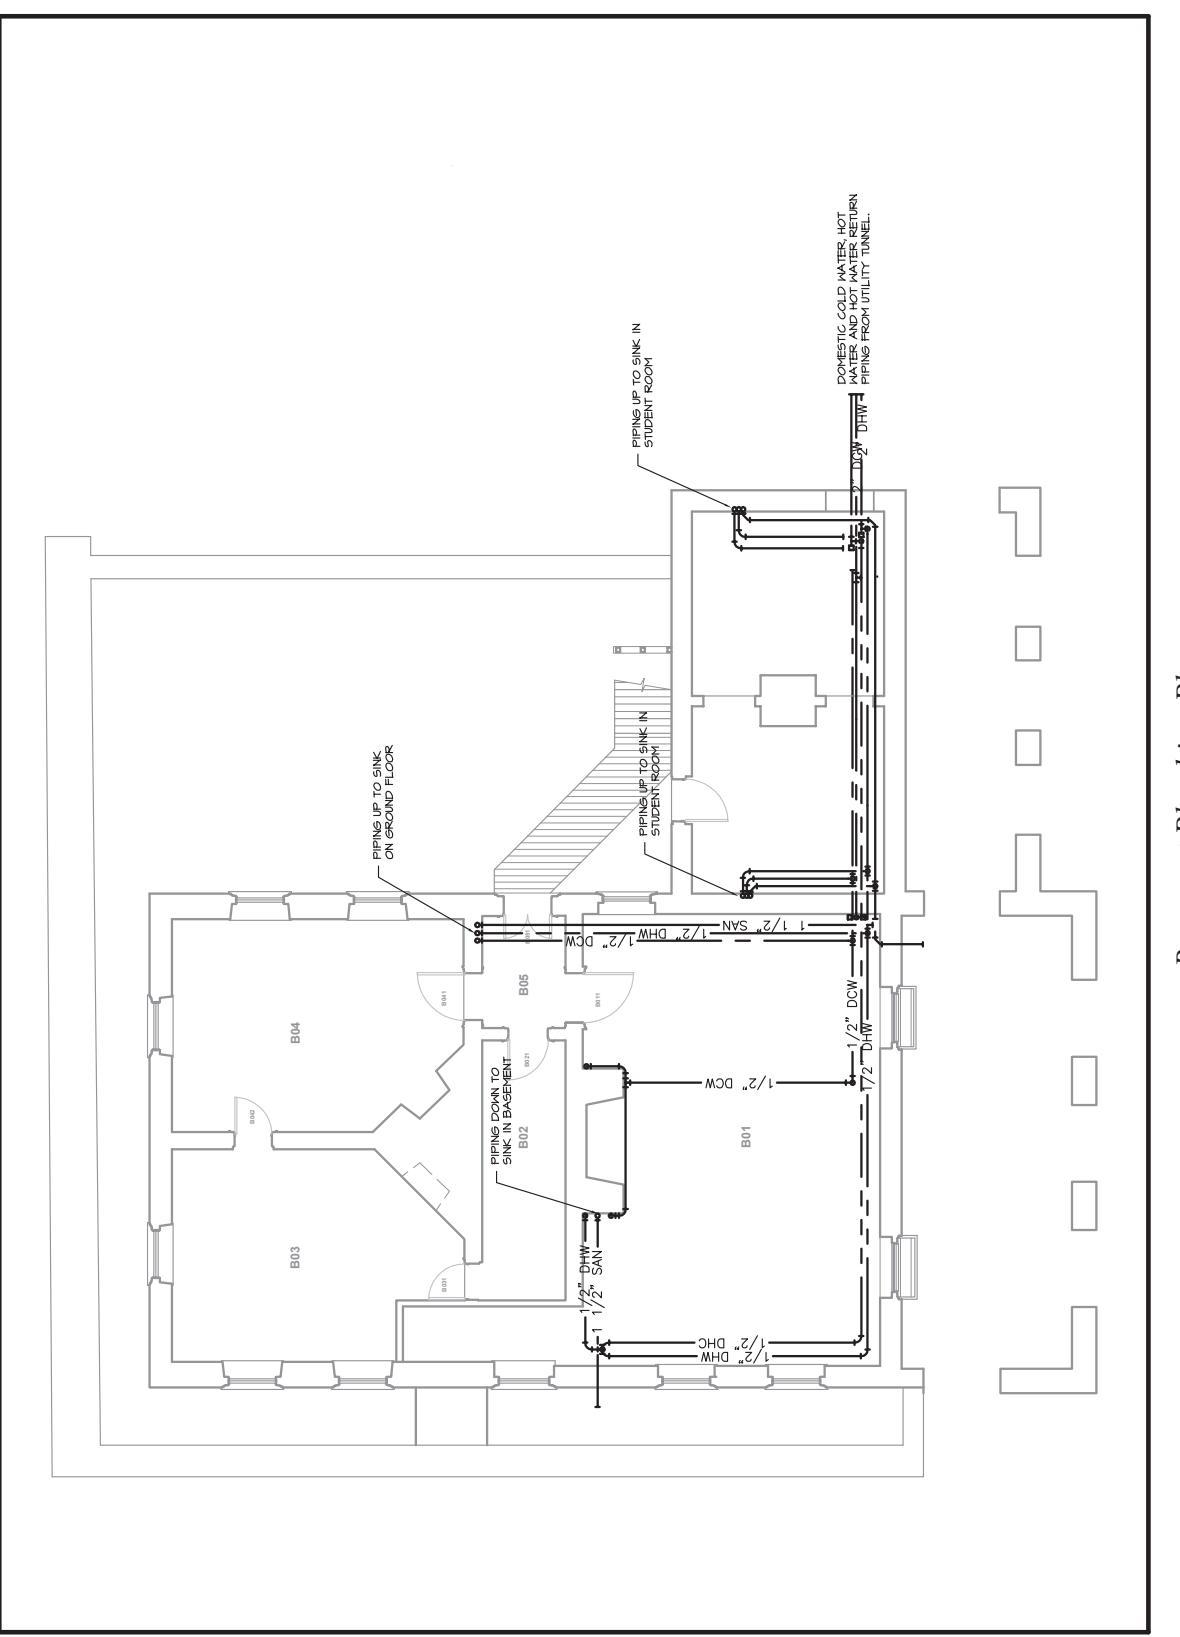
Basement Plumbing Plan

It is our understanding that a new sanitary system is being proposed for Hotel A. Care should be taken with determining where new pipe penetrations occur to ensure that additional damage is not done to historic fabric.

• Existing openings should be utilized to their fullest extent when planning and/or installing new services in order to minimize additional damage to historic fabric.

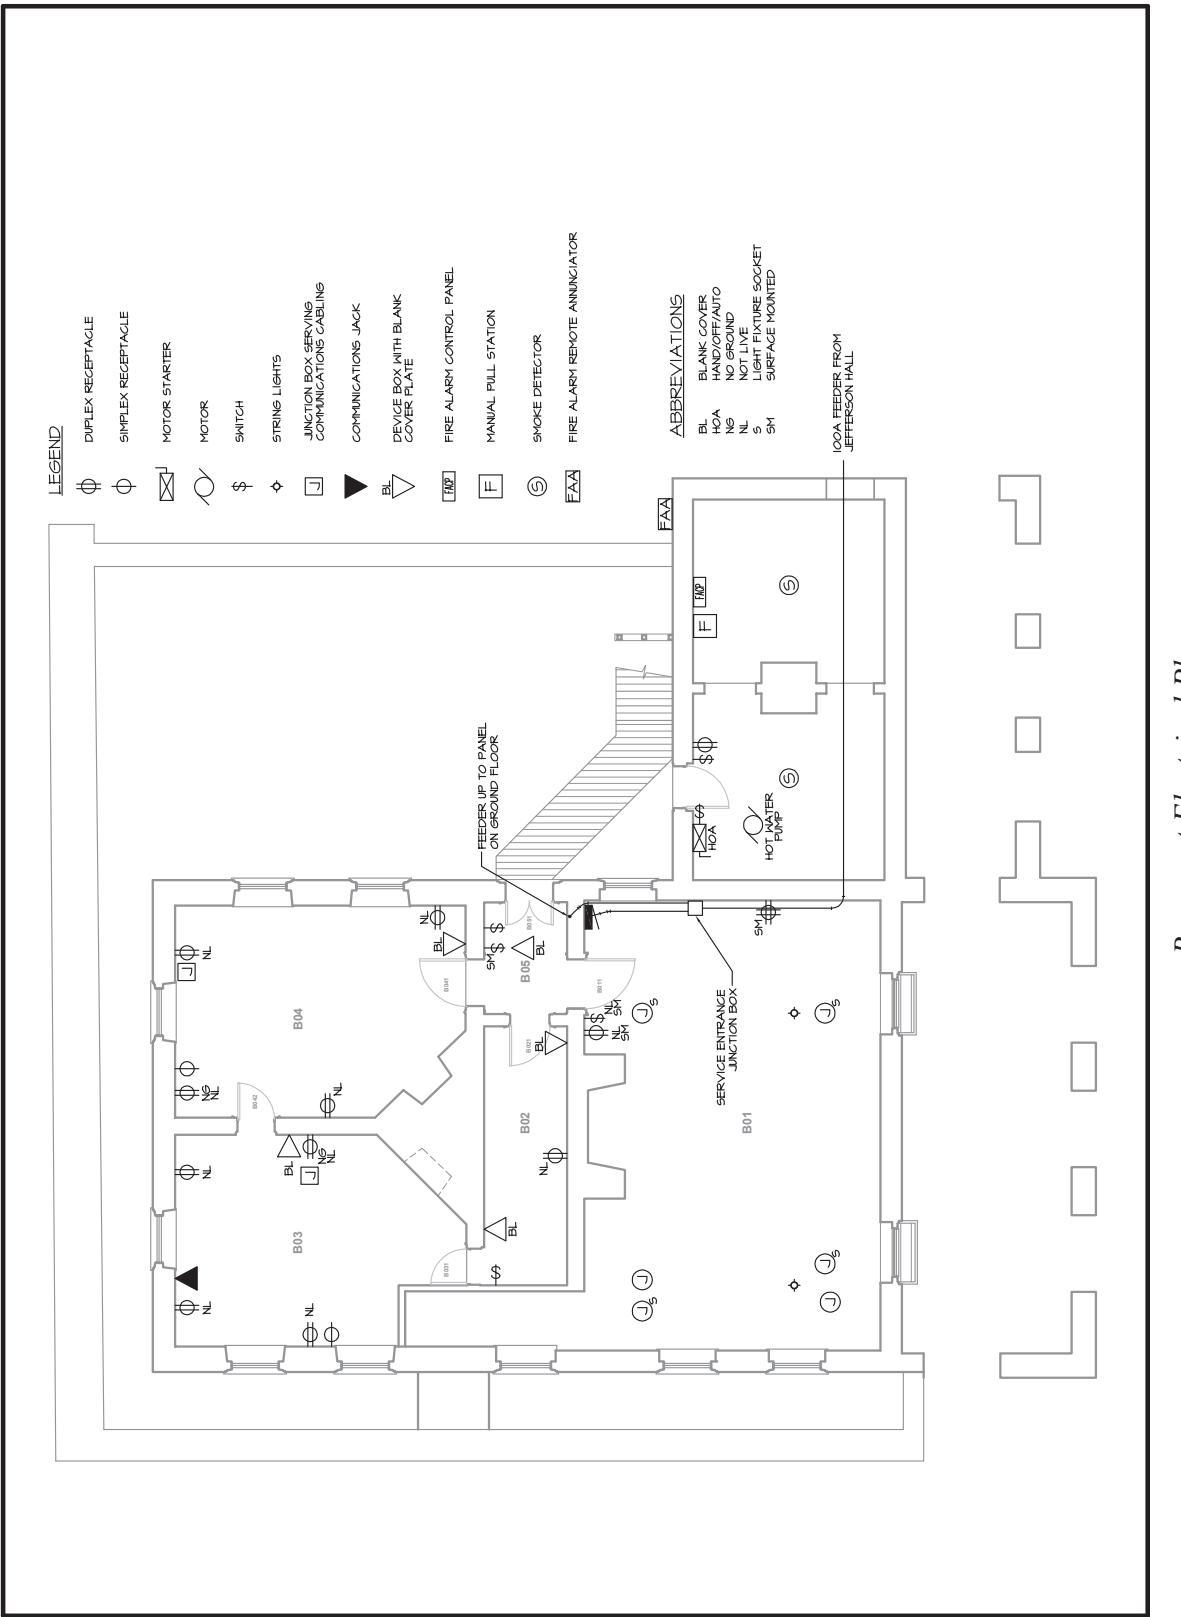
Basement Electrical Plan

There are abandoned circuit breaker panels in the basement that have been tagged, "DO NOT OPERATE." We would recommend that this extraneous system be removed to ensure that any old wiring system components have been removed in their entirety to ensure that the old system is no longer active. There are other abandoned equipment and feeders within the basement space below the student rooms that should be removed.

It appears that much of the circuitry within the basement has been abandoned and disconnected from the panels. There are a few active, surface-mounted receptacles installed throughout the basement that are served by surface-mounted conduit from the new panel boards. A single lighting circuit has been added within the basement which supplies power to certain fixtures for general illumination. This circuit has been strung loosely throughout the basement using NM (Nonmetallic-Sheathed) cable. NM Cable is not allowed by code to be run exposed in structures other than dwelling units per NEC Section 334.10.

In one of the basement rooms, compact fluorescent bulbs have been connected to the lighting circuit using open air splices. This condition is very dangerous and should be corrected immediately particularly considering the fact that there are dwelling units attached to the Hotel.

- Install a single disconnect to cut power to the electrical system in the case of fire or similar emergency. The disconnect switch(es) should be labeled with signage indicating that it is the main disconnect.
- Panel directories have not been labeled. Proper circuit labeling and documentation should be enforced to avoid confusion.
- Remove open air splices and provide code compliant lighting within the basement.
- Remove remains of electrical systems no longer in service.
- Remove exposed NM cable and replace with code compliant service.
- Replace branch circuit wiring on the first floor with code compliant service.
- Inspect and repair electrical connections to fixtures throughout the building.

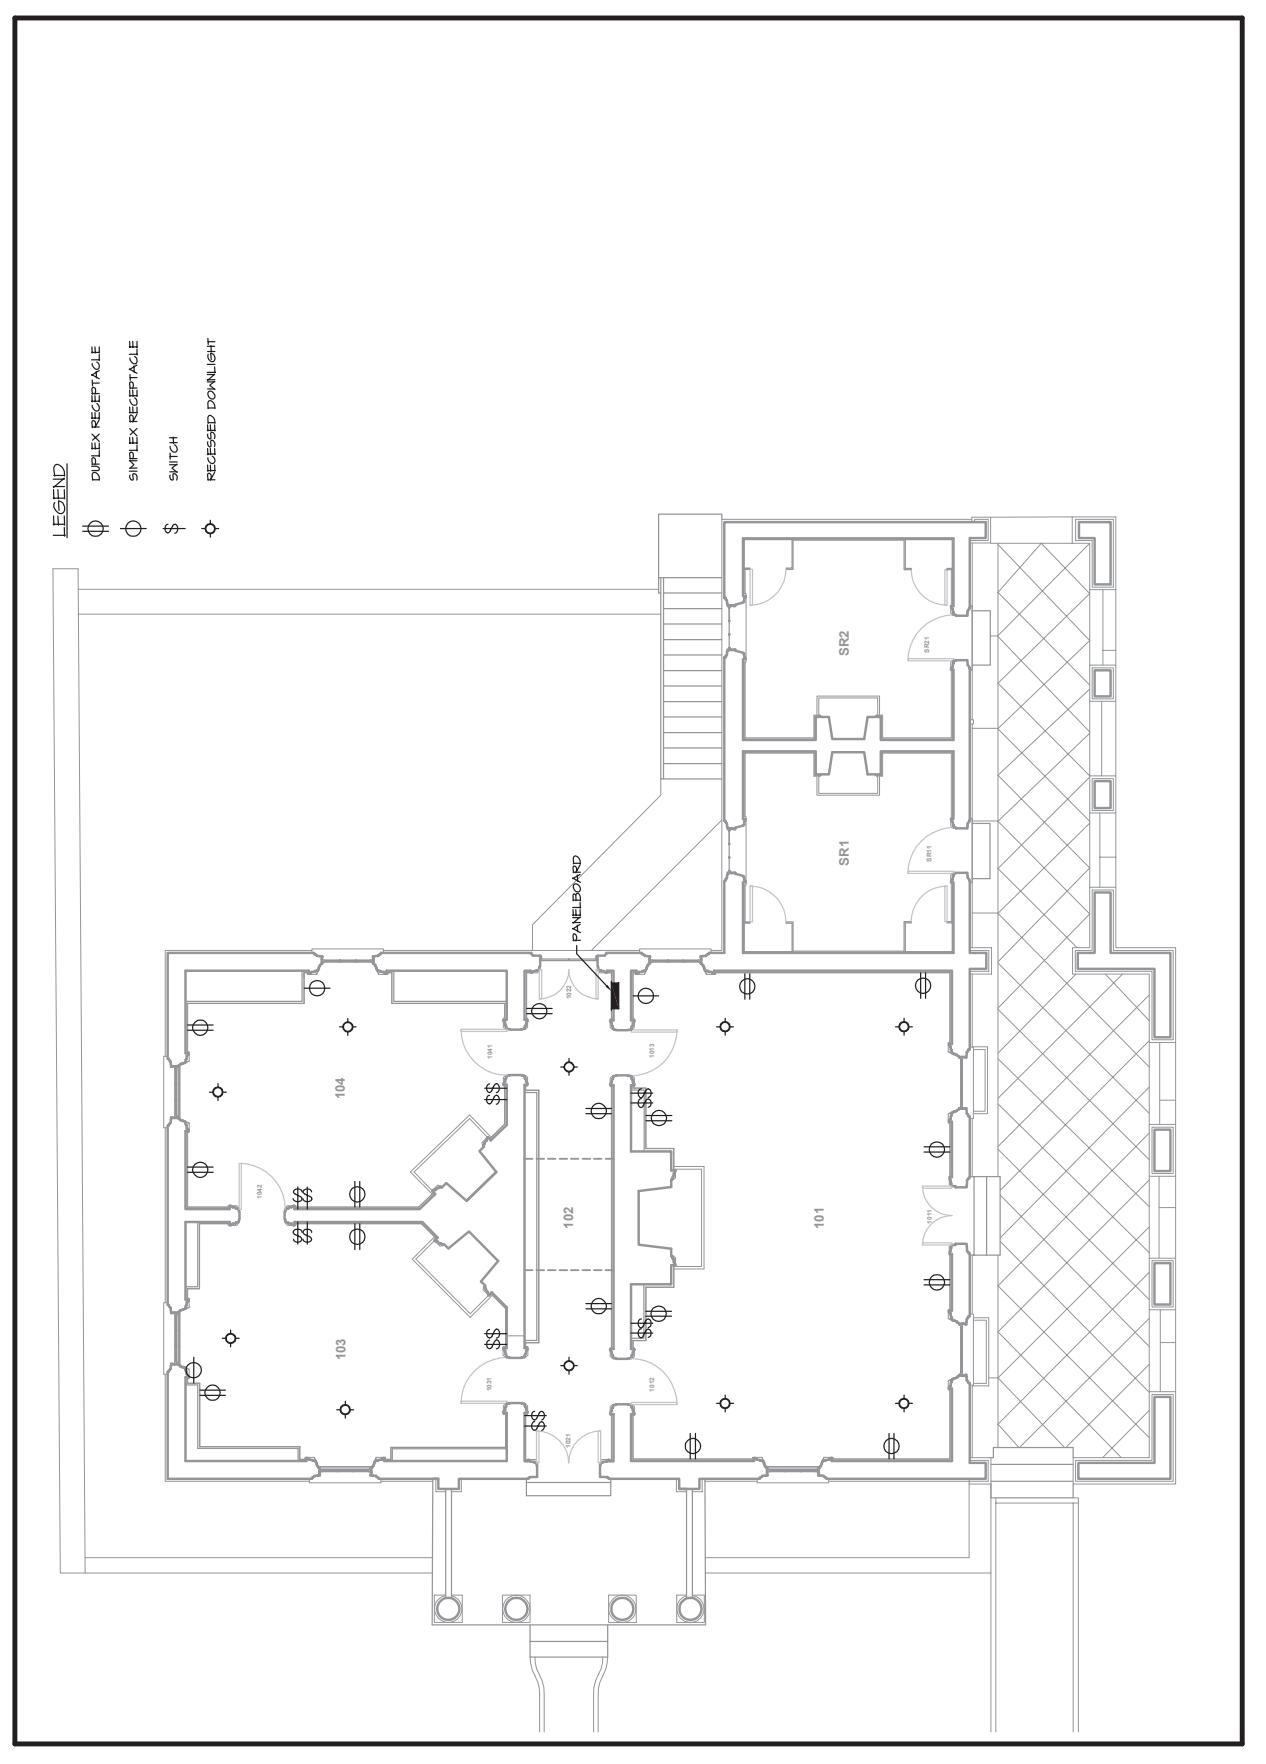
First Floor Electrical Plan

Both panelboards appear to be recently installed and are in good condition. The panel directories have not been labeled. Proper circuit labeling and documentation should be enforced to avoid confusion.

Much of the branch circuiting on the first floor is 1950's vintage or older and has been reconnected to the new panel board on the first floor. This wiring is beyond its useful life and should be replaced.
