McGUFFEY COTTAGE

H I S T O R I C S T R U C T U R E R E P O R T

HISTORIC STRUCTURE REPORT

JOHN G. WAITE ASSOCIATES, ARCHITECTS
2018

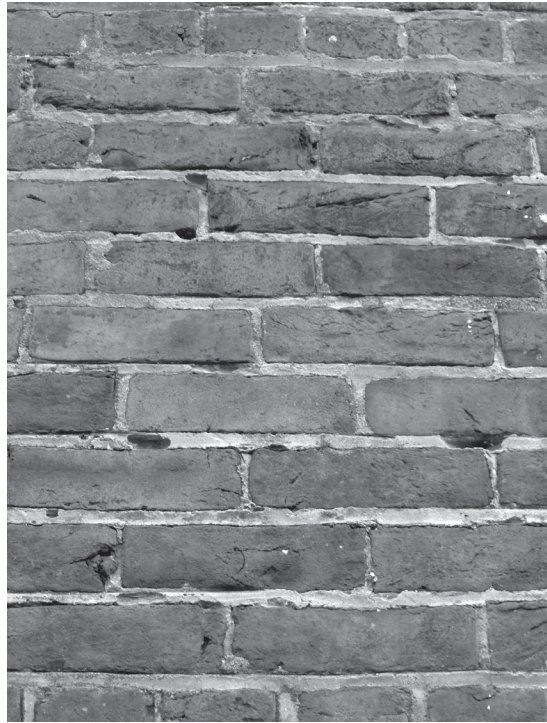
8. The repointing mortar is generally hard Portland cement mortar that is grey to beige to tan in

Figure 69. There are open pockets in the mortar joints near the center of the north elevation.

color. The hard mortar is not compatible with the soft handmade brick.

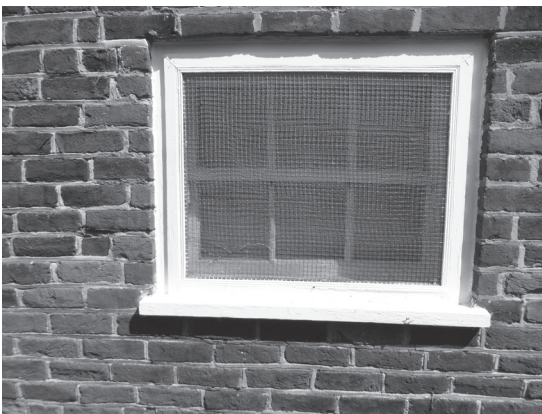
Figure 72. The hardware cloth covering the insect screens at the window openings is visually obtrusive.
