PAVILION VIII

UNIVERSITY OF VIRGINIA

HISTORIC STRUCTURE REPORT

JOHN G. WAITE ASSOCIATES, ARCHITECTS PLLC
2017

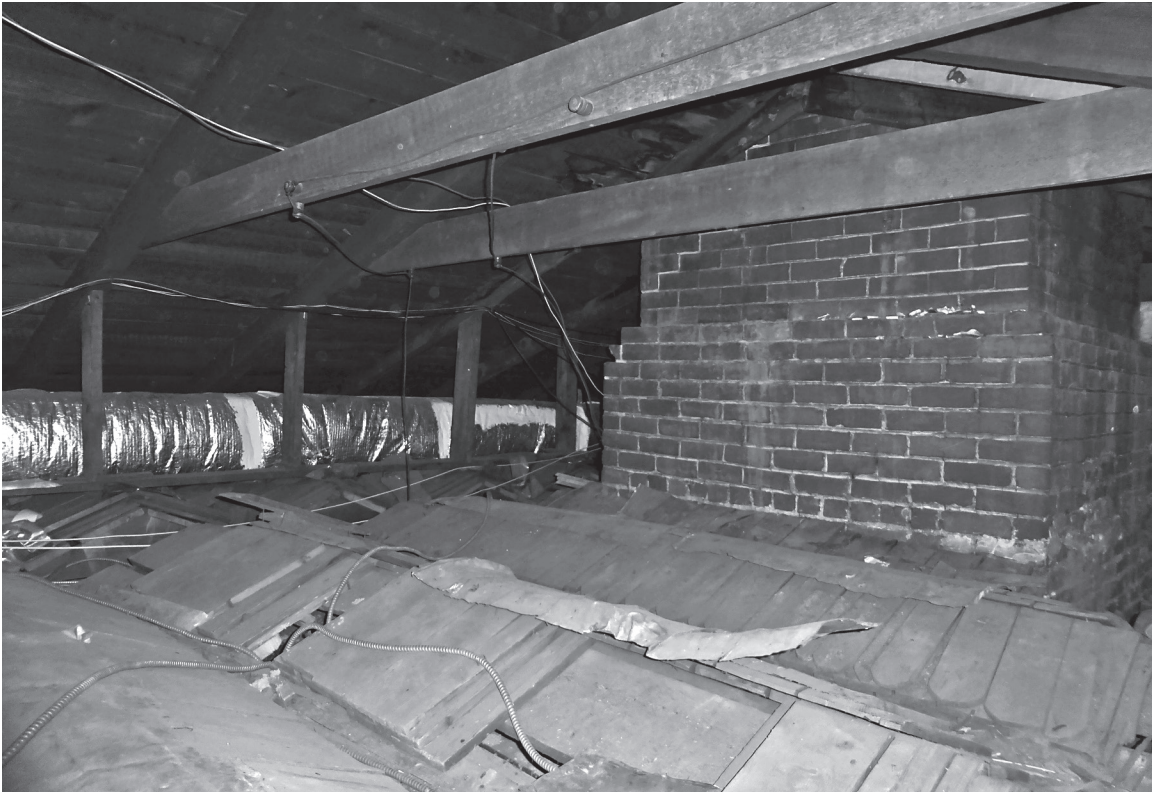
Attic above 1823 pavilion, looking northeast, with the surviving ridge-and-furrow roof and sheet metal flashing in the foreground.

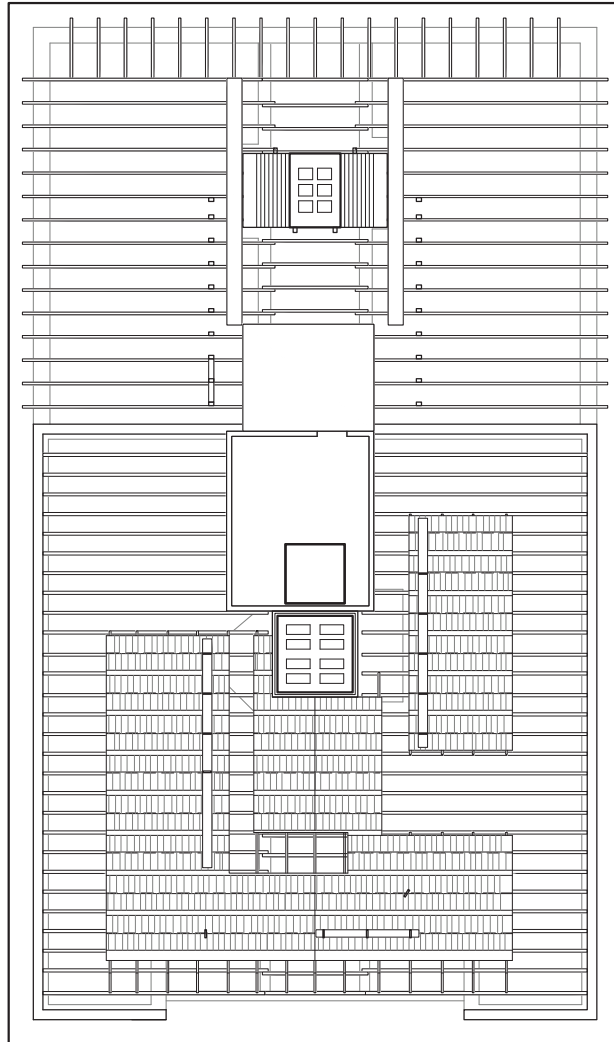
Attic plan
Note fragments of Jefferson's ridge-and-furrow roofing remaining at the west end of the attic.
