PAVILION X

EXTERIOR RESTORATION PLAN

E X T E R I O R R E S T O R A T I O N P L A N

MESICK COHEN WILSON BAKER
ARCHITECTS

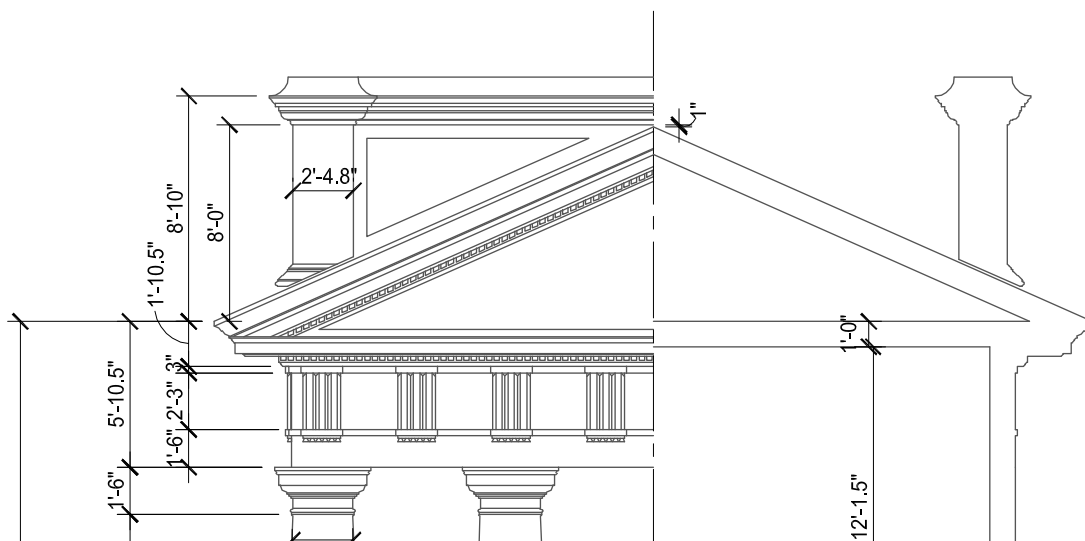
Figure 13. Detail of parapet at apex of pediment. Note the 1" clearance of the molding at peak.

As the accompanying elevation shows, the Attic parapet was designed to allow the upper molding profiles to miss the apex of the pediment by about one inch (Figure 13). Jefferson’s figures for the actual size of the parapet reveals that he simply proportioned the Attic parapet to fit his overall desired dimension in the same way that we would manipulate the size of an image on a copy machine. The “minutes” of the proportional system of the Attic story have no relationship whatsoever to the proportional system of the Doric order below, except that the width of the pilasters within the parapet was specified to be the same as the width of the diminished diameter of the Doric columns.

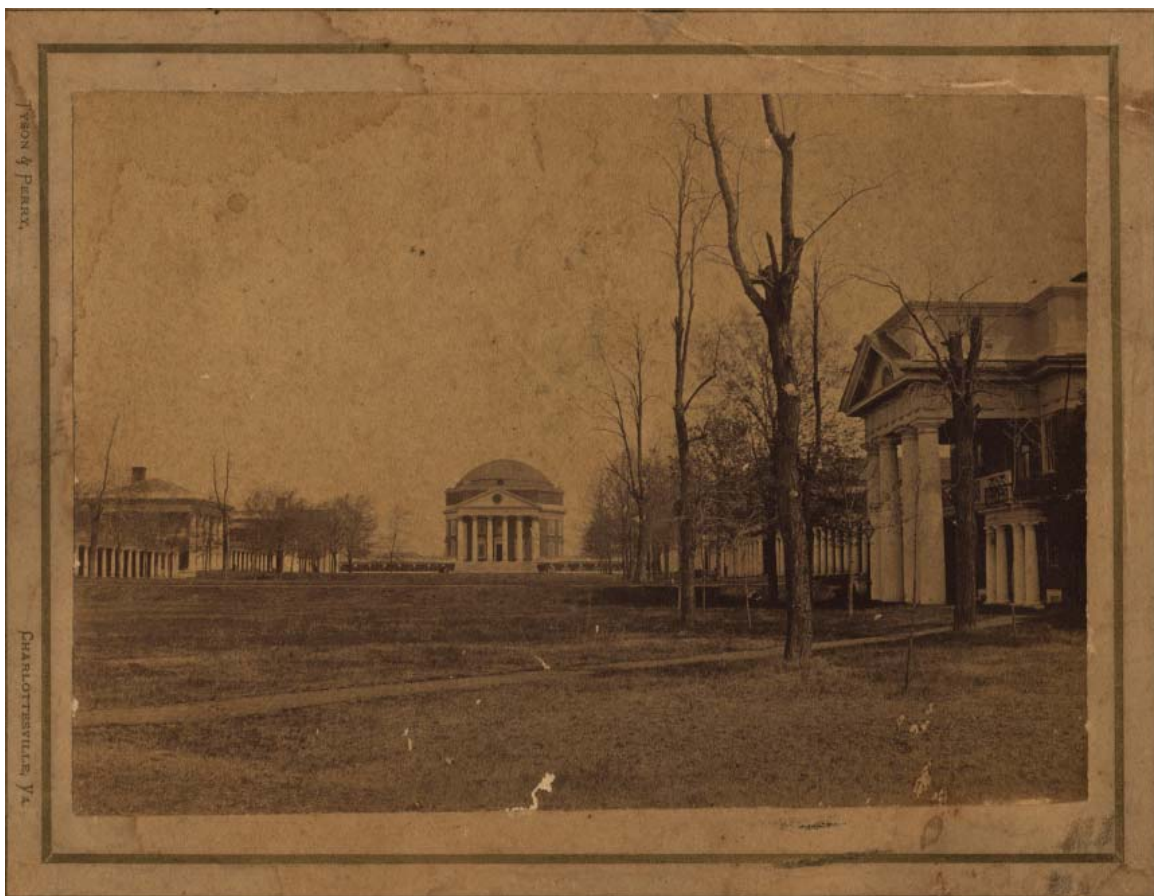
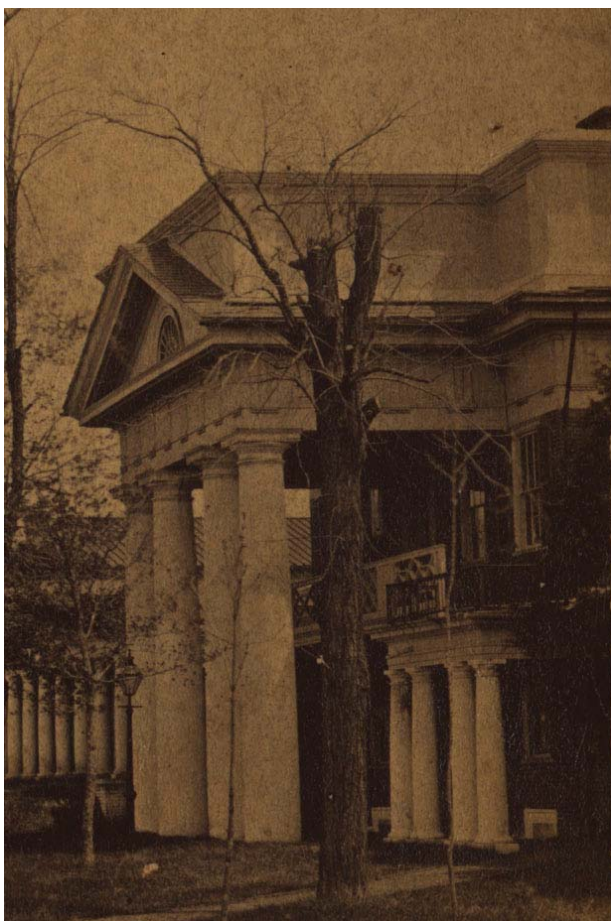
The parapet was removed from the building sometime in the early 1890s, but one photograph survives that shows the front third portion of the parapet as it extends out over the portico (Figure 14 + 14a). This photograph informs us that there were panels within the dado of the parapet, and the width of the margins of the dado is discernable. Unfortunately, there are no known early photos of the north and south sides of the pavilion, but John Nielson’s drawing of the south elevation of the Academical Village (N-354) not only shows the parapet but also shows a large panel situated along its center portion (Figure 15 + 15a). Since the rendering closely matches those portions of the parapet captured in the early photograph of the building, there is no reason to believe that Neilson’s depiction of the remainder of the parapet is not equally accurate.

Figure 14 and 14a. View of the Lawn. Before 1896. Pavilion X at the right edge of image. Detail (left) showing the parapet in situ. Albert and Shirley Small Special Collections Library, University of Virginia.

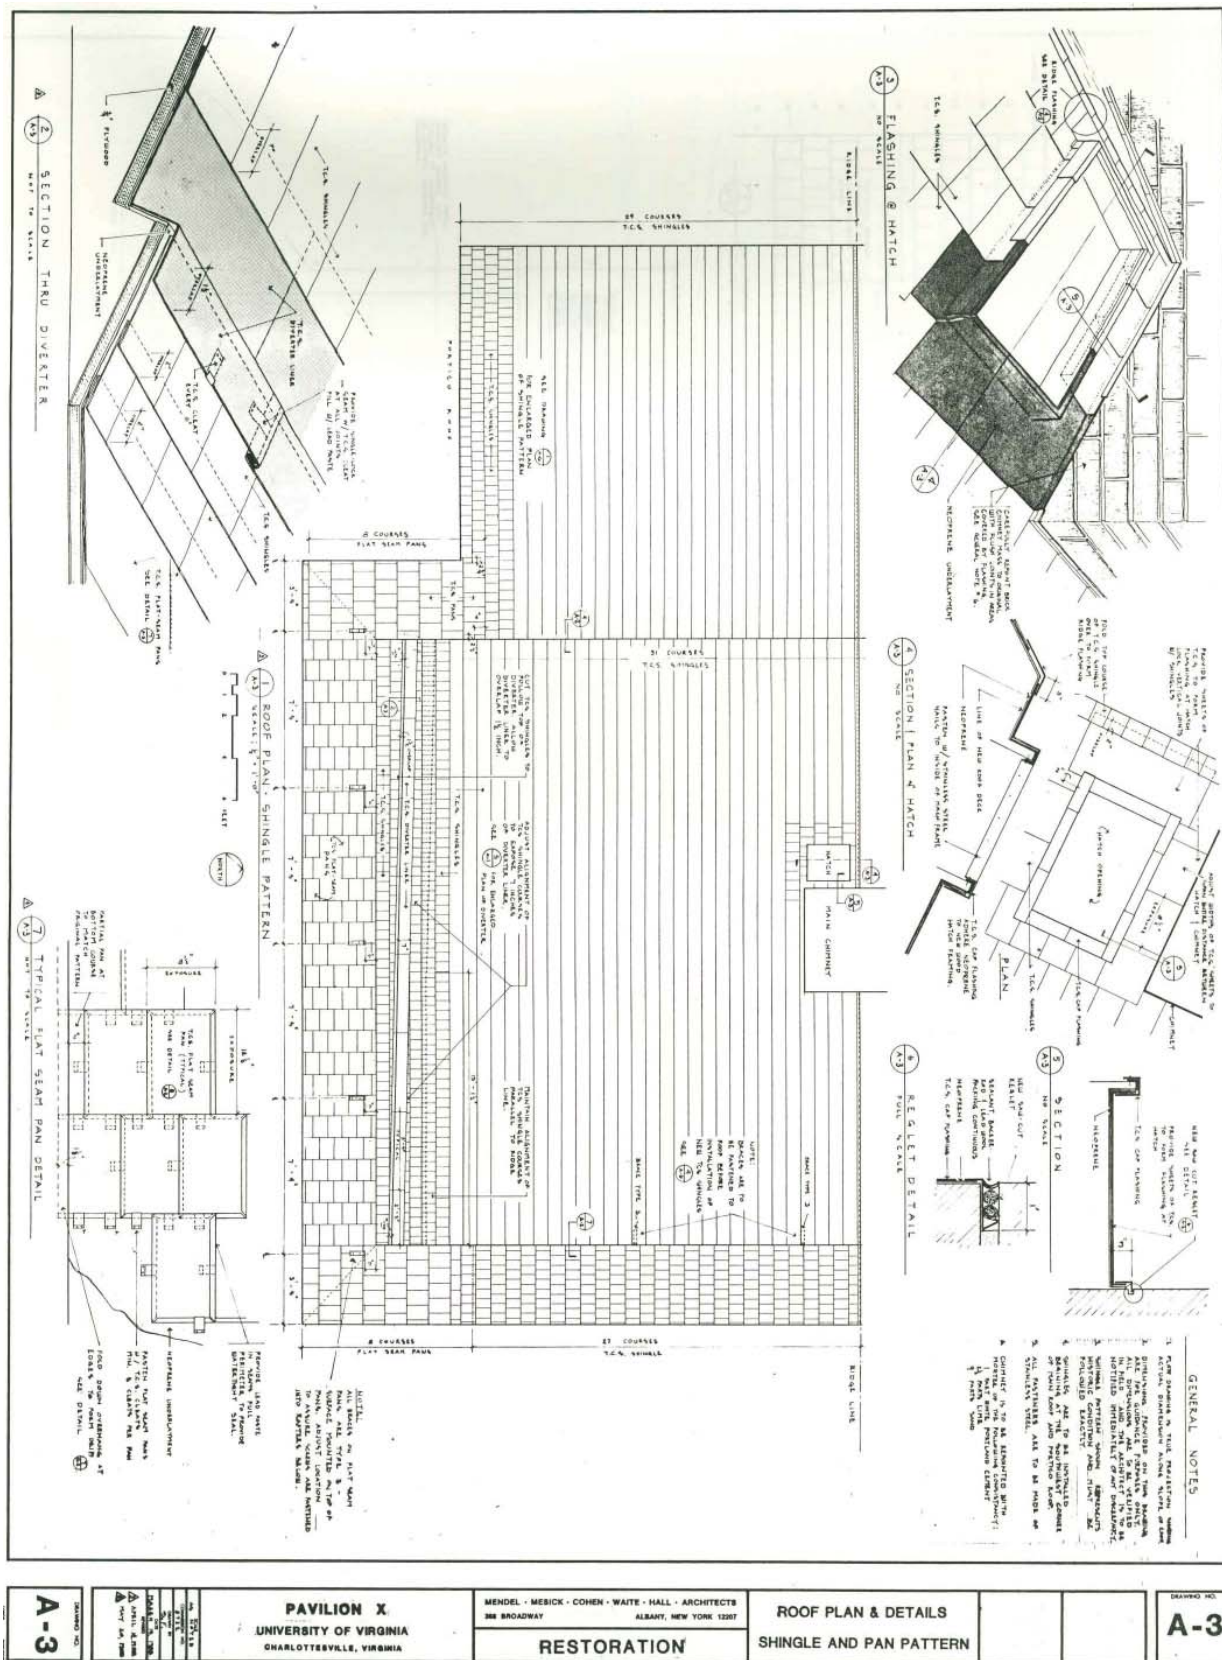
Figure 29 Pavilion X Roof Restoration. Sheet A-3 Roof Plan and Details. Shingle and Pan Pattern. Mendel Mesick Cohen Waite Hall Architects. March 1986.

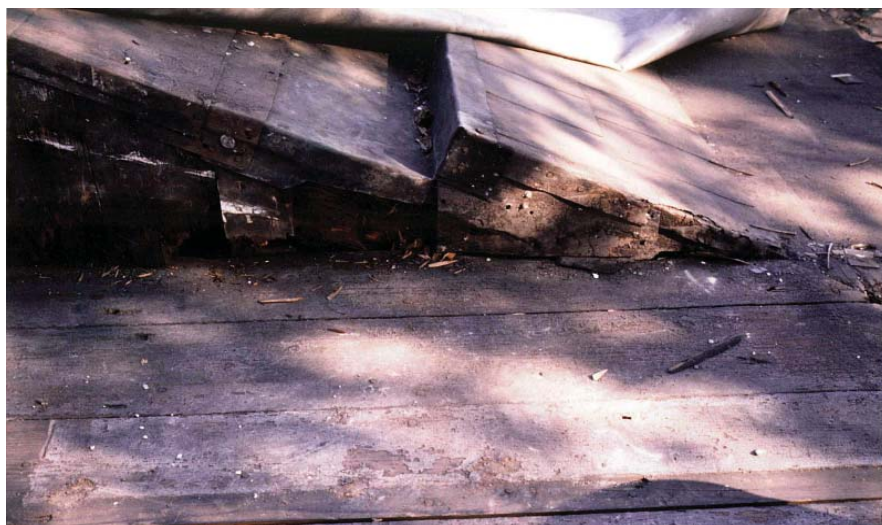
Figure 31 Detail of original downspout.

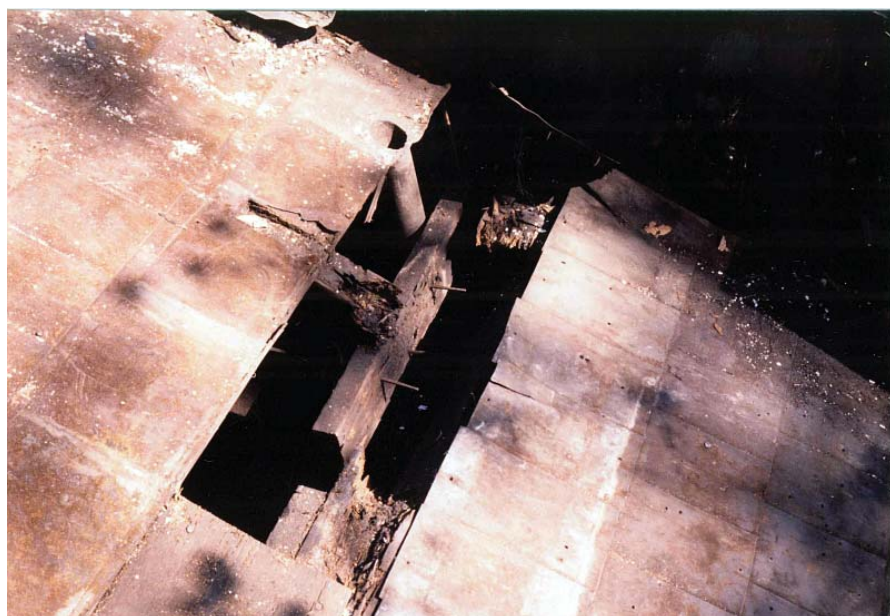
Figure 32 Fragment of an original roof bracket for the parapet.

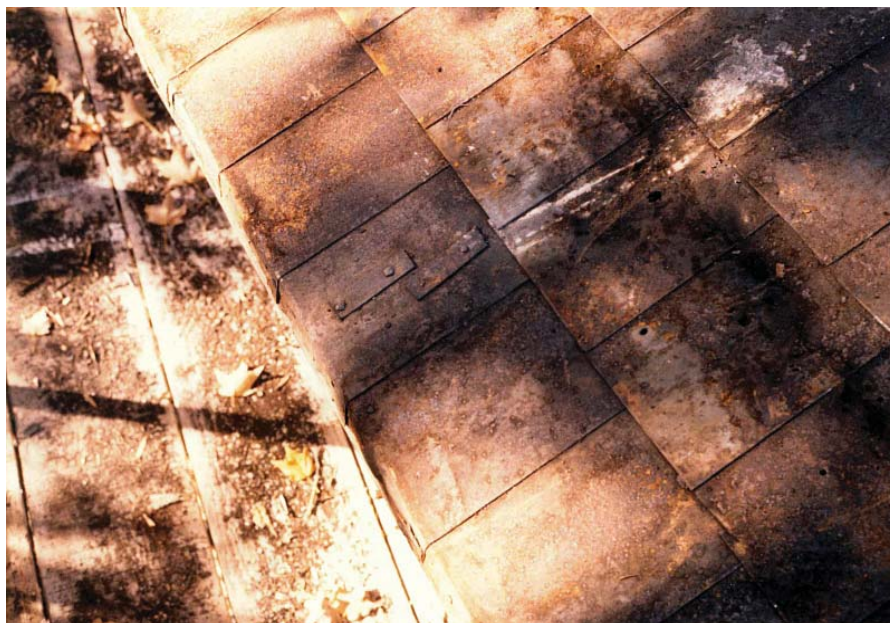
Figure 33 New stainless steel brackets were installed during the 1987 roof restoration in anticipation of restoring the parapet at a later date.

In 1987 the later period standing seam roof was removed and it was discovered that the original tin plated iron roof was encapsulated below (Figures 26-28). The earlier roof was carefully recorded and a new terne-coated stainless steel roof was designed to replicate the layout and original appearance of the original roof (Figure 29). The new roof once again encapsulated the historic tin shingles and a plywood separation layer and an EPDM membrane was laid down before the new shingles were installed. It was fortunate that the original roof was not removed when the standing seam roof was applied because very clear evidence survived of the original Philadelphia gutter, the locations of the original downspouts and the iron brackets that once held the enormous parapet up and off the roof (Figures 30-32). In fact, several of these brackets survived in-situ and were simply bent down before the later roof was installed. When the roof was installed, new stainless steel brackets copying the original brackets were fastened to the roof at the same locations in anticipation of the day when the parapet is restored to the building (Figure 33).

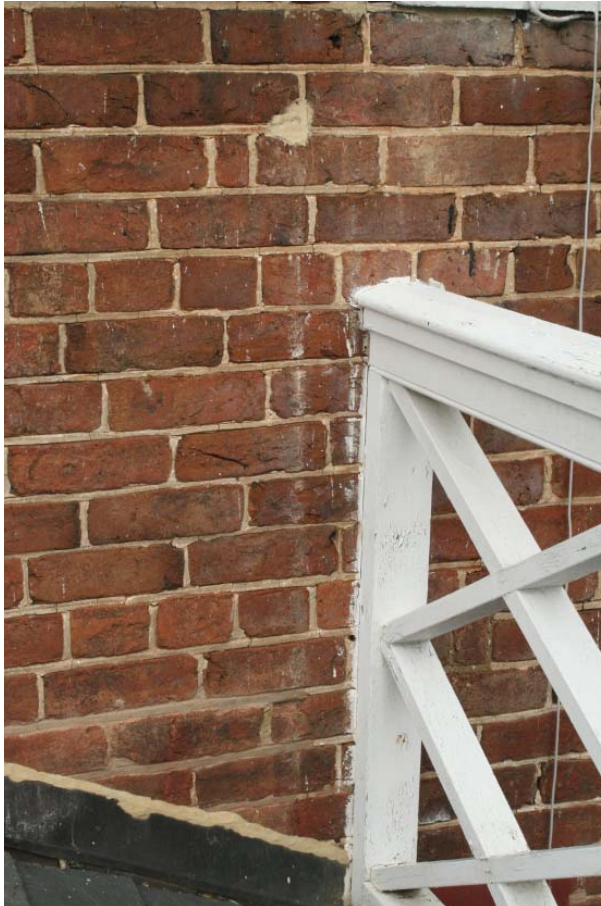
Figures 38 Scars and ghosts show the location of where the original Chinese rail joined the side-walls of Pavilion X.

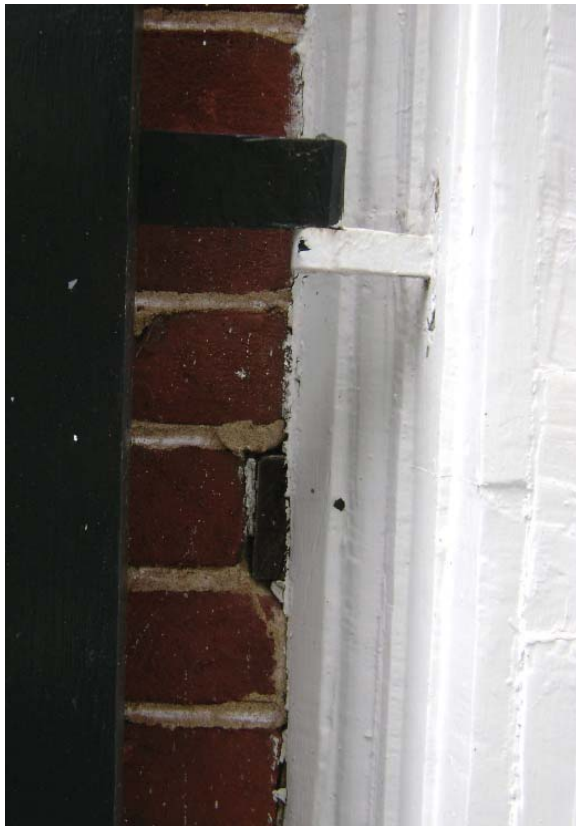
Figure 39 A portion of the original sill for the window in figure 37 remains buried in the masonry wall.

Removal of Jefferson fabric did not end in the 1830s. When the 1877-8 addition was constructed, the northern window at the first floor of the east façade was extruded down and made into a door that evidently opened into the wood porch constructed along the north wall of the addition (Figure 39). Evidence that this was once a window is clear. The architraves of the door/window each have a joint in the woodwork at the former window sill level. Moreover, a portion of the original sill was buried in the masonry wall of the addition and simply cut off (Figure 39). It is important to note that this opening was once again turned into a window by inserting a wood panel beneath the sash. The moldings within this panel reveal that it was actually made by cutting down a door, and it is possible that the door was from the Jefferson period, however its origins are unknown (Figure 39a). A second door opening was created at the bottom of the main stair that allowed access directly to the addition from the stair hall. This opening could only have been created by cutting through the original brickwork of the east façade.

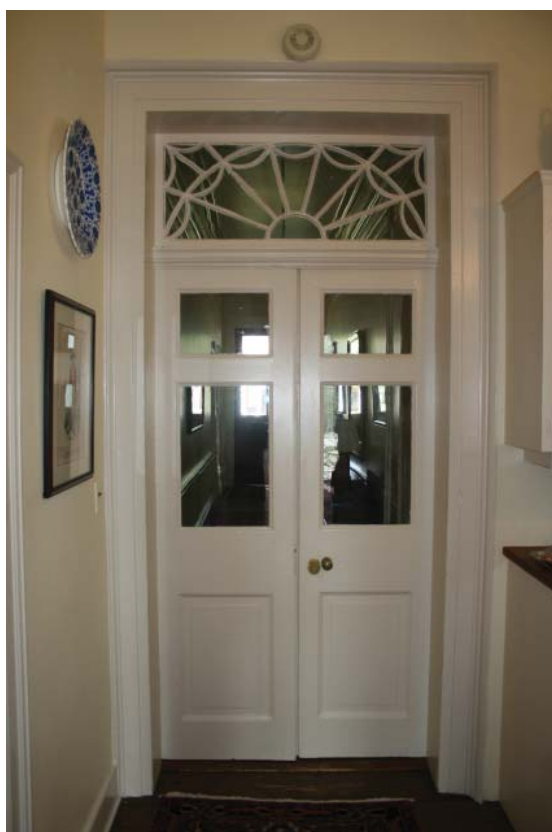
Figure 41

The original back (east) door together with its transom remains in place at the end of the center passage, enclosed by the later addition constructed off the rear of the pavilion (Figures 40 & 41). The cellar doors which lead from the pavilion into the basement area under the addition are also original to the pavilion's construction (Figure 42).

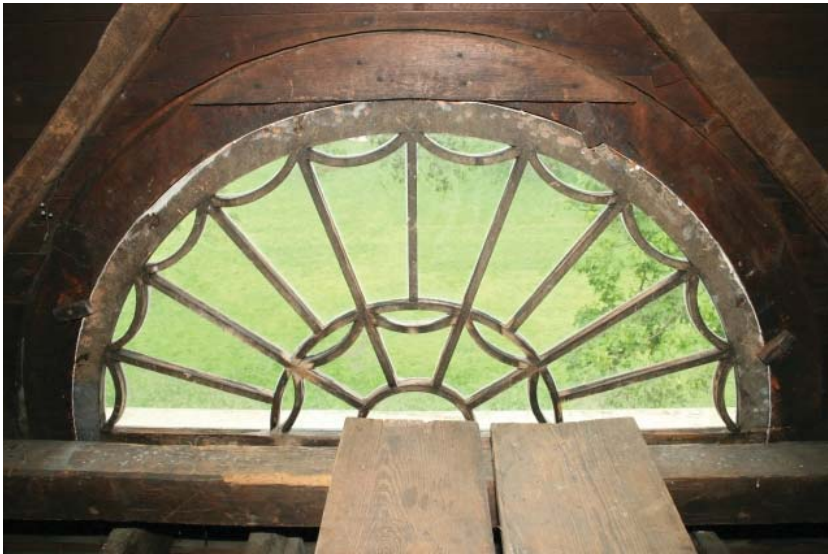
Figure 45 West attic fanlight. Inspection of the fanlights concluded that they were both later additions. Of the two fanlights the west sash appeared to be earlier, possibly dating to the late nineteenth century. The east sash appeared to date to the twentieth century.

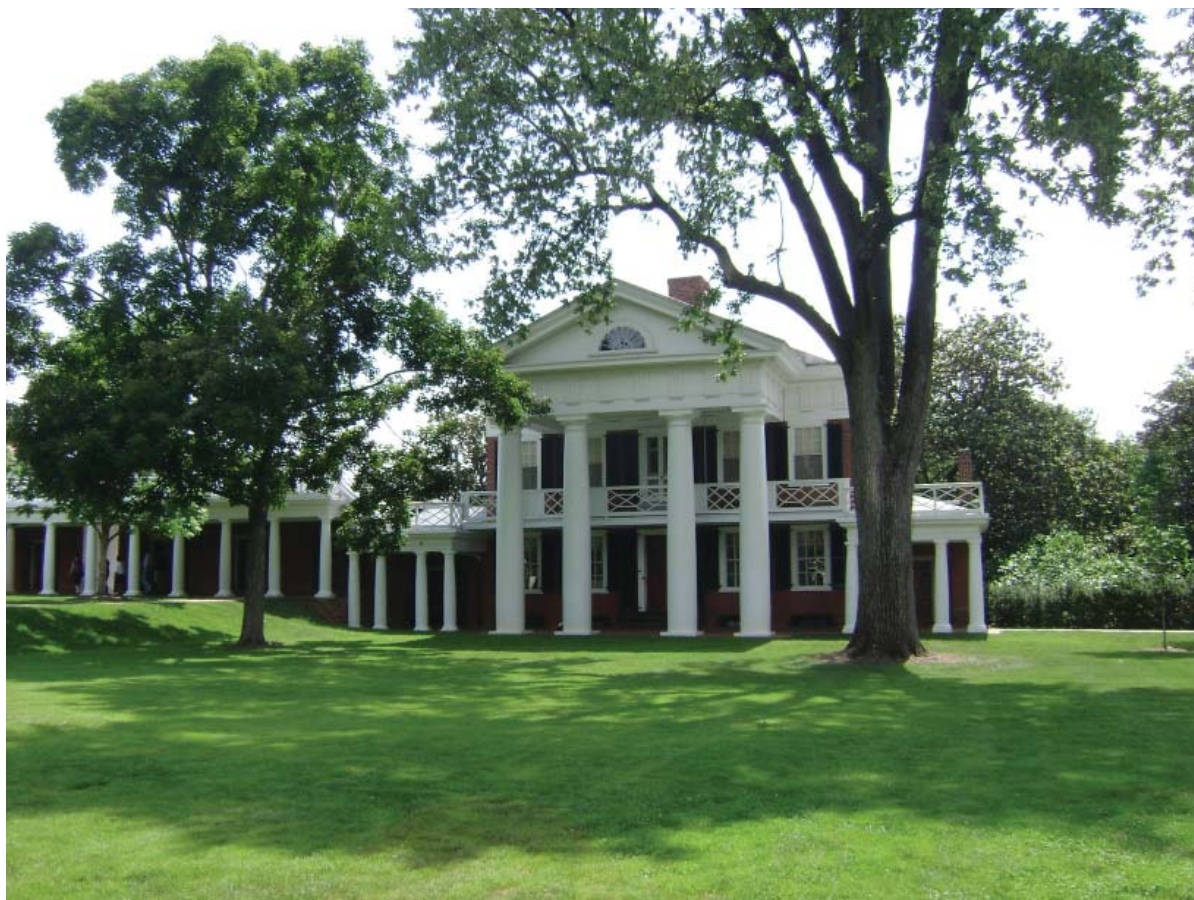
West (front) elevation

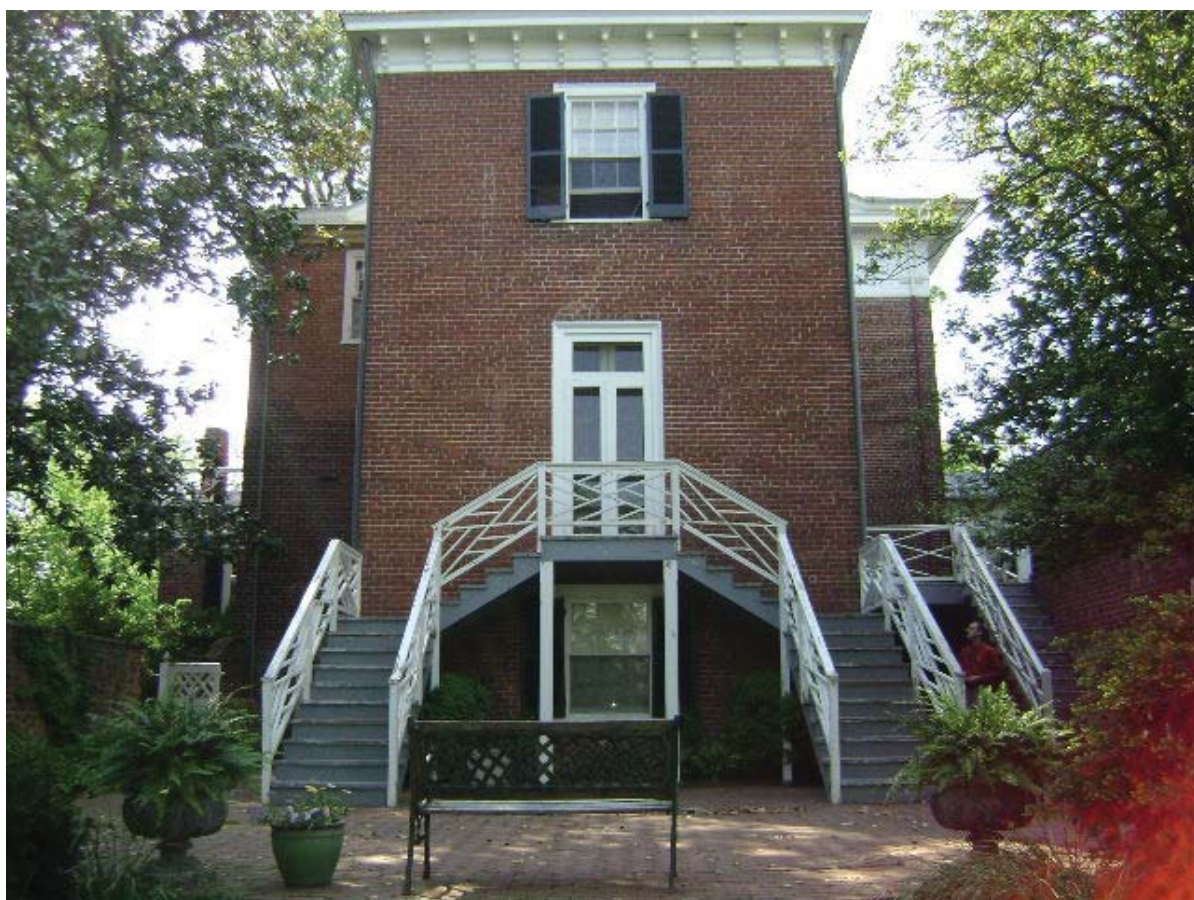
East (rear) elevation

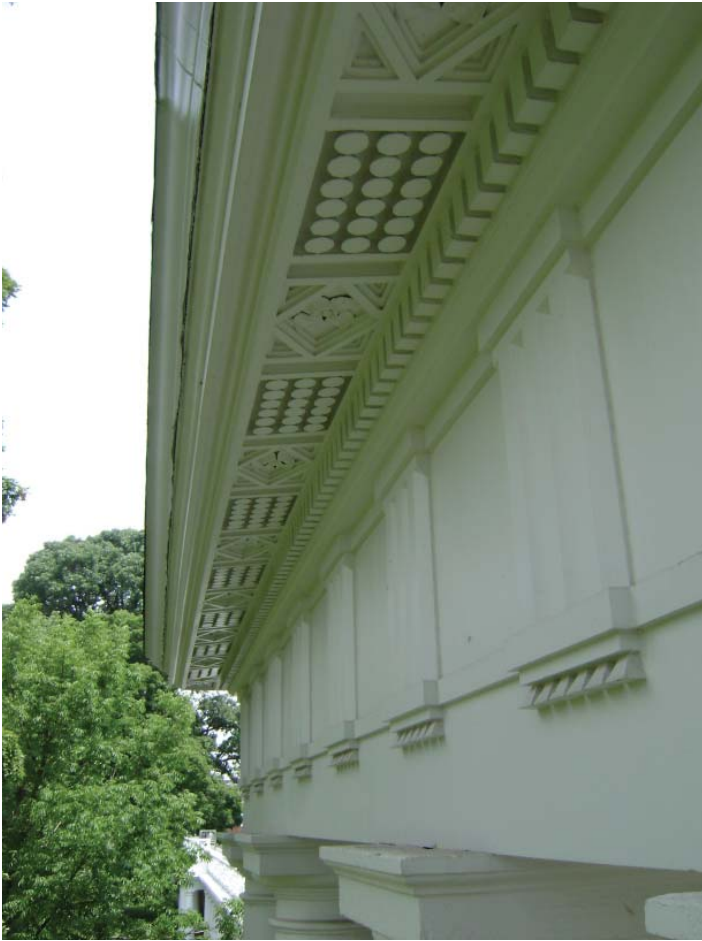
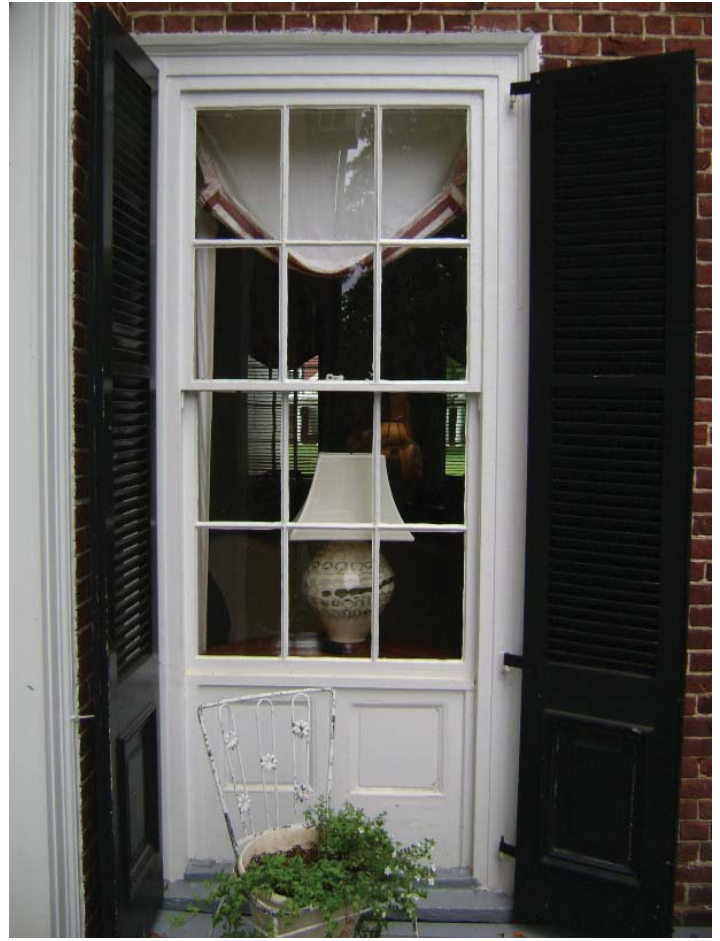
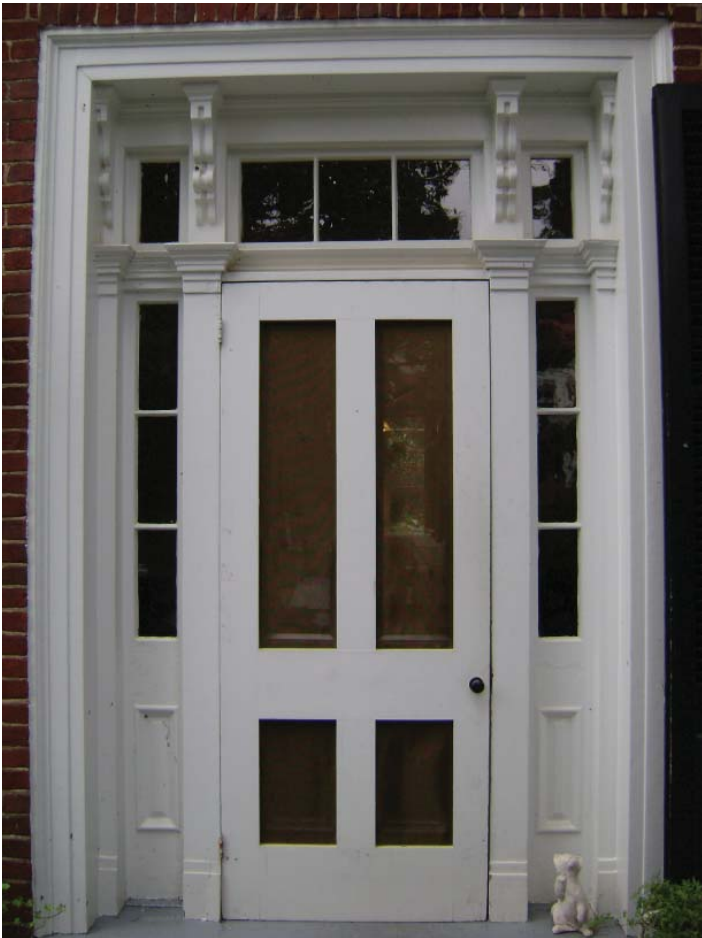
Upper left: Detail of entablature
 Upper right: North window opening on east elevation.
 Bottom left: East door opening

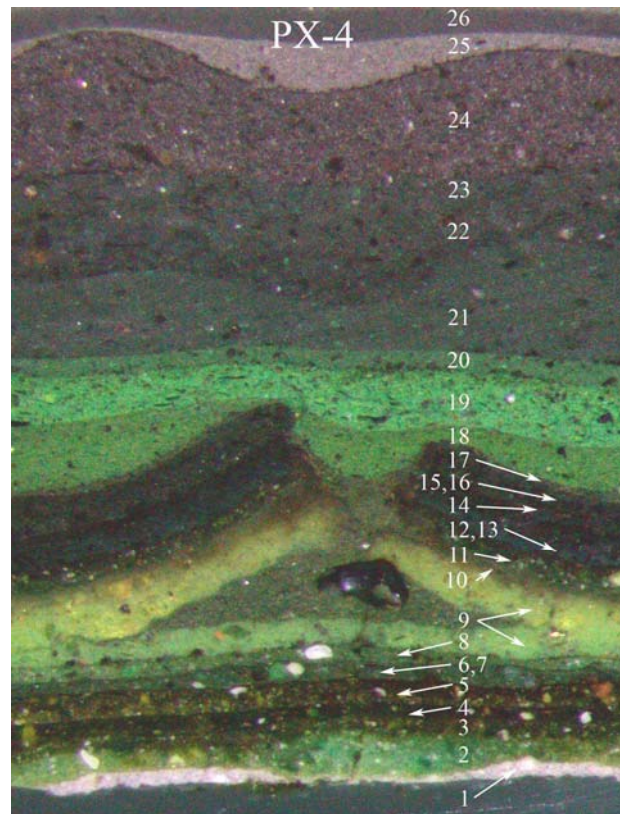
Pavilion X blind, west elevation

Addition blinds: A sample from a blind on the addition displays an initial finish made up of an off-white primer followed by a medium green finish that lines up with the 9th or 10th layer on a sample from one of the original blinds.
