THE THOMAS H. BAYLY BUILDING AT THE UNIVERSITY OF VIRGINIA

HISTORIC STRUCTURE REPORT.

November 8, 2013

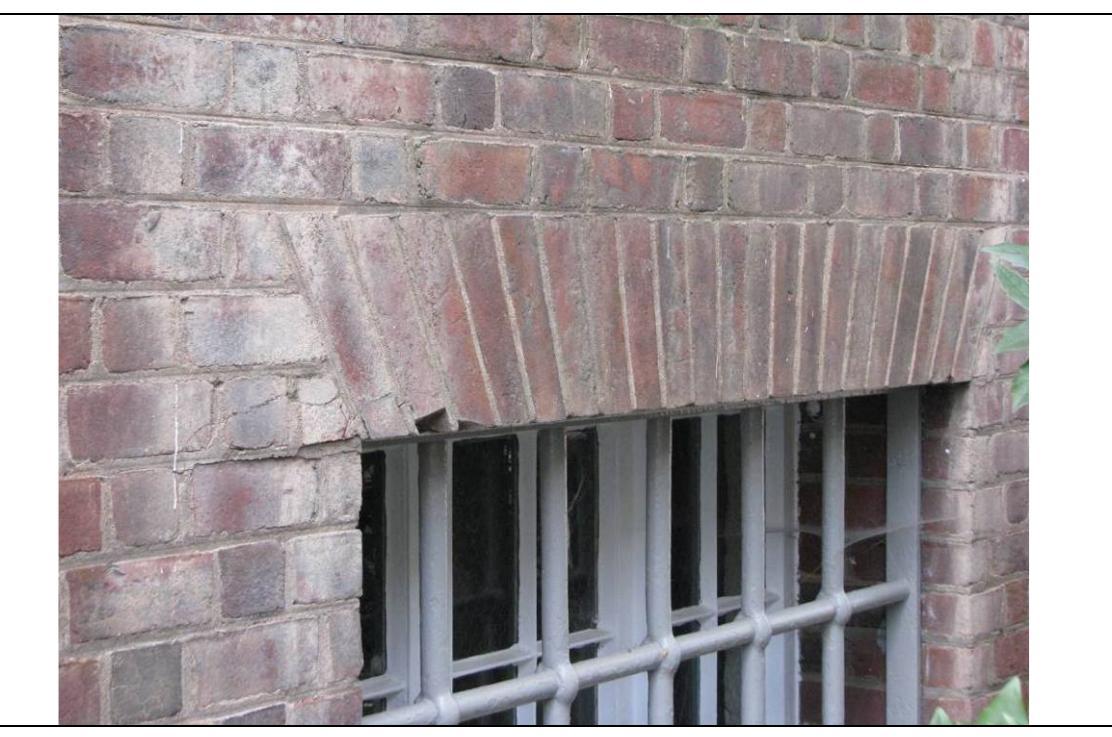
The facades are primarily composed of Flemish-bond brick fields framed within brick pilasters. Grapevine-tooled mortar joints vary between ³/₈-inch and ¹/₂-inch wide. Areas of light-colored staining, attributable to slough-off of weathered paint, are generally visible below the windows and at the base of the Portico. Molded brick pilaster capitals show degraded pointing and rough but intact head flashing. Atmospheric soiling is most prevalent at and below the water table and on the terraced west addition. Open

Figure 1.2.3-5: Distressed brickwork at window head, common at West and North facade basement openings. Photograph by John Milner Architects, November 2012.

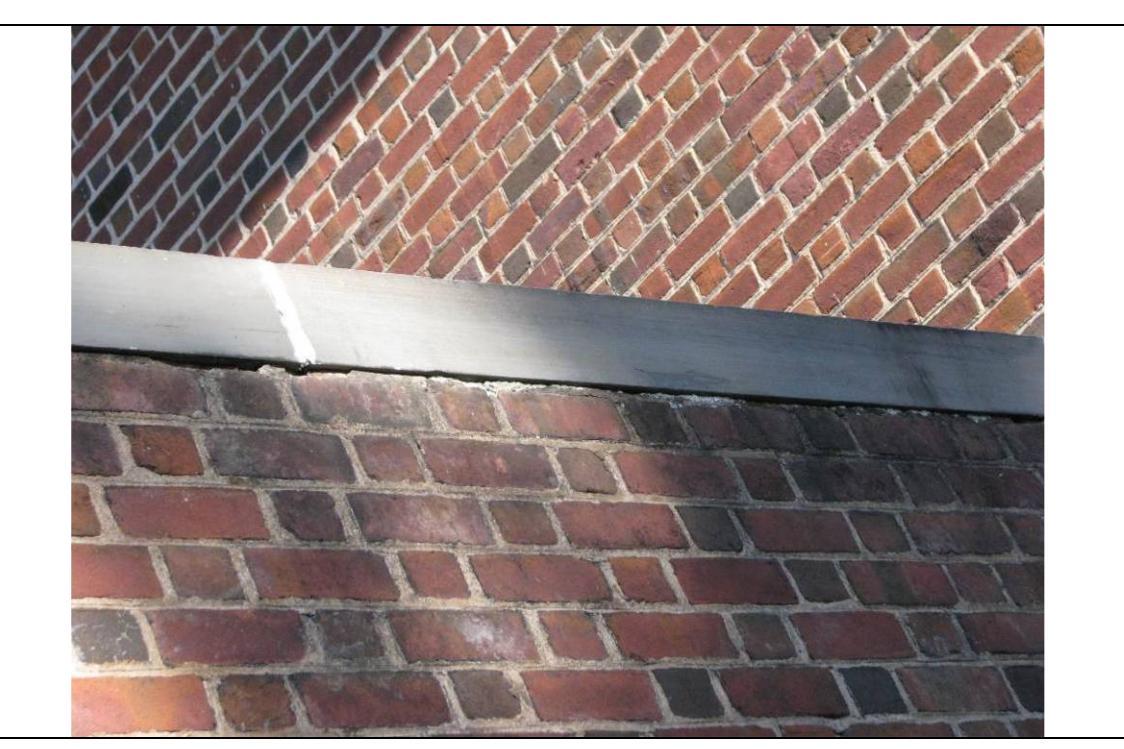
brick joints were noted on the interior side of the West Terrace parapet, attributable to water infiltrating the joints in the stone copings. The coping joints have been sloppily sealed with an inappropriately bright-colored sealant. Old repairs are visible on the exterior side of this parapet. Iron jacking of steel lintels has caused masonry cracks and spalling of jack arches over several basement-level windows and doors at the West and North facades. Abandoned open penetrations are visible at the northeast corner of the building. Areas of distressed brickwork were observed at stair cheek walls located directly south of the East facade [*Figures 1.2.3-2 through 1.2.3-9*].

Figure 1.2.3-6: Open joint below parapet coping at West Terrace. Photograph by John Milner Architects, November 2012.

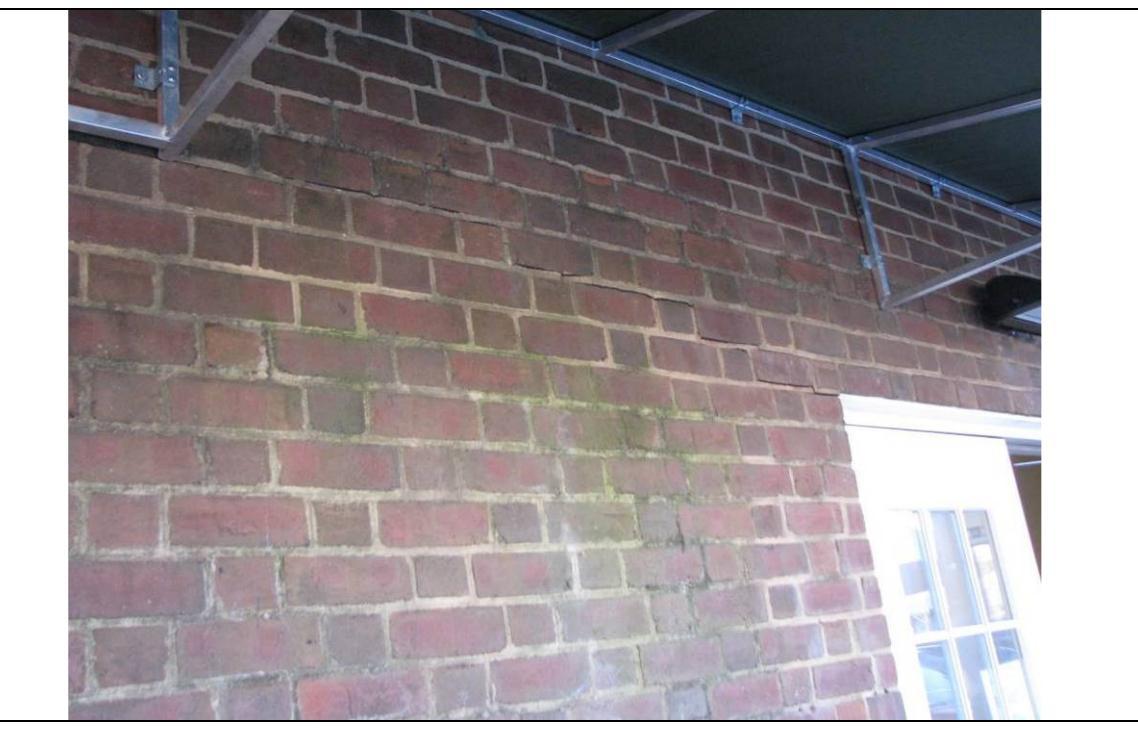
Figure 1.2.3-7: Running crack at Annex door head. Photograph by John Milner Architects, November 2012.

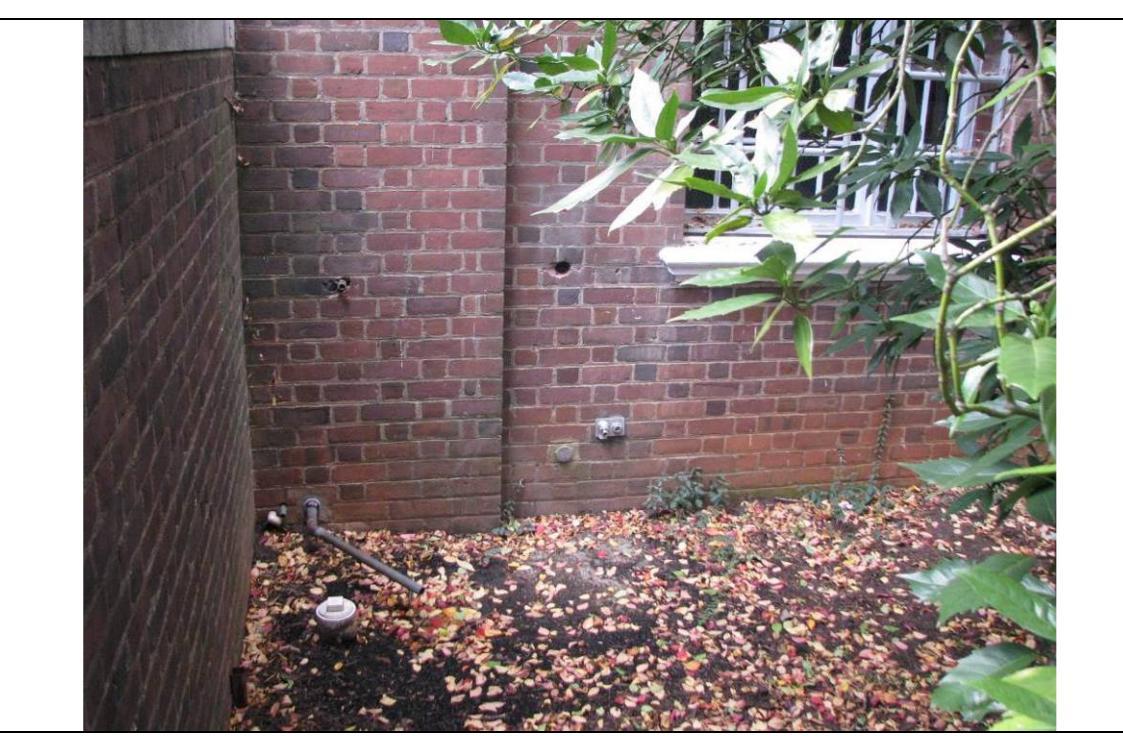
Figure 1.2.3-8: Abandoned open penetrations at northeast corner. Photograph by John Milner Architects, November 2012.

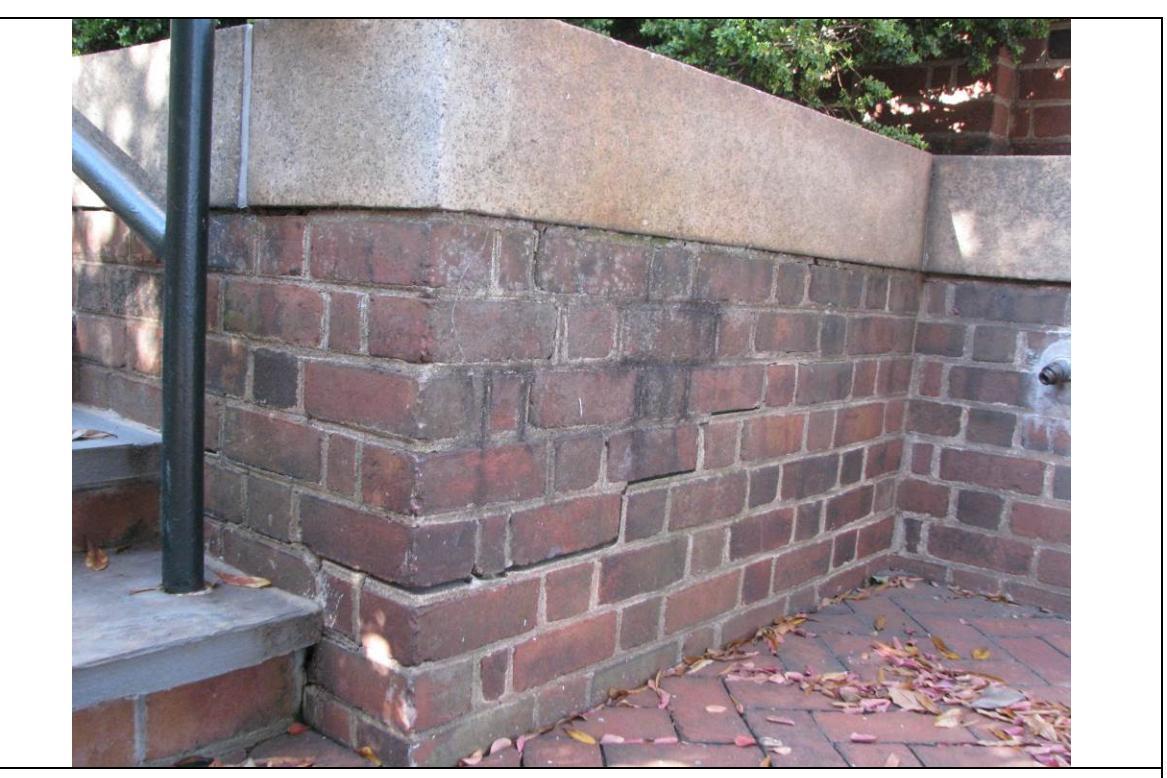
Figure 1.2.3-9: Distressed brickwork at south landscape wall. Photograph by John Milner Architects, November 2012.

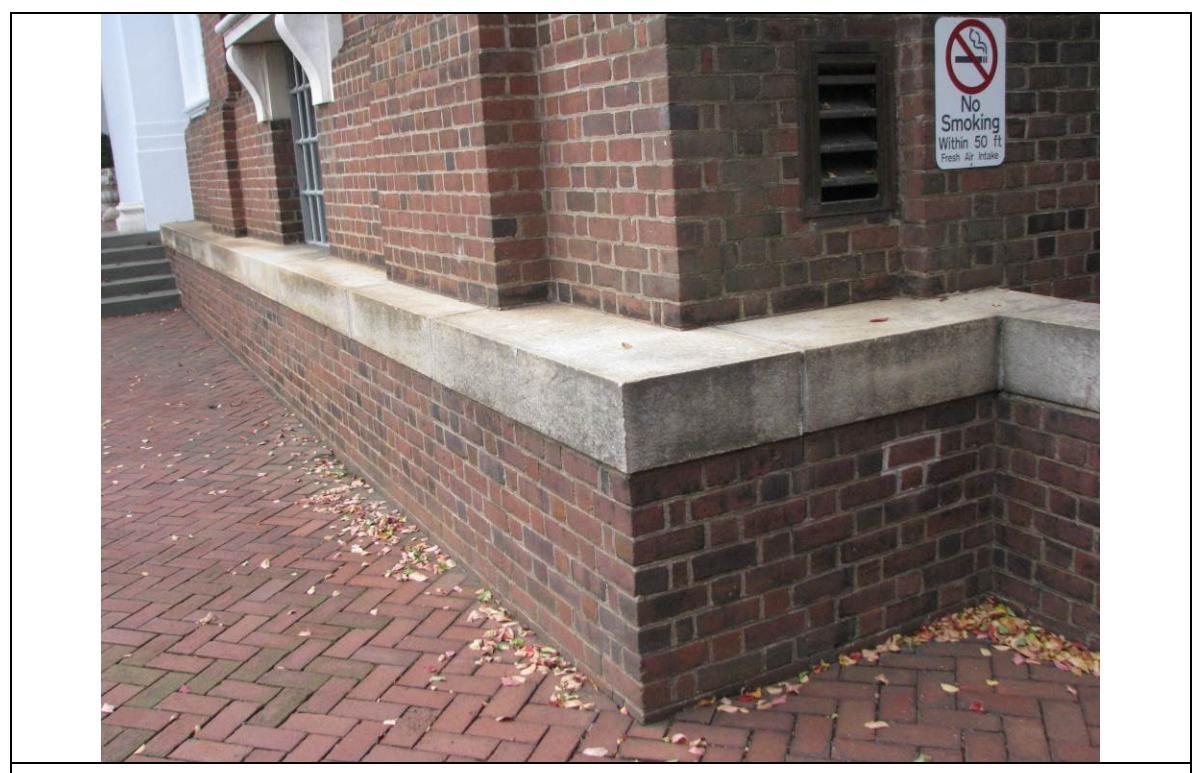
A plinth course of Mt. Airy Granite ashlars runs the length of the East (main) facade, continuing outward as a coping course on low, brick landscape walls. This stonework exhibits heavy atmospheric soiling. The narrow vertical and horizontal joints, generally ³/₁₆-inch thick, have been smeared with an aged, hardened tenacious sealant [*Figures* 1.2.3-10 and 1.2.3-11].

Figure 1.2.3-10: Soiled granite course. Photograph by John Milner Architects, November 2012.

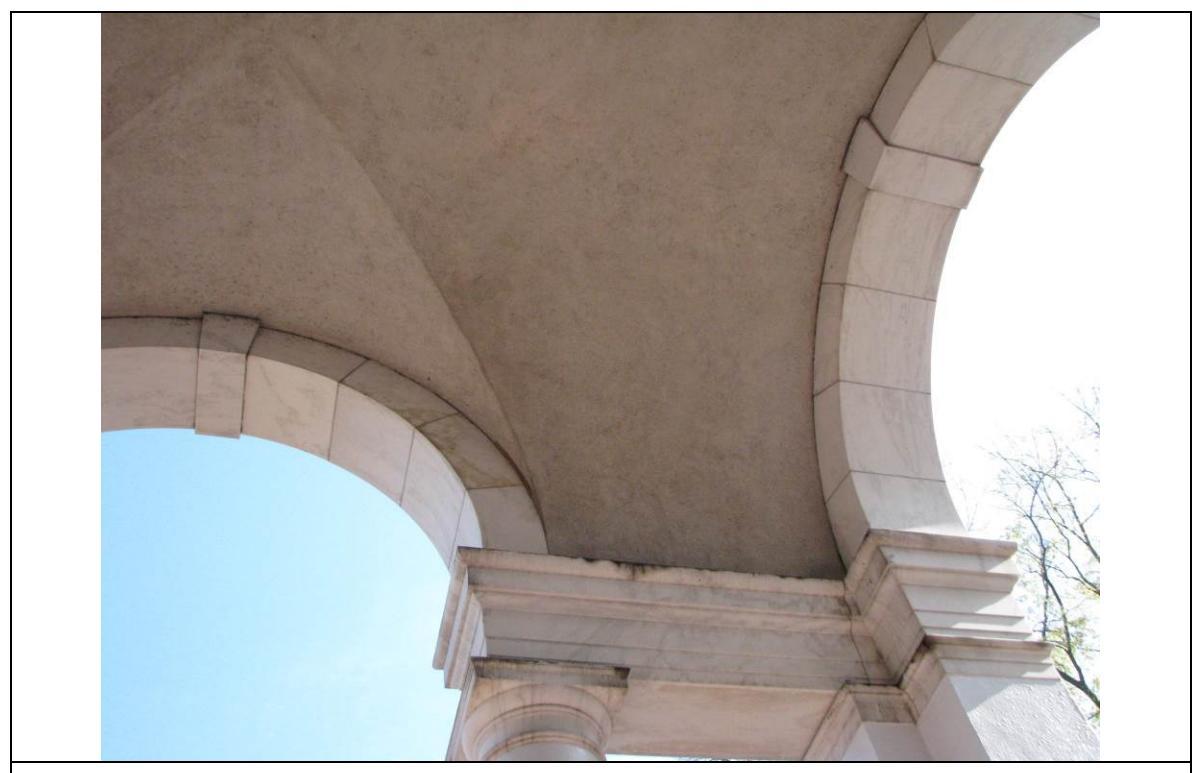
Marble column bases, capitals, imposts, archivolts, and keystones embellish the Portico. Inscribed Botticino marble paneling surrounds the main entrance door. Soiling is generally present within the Portico [*Figure 1.2.3-13*].

Figure 1.2.3-13: Soiling of Portico marble elements, typical. Photograph by John Milner Architects, November 2012.

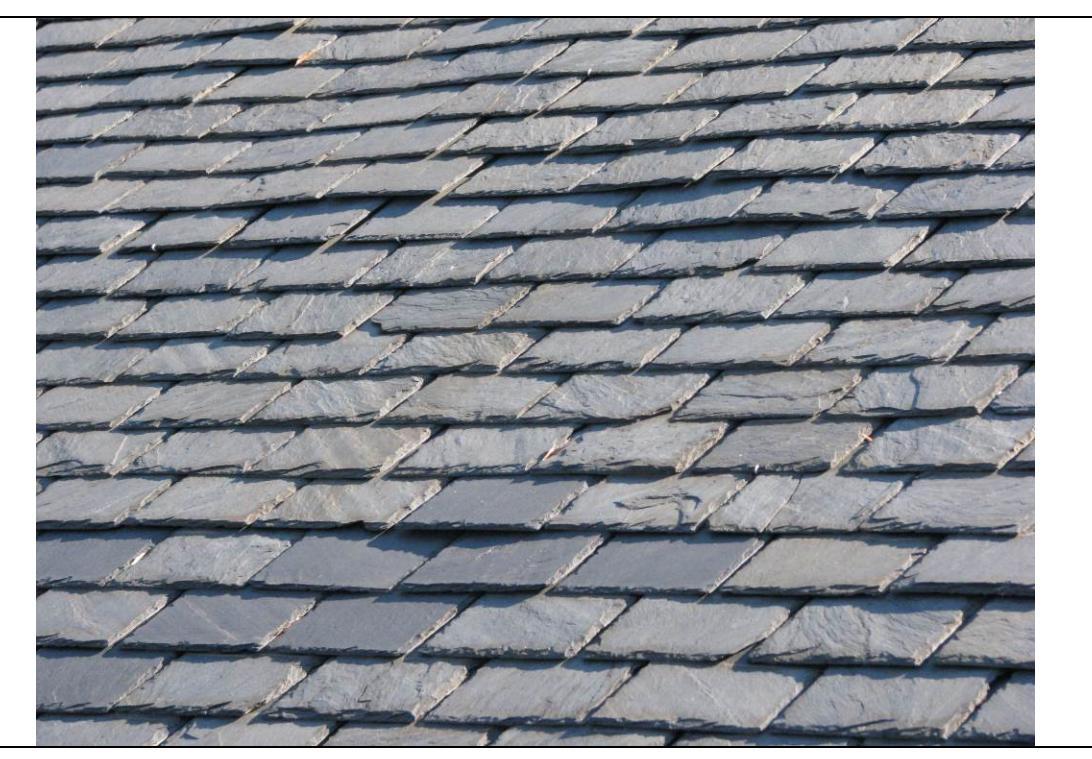
The main hipped roof and Portico roof are of slate construction with EPDM-lined gutters built into the upper cornice. The gray slates measure ¼ inch thick by 10 inches wide by 12½ inches long, with a 7-inch exposure. A circa 1999 field-formed, standing-seam copper roof completes the West elevation, terminating with an EPDM-lined gutter built into the entablature cornice and running continuously around the building. The metal roofs and gutters appear to be in good condition. A sheet-metal ventilator shows a damaged rotating mechanism. The main slate roof exhibits undulations associated with its support structure that negatively affect its integrity and durability. It appears to be marginally serviceable. No leaks were visible or reported. The hips are of the mitered variety, and valleys are of the open type. The ridge is improperly installed, without a saddle, ridge strip, or metal cap, and is filled with failing sealant. Broken and displaced tiles were observed, especially at the hips. Multiple areas of replaced slate are visible [*Figures 1.2.3-20 through 1.2.3-22*].

Figure 1.2.3-21: Slates susceptible to breakage at roof undulations. Poorly matched patch in foreground. Photograph by John Milner Architects, November 2012.

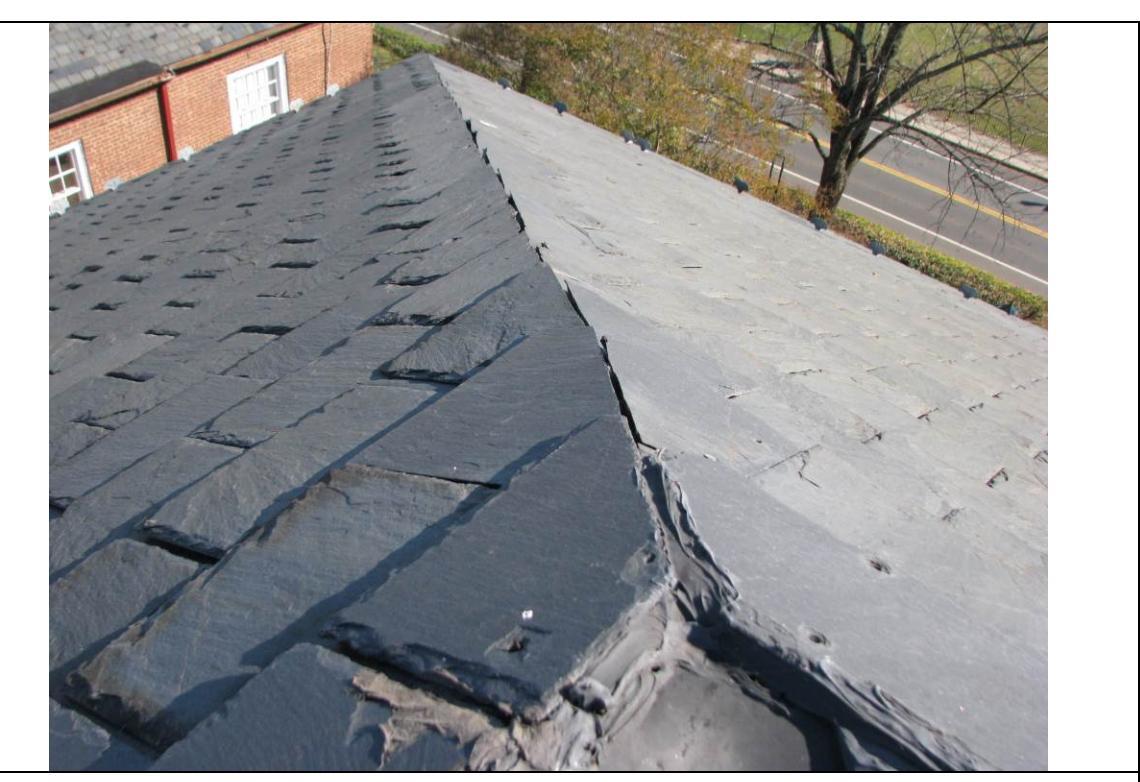
Figure 1.2.3-22: Mitered hip joint and caulked open ridge. Photograph by John Milner Architects, November 2012.

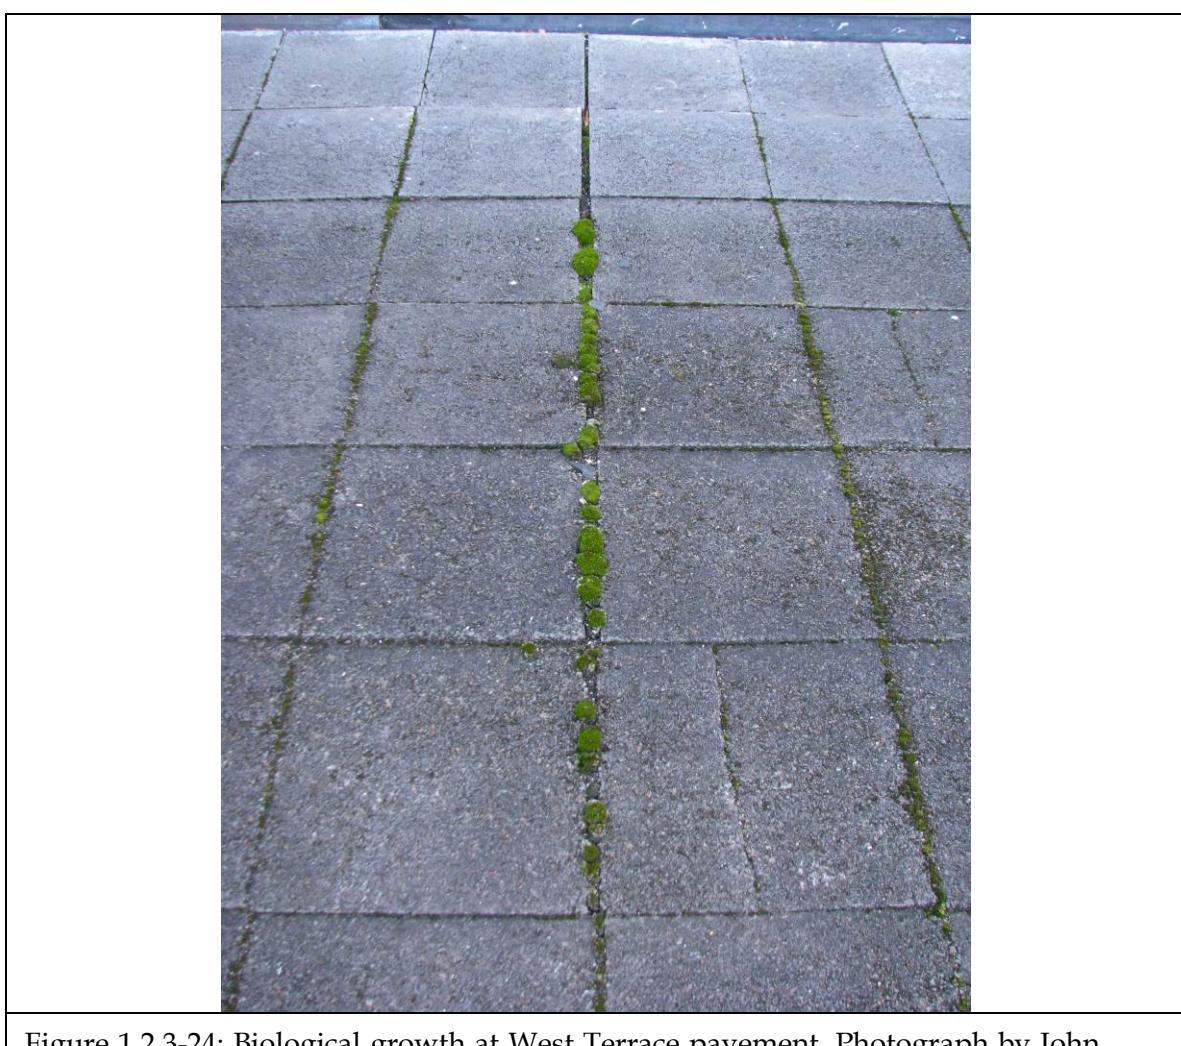
The second-floor West Terrace is paved with masonry tiles laid directly over an EPDM membrane. Extensive biological growth is present within seams and at edges—an indication of ineffective drainage resulting in moisture retention. Both roof drains are missing their grates [*Figures 1.2.3-23 and 1.2.3-24*].

Figure 1.2.3-24: Biological growth at West Terrace pavement. Photograph by John Milner Architects, November 2012.

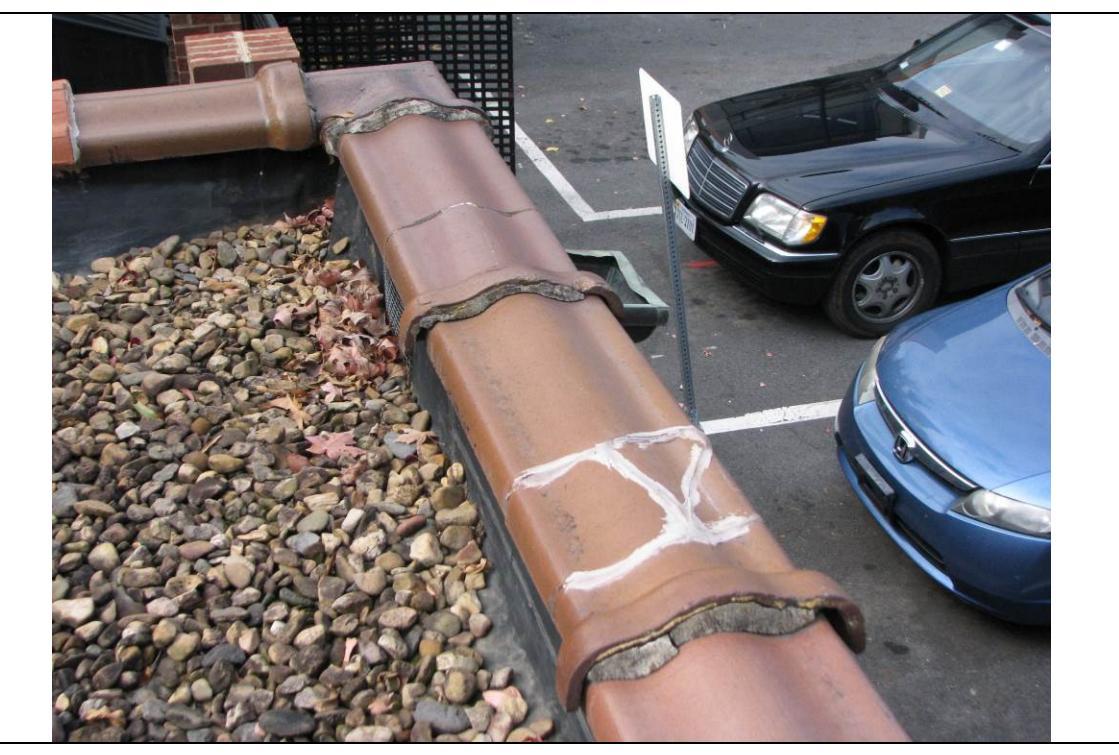
The single-story west Annex is covered with a low-slope, ballasted EPDM roof. A terracotta-coped parapet borders its north and west sides, with a metal-capped parapet on its south side. The membrane is pulling away from its substrate along the south parapet; however, its attachment to the parapet remains tentatively secure. A hole is visible in the membrane. A few cracked copings show mortar repairs. Three terracotta units have been replaced with poor color matches [*Figures 1.2.3-26 and 1.2.3-27*].

Figure 1.2.3-27: Sealant and mortar repairs at Annex parapet copings. Photograph by John Milner Architects, November 2012.

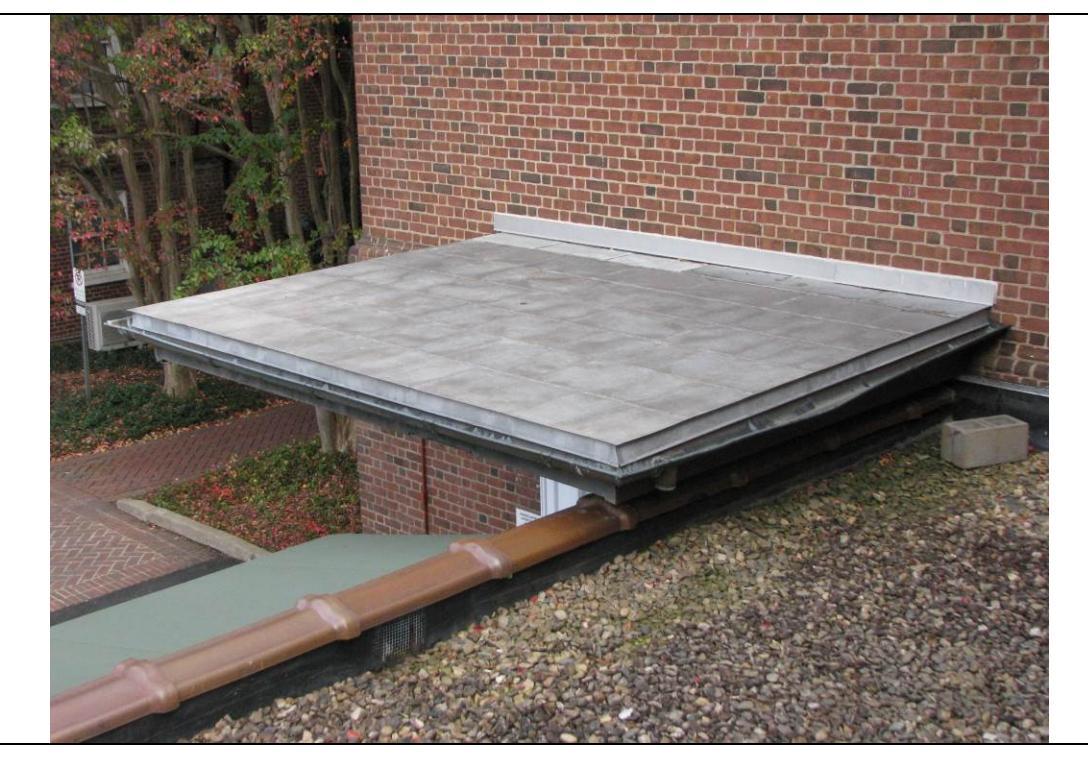
A steel-framed, sheet-metal-clad canopy over the west basement door is roofed with flatseam metal. A short portion of cladding is damaged at the fascia's lower edge. The underside of the canopy shows degraded paint. Its hung copper gutter is deformed on both sides [*Figures 1.2.3-28 through 1.2.3-30*].

Figure 1.2.3-30: Deformed gutter at West canopy. Photograph by John Milner Architects, November 2012.

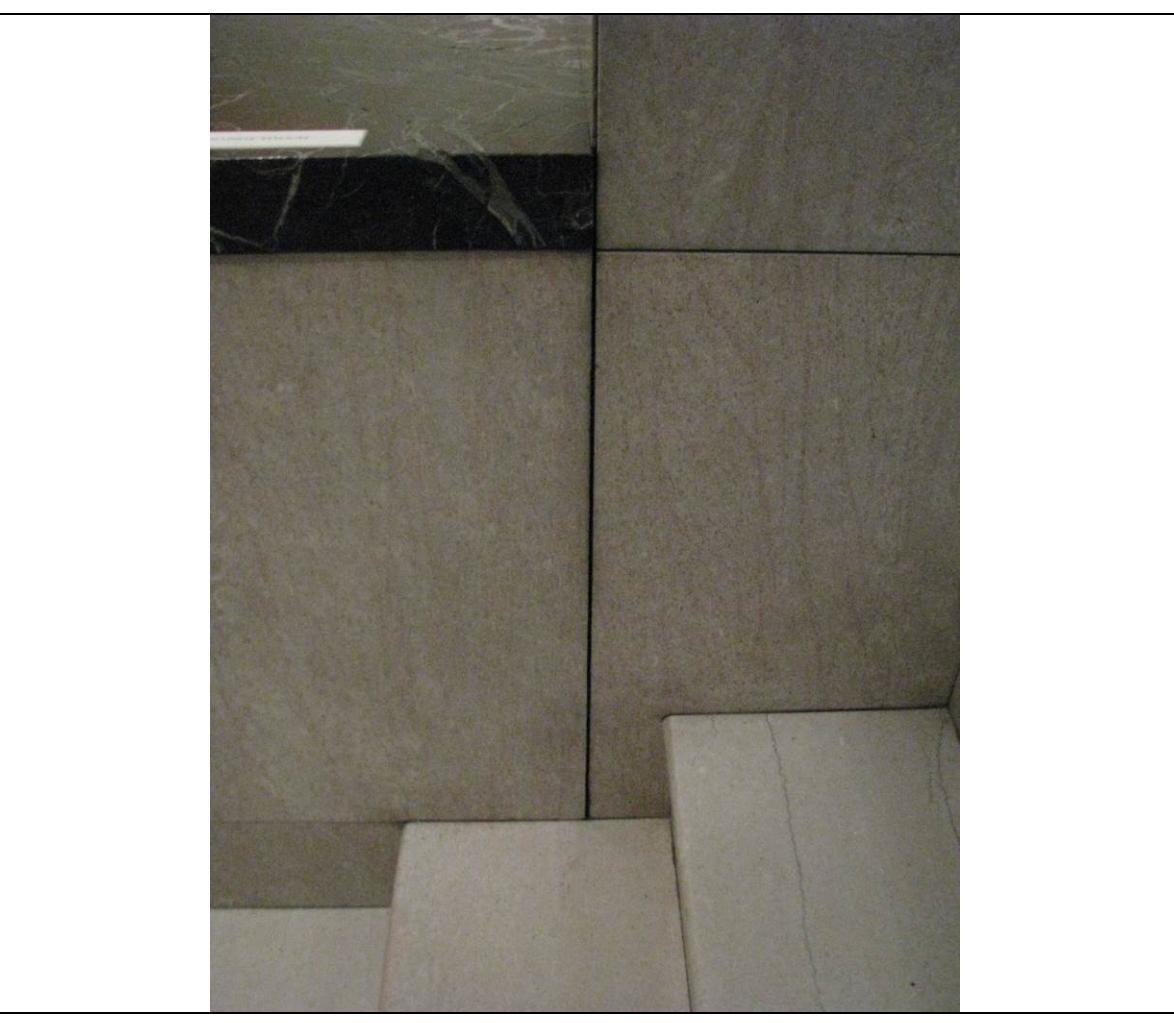
The main stairway is finished with Tennessee Tavarnelle marble treads, risers, and a landing set on a steel substair. The stairway wraps around a stepped, gray marble-paneled wall that becomes a guard wall at the upper level. This wall is finished with Levanto marble cap. Levanto stringer circumscribes the stairway, running continuously with the Stair Hall wall base. The center-wall capstones are chipped along the bottom edge in several places. Grout is missing from the majority of panel joints on the center wall. Slight movement was detected in one of the landing units [*Figures 1.2.3-34 and 1.2.3-35*].

Figure 1.2.3-35: Open grout joints in marble panels at stair. Photograph by John Milner Architects, November 2012.

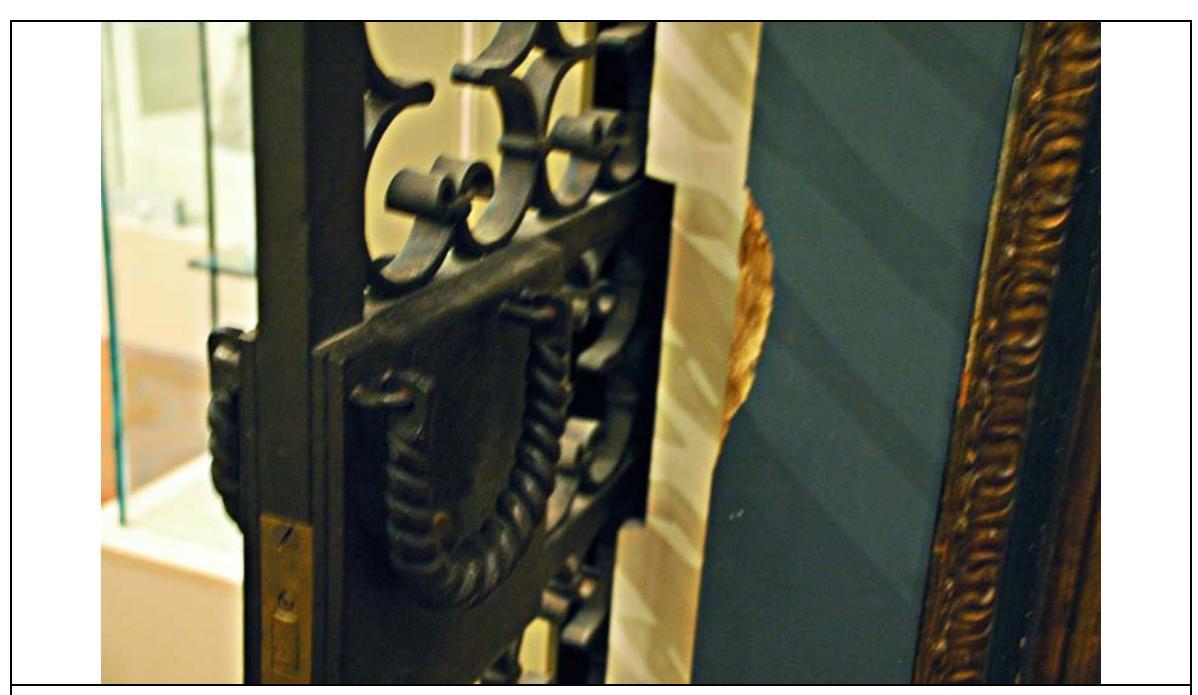
Original exposed interior painted wood elements include baseboards, door surrounds, window sills, radiator enclosures, and wood mouldings at the spring line of the second-floor cove ceilings. Wood doors, wall cladding, and moldings are present in nonpublic areas. Late-addition painted-wood elements include built-in casework. An ornate antique Italian door surround embellishes the entrance into the second-floor southwest gallery. Painted wood elements are in good condition. Damage attributable to rubbing of door pulls was found at the southwest gallery door jambs [*Figure 1.2.3-37*].

Figure 1.2.3-37: Damaged jamb at doorway to second-floor southwest gallery. Photograph by John Milner Architects, November 2012.

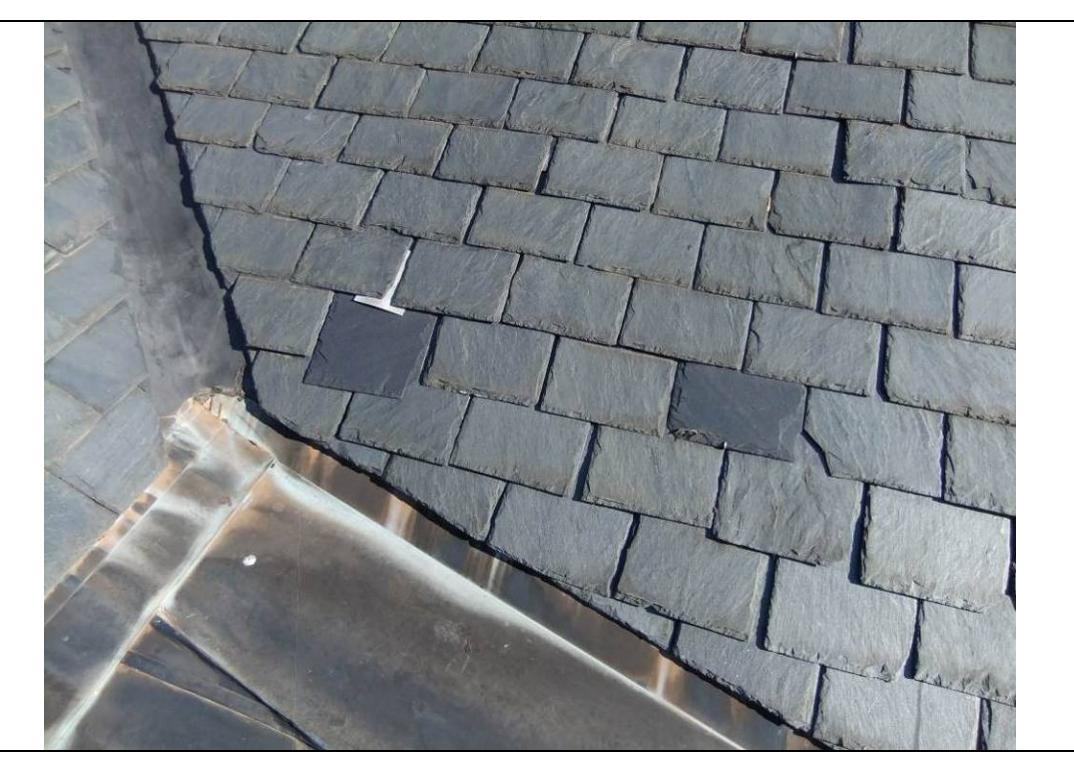
Overall, the roof framing is free of deterioration, and the original structural drawings appear to depict accurately the roof structural system. Per our review, it appears that the steel for the various truss elements was obtained from various manufacturers, including Pencoyd Iron Works (Pencoyd, PA) and Phoenix Iron Company (Phoenixville, PA). From our observations at the roof level, it appears that localized slate deterioration exists at the intersections of ridge lines and valleys [*Figures 1.2.4.1-9 and 1.2.4.1-10*].

Figure 1.2.4.1-10: Localized slate deterioration at valley of roof. Photograph by Robert Silman Associates, November 2012.

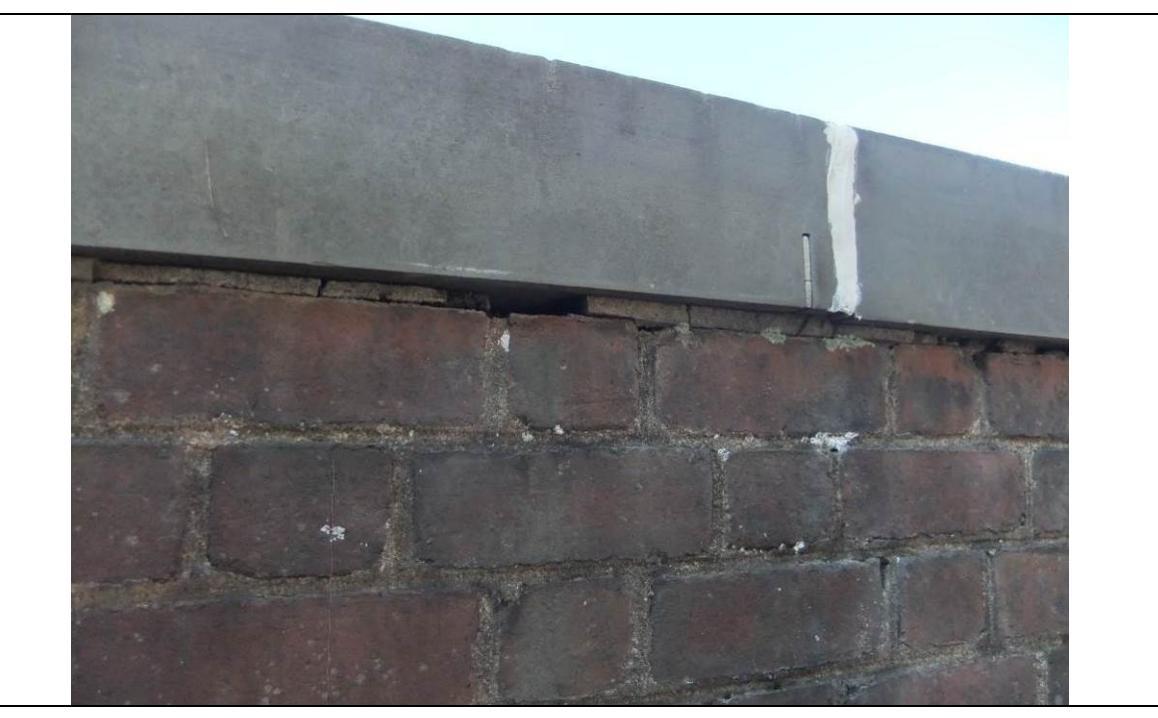
The West Terrace currently exhibits localized deterioration along the parapet walls [*Figure 1.2.4.1-11*]. At the inside face of the parapets, the existing mortar joints below the stone copings have deteriorated and have resulted in open joints [*Figure 1.2.4.1-12*]. Additionally, the roof drainage at this location appears to exhibit minimal slope, and significant biological growth has formed as a result.

Figure 1.2.4.1-12: Parapet of West Terrace. *Note*: Biological growth, caulking of head joints, and loss of mortar at bed joints. Photograph by Robert Silman Associates, November 2012.

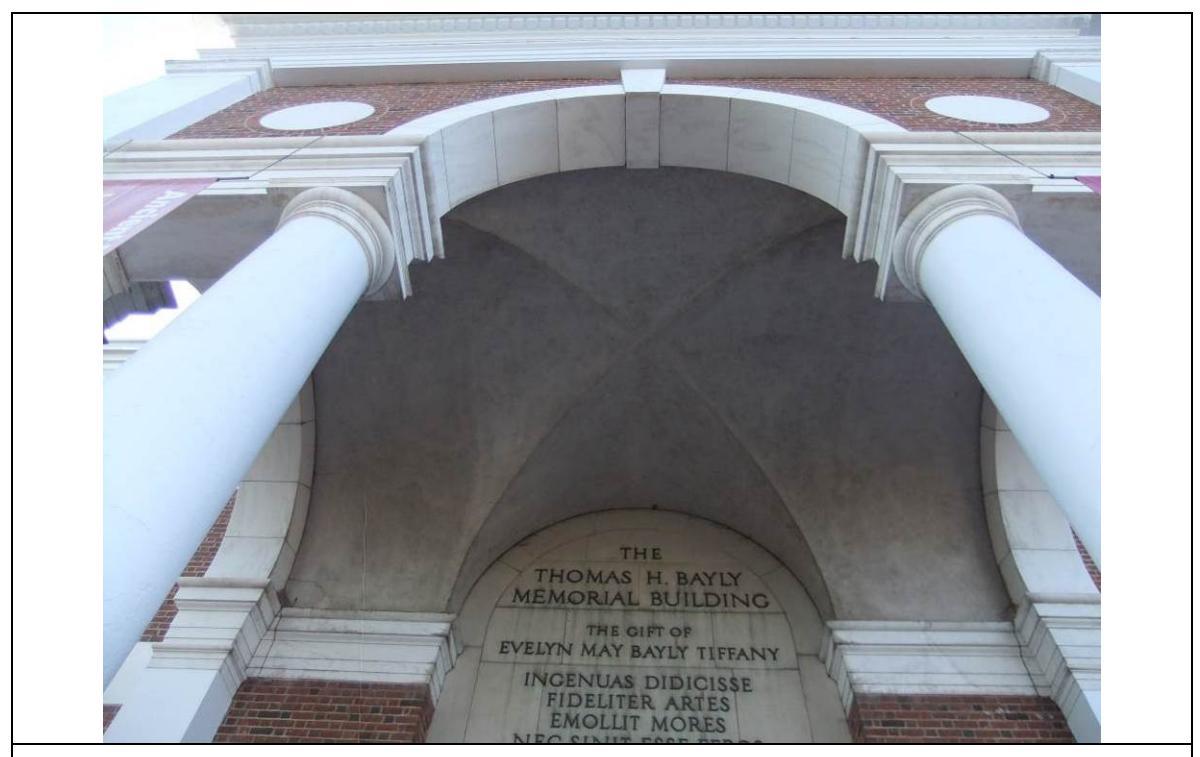
The existing Portico above the main entrance is constructed of unreinforced brickmasonry pier and columns with stucco supported by concrete foundations [*Figure* 1.2.4.16]. The existing stucco Portico ceiling is supported by the concrete and steel roof framing with the use of hanger rods. RSA noted localized cracking in the ceiling at the apex of each arched opening and the bottom corners [*Figures* 1.2.4.1-17 and 1.2.4.1-18, *respectively*]. The cracking appears to correlate to localized differential movement and/or shrinkage.

Figure 1.2.4.1-16: Underside of stucco Portico along East elevation. Photograph by Robert Silman Associates, November 2012.

These conditions do not appear to represent current life-safety concerns; however, it would be prudent to perform a closer inspection of these areas to ensure the stucco is soundly adhered.

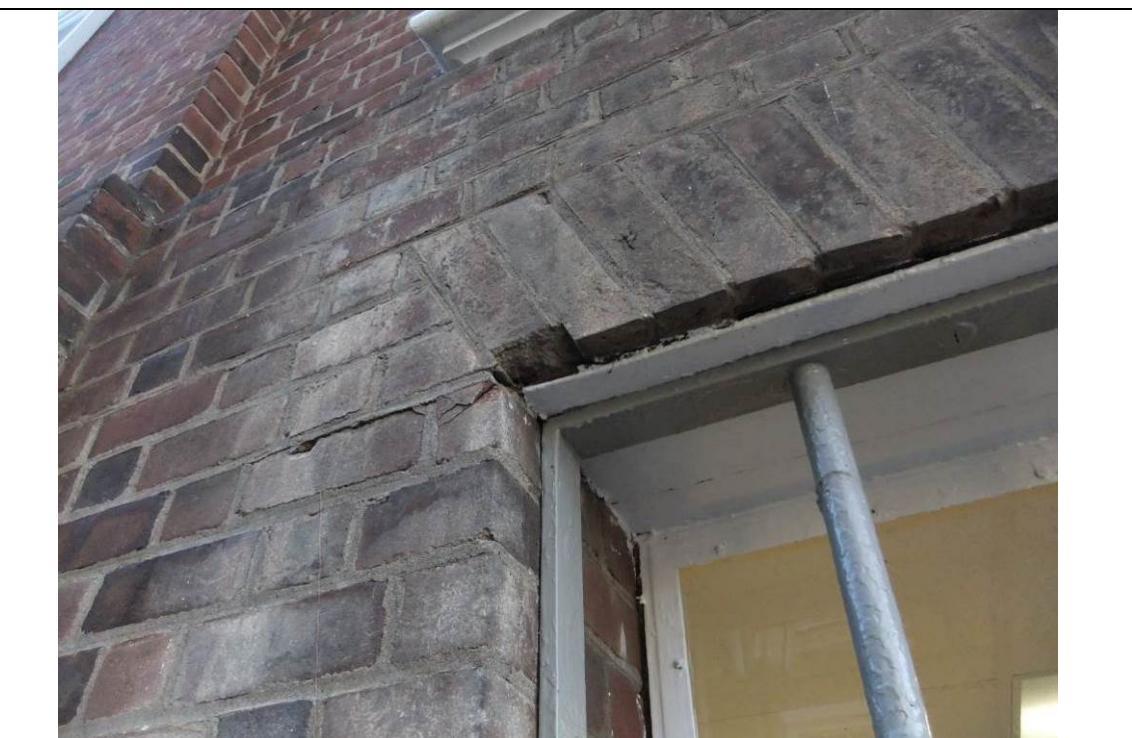
Figure 1.2.4.1-20: Deterioration of brick flat (jack) arch due to rust jacking of supporting steel lintels along North elevation. Photograph by Robert Silman Associates, November 2012.

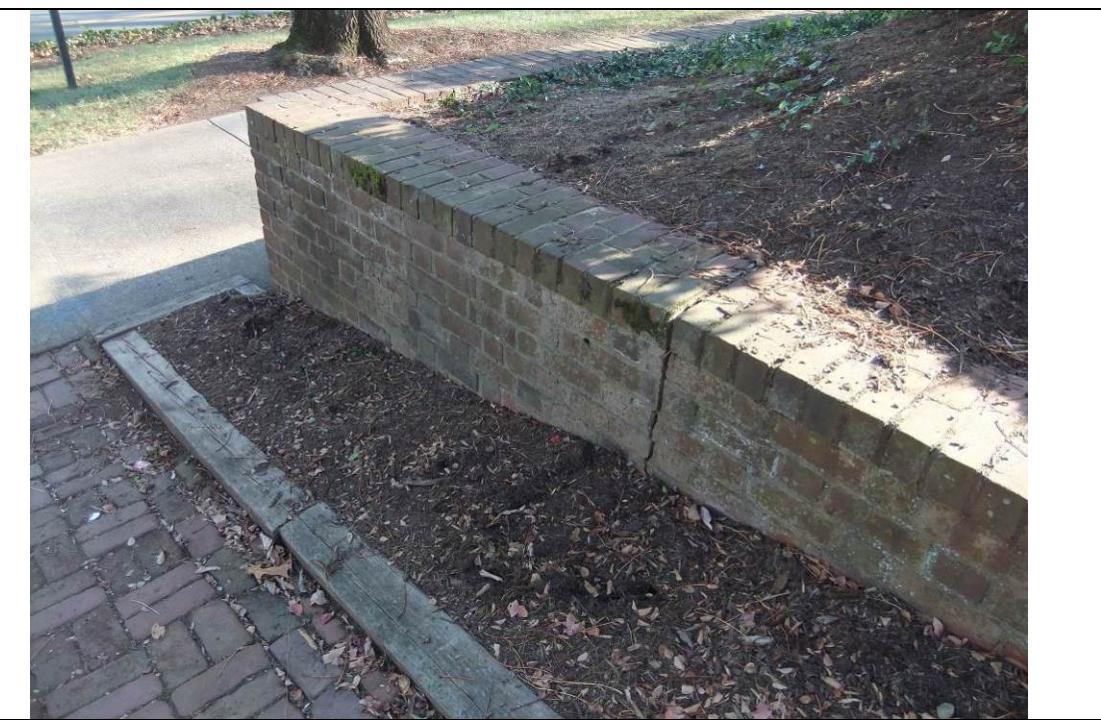
Figure 1.2.4.1-27: Localized brick-masonry vertical cracking at the retaining wall perpendicular to Rugby Road on the north side of the site. Photograph by Robert Silman Associates, November 2012.

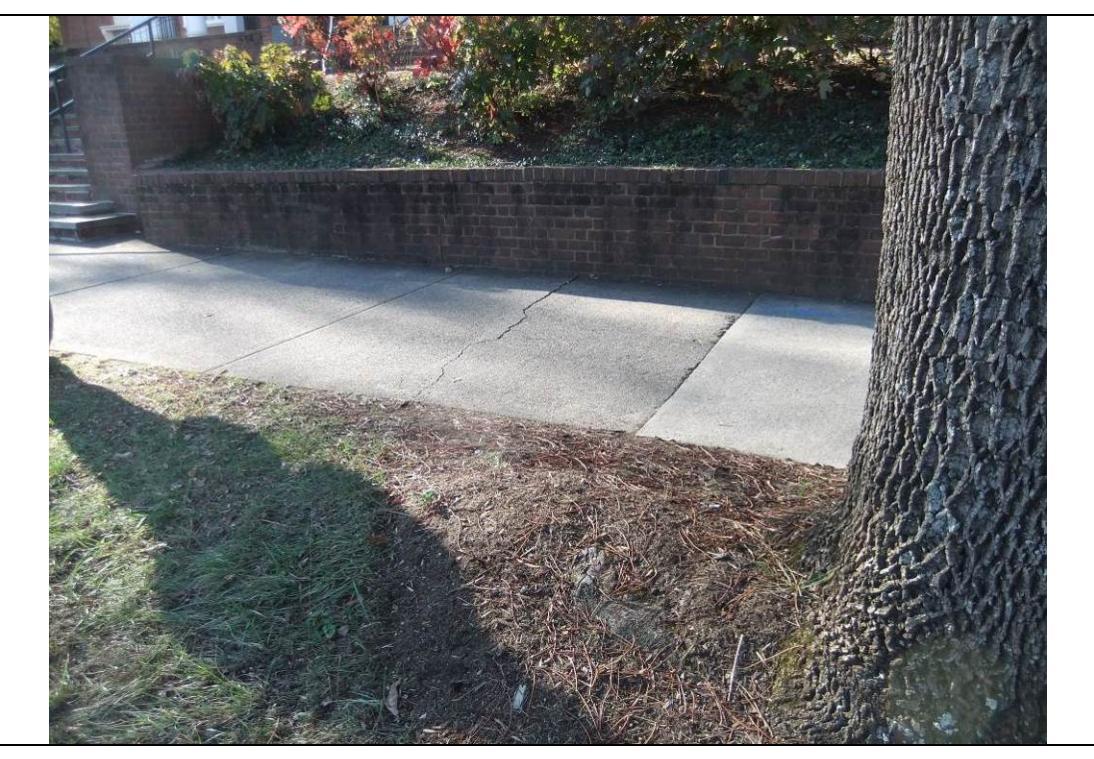
Figure 1.2.4.1-30: Cracking and heaving of concrete sidewalk slab due to tree-root encroachment. Photograph by Robert Silman Associates, November 2012.

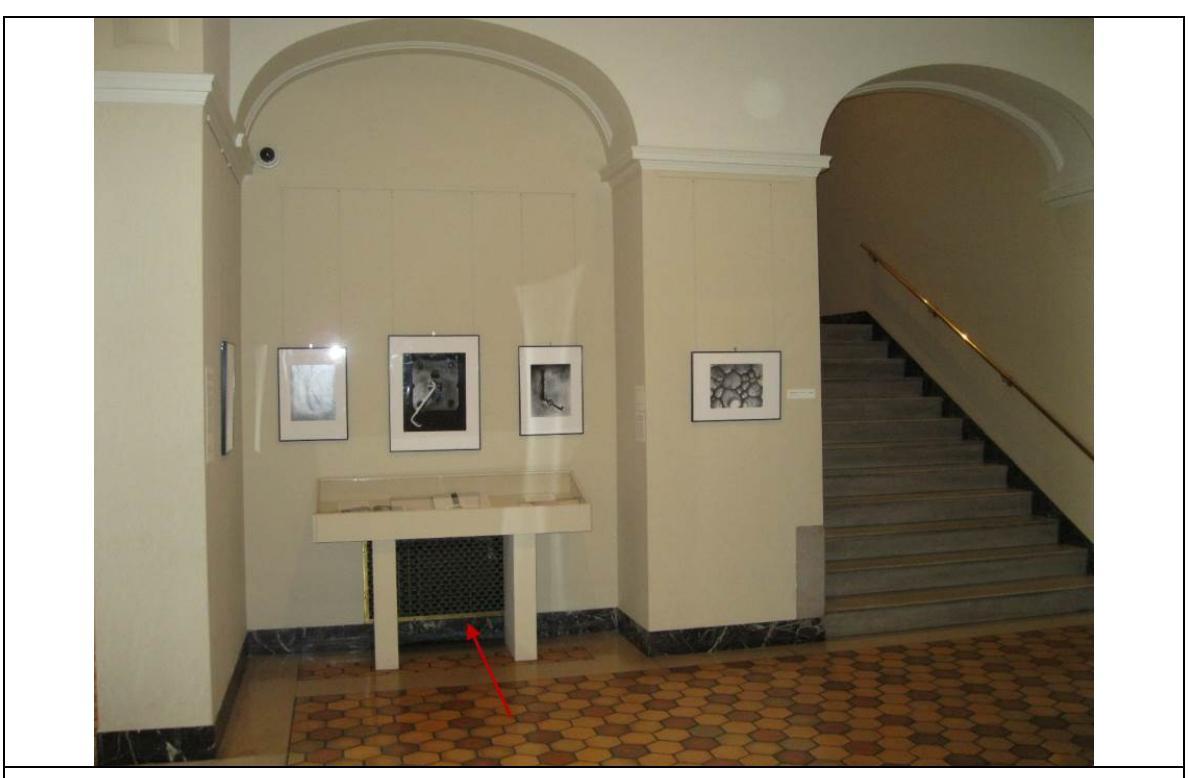
Portions of the building, including the private offices, the lower entry lobby, and the center stair, are heated with cast-iron radiators that receive hot water from the campus hot-water system. These radiators date back to the original heating system for the building. The entire building was originally heated with radiators, many of which were concealed in cavities in the walls. The cavities had grilles near the floor below the radiator and grilles high on the wall above the radiator so air would circulate past the radiator by convection. When the climate-control system was added in the 1970s, many of the radiators in the galleries were taken out of service. It is likely that most of the radiators were simply abandoned in place because many of the grilles remain in the walls [*Figure 1.2.4.2-2*].

Figure 1.2.4.2-2: Radiator grille in first-floor Stair Hall. Photograph by T. Newbold, December 2012.

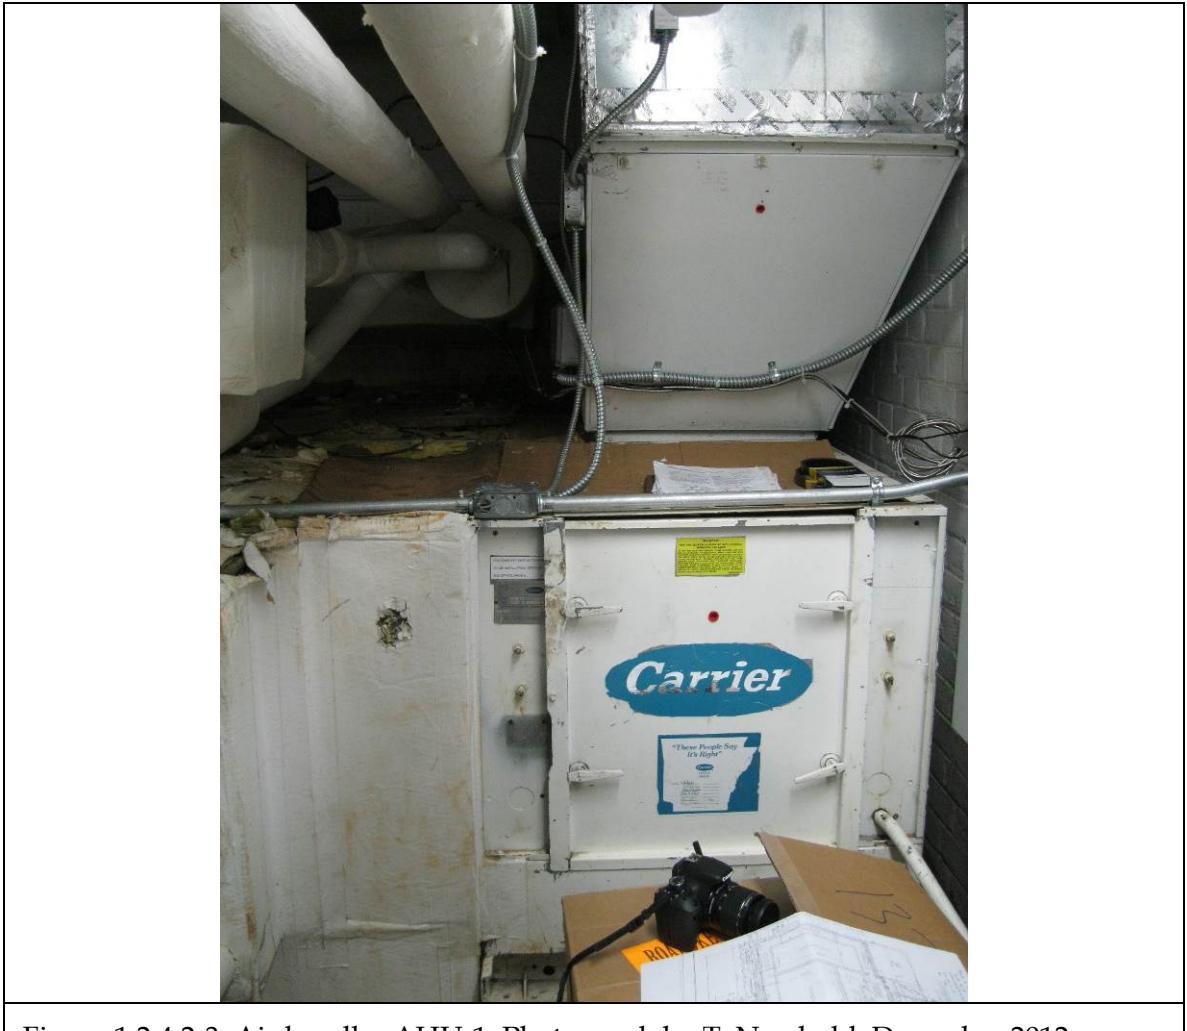
Figure 1.2.4.2-3: Air handler AHU-1. Photograph by T. Newbold, December 2012.

- 1. The carrier air handler and reheats were installed in 1986. The humidifiers were added in 2009.
- 2. The air handler is in fair condition. The cooling coils inside the air handler are showing some signs of age-related deterioration.

- 3. At 26 years old, AHU-1 is past the end of its projected useful life (coils have a 20-year projected life and fans have a 25-year projected life).
- 4. The ductwork in the mechanical room has been cut and patched numerous times over the years, and some of the repairs are poorly done.
