THE THOMAS H. BAYLY BUILDING AT THE UNIVERSITY OF VIRGINIA

HISTORIC STRUCTURE REPORT.

November 8, 2013

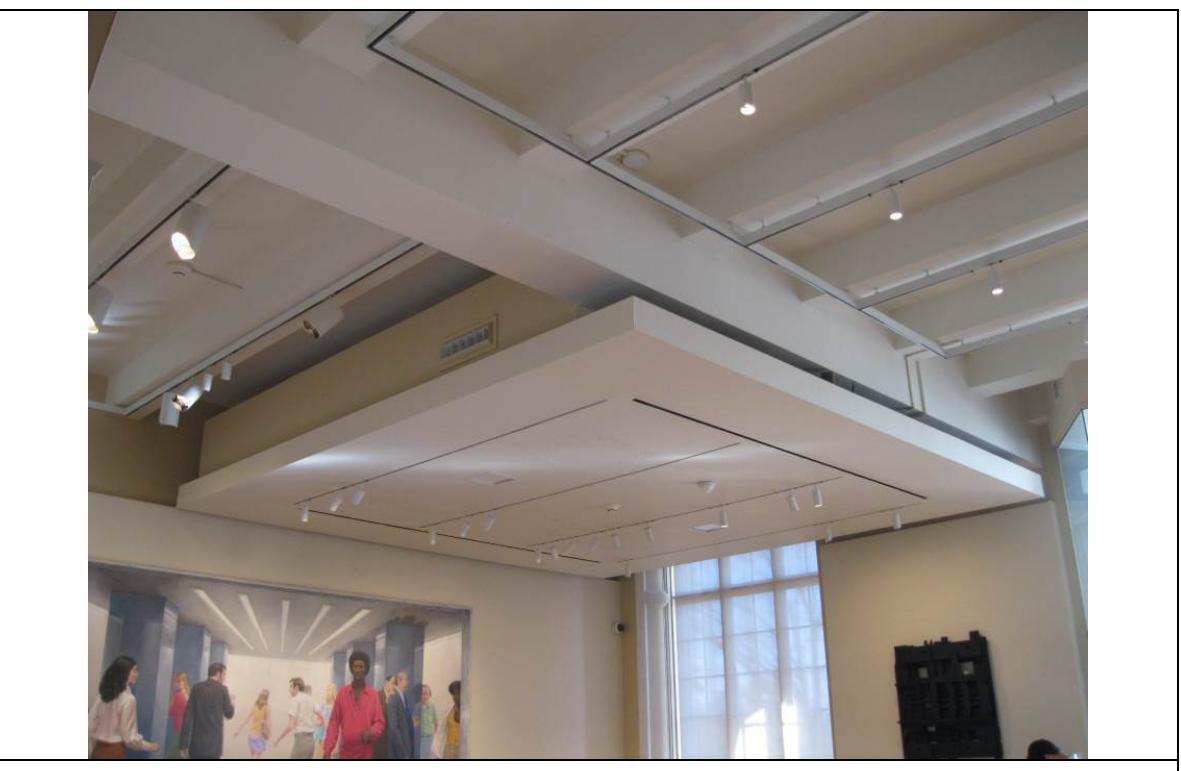
Figure 1.2.4.2-5: Enclosure concealing AHU-4 (typical for AHU-5). Photograph by T. Newbold, December 2012.

- 1. The air handlers were installed in 2009.
- 2. They appear to be in good condition.
- 3. The level of air filtration is not adequate for the long-term preservation of museum collections.

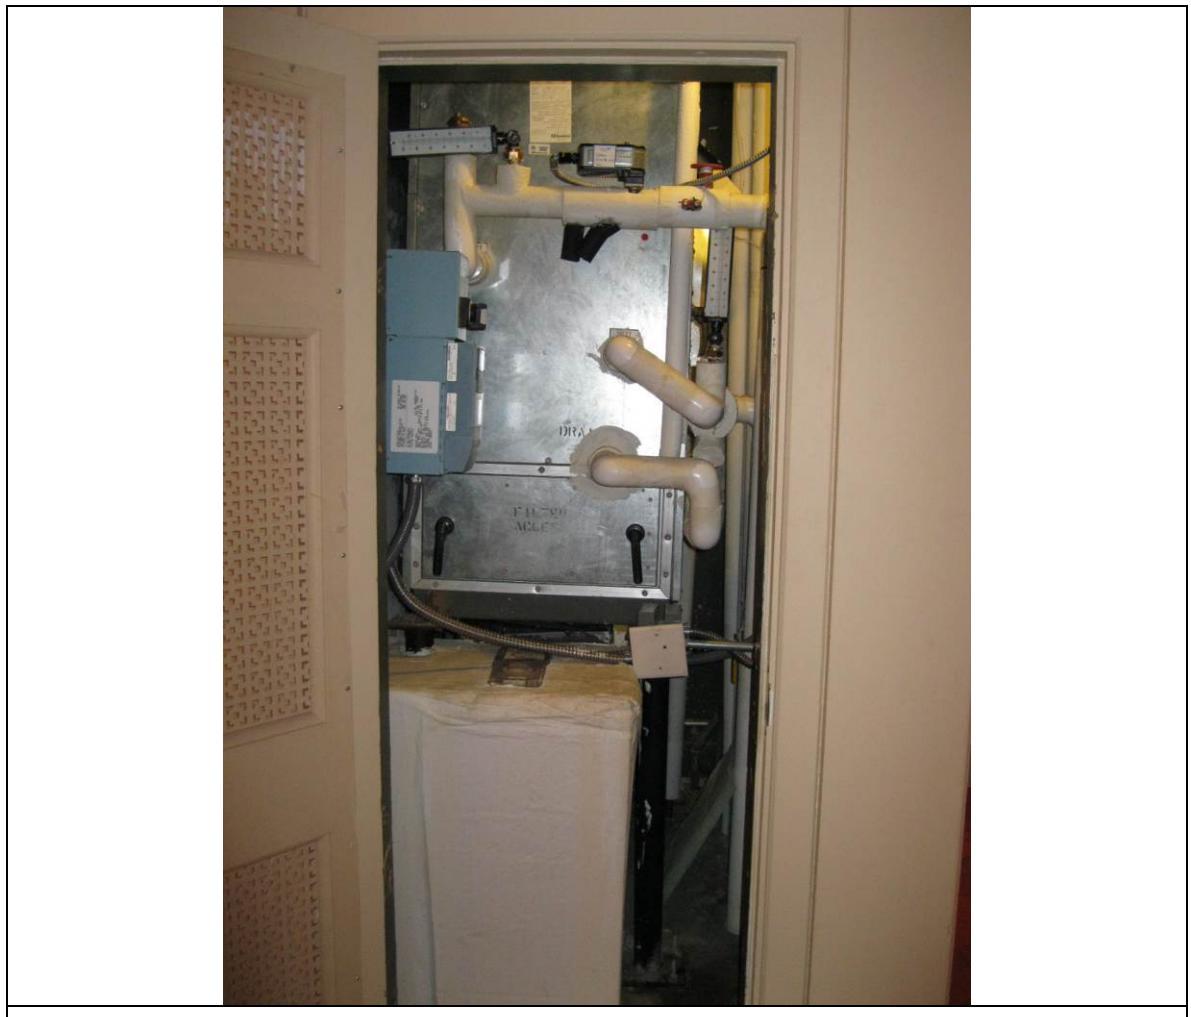
- 1. The air handler was installed in 2009.
- 2. The air handler appears to be in good condition.
- 3. The level of air filtration is not adequate for the long-term preservation of museum collections.
- 4. There is not adequate clearance around the air handler for proper service access
- 5. The air handler is located above Collections Storage, and the piping for the air handler runs above the ceiling of Collections Storage. A leak from the unit or piping poses a risk of water damage to the collections located below.
- 6. There is no safety system to alert the staff if there is a leak in the unit on the second floor.
- 7. The humidifier display screen showed the humidifier to be in a faulty condition and not operating. It was reported that this humidifier has been troublesome.

Figure 1.2.4.2-6: Air handler AHU-6 in second-floor closet. Photograph by T. Newbold, December 2012.

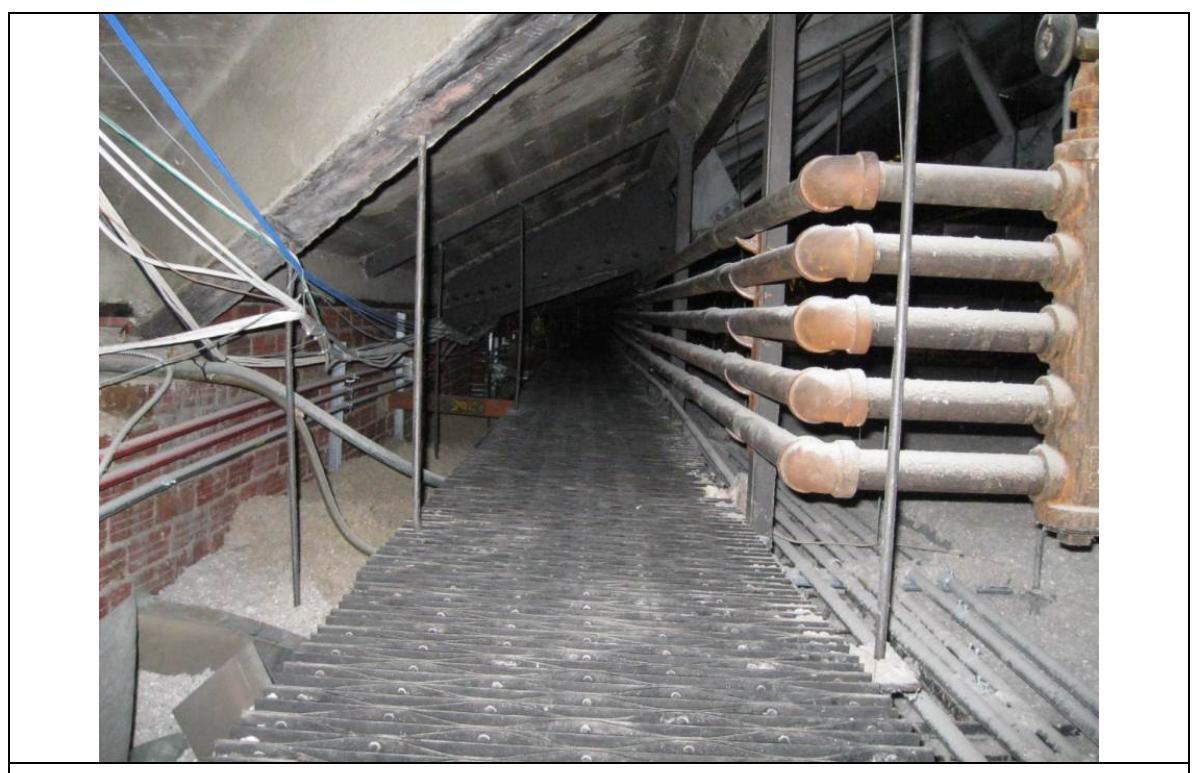
There is an abandoned skylight heating system in the attic [*Figure 1.2.4.2-7*]. At one time, there were skylights in the roof that required heating. When the skylights were removed and insulation was added to the second-floor ceiling, heat was no longer required in the attic. The skylight heating coils consisting of five parallel steel pipes are still in place. This system is shown on the original design drawings from 1933.

Figure 1.2.4.2-7: Abandoned skylight heating system in attic. Photograph by T. Newbold, December 2012.

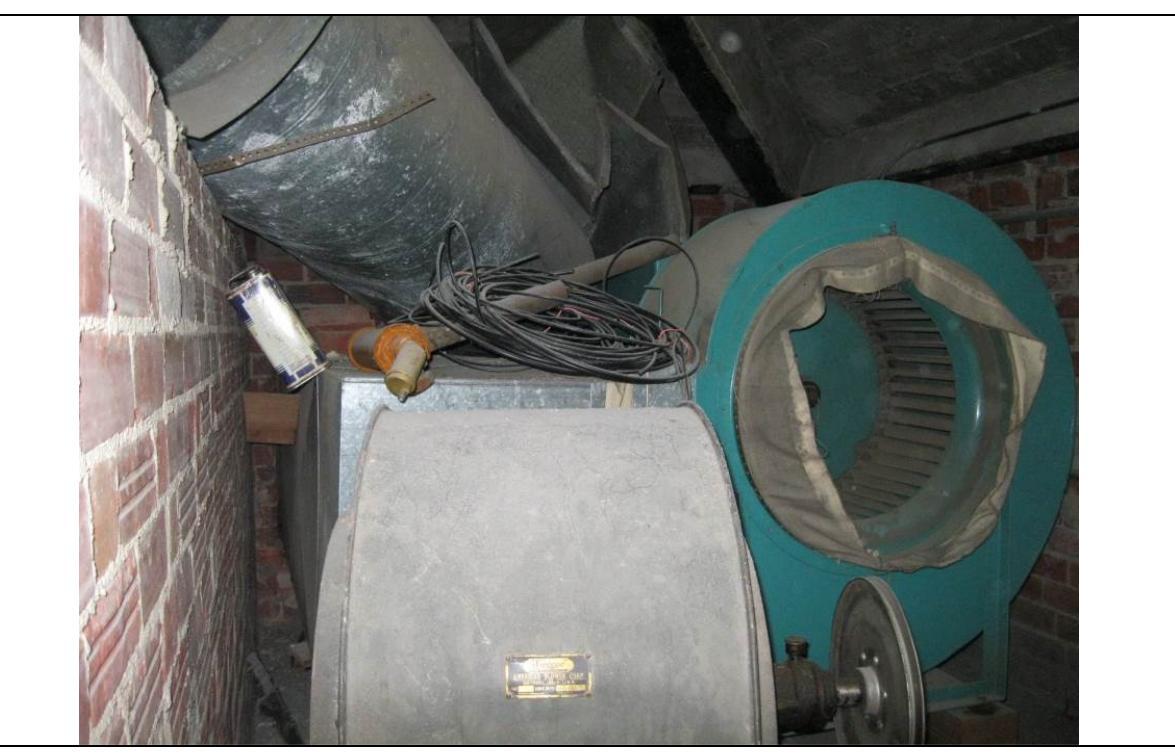
There are remnants of an abandoned ventilation system in the attic. There is an abandoned exhaust fan in the attic [*Figure 1.2.4.2-8*]. In reviewing the original design drawings from 1933, the exhaust fan drew air from the second-floor galleries and discharged the air through a large roof exhaust ventilator. The exhaust ventilator still remains but is now only open to the attic, acting as a passive ventilator [*Figure 1.2.4.2-9*]. Other roof ventilators shown on the 1933 drawings have been removed.

Figure 1.2.4.2-8: Abandoned exhaust fans in attic. Photograph by T. Newbold, December 2012.

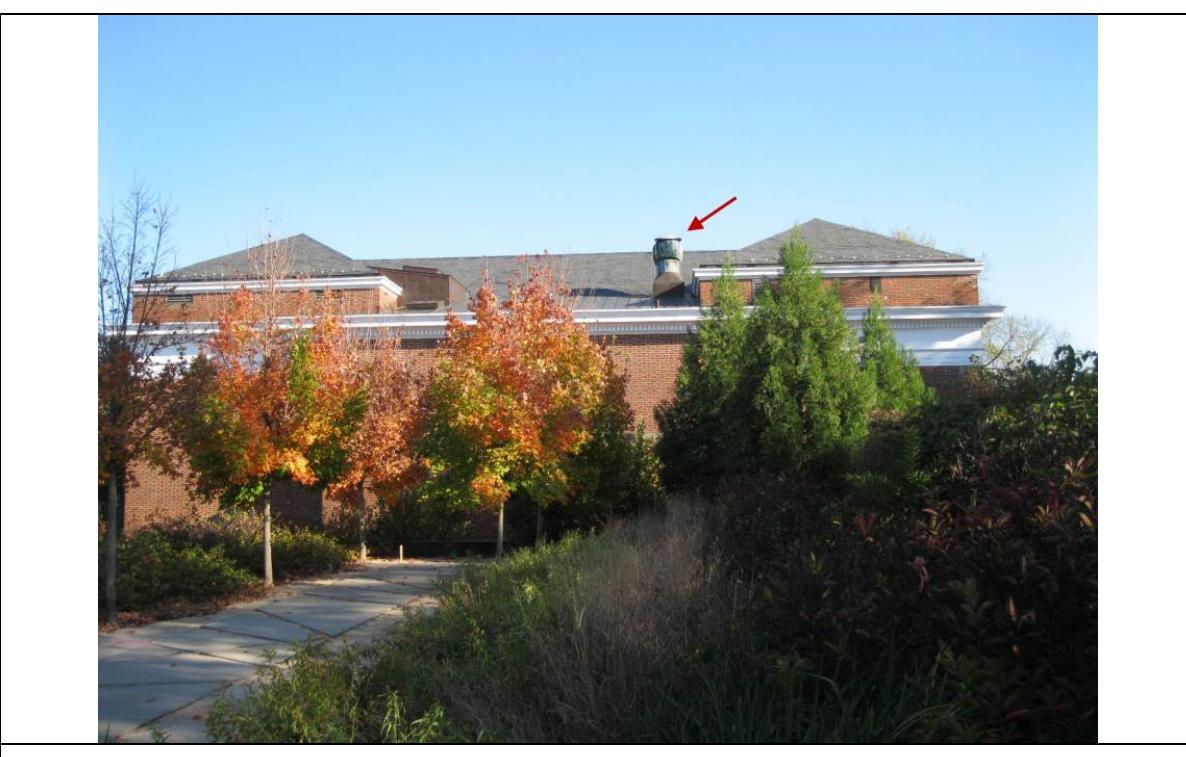
Figure 1.2.4.2-9: One remaining attic ventilator. Photograph by T. Newbold, December 2012.

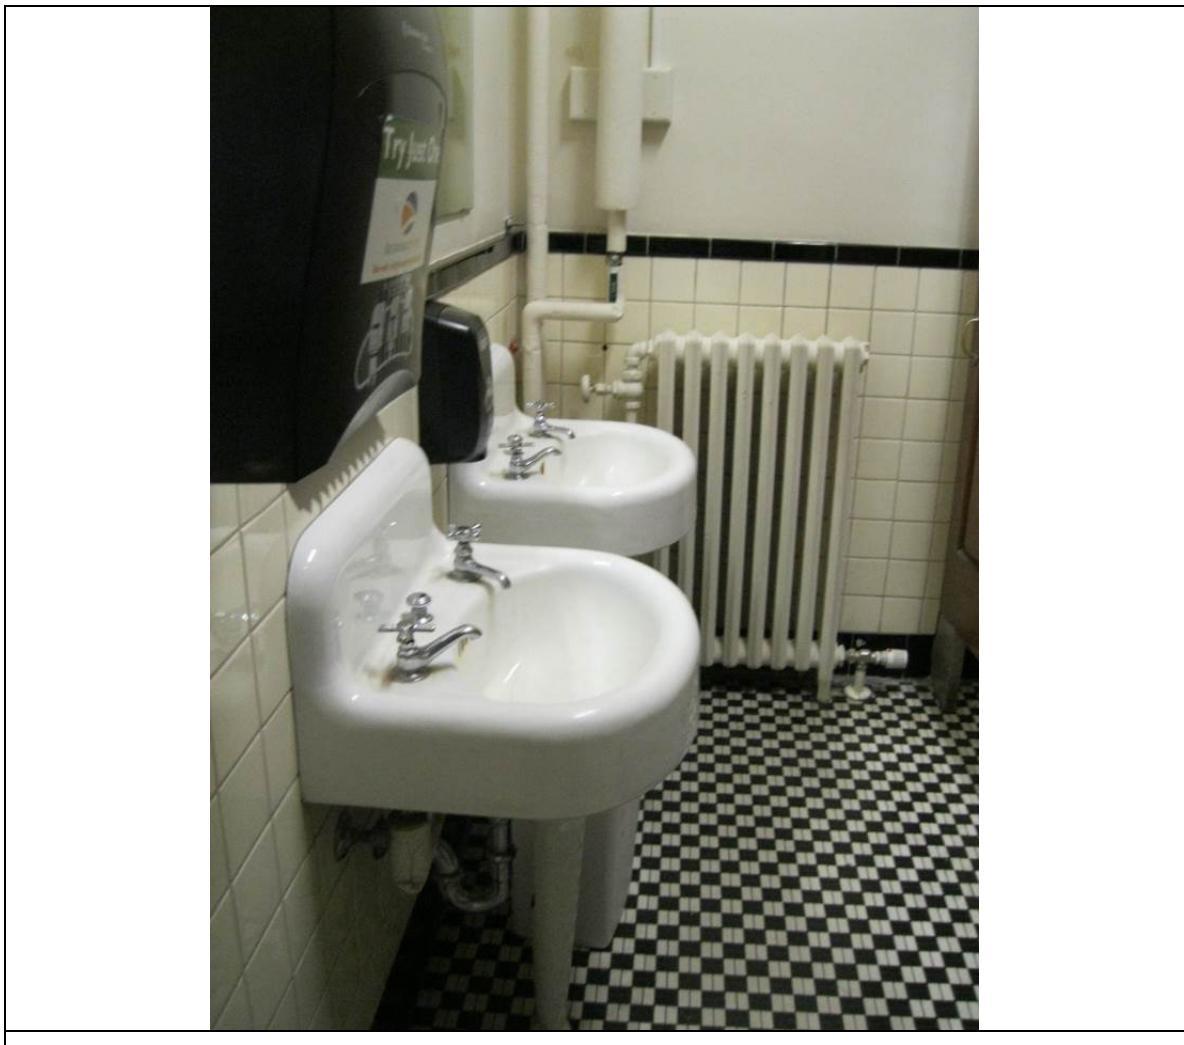
- 1. The public-restroom fixtures are an older style and not very water efficient.
- 2. The hot- and cold-water piping is exposed in the public restrooms on the first floor and in the Annex.

Figure 1.2.4.2-10: Typical lavatories in public restroom. Photograph by T. Newbold, December 2012.

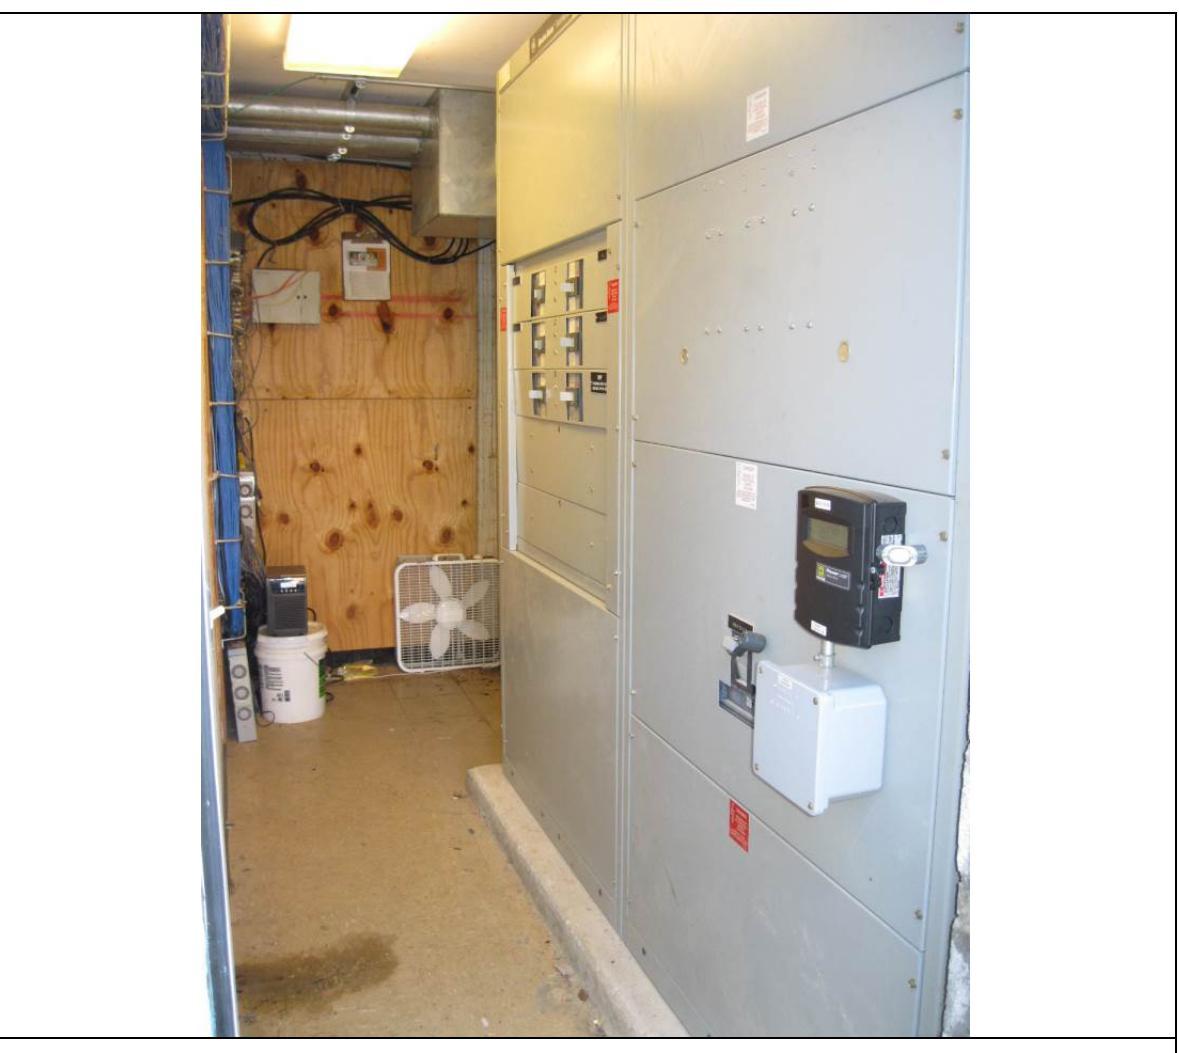
Figure 1.2.4.2-11: Main distribution panel in Annex. Photograph by T. Newbold, December 2012.

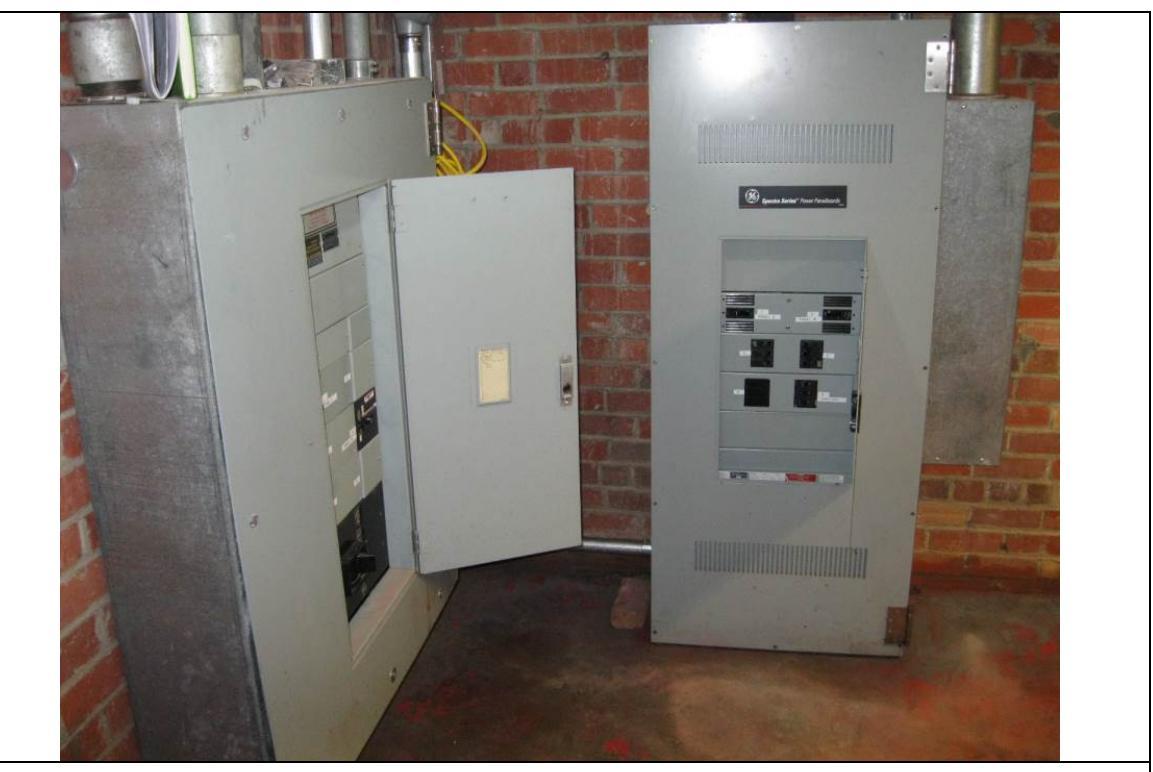
Figure 1.2.4.2-12: Distribution panels DP-1 and DP-2 in Annex elevator Modulation Error Ratio. Photograph by T. Newbold, December 2012.

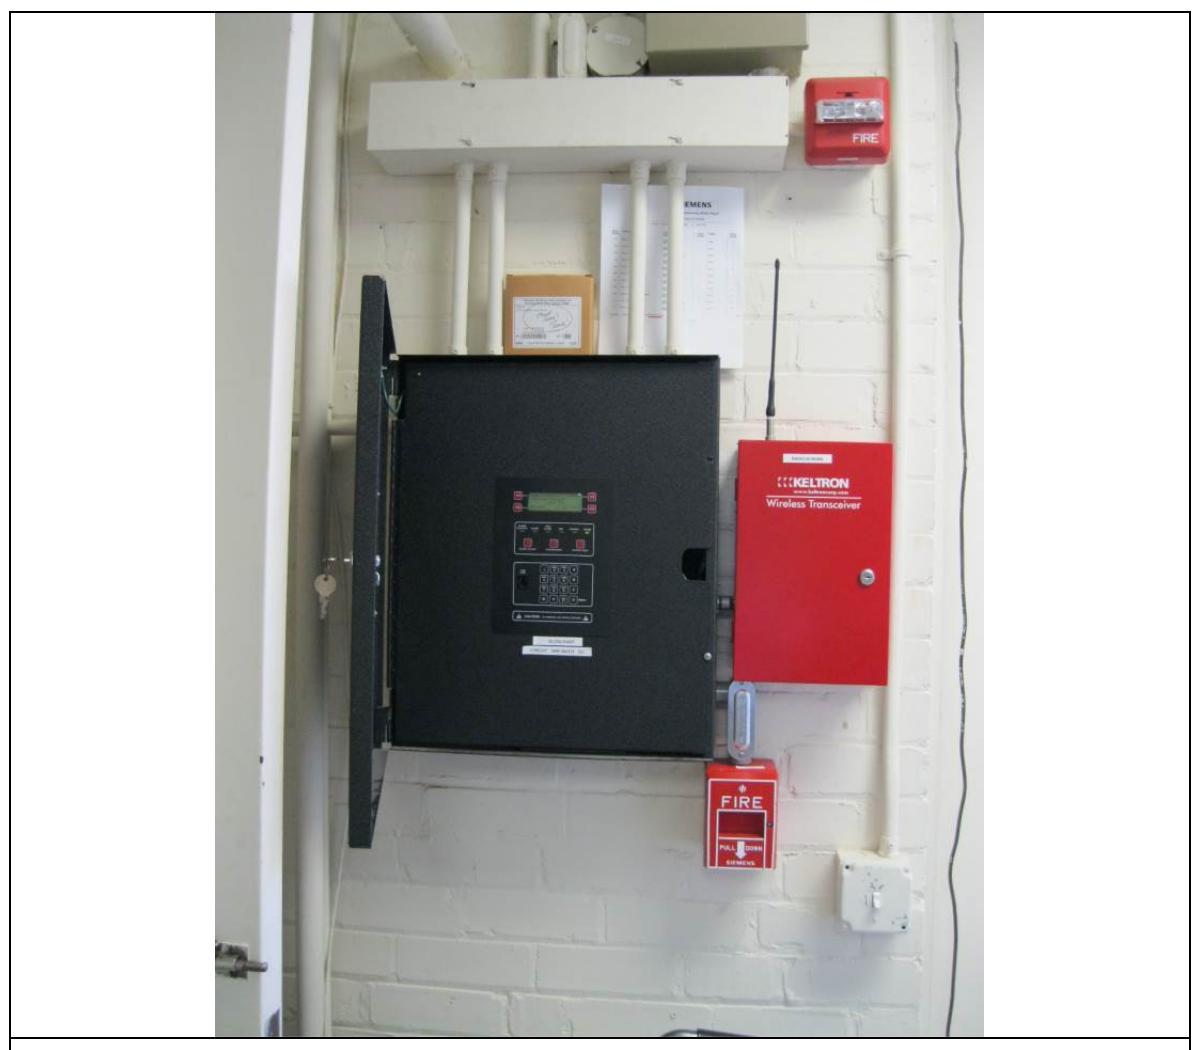
- 1. There is no fire detection in the attic.
- 2. The fire-detection system is modern, code compliant, and in good condition.

Figure 1.2.4.2-13: Fire-alarm control panel adjacent to lower-level entrance. Photograph by T. Newbold, December 2012.

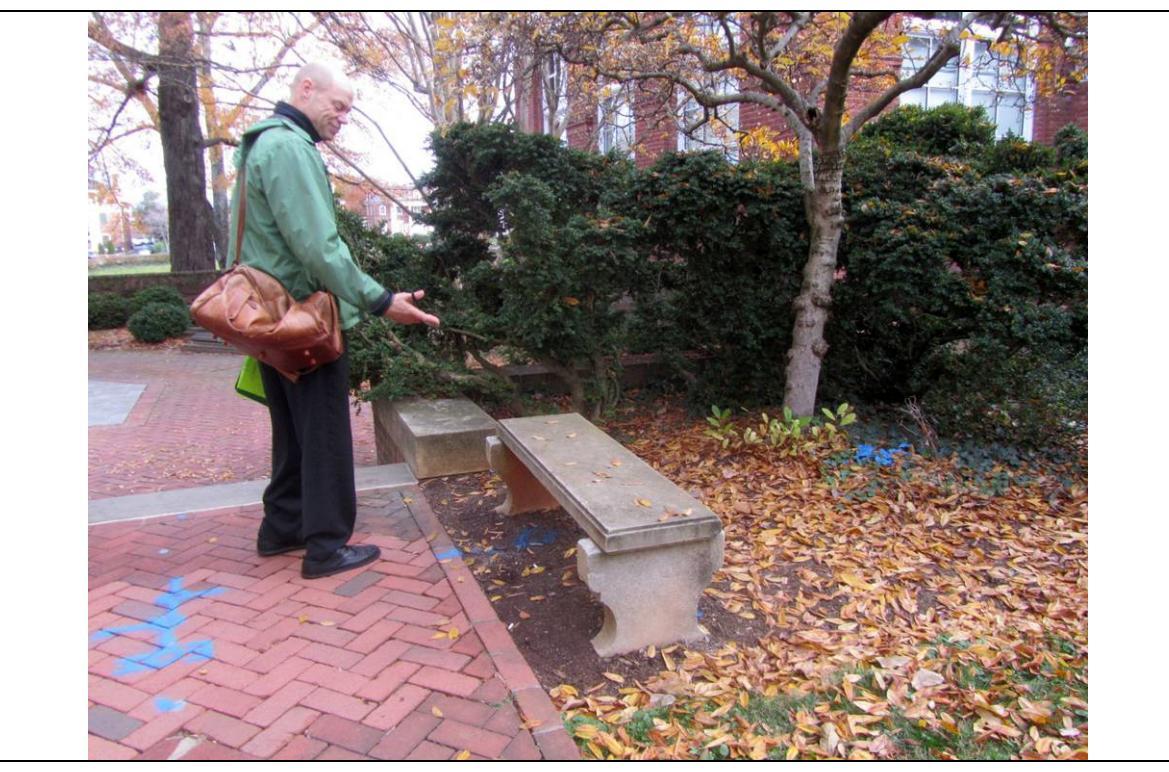
Figure 1.3.1-19: Concrete seat and legs of a bench in a nonhistoric position within the South Garden. Photograph by Heritage Landscapes, November 2012.

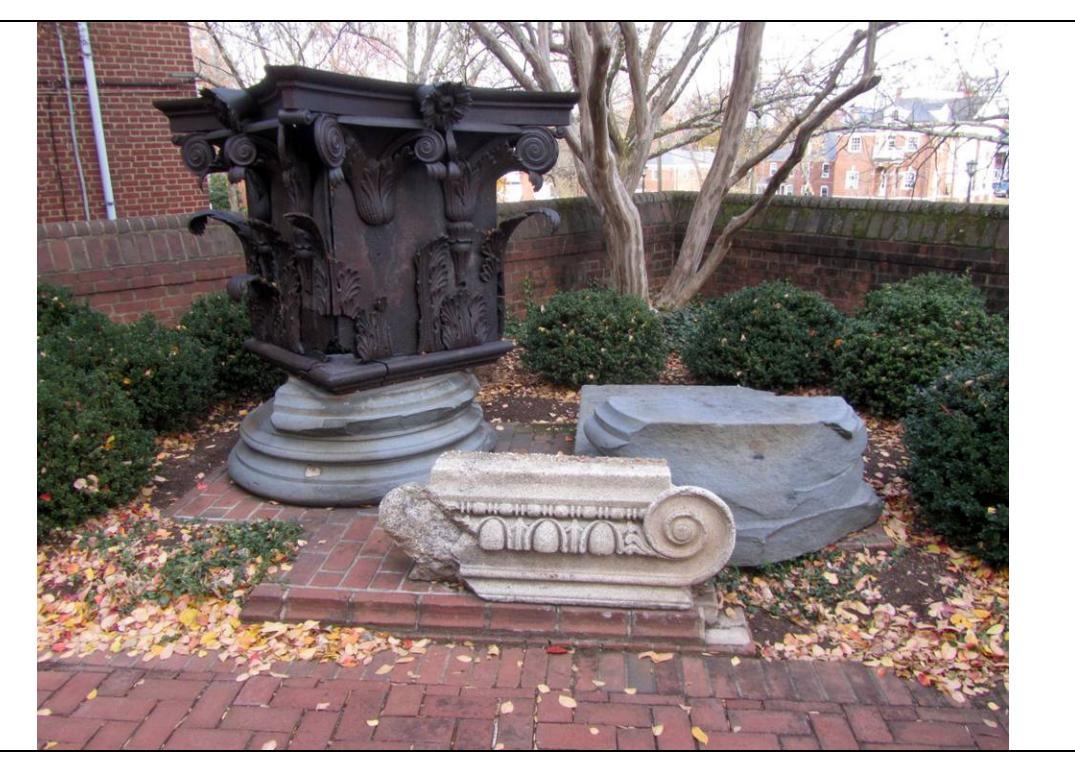
Figure 1.3.1-21: Capital, base, and other architectural fragments on raised brick pad in the northeast planting bed. Note corner brick missing on pad. Photograph by Heritage Landscapes, November 2012.

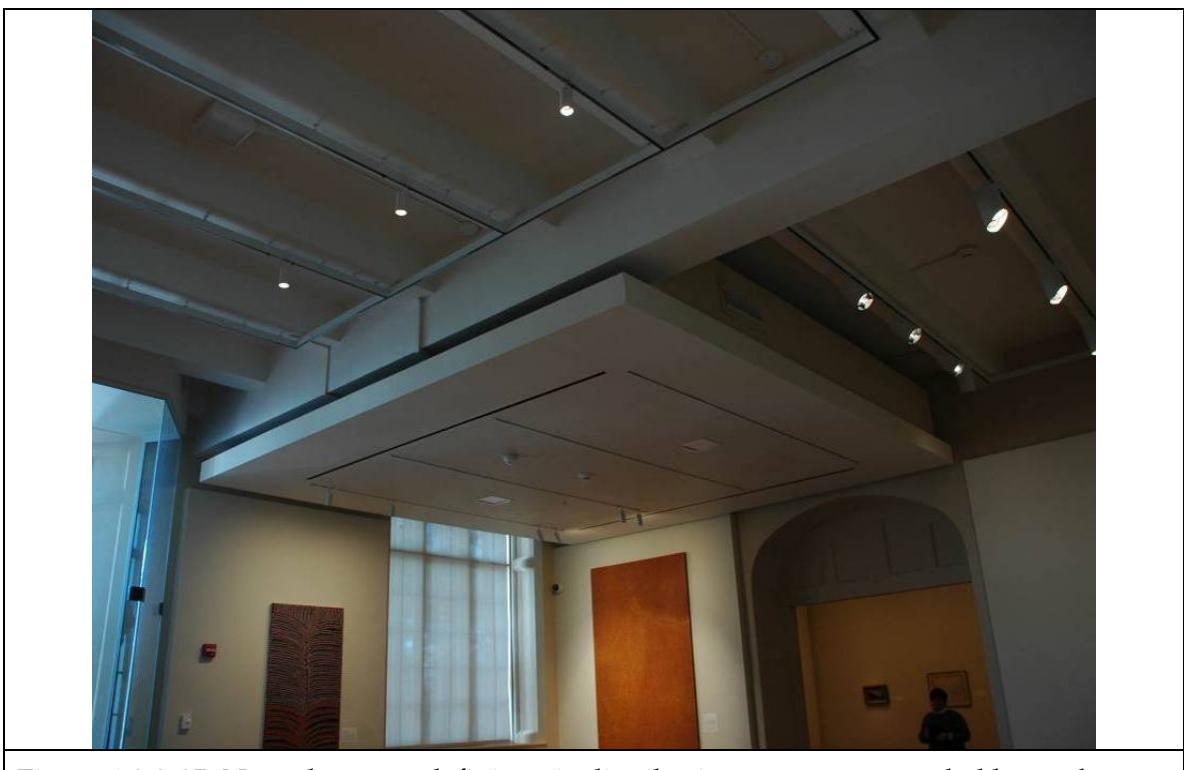
Figure 1.3.2-25: Non-character-defining air-distribution system suspended beneath Exhibition Lobby ceiling. Photograph by John Milner Architects, November 2012.

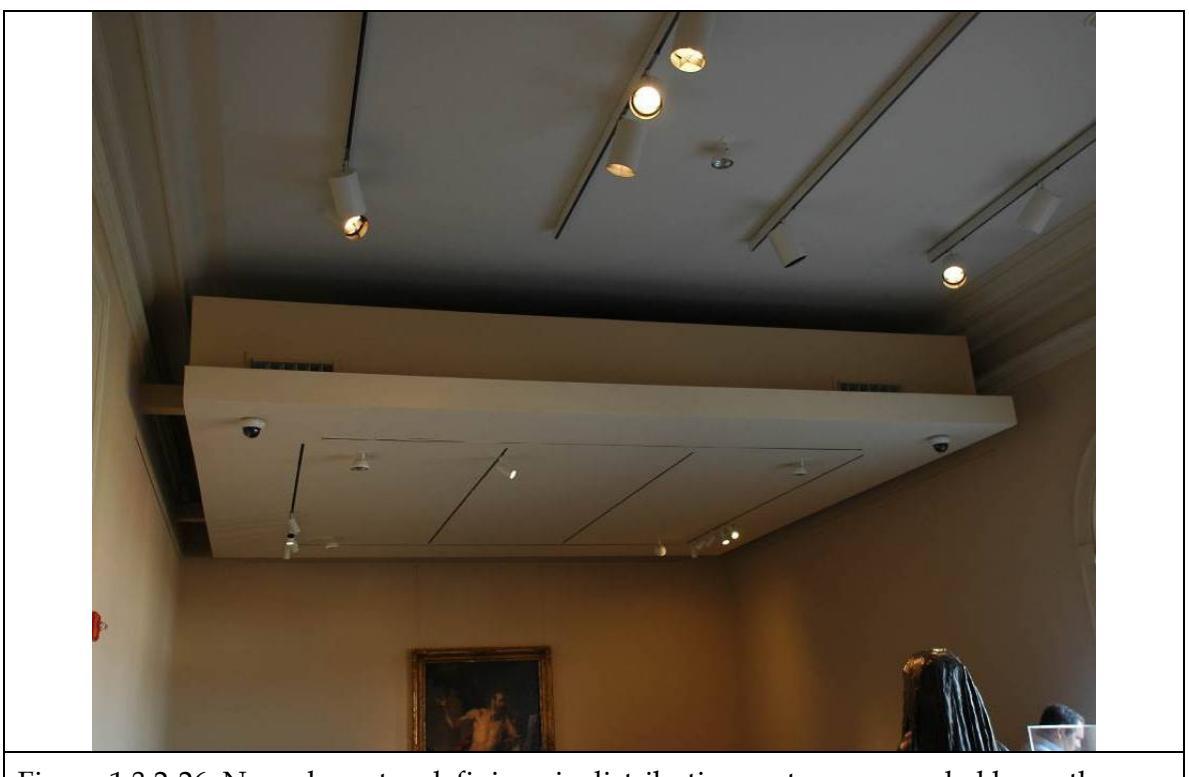
Figure 1.3.2-26: Non-character-defining air-distribution system suspended beneath Upper Stair Hall ceiling. Photograph by John Milner Architects, November 2012.
