# UNIVERSITY CHAPEL HISTORIC STRUCTURES REPORT

**FINAL REPORT**  
**24 JANUARY 2008**

**QUINN EVANS|ARCHITECTS**  
**1214 Twenty-eighth Street, NW**  
**Washington, DC**

**Facilities Management**  
**University of Virginia**

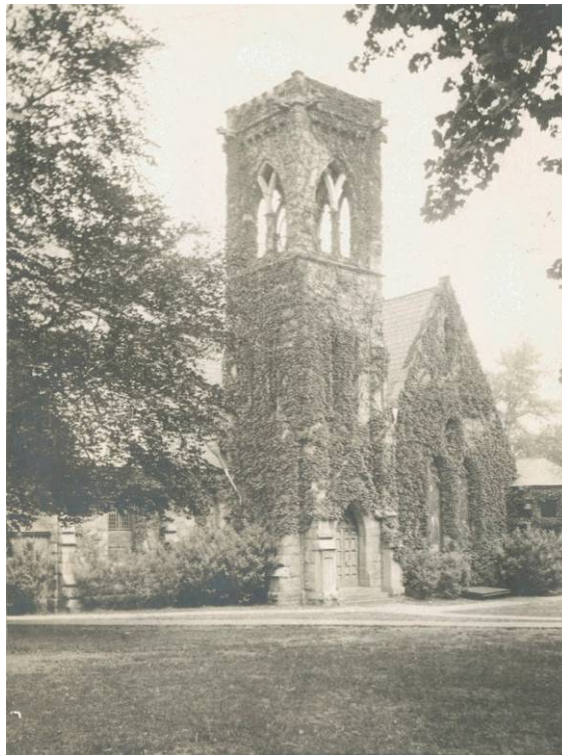
**Figure 2.16**

| By 1911 through 1920s | Heavy ivy-like vines covered the building, as evident in several historic photographs in the UVA Special Collections. (Figures 2.15 – 2.18) |

Heavy ivy-like vines cover the bell tower and east choir exterior walls, 1915, photographer unknown. (Special Collections, University of Virginia Library)

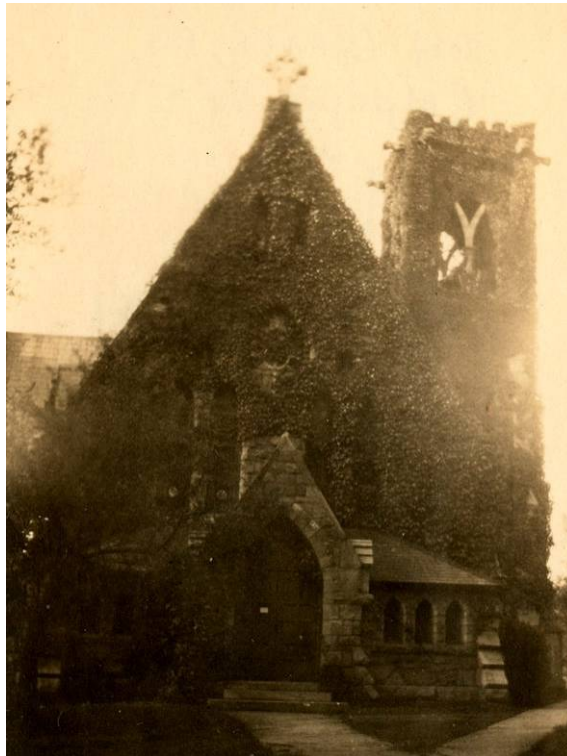
**Figure 2.17**

Heavy ivy-like vines cover the main (south) façade and the bell tower, ca. 1920-1925, photographer unknown. (Special Collections, University of Virginia Library) (image cropped)

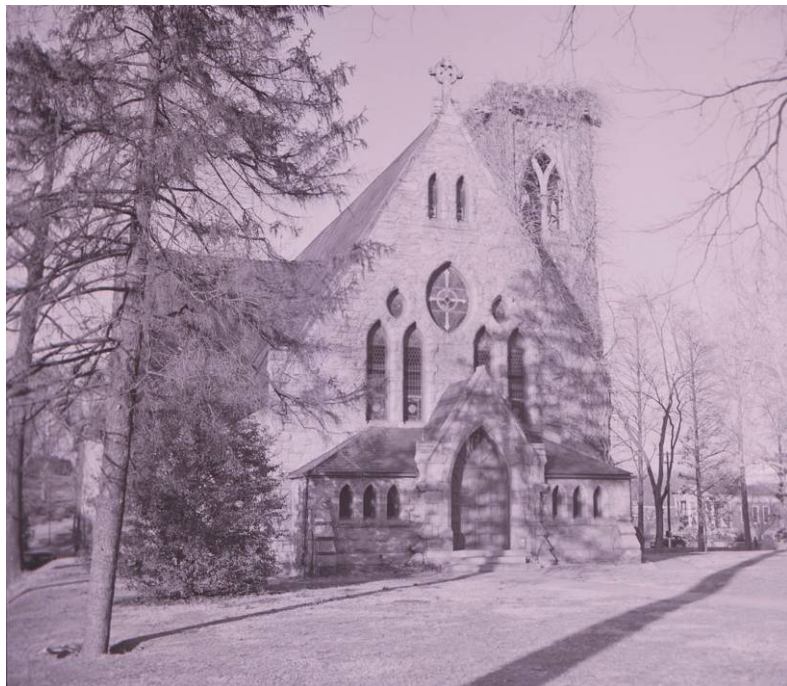
**Figure 2.18**

Dead vines cover the façade and bell tower, ca. 1940s, Dick Anderson. (Special Collections, University of Virginia Library) (image cropped)

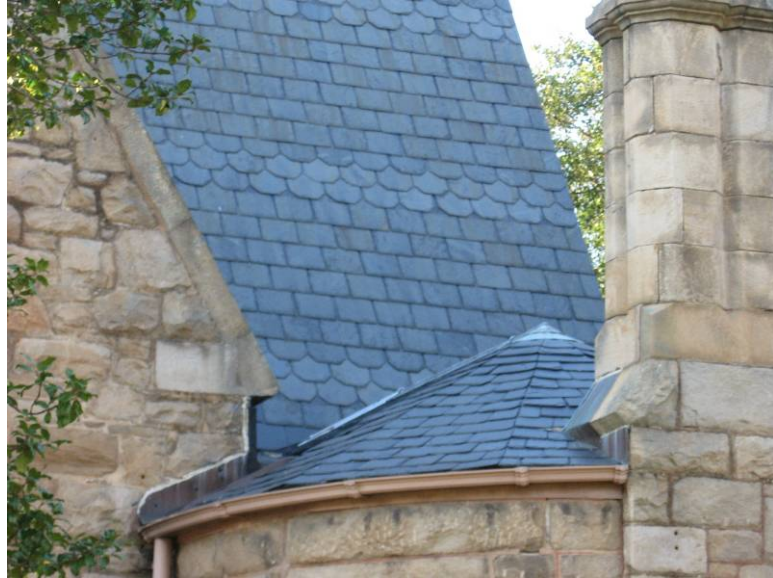
**Figure 3.8**

The current slate roof is a 1991 replacement in-kind of the original slate roof. The steeply pitched roof has a pattern of six rows of rectangular tiles alternating with six rows of scalloped tiles that mimic the original slate roof. (Figures 3.8 - 3.9)

Detail of slate roof on east façade. (QE|A, 2006)

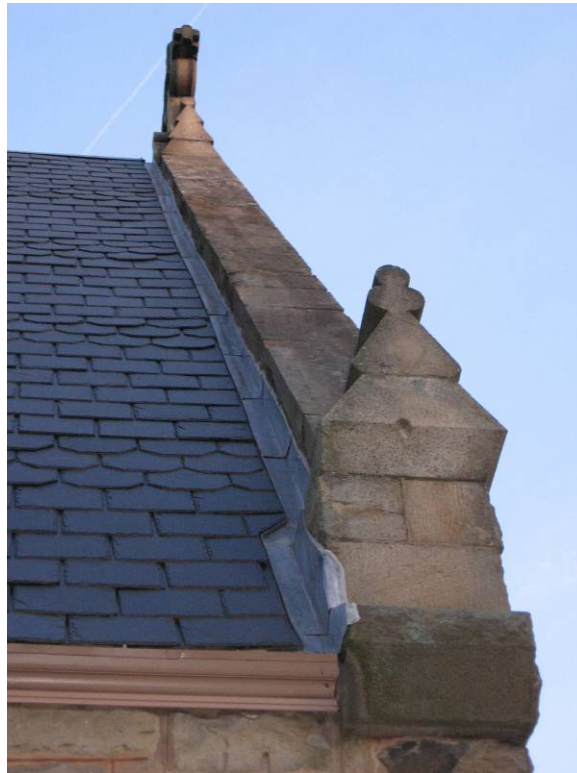
**Figure 3.10**

Based upon drawings dated 1991, the roof deck was to be replaced and repaired as needed and the slate tiles were to be salvaged and reused if they were in good condition. Flashing was to be replaced as were most gutters and downspouts. The only roofing to be left in place was the vestry roof. It is assumed that the current vestry roof is part of the original construction. (Figures 3.10)

Detail of copper gutters and flashing at south parapet.  
(QE|A, 2006)

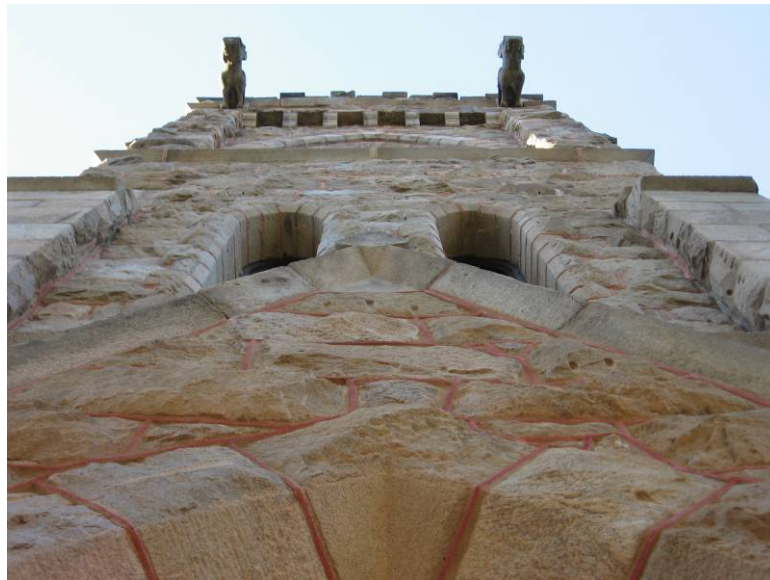
**Figure 3.15**

There are several pointing types used throughout the stonework. One type in particular covers approximately 75% of the wall surface and was identified as the earliest pointing type. There have been between 5 and 10 different pointing campaigns on the Chapel. The University Chapel Stonework Investigation dated 2005 deemed that the earliest extant pointing is highly likely the original pointing mortar. The original mortar can be distinguished with the following visual characteristics: thin red striping and a beige base mortar with a center raised to receive the red striping. (Figure 3.15)

Detail of the new repointing. (QE|A, 2007)

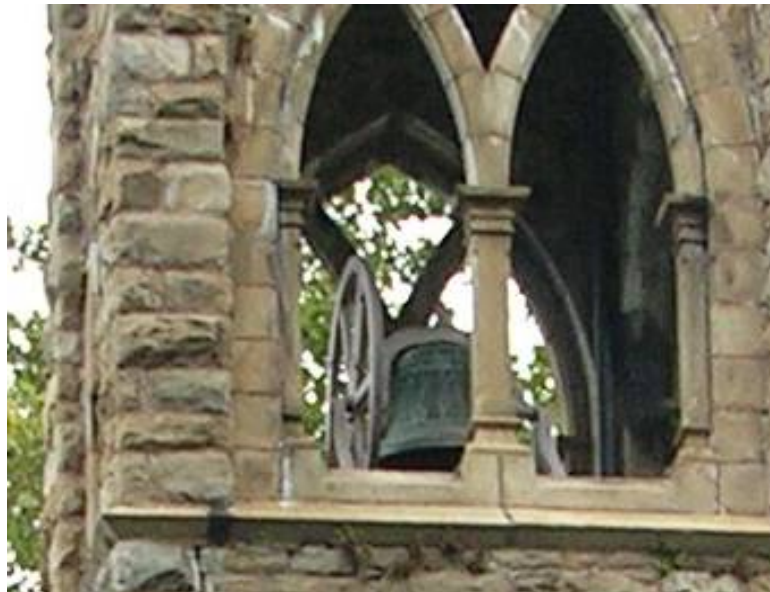
**Figure 3.19**

Detail of the bell and yoke. (QE|A, 2005)

This photo was taken prior to the tower and ongoing bell restoration.

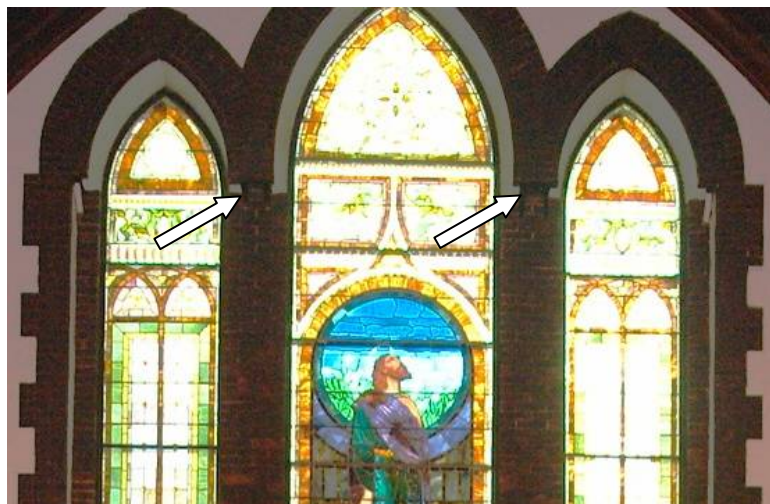
**Figure 3.41**

Though it is highly speculative, it is possible that a pair of columns were originally intended to flank the center memorial window of the chancel. On either side of the window, there are two simple brackets that support the springing of the arched brick window surrounds (Figure 3.41). The window sill is deep enough to receive a column and its base similar in size to the large columns at the intersection between the nave and transepts.

Detail of windows on the north wall of the chancel.

Note the small brackets at the springing of each arch. It is possible that the original design intent would have been to add columns to support the arches.

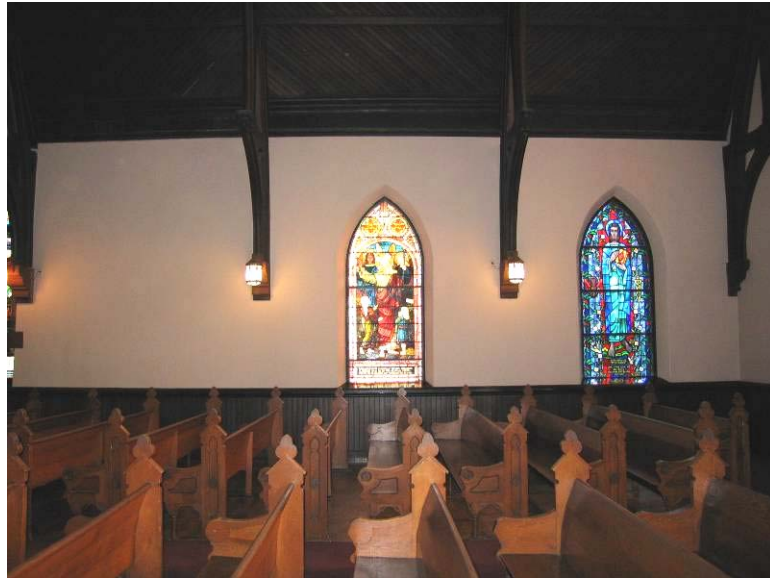
**Figure 3.48**

As described in an article in The Virginia University Magazine written before the completion of the interior finishes, the walls were to be either painted or frescoed.<sup>12</sup> Currently the plaster walls are painted with a single beige paint color. (Figure 3.48) Damaged plaster in the narthex and bell tower has revealed at least two shades of green underneath the current paint. The walls in the carillon equipment closet in the vestry are painted a deep teal green. Without a comprehensive paint color analysis, it is unclear as to the original paint scheme and subsequent schemes. Of note, there is only a very thin wood trim around the windows of the nave, chancel, and transept. The splayed door and window plaster jambs have a rounded corner with a small reveal.

East wall of the nave.  
(QE|A, 2006)

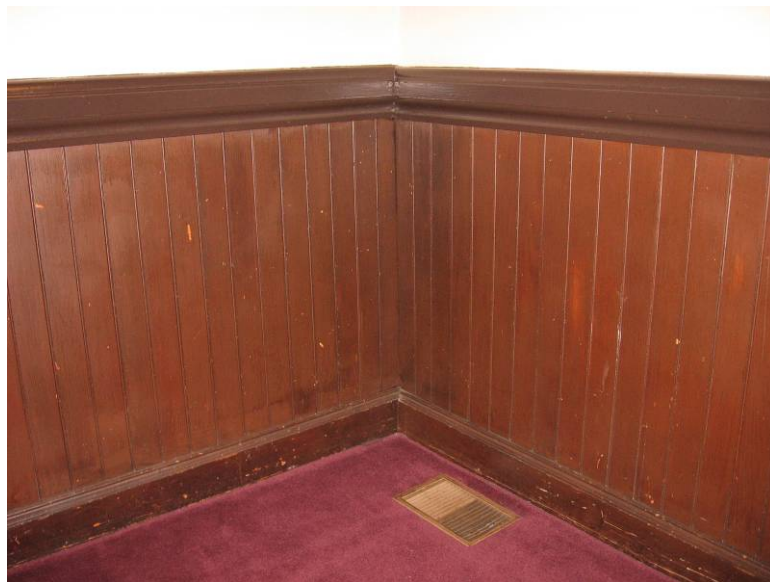
**Figure 3.49**

The approximately 3'-0" tall wainscot consists of a wood beadboard panel, baseboard, and chair rail. In most every location, the chair rail has been painted brown. In the northwest closet in the vestry, the chair rail along the original wall of the vestry is painted on the upper half while the lower half is coated with the same translucent brown as the beadboard panel and baseboard. The paneling and baseboard may have originally been "grained pine" and then given an oil finish (see ceiling discussion below). There appears to be several different layers of translucent brown coatings on the paneling and the baseboard. (Figures 3.49)

Detail of wainscot, at the  
southeast corner of the nave.  
(QE|A, 2006)

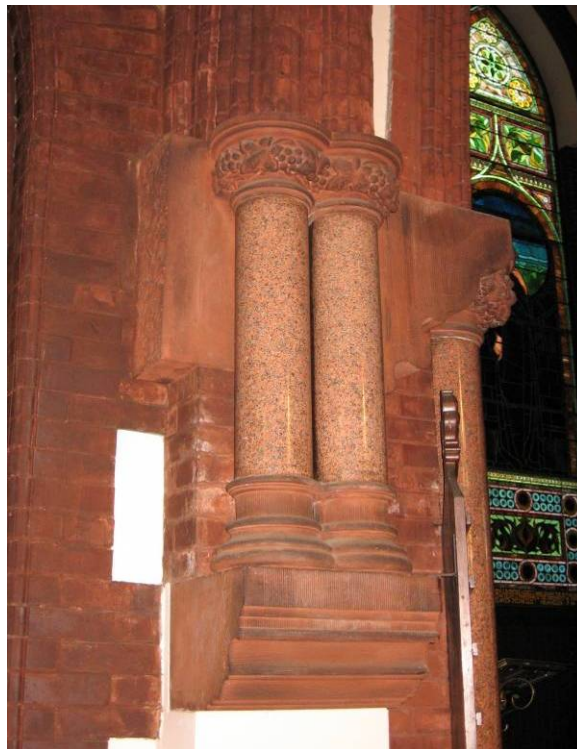
**Figure 3.53**

finest art in their workmanship.”<sup>14</sup> Each pair of column capitals has a different leaf depicted. (Figures 3.53) The surfaces of the brackets and pedestals are striated. Of note, it appears that one edge of the northwest bracket (between the west transept and nave) was never trimmed down and finished.

Detail of the shorter granite columns & sandstone capitals and bases at the west transept. (QE|A, 2006)

Note that there are two different styles for the short and tall columns. Note the unfinished end of the red sandstone bracket behind the short columns.

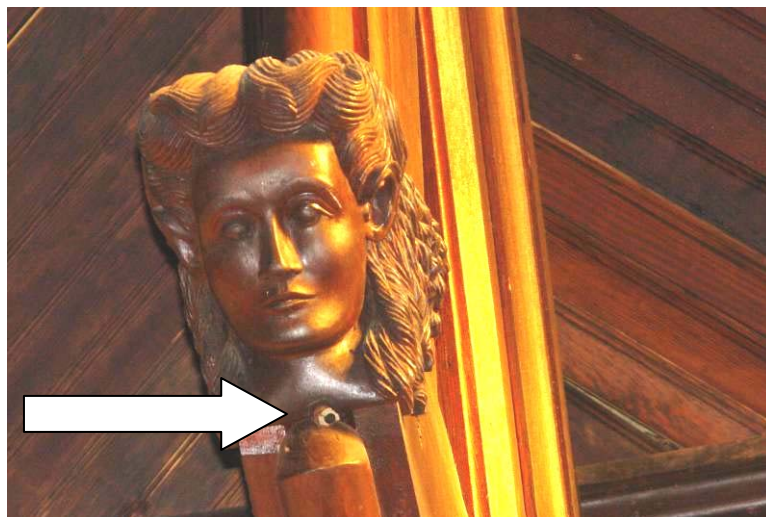
**Figure 3.55**  
Detail of carved head at the  
truss. (QE|A, 2006)

Carved wooden heads are at the end of each horizontal beam projecting at the top of the wall. The heads appear to be similar to each other and depict an inexpressive female. There are at least two different hairstyles depicted. At the base of each woman’s neck is a pipe. This most likely was the gas conduit for the previous light fixture. (Figure 3.55)

Note the gas bib beneath the  
carved head.

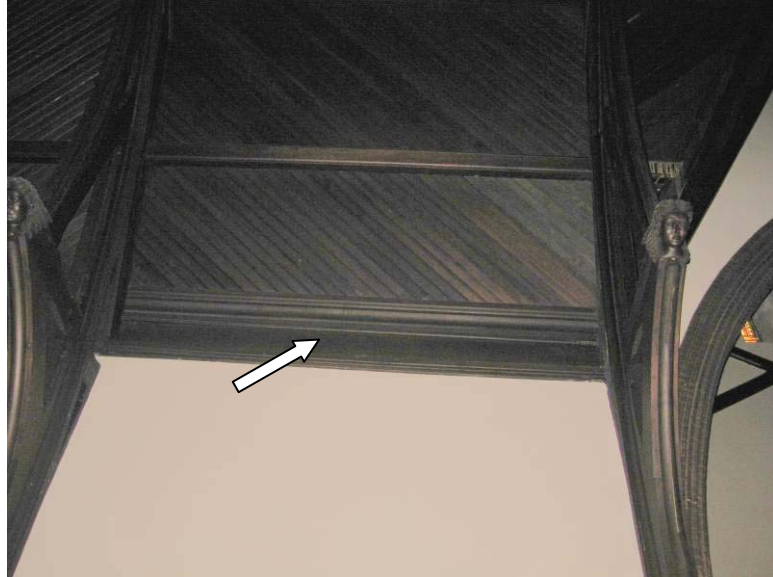
**Figure 3.58**

Detail of the beadboard ceiling in the west vestibule.  
(QE|A, 2006)

Note the two different edge treatments on the purlins: rounded and chamfered.

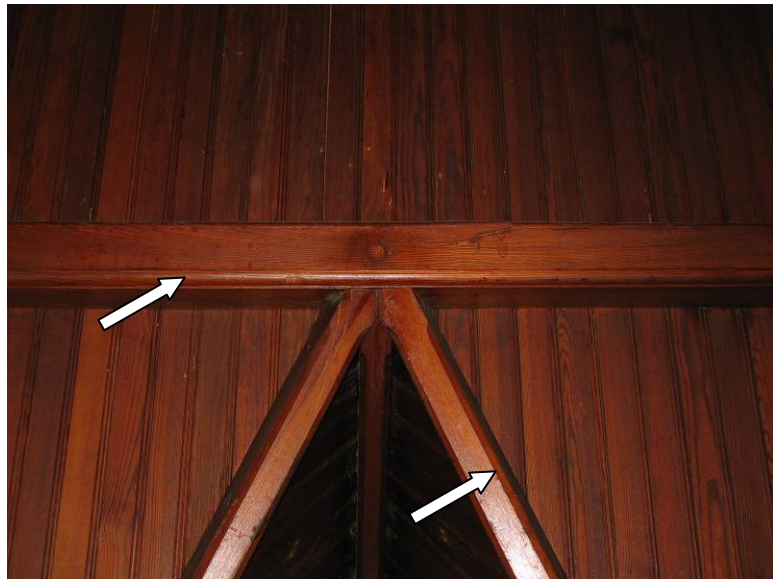
**Figure 3.59**

Detail of the vestry brackets, crown molding, and beadboard ceiling. (QE|A, 2006)

Note the crown molding that is different from that in the nave.

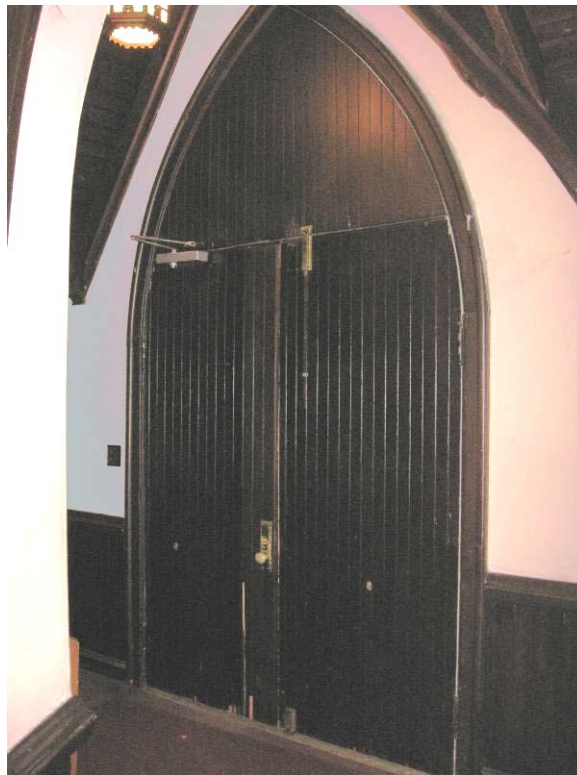
**Figure 3.64**

Door into the nave, (door 109c, door 109b is similar). (QE|A, 2006)

Note the split transom.

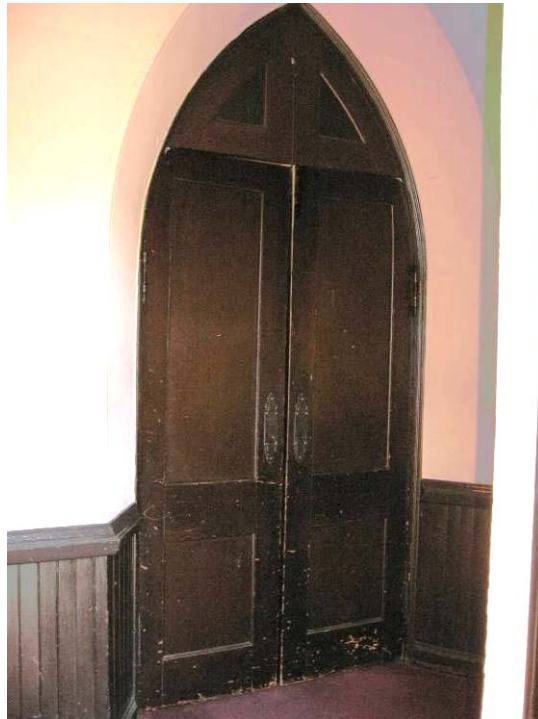
**Figure 3.65**

Door into the vestry (door 106b). (QE|A, 2006)

This is the only door with gothic style cusps in the upper arched portion of the door. Also, the arched portion is part of the door and not split to create a transom like the other doors (except the one to the organ chamber).

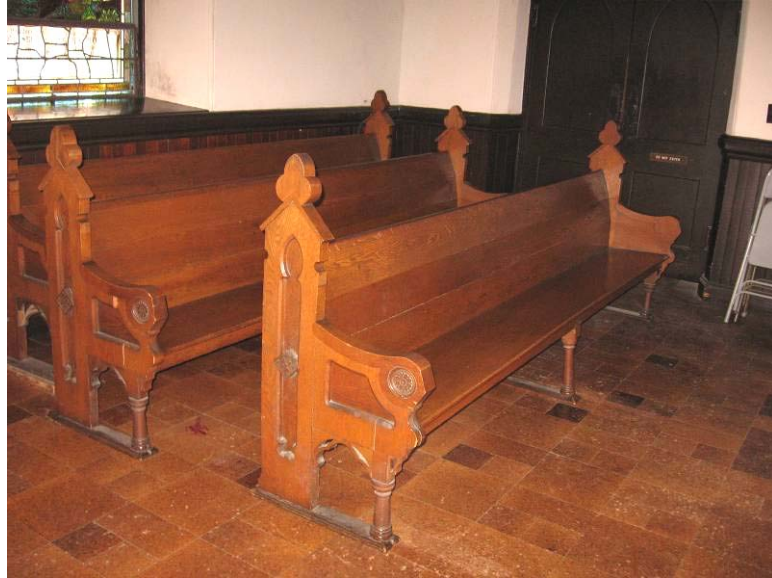
The oak pews are most likely original (Figure 3.73). Some of the original pews had been destroyed by the 1910 fire. They can be seen in the historic photograph of the interior. The pews were intended to seat 350.<sup>16</sup> The current legal capacity in the Chapel is 250 (see chapter 6).

**Figure 3.73**  
Oak pews in  
east transept.  
(QE|A, 2006).

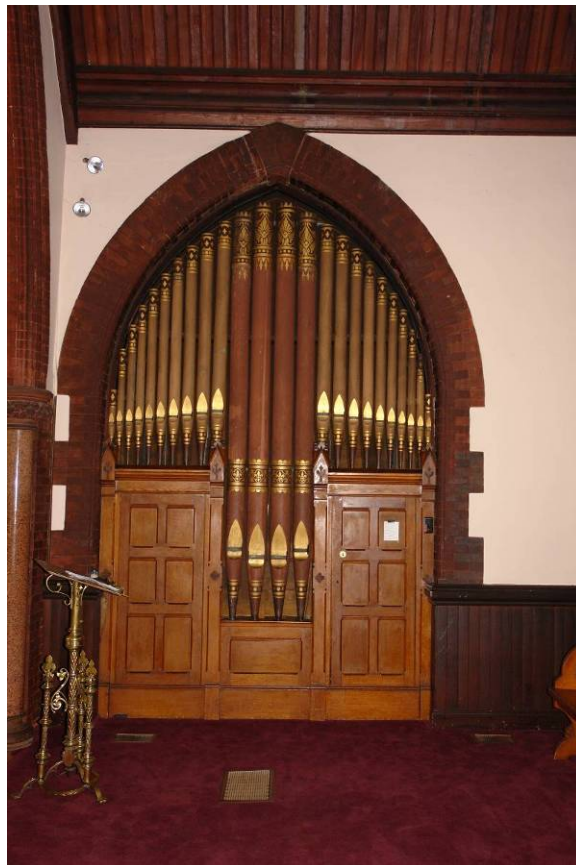
The facade pipes enclosing the organ chamber are from the original Roosevelt organ and were kept as a decorative screen after the installation of the current organ in 1953. The pipes are decoratively painted in red, a darker red, and gold. (Figure 3.74)

**Figure 3.74**  
Organ façade  
pipes from the  
original organ  
on the west wall  
of chancel.  
(QE|A, 2006)

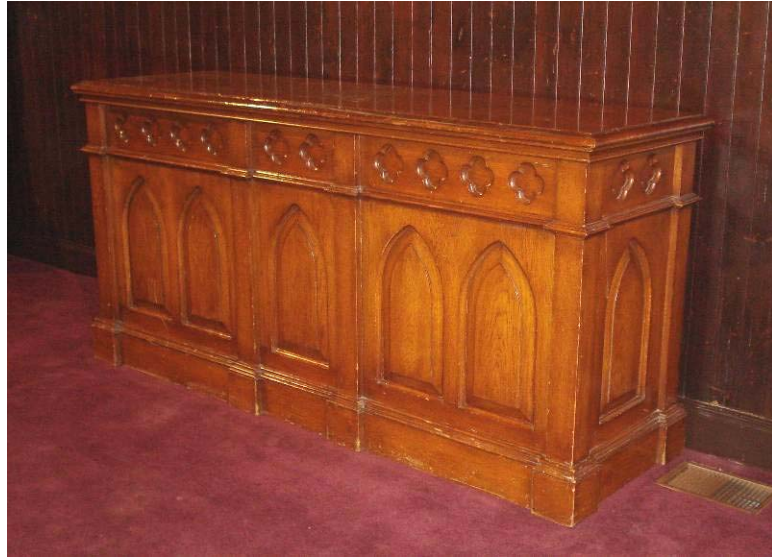
The Gothic Revival altar is similar to the clergy chairs and stand but does not have matching details. The interior of the altar is made of plywood and stamped “Weldwood US Plywood” and probably dates to the 1950’s. There is no altar in the historic interior photo. (Figure 3.75)

**Figure 3.75**  
Altar in the  
chancel. (QE|A,  
2006)

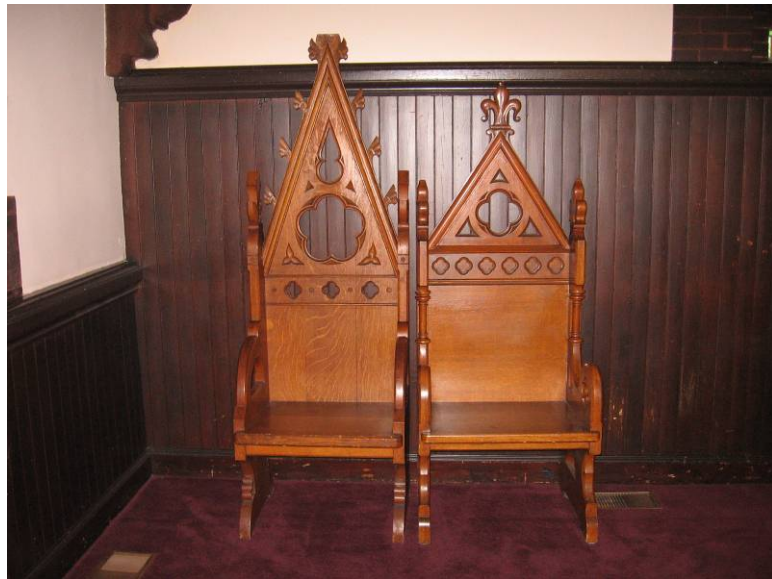
There are four Gothic Revival clergy chairs with one being taller and slightly more ornate than the other three. (Figure 3.76 and 3.77) The tall chair and the two of the three shorter chairs are a set. They all have a geometric foliage pinnacle, three quatrefoils across the top of the back, chamfered edges at the sides, and vertical back boards.

**Figure 3.76**  
Two of the four  
clergy chairs.  
(QE|A, 2006)

Note the two different types of pinnacles and the number of quatrefoils across the back.

Note that the taller chair on the left is visible in the historic interior photo, Figure 3.78.

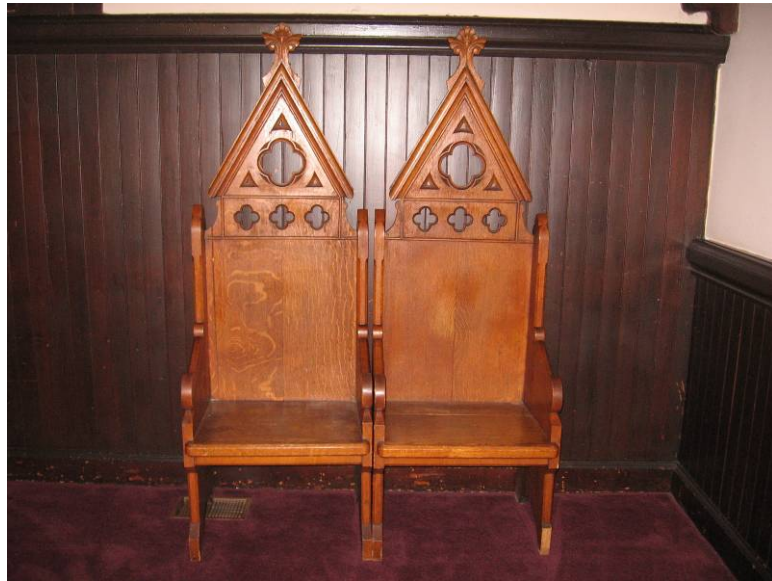
**Figure 3.77**  
Two of the four  
clergy chairs.  
(QE|A, 2006)

Note the pinnacles and the number of quatrefoils across the back match the taller chair in the previous photo.

Note that at least one of these two chairs is visible in the historic interior photo, Figure 3.78.

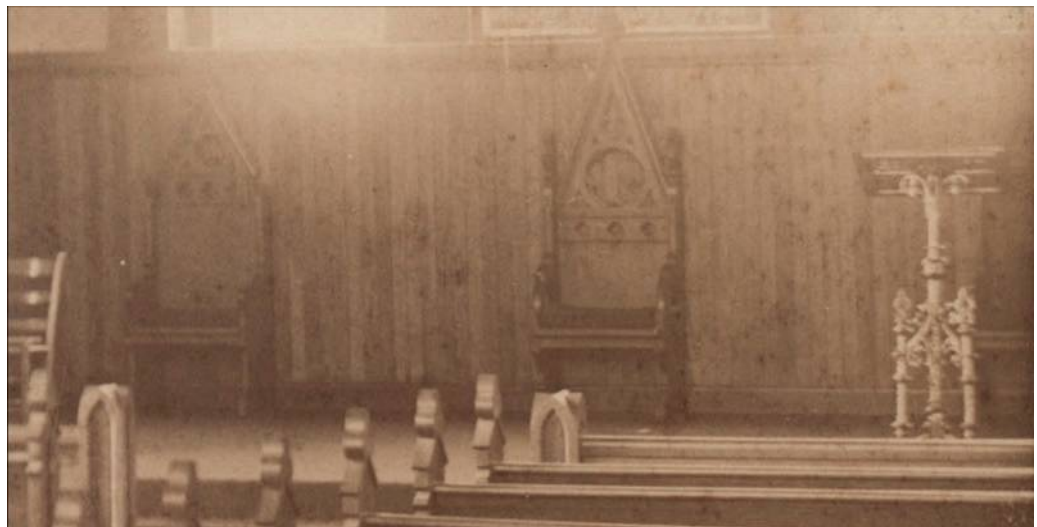
These three chairs are presumably the same as the three in the historic interior photo where the tall chair is centered along the north wall of the chancel and is flanked by two others. (Figure 3.78) Therefore, the tall chair and the two matching chairs can be considered as original furnishings.

**Figure 3.78**  
Detail of  
historic photo  
of chancel,  
undated,  
photographer  
unknown.  
(Special  
Collections,  
University of  
Virginia  
Library)

Note the taller clergy chair (Figure 3.76) in the center flanked by one of the shorter clergy chairs (Figure 3.77) and the brass lectern. Almost visible is the other shorter clergy chair (Figure 3.77) on the far right of the photograph.

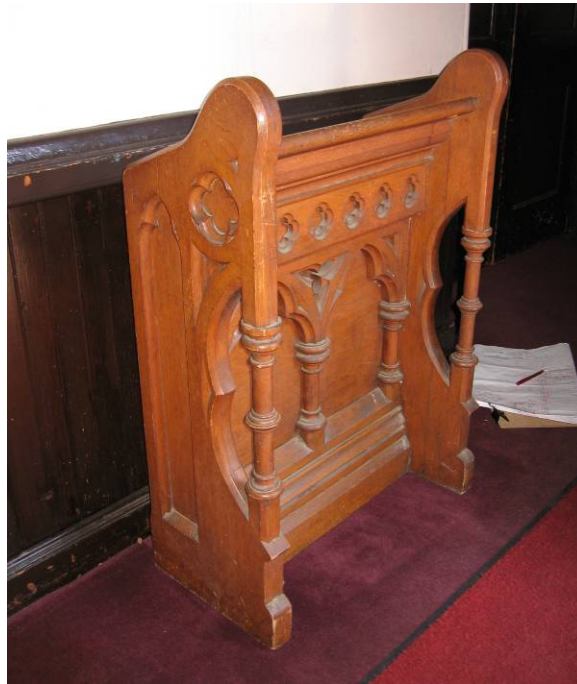
stand and positioned in the chancel. It could also have been a registration or guest book stand. The stand matches in style, material; construction of the stand matches that of the fourth clergy chair that is not part of the original set. (Figure 3.79)

**Figure 3.79**  
Stand in the  
narthex. (QE|A,  
2007)

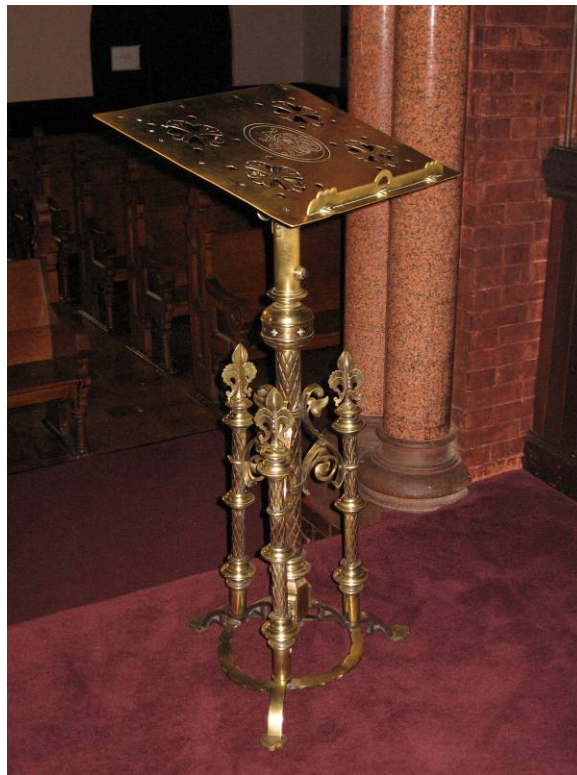
The brass lectern is visible in the historic photo and is considered as an original furnishing. The brass lectern is supported by a post which rests on three legs. Fleur de lis cap the incised posts of the three legs. (Figure 3.80)

**Figure 3.80**  
Detail of the  
brass lectern.  
(QE|A, 2006)

Note that the same lectern is visible in the historic interior photo, Figure 3.78

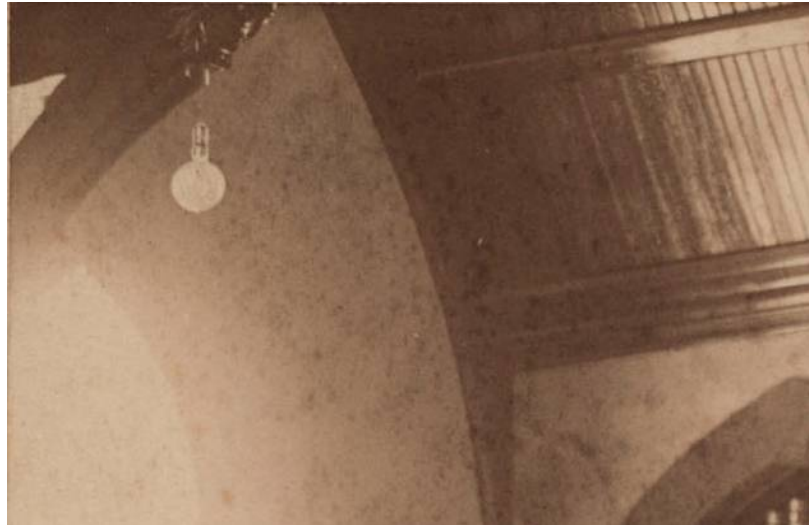
**Figure 3.88**

Detail of historic photo of  
transept, undated,  
photographer unknown.  
(Special Collections,  
University of Virginia  
Library)

Note the bulb-like electric  
fixture hanging from the  
neck of the carved head at  
the truss.

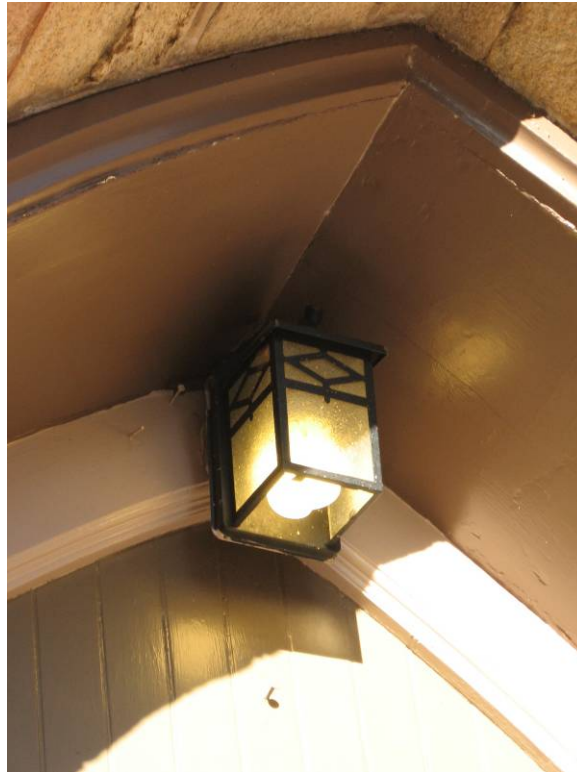
**Figure 3.89**

Intrusions to the site and exterior of the Chapel include the pole light fixtures, the wall sconces on the building, the temporary aluminum ramp to vestry, the moveable ramp to main entrance, the site furniture, and the brick paved sidewalks. These intrusions are necessary to accommodate the current functions of the Chapel and its surroundings. The historic photographs from the period of significance and slightly after do not seem to show any exterior light fixtures though it is difficult to tell from them. (Figures 3.89 - 3.93)

Wall sconce fixture at entrance into bell tower.  
(QE|A, 2006)

Note that a similar light fixture is located above the main entrance.

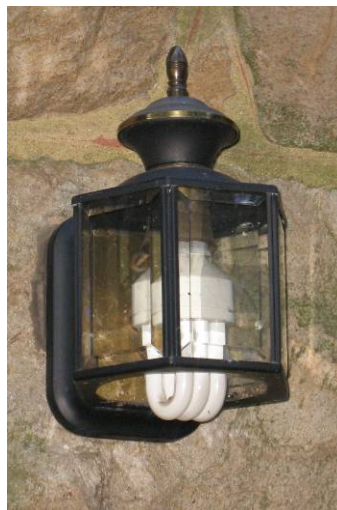
**Figure 3.90**

Wall sconce fixture at door to vestry. (QE|A, 2006)

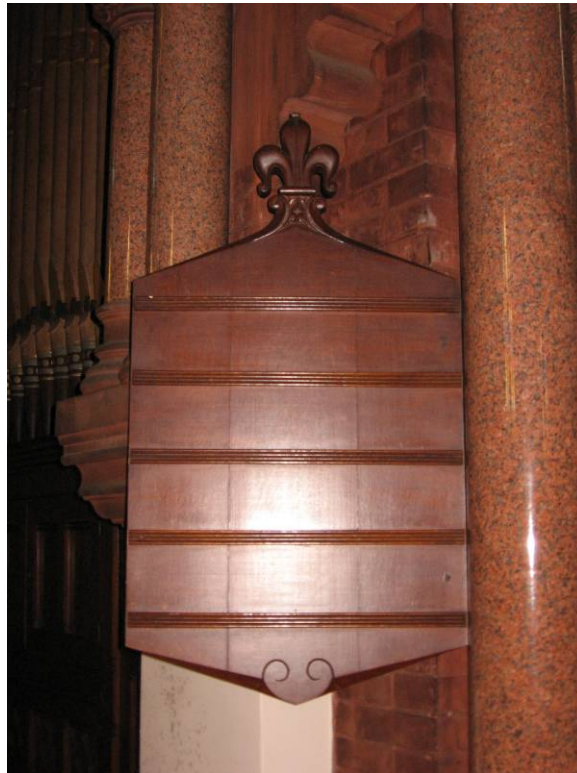
The existing hymn plaque near the west transept is not seen in the earlier undated historic photograph (Figure 2.14). It can be inferred then that the two hymn plaques were not installed during the period of significance. The fleur de lis at the top of the plaque is the same style as that found at the top of one of the clergy chairs, which are also missing from view in the historic photo. It is possible too, that this clergy chair was placed around the same time as the hymn plaques. (Figures 3.95)

**Figure 3.95**  
West hymn plaques. (QE|A,  
2006)

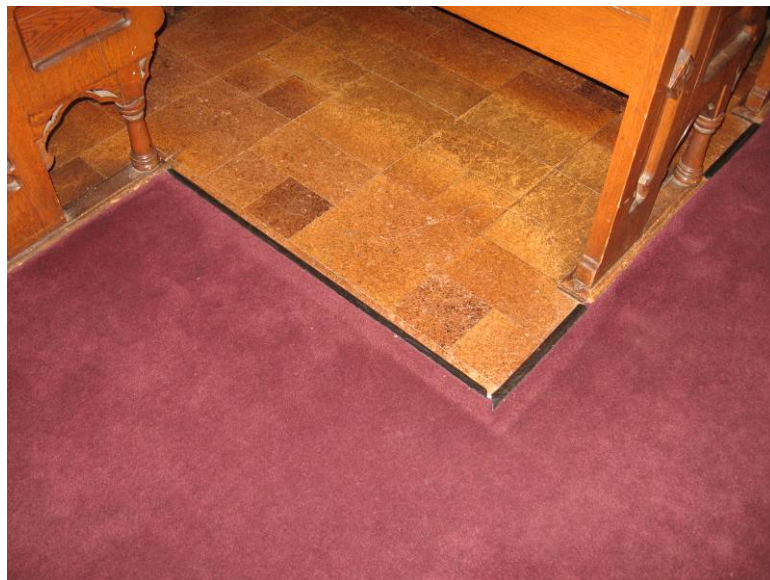
The intrusions to the interior of the Chapel include the addition of two drywall-enclosed closets in the vestry, the interior light fixtures (the gothic revival fixtures and the spotlights in the chancel), the carpet, the cork tile flooring, the brown linoleum in the vestry<sup>17</sup>, some of the door hardware (i.e. the lacquered polished brass flush bolts and locksets at door 107a), the 1953 Aeolian-Skinner organ console, the hymn plaques, the phosphorescent exit signs, additional furniture, and possibly two of the clergy chairs. (Figures 3.94 and 3.96)

**Figure 3.96**  
Detail of the cork tile  
flooring and carpeting at the  
south end of the nave.  
(QE|A, 2006)

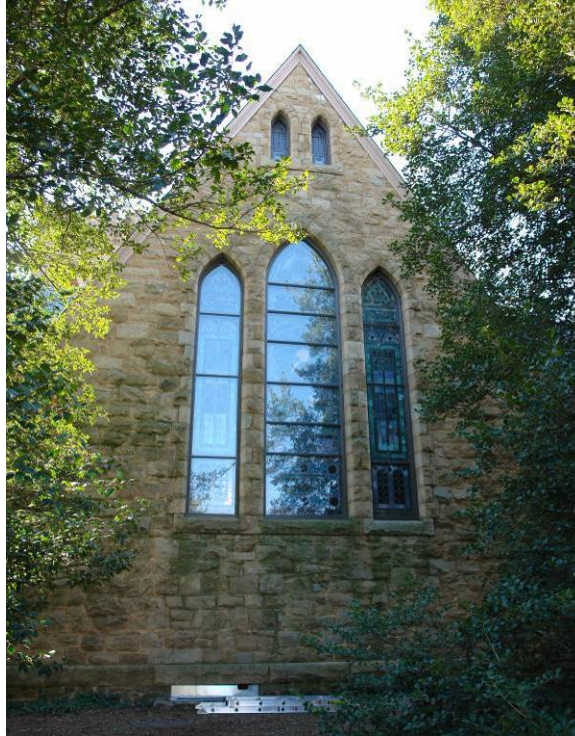
**Figure 4.1**

The stonework is in fair condition. There is evidence of biological growth, cracking, spalling, staining, missing or loose mortar, and intentional damage. Much of the biological growth is on the north facade of the Chapel which is very shaded and in close proximity to the several large holly trees. (Figures 4.1) Other concentrations of biological growth primarily occur on the west façade buttresses where the rainwater pours off the roof without the aid of a gutter. (Figures 4.2 and 4.7) Another concentration of biological growth is along the length of the downspout between the vestry and the east transept. Most of the buttresses around the Chapel and projecting surfaces do have some accumulation of biological growth.

Biological growth on stonework, north facade. (QE|A, 2006)

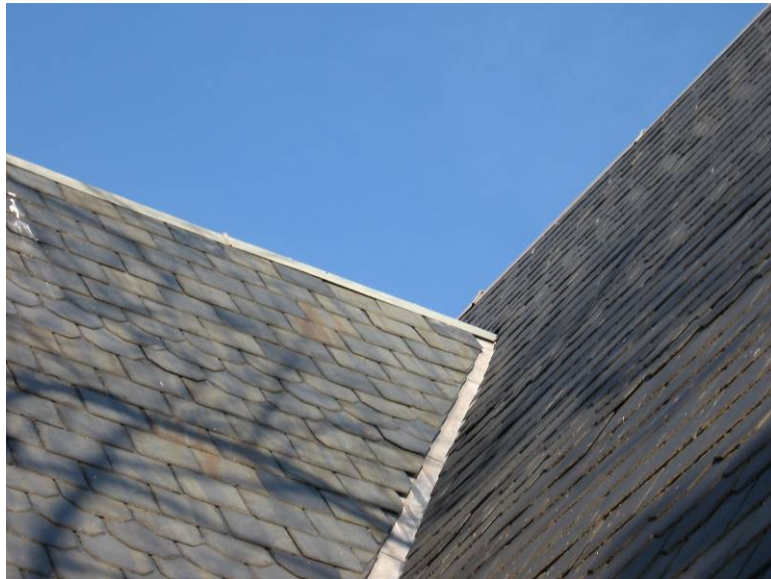
**Figure 4.5**

The slate tiles are in good condition. The tiles are fairly new having been installed in 1991 and do not show much wear.<sup>3</sup> (Figure 4.5)

Slate roof, west façade.  
(QE|A, 2006)

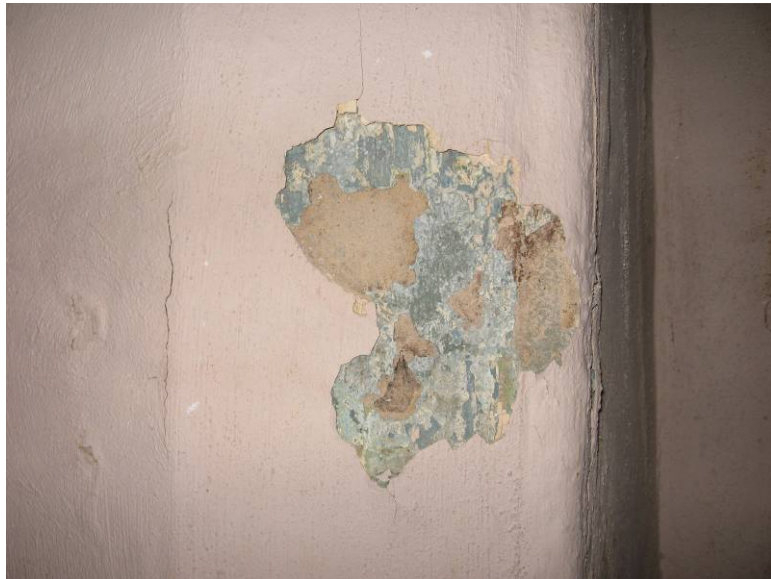
An advantage to all this damage is the revelation of different paint colors, particularly different shades of green as well as lighter colors, under the current beige paint color. (Figures 4.12) The north and west walls inside the northwest closet of the vestry is a deep blue-green color. (Figures 4.13) As will be discussed in Chapter 6 and 7, an in-depth paint investigation and analysis is recommended to fully understand the original paint scheme.

Damaged plaster and paint at the right jamb of door 108b of the east vestibule of the bell tower. (QE|A, 2006)

Note the different paint colors that are revealed.

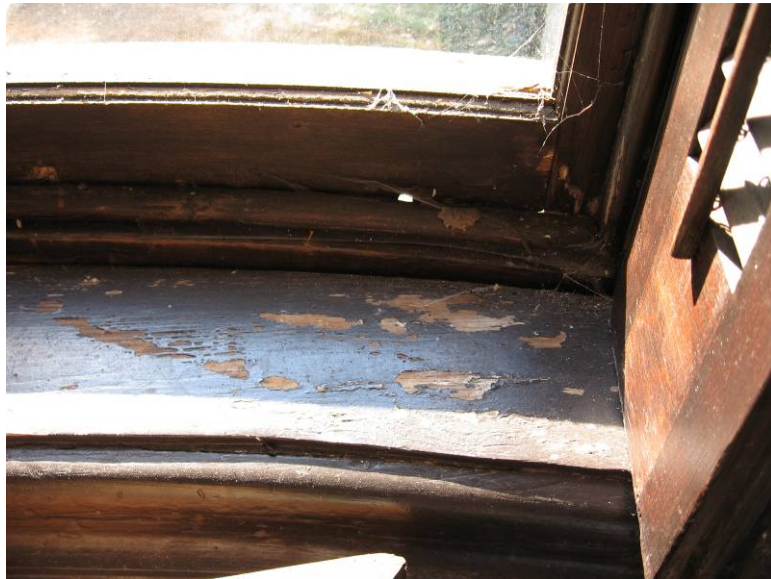
Scuffed and removed coating on sill of window mullion between windows #37 along south wall of vestry. (QE|A, 2006)

This is the most severe of all of the scuffed and scraped window sills in the vestry.

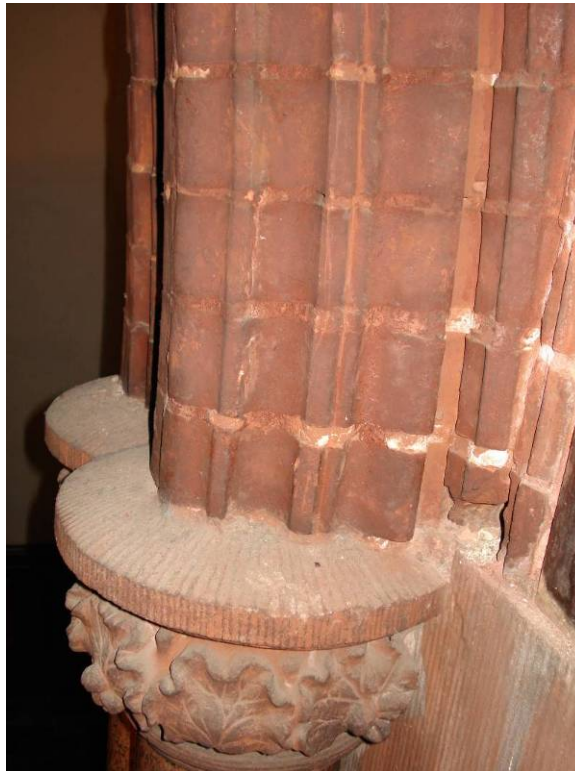
Red coating wearing off on pressed brick arch and revealing white mortar beneath, column at south end of east transept. (QE|A, 2006)

Note the amount of dirt and dust on top of the capital.

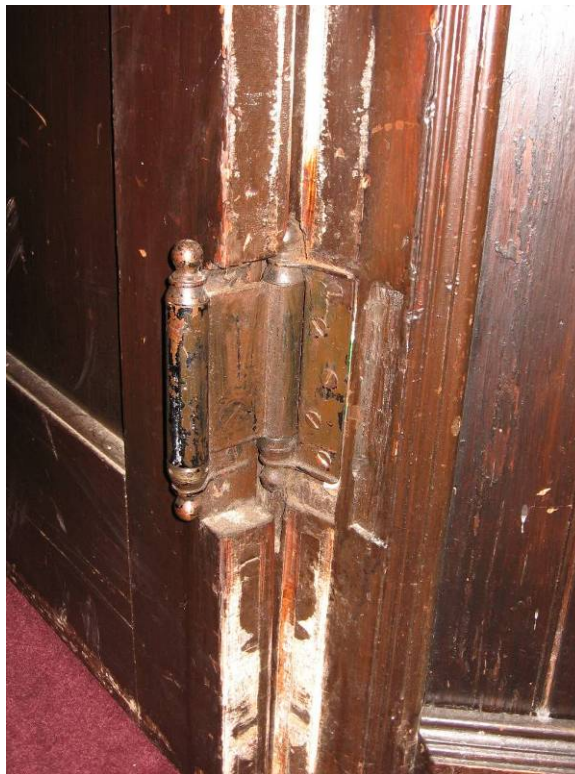
Chipped paint on lower right hinge to door 109b in the narthex. (QE|A, 2006)

Note at least three different colored coatings on the hinge.

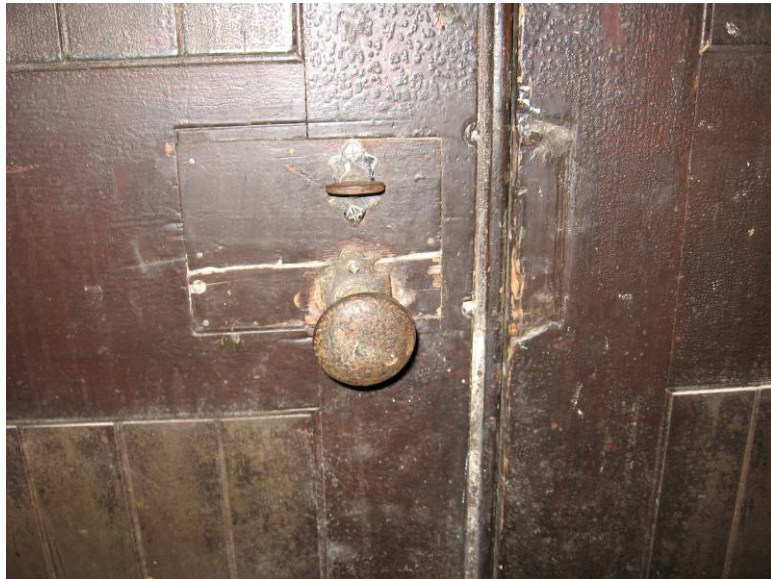
Patch in door 108a, interior face. (QE|A, 2006)

The thumb turn, escutcheons, and doorknob are most likely original but the deadbolt (as seen on the exterior face) is a modern addition. Note also the aged varnish.
