PRESIDENT'S HOUSE ON CARR'S HILL

BUILDING ASSESSMENT & SCHEMATIC DESIGN FINAL REPORT

JOHN MILNER ASSOCIATES, INC.
FEBRUARY 28, 2006

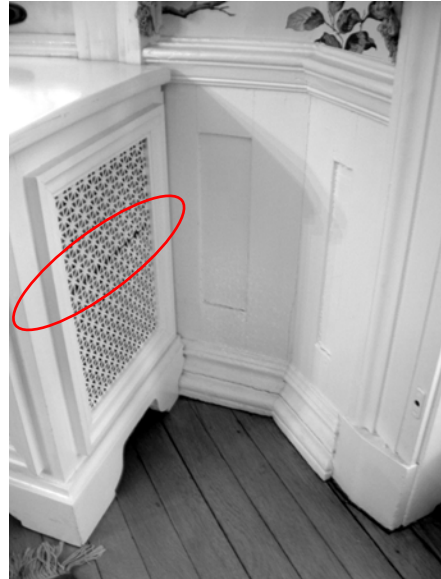
Split radiator grille (Item 3).

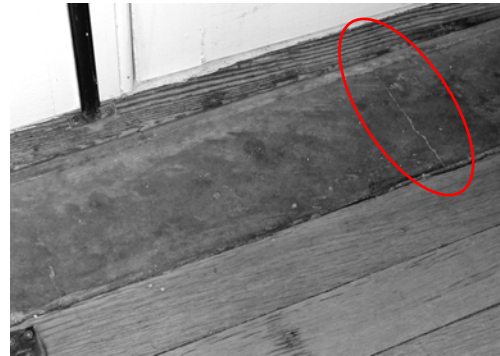
Cracked concrete threshold (Item 5).

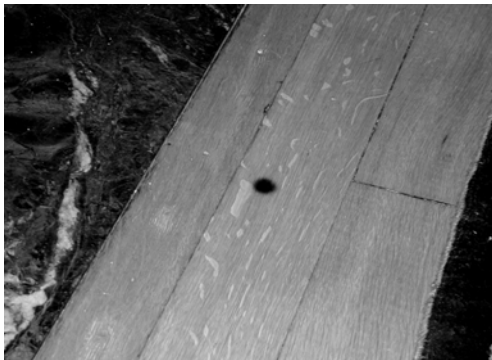
Burn mark in oak floor (Item 6).

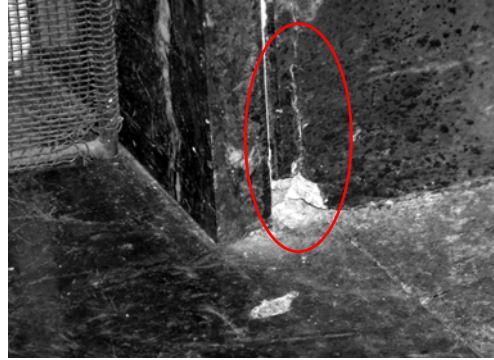
Crack in firebox masonry (Item 7).

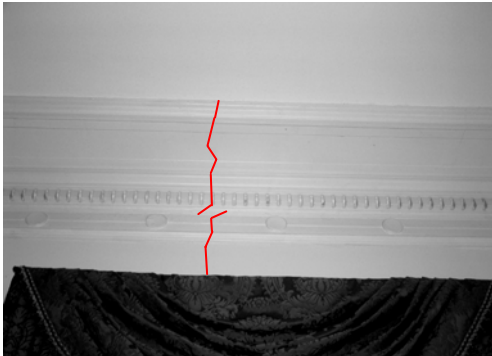
Plaster cracking in crown molding (Item 8).

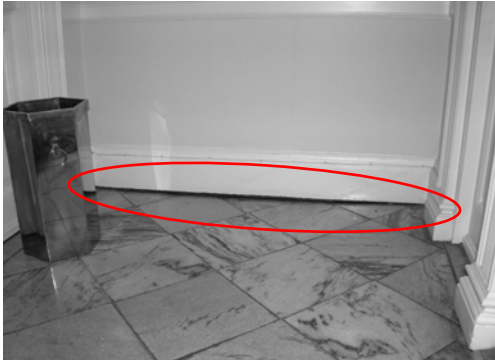
Gap between floor and baseboard (Item 5).

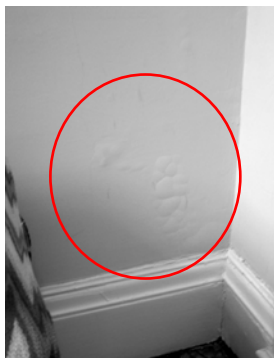
Blistering of paint (Item 7).

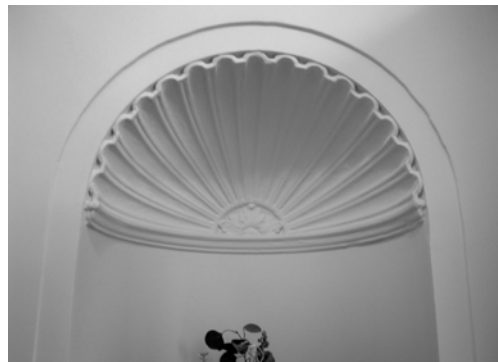
Paint build - up on clam-shell detail (Item 8).

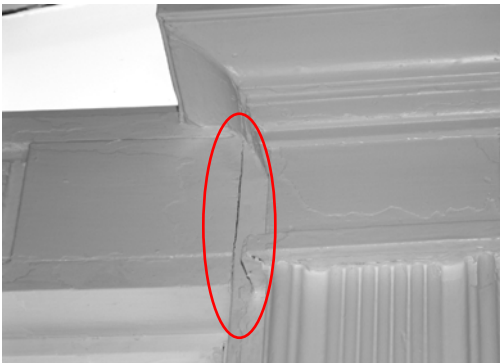
Opening of joint in trim (Item 5).

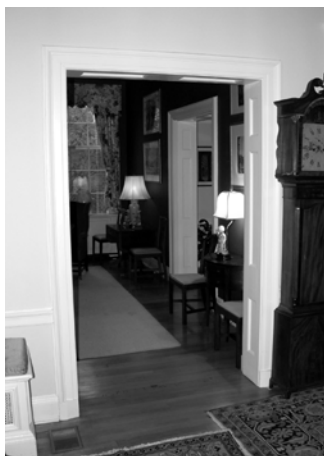
Removed doors (Item 9).

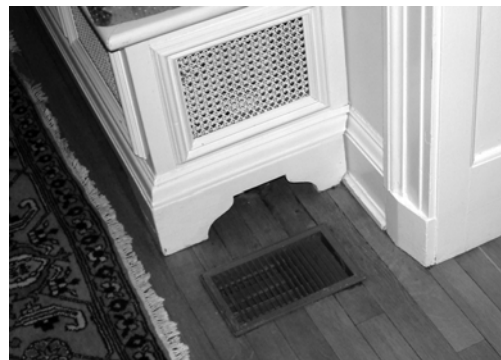
11. The two supply and one return floor metal grilles at floor registers are not flush to the floor and are scratched.

Floor grille (Item 11).

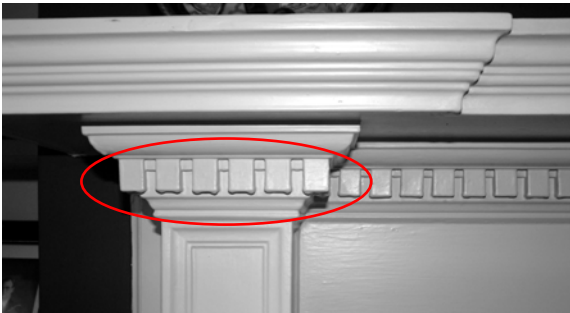
Paint build-up on mantel (Item 7).

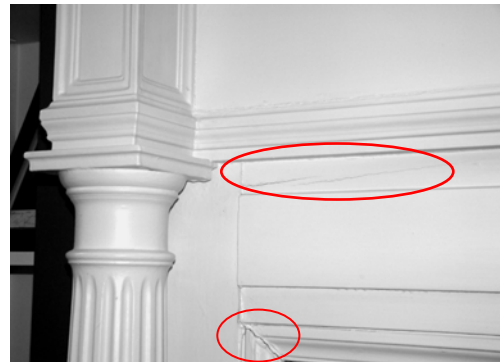
8. Open joints between pieces of wood trim are present on components of the fireplace surround.
9. The flat woodwork above the fireplace opening has a series of cracks.

Open joints and cracking of wood (Items 8 & 9).

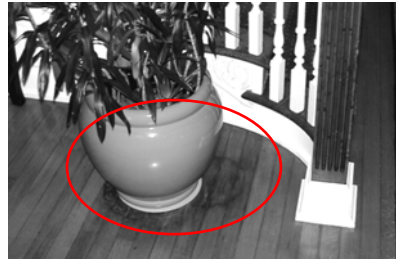
Water stain on wood floor (Item 4).

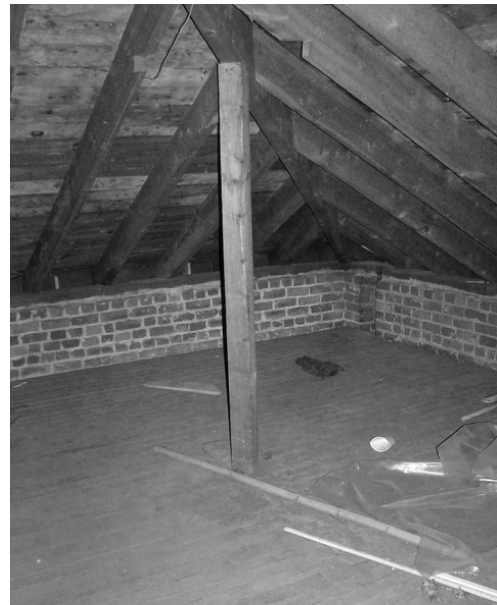
Photo 4 (right): A 4x4 post supporting the hip beam.

The more common means of load transfer for the roof at the President's House relies on vertical support along the hips and ridges of the roof profile (Photo 4). Because the perimeter wall is generally higher than the attic floor and the rafter base connection detailing offers little capacity for the resistance of a horizontal thrust, most of the roof load must be transferred vertically down through the main-floor levels. The typical means by which the roof loads get transferred down to the third-floor level is by way of timber posts as well as knee walls or interior partition walls (Photo 5). This transfer of roof load through interior walls results in very apparent displacements at the third-floor level. RSA made general notations of high and low points within the floor level in Figure S-3. These displacements have also been well documented and quantified in previous surveys.

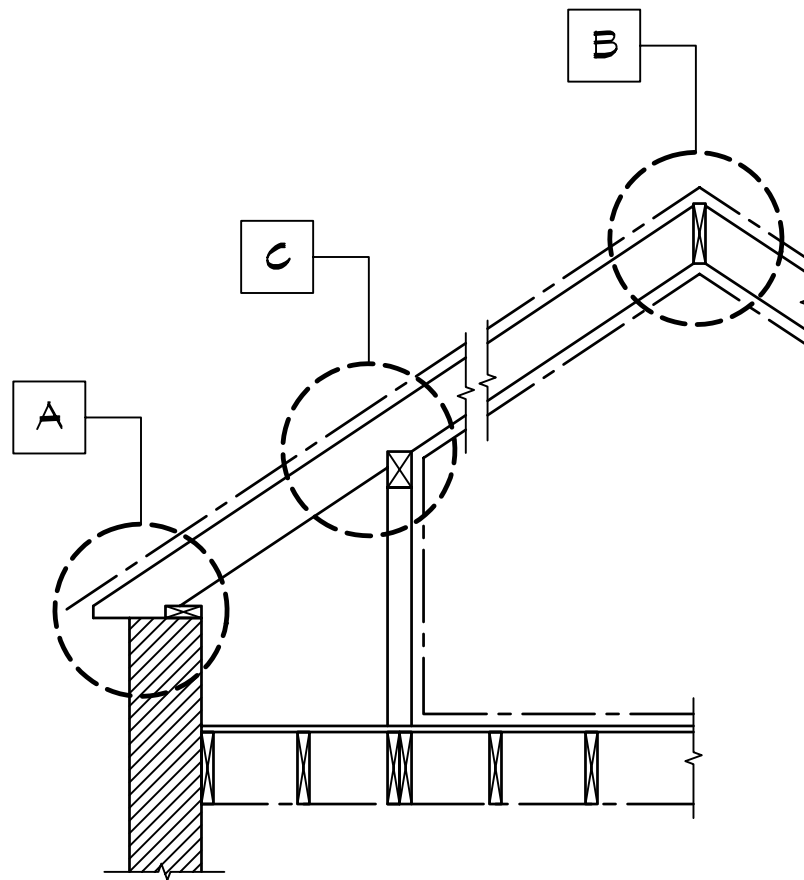
DETAIL A:

THE RAISED SILL FOR THE RAFTER SUPPORT ABOVE THE ATTIC FLOOR AND THE NATURE OF THE RAFTER CONNECTION GENERALLY PROVIDES ONLY VERTICAL SUPPORT AT THE EXTERIOR WALL. THE INABILITY TO RESIST HORIZONTAL THRUST AT THE BASE OF RAFTERS RESULTS IN THE REQUIREMENT TO PROVIDE VERTICAL ROOF SUPPORT WITHIN THE FLOOR PLAN.

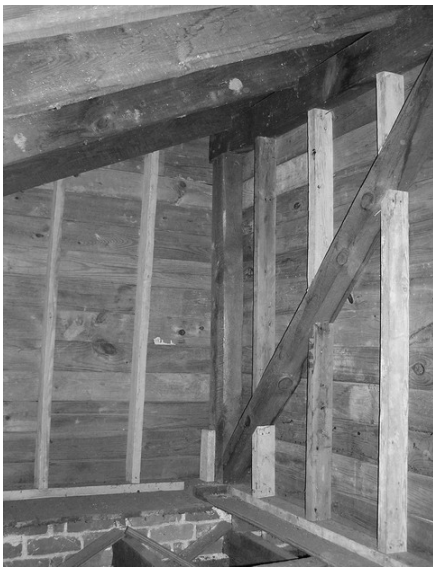
Photo 5: The knee wall supporting the roof above the portico.

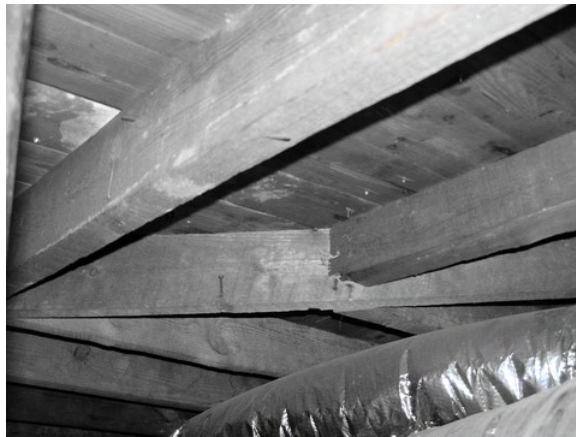
Photo 6: The shallow hipped roof construction of the center section of the roof surrounding the skylight.

The largest displacements on the third-floor level occur around the central corridor, in the vicinity of the skylight. This portion of the roof is a much shallower sloped hipped configuration (Photo 6), with the hip beams apparently posting down onto the light ceiling framing below. The ceiling framing (indicated as 2" x 6" @ 20" o.c. on the original drawings is consistent with the limited visual observation on site) is far too small to span fully across this central portion of the roof and therefore must bear on the interior partitions. As such, it appears clear that the loads of the central roof are transferring down to the third-floor joists in an area that was not apparently designed to support these loads.

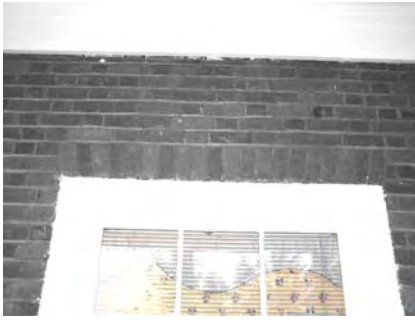
Some small movement in the tile finish of the bathroom in Room 219 was observed (Photo 7). Looking at this portion of the wall from the exterior porch (Room 218), some additional distress in the form of cracking in the exterior masonry wall was found (Photo 8). Smaller-scale cracking in the masonry was also observed in this wall from the first-floor level, which is apparently associated with the functioning of the flat arch, or *jack arch*, over the first-floor window below (Photo 9). The jack arch was measured as only 7 inches deep for a 4'-1" clear span, with a very shallow *skewback*, or projection of the upper portion of the arch over the bearing face of the masonry opening. The original drawings indicate that behind the jack arch, which is shown to only occur in the outer wythe of brick, there is likely to be a segmental brick arch consisting of two brick wythes. The segmental arch has a physical rise to its makeup which affords it significantly greater spanning capacity. It may be that additional loads are being introduced over the window opening from the porch-floor framing which are overstressing the masonry assembly, particularly in the outer wythe which has a limited spanning capacity.

Photo 9: The flat arch supporting the wall and window, depicted in Photo 8.

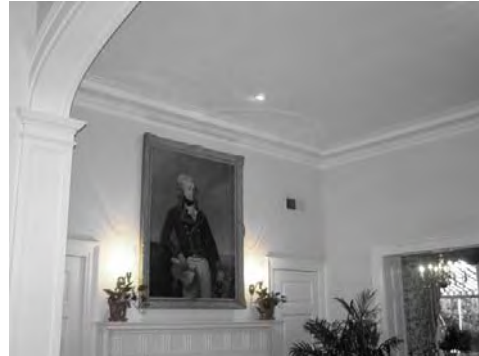
Photo 10: Ceiling of Room 109 on the first floor sagging below Closet Room 216A..

Significant deflections in the first-floor ceiling were noted below the second-floor corridor wall near Closet Room 216A (Photo 10). The deflection appears to correspond to similar large movements at the third-floor level in this area and are likely the result of insufficient support of interior load-bearing walls or partitions.

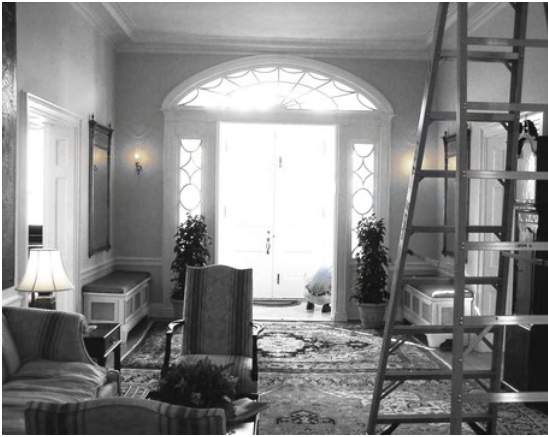
Photo 11: The vestibule wall between Rooms 104 and 108.

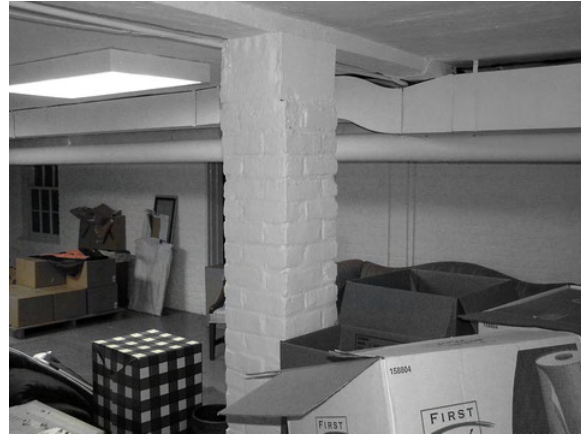
Photo 12: A brick masonry pier in the center of Room B02 supporting the timber girder above.

From the basement, the framing appeared to correspond well to the original drawings, with timber girders spanning between brick masonry bearing walls and piers (Photo 12). Some cracking in the timber girders themselves and in the interface between girder and ceiling was observed (Photo 13). In addition, there are significant areas of girder notching and penetrations by conduit and piping that are undoubtedly resulting in localized reductions in both bending and shear capacity (Photos 14, 15, and 16).

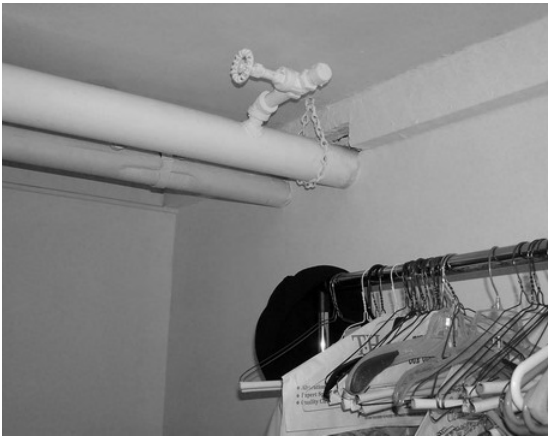
Photo 15: The 8"x10" first-floor girder between Rooms B08 and B10 suffers from several service penetrations.

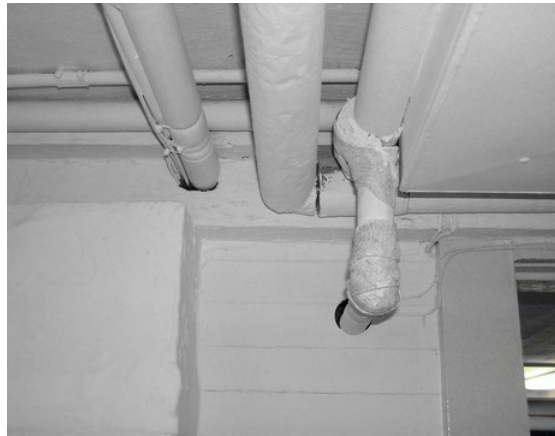
Photo 16: Several penetrations made through the 8"x10" first-floor girder between Rooms B09 and B04.

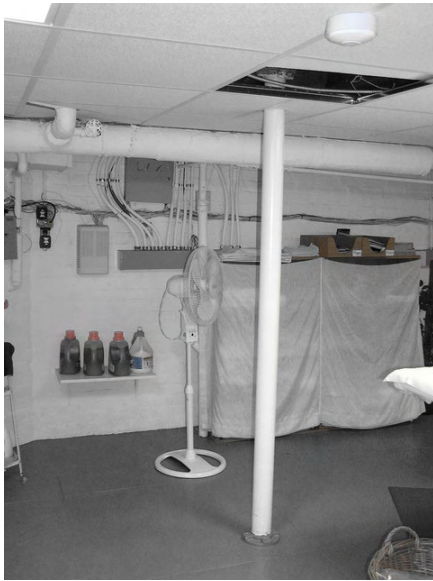
A makeshift steel pipe column is installed in the laundry area (Room B01, Photos 17 and 18). The column location roughly corresponds to the dividing wall between the kitchen and pantry rooms on the first floor. The column is not well connected or braced below the first-floor framing and does not appear to bear on a footing, but only on the existing slab on grade. It appears likely that the column was installed in response to excessive floor deflections.

Photo 17: Pipe column in Room B01 below first-floor wall between kitchen and pantry.

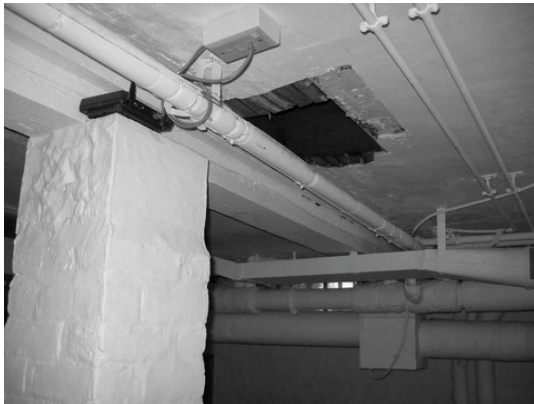
Photo 20: Probe 1 next to the 8x12 girder in Room B04, under Room 111

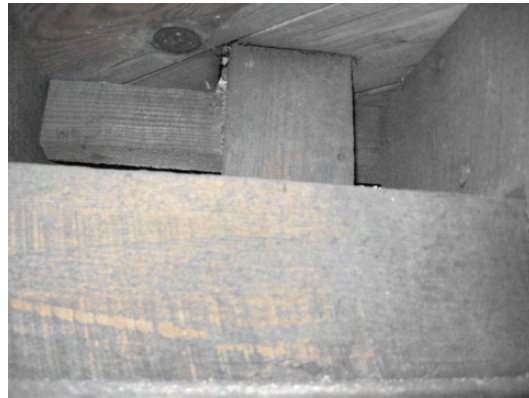
Photo 21: Probe 1 -- A post or wood stud resting on the 8x12 girder in Room B04

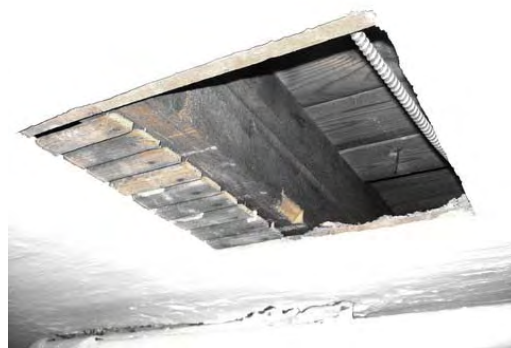
Photo 23: Probe 2 in Room B09 is below the vestibule in room 108

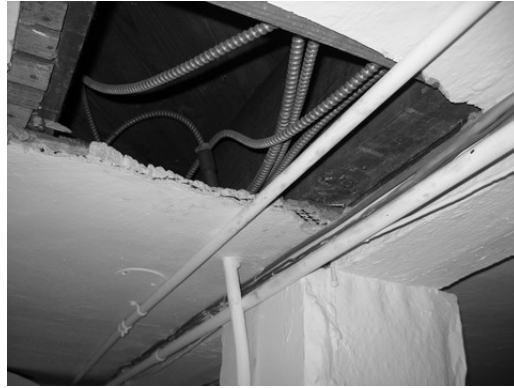
Photo 25: Probe 3 in Room B02 adjacent to the 8x10 first-floor girder supporting the wall between Rooms 104 and 106.

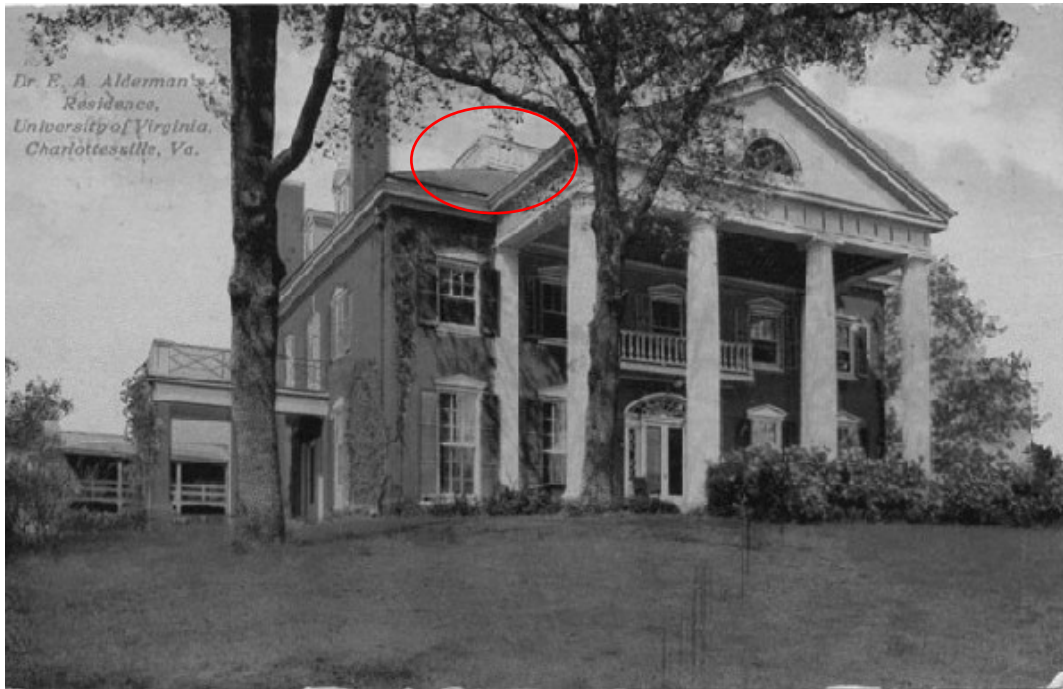
6. Balustrade. The McKim, Mead & White design included a wood balustrade surrounding the upper portion of the roof. Based on archival evidence, it is known that the balustrade was constructed and remained until at least the second decade of the twentieth century. It no longer exists and no information could be located to indicate the date of removal. The assumed reason for its removal is that the wood deteriorated. There are limited locations from which it can be seen. Nevertheless, it is recommended that consideration be given to reinstalling the balustrade. If there is concern regarding the installation of a wood structure that will take continued maintenance and periodic replacement, consideration should be given to replicating the balustrade with a fiberglass reinforced polyester custom fabrication using historic details.

Postcard dated 1914 - 1921 (University of Virginia Visual History Collection).

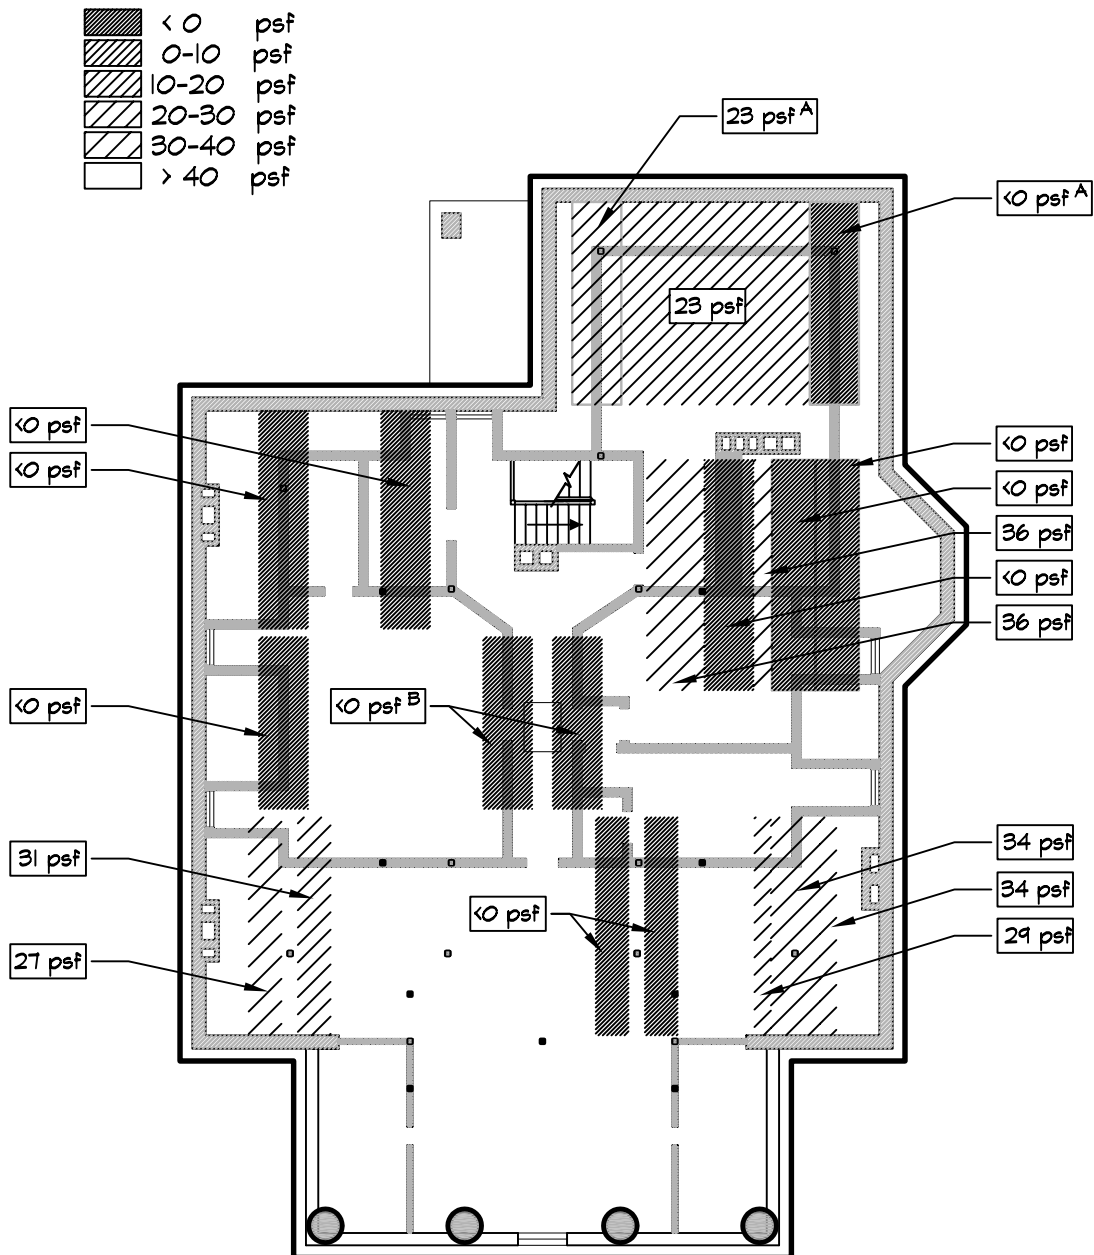
Figure S-11 indicates calculated live-load capacities at the third-floor framing level. The typical floor joists are found to have a residual live-load capacity generally greater than the code-required 30 psf for habitable attics and sleeping areas. Isolated areas below interior walls and posts which transfer roof loads result in localized overstress of the floor framing, and often correspond with some of the largest areas of localized sagging in the floors.

A IF THE WALL AND ROOF LOAD IS SPREAD TO AT LEAST 5 JOISTS THEN THE LIVE LOAD CAPACITY IS GREATER THAN 40 PSF.

B IF THE ROOF LOAD IS REMOVED AND THE REMAINING LOAD IS SPREAD TO AT LEAST 3 JOISTS THEN THE LIVE LOAD CAPACITY IS 43 PSF.

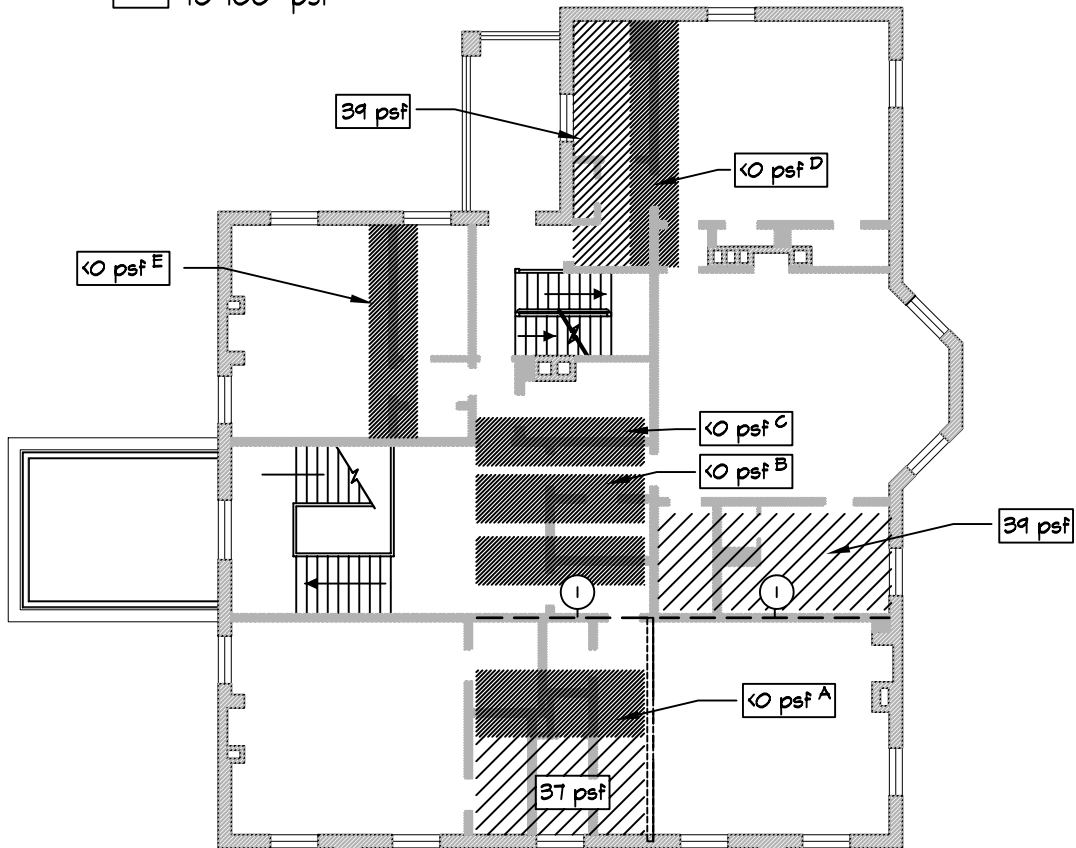
Figure S-12 indicates calculated live-load capacities at the second-floor framing level. Similar to the general floor framing at the third-floor level, most of the floor areas can support greater than 30 psf live load, which is required for sleeping areas, or 40 psf required elsewhere. Noted exceptions to this are the upper hall or landing area and the bathrooms to the south (Rooms 206 and 207), where calculated live-load capacities are insufficient to meet code requirements. The main walls to the north and

① BEAM OVERSTRESSED DUE TO DEAD LOAD

- A IF THE WALL LOAD IS SPREAD TO AT LEAST 3 JOISTS THEN THE LIVE LOAD CAPACITY IS GREATER THAN 40 PSF.
- B IF THE WALL LOAD IS SPREAD TO AT LEAST 3 JOISTS THEN THE LIVE LOAD CAPACITY IS GREATER THAN 22 PSF. IF THE WALL LOAD IS SPREAD TO AT LEAST 5 JOISTS THEN THE LIVE LOAD CAPACITY IS GREATER THAN 43 PSF.
- C INSERCTION OF NEW BEAM AT THIRD FLOOR LEVEL WOULD INCREASE LIVE LOAD TO 34 PSF.
- D IF THE WALL LOAD IS SPREAD TO AT LEAST 3 JOISTS THEN THE LIVE LOAD CAPACITY IS GREATER THAN 6 PSF. IF THE WALL LOAD IS SPREAD TO AT LEAST 5 JOISTS THEN THE LIVE LOAD CAPACITY IS GREATER THAN 23 PSF.
- E IF THE WALL LOAD IS SPREAD TO AT LEAST 5 JOISTS THEN THE LIVE LOAD CAPACITY IS GREATER THAN 13 PSF.

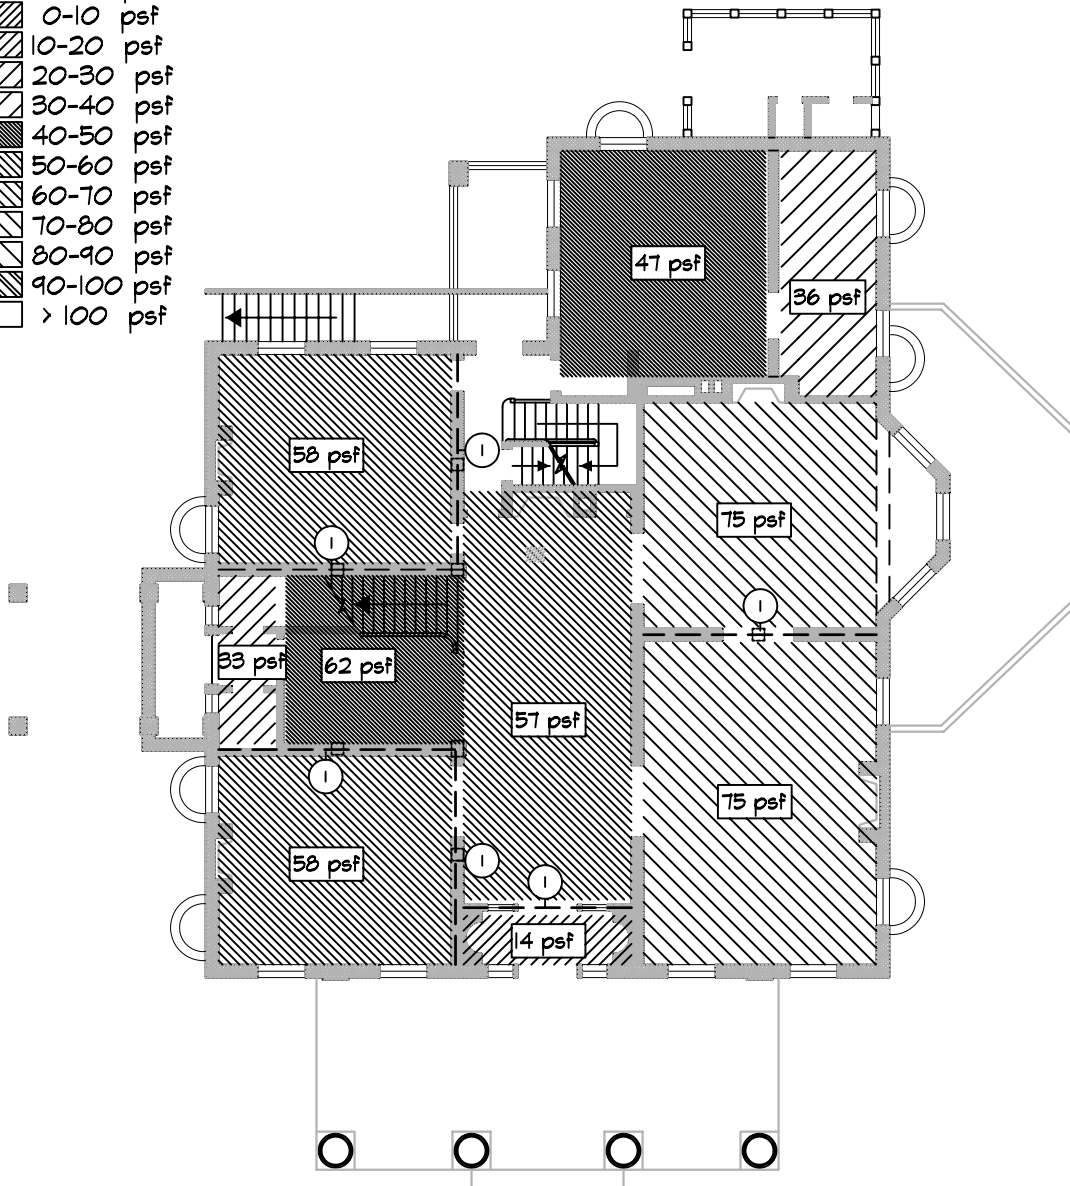
FIRST FLOOR PLAN W/ LIVE LOAD CAPACITIES OF FIRST FLOOR FRAMING

Figure S-13 shows the calculated live-load capacities. The floor joists are generally well above the 40 psf code-required live-load, with some noted exceptions. The areas of stone or tile finish at the main entrance vestibule and west-hall entrance have significantly reduced live-load capacities and, in the case of the main vestibule, show excessive deflections. Most of the timber girders supporting first-floor bearing walls were found to be overstressed to a significant degree under the imposed dead loads, prior to the application of allowable live loads. These findings corroborate observations of deflections and plaster cracking in the walls and floors above. The timber members themselves are frequently split along the grain at both the side and bottom faces.

① BEAM OVERSTRESSED DUE TO DEAD LOAD

Given the reported heavy use of the lower level, RSA recommends a detailed evaluation of the floor joists in the heavily loaded areas. These high-traffic areas may experience as much as 100 psf on some occasions. Further discussions with the owner may shed light on the frequency of these events, which may in turn be translated into a relevant load duration factor for the wood-joist analysis. Another reason for a more detailed study is the likely history of utility modifications and potential cutting in the wood which was very apparent in some of the timber girders.

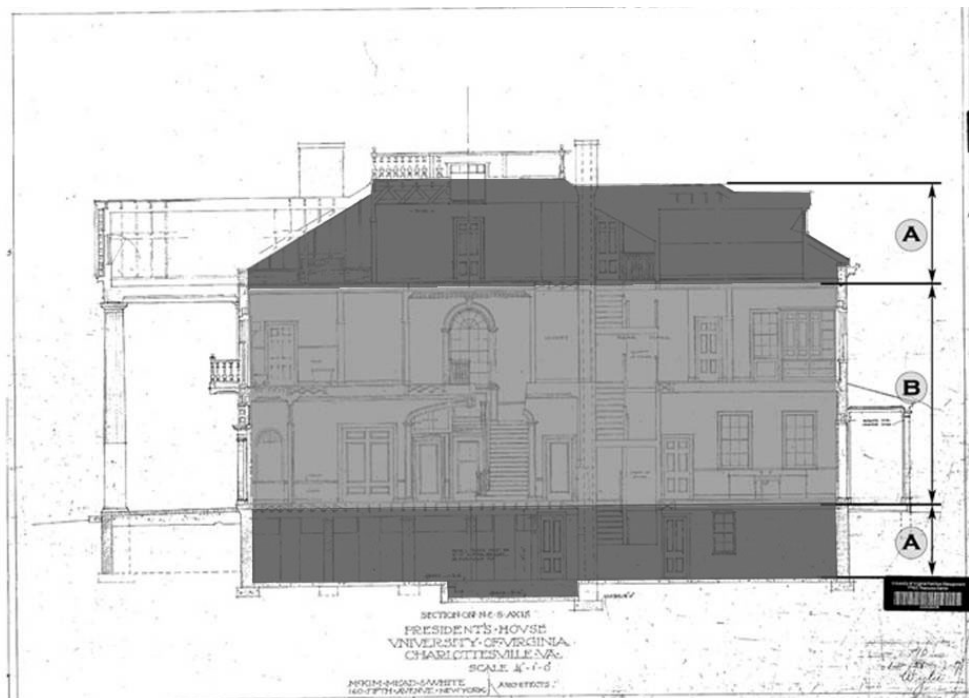
Figure S-14: Strengthening and Preservation Approach. Zone A indicates areas of significant structural intervention. Zone B indicates areas of preservation with minimal structural intervention.

One immediate approach to the reduction of damage is to focus reinforcement only within areas of overstress. The current design calls for floor reinforcement in areas of overstress as well as areas which are shown to have sufficient capacity, but suffer from sagging or floor unevenness. The clear drawback to taking this alternate approach would be that the occupants would need to live with uneven and perhaps somewhat flexible floors in the known areas. It is our opinion that this compromise is merited given the savings in cost, time of construction, and the preservation of historic fabric and is appropriate for a building of this historic significance. This compromise, however, is not sufficient to address all the significant structural issues within the home, and there remain a number of sensitive finish areas that would require substantial structural reinforcement with the Zone B area under the current loading configuration.

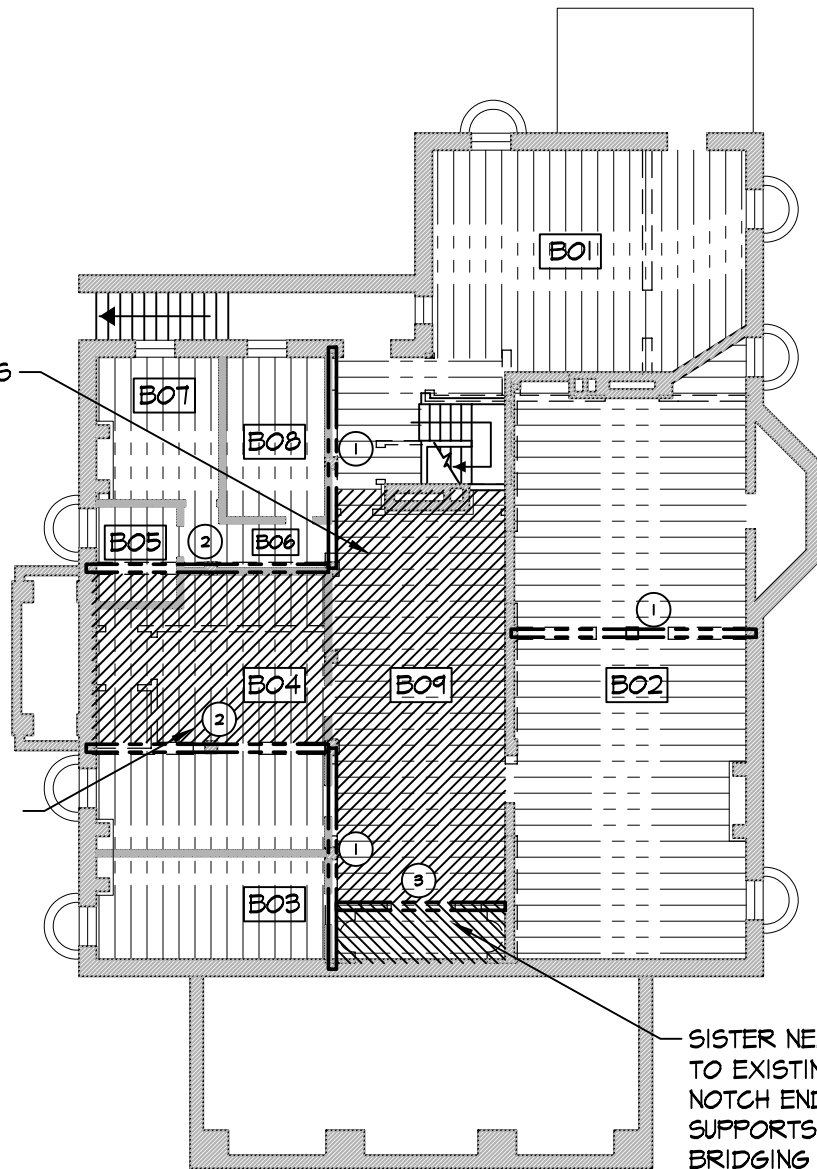
- ① EX. 8X10 GIRDER OVERSTRESSED FROM EXISTING LOADS. REMOVE JOISTS ADJACENT TO THE GIRDER AND ADD (2) C8X18.75 STEEL CHANNELS, ONE TO EITHER SIDE OF THE GIRDER W/ STAGGERED THRU-BOLTING @ 2'-0" O.C. PROVIDE WOOD BLOCKING OVER THE GIRDER AND NEW CHANNEL TO SUPPORT THE FLOOR BOARDS. SHIM TIGHT BETWEEN STEEL & MASONRY SUPPORTS. WIDEN MASONRY POCKET AT EXTERIOR WALLS. SERVICES TO BE RELOCATED AS REQUIRED.
- ② EX. 8X12 GIRDERS OVERSTRESSED FROM EXISTING LOADS. REMOVE NAILERS ADJACENT TO THE GIRDERS AND ADD (2) C8X18.75 STEEL CHANNELS, ONE TO EITHER SIDE OF THE GIRDER W/ STAGGERED THRU-BOLTING @ 2'-0" O.C. PROVIDE WOOD BLOCKING OVER THE GIRDER AND NEW CHANNEL TO SUPPORT THE FLOOR BOARDS. SHIM TIGHT BETWEEN STEEL & MASONRY SUPPORTS. WIDEN MASONRY POCKET AT EXTERIOR WALLS.
- ③ SISTER (2) NEW 2X10 JOISTS TO EX. DOUBLE 2X10, NOTCHED AT BEARINGS.

SISTER NEW 2X10 JOISTS
TO EXISTING 2X10 @ 16"
O.C. NOTCH ENDS TO
BEAR ON SUPPORTS.
PROVIDE NEW BRIDGING
AT MIDSPAN.

SISTER NEW 2X10 JOISTS
TO EXISTING 2X10 @ 12" O.C.
NOTCH ENDS TO BEAR ON
SUPPORTS. PROVIDE
BRIDGING AT MIDSPAN.

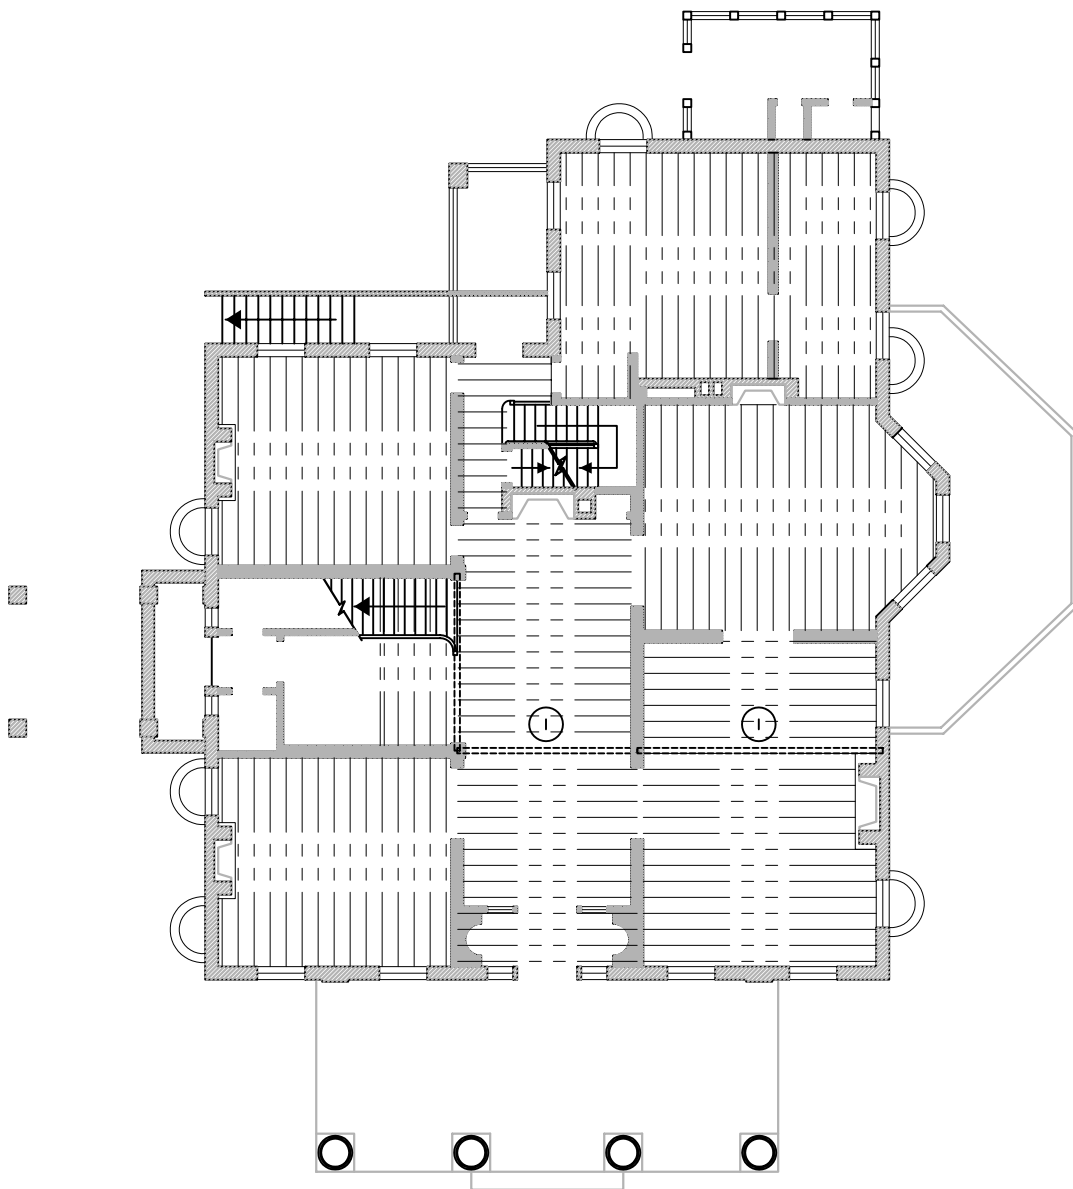
① OVERSTRESSED BEAM INTERVENTION OPTIONS:

OPTION #1 - REINFORCE EACH BEAM FROM BELOW WITH (4) $1\frac{3}{4}$ "x11 $\frac{7}{8}$ " LVLs OR (2) C8X18.75 STEEL CHANNEL. INTERVENTION WILL RESULT IN DAMAGE TO PLASTER CEILING FINISHES ON THE FIRST FLOOR.

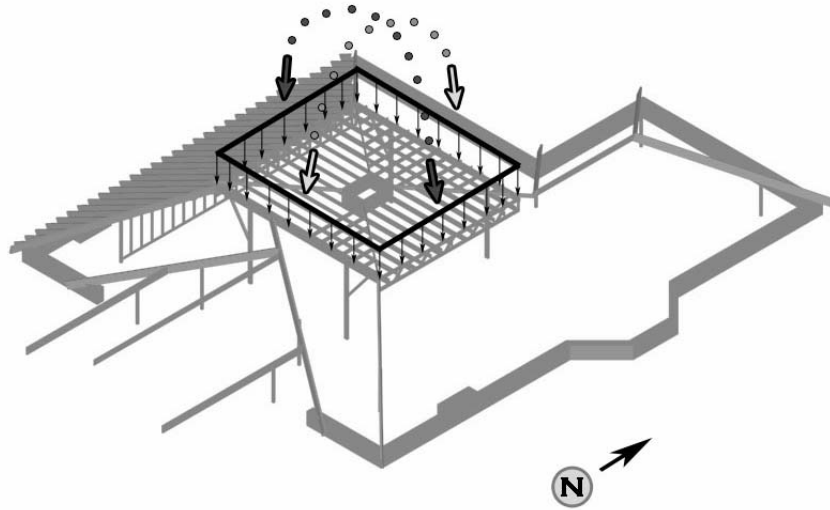
Figure S-18: Corner Diagram depicts transfer of central roof loads around skylight to ridge beams at peak of high roof.

RSA proposes reinforcing the roof structure with the objective of shifting roof loads and some third-floor loads to areas of greater structural capacity. Emblematic of this general approach is the area around the central skylight. As noted above, our findings show that one of the main problems at the third floor framing level is the transfer of roof load through the corridor partitions. Our initial approach to addressing this would be to remove both the roof and ceiling loads from this central area by modifying the structure to span further out to the main high roof perimeter. This concept is depicted in Figure S-18. In practice it could be readily achieved by strengthening the ceiling joists to make the full span, or by working with the shallow-hip roof system in combination with the ceiling joists to affect a tied truss-like system. Spanning over the corridor partitions as such would mean that the reinforcement below these corridor walls would no longer be required. RSA recommends sistering the existing ceiling joists around the skylight with new 1 3/4"x 7 1/4" LVLs to direct the roof loads above to the perimeter of the square and not to the unsupported partition walls below. Also, the addition of two 1 3/4"x11 7/8" LVLs to all four sides of the square are necessary to hold the additional weight and transfer it to the existing posts. Both intervention Options #1 and #2 require the reinforcing of this central square.

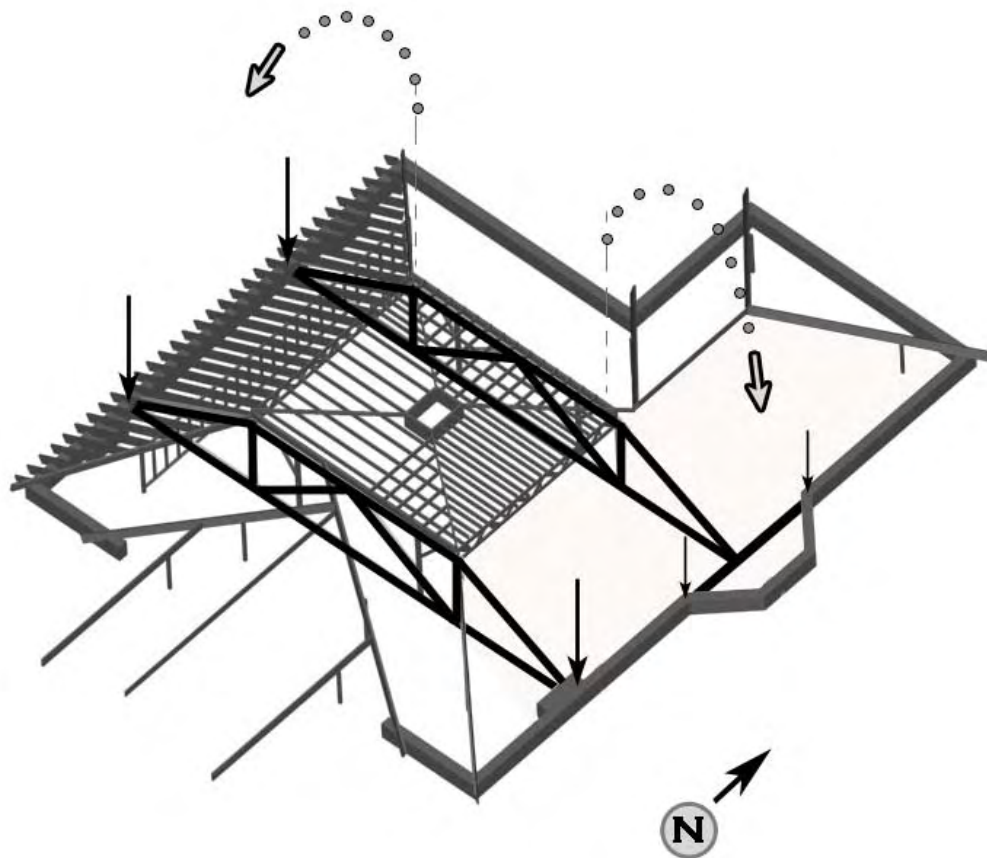
Figure S-20: Concept Diagram depicts intersection of attic trusses to minimize loads transferred to floor levels below.

A more dramatic intervention at the attic and roof level, such as that depicted in Figure S-20, could remove an even greater amount of load from the interior framing and transfer it directly to the perimeter masonry bearing wall using a built-up truss system within the attic space. The details of the truss intervention are elaborated on Figure S-21 as Option #2. In this option the proposed truss would likely be built up from light structural steel sections and bolted together on site. The truss would support not only the central roof section but also the connection between the two roofs and some third floor wall loads making the additional support proposed on the second floor framing in Option #1 unnecessary. The south side works well with this approach in that the new truss could be built within the unfinished attic space. The north side presents more conflicts with the existing architectural layout and finishes, however we feel the system could be accommodated if it proved necessary. The approach requires further

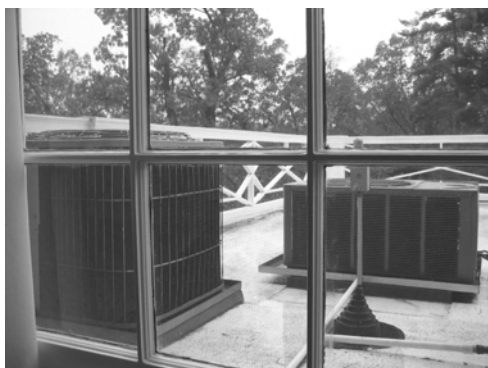
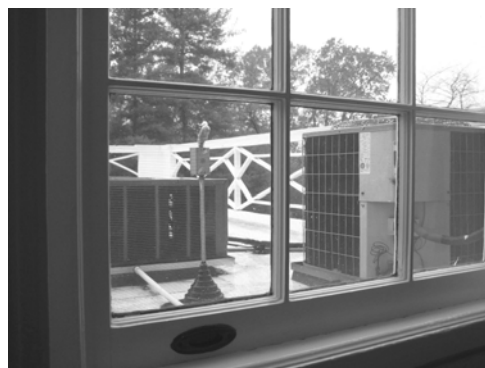
Outside units on Porte Cochiere (Item 3).

3. Replace split systems (air handlers and outdoor units) with blower coils that utilize CHW and HW coils (4-pipe units). All air handlers should be configured for summertime dehumidification and wintertime humidification control. In addition, the units can be used for space heating during temperate months (Note that measures to reduce/prevent outside air infiltration through the building envelope—such as weatherstripping of windows and doors—should be implemented to accomplish effective humidity control.) Connect to existing ducts and rebalance airflows according to calculated loads. Outdoor air-intake ducts are not deemed necessary, since the air handlers will only operate on demand from thermostats and, therefore, provide only intermittent building pressurization. Outside air should be introduced into the building through a 4-pipe blower coil located in the attic, which tempers and dehumidifies the air. This air would provide make-up for bath and kitchen exhaust fans and positively pressurize the building to minimize undesirable air infiltration.

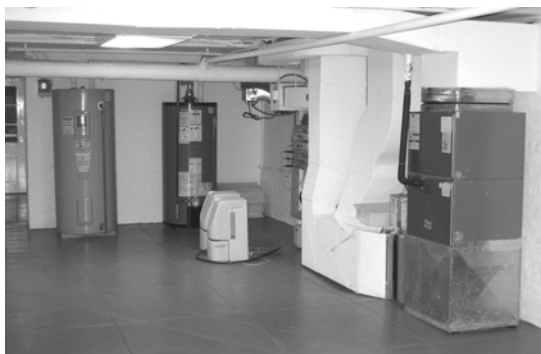
Water heaters in basement (Item 1) AH#1, floor-mounted dehumidifiers also shown.

1. The current plumbing systems have the capability to provide adequate service to the plumbing facilities throughout the house. However, the age and condition of some components—branch piping, faucets—hinders provision of such modern conveniences as reliable delivery of properly tempered water at adequate pressure. Therefore, replacement of some components is recommended, including replacement or abandonment of old galvanized steel water-supply piping embedded in walls above the basement, installation of new-hot and cold-water pipe risers to existing fixtures in each bathroom, and replacement of water closets with new low-consumption-type fixtures.

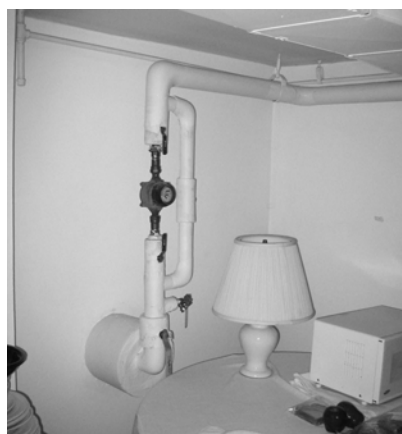
Domestic water service and meter (Item 1).

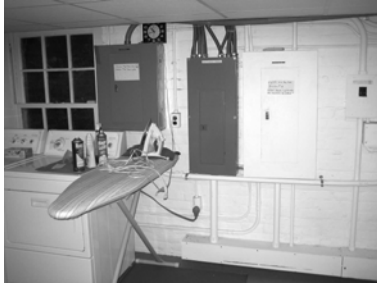
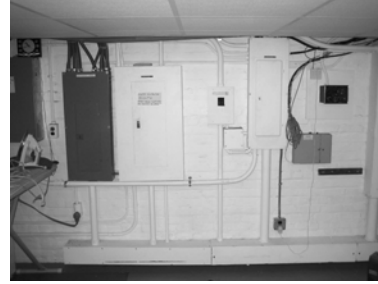
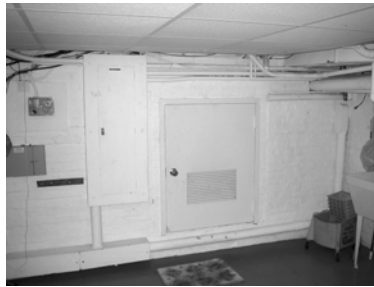
basement. Some equipment, devices and wiring are dated and warrant replacement during a major repair project.

Main electrical panels in Laundry B01 (Item 3).

2. Upgrade electrical service from Bayly Art Museum to 400 amps.
3. Replace the existing main panels (Figures E-1 and E-5) in Laundry B01 with new (Figures E-6 and E-7): 1) Install new main distribution panel with main breaker and breakers for sub-panels; 2) install grounding system for main distribution panel; 3) install new sub-panels to serve existing branch circuits; 4) extend existing branch circuits to new panels; 5) replace sub-panel at second-floor stair hall with new; 6) verify all connected loads and provide up-to-date panel directories.

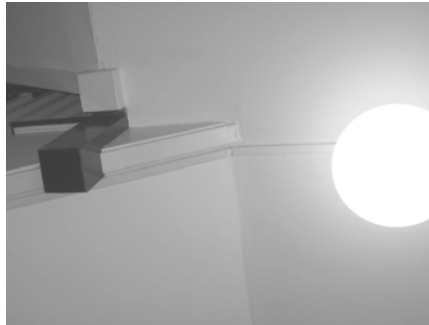
*Surface raceway at ceiling
of Stair 119 (Item 7).*

5. Replace all “BX” and “greenfield” branch circuits with wiring in EMT conduit or type MC cable. Note that most receptacles are installed in base molding of walls.
6. Replace old, worn, and painted-over receptacles, switches and device plates with new of color and type suitable to the room finishes.
7. Replace surface raceways in first, second and third floors with concealed branch circuit wiring.

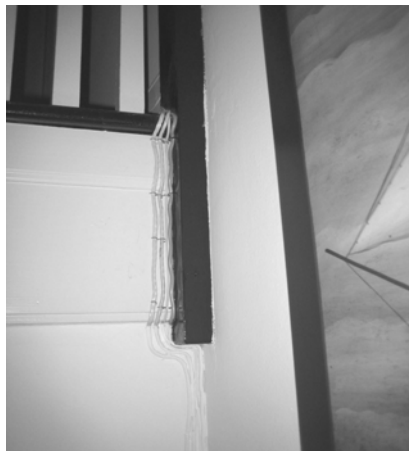
*Surface-mounted cabling at of
Stair 119 (Item 2).*

9. Install a UL-certified lightning protection system to include air terminals, down conductors and grounding rods. All down conductors to be run in conduit and concealed within the building fabric.
10. Conceal low-voltage wiring where currently surface mounted.
