UNIVERSITY OF VIRGINIA

THE ROTUNDA

HISTORIC STRUCTURE REPORT

JOHN G. WAITE ASSOCIATES, ARCHITECTS PLLC

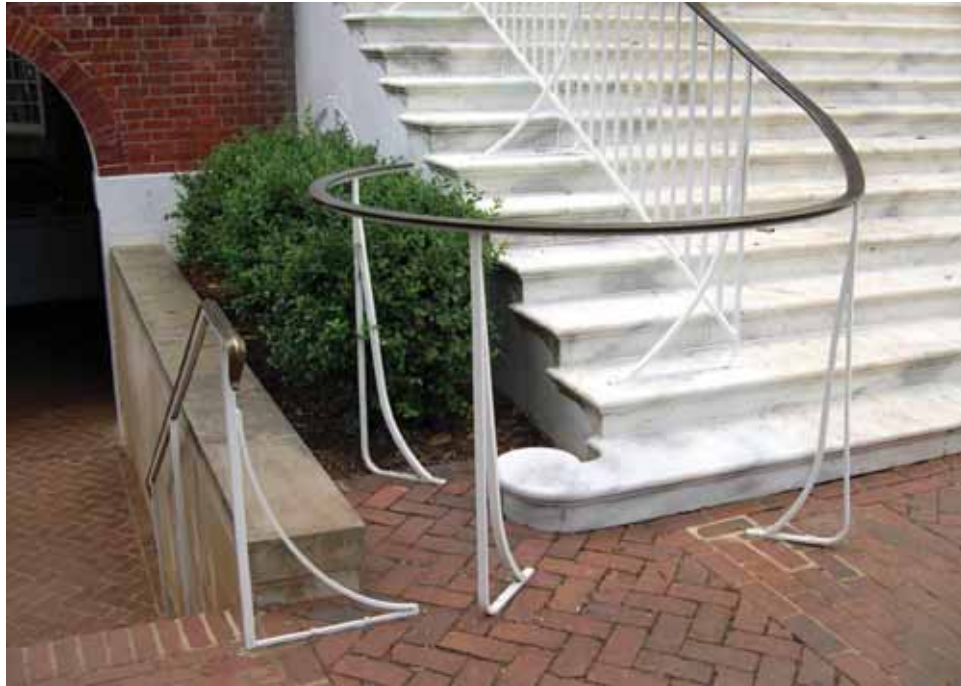
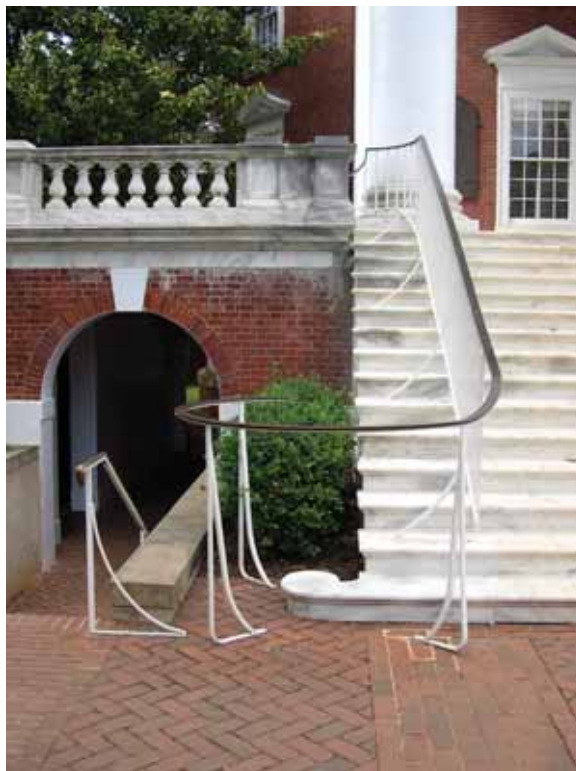
South Portico Stair. [JGWA, 2006]

South Portico Stair. The design of the modern iron-and-bronze railing competes with the architecture and detracts from the historic character of the building. [JGWA, 2006]

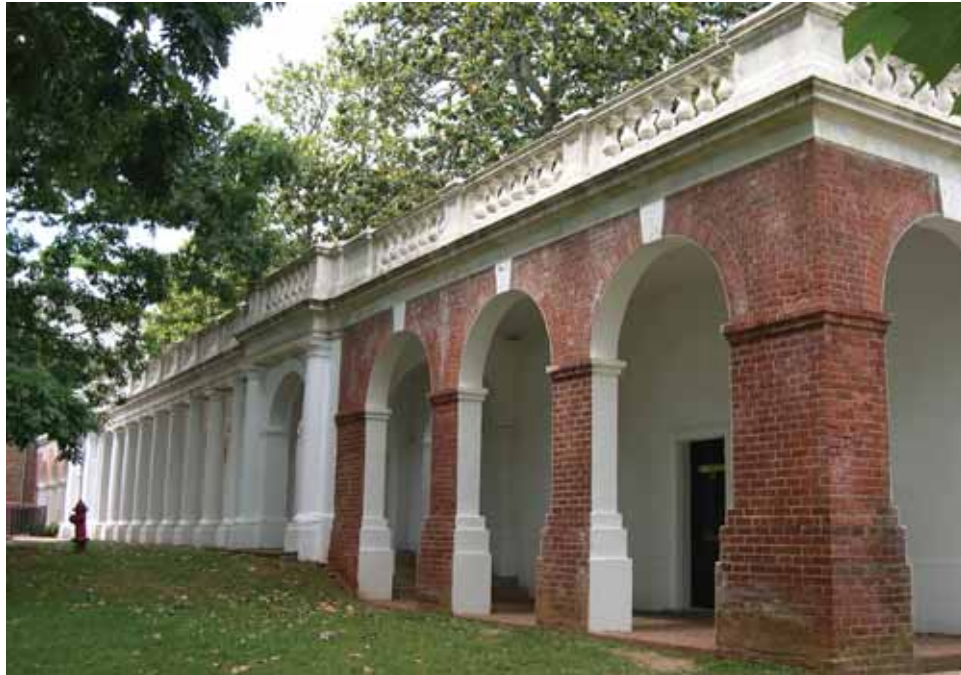
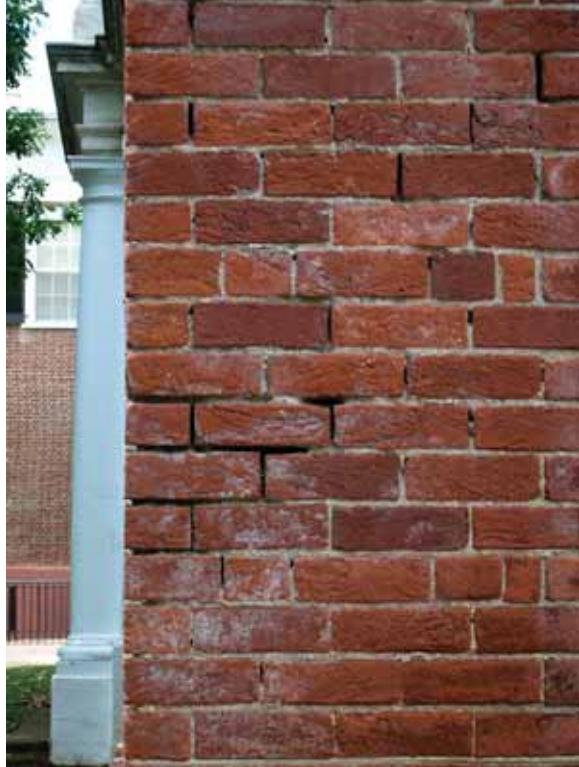
Northeast Wing, Northeast corner. [JGWA, 2006]

Northeast Wing, Northeast corner. The mortar is eroded, and there are open joints in the brickwork. The brick has been grit blasted to remove paint. [JGWA, 2006]

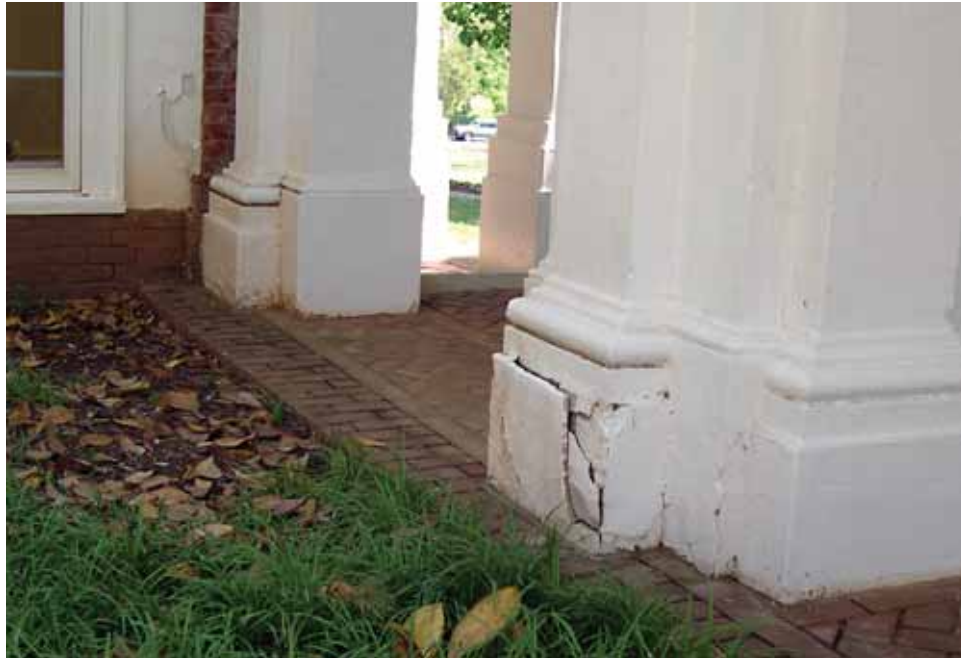
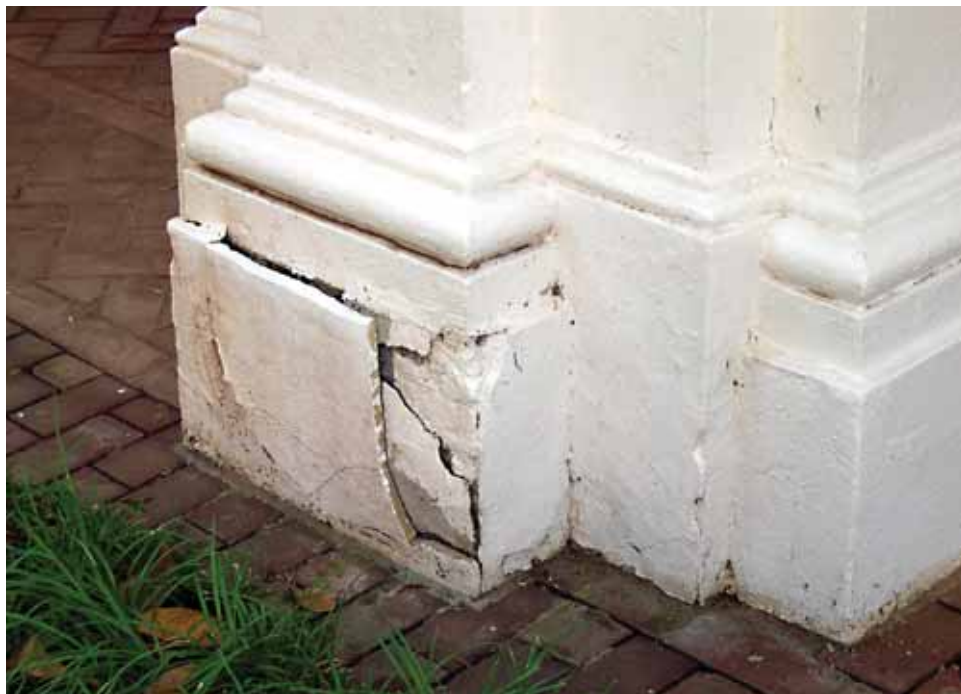
East Colonnade, West Elevation. [JGWA, 2006]

East Colonnade, West Elevation. The parging on the pier at the north end of the colonnade has seperated from the underlying brick construction. [JGWA, 2006]

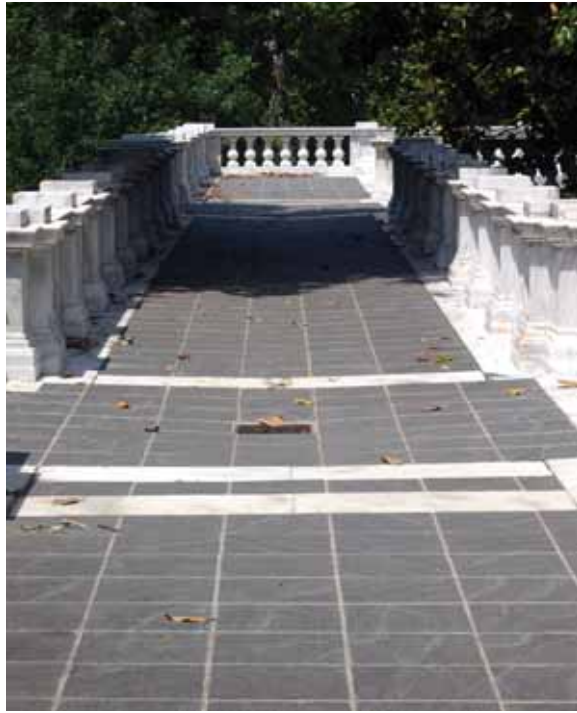
West Terrace. Debris from the magnolia trees accumulates on the terrace. [JGWA, 2006]

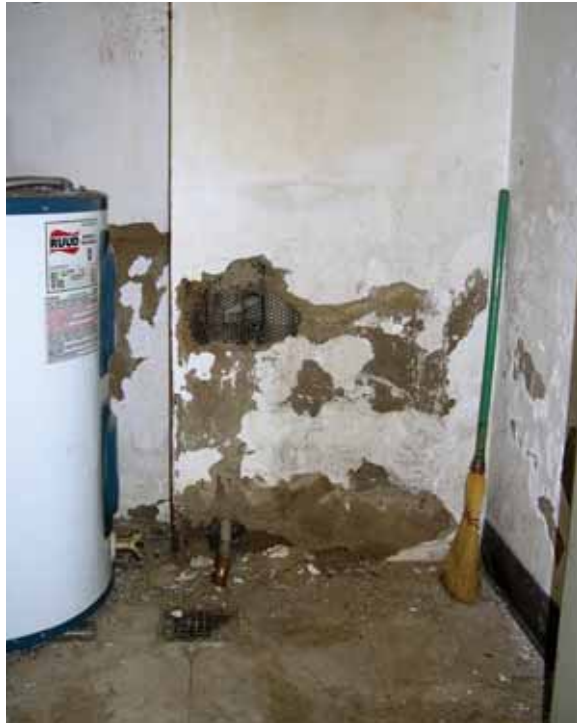
Closet (T102B), women's toilet room, below the south portico (cryptoporticus). [JGWA, 2006]

Rising damp has caused the wall plaster in Closet (T102B) to deteriorate, exposing the metal lath and brown coats of plaster. [JGWA, 2006]

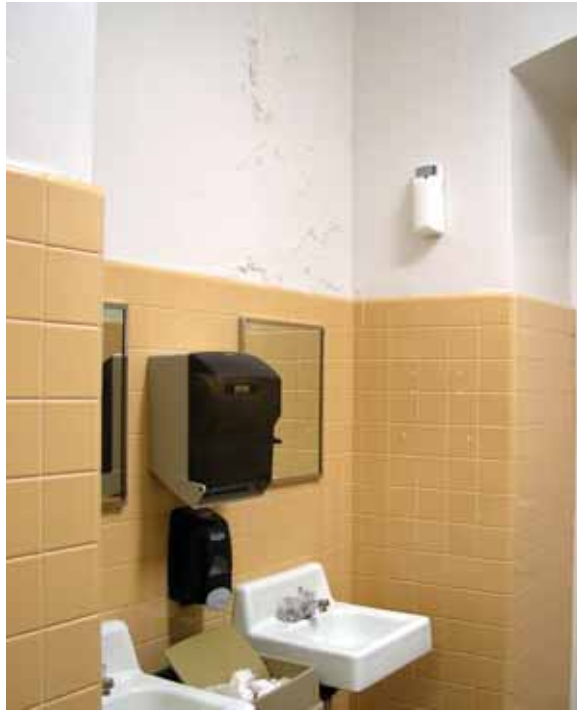
*Men's Toilet Room (T113),
looking northeast. [JGWA,
2006]*

*The plaster wall and ceiling
surfaces in the northeast
corner of the Men's Toilet
Room (T113) are badly
blistered. The plaster is
friable, and the painted finish
is peeling as a result of water
infiltration. [JGWA, 2006]*

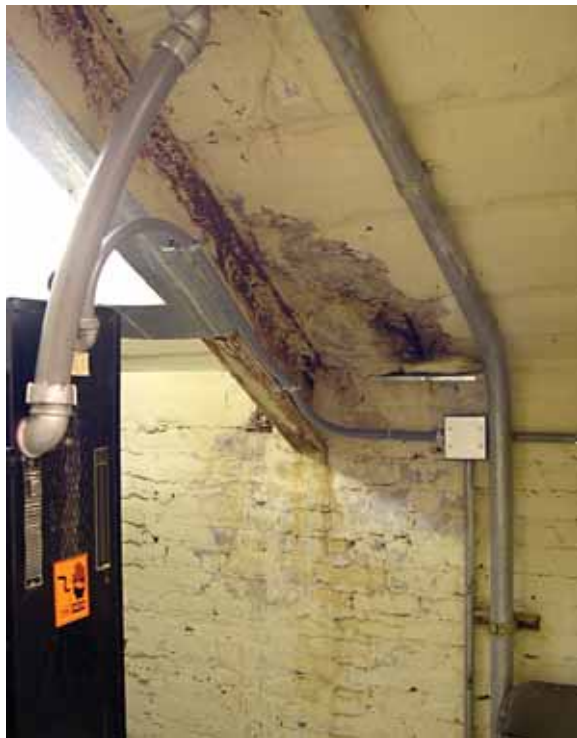
The exposed steel beam supporting the sloped concrete ceiling of Elevator Machine Room (110A) has significant surface rust. The rust is more advanced at the beam's bearing point in the north wall. Galvanized sheet metal and acrylic glazing have been installed above the elevator machinery to protect the equipment from water infiltration occurring in the north portico steps above. [JGWA, 2006]

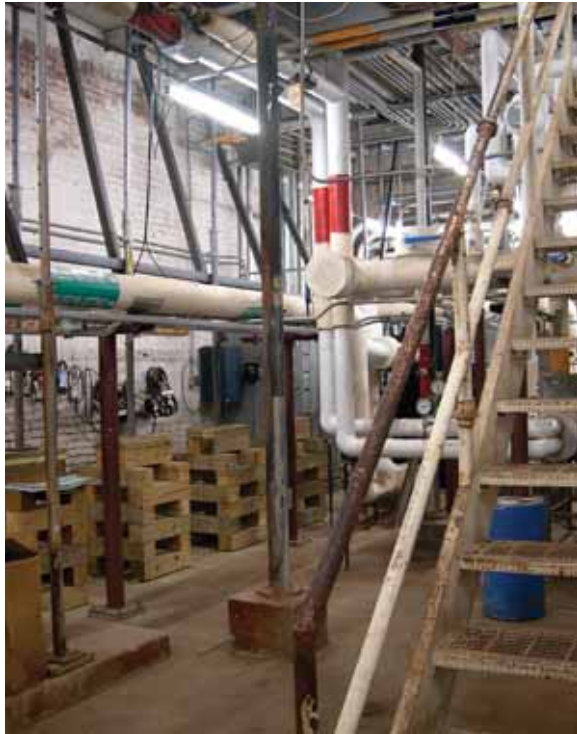
Generations of temporary shoring have been introduced in the Mechanical Room beneath the north portico to support the ceiling and terrace construction above. [JGWA, 2006]

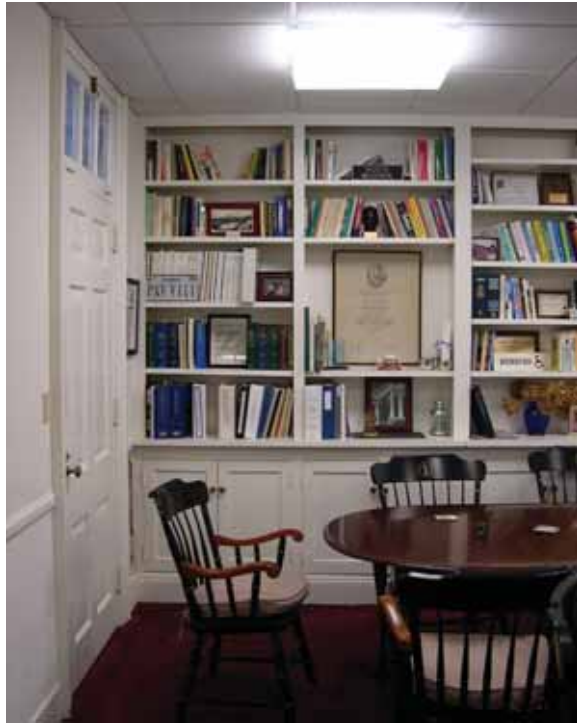
Southwest Wing, office of the Vice President for Student Affairs (124), looking west. The suspended acoustical tile ceiling and surface-mounted fluorescent light fixtures detract from the historic character of the space. The suspended ceiling obscures the upper architraves of the door/transom openings. [JGWA, 2006]

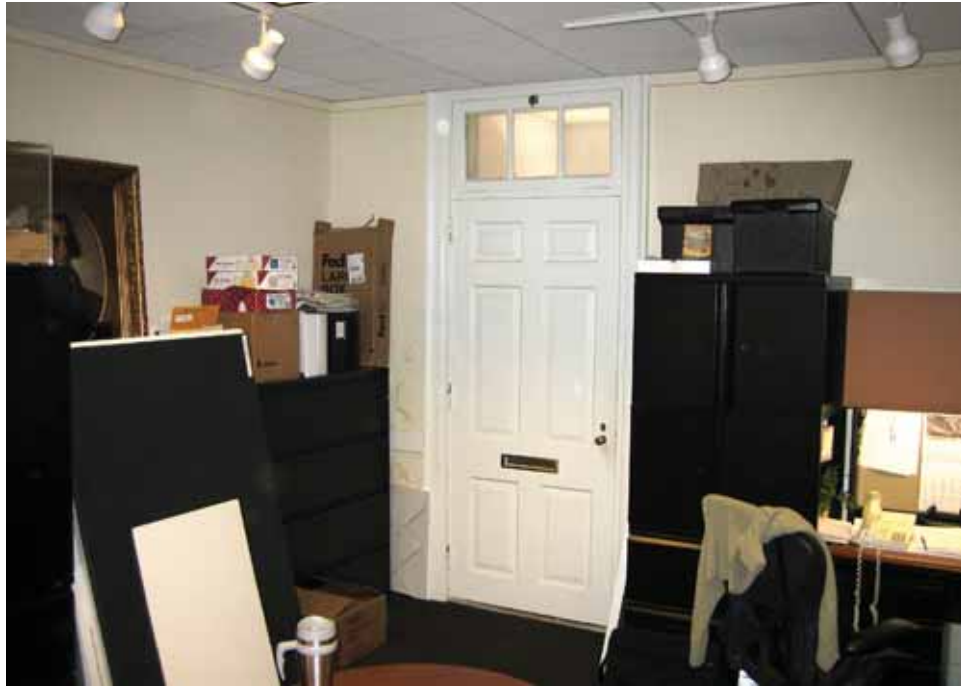
Southeast Wing, room 154, looking south. [JGWA, 2006]

The wall plaster on the south elevation of room 154, to the east of the door opening, is friable. Water infiltration has caused the plaster to "bloom." [JGWA, 2006]

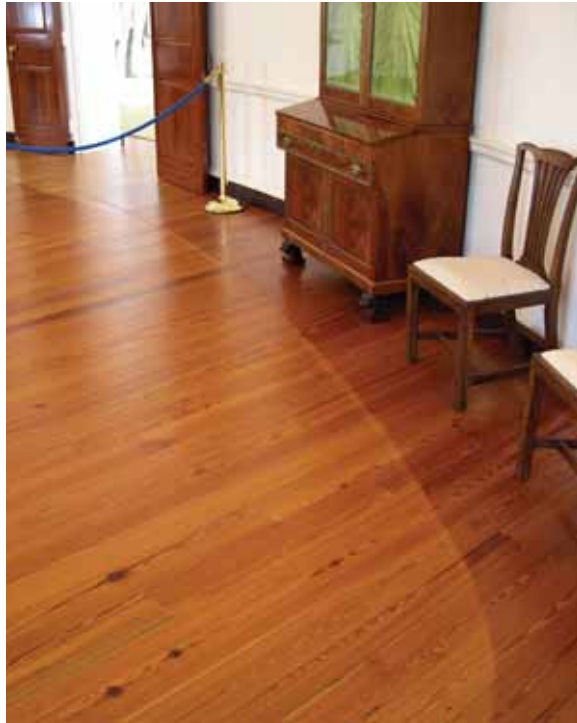
The floor finish in the President's Reception Room (Upper West Oval Room 201) is discolored as a result of UV degradation. This was made apparent by the removal of the large oval rug that was located in the center of the room. [JGWA, 2006]

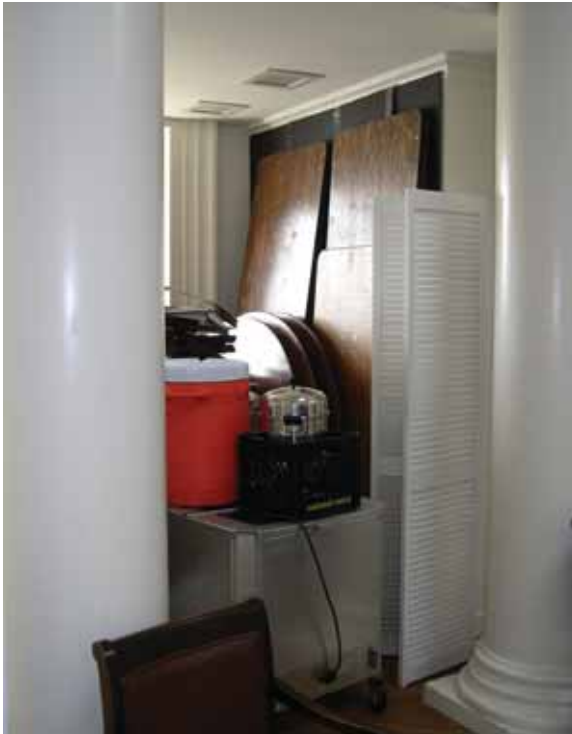
The ad hoc storage of tables and catering equipment in one of the alcoves of the Dome Room (301) has contributed to the abrasion and wear of the room's finishes. [JGWA, 2006]

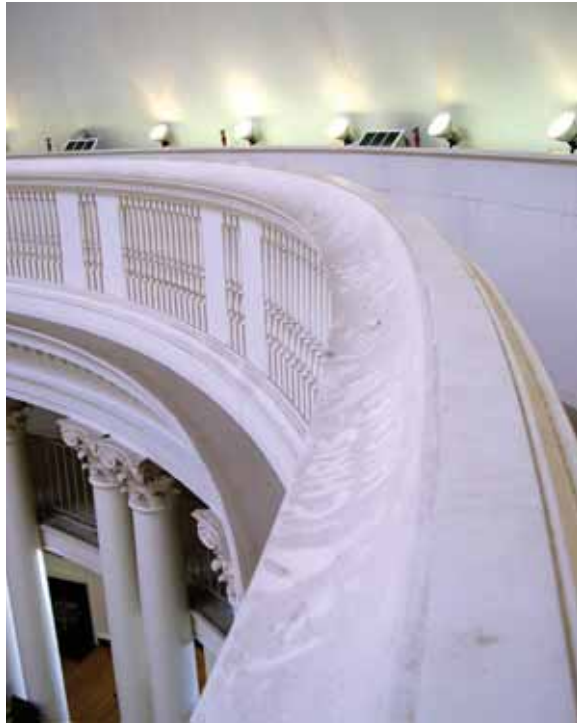
Prior to a December 2006 mold remediation project the Upper Gallery (C501) railing was covered with dust and mold growth. [JGWA, 2006]

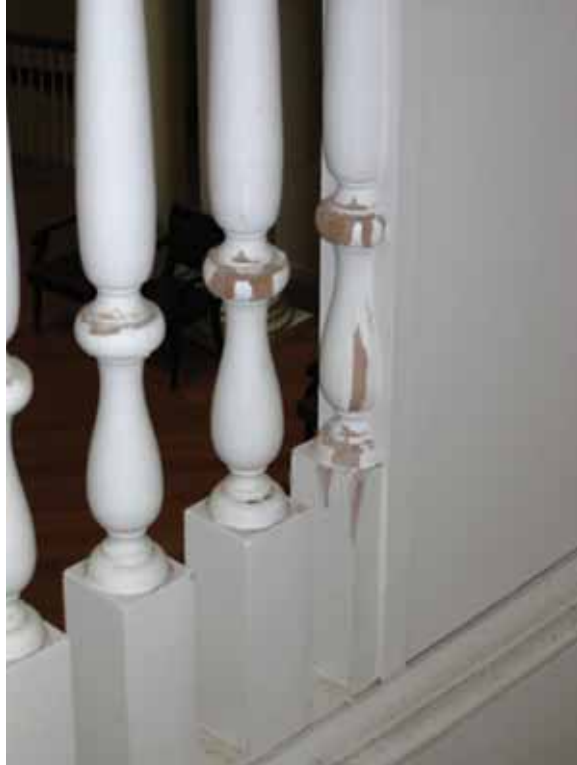
The paint on the balusters of the Upper Gallery (C501) railing is peeling; the wood substrate is exposed. [JGWA, 2006]

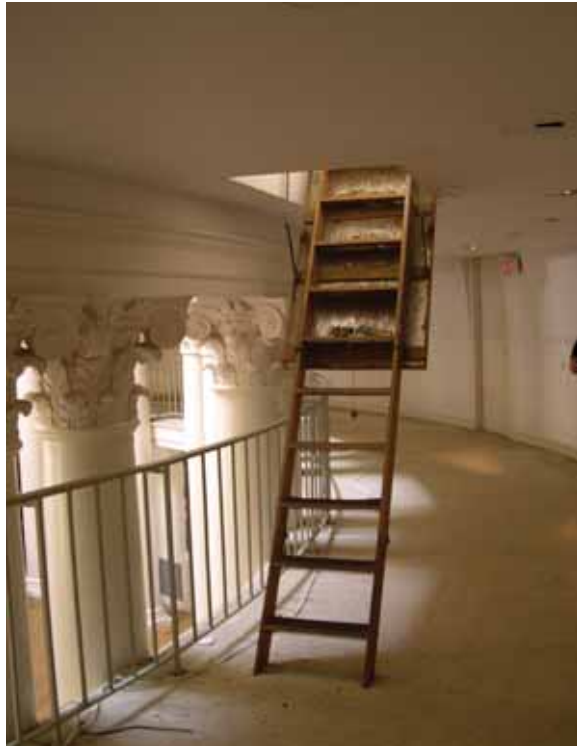
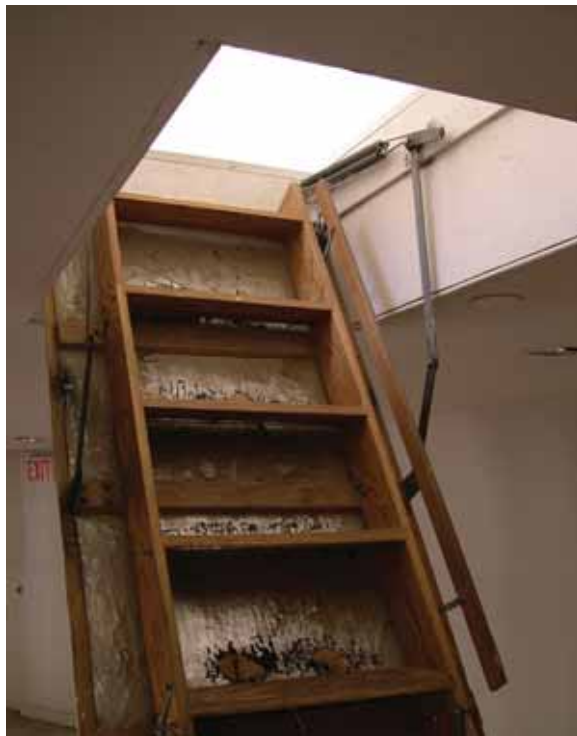
Middle Gallery C401).[JGWA, 2006]

Middle Gallery C401).[JGWA, 2006]The folding ladder stairs providing access to the Upper Gallery of the Dome Room (C501) are of a residential character and quality. The stairs and the reveals of the stair openings are dirty, worn, and abraded. [JGWA, 2006]

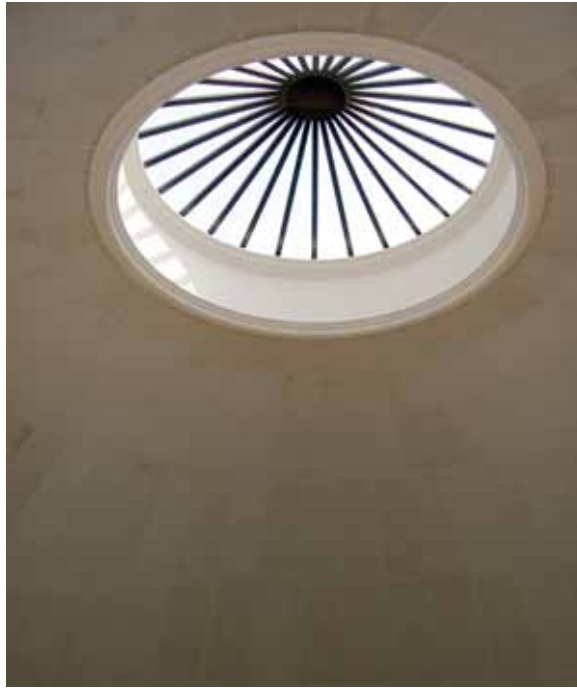
The glass of the skylight oculus is heavily abraded; from the interior, it appears to have a spider-web network of cracks. [JGWA, 2006]

2. Replace the modern aluminum-framed skylight at the oculus of the dome with a vented skylight replicating the framing and appearance of the sixteen foot diameter circa 1826 skylight.

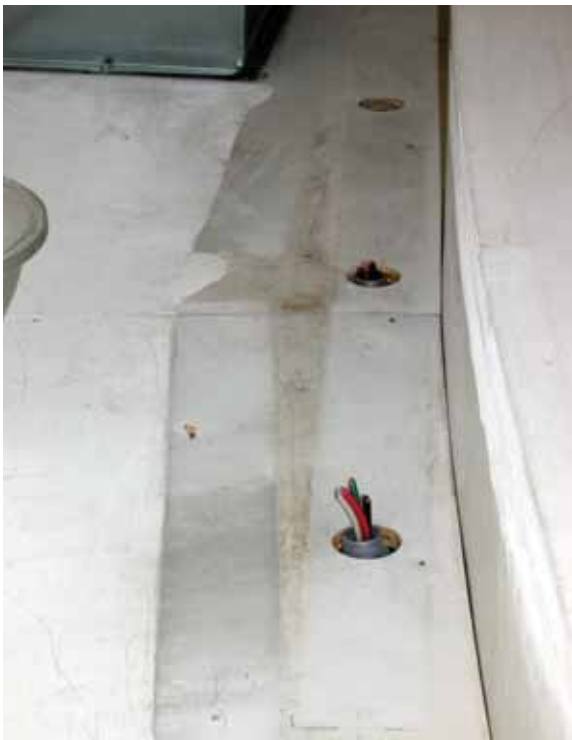
The fluorescent strip lighting fixtures at the base of the dome were removed in December 2006 as part of the mold remediation project. Exposed conductors protruding from conduit remain; these conductors may present an electrical shock hazard. [JGWA, 2006 (top), 2007 (bottom)]

1. Provide new electrical wiring and devices throughout the building to replace the existing thirty year old wiring and equipment.
2. Provide new piping and plumbing fixtures throughout the building to replace the existing equipment.

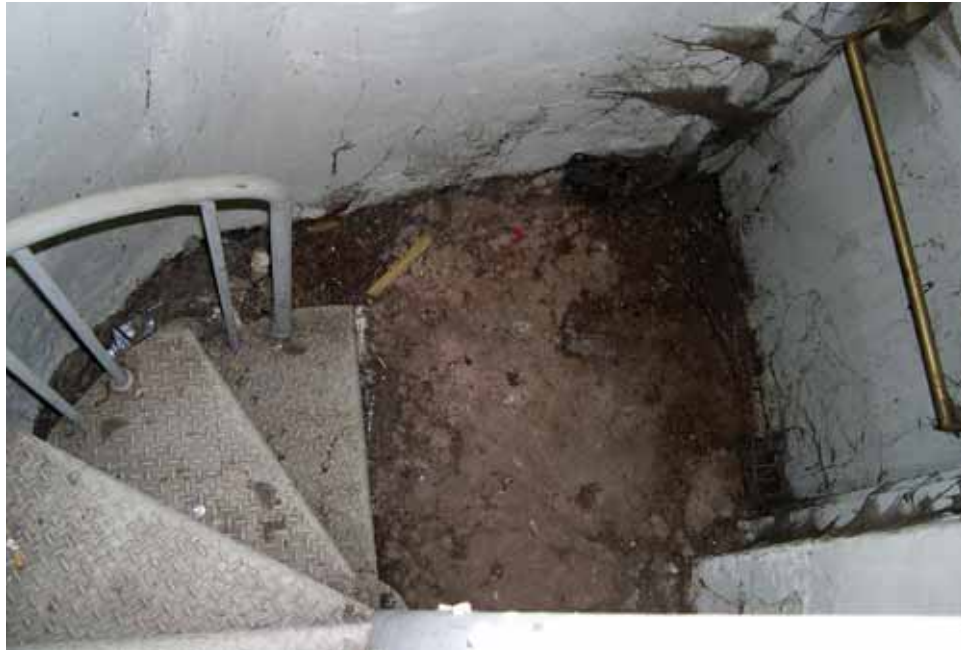
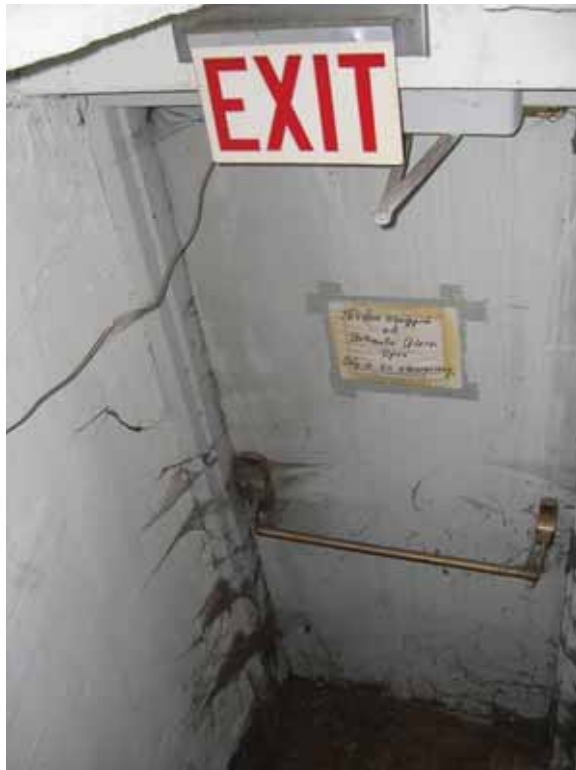
The emergency exit door (left) and floor slab (above) of the Northwest Fire Stair (C117) are dirty and covered with cob webs. The illuminated exit sign is not working. [JGWA, 2006]

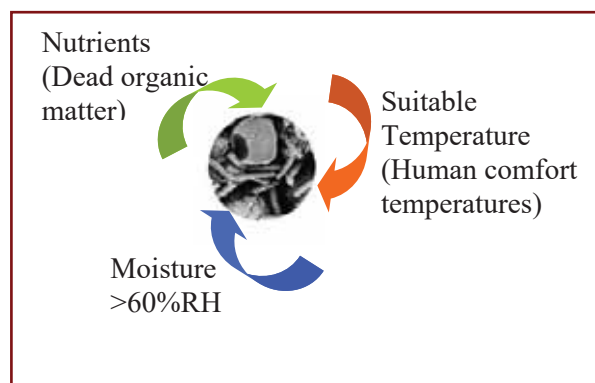
Mold growth generally results from a combination of mold spores, food sources in the form of organics and dust, temperatures between 65°F and 90°F, and relative humidity above 65%. Since mold spores, favourable temperatures, and food sources exist in most buildings, controlling relative humidity is the only means available to avoid microbial growth problems. The potential factors contributing to mold problems are outlined below:

- The air-handling unit, AC#1, serving the Dome Room has a chilled-water cooling coil for dehumidification and cooling. It is likely that the chilled water supply temperature during moderate outdoor conditions is not low enough to provide adequate dehumidification. Relative humidity levels in the Dome Room (301) may exceed 60%~70% for extended periods.
- Mold spores are in relative abundance during mild seasons.
- Any source of water leakage and infiltration of moisture must be investigated.
- Abundant vegetation on the campus provides the necessary mold spores. This combined with relatively high humidity levels can result in microbial growth problems.

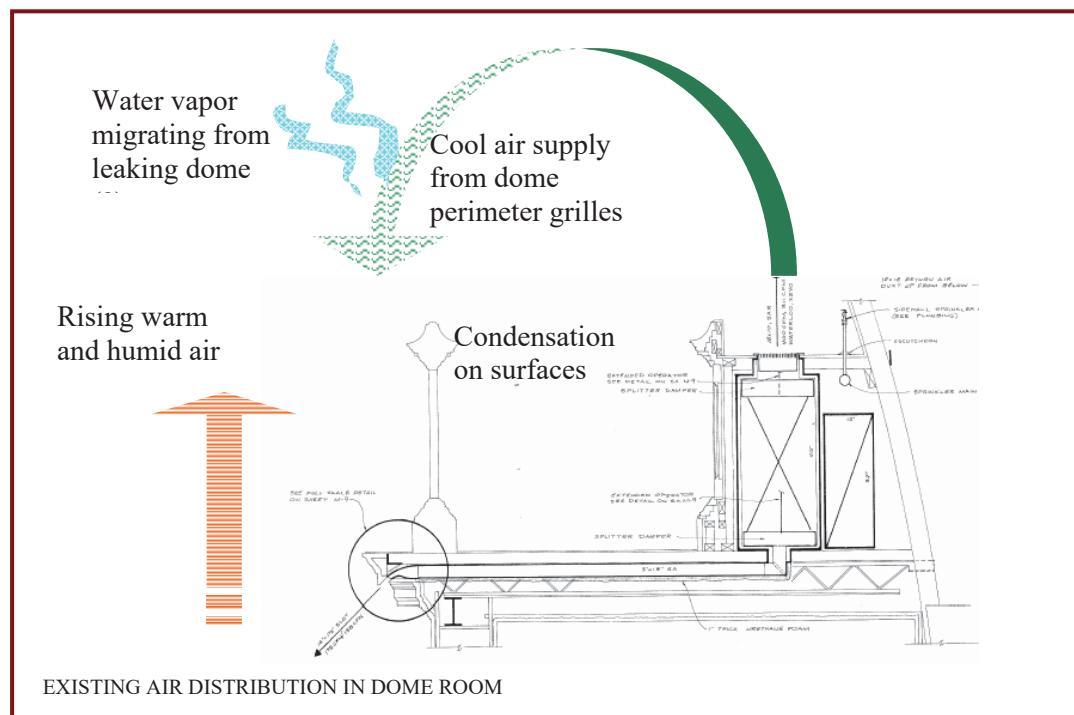
- It is also likely that the current air distribution is suspect. The cold air supply at the dome perimeter mixes with the rising warm and humid air in the upper gallery zone leading to surface condensation on railing surfaces. This promotes conditions conducive to microbial growth. This may be checked by measuring the temperature and humidity profile three feet on either side of the upper gallery railing.
- Infiltration of untreated air due to the buoyancy effect inherent in the Rotunda's design must also be investigated. Untreated air with high moisture content will raise the relative humidity in the space. When untreated outdoor air comes in

contact with cold surfaces (cold air from perimeter dome supply) it can cause condensation, promoting conditions for mold growth.

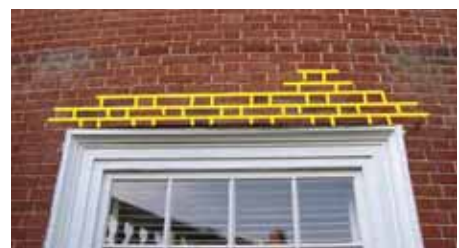
The exterior brick masonry appears in generally sound structural condition, with no observed locations of significant cracking or masonry displacement. Evidence of past structural repairs or modification is apparent over the window openings at the basement and second floors (the first floor windows are ornamented with a sheet metal pediment detail over each window, concealing the brickwork directly over the opening). In the locations of observed modification, a change in mortar color and

Figure 3: Above the windows in the cylindrical walls of the Rotunda the first few rows of brick have been repointed, likely from 1970s restoration and lintel replacement (altered mortar highlighted for clarity).

texture was apparent with the three or four courses directly above the window frame (Figure 3). Review of the Ballou & Justice drawings from the 1970s shows the majority of the exterior lintels being replaced with steel angles. One exception is at the east and west central, “false” windows, which are indicated on the drawings to retain the existing rail lintels (Figure 4).

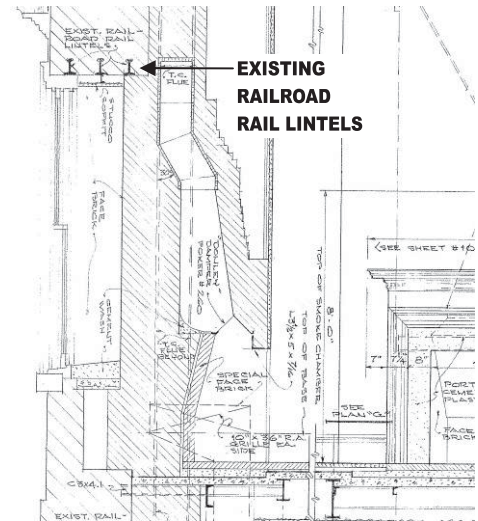
Figure 4: The 1970s drawings depict 3 existing lintels above the first floor windows. (Detail from Ballou, D-4)

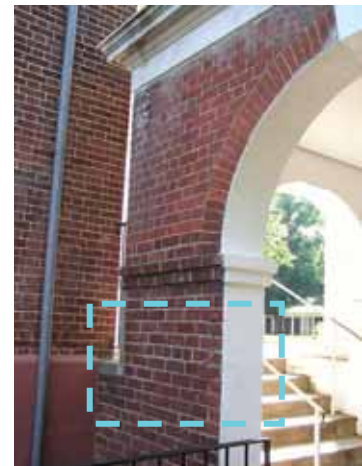
The southern most piers on both the east and west arcades have horizontal cracks at the grade level of the Lawn, running all the way through the pier. As the crack travels north toward the first arched opening the crack widens (Figure 5). These piers are laterally supported at the Lawn level and below by adjacent buildings, but the top half of the pier is not restrained, resulting in an eccentricity between arch thrust and resisting support (Figure 6). This eccentricity results in bending in the masonry pier and a resulting in-plane rotation or uplift when the tensile capacity of the mortar is exceeded, consistent with the observed cracking. A more developed explanation of the resulting stresses is given in the Structural Analysis section of this report.

Figure 5: South end of East Arcade. Cracking and rotation in end pier.

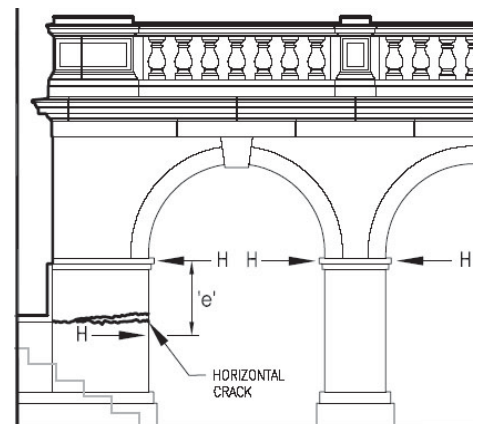
Figure 6: On both the east and west arcades a horizontal crack has formed at the grade level of the Lawn.

The horizontal cracks observed on the southern most piers of both the east and west arcades (depicted in Figure 7) have been further evaluated given that the source of this cracking appears to be the direct result of thrust resistance from the adjacent arch. The arcades support terraces above at the Rotunda's first floor level. For the load analysis, the current applicable building code requires a 100 psf live load for such terraces, particularly where used as places of assembly. Dead loads on the arches were assumed based on visual observation and on documentation of the terrace framing from previous investigations. The terraces above produce a uniform load on the supporting arches. Through the arching mechanism the uniform forces are redirected into a horizontal force and a vertical reaction force at each end (see Figure 34). In the arcades, the arches are observed to perform well when the horizontal thrust is resisted by either a large mass or an opposing force, like the horizontal thrust from an adjacent arch. As previously discussed, problems in maintaining the form of the arch occur when there is some support movement generated by insufficient resistance to the horizontal thrust. Figure 35 depicts the forces on a pier cross section which is subjected to both axial load and to bending, here the result of an unbalanced horizontal thrust (H) acting at some eccentricity (h). The vertical P force created from the loads above the arch and dead weight of the pier itself is distributed evenly over the cross section of the pier. The horizontal force, H is applied at the spring of the arch. The Horizontal force (H) creates a rotational force (or bending moment) in the pier that must be resisted internally by the compressive and tensile capacity of the masonry and ultimately by the coupling forces at the base of the pier. Mortar in brick masonry provides the tensile capacity of the structure, which is very limited in comparison to its compressive strength. As such, when the tensile stresses resulting from bending are only slightly greater than the compressive stress, cracking in

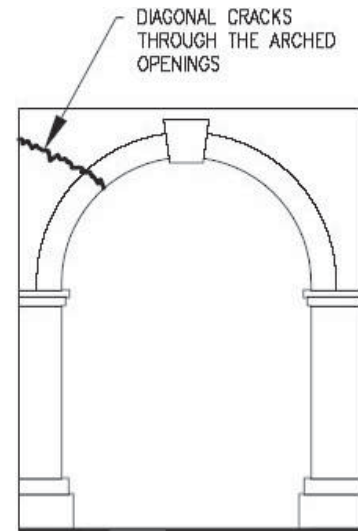
Several arched openings in the arcades have diagonal cracks emanating from about a third of the way up the arch to the underside of the terrace above (Figure 7). These observed cracks were typically through the full depth of arch construction. The diagonal cracking pattern is likely the result of minor shifting in the original semicircular arch profile. Typically, such shifting derives from insufficient thrust resistance. In the four terrace pavilions transitioning between the arcades and colonnades, cracking and displacement tends to occur where the arch thrusts are not balanced with the thrusts from adjacent arches (Figure 8). Similar to the cracking described above, a more developed explanation of such arch behavior is given in the Structural Analysis section of this report.

Figure 7: In several locations in the east and west arcades cracks were observed diagonally radiating from the arch.

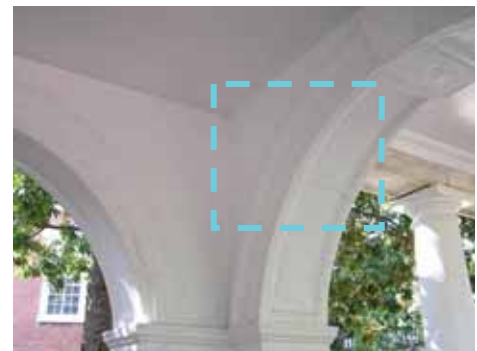
Figure 8: Transitional pavilion at east terrace -- arch cracking at lines of unbalanced thrust.

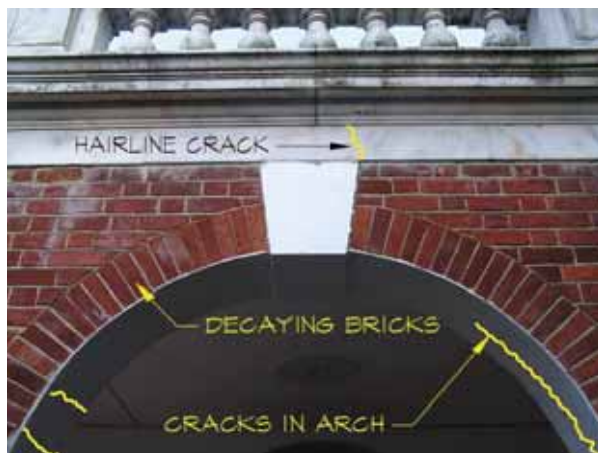
running longitudinally along the underside of the arches. Visual evidence of recent repointing suggests the possibility of repairs being performed with a stiff mortar. This location has suffered more than other areas, perhaps because it is often in the shade and therefore retains moisture for more extended periods of time. The sustained presence of moisture in the masonry, along with the possibility of excess stiffness in repair mortars, when subjected to freeze-thaw cycling are possible causes for the observed excess deterioration (Figure 9).

Figure 9: North end of west terrace masonry cracking and deterioration.

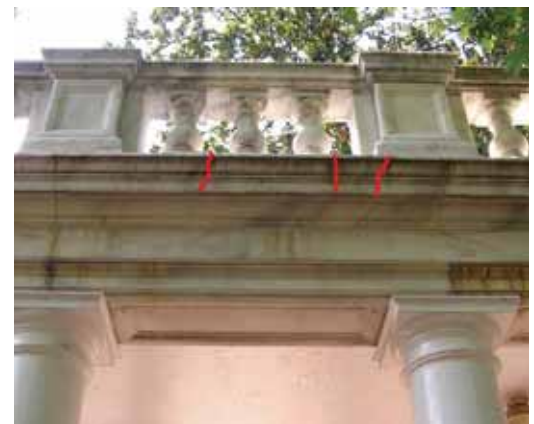
In the area of the central colonnades on both the east and west elevations, there is visual evidence of significant water infiltration of the marble construction. Various forms of staining and apparent surface-level hairline cracking or crazing was pervasive (Figure 10). Cracking in the cornice elements appeared largely cosmetic, however should be addressed by a masonry specialist to preserve the life of the stone and minimize water penetration and entrapment into the terrace assembly. For the marble lintels spanning between columns, cracking also appeared largely cosmetic. RSA observed cracks of more significant width in several locations, however even these did not appear to correspond to structural inadequacies, given their disposition within the lintel cross section and span. Once again, sustained moisture penetration into the stone and terrace assembly is a concern. Water penetration in this area has been investigated and is reported in the 1997 report of Stoneking / Von Storch Architects with Wiss, Janney, Elstner Associates, Inc. The report concluded that the waterproofing terminations under the terrace stone and the flashing beneath the balustrades are inadequate. It is unknown whether the recommendations to remediate the problem were implemented.

Figure 10: Vertical hairline cracks were observed in the marble cornice and lintels.

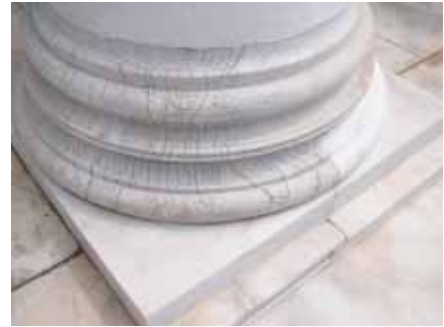
Many of the column bases have suffered from hairline cracking or crazing, like spider webs over the whole surface. Some of the bases have Dutchman repairs, where presumably deteriorated stone has been removed and a new piece of stone fitted into the spot (Figure 11). It is most likely that the stone deterioration is the result of material decomposition from weathering and sustained moisture.

Figure 11: Many column bases have extensive surface cracking. The smooth white surface to the right is a replacement piece of stone, a Dutchman repair.

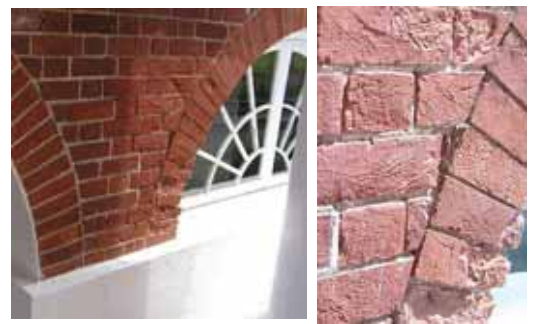
On either side of the south portico, in the flanking arcades, RSA observed a number of areas exhibiting significant masonry deterioration (Figure 12). Above some of the most severe areas weep holes draining the terrace were observed; this observation points to a clear connection between masonry deterioration and water infiltration and entrapment. With sustained water infiltration and entrapment in masonry assemblies, which are then subjected to freeze-thaw cycling, both mortar and masonry unit decomposition is the predictable outcome. Also, below the arcade windows, RSA observed a repeated pattern of vertical cracking following the window jambs downward into the corridor walls which retain the higher elevation soil on the Lawn side. It appears that the majority of the visible cracks are through the full thickness of the wall (Figure 13).

Figure 12: The bricks between the arch windows show significant material decomposition corresponding to areas of increased water penetration.

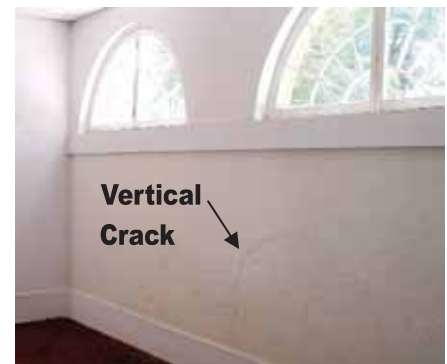
Figure 13: South terrace corridor – interior cracking below windows.

Below the window arcades the vertical cracking pattern in the retaining wall appeared to happen most often below windows. Most commonly two distinct cracks have developed, projecting vertically downward from the jambs of the arched window above. The piers between the windows have much less cracking. The typical cracking pattern is depicted in Figure 37. Preliminary analysis shows that the portion of the wall below the windows can not support the lateral soil pressure as a vertical cantilever, but must distribute their loads horizontally to the piers. It is likely that this cracking is associated with the horizontal transfer of lateral soil pressures, particularly if water is not properly draining away from the foundation wall on the Lawn side. The vertical cracking occurs primarily below the arched openings where the masonry is essentially unloaded by gravity loads from above. The vertical compressive stress in the pier masonry adds stability and reduces the likelihood of cracking. Cyclic effects of freeze-thaw or thermal loads also likely contribute to cracking in the wall areas between the piers. Vertical cracking on both faces of the wall are indicative of such movements.

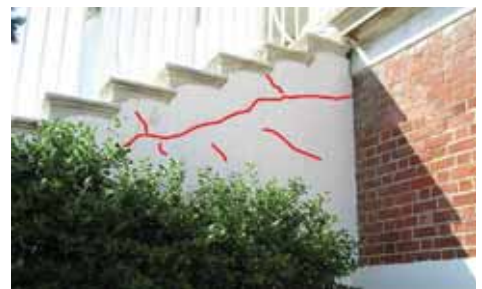
Cracks were observed in the stucco on the side elevations of the south stairs. The cracks were most likely caused by movement of the supporting stair arch behind the stucco finish (Figure 14).

Figure 14: A sloping crack running below the stairs was observed on the east elevation.

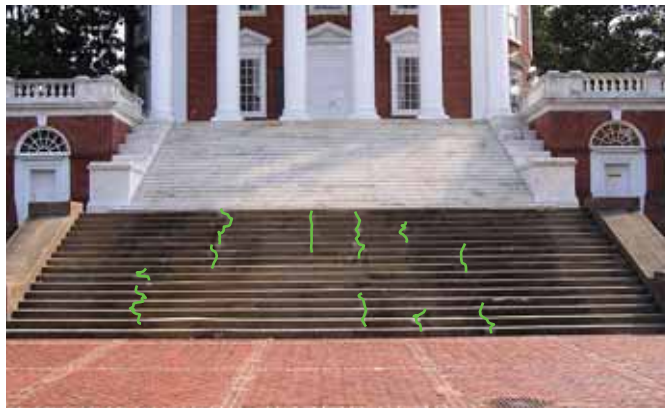
On the northern side of the Rotunda the grade falls quickly requiring multiple sets of stairs. The upper stair, similar to that of the south side, is surfaced in marble which is set atop a steel and reinforced concrete roof structure. Below the stairs to the portico are Store Rooms 109 & 110 and a large Mechanical Room. The landing at the base of the marble stair is surfaced in square stone pavers bordered by concrete bands. Ponding water was observed in this area. The stone pavers and concrete are significantly deteriorated, especially at the intersection of the two materials (see Figure 16). The concrete stairs on grade below the upper terrace are also deteriorating. There are numerous cracks and spalls throughout the stairs that have been patched with a cementitious mortar (see Figure 17 and Figure 18).

Figure 17: The north stairs approaching the Rotunda have several cracks and patches.

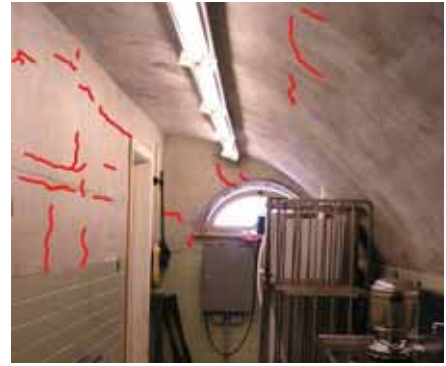
Under the south stairs there is a room for used to support catering functions. The ceiling of the room is vaulted like half of a masonry barrel vault (Figure 15), which serves as the spanning structure for the south stairs. The wall surfaces three feet above the floor level are lined cracks. The most significant crack in the ceiling runs in an east-west direction approximately two-thirds above the spring point of the vault. The observed east-west longitudinal cracking appears to be the result of the masonry vault spreading southward causing minor flattening of the half-

barrel profile. This is the same movement that has caused cracks on the side elevations of the south stairs. No major instabilities were apparent. At this point the cracking is considered only minor and is not a structural concern. Further discussion of this structure is offered in the Structural Analysis section.

Figure 15: The walls and ceiling of the catering room below the south stairs has numerous cracks.

The cracks in the ceiling of the Catering Room (depicted in Figure 15) correlate to the cracks on either side of the south portico stairs (shown in Figure 14). Shifting or settlement of the soils below the bottom end of stairs, which serves as the support for the horizontal thrust generated by the loaded half-vault, would cause deformation and the development of tension cracking in the vault; such cracks would form perpendicular to the spanning of the barrel vault, as has been documented in RSA's recent survey (Figure 38).

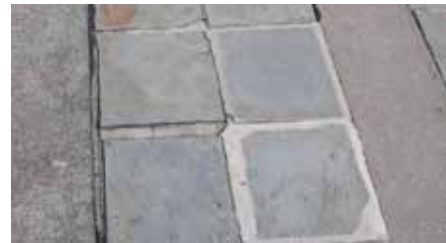
Figure 16: The terrace on the north side has obviously been repaired several times and remains in a deteriorated state.

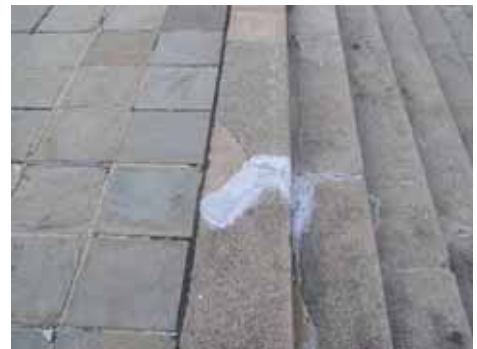
Figure 18: Attempts to repair the spalling concrete at the interface of the slate pavers and cracks running down the stairs are failing.

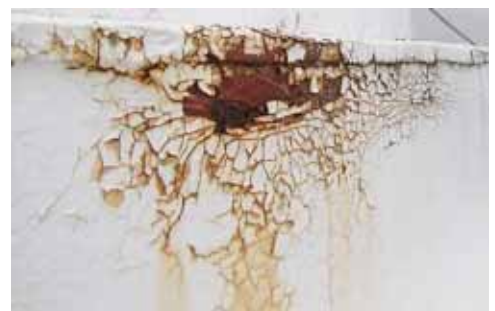
The roof structure noted on the 1972 drawings by Ballou and Justice, Architects & Engineers is the outer Guastavino tiled dome from the McKim, Mead & White era. The 1970s drawings indicate the application of new roofing, consisting of a flat-seamed metal over 1 5/8" insulation. The metal roofing is tied to the tile structure through 2x2 treated wood strips, spaced at a maximum of 20 inches, fastened with 1/4" diameter bolts with lead cinch anchors. Localized rusting was observed on the surface of the dome roof (see Figure 19). Although it appears that such roofing deterioration creates clear

Figure 19: The metal roofing is corroding and exfoliating causing the paint to peel and blister, this is especially evident at joints and corner seams.

avenues for water infiltration, no structural implications were visually apparent at this time. Refer to architectural recommendations for roofing treatments.

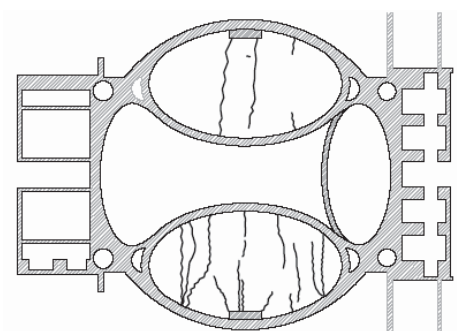
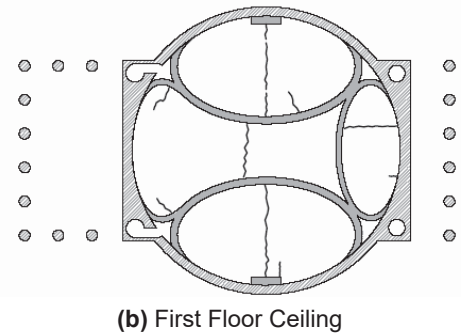
(a) Basement Ceiling

Across the ceilings of the east and west oval rooms hairline cracks were visible (Figure 26). The most noticeable cracks run the width of the ellipse (from the center of the fireplace through the two sprinkler heads), essentially splitting the two rooms in half. The cracks typically run parallel (east-west) and they tend to originate above window or duct openings or emanate from a sprinkler head. The Dunbar, Milby & Williams Report from 1990 noted hairline cracks on walls and ceilings of the West and East Oval Rooms and the basement rooms below. The hairline cracks were also observed radiating

from the lintels and sills of many windows and vents in each room. As depicted in drawings S-3 and S-4, the ceiling cracking appears to have some correlation to the layout of floor framing in the floor level above. This is discussed further in the Structural Analysis section.

Figure 26: Hairline cracks were observed in the ceilings of the east and west oval rooms on both the basement (a) and first floor (b) ceilings.

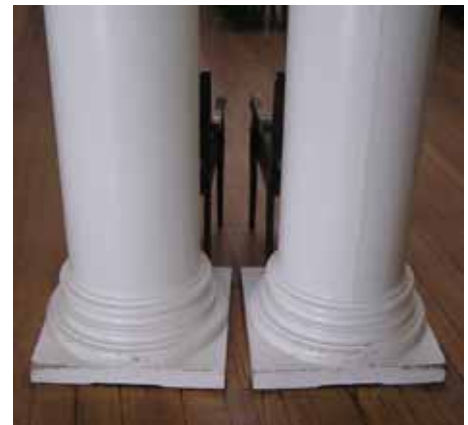
The domed “Reading Room” on the second floor is encircled by 20 pairs of columns of the Composite Order. One column in every pair has 2 vertical cracks, one on the surface facing the center of the room and one crack on the side of the column facing the exterior windows (Figure 27). These visible cracks are up to a 1/4 of an inch wide. Examination of the 1972 drawings shows that the restoration called for steel columns in one of each pair of columns. Direct comparison reveals that the cracked columns consistently are the ones encasing the structural steel. All crack pairs are 180 degrees from each other, as if the decorative encasement was installed in two halves and brought together to enclose the structural column. The cracking appears to be the result of a failed seam in the architectural finish. The finish failure may be the result of temperature or humidity cycling in the domed space.

Figure 27: One in every pair of columns in the reading room has two vertical cracks.

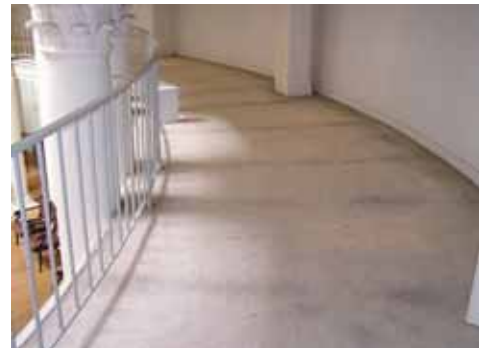
On the top surface of the Middle Gallery, RSA observed regularly spaced black stains in the carpet. The stains are linear from the exterior wall and create a regularly spaced radial pattern (**Error! Reference source not found.**). The stains also appear to be along the inside face of the exterior finish wall. It is possible that the staining is the result of moisture transmission along the top of the slab and may correspond to locations of seams in the carpet underlayment, perhaps in a layer of plywood. This moisture may be infiltrating the columns through the connection of gallery steel to structural steel column, which may relate to the finish cracking in the column encasements.

Figure 30: Radiating black stains are visible on the carpet in the middle gallery.
