UNIVERSITY OF VIRGINIA

THE ROTUNDA

HISTORIC STRUCTURE REPORT

JOHN G. WAITE ASSOCIATES, ARCHITECTS PLLC

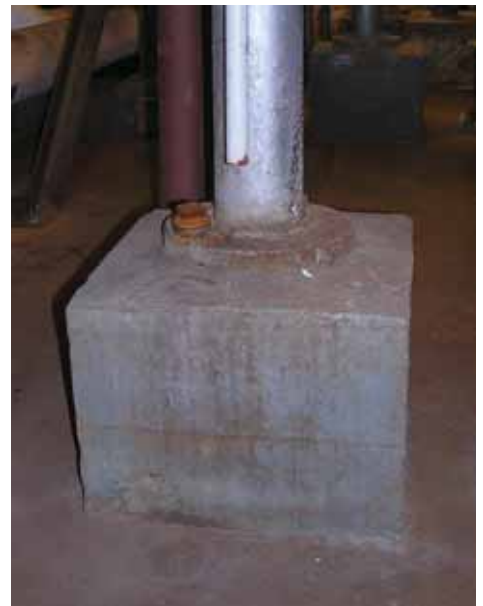
Most likely the original design from the McKim, Mead & White era had six 4½" diameter steel pipe columns supported on 16" square concrete pedestals raised 13" above the slab height (Figure 31). There are two additional columns of the same size with raised rectangular pedestals placed off the column grid. The middle section of the ceiling appears to have been reconfigured at some point and extra columns were added. These columns are 2" in diameter and situated on timber cribbing piers constructed from 6x6 (Figure 32). Furthermore there are two rows of four 2" diameter aluminum shoring columns braced together. The shoring towers are in locations where the ceiling appears to be greatly deteriorated.

Figure 31: A steel pipe column with a concrete base found in the mechanical room below the north stairs.

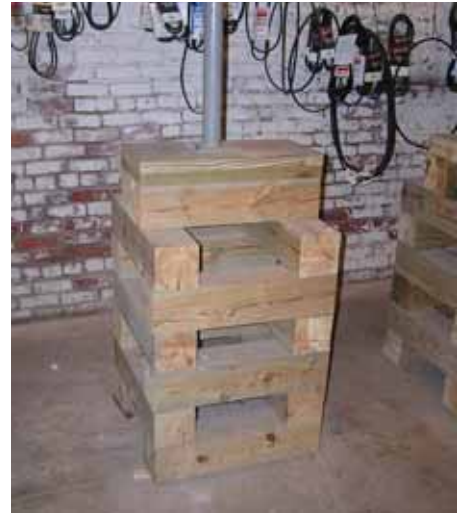
One explanation for the abundance of new columns and shoring is that for graduation students assemble above the space on the north stairs for the procession. Given the history of water penetration and deterioration, we now find multiple campaigns of shoring which likely were deemed important to provide additional safety in this highly loaded area.

Figure 32: Extra columns were added to the space below the north stairs.

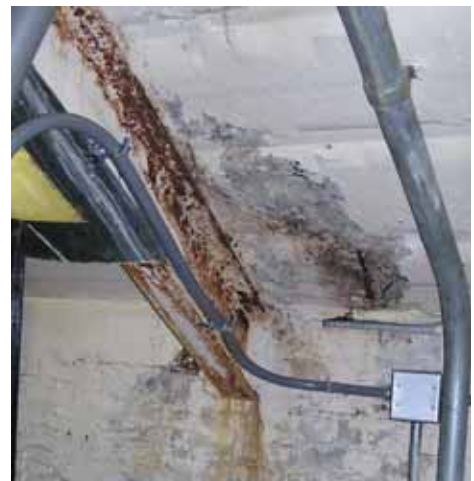
The ceiling of the two storage rooms is the underside of the North Stair structure. The stair framing appears to be a sloped concrete slab supported on I-beams spaced approximately 5 feet apart. Water has damaged the lower ends of most of the steel beams and adjacent concrete and rebar (see Figure 33). Remnants of steel beams embedded in the bearing wall were observed, perhaps indicating that the original steel had suffered significant deterioration and was removed and replaced with the current steel members. It appears that the rooms continue to suffer from water infiltration, as the existing beams and some of the slab and wall surface show signs of water staining. The steel has surface rust, however the overall cross-sectional loss does not appear significant.

Figure 33: Due to water infiltration, the steel support of the North Stair is corroding. The structure is exposed in Storage Rooms No. 109 and 110.

It appears that water continues to penetrate into the paving layer of the north stairs. The deterioration of the paving system and stair structure will continue unless adequate removal of water from the stairs is achieved.

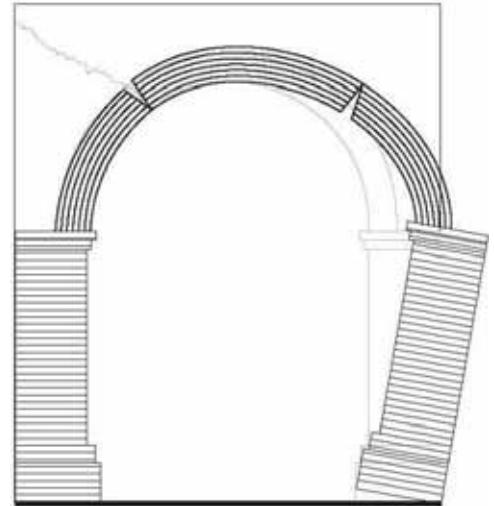
Figure 36 depicts the response of a pier-supported arch with insufficient thrust resistance. The crack patterns depicted are consistent with some cracking observed on site at areas where the arches are not directly supported laterally at the arch spring points.

Figure 36: Shifting support causing deformation and cracking in arch.

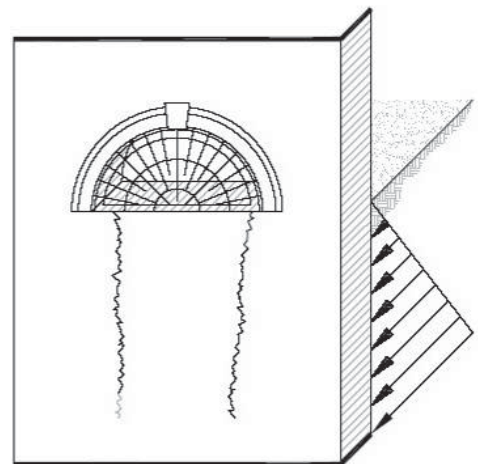
Below the window arcades the vertical cracking pattern in the retaining wall appeared to happen most often below windows. Most commonly two distinct cracks have developed, projecting vertically downward from the jambs of the arched window above. The piers between the windows have much less cracking. The typical cracking pattern is depicted in Figure 37. Preliminary analysis shows that the portion of the wall below the windows can not support the lateral soil pressure as a vertical cantilever, but must distribute their loads horizontally to the piers. It is likely that this cracking is associated with the horizontal transfer of lateral soil pressures, particularly if water is not properly draining away from the foundation wall on the Lawn side. The vertical cracking occurs primarily below the arched openings where the masonry is essentially unloaded by gravity loads from above. The vertical compressive stress in the pier masonry adds stability and reduces the likelihood of cracking. Cyclic effects of freeze-thaw or thermal loads also likely contribute to cracking in the wall areas between the piers. Vertical cracking on both faces of the wall are indicative of such movements.

Figure 37: Below the window arcade on the south elevation the wall is retaining the south lawn.

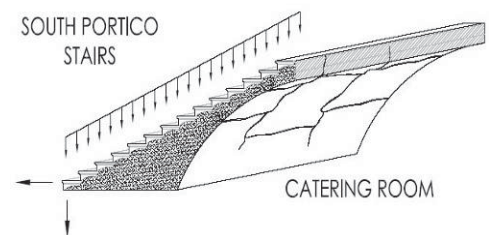
The cracks in the ceiling of the Catering Room (depicted in Figure 15) correlate to the cracks on either side of the south portico stairs (shown in Figure 14). Shifting or settlement of the soils below the bottom end of stairs, which serves as the support for the horizontal thrust generated by the loaded half-vault, would cause deformation and the development of tension cracking in the vault; such cracks would form perpendicular to the spanning of the barrel vault, as has been documented in RSA's recent survey (Figure 38).

Figure 38: The cracks in the Catering Room ceiling may have resulted from settling below the South Portico Stairs.
