H I S T O R I C S T R U C T U R E R E P O R T

THE MEWS

UNIVERSITY OF VIRGINIA

DLR GROUP
2021

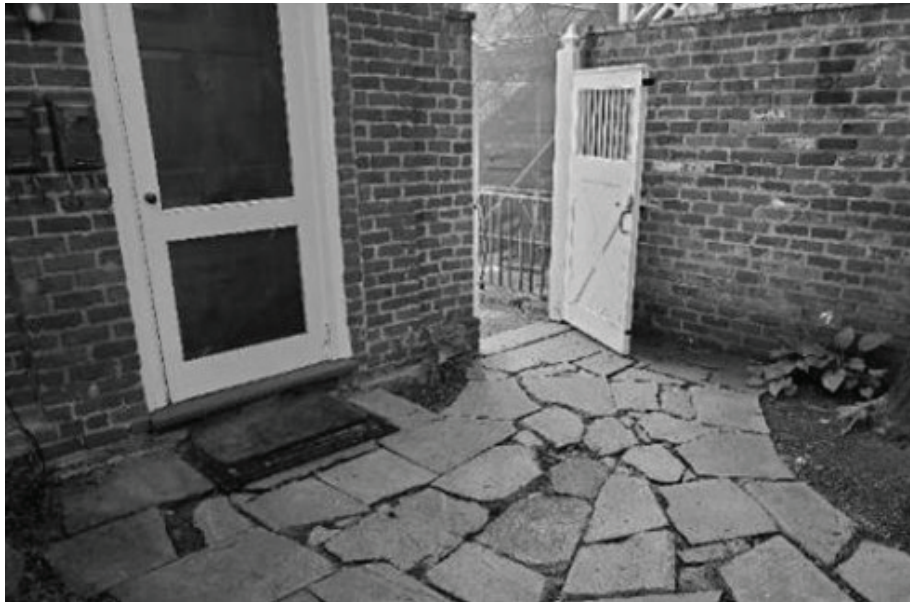
The Mews is currently not accessible, with external steps to the second floor and a 6-inch threshold at the main first-floor entrance. The kitchen entrance is approximately 12 inches above grade and cannot be accessed due to the narrow passage between the second-floor steps and garden wall.

The courtyard could be considered accessible with the gate in an open position. Slopes in the alley leading to the gate are right at 5 percent. Without a landing, this slope would be acceptable only with the gate in the open position. The irregular bluestone paving is questionable as a surface for an accessible route. The 36-inch-wide gate opening is sufficient. If grades could be adjusted to provide a landing, the 11-inch separation between the gate and the face of the building is just short of the required 12-inch separation needed for opening the gate.

Figure 52. The threshold at the main first-floor entrance and the irregular bluestone paving present accessibility issues.

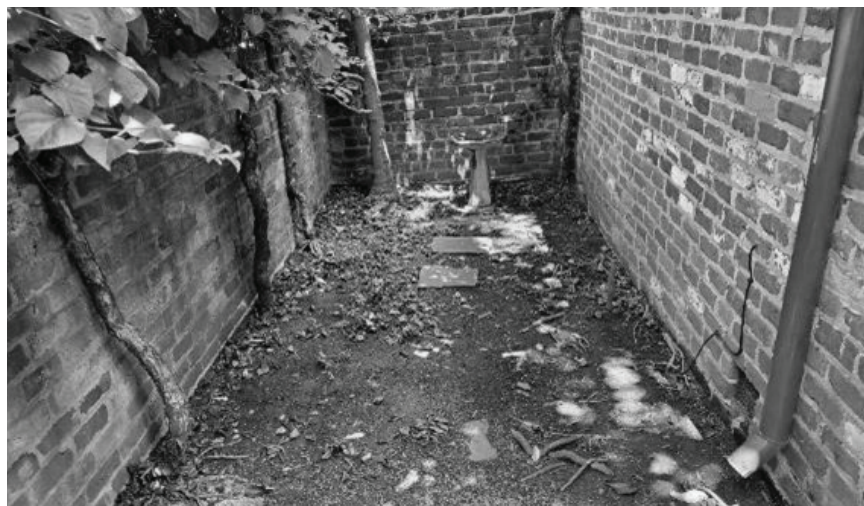
and is piped above grade to outlet at the southwest corner of the building. The second-floor patio on the west end of the building drains to a gutter with a roof leader that outlets into the courtyard garden west of the building. The significant amount of water draining from the roof and second-floor patio is trapped in the courtyard garden west of the building. It appears that as this water infiltrates, it is making its way into the crawl space under the kitchen.

Figure 53. Water from the roof and patio along with surface runoff collect in this area west of the building, with no means of exiting the walled garden.

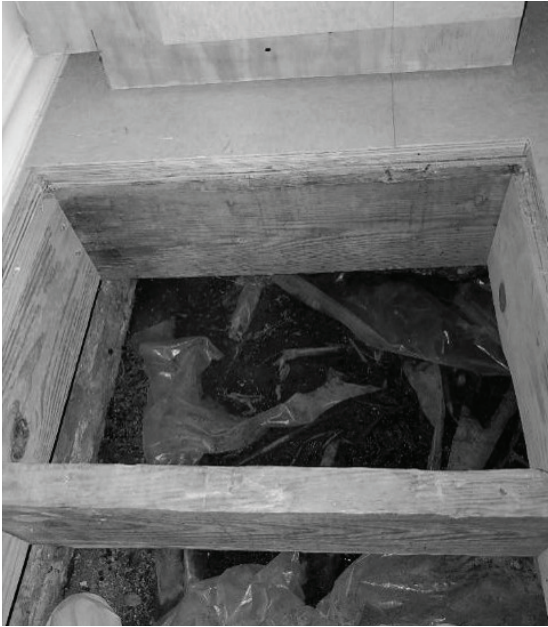
Figure 94. Detail view of crawl space access in kitchen. 7/28/2020

The three separate crawl spaces beneath the Mews correspond roughly to the area beneath the bedroom (c.1829), the living room (c.1881), and the kitchen (c.1938-1950). Each of the three crawl spaces has a separate floor hatch for access, and they are divided by the masonry load-bearing walls that roughly divide the space into thirds. The crawl spaces were excavated in 2016 to provide space to remove asbestos and make improvements to utilities. The floor in all three areas is soil with a plastic moisture barrier having been placed over most of the floor areas. The central and eastern portions are dry, but the area under the kitchen is visibly taking on water from both the plumbing pipes and exterior drainage from along the west wall of the kitchen. While the leakage from the existing pipes appears to be a simple maintenance issue, possible remedies for the water infiltration from the exterior are discussed in Section 3: Site and Landscape Recommendations.

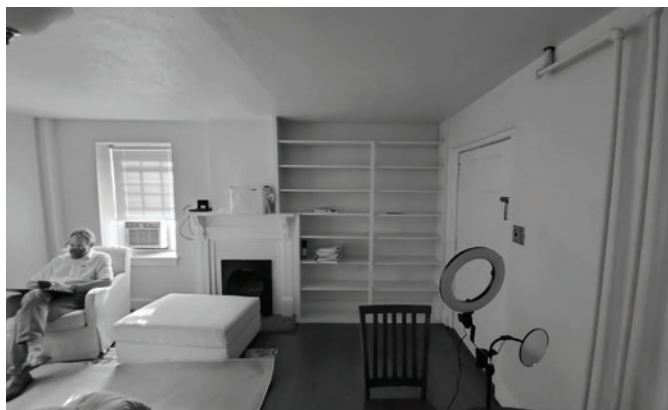
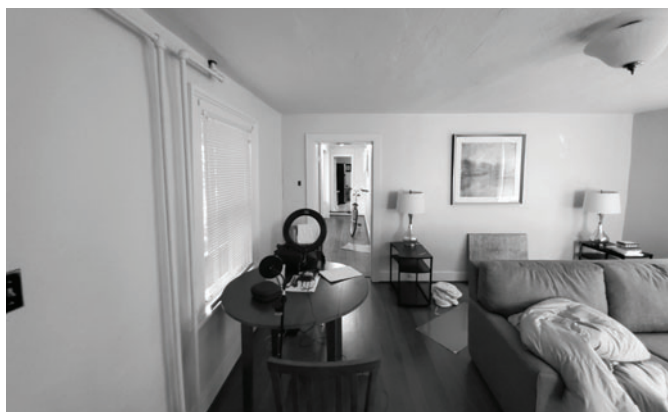
The first floor living room space consists of unadorned painted plaster walls and ceilings with simple wood base and casing at doors. Some cracking is evident on the ceiling, but the overall plaster condition is good. Exposed radiator pipes serving the second floor are visible on both the north and south walls. The wood floor and access hatches were installed with the 2016 excavation and abatement of the crawl space. The wood floor is in excellent condition, but latch hardware needs replacement.

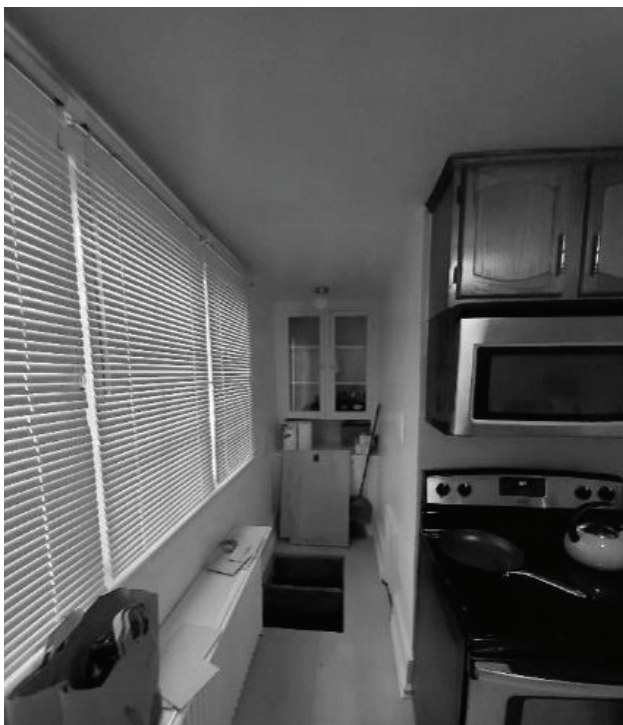
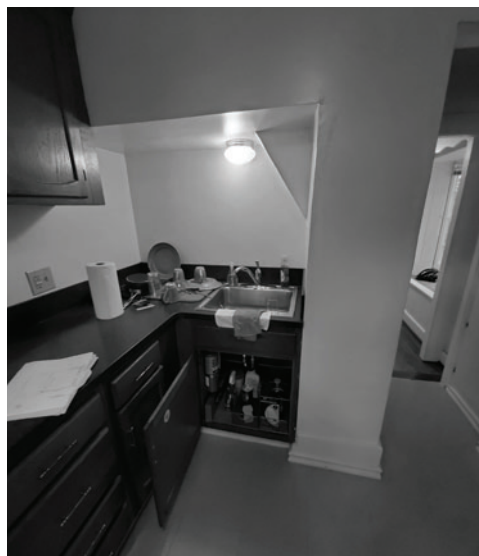
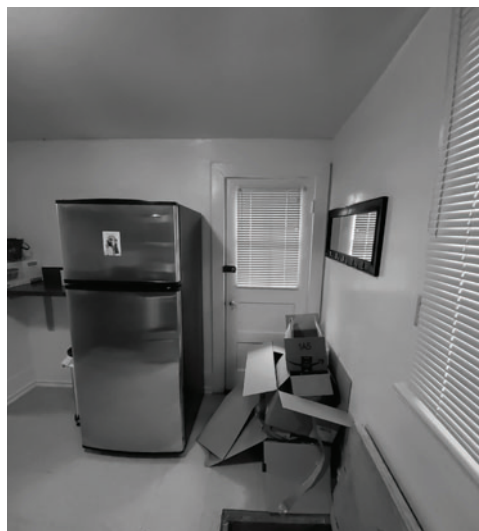
The kitchen floor transitions from wood to a vinyl tile floor product. Two sets of access panels open to the crawl space. The vinyl tile has lost adhesion to the plywood face of the access panels. The hinges for the south access door are binding with use and causing damage to the wood substrate. Fixtures in the kitchen are contemporary, as is the kitchen counter and cabinetry. Built-in millwork for storage exists as a pantry-type closet at the hallway entry and a set of upper cabinets at the northwest corner of the kitchen.

The kitchen addition dates to circa 1938–1950. The addition modified and worked around the masonry and chimney configuration of the original circa 1829 construction, leading to the oddly shaped nook above the current sink location. Plaster at the walls and ceiling is in relatively good condition, with only minor cracking evident on the ceiling.

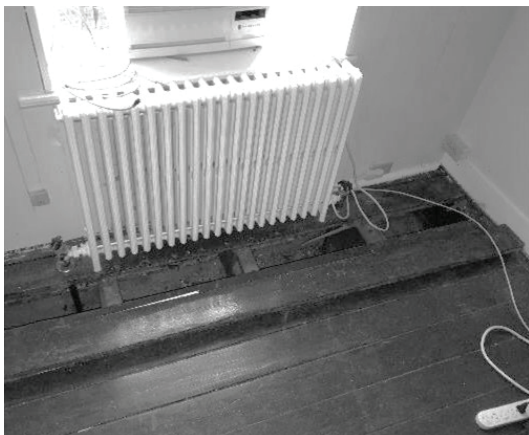
The removal of wood flooring for inspection supports the belief that the floor is original to the second-story addition work circa 1881-1882. Keeping the flooring intact and in place should be a high priority. Portions of the plaster ceiling below remain in place and are visible with the floorboards removed. Other areas of the plaster ceiling below have been replaced or patched with boards attached to the underside of the joists. This patchwork likely explains the need for the acoustic ceiling panels that have been used to cover the ceiling in the central bedroom and hall area on the first floor.

Figure 112. Image showing area of exploratory probe beneath existing second floor wood flooring. 11/5/2020

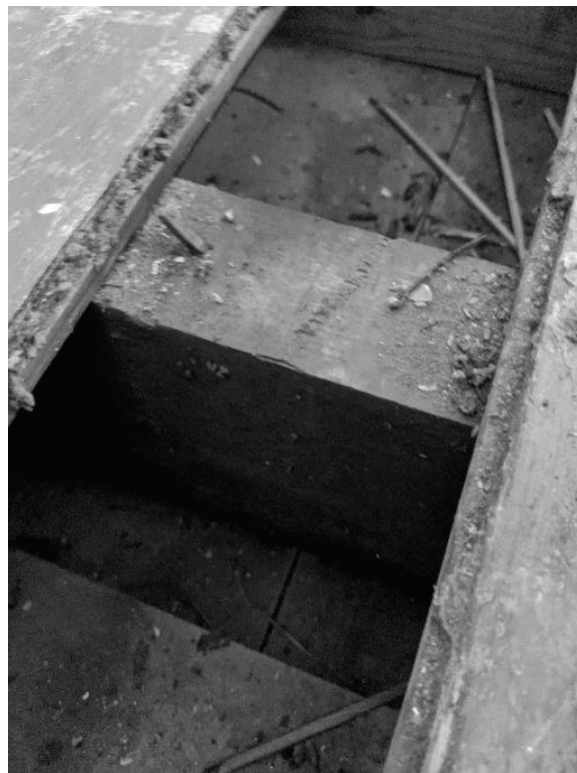
Figure 114. Detail image of existing wood floor joist. 11/5/2020

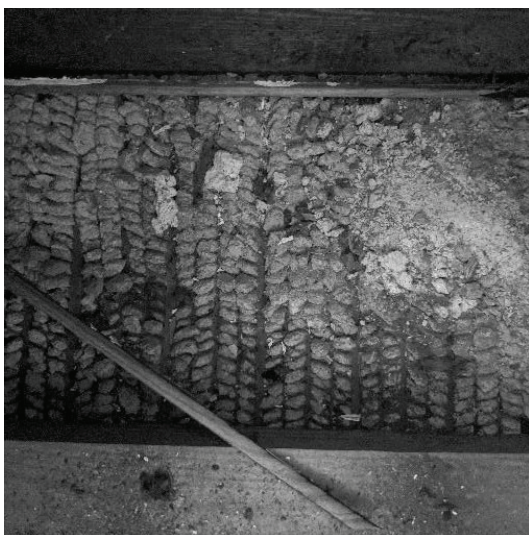
Figure 113. Image of a remaining portion of first floor plaster ceiling seen from between the floor joists above. 11/5/2020

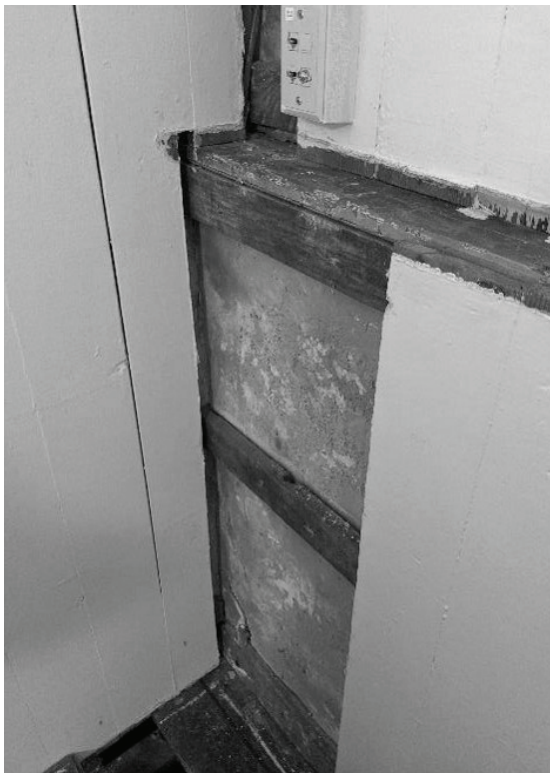
The removal of the wood panel and cap molding from the wainscoting reveals a profile that reflects a change of thickness in the exterior wall. The backside of the exterior masonry is visible through a damaged portion of the mortar used to face the interior side of the wall. The wainscoting is used to conceal conduit in some locations but does not appear to have been built solely for this purpose. This wall configuration was likely built as part of the change from the previous one-and-a-half-story construction to the full two-story construction, likely dating circa 1881–1882. The early base and plaster found behind the wainscoting is an important historic feature that should be carefully considered before any major alterations are considered.

Figure 115. Image showing removal of wood wainscot to expose brickwork at northwest corner of second floor living room. 11/5/2020

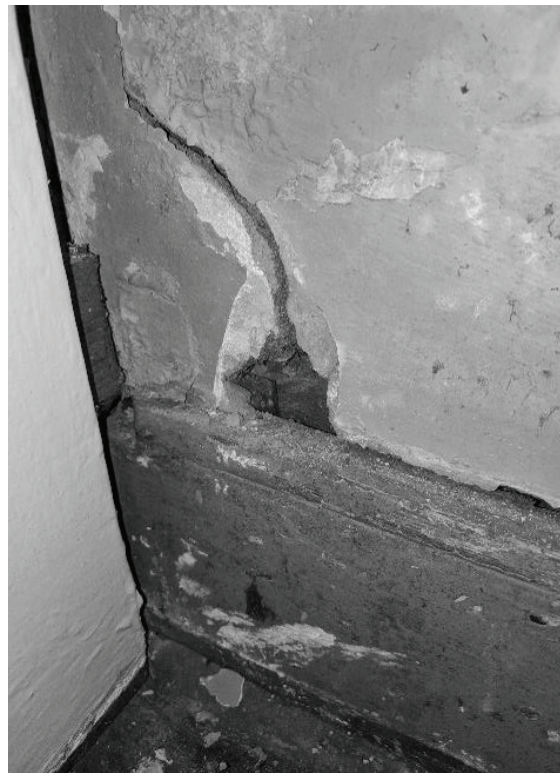
Figure 116. Detail image showing masonry behind a layer of mortar used to face the interior of the exterior masonry wall. 11/5/2020

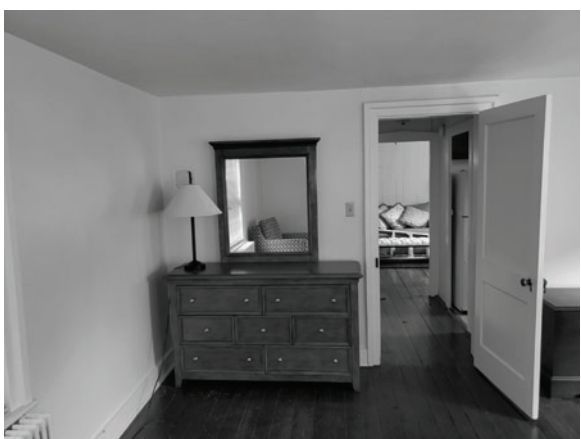
The second floor bedroom walls and ceiling are plastered and in good condition with only minor cracking. The walls, doors, and windows are trimmed with simple wood base and casings. A minimal wood crown has been added at the wood closet construction. The wood floor is possibly original to the raising of the Mews to a full two stories circa 1881, but the removal of flooring to inspect and confirm this suspicion was not undertaken. The chimney and fireplace along the east wall have a clean wood lintel and surround a cast-iron fireplace insert. The board-and-batten construction found in the living room is not evident here except for the closet construction; electrical conduit and wiring have been concealed by means of a built-out chase that has been painted to match the surrounding plaster walls.

*Figure 122. View of second floor bedroom, looking west.
7/28/2020*

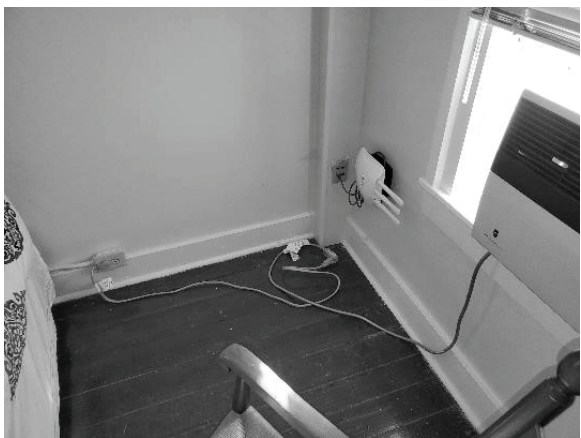
*Figure 123. View of second floor bedroom, looking east.
7/28/2020*

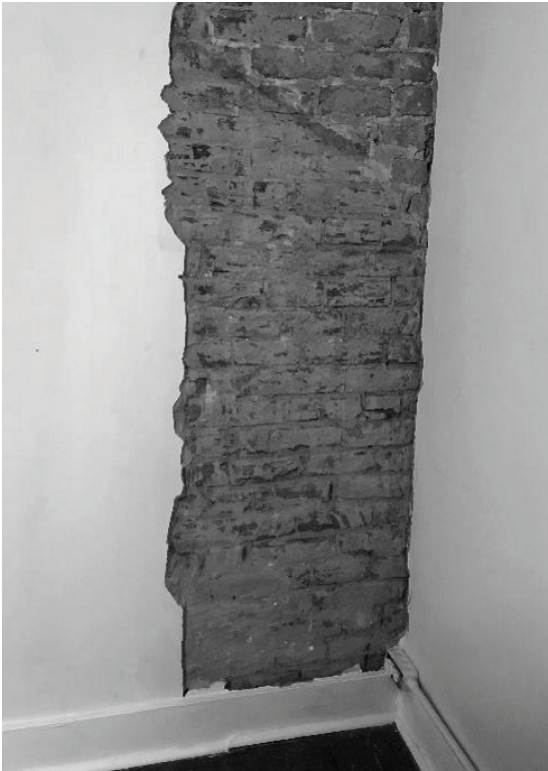
Location of the west wall of the second floor bedroom suggests that it might have been built directly above one of the exterior walls originally used to define the garden areas west of Pavilion III circa 1821–1822. As suspected, the upper portion of the wall displays a change in craftsmanship that indicates the wall was not finished to the degree typically expected for an exposed masonry wall. The upper portion of the wall was most likely added with the second-story addition work dating circa 1881–1882. The wall being built to extend the existing wall upward and to receive a plaster finish would explain the disregard for the appearance of the mortar work. Additionally, the angled discoloration visible near the top of Figure 2I-34 may indicate the roof line of the previous one-and-a-half-story construction before it was raised to a full two stories. With this wall dating to the 1800s, penetrations and modifications to this area should be minimized. Large-scale modifications to this wall should be heavily discouraged.

Figure 125. Image showing removal of plaster to expose brickwork along west wall of second floor bedroom. 11/5/2020

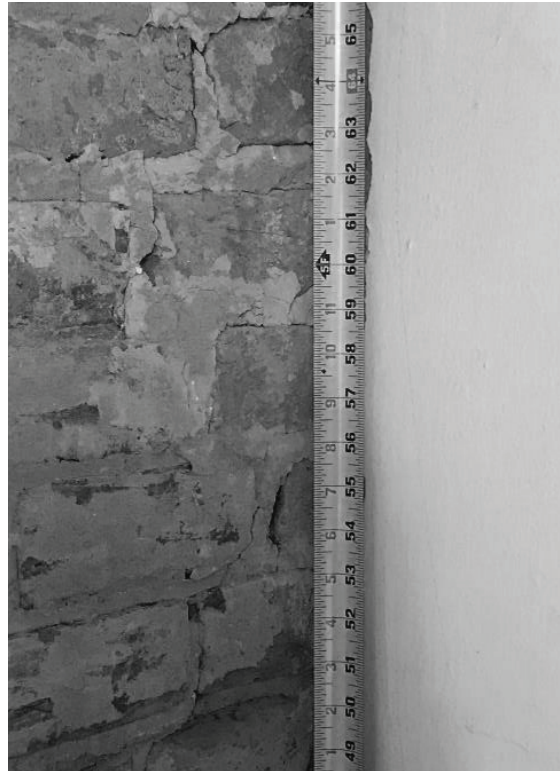
Figure 126. Detail image showing change in mortar technique at approximately 59 inches above the finished floor. 11/5/2020

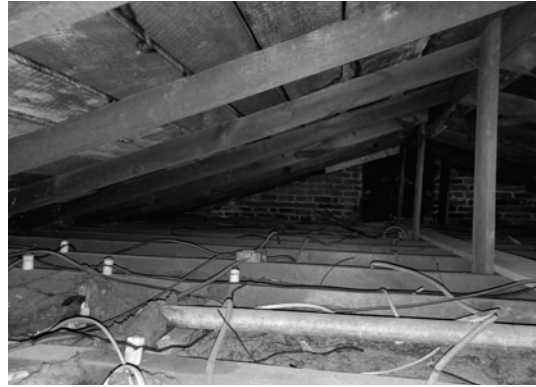
*Figure 128. View of attic space, looking east.
7/28/2020*

The attic is accessible through a ceiling hatch in the second-floor hallway. Even with recent rain, the attic space is dry, with no sign of water damage. The joists are crisscrossed with knob and tube electrical wiring as well as more contemporary electrical wiring run in flexible conduit. The top side of the second-floor plaster ceiling is visible in areas where the batt insulation has been rolled back to make electrical modifications.

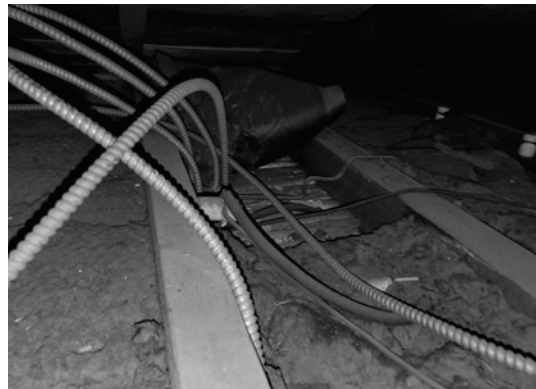
*Figure 129. Detail view of attic electrical conduit.
7/28/2020*

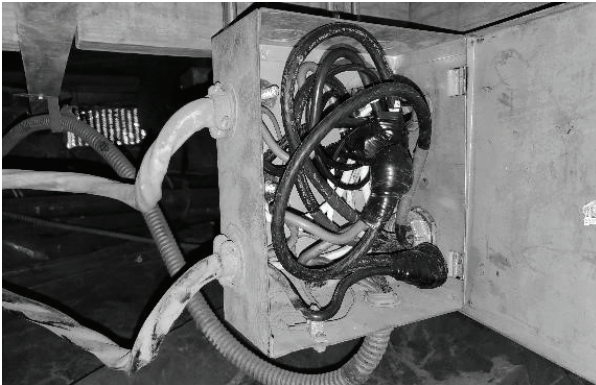
Figure 130. Detail view of crawl space junction box. 7/28/2020

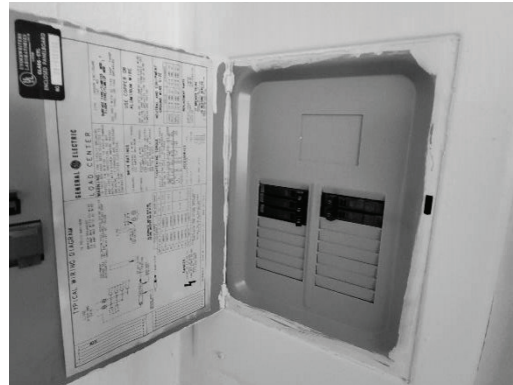
Figure 131. Detail view of first floor distribution panel. 7/28/2020

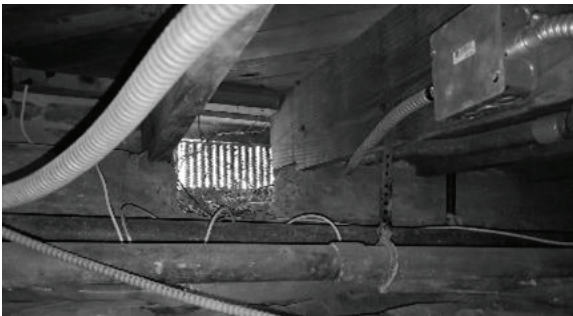
Sanitary piping in the crawl space is leaking and should be replaced. The existing 4-inch terra cotta building sewer, which connects to a manhole in Mews Alley, has reached the end of its useful service life and should be replaced. The building has two storage-type, electric water heaters – one on each floor. The water heater on the first floor is located in a closet in the living room. The water heater on the second floor is installed in a cabinet in the kitchen. A PVC vent pipe that exits through the second floor patio roof is not firmly secured to the building should be relocated or secured.

Figure 132. (Above) Detail view of north side of crawlspace below living room. 7/28/2020

1. The existing sanitary piping in the crawl space is leaking and should be repaired or replaced.
2. Any remaining steel domestic water piping should be replaced with copper. Abandoned piping should be removed. Domestic water piping should be insulated.
3. The existing 4-inch terra cotta building sewer, which connects to a manhole in Mews Alley, has reached the end of its useful service life and should be replaced.

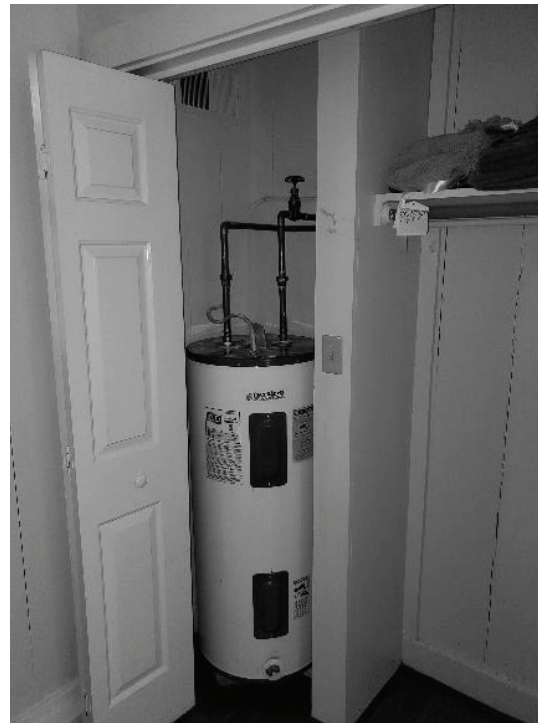
Figure 133. (Left) Detail view of first floor hot water heater. 7/28/2020

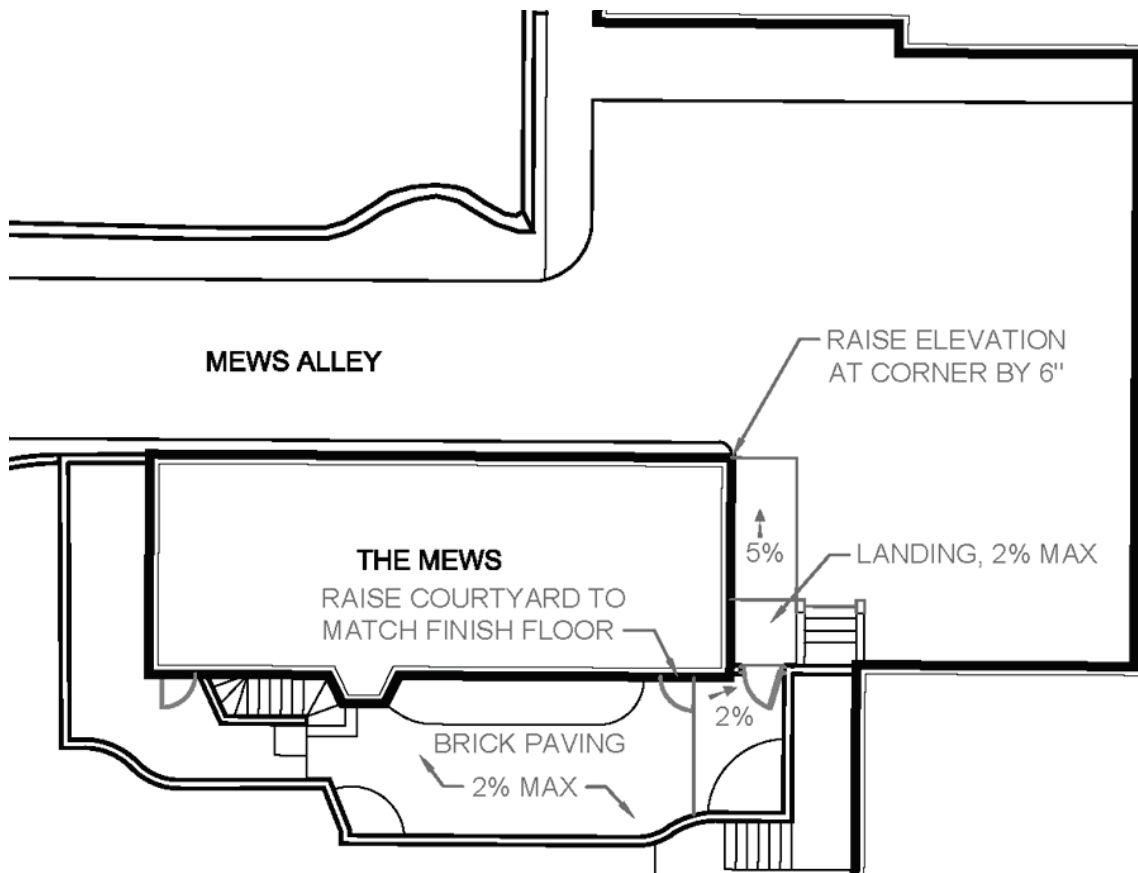
Figure 135. Accessible route to first floor from Mews Alley.

An option has been identified for making the first floor of the Mews accessible by raising the level of the courtyard 6 inches to be flush with first-floor finished floor elevation with 2 percent slopes away from the building. The existing irregular bluestone paving in the courtyard would be replaced with paving more consistent with University standards and accessibility requirements.

Access from Mews Alley would require adjustment to elevations in the alley as part of the planned Mews Alley improvements. The elevation at the southeast corner of the building would need to be raised approximately 6 inches to allow for a 5 percent slope up to a landing at the gate. Inside the gate, a 2 percent slope up to the door would allow grade to meet finished floor elevation and promote drainage through the gate. This approach would not require handrails, leaving the courtyard open and avoiding conflicts with the parking in Mews Alley. Changes in grade in the alley would require an additional step on the stairs down the breezeway leading to the Pavilion III garden. Additional modifications at walks and parking adjacent to Pavilion I might be needed, depending on the final grading design.

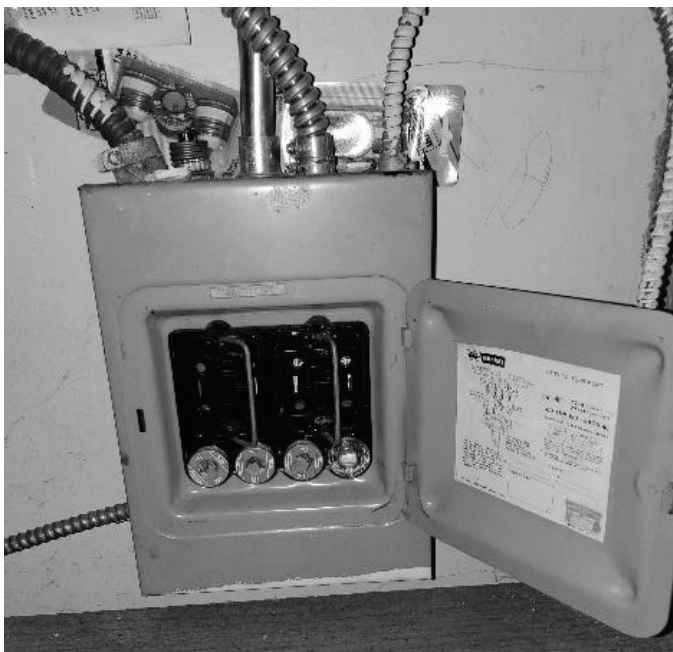
Figure 136. Panelboard below second-floor kitchen sink.

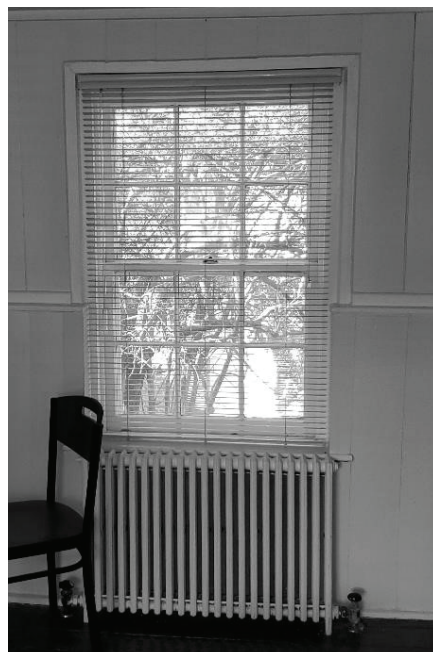
The Mews does not have a central air conditioning system. Multiple window-mounted air conditioners are installed. This type of air conditioner is typically inefficient, noisy and visually unappealing.

Figure 137. Typical radiator and window air conditioner configuration.

1. The existing radiators are functional in the space. Window air conditioners should be replaced with higher-efficiency units when necessary due to failure.
2. Heating hot water piping in the crawl space should be insulated.
