# THE ROTUNDA

H I S T O R I C   S T R U C T U R E   R E P O R T  
S E C O N D   E D I T I O N

JOHN G. WAITE ASSOCIATES, ARCHITECTS

So much information was uncovered during the restoration that the University asked John G. Waite Associates, Architects to update the 2008 historic structure report. This second edition includes new information on the structural analysis, mechanical systems, and archaeological findings. The architectural description and measured drawings were updated to reflect current conditions. Research conducted on the historic heating systems, the water supply, and the portico column capitals is now incorporated into the history, as is a summary of the restoration. The discovery of the chemical hearth in the lower east oval room during the work led to a separate historic structure report; a summary of its history and its discovery have been added to this edition. Besides John G. Waite Associates, Architects, the team for this work included:

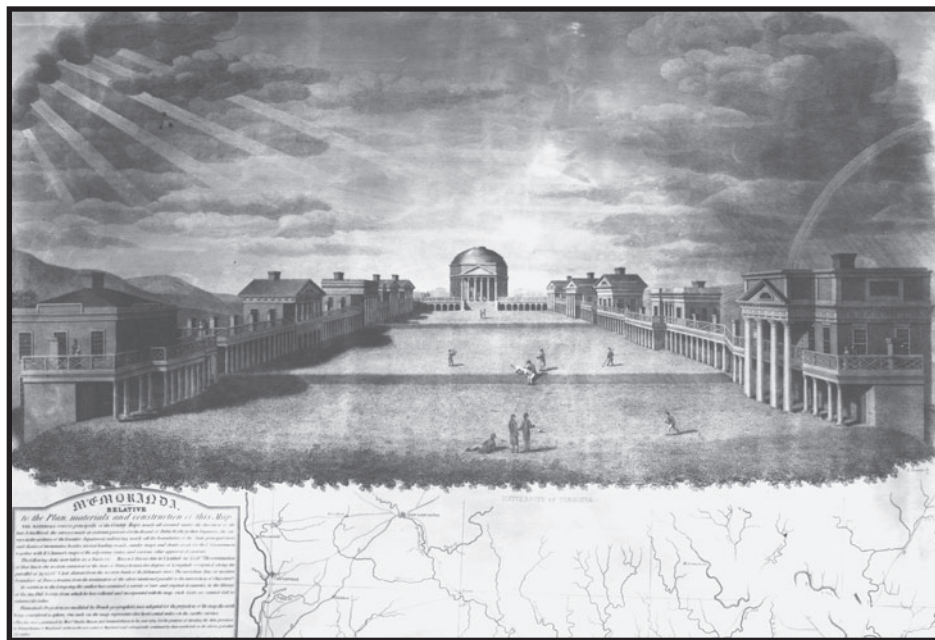
FIGURE 26. *Benjamin Tanner, University of Virginia from the south, 1826, engraving based on an 1824 drawing.*

The series of images taken from the south record the terraces in various forms. The view by engraver Benjamin Tanner from 1826 (Figure 26) appears to be the most accurate, showing arcades flanking the Rotunda steps. Physical and photographic evidence indicates that the arches were in fact lunette-form window openings, originally open and later (probably 1841) fitted with sash. The original open-arch appearance of the terraces is best illustrated by the March 1824 drawing of the north face of one of the gymnasia arcades by John Neilson (Figure 23).

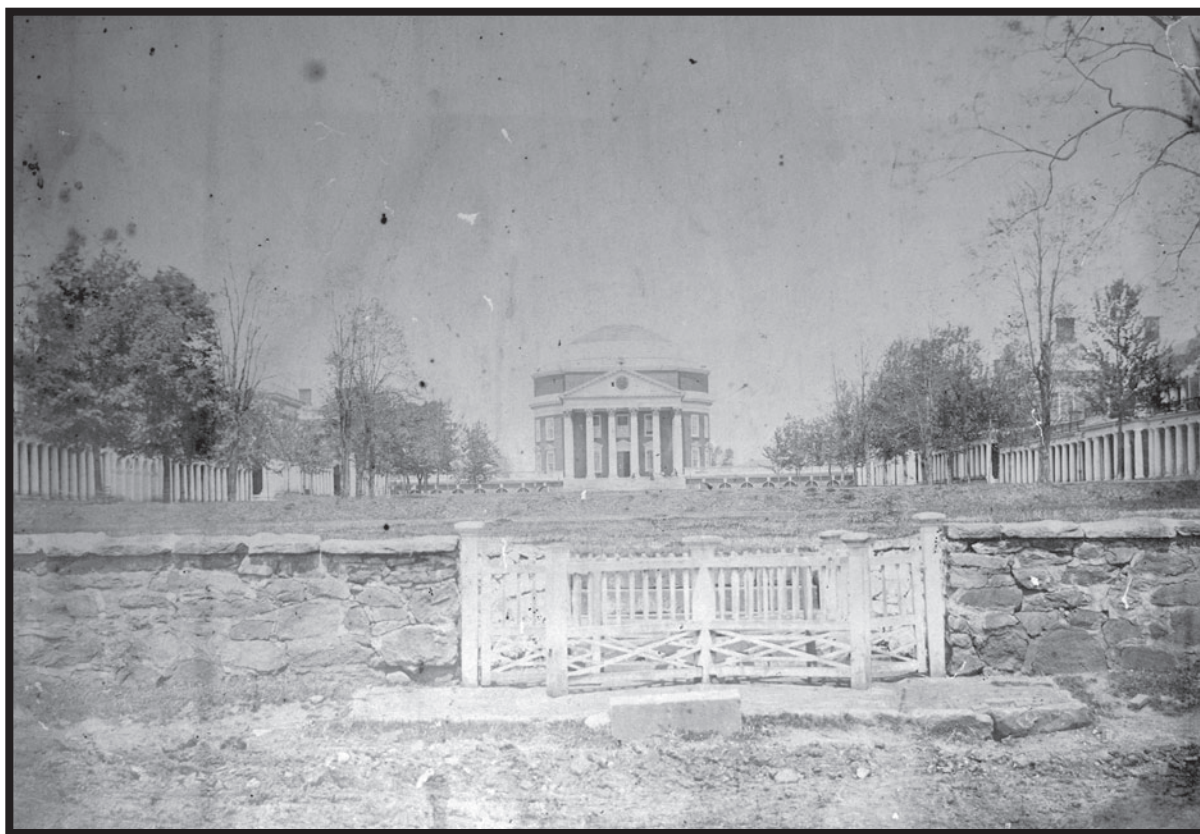
FIGURE 32. *The Rotunda and the Lawn from the south, 1868. This image is the earliest known photograph of the Rotunda.*

There are numerous photographs that record the Rotunda as reconstructed and enlarged by McKim, Mead and White, but only a handful that show the building before 1895. The earliest photograph, from 1868, shows the Rotunda and flanking terraces as seen at a distance from the south (Figure 32).

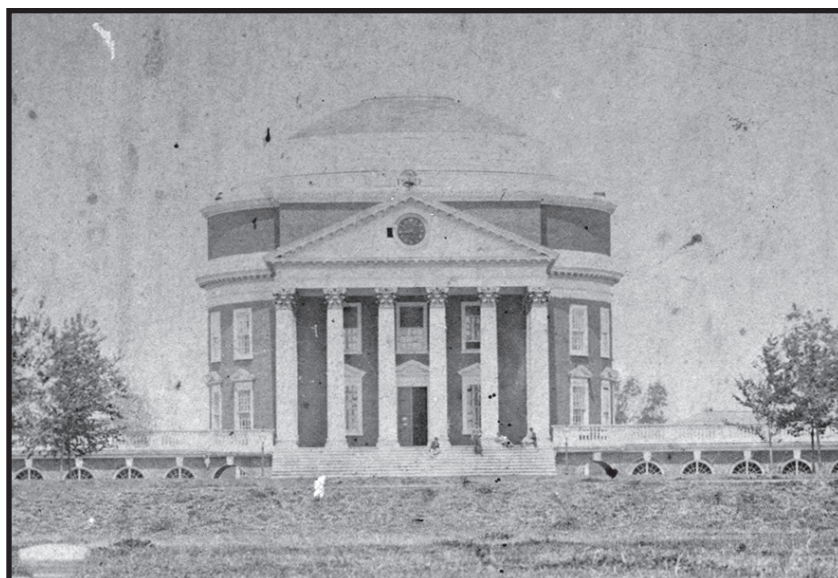
FIGURE 33. *Detail of the 1868 photograph, showing the bell centered at the base of the dome.*

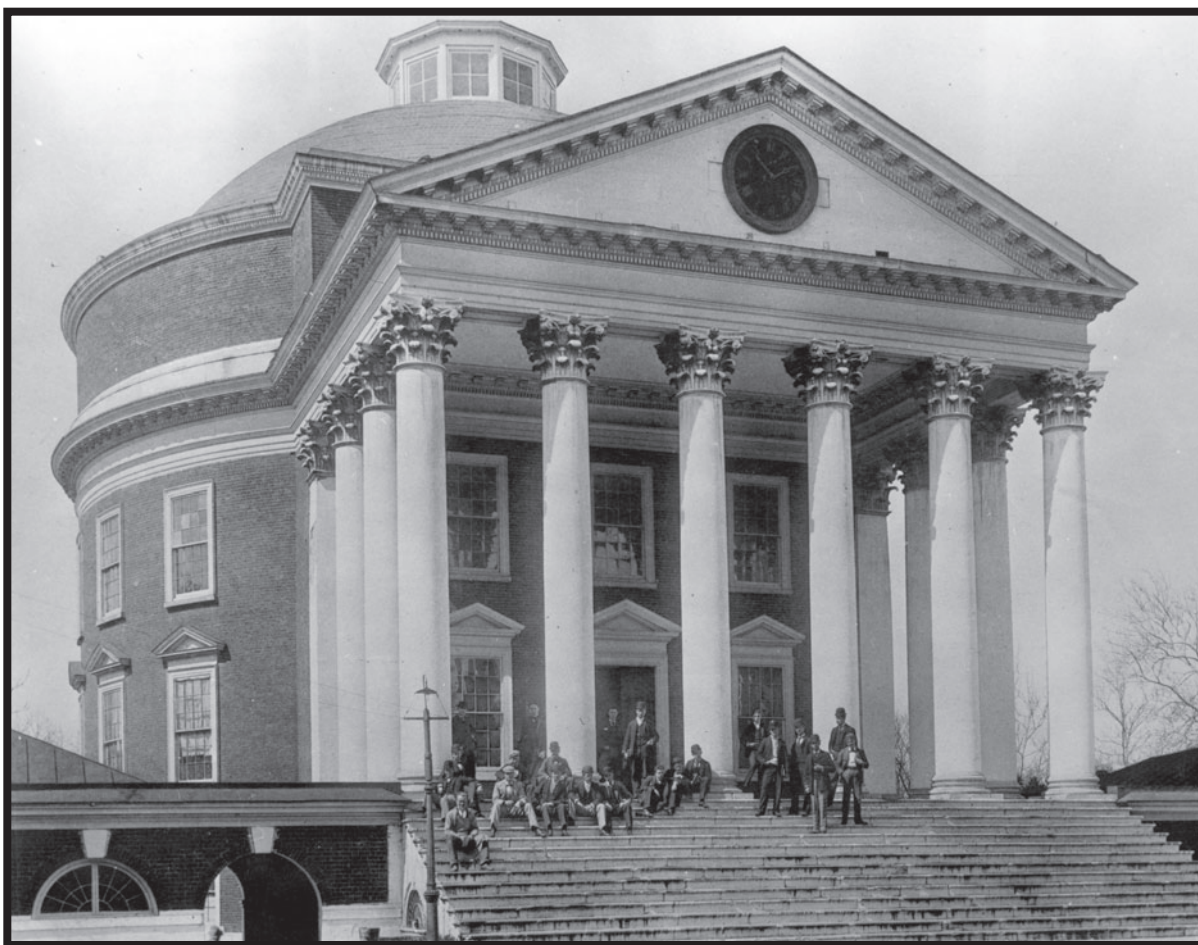
FIGURE 39. *The Rotunda from the southwest, 1892, showing the lantern over the oculus of the dome. The balustrades have been removed from the terrace wings.*

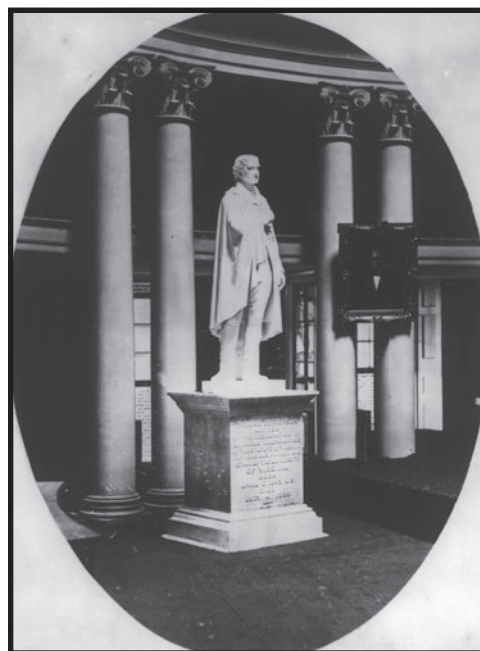
FIGURE 44. *The Dome Room, 1890, showing the floorboards laid east-west.*

*Floor:* The floor is finished with random-width heart-pine antique floorboards, ranging from 3" to 6" wide. The boards are laid east-west based on an 1890 Kenneth Brown photograph acquired during the mid-1970s restoration (Figure 44).

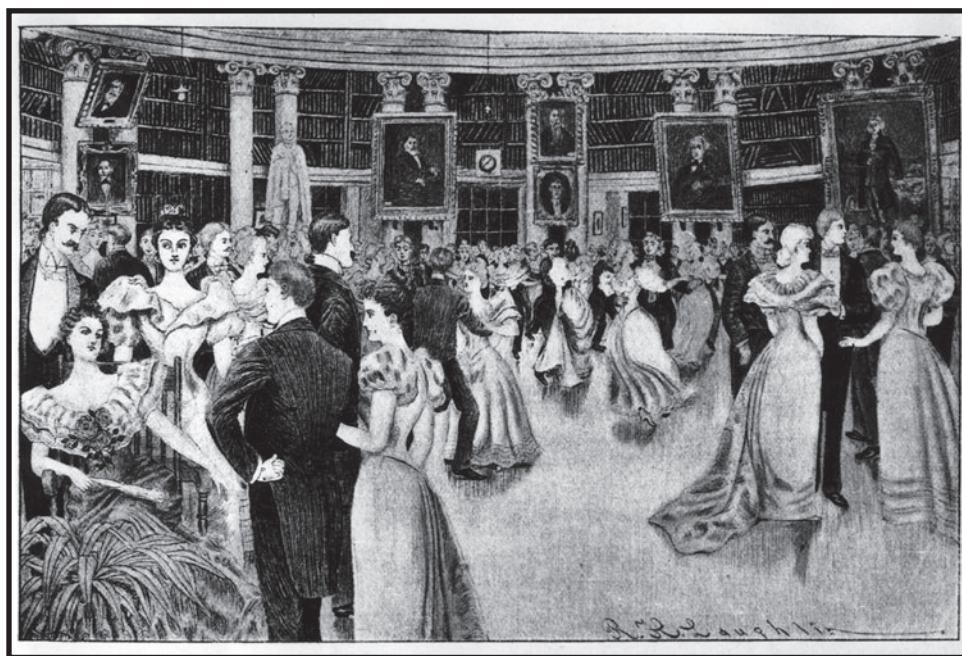
FIGURE 47. *The Dome Room before the 1895 fire, showing the bookcases against the north wall, engraving by Moss Eng. Co., New York.*

Many, if not all, of the bookcases were in place in the Dome Room in late 1826, and they can be seen in the pre-fire images, which show the bookcases, with their glazed doors, positioned on the Dome Room floor below the lower balcony (Figure 46). Cases are also seen lining the walls below the lower balcony and on that balcony (Figure 47).

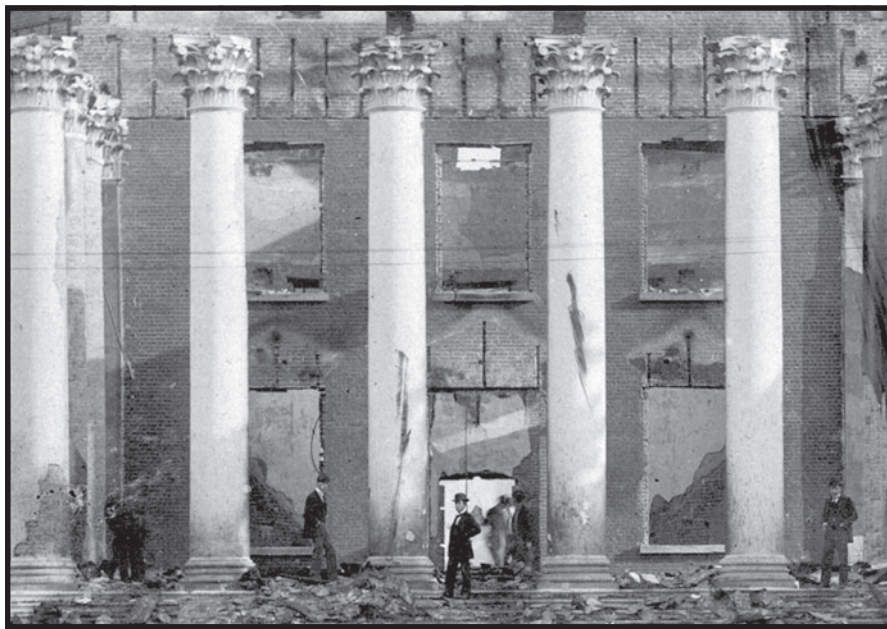
FIGURE 54. *Detail of the October 28, 1895, photograph. The locations of the original nailing grounds and the outlines of the pediments are clearly shown above the first-story openings. Fragments of the original interior finishes can be seen through the openings.*

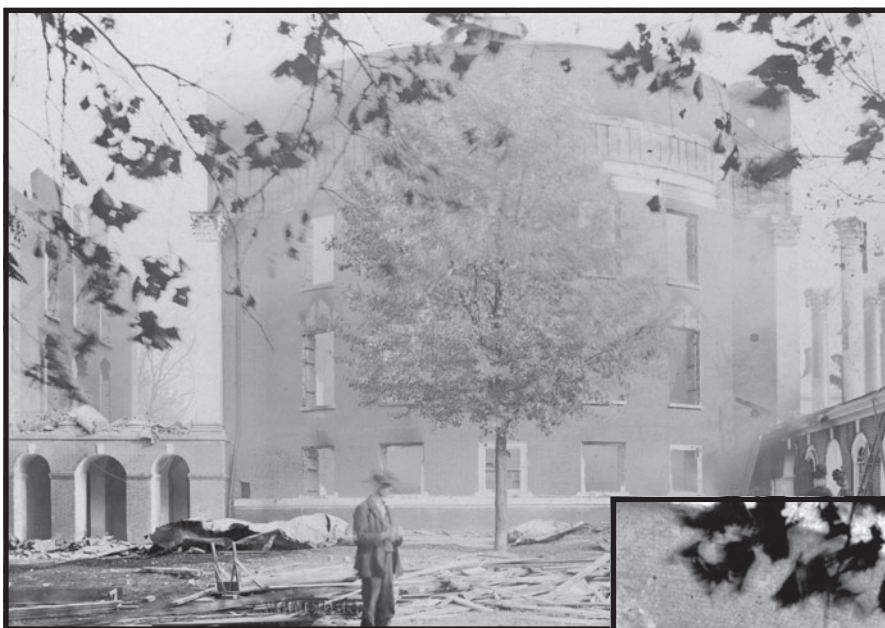
FIGURE 55. *The Rotunda from the west after the 1895 fire, photograph by Wampler.*

The west elevation is currently a mirror image of the east elevation, but the post-1895 fire photograph taken by Wampler (Figure 55) reveals some features that were unique to this elevation. In the photograph, the south buttress wall surface includes four small circular openings, one above the other. The very top opening is in the attic story. Fire debris obscures the wall surface at ground-floor level, where a fifth opening may have existed. These openings may have been vents for the shaft that housed the bell rope. The origin of the openings is unknown, and they do not appear in the 1892 photograph of the Rotunda from the southwest. The Wampler image also records a small rectangular opening at the bottom of the west buttress, just above the stone water table.

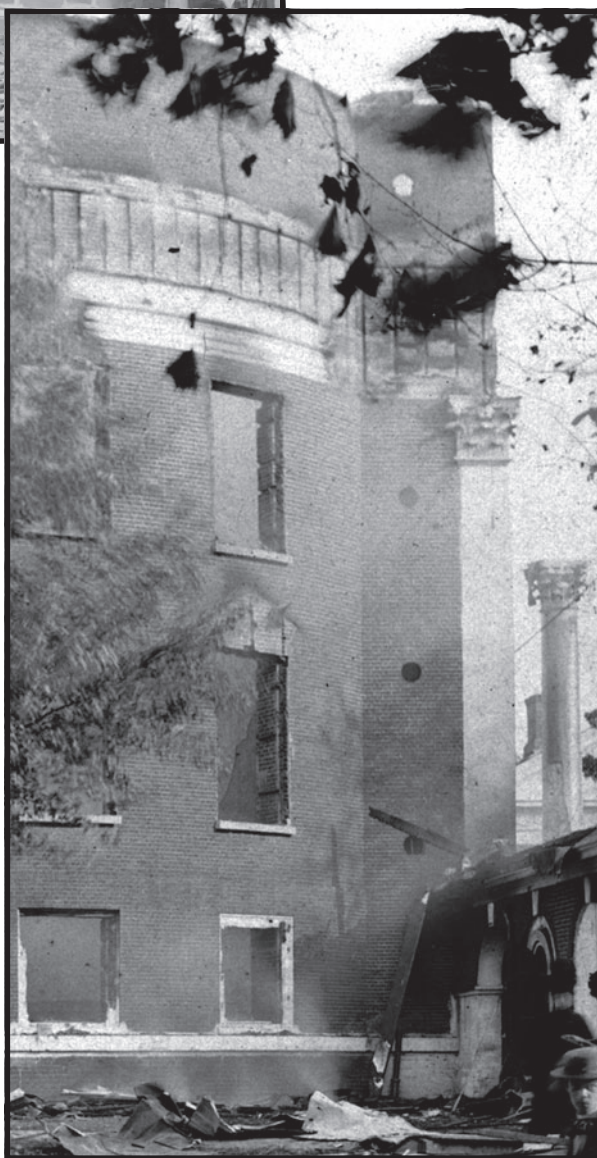
FIGURE 56. *Detail of the 1895 view from the west, showing evidence of the window reveals and the round openings in the west face of the south portico.*

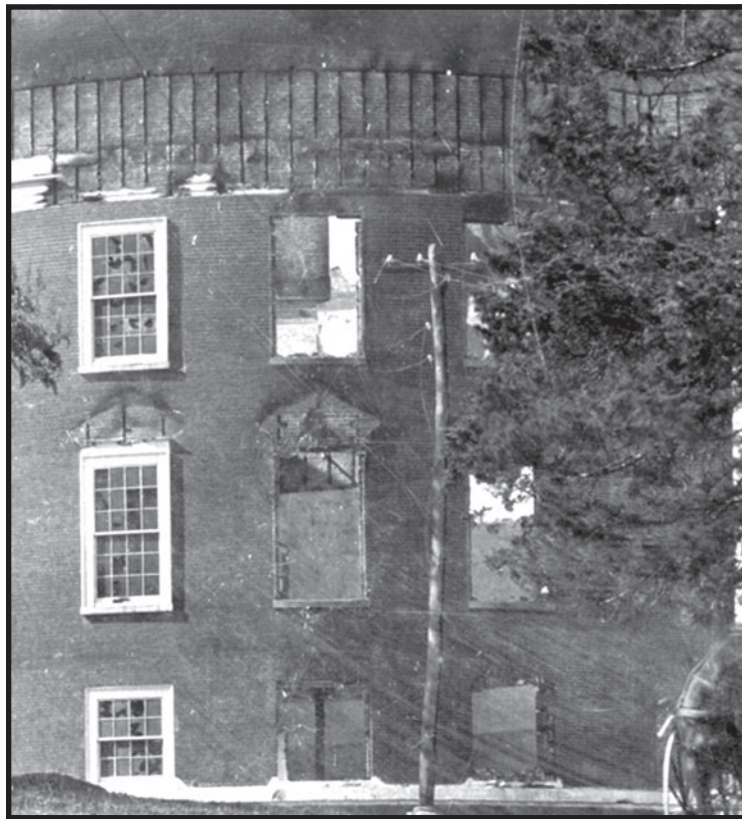
FIGURE 58. *Detail of the view from the east after the fire. Surviving interior finishes are visible through the window openings.*

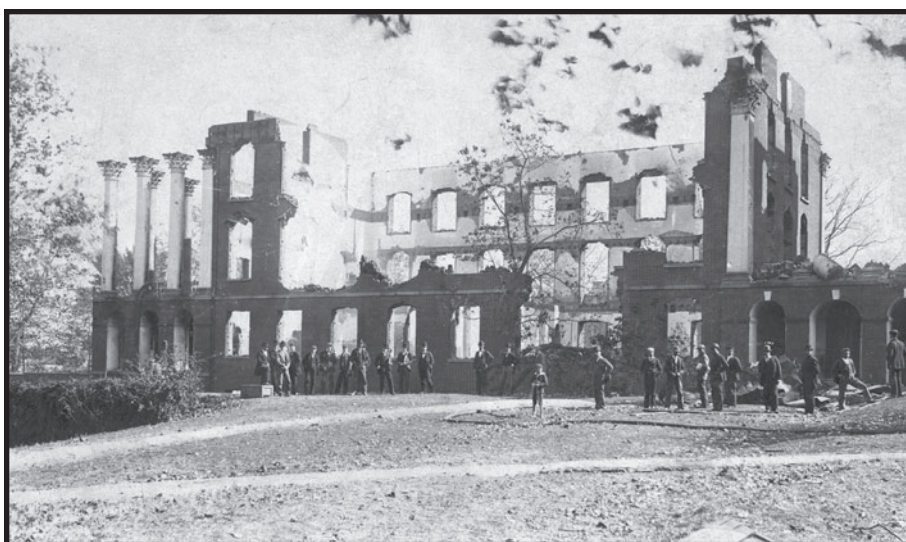
FIGURE 60. *The Annex after the fire from the southwest, 1895, photograph by Rufus Holsinger.*

The current window entablatures and pediments differ in proportion from those seen in pre-fire photographs. The old images record a frieze that is only three bricks in height; the current sheet-copper frieze is a full five brick courses in height. The reason for this change, made by McKim, Mead and White, is unknown. Post-fire photographs reveal that the destroyed wood frieze and pediment were attached above each opening to three symmetrically placed vertical wood nailers affixed to the brick wall surface (Figure 53). The identical method of attachment can be seen in post-fire photographs of Robert Mills's Annex (Figure 60).

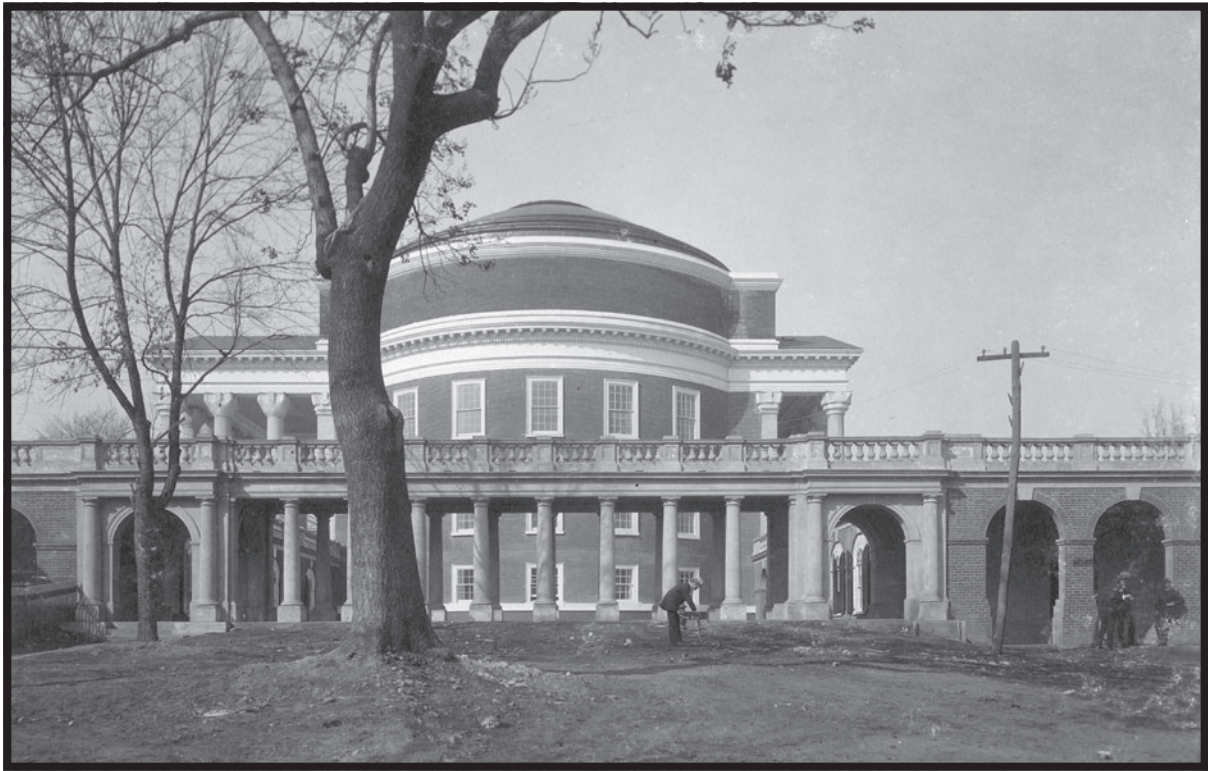
FIGURE 77. *The Rotunda and colonnade from the east, after the post-fire construction. Note that the column capitals have not yet been carved.*

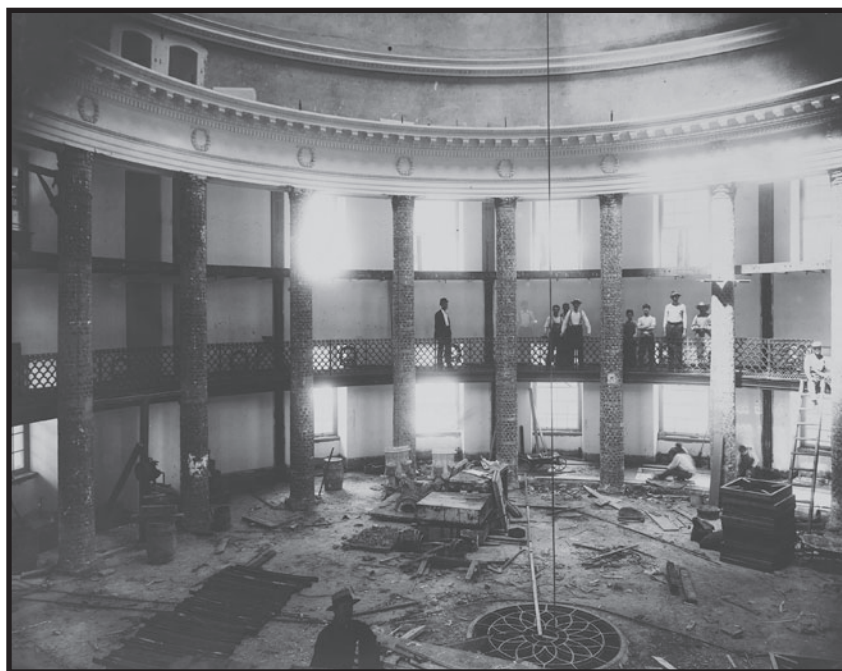
FIGURE 79. *Dome Room under construction.*

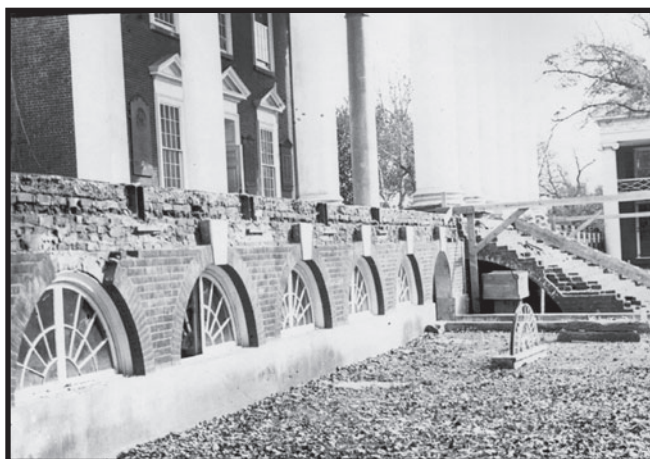
FIGURE 93. *Southwest wing and south stairs during the reconstruction of the portico steps.*

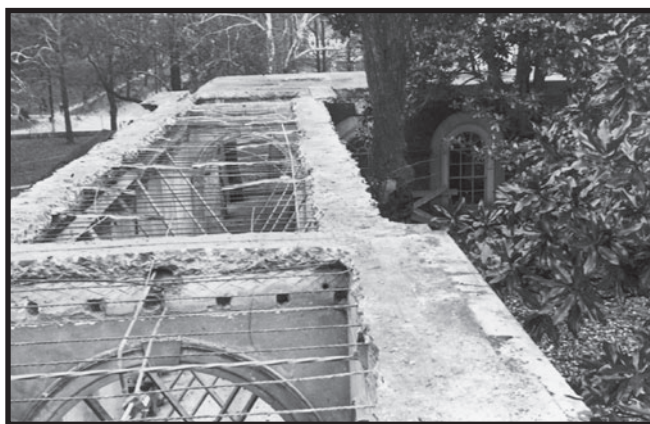
FIGURE 94. *Northwest and southwest wings and west colonnade looking north during the reconstruction of the terraces, 1939.*

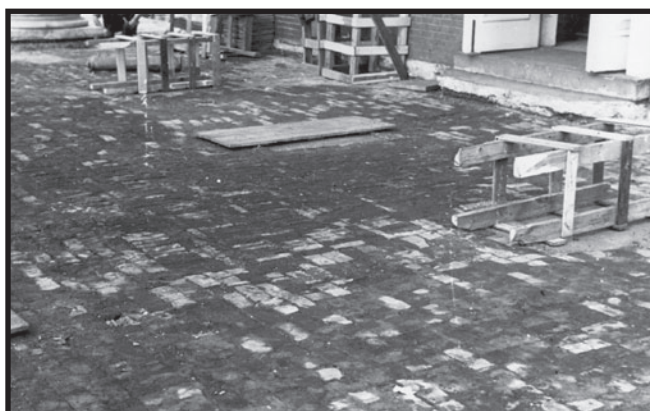
FIGURE 95. *The south portico floor during construction, 1939.*

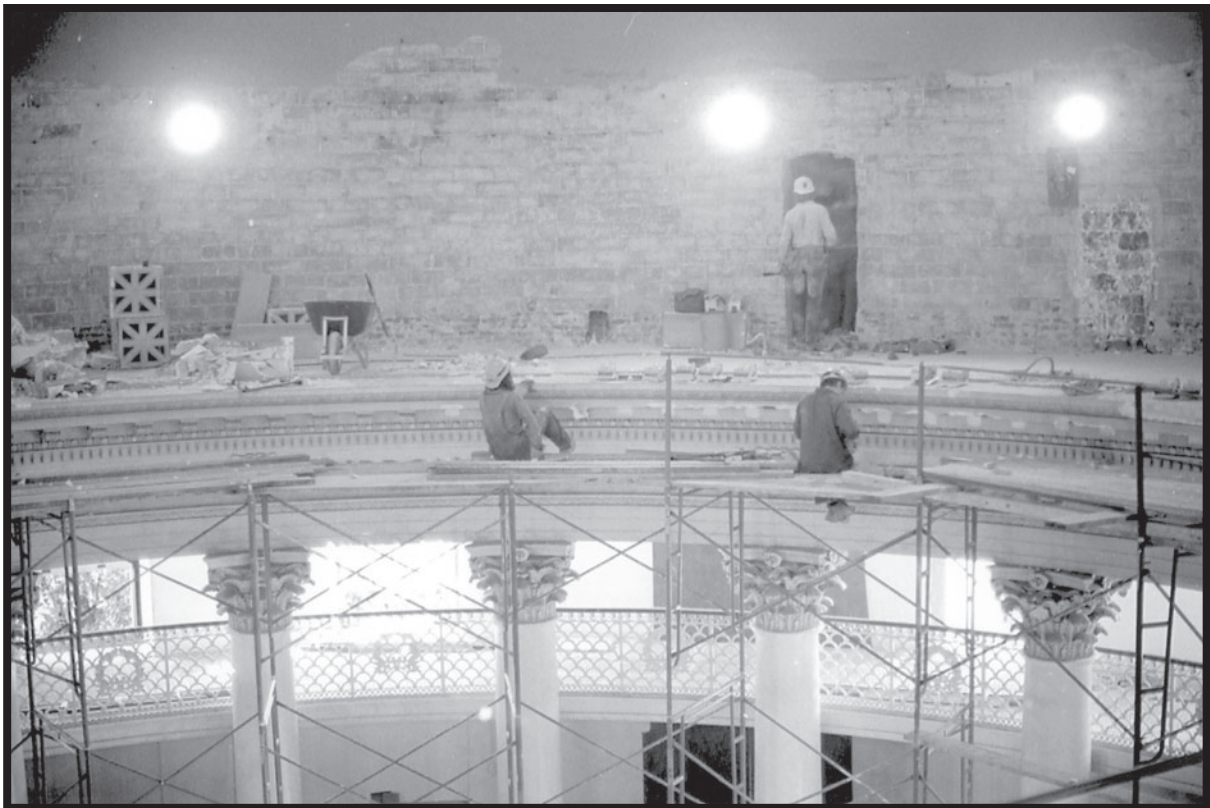
FIGURE 107. *The interior of the Rotunda during demolition, 1974. The brick that was laid up against the original outer wall in 1898 to support the Guastavino tile dome conceals any pre-fire evidence that might remain on the walls.*

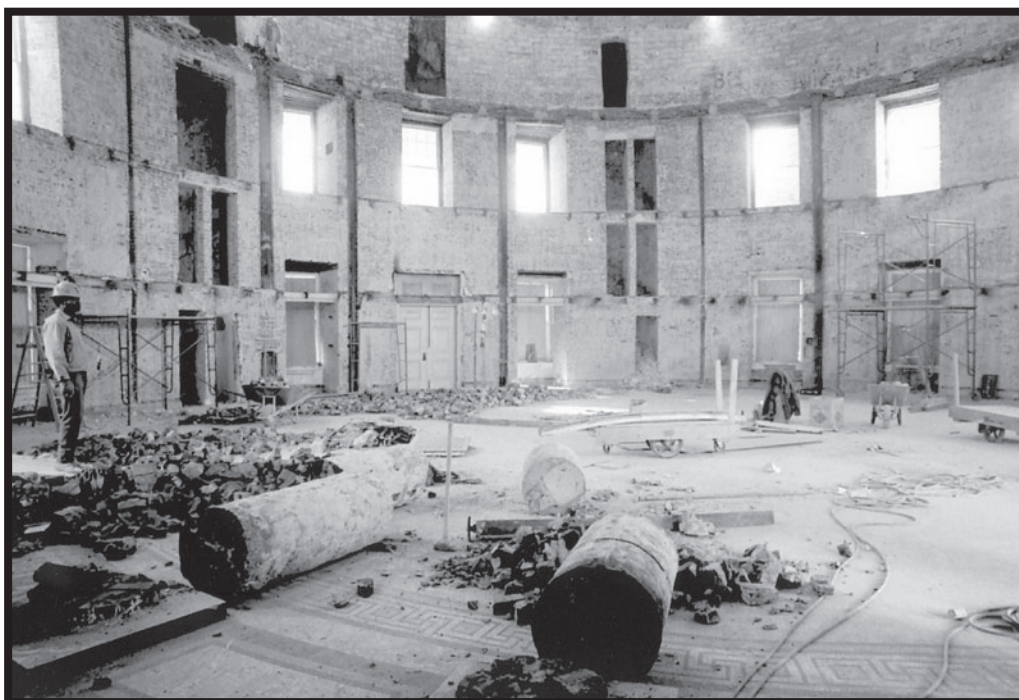
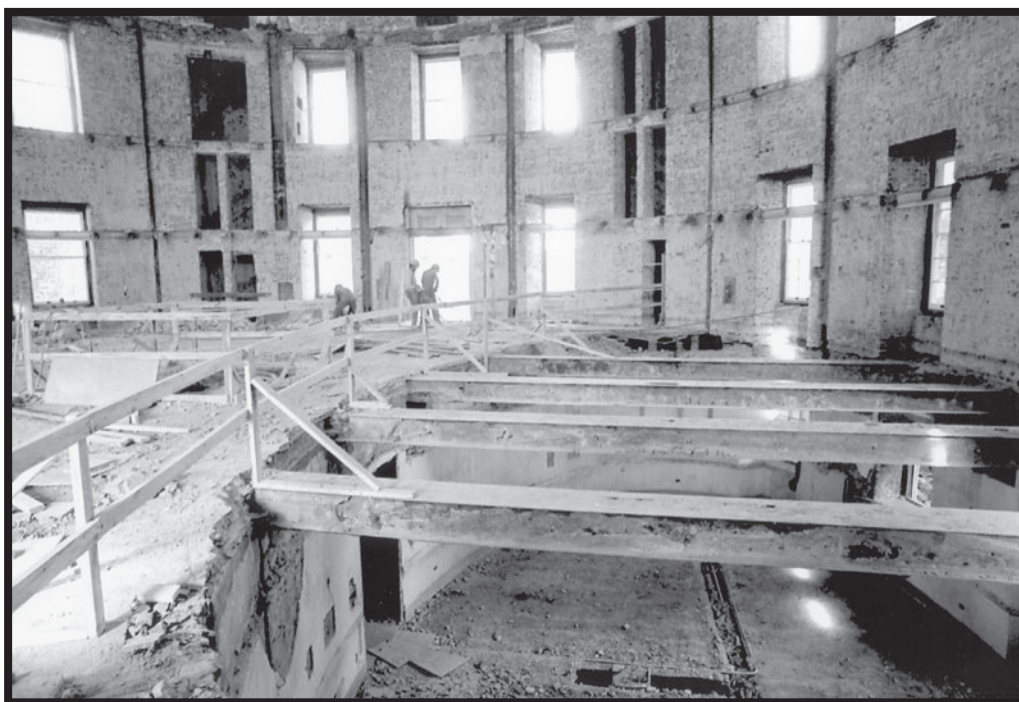
FIGURE 108. *The interior during demolition, 1974.*

FIGURE 109. *Demolition of the floor on the main level, January 14, 1974.*

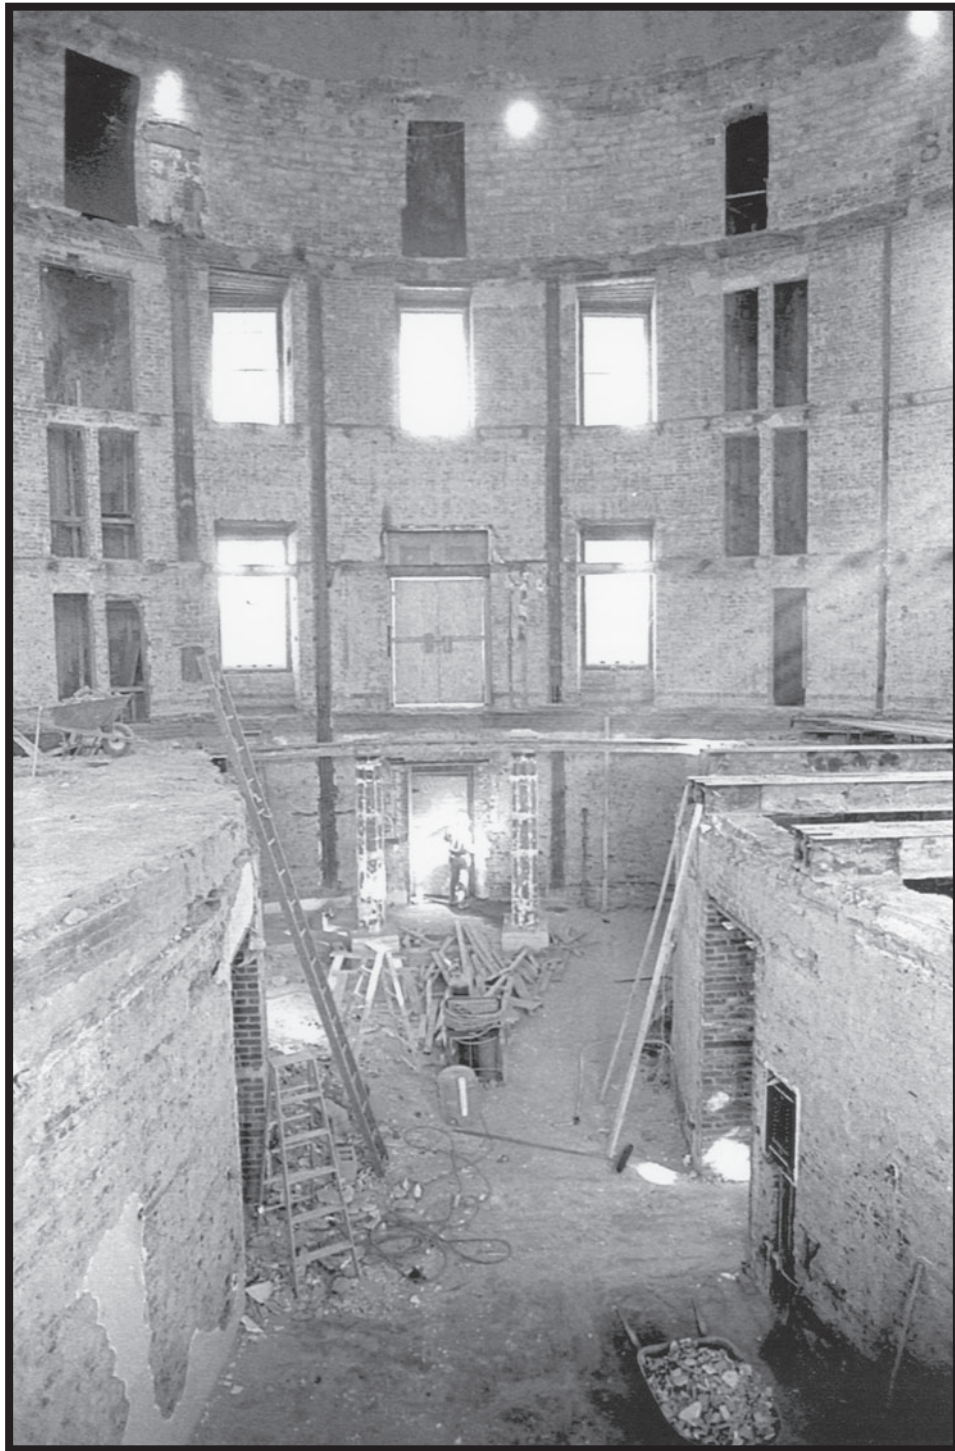
FIGURE 111. *The interior during demolition, January 30, 1974. The ground-floor walls to the right and left survive from the original construction.*

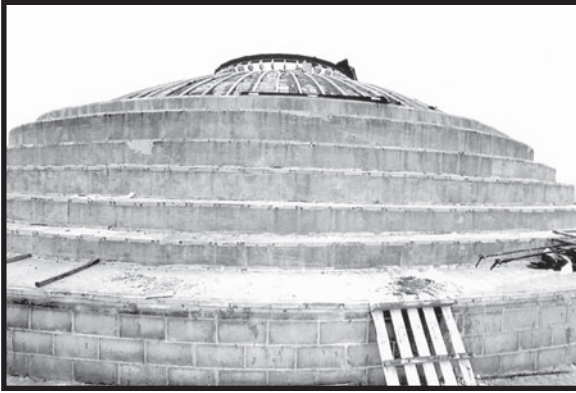
FIGURE 112. *The dome during the reconstruction of the skylight, November 18, 1974.*

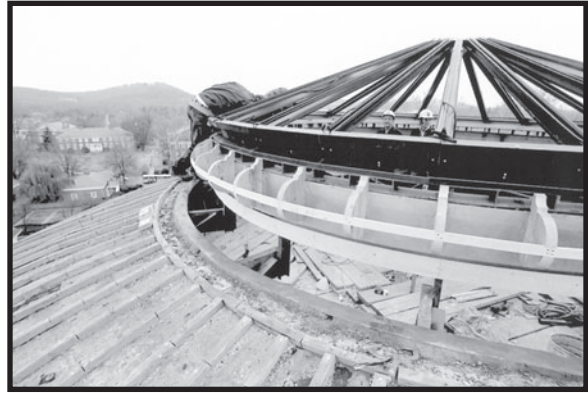
FIGURE 113. *The new extruded-aluminum skylight frame during the reconstruction, November 18, 1974.*

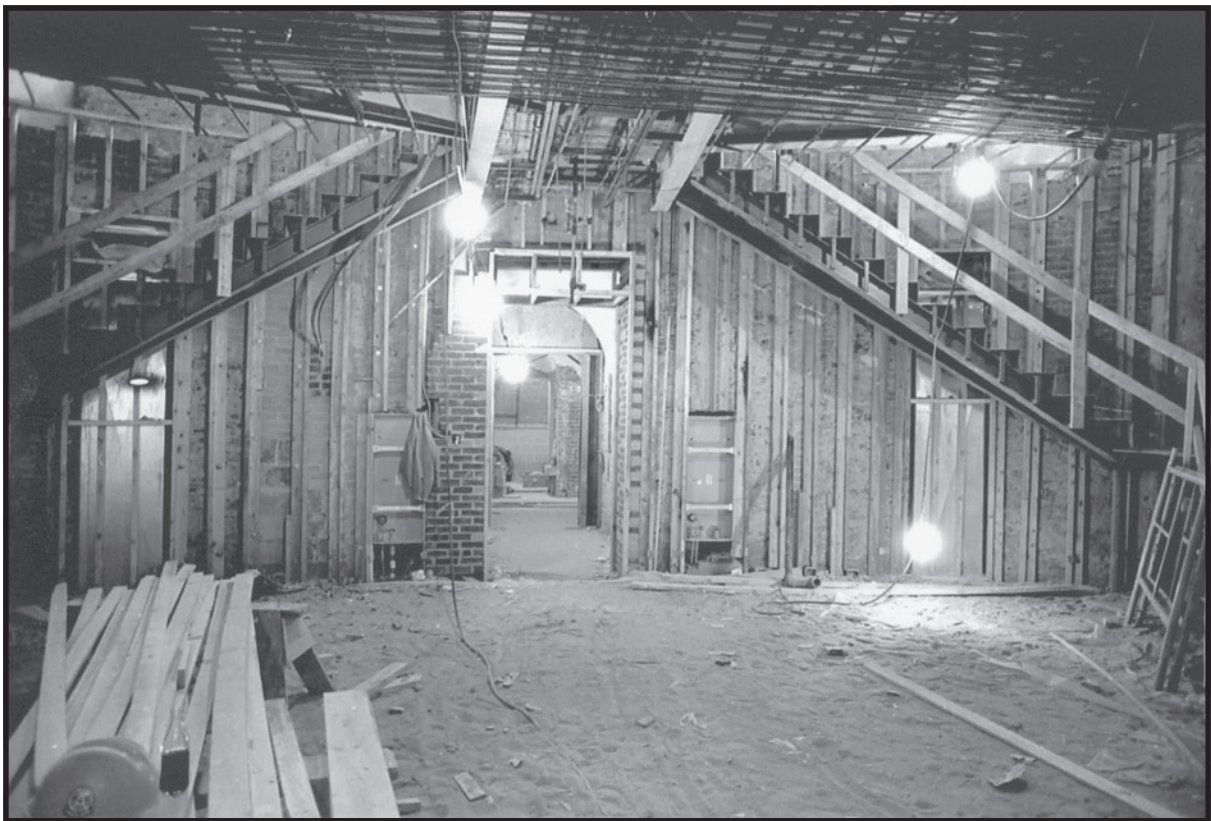
FIGURE 114. *Construction of the ground floor looking south, May 8, 1975. The steel for the new stairs is in place.*

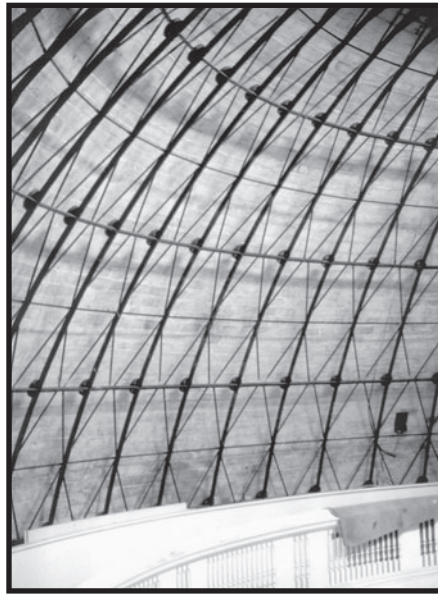
FIGURE 115. *Framework for the acoustical ceiling in the Dome Room, October 10, 1975.*

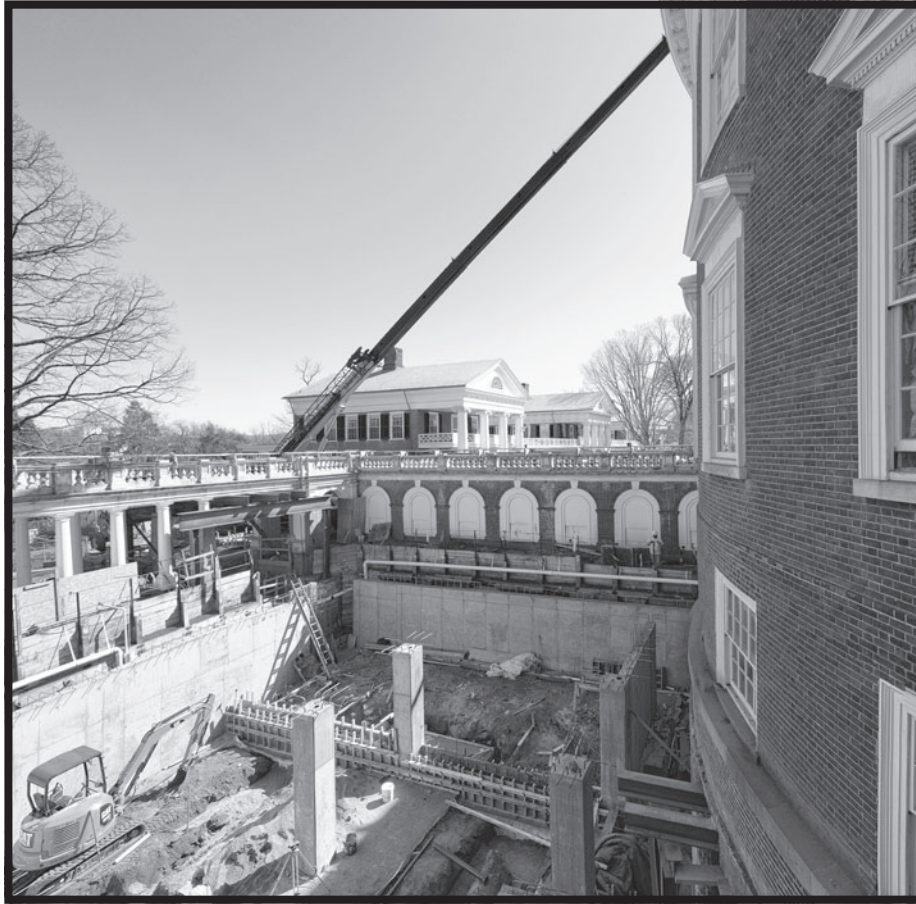
FIGURE 118. *Excavation of the east courtyard for the new underground vault, 2015.*

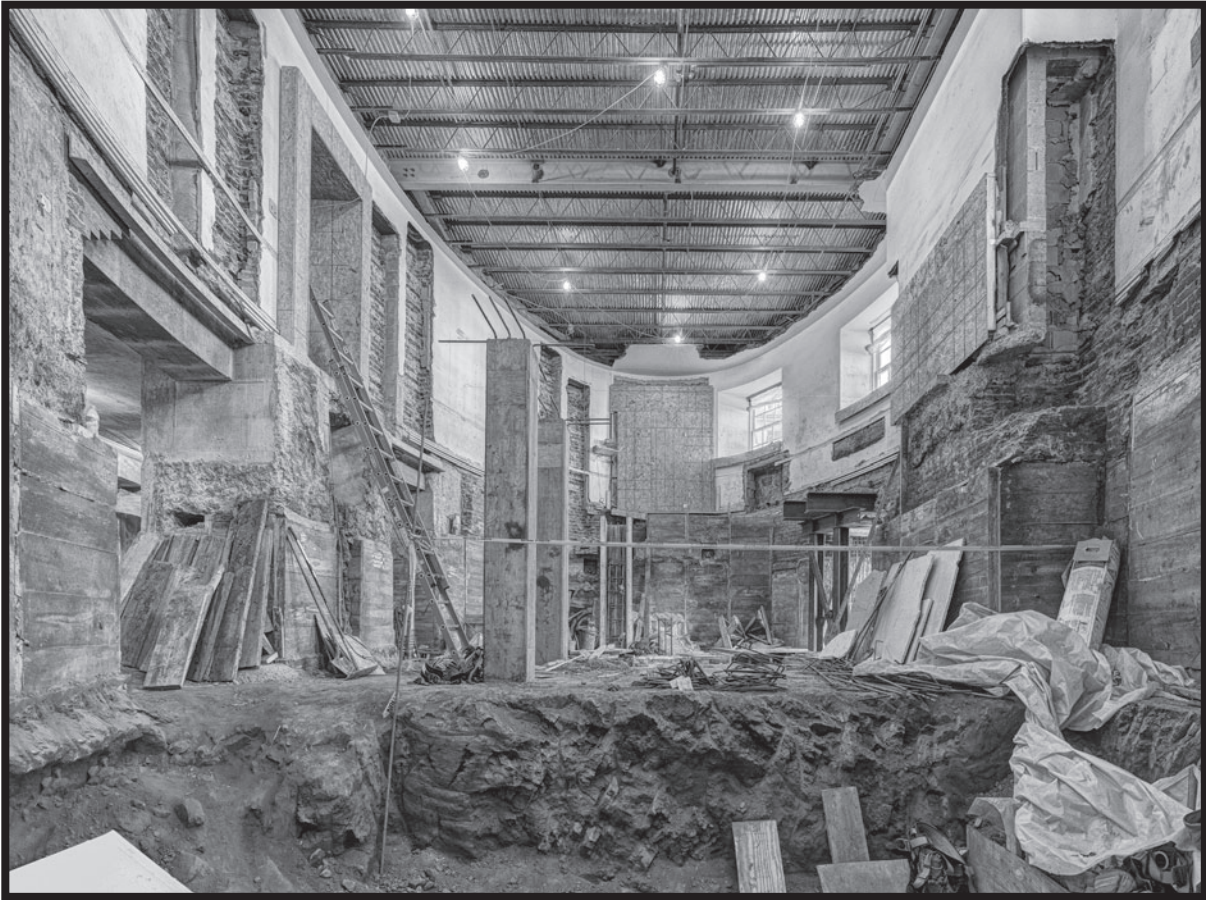
FIGURE 120. *Construction of the vault below the ground-floor east oval room, 2015.*

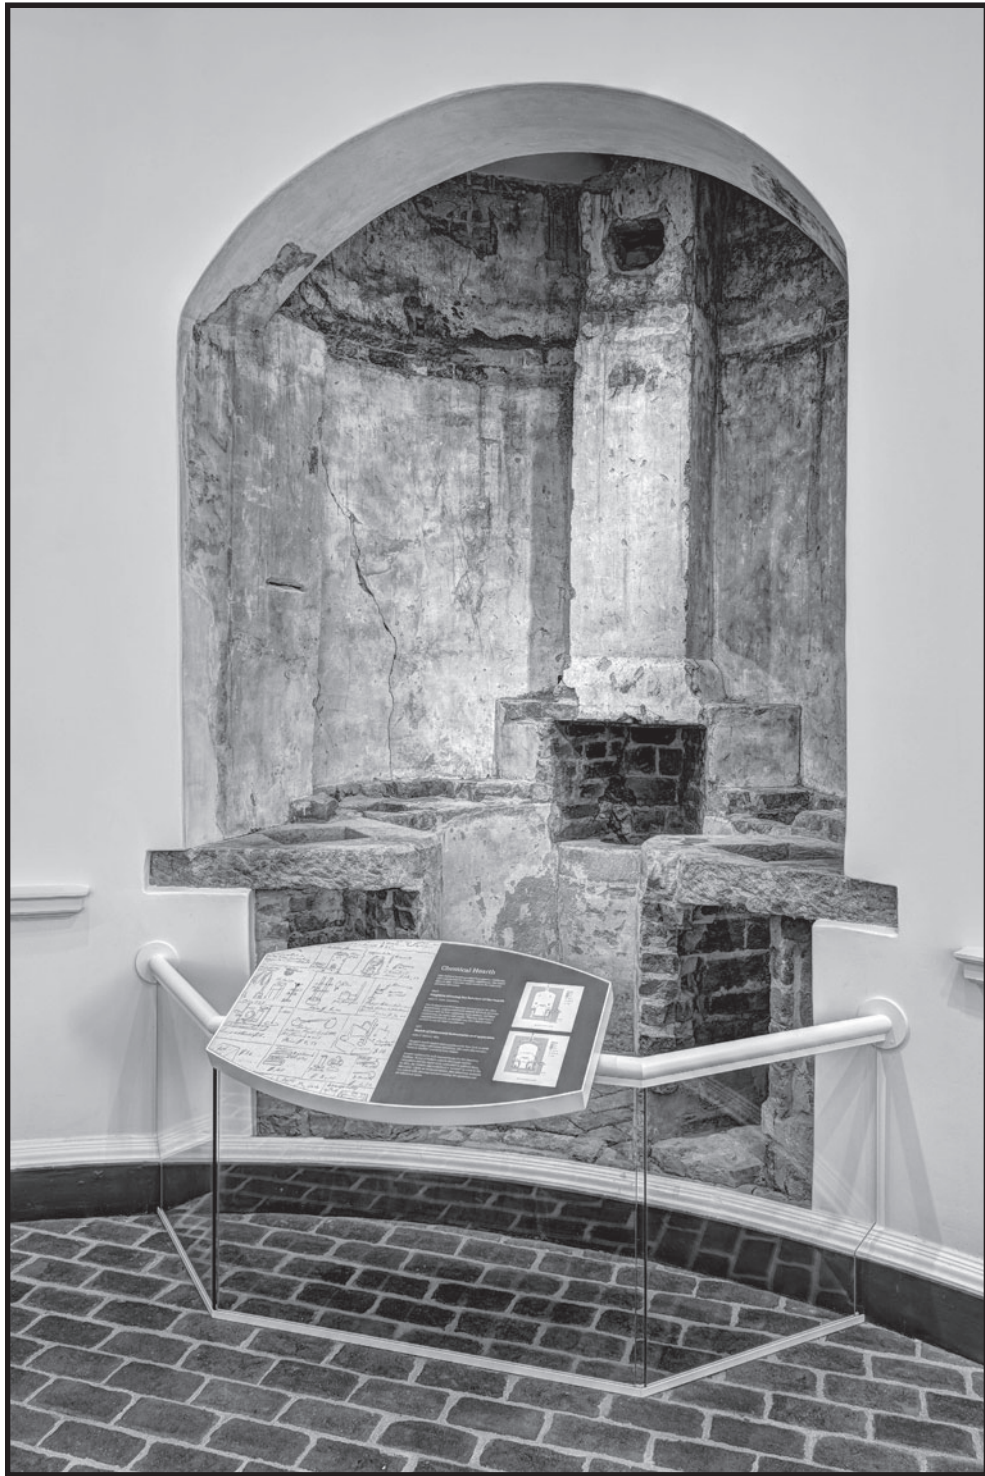
FIGURE 123. *Chemical hearth in the lower east oval room.*

Over the course of the next few weeks, a series of probes was undertaken by University masons to partially open up the niche for examination and documentation. A separate historic structure report for the chemical hearth was commissioned by the University and completed by John G. Waite Associates, Architects in January 2017.<sup>65</sup>

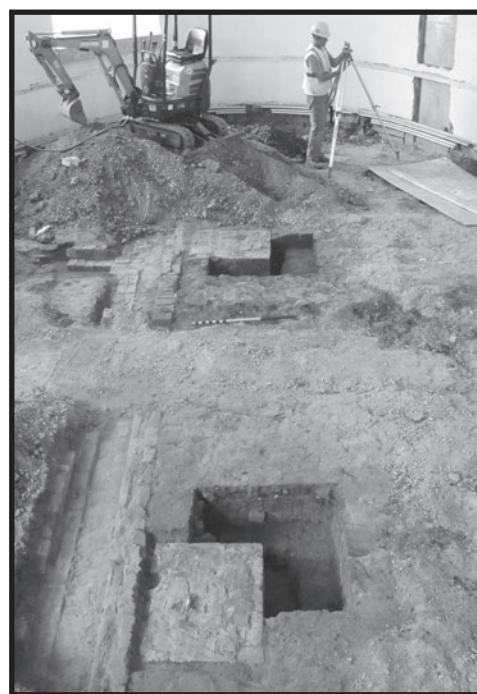
FIGURE 139. Lower east oval room, looking south, showing centrally located brick piers (top and bottom), adjacent excavation units, and remnant McKim, Mead and White brick conduit (left of piers).

Previously undocumented architectural features were identified in the lower east and west oval rooms. In both rooms, two truncated brick piers set on 16-foot centers, each measuring approximately 2.8 feet square, were identified in line with the central axis of each space. Each of the brick piers possessed remnants of soft lime-based mortar and ghost outlines of at least one additional course of brick above their top surface, suggesting that they once extended to a greater height. Archaeological excavation adjacent to the brick piers identified a narrow builder's trench for each pier. Other than brick and mortar fragments, no diagnostic material culture was recovered from the trench fill. The alignment of the brick piers with the central north-south axis of both oval rooms suggests that they served a structural purpose, most likely as foundations for posts, which, in turn, likely supported a central beam in the ceiling. Their association with a soft lime-based mortar suggests a construction date prior to the 1895 fire.

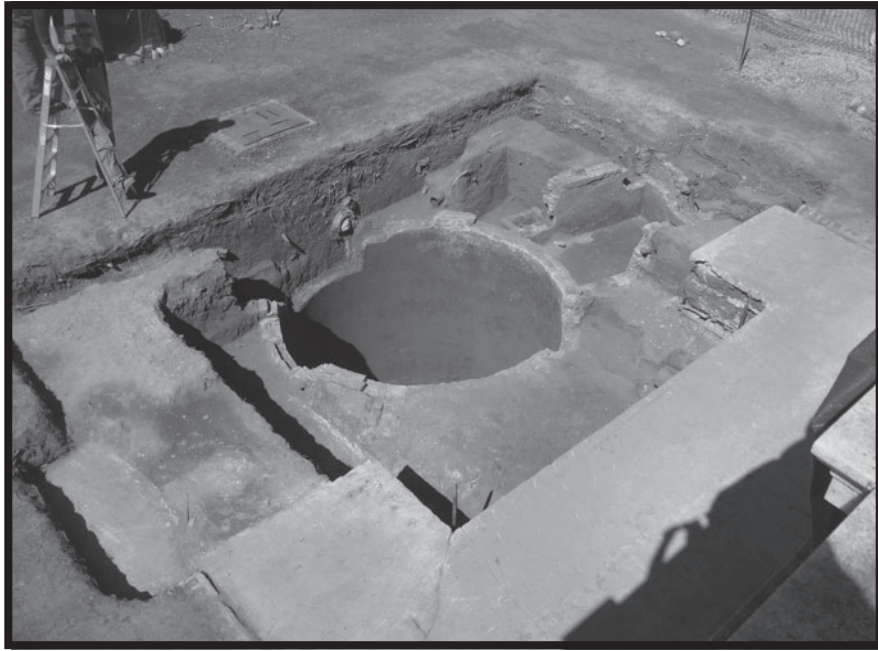
FIGURE 142. *Fully excavated cylindrical brick cistern and northern tank and valve box in east courtyard.*

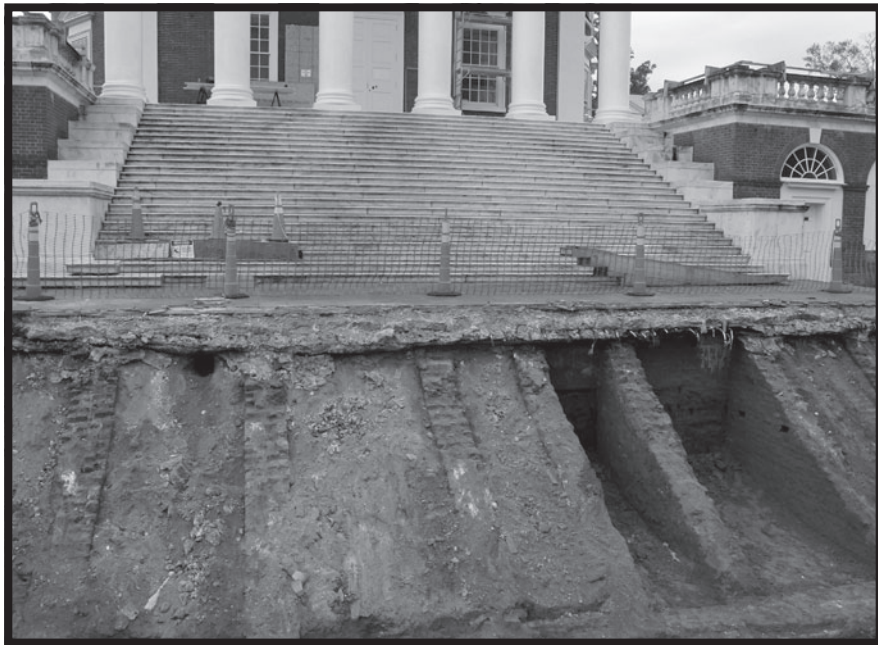
FIGURE 143. *The north facade of the Rotunda, the north steps to Rotunda, and the supporting brick buttresses (foreground).*

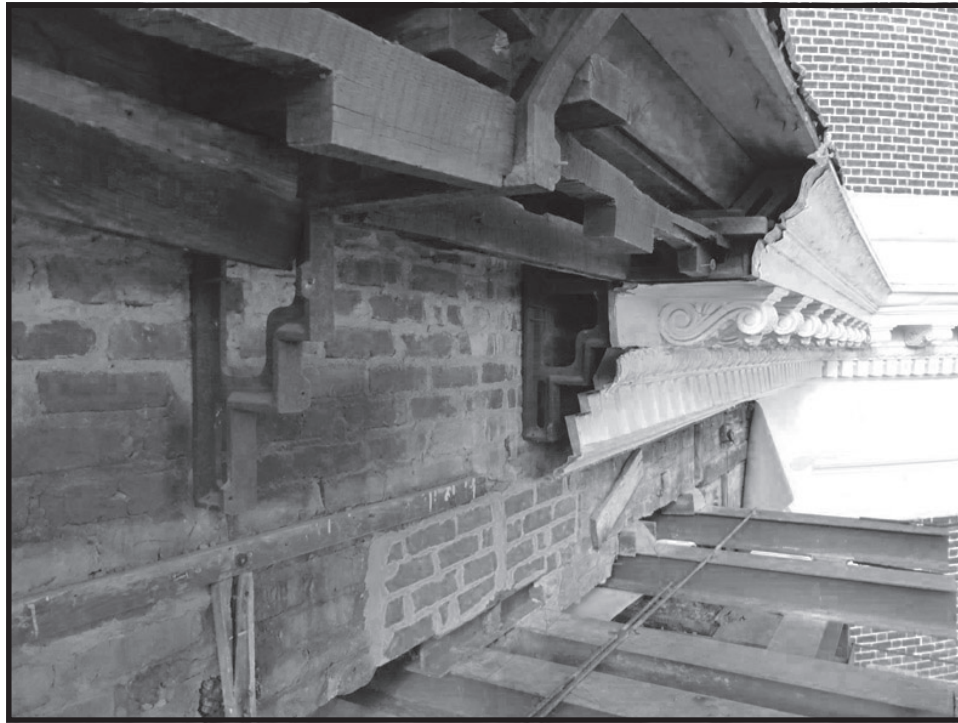
FIGURE 174. *Intermediate cornice and support system revealed during restoration.*
