# THE ROTUNDA

H I S T O R I C   S T R U C T U R E   R E P O R T  
S E C O N D   E D I T I O N

JOHN G. WAITE ASSOCIATES, ARCHITECTS

So much information was uncovered during the restoration that the University asked John G. Waite Associates, Architects to update the 2008 historic structure report. This second edition includes new information on the structural analysis, mechanical systems, and archaeological findings. The architectural description and measured drawings were updated to reflect current conditions. Research conducted on the historic heating systems, the water supply, and the portico column capitals is now incorporated into the history, as is a summary of the restoration. The discovery of the chemical hearth in the lower east oval room during the work led to a separate historic structure report; a summary of its history and its discovery have been added to this edition. Besides John G. Waite Associates, Architects, the team for this work included:

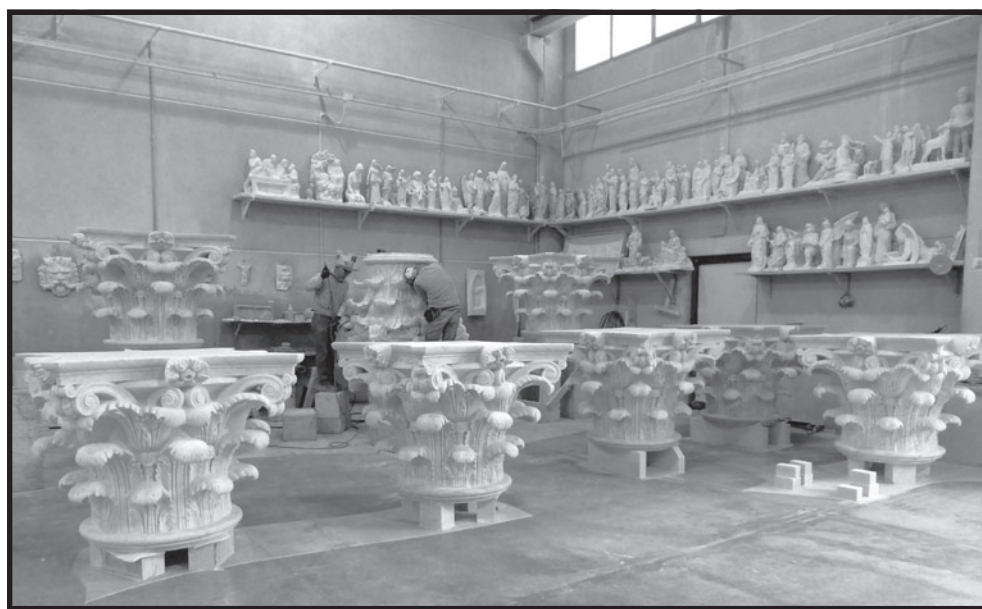
FIGURE 176. *New column capitals in Italian workshop.*

By 2000 the deterioration of the 1896 capitals necessitated their replacement. For the 2016 restoration, new capitals, each weighing 7,000 pounds, were carved in Carrara, Italy, of the same marble specified by Jefferson to match the design and craftsmanship of Jefferson's originals. Fragments of the originals and pre-fire photographs were analyzed using computer enhancement to authenticate the design of the new capitals.

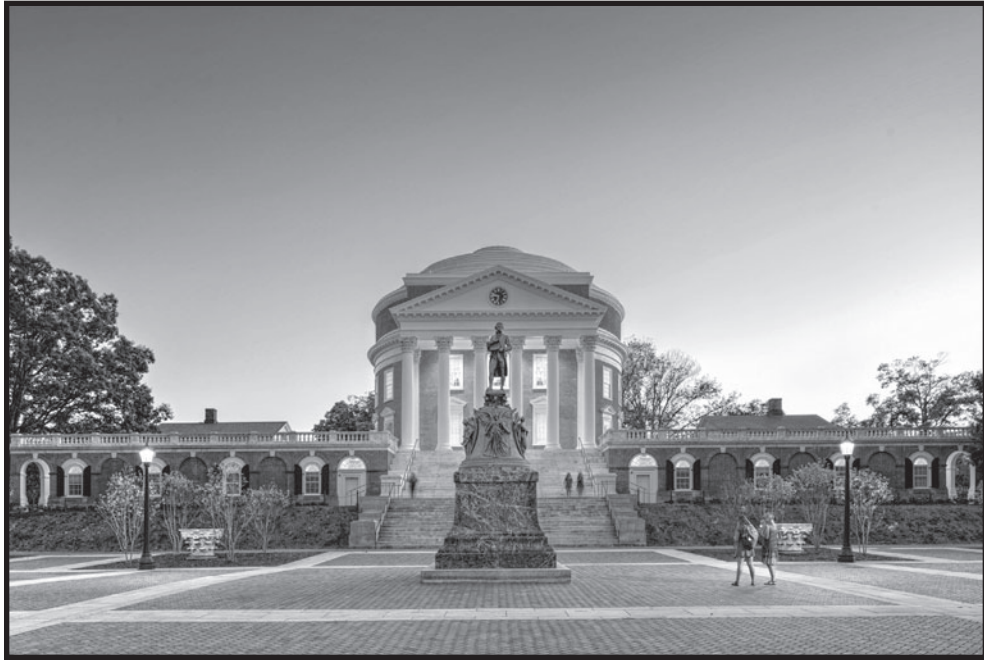
FIGURE 177. *North elevation.*

The north elevation generally duplicates the conditions of the south elevation. To the east of the doorway three vertically-placed bronze plaques mounted to the brick wall memorialize soldiers from the University who died in World War II, Korea, Vietnam, and Iraq.

At some date during or after the original construction, three window openings were placed in the wall surface above the doorway. Neither Jefferson’s nor Neilson’s floor plans show window openings in this location, and no evidence was found of openings during the recent restoration work. Post-fire photographs show that the existing elements are attached to the brick surface at each opening by three evenly spaced vertical wood nailing strips, the same condition seen on the other facade and on the Mills Annex.

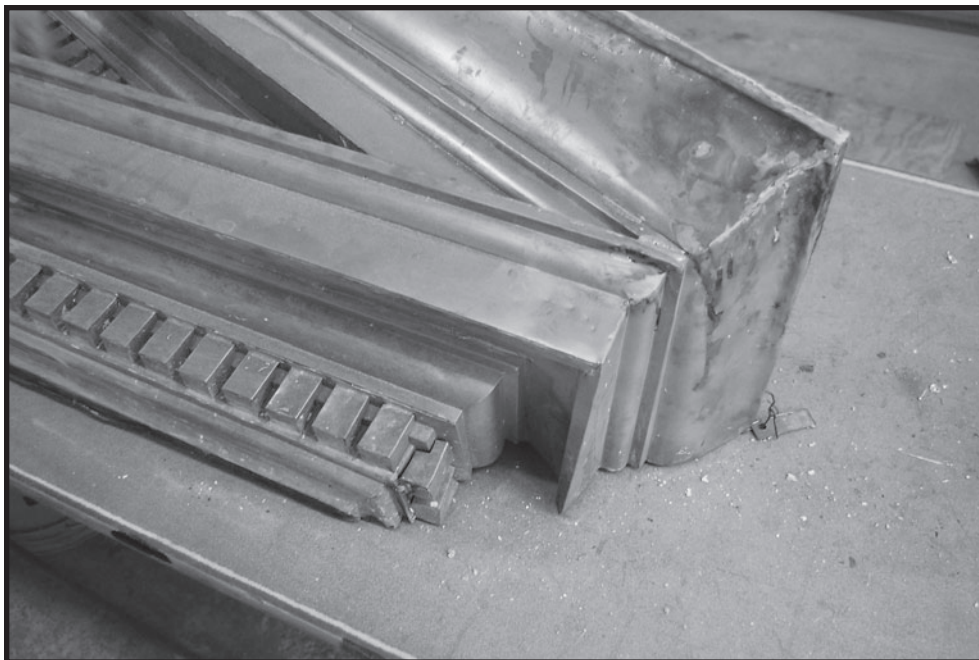
FIGURE 180. *Copper pediment from ground-floor window during restoration.*

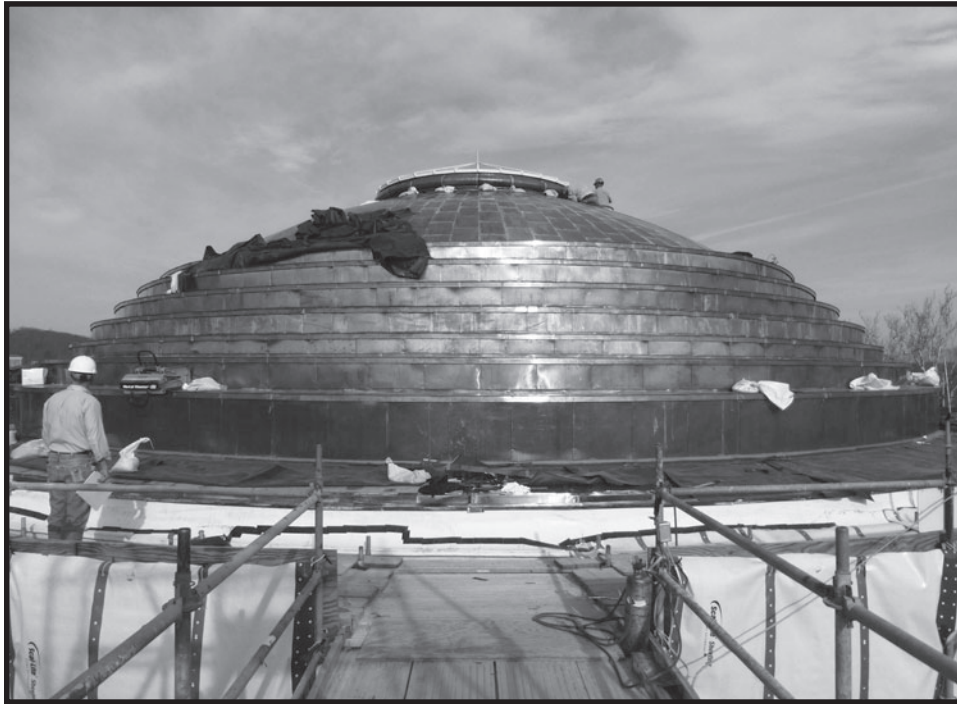
FIGURE 181. *The roof under construction, 2013.*

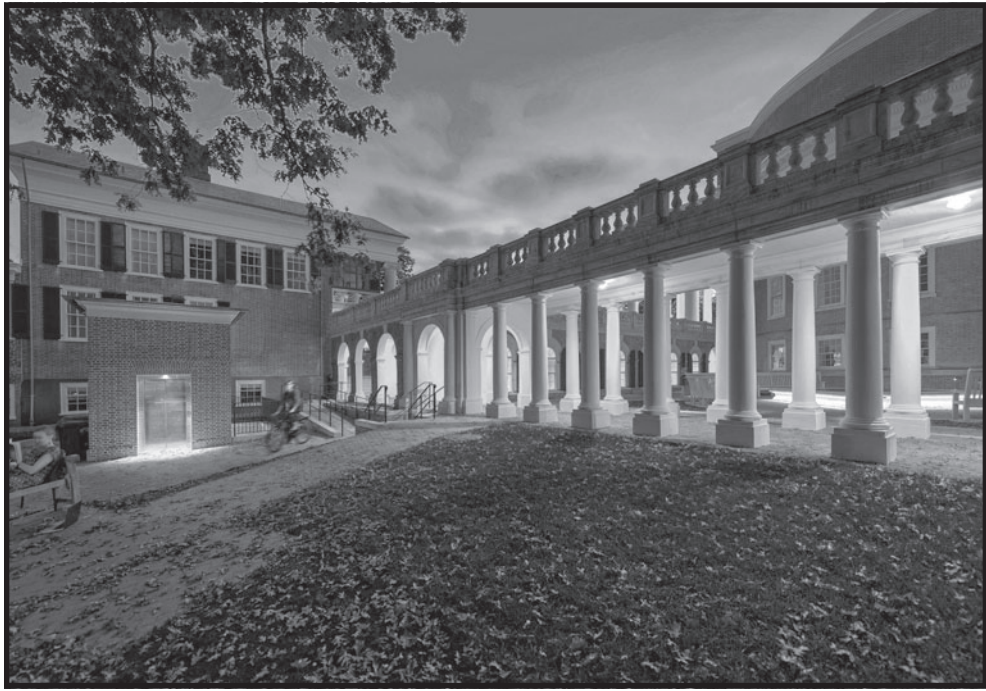
FIGURE 187. *The east colonnade and new elevator to the vault.*

In the 2016 restoration, an elevator and a stair with access to the new vault were constructed to the east of the Rotunda. The concrete stair wraps around the south and east sides of the central brick elevator structure, descending within a brick-lined retaining wall. The elevator structure is built of brick, laid in Flemish bond, with a four-course-high base at the ground level. At the top, a painted wood frieze and entablature extend up to a shallow pyramidal roof covered in flat-seam metal.

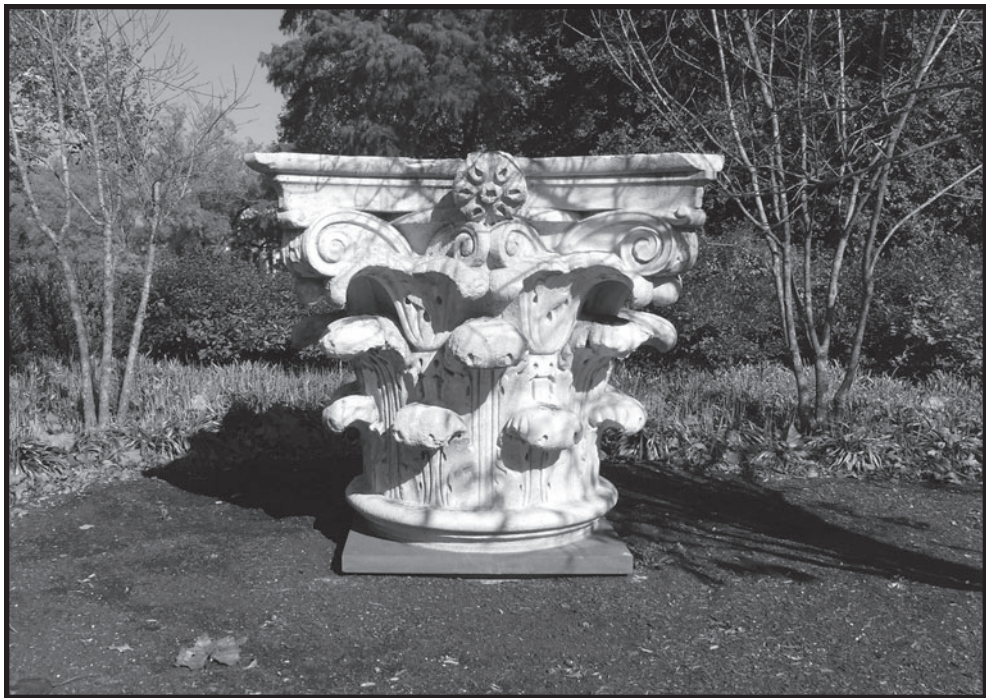
FIGURE 192. *One of the 1896 marble capitals now placed on the north terrace.*

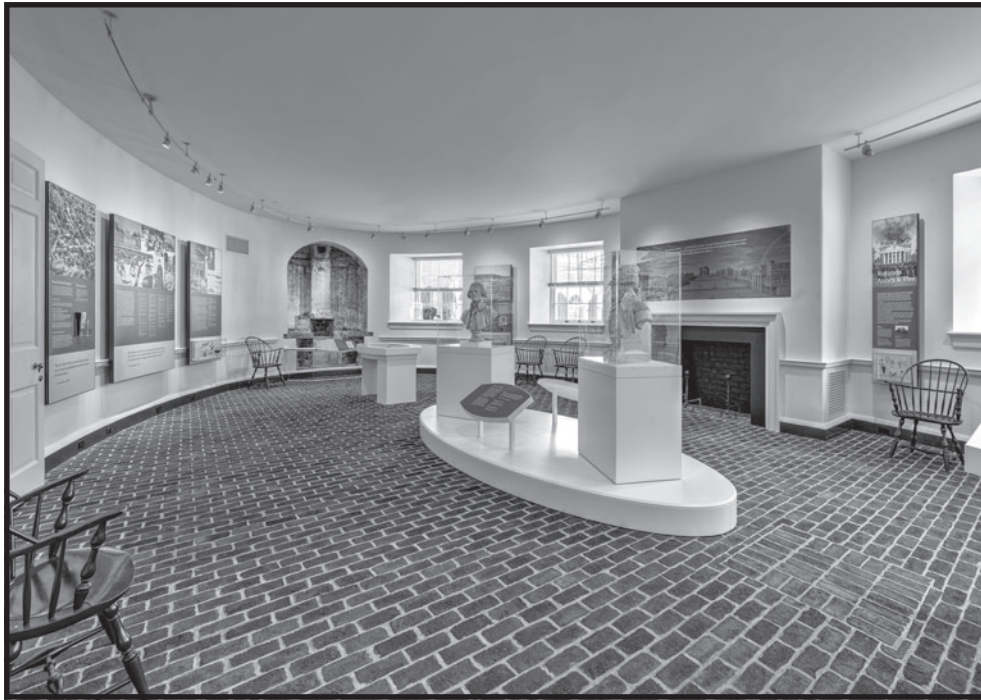
FIGURE 195. *Lower east oval room (103), looking north.*

The 2016 restoration uncovered Emmet's chemical hearth that occupies a semicircular niche at the north end of the east oval room. Two shallow piers support a shallow brick arch at the opening. The ceiling of the niche is a flat surface constructed of red Guastavino tile, and the floor of the niche is loose clay brick laid in a herringbone pattern set on a sand bed. The hearth floor, approximately 7¾" above the current floor level of the east oval room, may represent the historic floor level of the room. Projecting from the walls of the niche are five distinct work stations constructed of brick with a thin plaster finish. At the outermost and center stations, stone slab work surfaces sit atop brick fireboxes. The intermediate stations have exposed brick work surfaces above plastered brick chambers. A brick chamber with a corbelled brick hood rises above the center station. See the Chemical Hearth section of this report for a more thorough discussion.

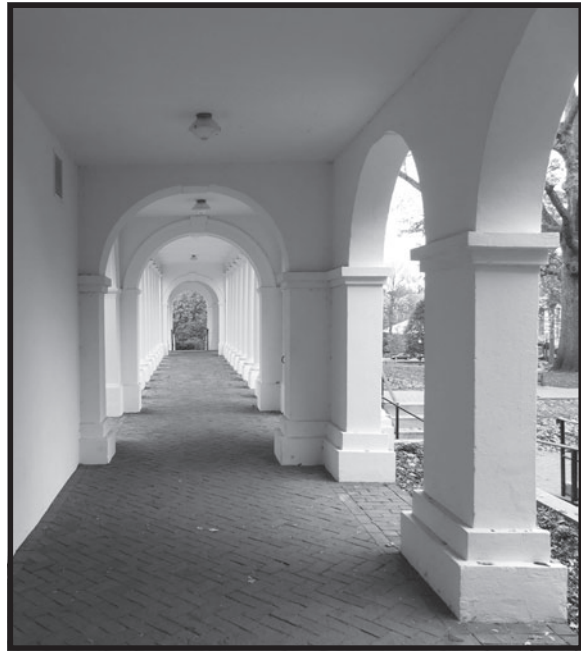
FIGURE 204. *Southeast wing, east exterior passage, looking north.*

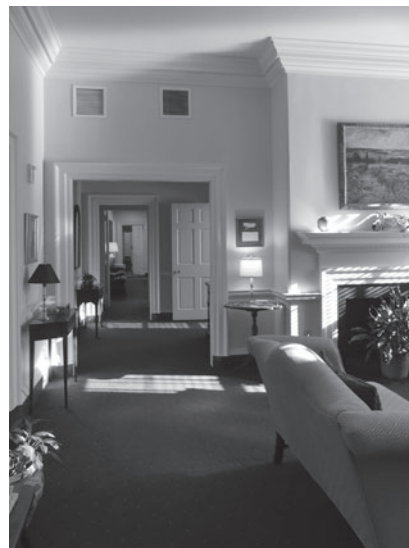
FIGURE 206. *Room 130 in the northwest wing, looking east.*

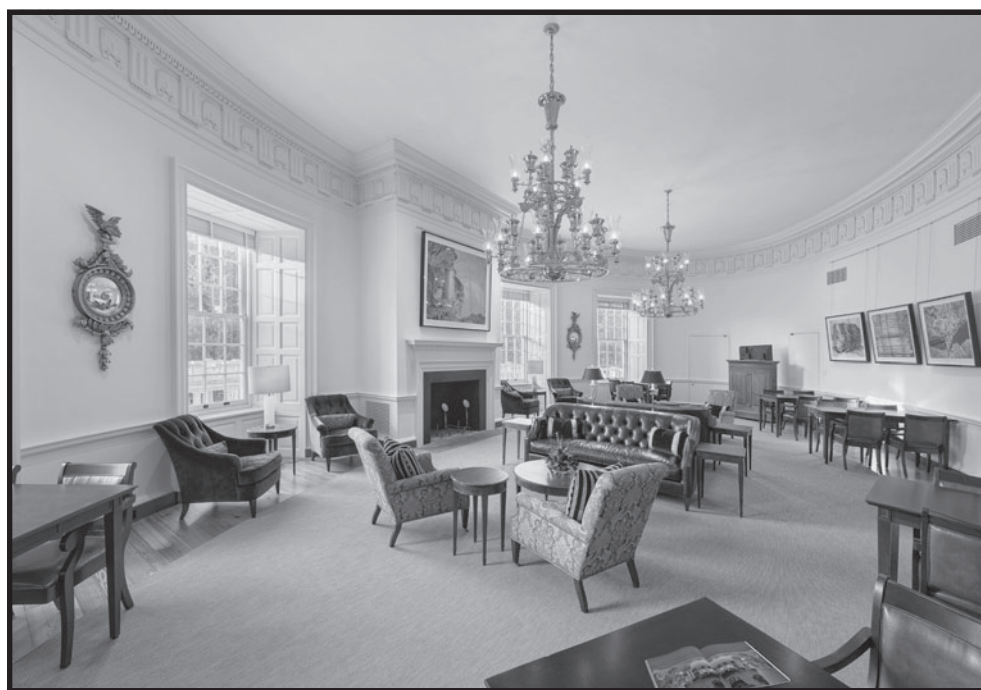
FIGURE 211. *Upper west oval room (201), looking north.*

*Fireplace:* A mid-1970s concrete-block chimney breast projects 3' 2 $\frac{3}{4}$ " from the west wall. The brick-lined firebox is painted black, as is the plain plaster surround. The surround is bordered by a 7 $\frac{1}{4}$ " wide two-fascia architrave. Above the architrave a plain frieze extends up to a denticulated crown molding, which supports the mantel shelf. While similar in style to the pavilion fireplace mantels, the profile and moldings are slightly different in this mantel reconstruction. The firebox and hearth are paved with brick.

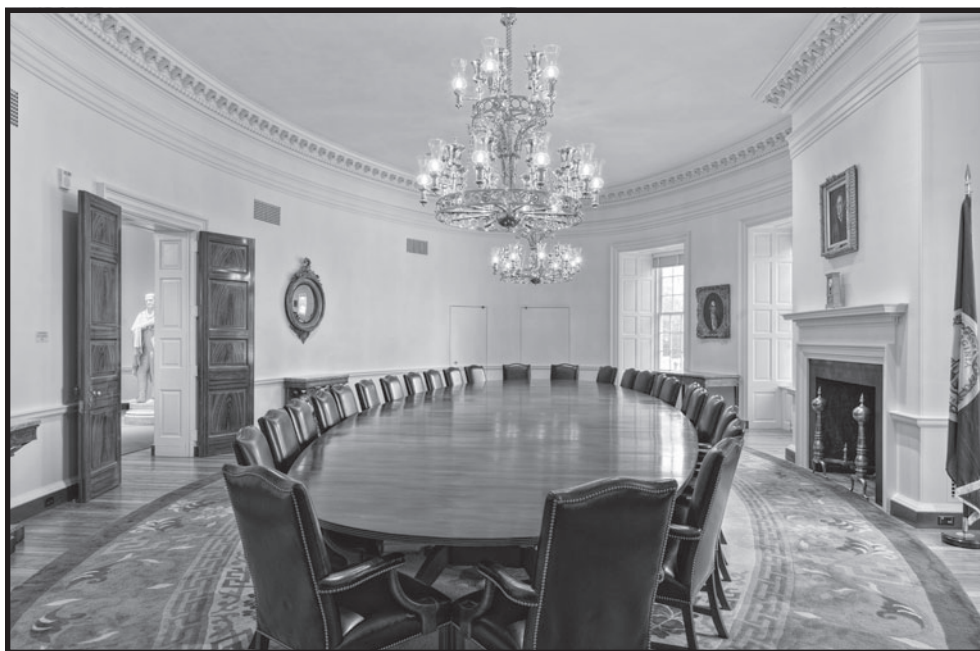
FIGURE 212. *Upper east oval room (202), looking north.*

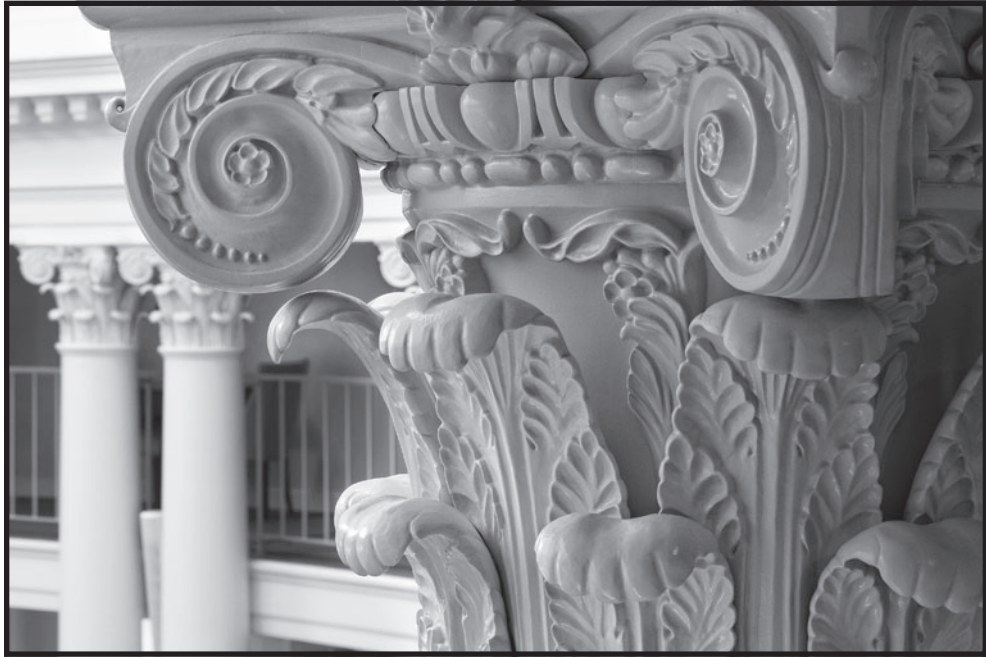
FIGURE 216. *Dome Room (301), column capitals.*

The original capitals, carved by Philip Sturtevant of white pine from Maine, were destroyed in the 1895 fire. The 1970s renovation installed plaster capitals that approximated the originals; these features were replaced in 2016 with new, more accurately detailed mahogany capitals. The design of the new capitals relied on the pre-fire photographs of the Dome Room and other examples of Sturtevant's work, as well as letters between Sturtevant and the University's proctor, Arthur S. Brockenbrough, which included details on Jefferson's specifications for the capitals.

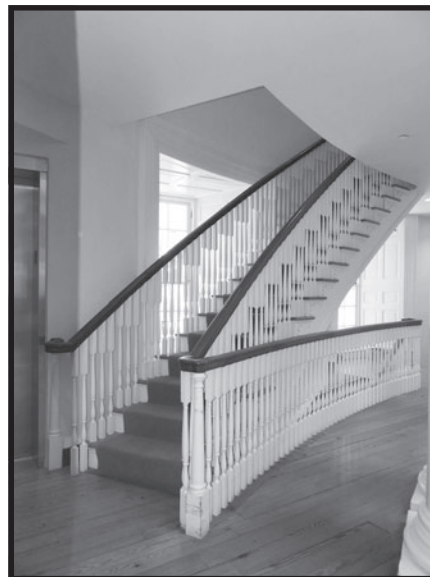
FIGURE 217. *Dome Room (301), new stair to middle gallery.*

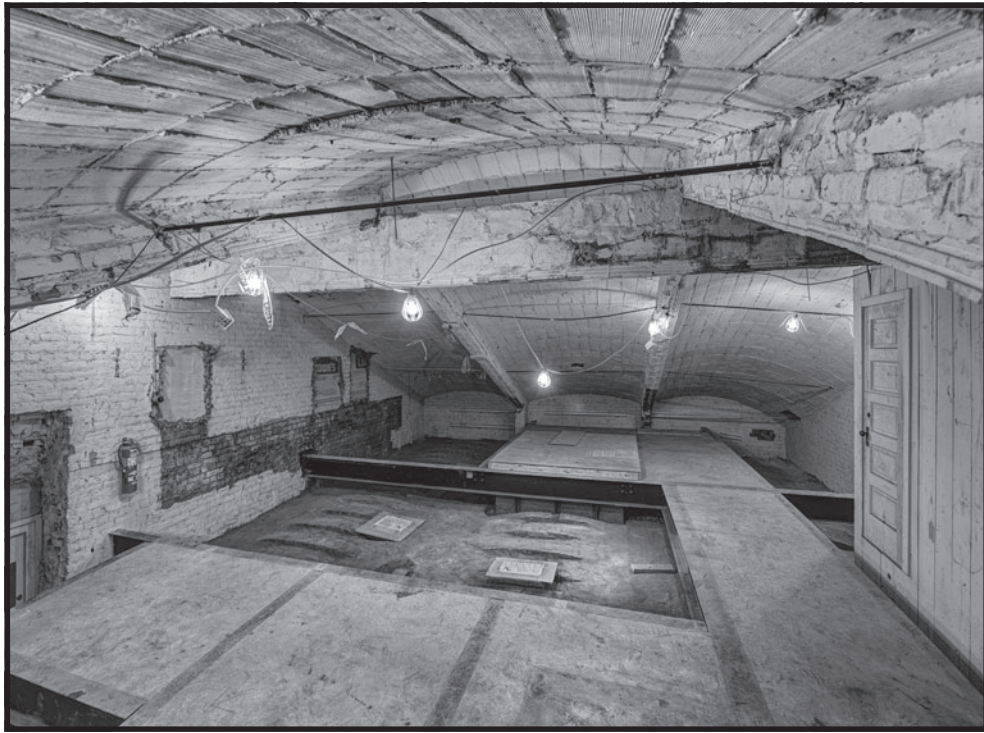
FIGURE 219. *South portico attic (M402) before installation of mechanical equipment.*

Against the south wall, the clock room is enclosed with vertical tongue-and-groove boards fastened to wood framing; according to the 1973 drawings, the north partition was moved 2' 3" to the south to provide room for the air-handling equipment.

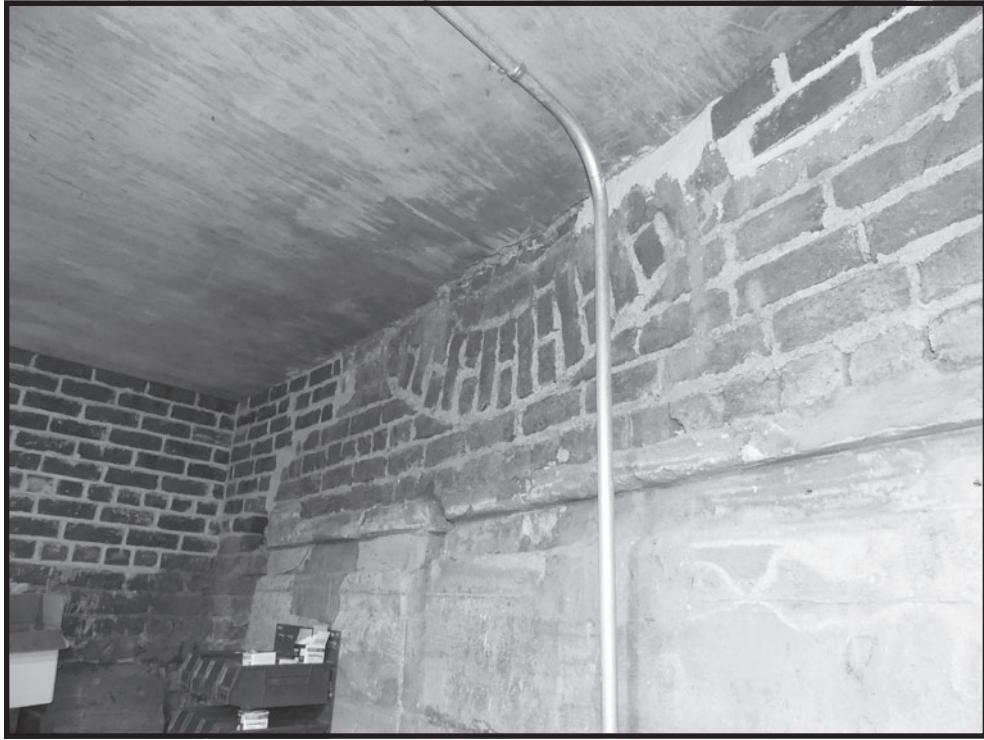
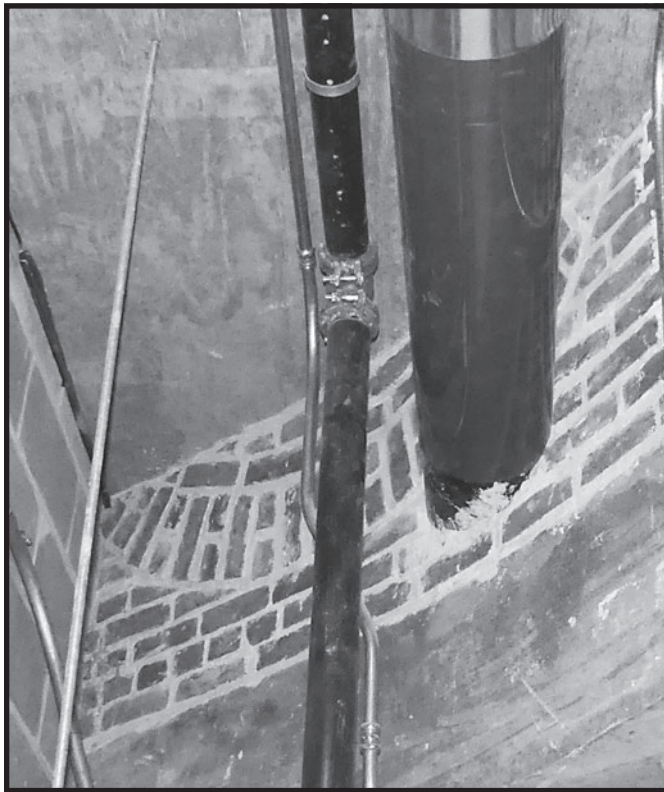
FIGURE 223. *Inverted arches in the original foundation, now revealed in corridor C003 and room M004.*

The excavation revealed the original brick foundation of the Rotunda. Two sections of the interior foundation walls are now visible in the west lobby (C003) and in one of the mechanical rooms (M004). The brick is laid in a combination of stretcher bond and common bond with thick mortar joints. Both sections include inverted brick arches, built of soldiers alternating with pairs of rowlock bricks.

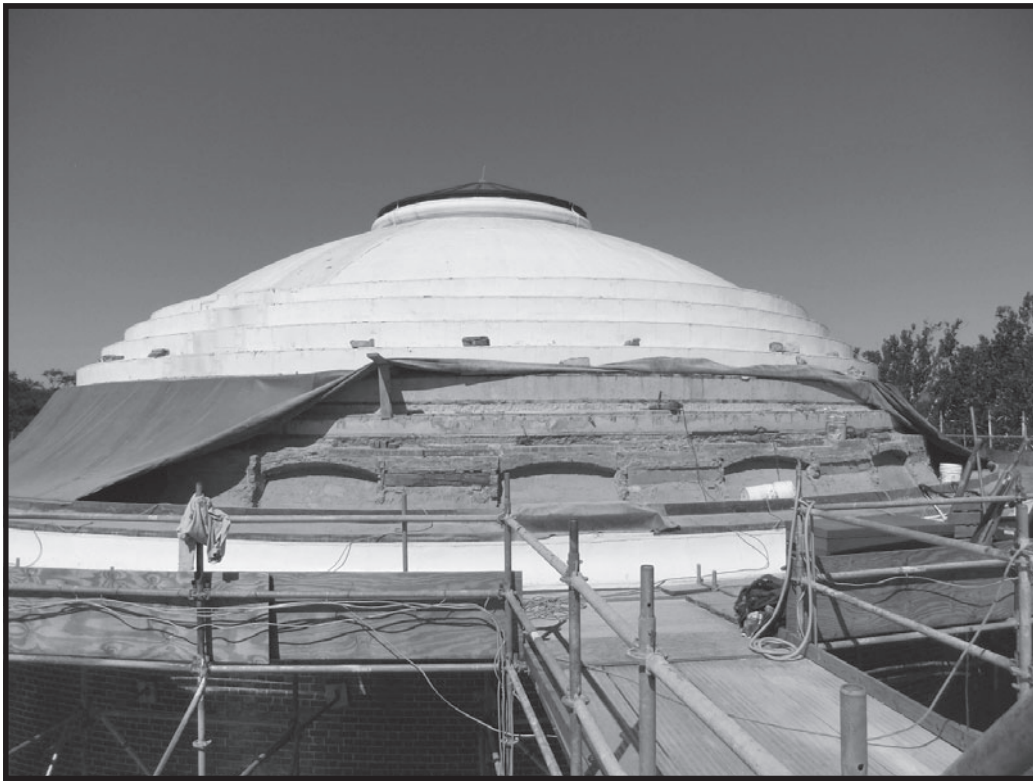
FIGURE 229. Removal of the lower step rings during the roof work uncovered a series of perimeter arches and piers.

The construction phase of the roof replacement uncovered some previously unknown aspects of the McKim, Mead and White construction. When the lower step rings were removed, a series of perimeter arches and piers was revealed. This

discovery paralleled the finding of glass inserts in the lowest step ring, which indicated that at some point a series of perimeter skylights was considered. The arches were infilled with tile. Like the drum of the Pantheon, these arches are in effect like relieving arches and will still likely have some residual stiffness that would tend to direct load to the piers.

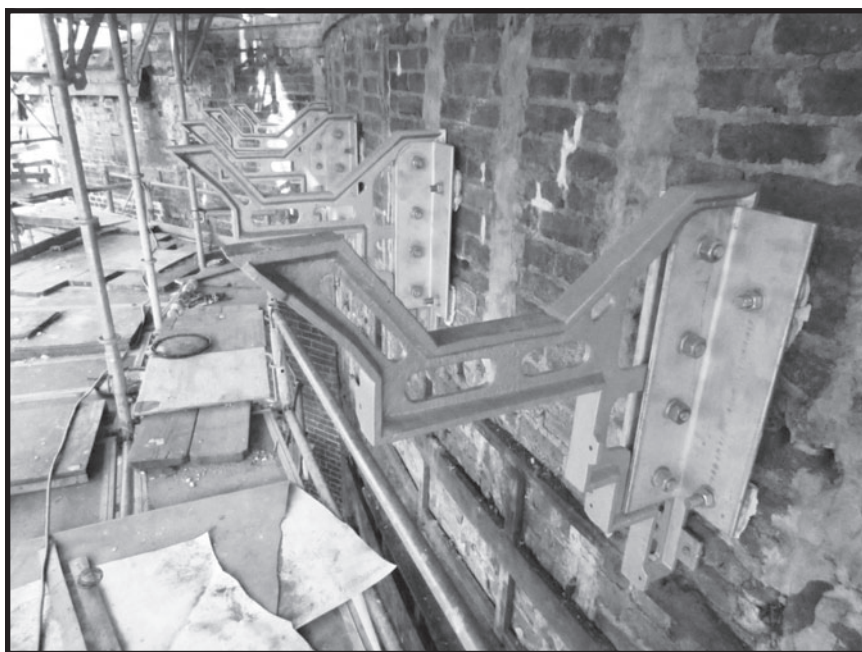
FIGURE 230. *Reinstallation of the exterior cornice brackets. The McKim, Mead and White brackets were cleaned and recoated, and new angles were added to provide additional support.*

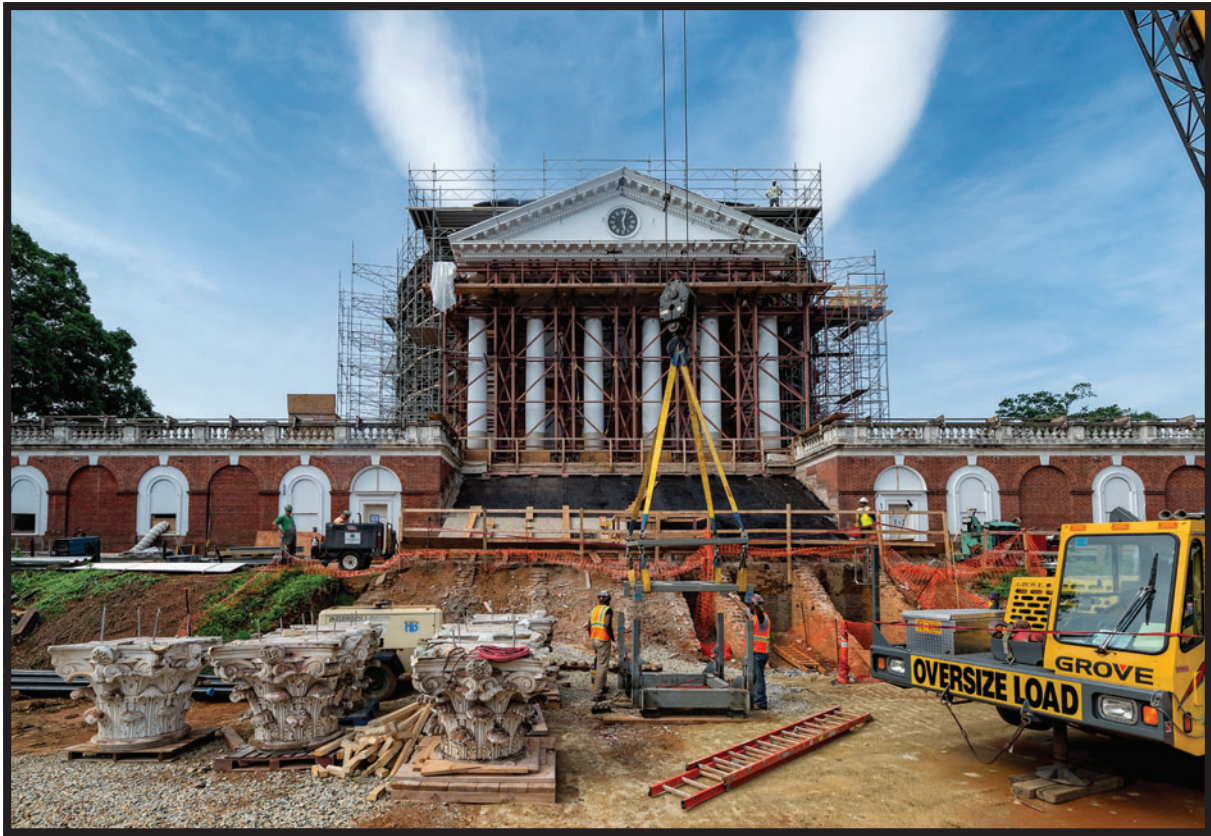
*The Rotunda under construction, June 2016. In this view from the north, the 1890s capitals have been removed and sit in the foreground. Note the exposed buttresses beneath the north stairs.*

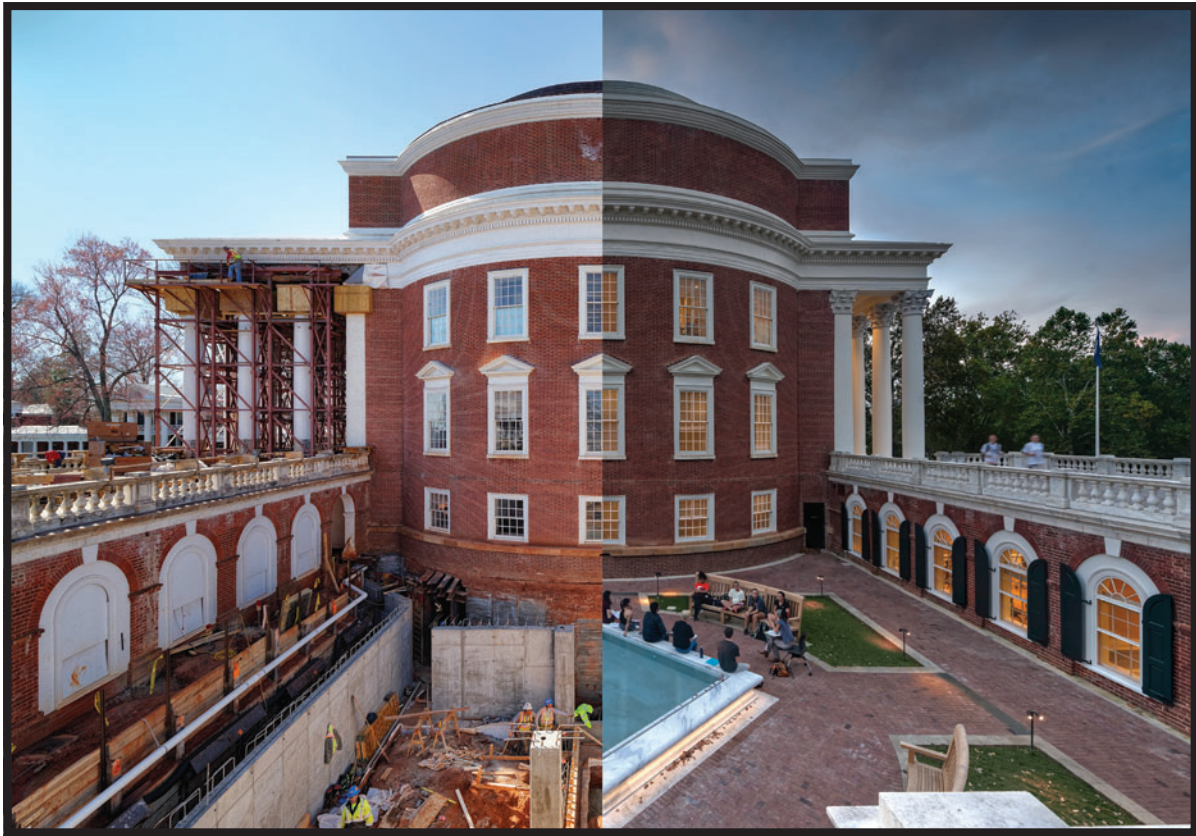
*The Rotunda: (left) during construction, showing the excavation and underpinning for the mechanical vault below the east courtyard; (right), view of the completed restoration and renovation, 2016.*
