Alderman Library Planning and Assessment Study

Project Formulation Report
Strategic Planning Study for Alderman Library Renovation
Prepared for University of Virginia Libraries
by DEGW North America
10 September 2007

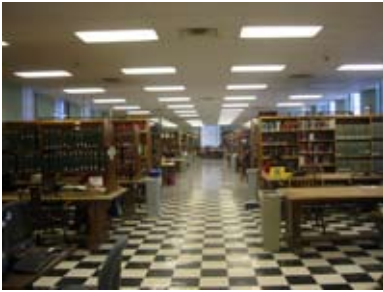
Existing Condition Longitudinal Section

The East Wing is composed of major historical reading rooms, topped by administrative offices on level 5:

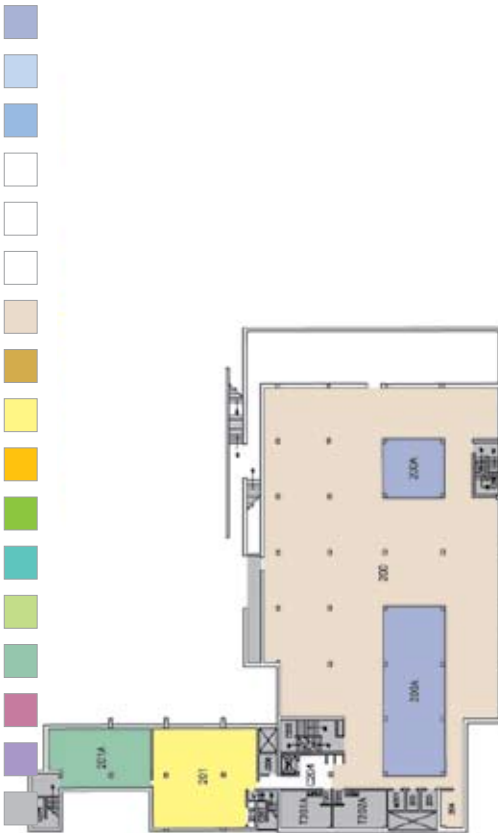
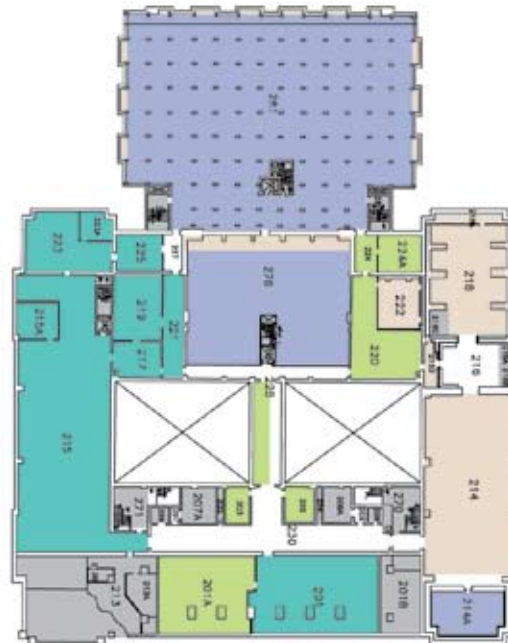
Existing Condition First Floor

- Processing Staff space in West wing
- McGregor and Barrett historic reading rooms in East wing (formerly special collections spaces)
- Finance, Human Resources, and Digital Library Production Services staff space
- Existing "New" Stacks at North portion of building, with perimeter study carrels
- "Old" Self-supporting stacks at building core
- Partial Base of lightwells separated by enclosed bridge element
- Clemons
 - Open plan study space with interspersed collection zone in main wing
 - Large classroom in West wing

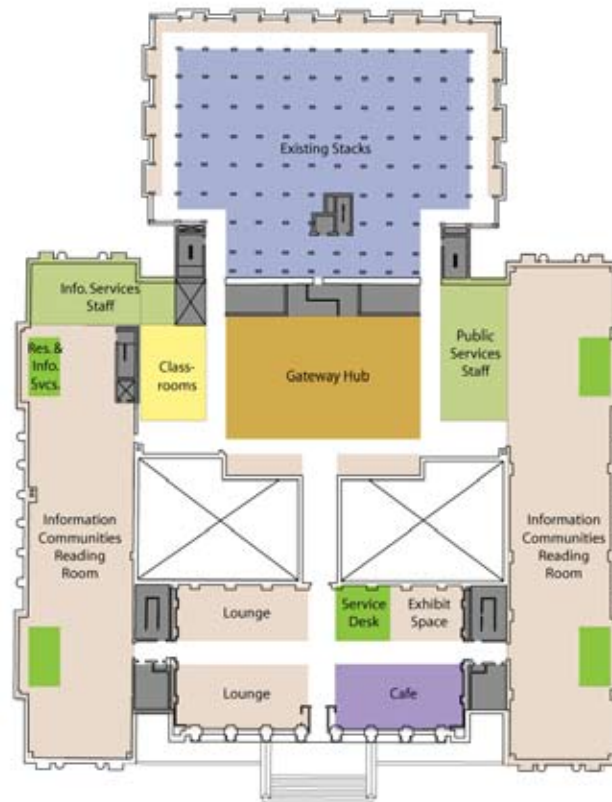
Atrium Scheme Fourth Floor

Key Space Attributes

-Reference Reading Room and West Wing (formerly Scholar's Lab) renewed as Information Communities Reading Rooms (themed, mobile collection, small groups)

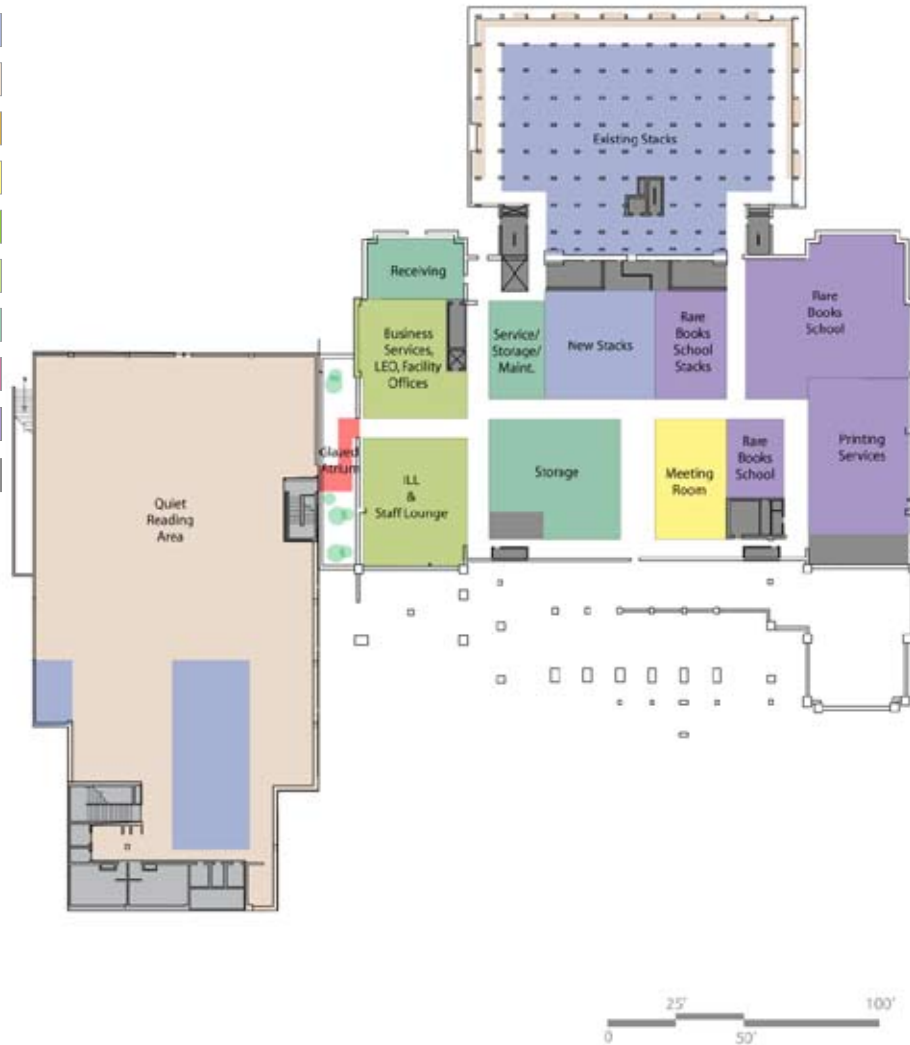
Key Space Attributes

- Expanded / Relocated Rare Book School stacks and meeting/office space
- New Stacks ranges pulled back - double-height user space on 3 sides
- Light-wells in-filled to create atrium base, area created used for storage and RBS conference + exhibit
- New core with shafts + stairs at "New" stacks transition
- Base of "old stacks" replacement used for stacks
- LEO, Facilities, Business Services remain and ILL/IT offices relocated to SW Corner overlooking connector garden
- Printing Services remains in place
- Maintain existing connector to Clemons for staff only

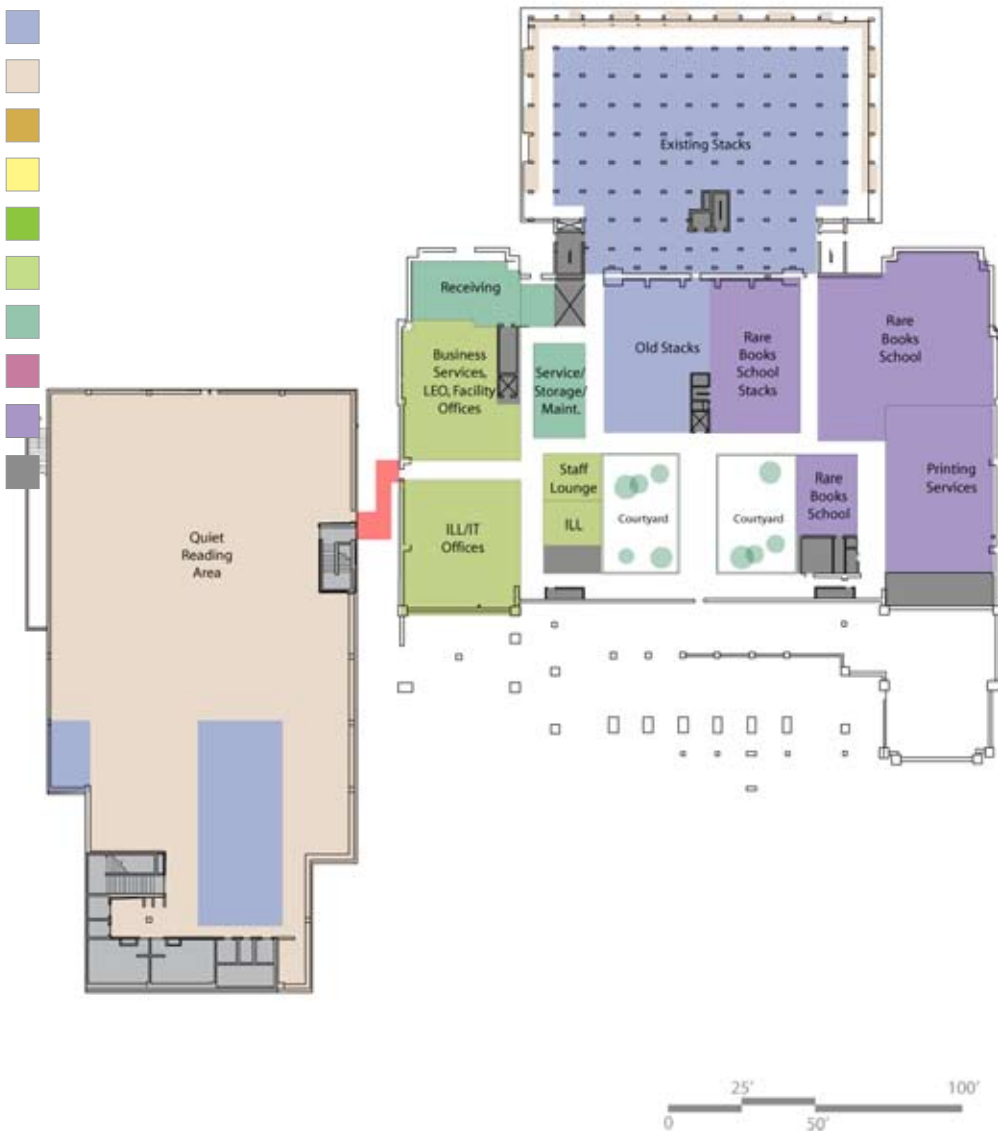
Key Space Attributes

- Expanded / relocated Rare Book School Stacks and meeting/ office space
- New Stacks collections pulled back 4'-0" from perimeter to create user space (carrels perpendicular to window)
- Base of light-well base accessible as courtyard, with minor excavation as req'd for plantings
- Staff Lounge adjacent to courtyard
- Facilities, Business Services reduced and some LEO to remain
- Corner ILL/IT offices at SW
- Printing Services remains
- New Freight Elevator at 1963 infill zone

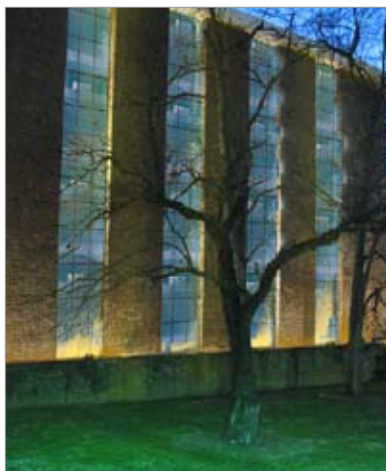
Though the “New” stacks provide valuable shelving capacity and individual work space in their perimeter carrel zone, these study spaces are of low quality due to low ceiling heights, desk configurations, and a lack of access to light and view. In addition, the exterior appearance of the “New” stacks building is poor in comparison to the surrounding buildings and original library structure, which is particularly unfortunate given that the stacks are often the first thing one sees upon arriving at central grounds from University Avenue.

Two alternates have been identified to address these shortcomings: first, removing the mezzanine slabs of the perimeter column-bay of

Addition of windows to New" Stacks facade

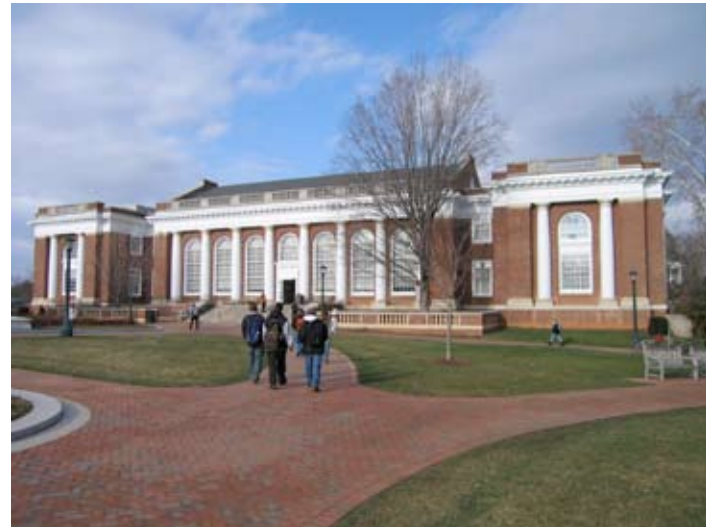
1936 Building South Elevation

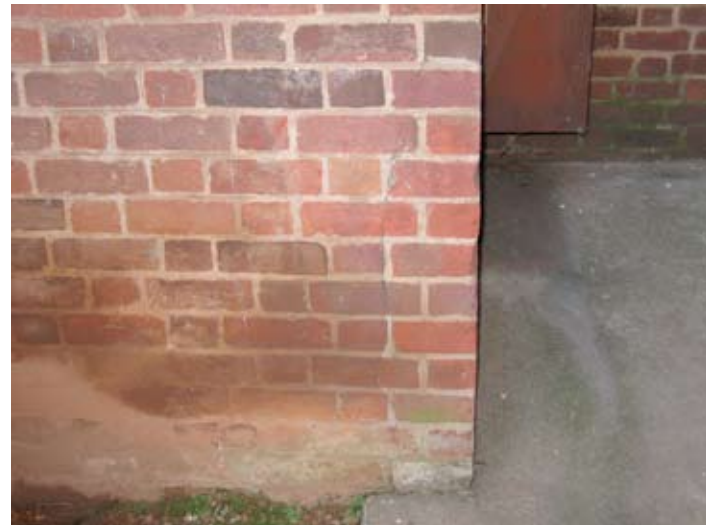
Minor brick cracks

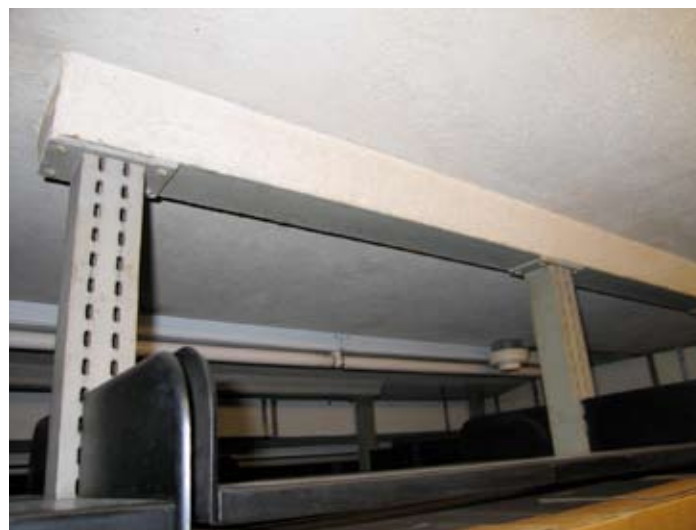
1936 Building Stacks 3rd Tier Transfer Beam

The “Old Stacks” in the original building presents structural issues whether removed, renovated or retained. It likely does not meet Code fire-rating requirements and any modification to the framing such as removing columns or areas of floor would require new framing and foundation work. It also appears that the interstitial floors in this system provide some bracing to the main building columns. The main building columns may require the addition of bracing if the old stack system is modified or removed.

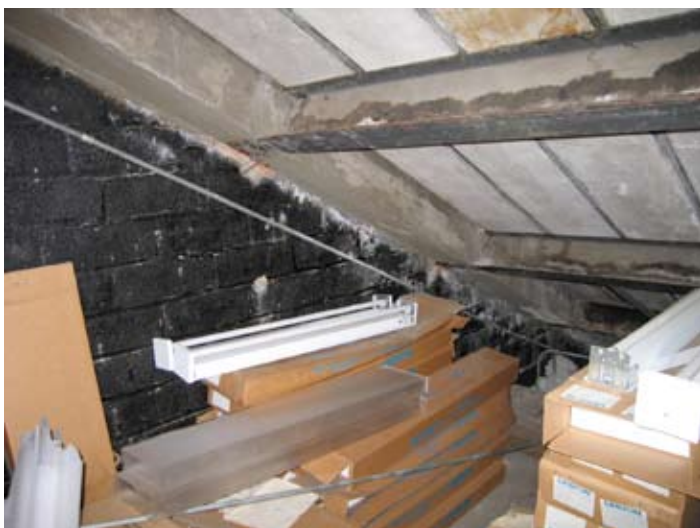
1936 Building Sloped Roof Framing

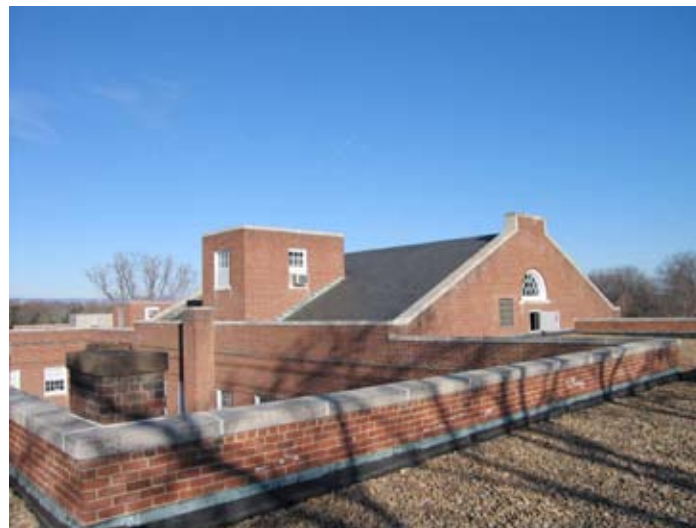
North Gable End Wall
